The Home Inspector

Many problems with installations of LP SmartSide siding

By Reuben Saltzman | OCTOBER 6, 2015 — 6:19AM

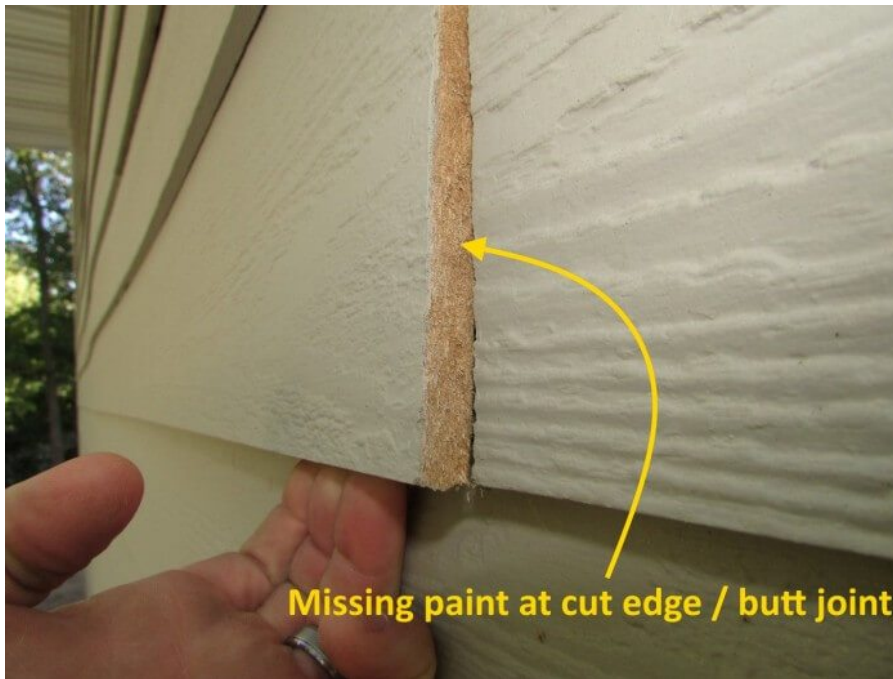
Without a doubt, the most common installation error that I find with LP SmartSide® is missing paint at the cut edges. The manufacturer requires all exposed surfaces to be primed and painted.

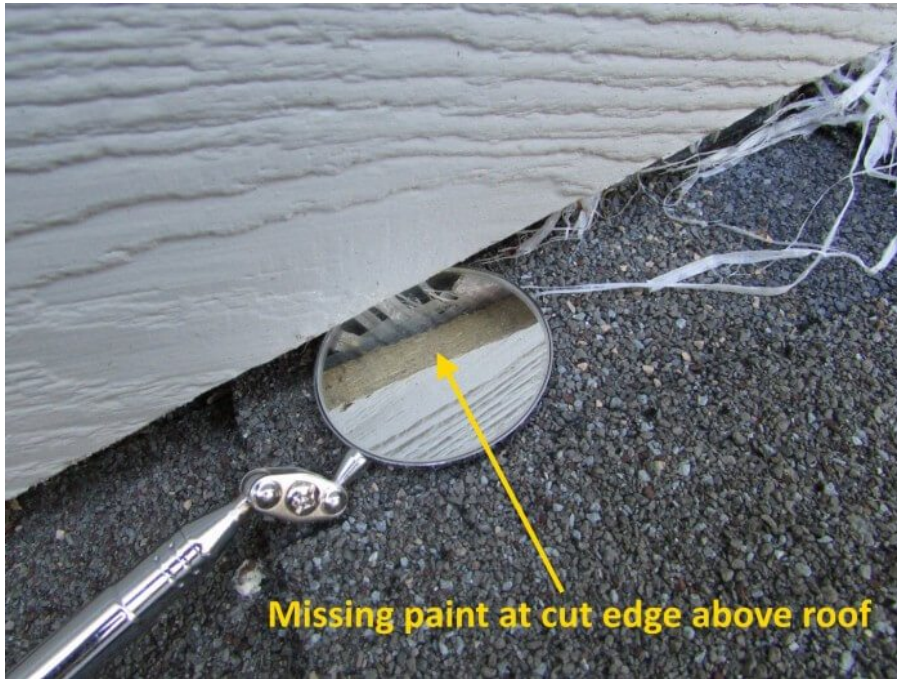
Missing paint at cut edge above roof

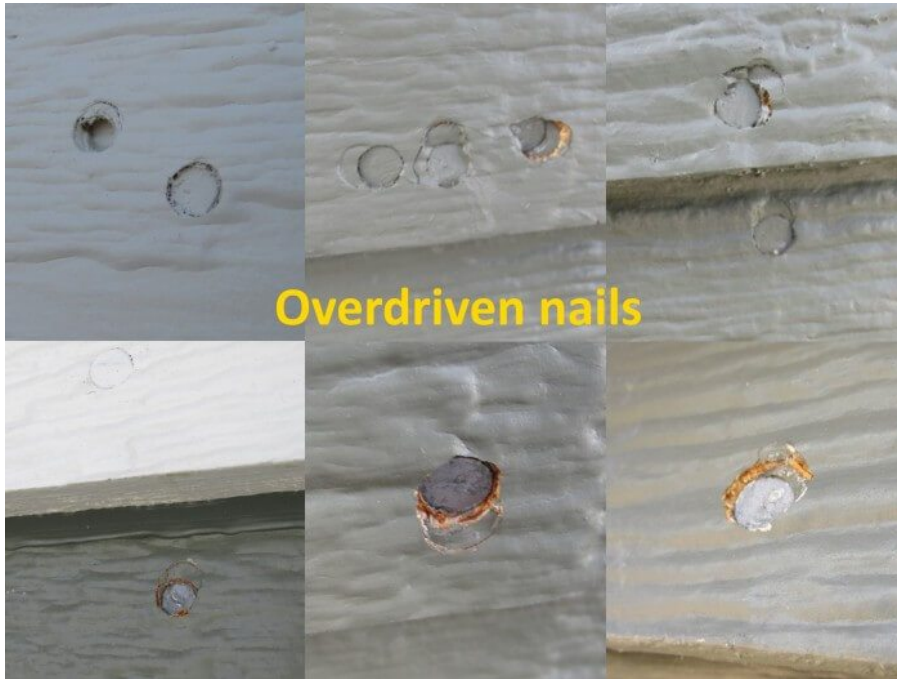
This is another common defect. Here's a small collage of overdriven nails.

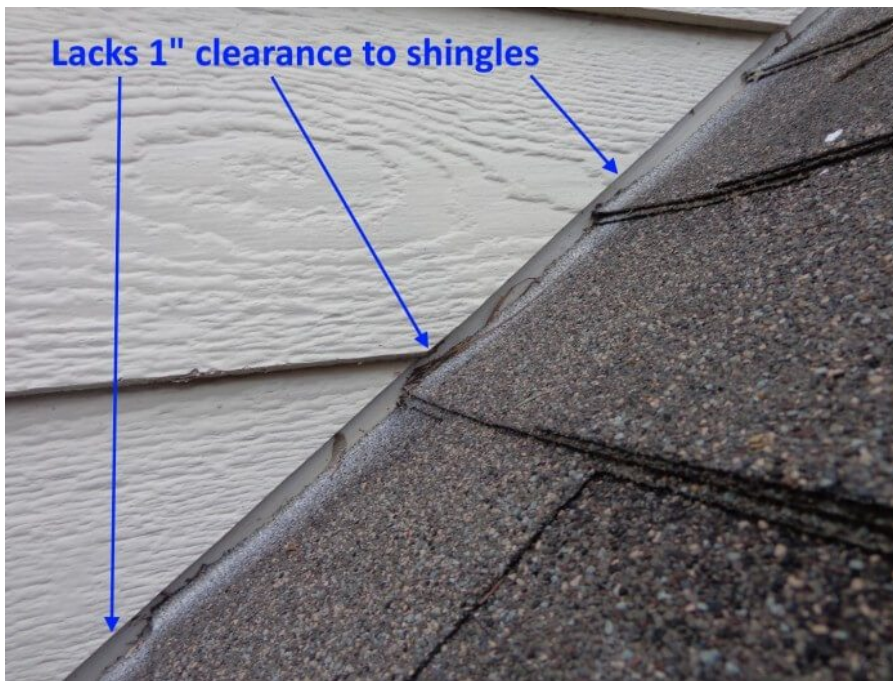
The manufacturer also requires 1" clearance to shingles. This is *usually* done right, but not always.

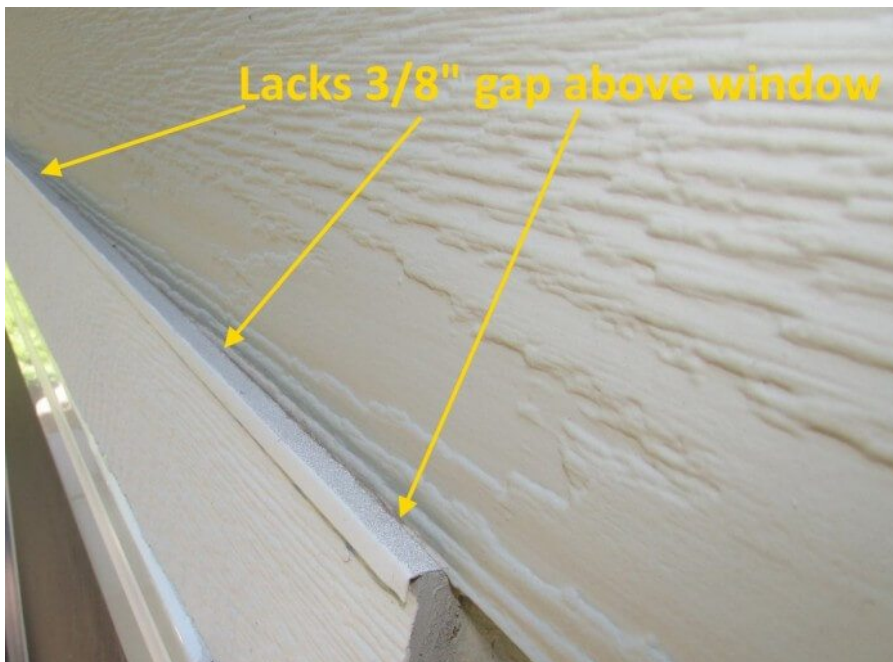
This is rarely done.

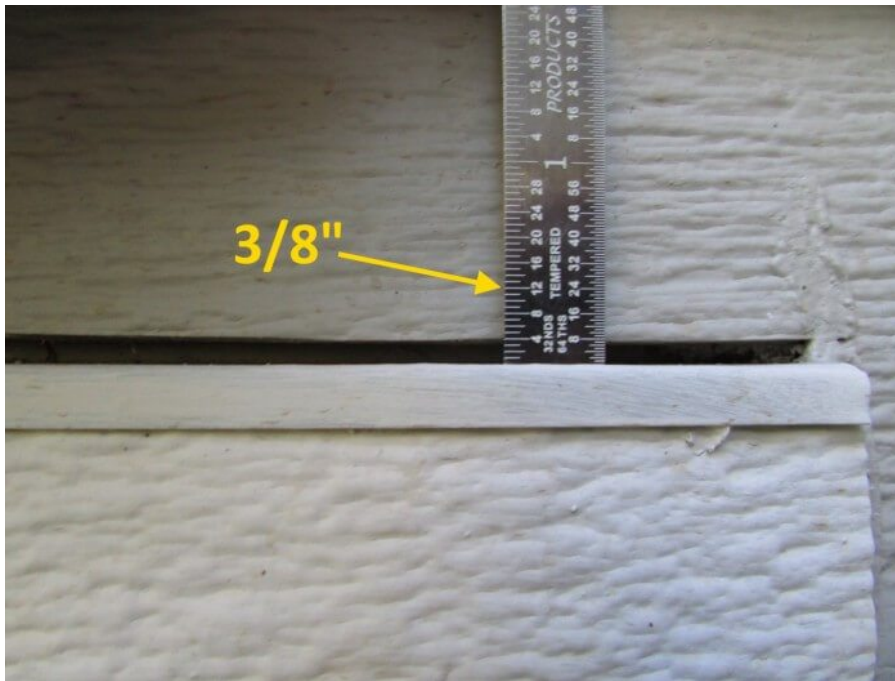
A 3/8" gap is a BIG gap. Even when a gap is left here, it's usually not what the manufacturer requires.

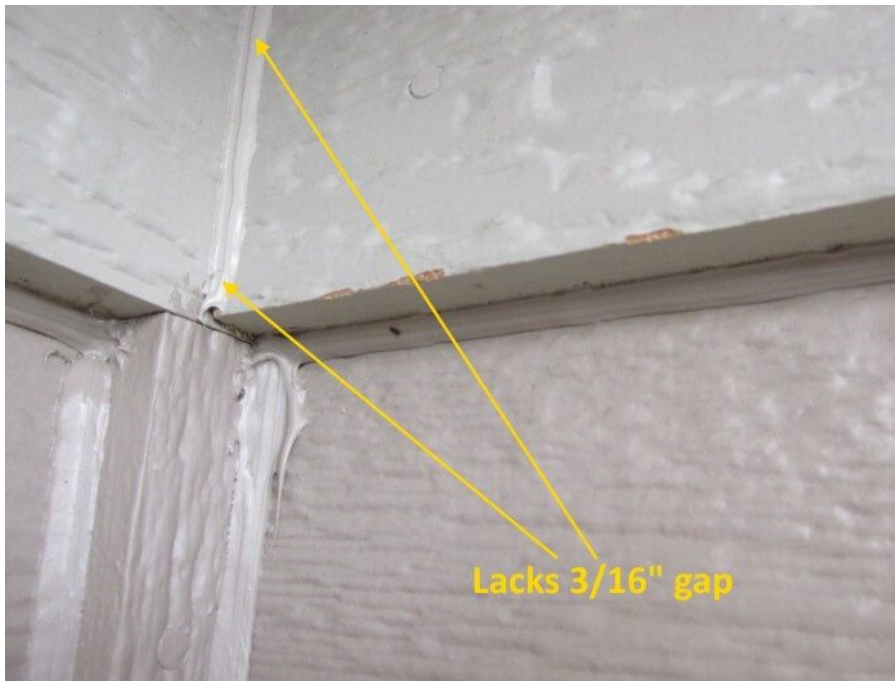
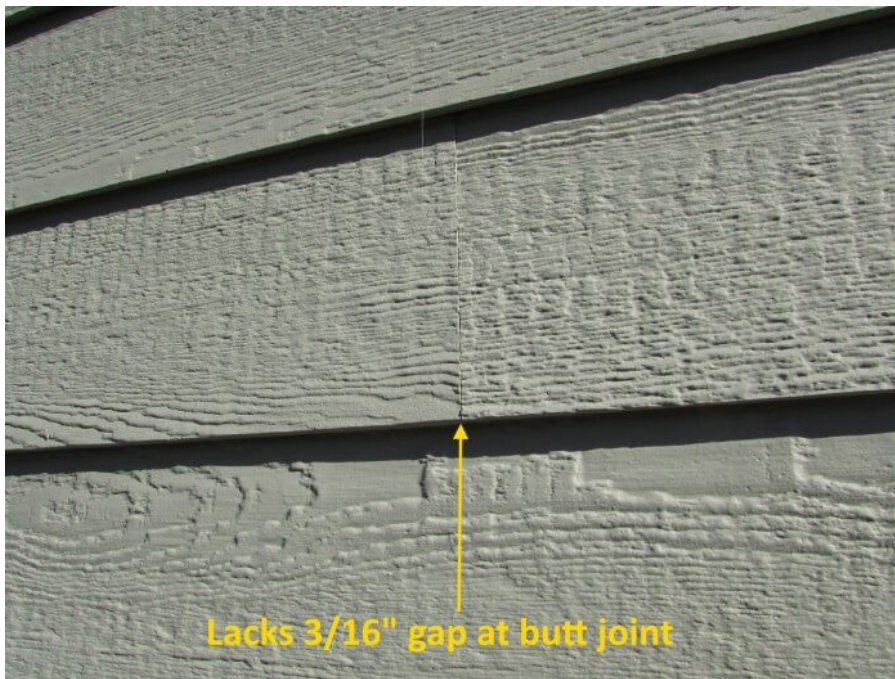
The manufacturer requires a 3/16" gap at the end of each piece of siding. This includes butt joints, and places where the siding terminates vertically against windows, doors, and other fixtures.

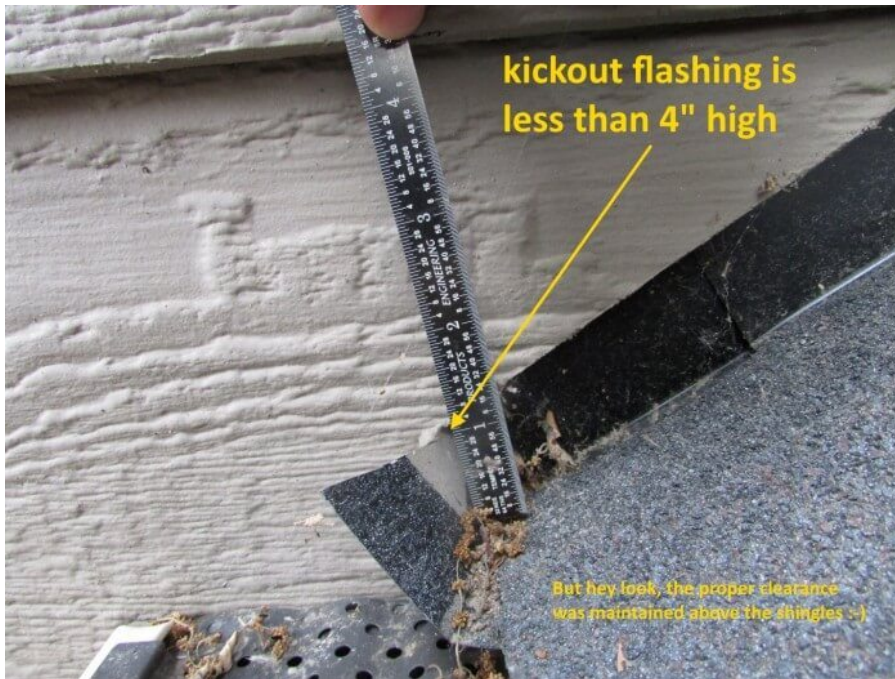
LP SmartSide® requires flashing to have a 4" upper leg. This means the kickout flashing needs to be 4" high. This usually isn't done.
