Facilities Condition Assessment Program

Milwaukee/Michigan Parking Garage

May 2011

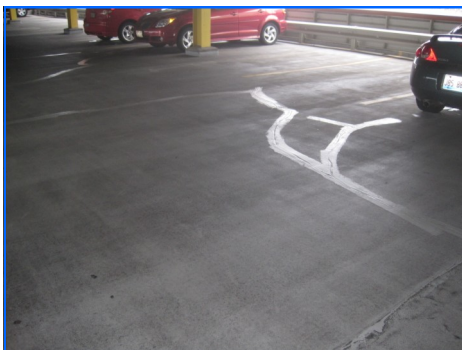
Milwaukee/Michigan comprises 135,000 square feet of elevated concrete parking and an additional 7,000 square feet of elevated floor ramps. The concrete parking contains a membrane, whereas the concrete ramps contain sealer application

The membrane application at Floors 5 and 6 is scheduled for replacement in 2011. Parking should plan for membrane replacement at Floors 2 through 4 by 2017. Subsequent membrane replacements should be anticipated every 15 years.

Membrane floor with prior repairs

Elevated concrete surface repairs should be conducted in coordination with membrane replacement. Sealer should be applied to ramps at this time.

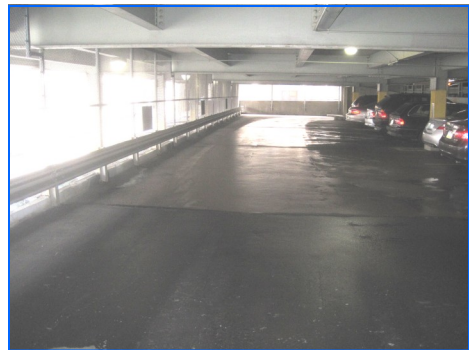
Milwaukee/Michigan comprises approximately 27,000 square feet of on-grade concrete at the lower level. The concrete is in fair condition with cracks were observed.

On-grade concrete

Parking should budget for partial replacement of on-grade concrete by 2018.

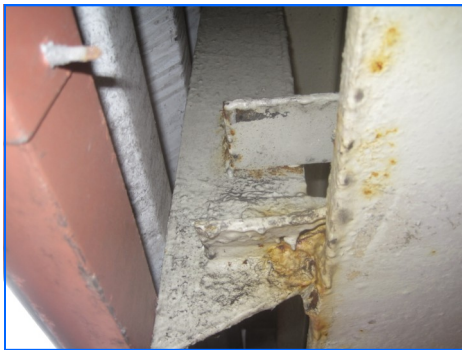
The structural steel frame, concrete walls, and EIFS at south all contain a paint finish application. The finish application is in fair overall condition. Isolated locations of rust are located throughout the garage.

The existing paint finish application requires lead abatement or encapsulation. Therefore, the initial paint finish application is projected at a higher cost. Subsequent paint finish applications are expected to be less costly.

Paint finish with rust

The useful life of a paint finish application is up to 15 years. Parking should budget for the initial lead abatement paint finish application by 2015, and subsequent paint finish application by 2030. Johnson Controls , Inc. conducts touch paint finishes annually.

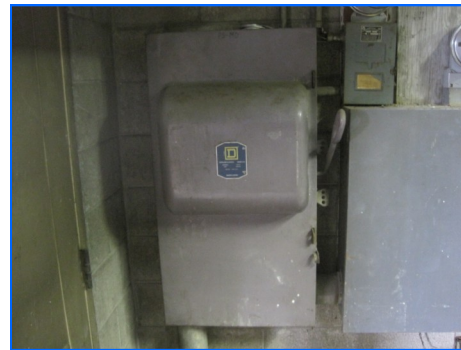
Milwaukee/Michigan comprises two levels of electrical distribution: Secondary and Branch Circuits/Panels. The condition of these components is reported as good/fair.

Secondary distribution

Based on condition, parking should anticipate replacement of the Secondary Distributions and Branch Circuits/Panels 2021.

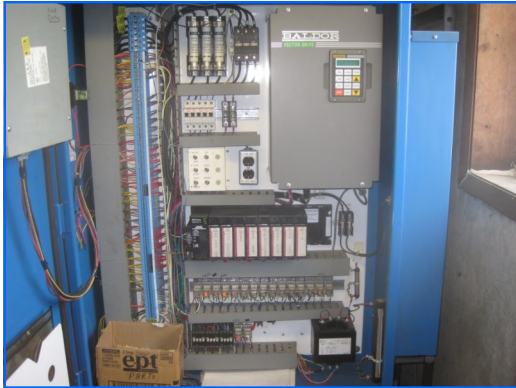
One elevator serves Milwaukee/Michigan parking structure. The useful life of traction elevators hoists and controls is up to 45 years. Parking should anticipate its upgrade by 2024.

Elevator controls

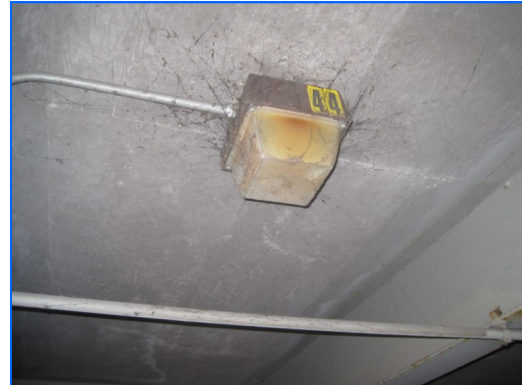
Milwaukee/Michigan contains approximately 145 light fixtures. The useful life of light fixtures is up to 35 years. Based on condition, Parking should fund light fixture replacement by 2021.

Light fixture

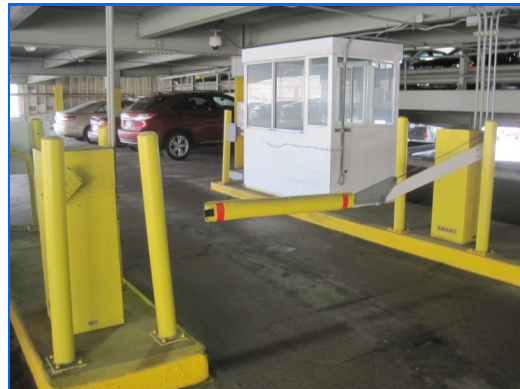
The useful life of these components and operating systems is up to 12 years. Parking should anticipate it replacement by 2018 and 2030. Interim repairs/replacements and upgrade to individual components should be funded by O+M.

Gate arm at exit

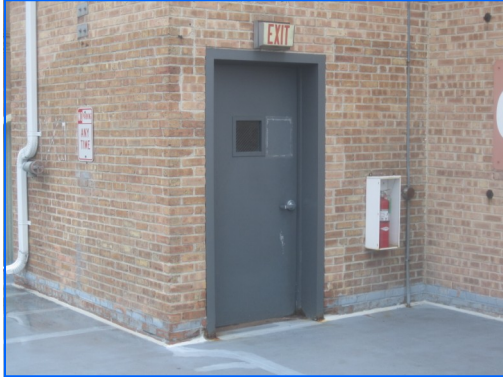
Milwaukee/Michigan comprises 16 steel doors. The useful life of metal exterior doors is up to 35 years. Based on the varied conditions, Parking should anticipated phased replacement of 16 doors by 2020.

Typical metal door

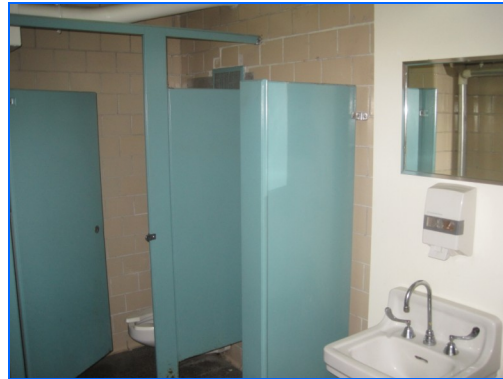
Milwaukee/Michigan comprises two lightly used offices/storage rooms, and two rest rooms. Interior renovations should be conducted every 30 years. Parking should budget for the next interior renovation by 2020.

Typical rest room finishes

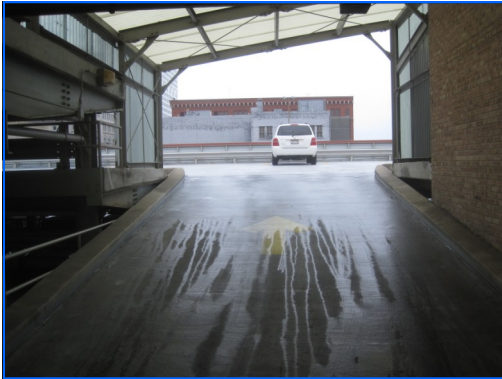
Milwaukee/Michigan comprise four metal framed, fiber-glass roofed structures at the 6th floor (roof level). The useful life of these structures is up to 40 years. Parking should budget for their replacement by 2027. Interim repairs should be funded from O+M.

Ramp/roof structure
