The following information describes the repair of the sewer at 5018 W. State St. Milwaukee, WI 53208, phone number 414-778-1200. I am filing a claim on the City of Milwaukee for the damage done as described, at a charge of \$16,960.00. The sewer destruction caused many thousands of dollars in repair work and loss of revenue in the business. I am respectfully looking forward to a just and timely resolution.

This is a summary of conditions discovered in the road in front of 5018 W. State Street. We at Sparrow Plumbing were contracted to do remodeling plumbing work inside the building for future tavern/restaurant. Upon the start of our work we discovered the main sewer was plugged at the clean-out (C.O.) at the front of the basement (near State Street).

CROSS SECTION OF ROAD  
(SHOWING SEWER PIPE BREAK)

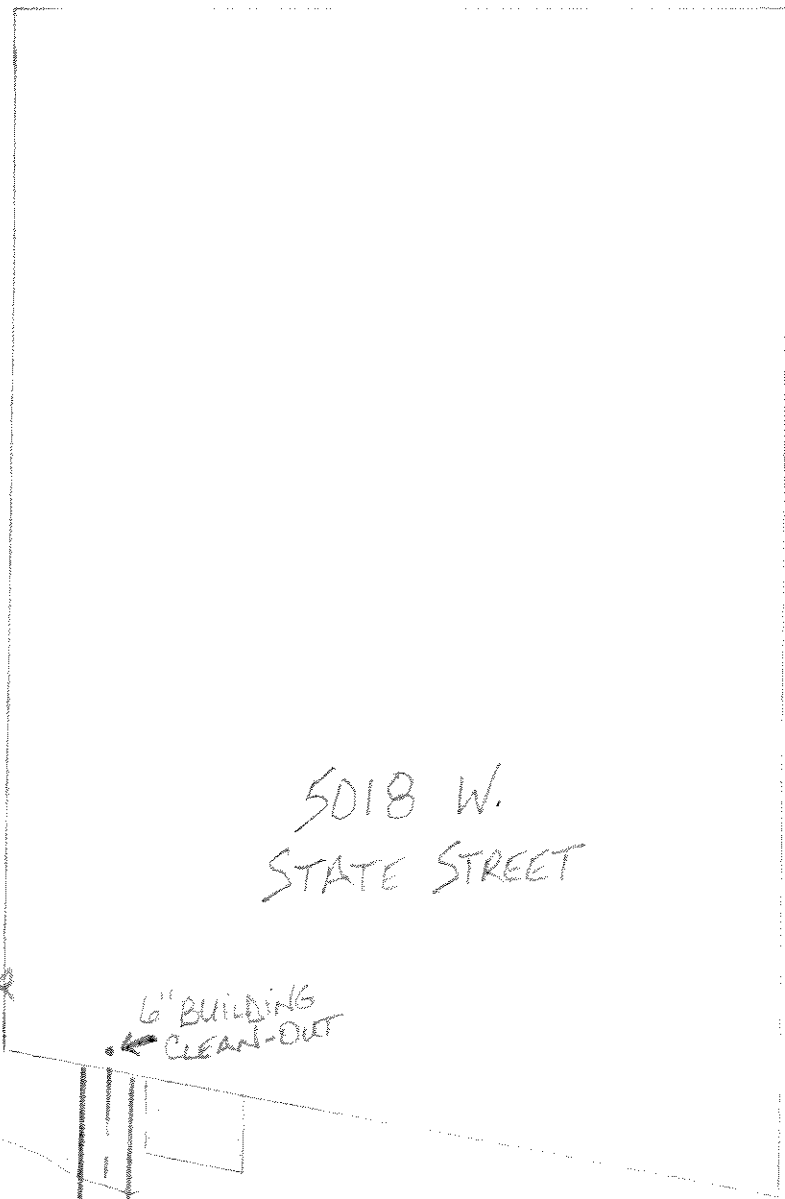
3' WIDE TRENCH  
NEW 6" PVC SEWER

6" BUILDING  
CLEAN-OUT

MMSD CONC SEWER

SANITARY SEWER

CENTER LINE W. STATE STREET

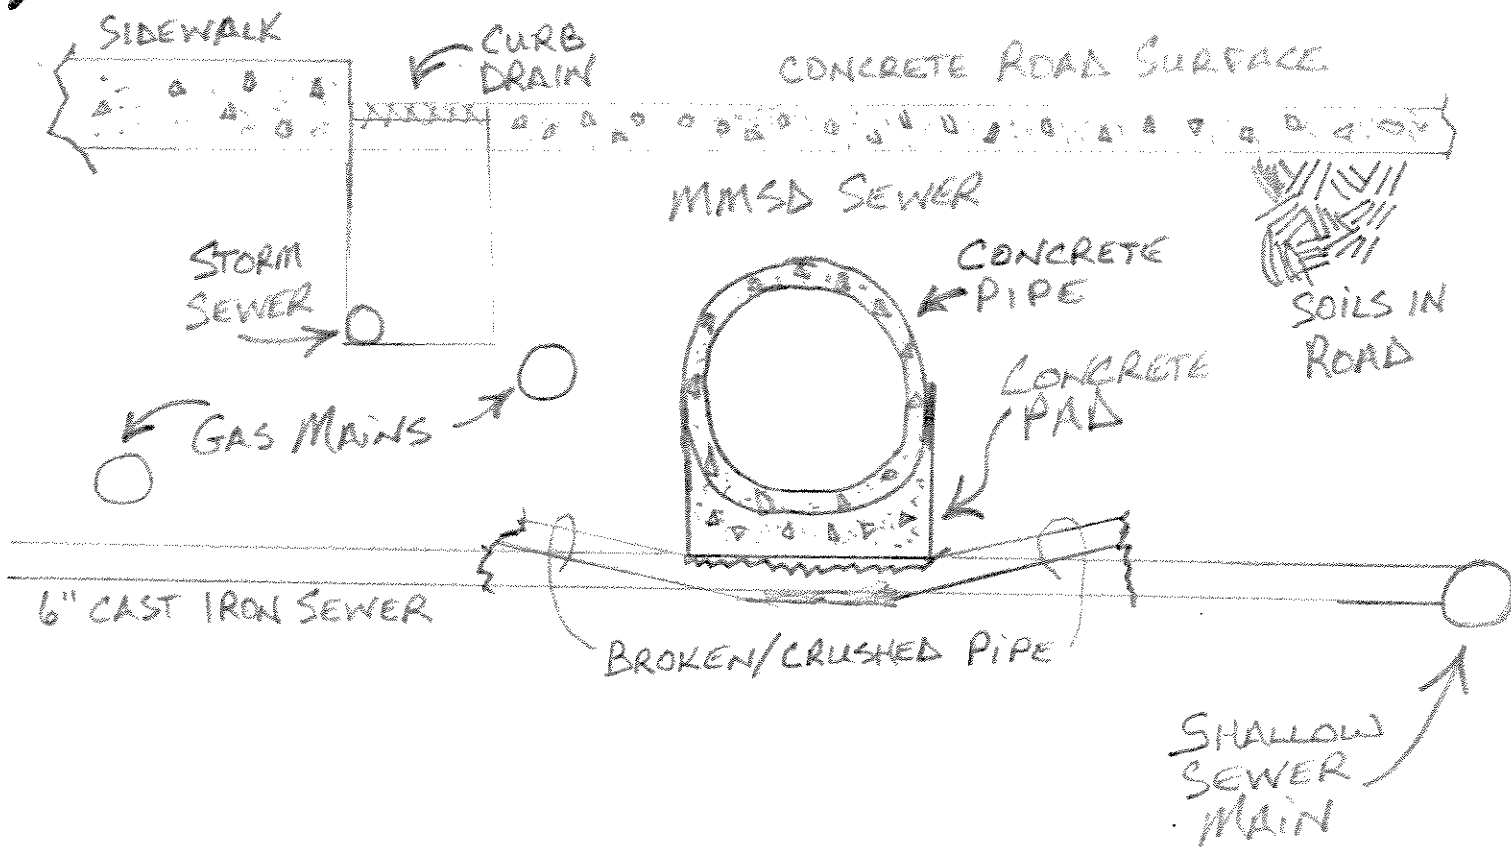
Upon locating the broken sewer pipe, we discovered it had been crushed by the 48" MMSD sewer pipe. The 6" cast iron pipe serving the building was crushed directly under the MMSD sewer with the broken pipe sticking up on both sides of the MMSD pipe. It was obvious the weight of the MMSD concrete sewer pipe, laid directly on top of the cast iron pipe, was too much and crushed the cast iron pipe. In fact the bottom of the MMSD concrete pipe, which has a concrete pad under it, was lower than the top of the sewer main in which the 6" cast iron was connected to. This made it necessary to dig down 2' more for a deeper main about 2' south of the other main. The connection to this main allowed for a pitch on the new pipe and some clearance under the MMSD concrete pad and pipe. The new pipe was laid in the 6" PVC pipe, stone bedding, and slurry backfill through the road area. This pipe was replaced from the main in the center of the road to a new clean-out inside the building.

Upon receiving this news the owner immediately asked, "How could this happen, and who's at fault?" We called the City Road Engineer, the MMSD engineer, and the Water Department to ask these questions. After a great deal of finger pointing, no one stepped forward. The City Engineer had stated that they were not at fault. The MMSD Engineer would not commit to their pipe settling on the building sewer, and the Water Department would not admit that their leak could have eroded soils causing the pipe to be crushed. The fact is that the building sewer was crushed directly under the MMSD concrete pipe and pad. Please review the drawing attached to this letter.

- Work Completed: RE-PAIR CRUSHED SANITARY SEWER
- \* SAW CUT & EXCAVATE ROAD FROM BUILDING TO SANITARY MAIN IN MIDDLE OF STATE ST.
  - \* RE-PLACE 6" CRUSHED CLAY PIPE w/ NEW 6" PVC PIPE FROM BUILDING CLEAN-OUT TO SANITARY MAIN.
  - \* INCLUDES: BACKHOE & VAL TRUCK FOR EXCAVATION; SKINLOADER & DUMP TRUCK FOR REMOVAL/BACKFILL; STONE & SLURRY TO BACKFILL ROAD/SIDEWALK AND CONCRETE TO PATCH ROAD/SIDEWALK
- NOTE: SANITARY SEWER WAS CRUSHED BY 48" MMSB SEWER PIPE LAYED ON TOP OF 6" SEWER LATERAL.
