Certificate of Appropriateness

2402 N. SHERMAN BL.

Sherman Boulevard Historic District

2402 North Sherman Boulevard, Historic Sherman Boulevard

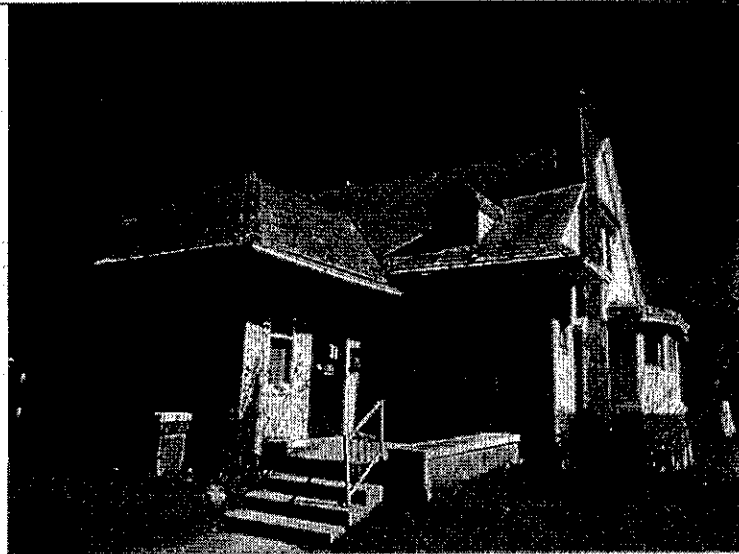
Tuckpoint and step flash chimneys .

Strip and sheathe roof. Shingle with red asphalt shingles.

Repair eaves and soffits

Install gutters in profile to match original gutters with matching downspouts.

Mortar for masonry work, including chimneys and remainder of house, must match the original in hardness, color, texture, finish.

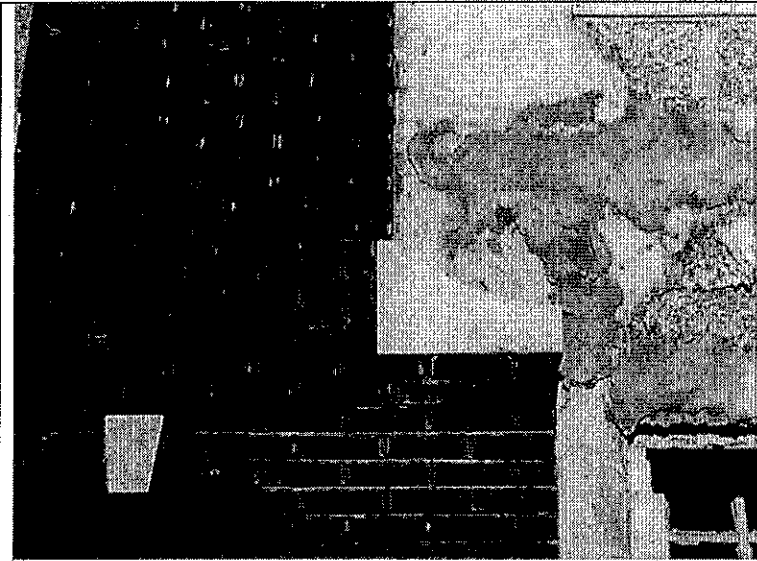
Tuckpoint deteriorated masonry joints

Repair all deteriorated stucco and remove and replace all improperly repaired stucco

New stucco must be traditional in composition and match the original in finish texture. No EIFS or foam systems are allowed.

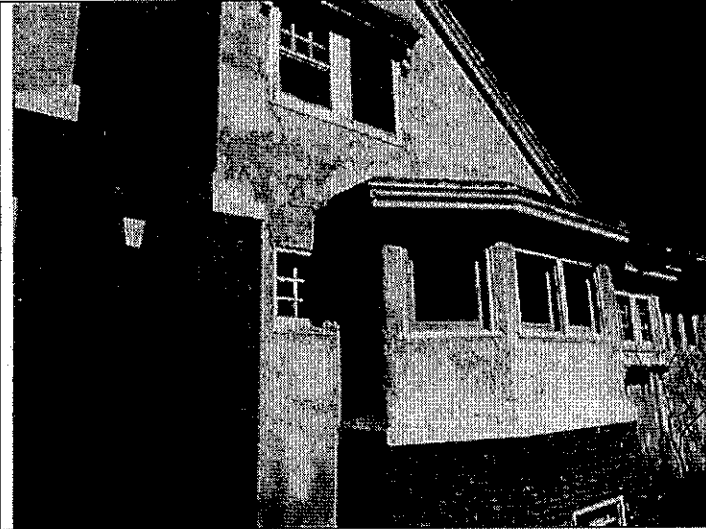
South bay roof structure requires repair, rebuild and resheathing with metal or copper. Rebuild built-in gutters. Preserve roof details here.

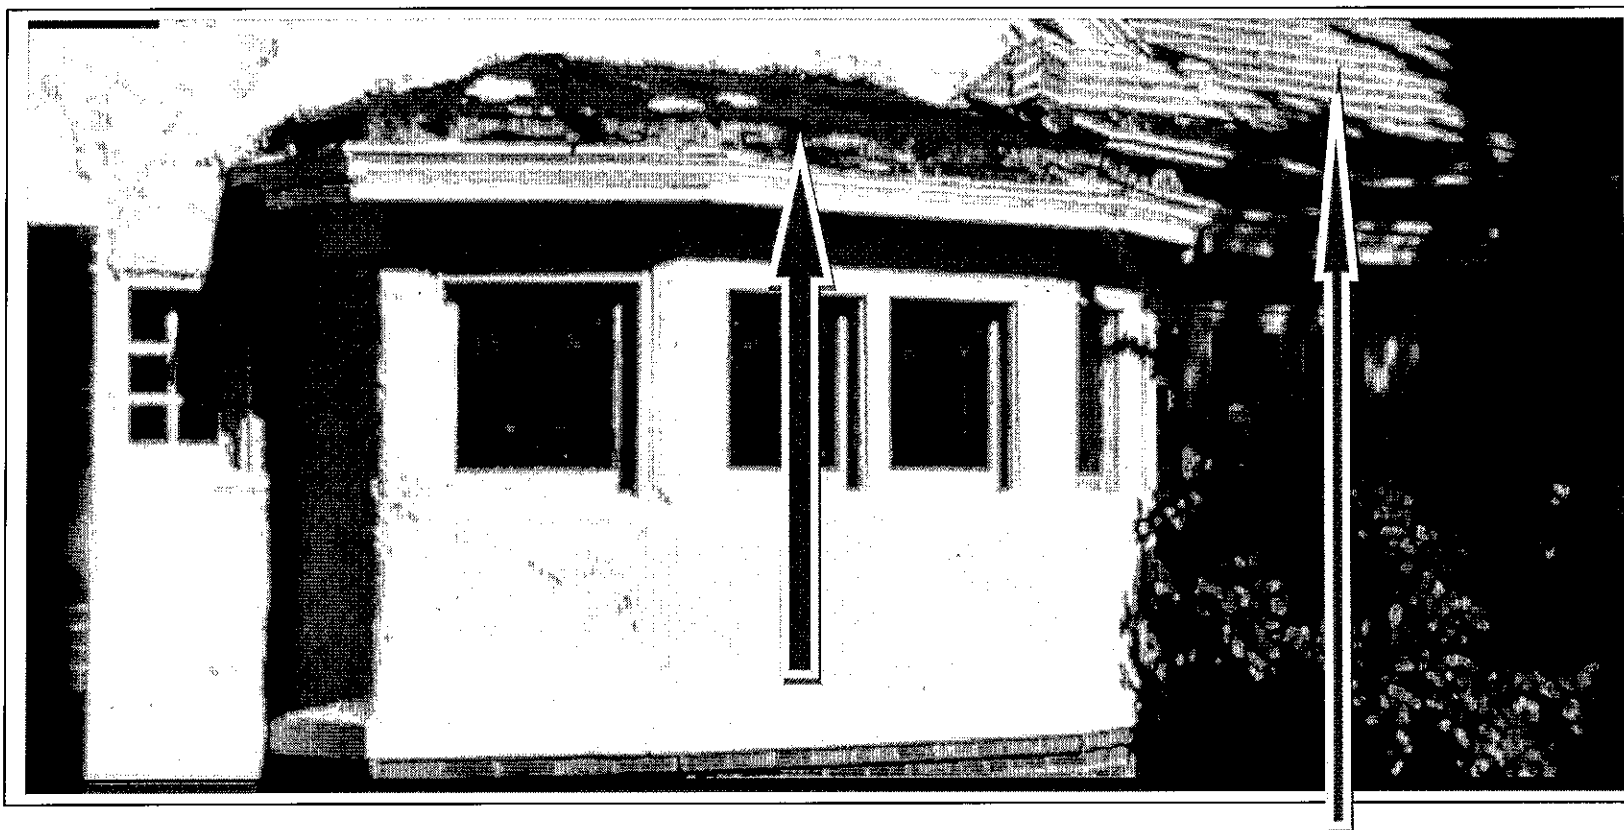
Roof on south bay is deteriorated. Built in gutters to be rebuilt with copper. Gutters next to bay are deteriorated. Make sure compatible metals to be used to prevent corrosion.

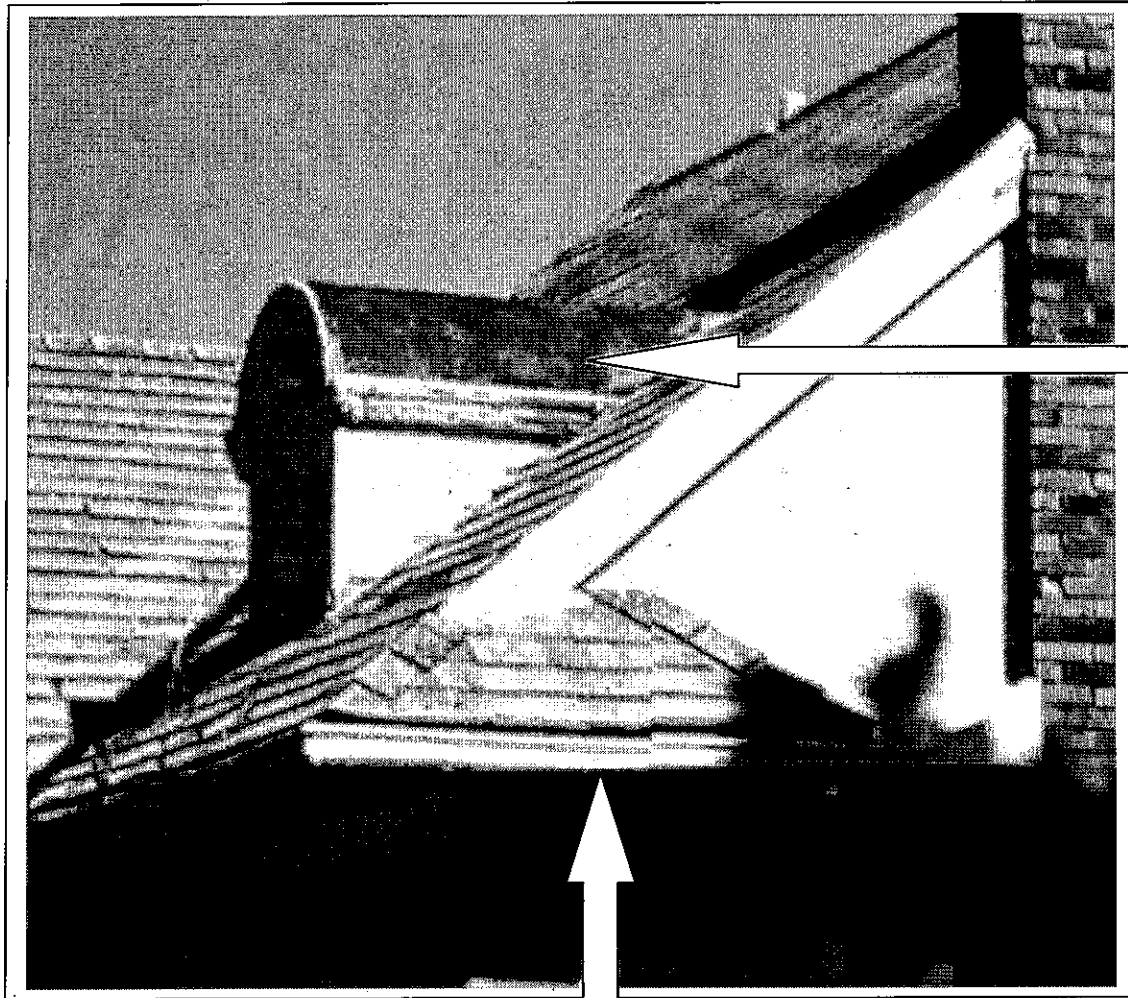
Front dormer has metal roof that is deteriorated

Current gutters may be copper. Copper will corrode aluminum. Both dormer roof and gutters have to be copper or both roof and gutters have to be made of metals that will be compatible.

Front dormer requires repair and any new wood trim must match the original. Decay resistant wood is to be used. Dormer roof is to be evaluated to determine if it is to be repaired or replaced. If replacement is required, copper is the preferred sheathing. However, copper can have a corrosive effect on aluminum gutters. If the current gutters are copper, their repair is preferable to replacing with aluminum gutters.
