OBSERVATION REPORT DESCRIPTION:

Performed an observation of the existing fire damage single-family residence located at 1942 S Muskego Ave in Milwaukee, Wisconsin.

August 6, 2024 / 24-314

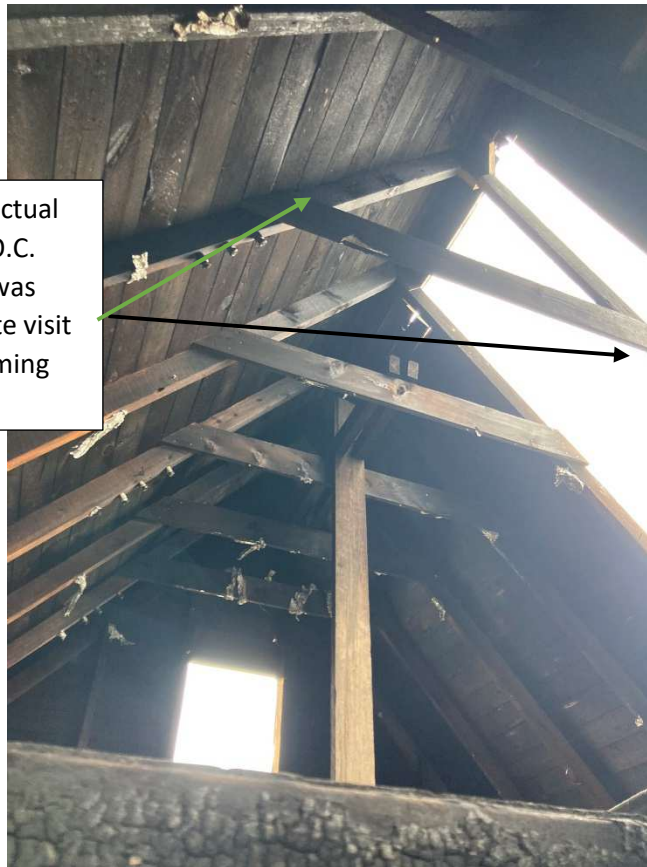
Picture 1: Existing Roof Framing.

The existing main roof and ceiling framing along the northeast side as well as the southeast side were observed to be fire damaged. The existing roof and ceiling framing appears to be actual 2x4's at 16-inches on-center (O.C.) (Picture 1 & 2).

Appears to be 2x4 actual roof rafters at 16" O.C. Portion of framing was removed prior to site visit with temporary framing installed in place.

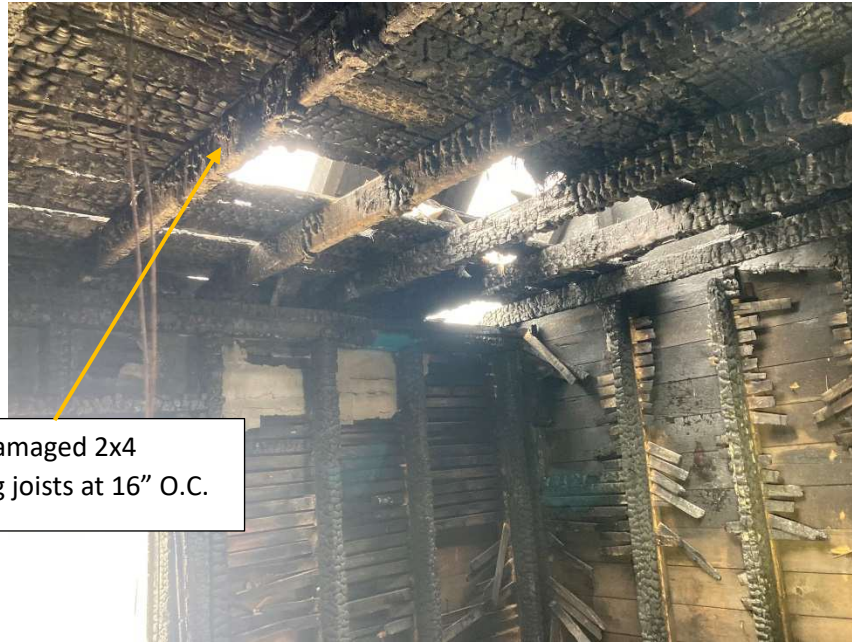
Picture 2: Existing Fire Damaged Ceiling Framing.

Existing fire damaged 2x4 (actual) ceiling joists at 16" O.C.

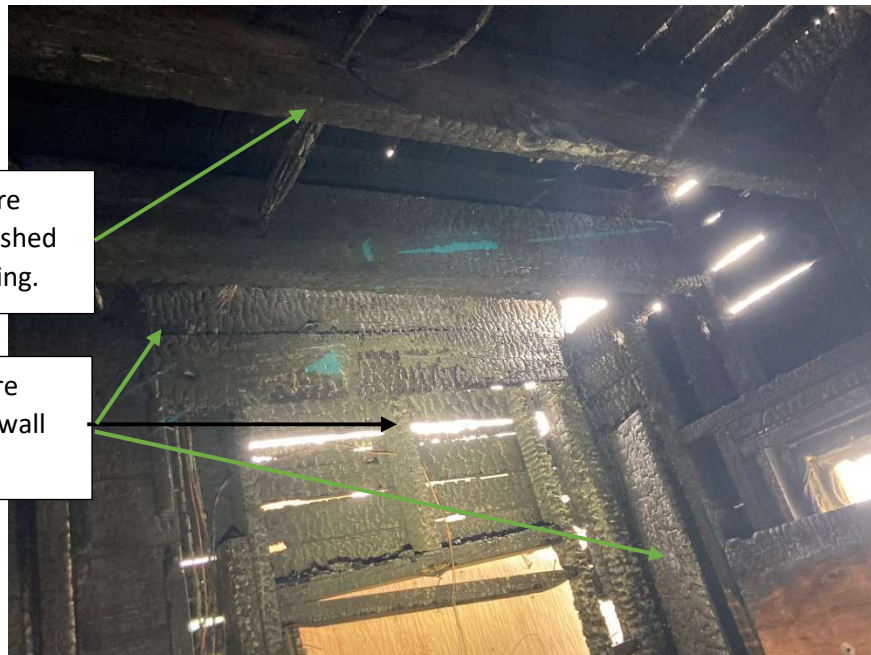
Picture 3: First Floor Southeast Fire Damage.

The southeast portion of the first floor was observed to be fire damaged (wall framing and shed roof framing). New framing appears to have been added recently based on the size and appearance of the dimensional wood members and appears to have been to attempt to relevel the floor, walls and windows as the building appears to be settling to the southwest side (Pictures 3 & 4).

Existing fire damaged shed roof framing.

Existing fire damaged wall framing.

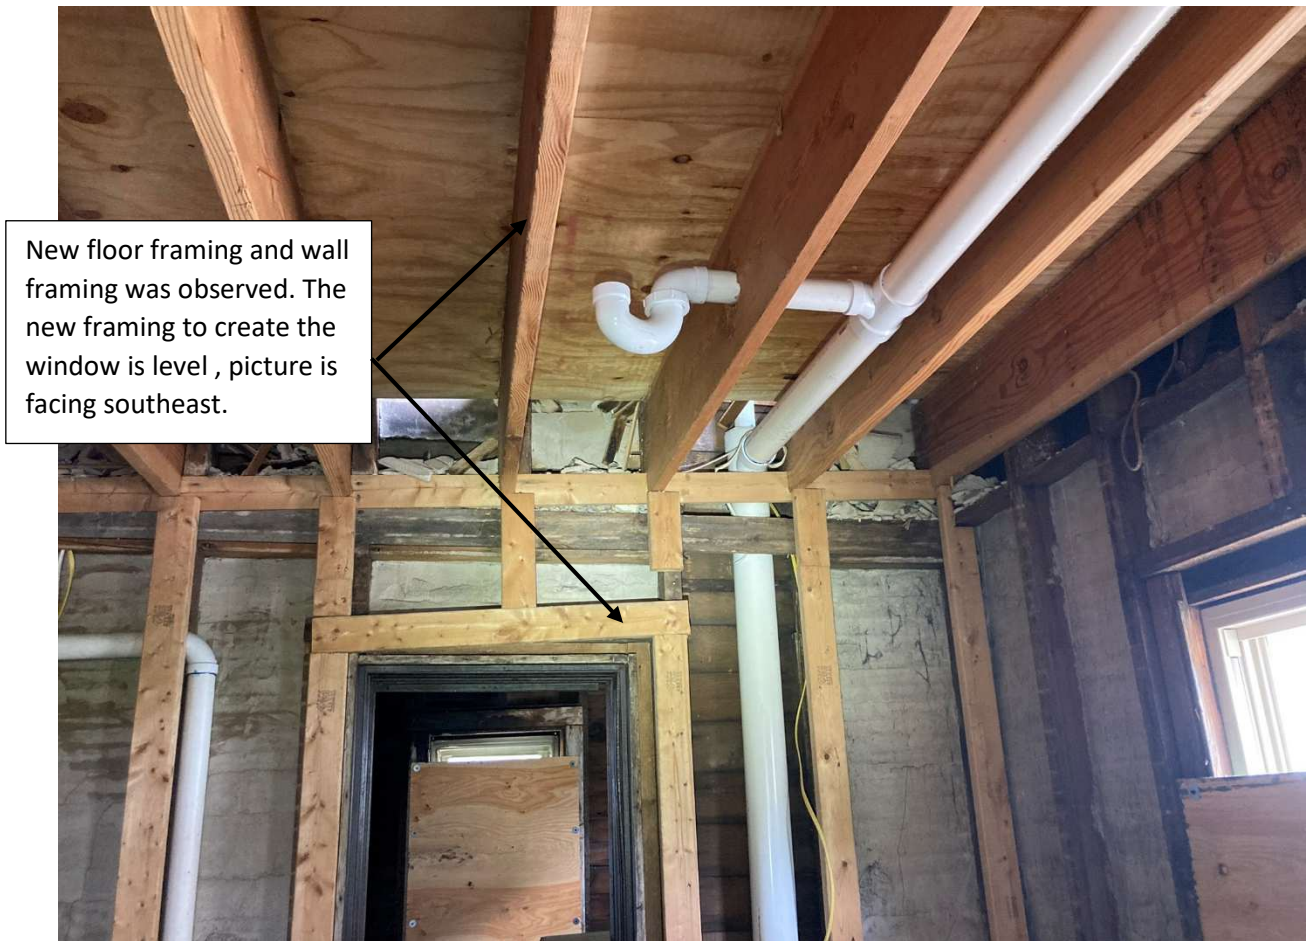
Picture 4: Newer Framing Members Observed.

New floor framing and wall framing was observed. The new framing to create the window is level, picture is facing southeast.

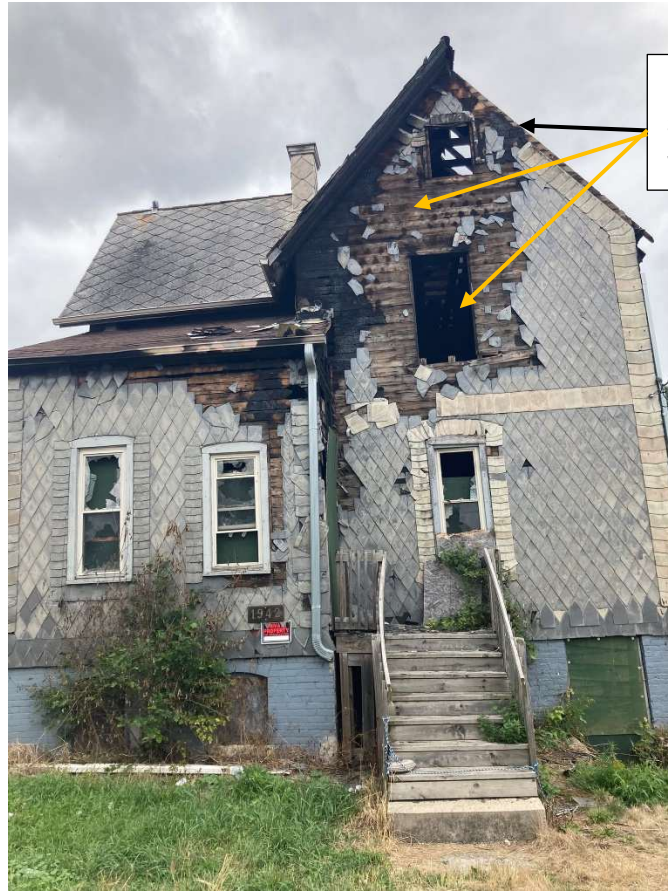
Picture 5: Southeast (Rear) Elevation.

The existing roof and siding finish appear to be slate tile and all of the existing windows are assumed to have been damaged during the fire (Pictures 5 & 6).

Fire damaged roof, slate tile siding & windows.

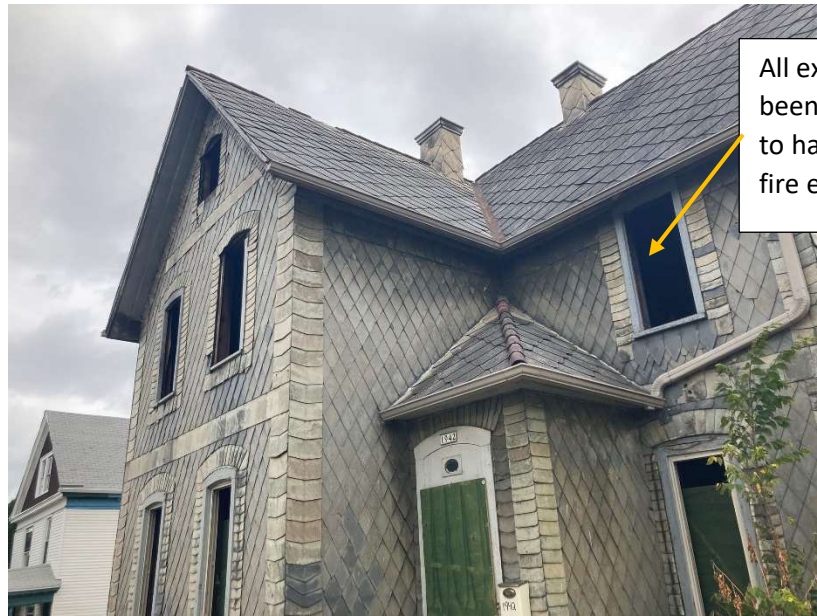
Picture 6: West Corner Elevation.

All existing windows have been removed, assumed to have occurred during fire event.
