***Fire Escape
Existing Conditions Report***

Site: #176 Golda Meir Lower Campus

Address: 1555 Dr. Martin Luther King Drive

RE: Fire Escape Inspection Report
Golda Meir Lower Campus
MPS Site #176
1555 Dr. Martin Luther King Drive

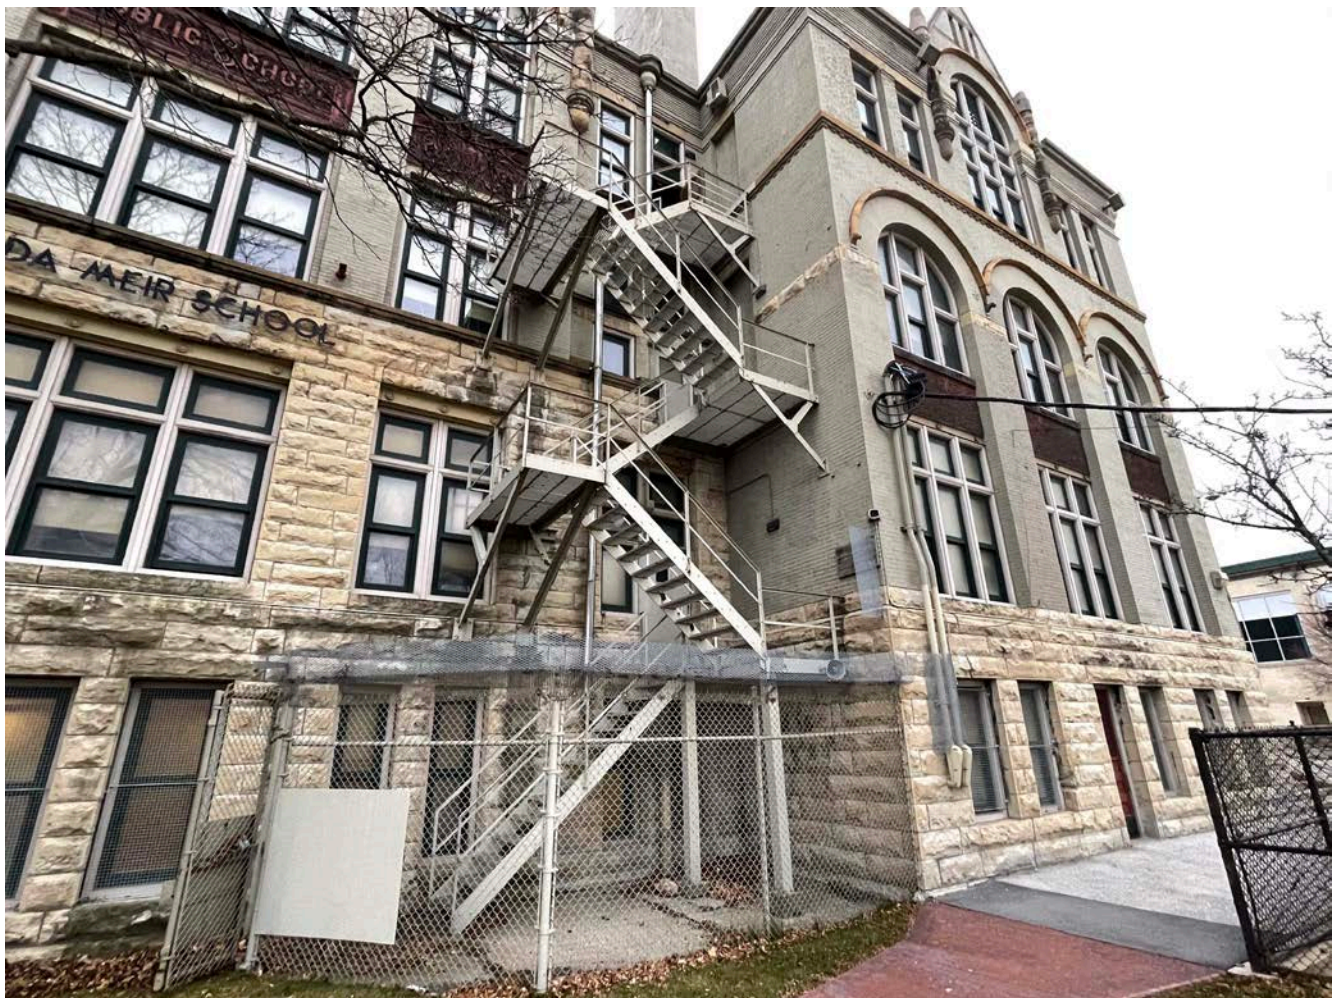
There are three fire escapes at this site. Fire Escapes #1 and #2 are replacement fire escapes (not original to the building) and are in good to fair condition. Fire Escape #2 will likely need paint maintenance before the next 5 year critical examination.

Finish: Painted steel in good condition.

Overall View of Fire Escape #1 (Looking North West)

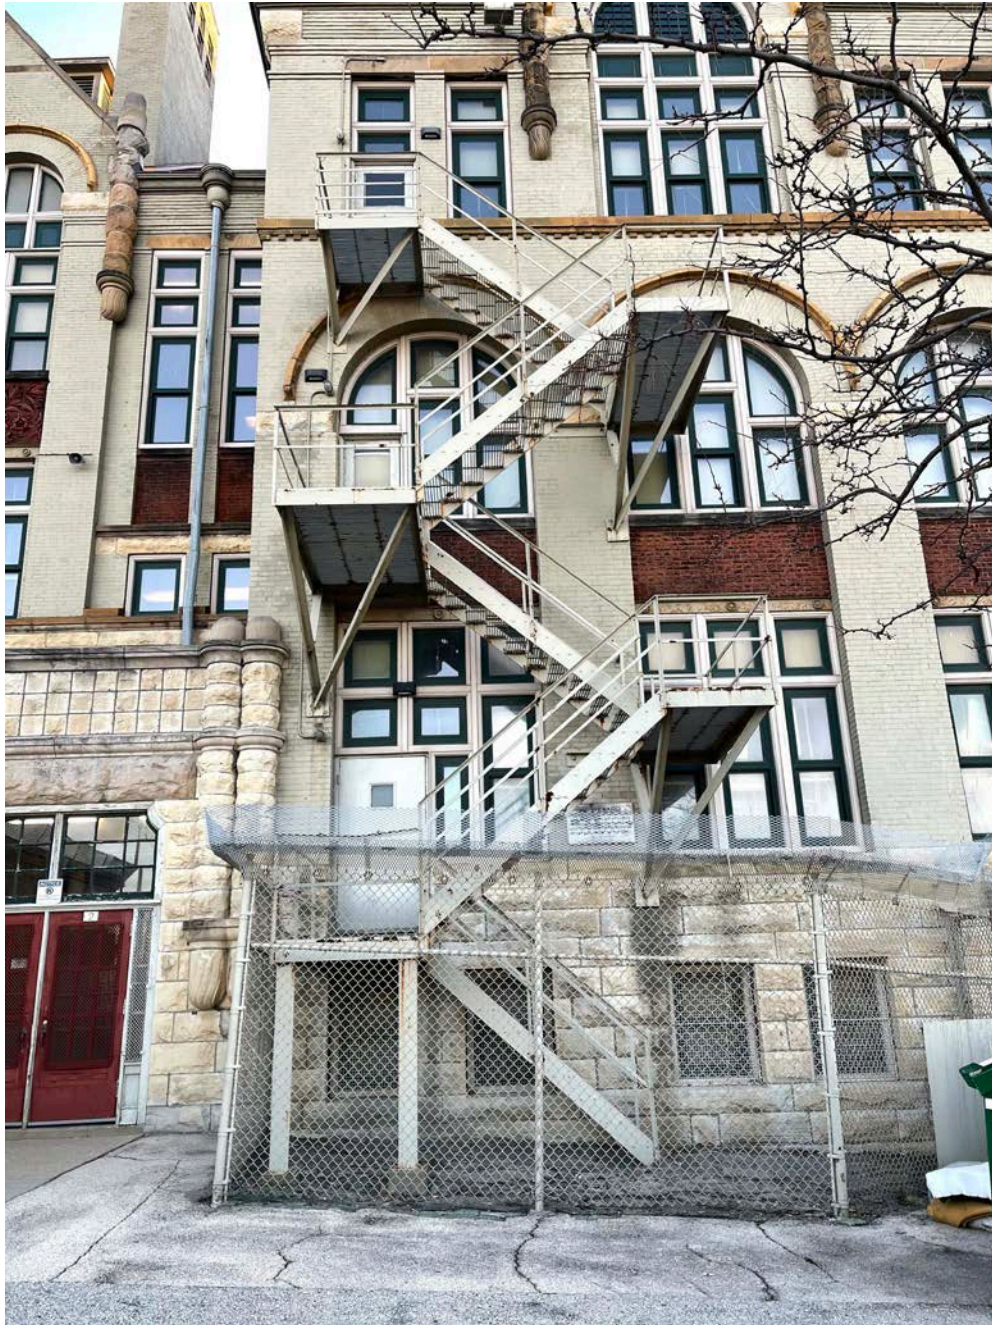
Finish: Painted steel in fair condition.

Overall View of Fire Escape #2 (Looking East)

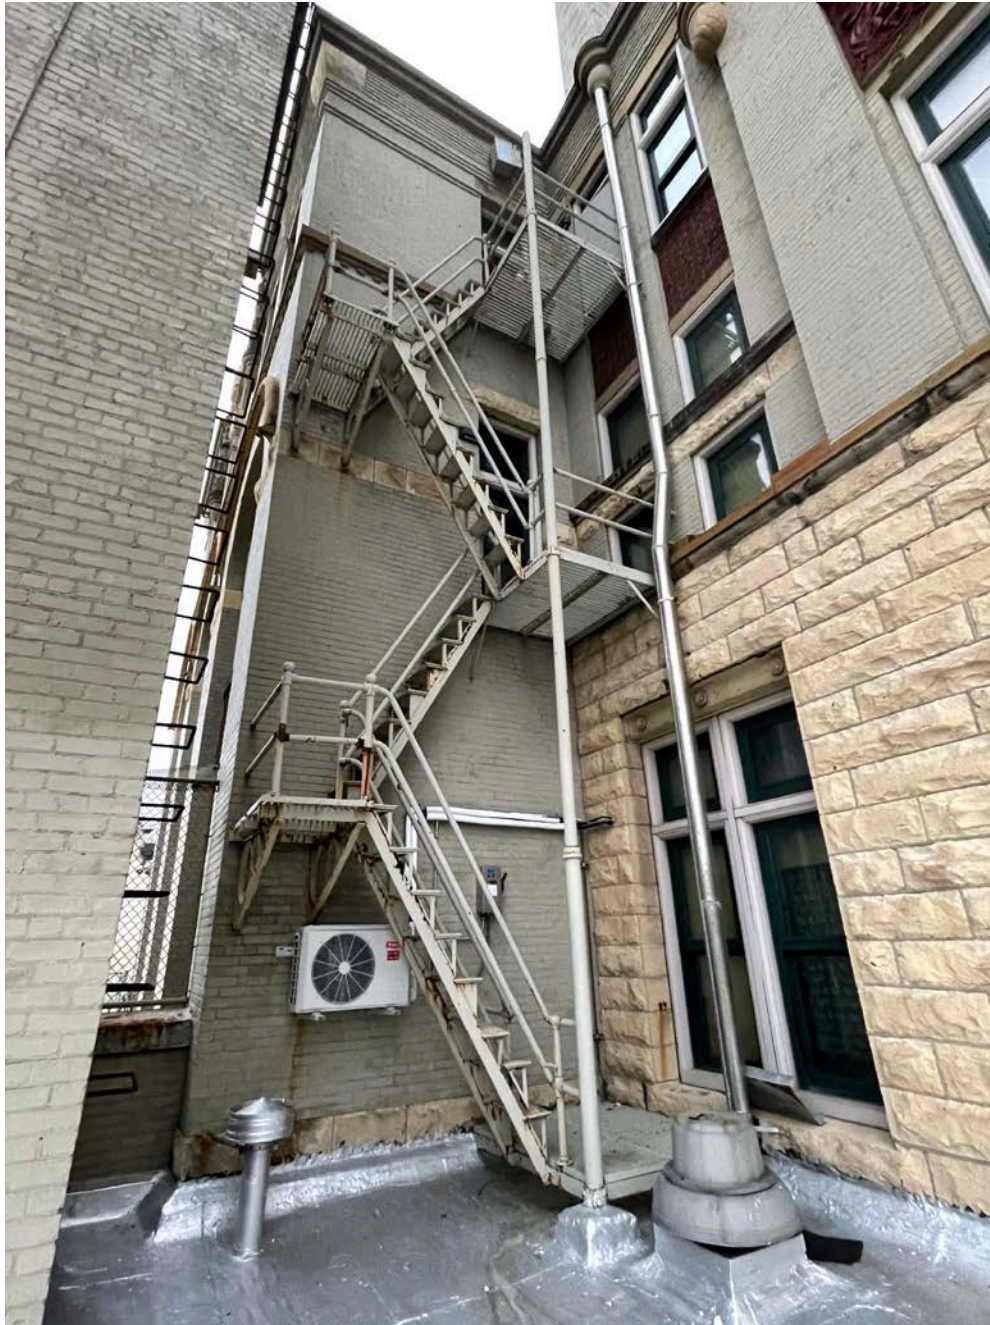
Fire Escape #3 is original to the building and is in poor condition. This fire escape has an immediate need for repair and we recommend closure until repairs can be made. Additionally we recommend a building code impact study to review the potential for de-commissioning and removal of this fire escape.

Fire Escape #3: Egresses from the third floor Gym 31 to enclosed roof area above the boiler room with no egress to the public way. No other rooms utilize this fire escape. The code requirement for this fire escape should be investigated. Located on west face of building.

Notes: 1 3" column, 2 angle brackets, 4 scroll brackets, No handrails on building side.

Overall View of Fire Escape #3 (Looking North East)

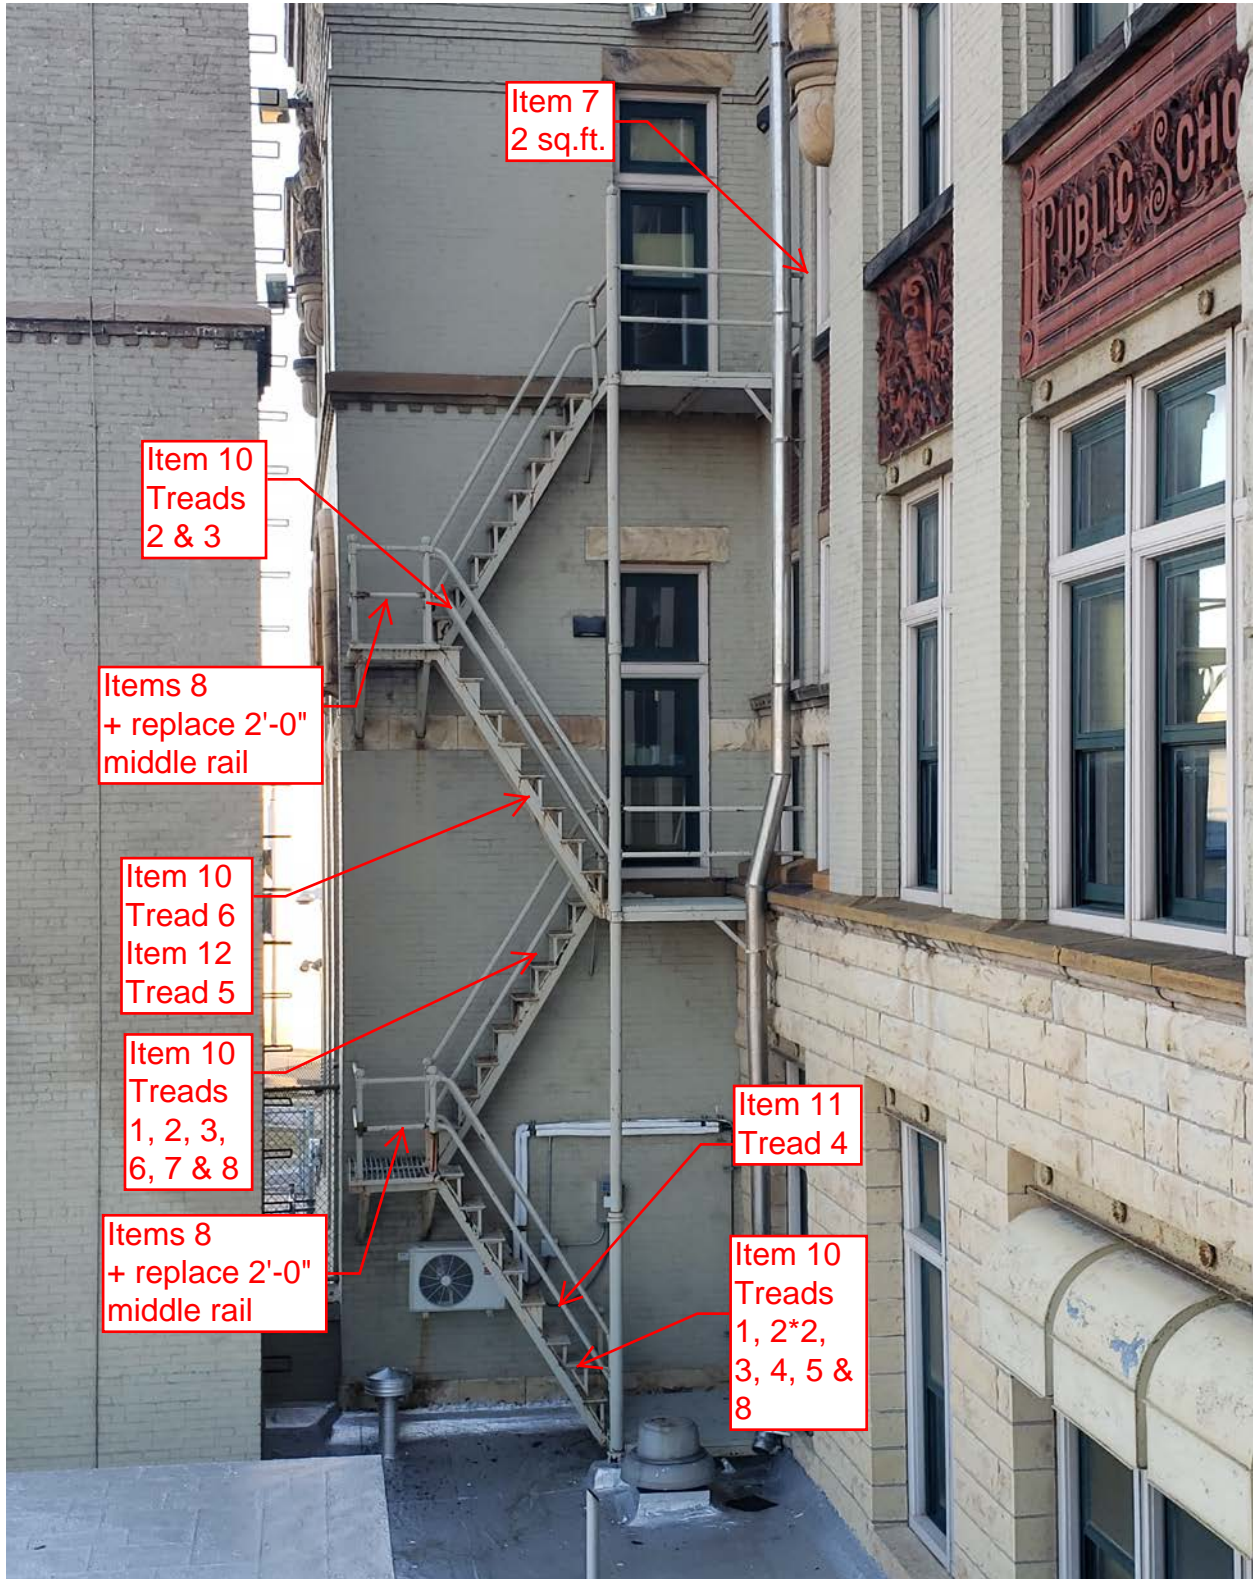
Figure 3 Fire Escape FE#3

From the observations of the fire escapes at 1555 Dr. Martin Luther King Drive, we conclude that fire escapes FE#1 and FE#2 are in good and safe condition with exception of a few minor maintenance items. When these maintenance items are corrected, the fire escapes will perform their intended functions. Fire escape#3, however, is in poor condition and should not be used until critical repairs have been made or it is abandoned.

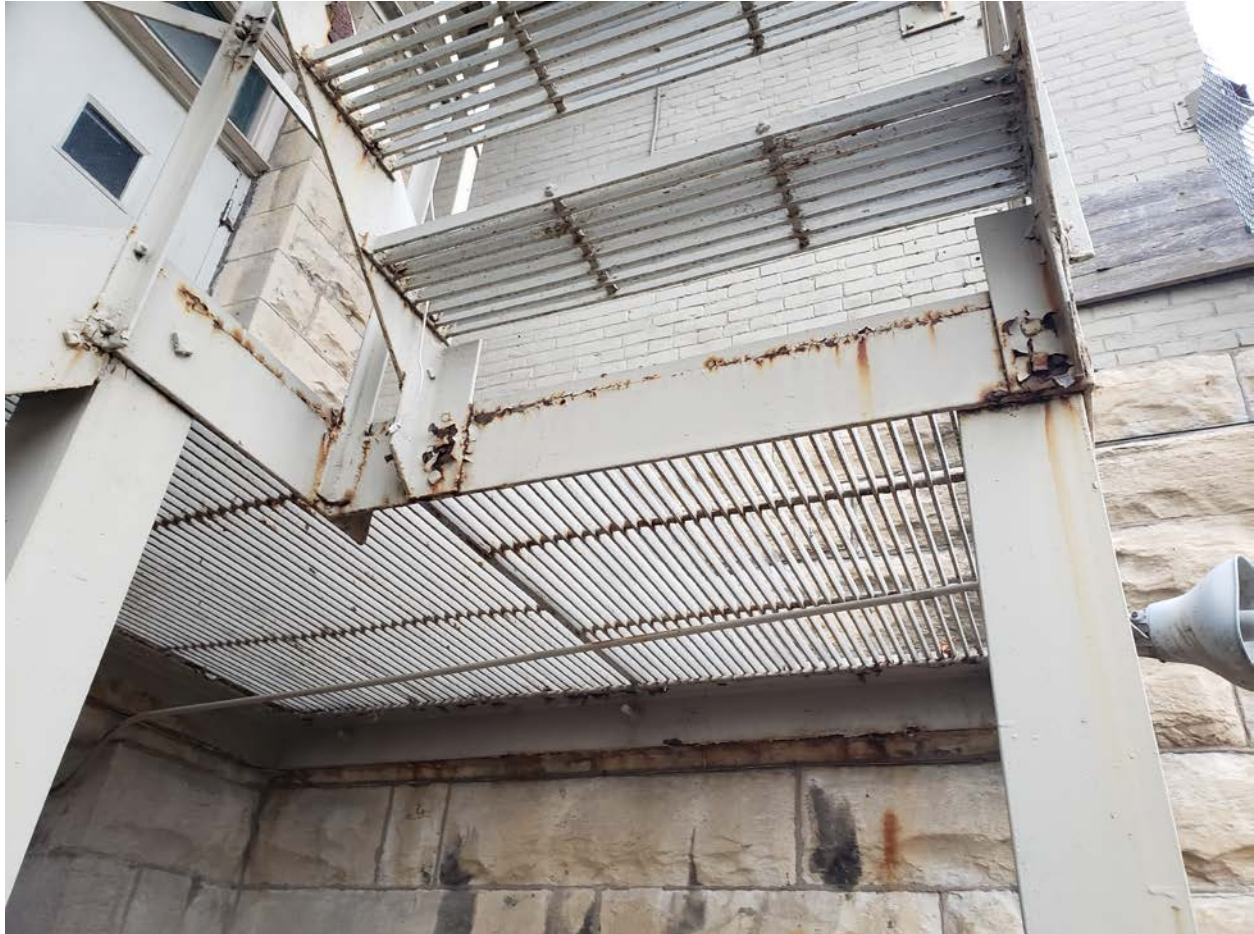
1. **Findings:** The entire metal frame has multiple degrees of corrosion varying from bubbled paint to members pitted due to material loss. None of the members appeared to be structurally compromised and in need of repair except those noted below.

Figure 4 Common corrosion found on FE#1 and FE#2

Recommendations: Properly clean corroded portions of the metal frame to bare steel. Re-inspect to confirm no significant loss of section in any of the members. Reinforce or replace any members with a 10 percent loss of section. Steel cleaning should be completed before other repairs have begun. Paint with a rust inhibiting paint. All prime and final painting shall be completed after all repairs have been made.

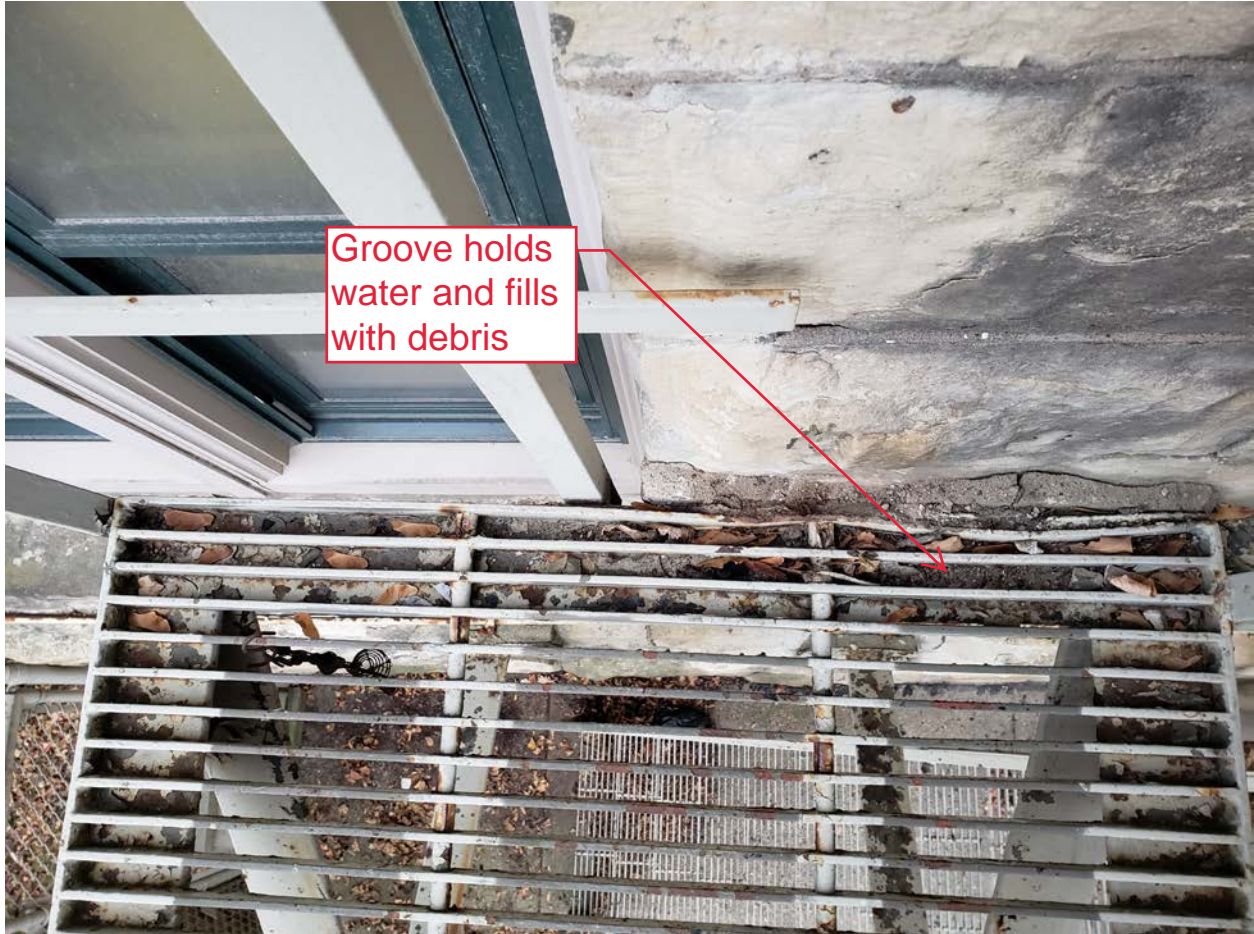
- Findings:** Grating over support angles attached to the building face have no means to drain water. The grating slots catch debris and hold water worsening corrosion conditions.

Figure 5 Enclosed Grooves of Bar Grating Trap Water and Debris Which Accelerate Corrosion

Recommendations: Clean all debris out of grooves and clean steel for painting. Drill 1/4" diameter holes at 12" on center in center of groove through the horizontal leg of the angle below the groove. Stagger holes 6" from holes of an adjacent groove. Remove and replace any bars in grating that are corroded 50% or more.

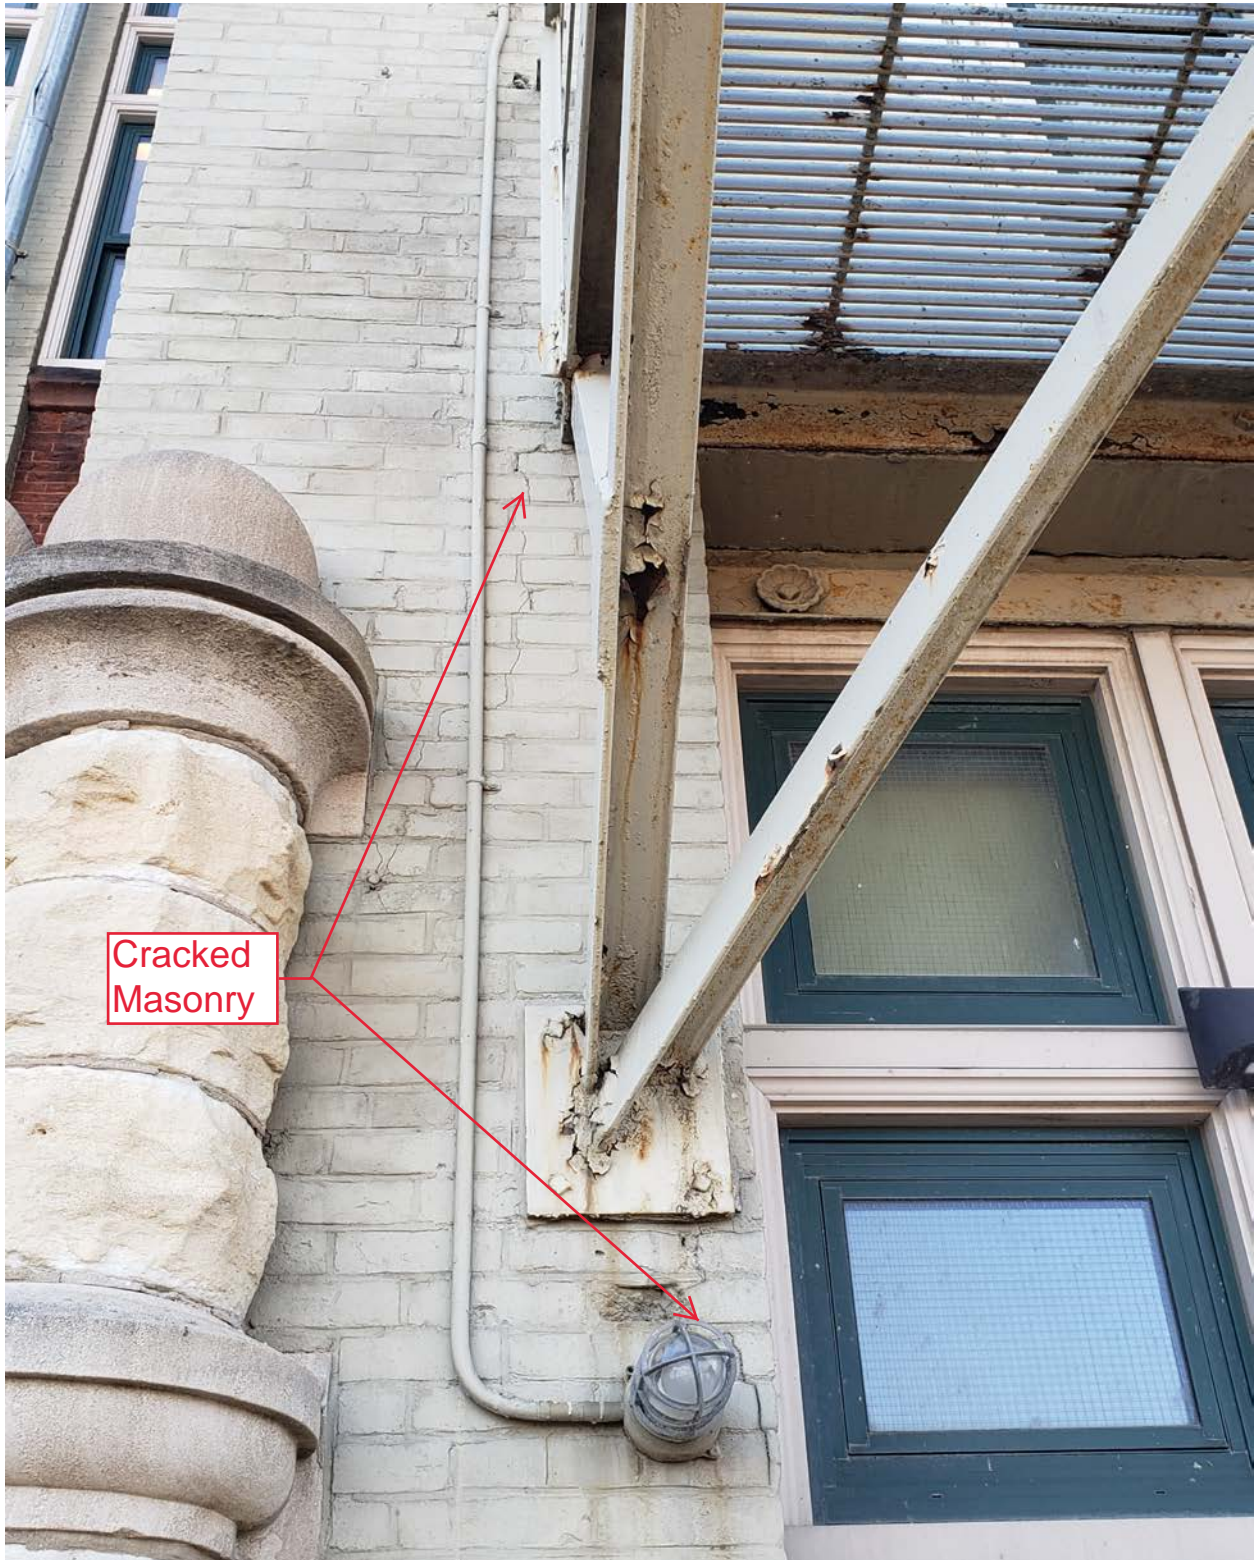
4. **Findings:** Masonry around and below fire escape support bracket has spalling and cracking. The condition will worsen as cracks fill with water and experience freeze-thaw cycles.

Figure 6 Cracking Masonry at and Around Fire Escape Support Brackets

Recommendations: Tuckpoint masonry at and round around support connection bracket.

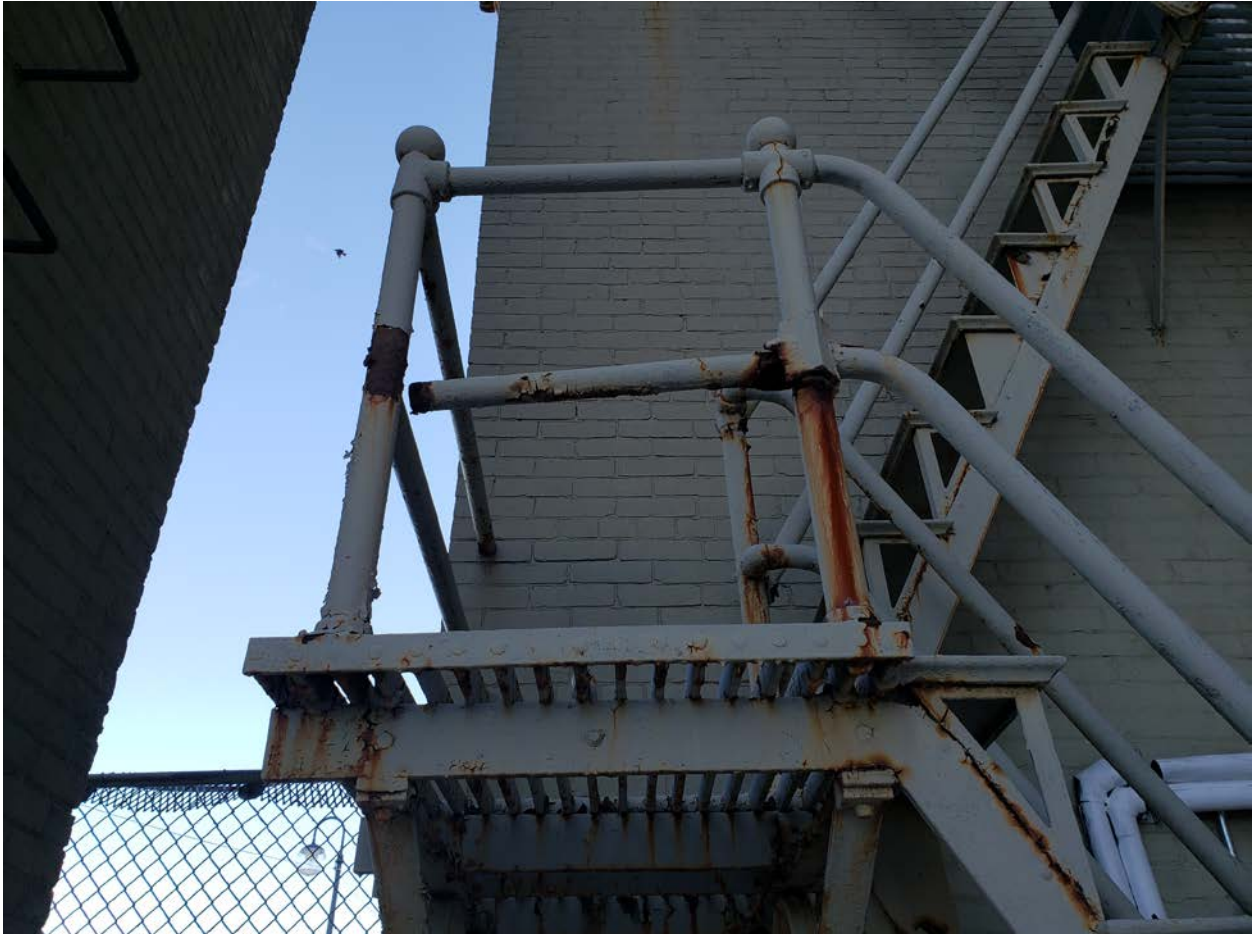
Figure 7 Broken and/or Missing Railing Connection Brackets

- Findings:** Railing post base connection flange is broken compromising post connection to landing.
Recommendations: Remove and replace flange. Or provide new post to landing beam connection.
- Findings:** Railing post to rail connection bracket is fractured and/or missing pieces.
Recommendations: Replace connection bracket and reattach rail to post. Or provide new welded rail to post connection.

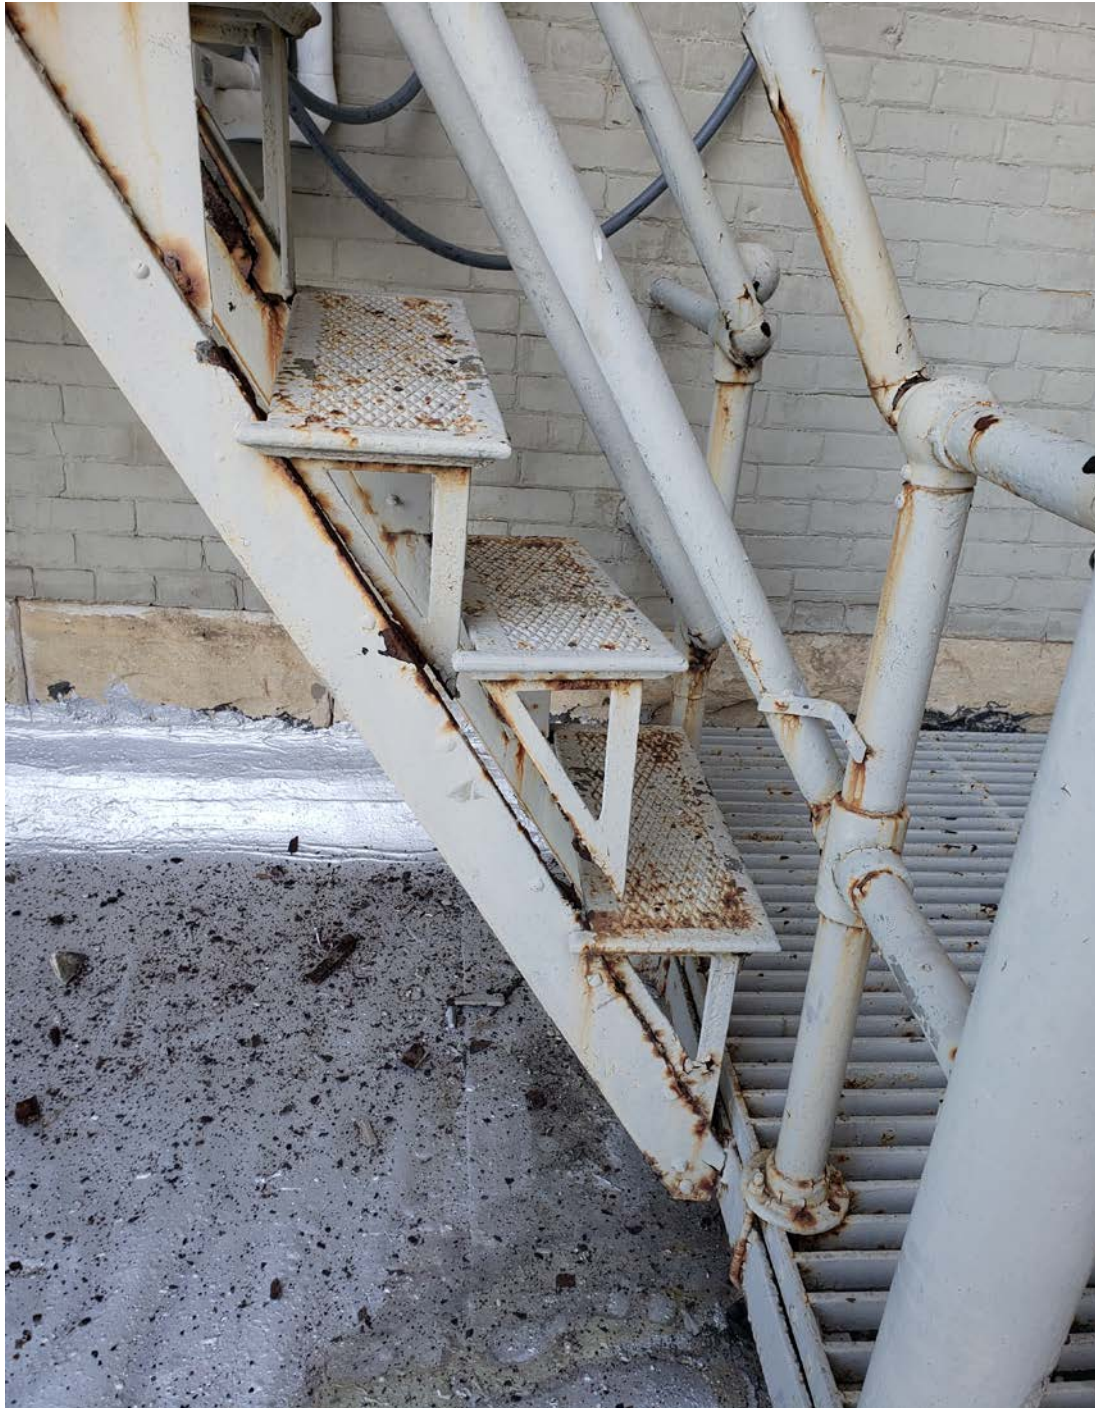
Figure 7 Failed Tread Bracket Connection

10. **Findings:** Tread support bracket is broken.

Recommendations: Replace support bracket made of welded L1x1x1/8 matching existing bracket configuration. Attach bracket to stringer and tread.
