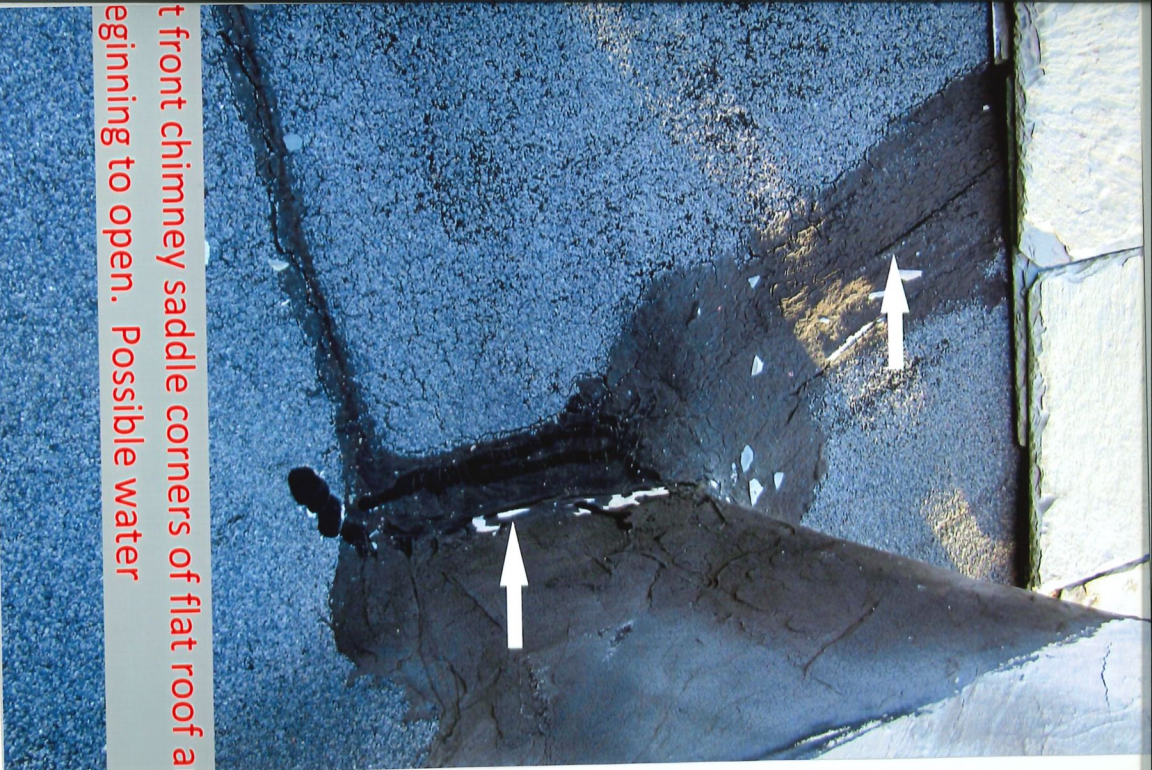
Front chimney saddle corners of flat roof are beginning to open. Possible water

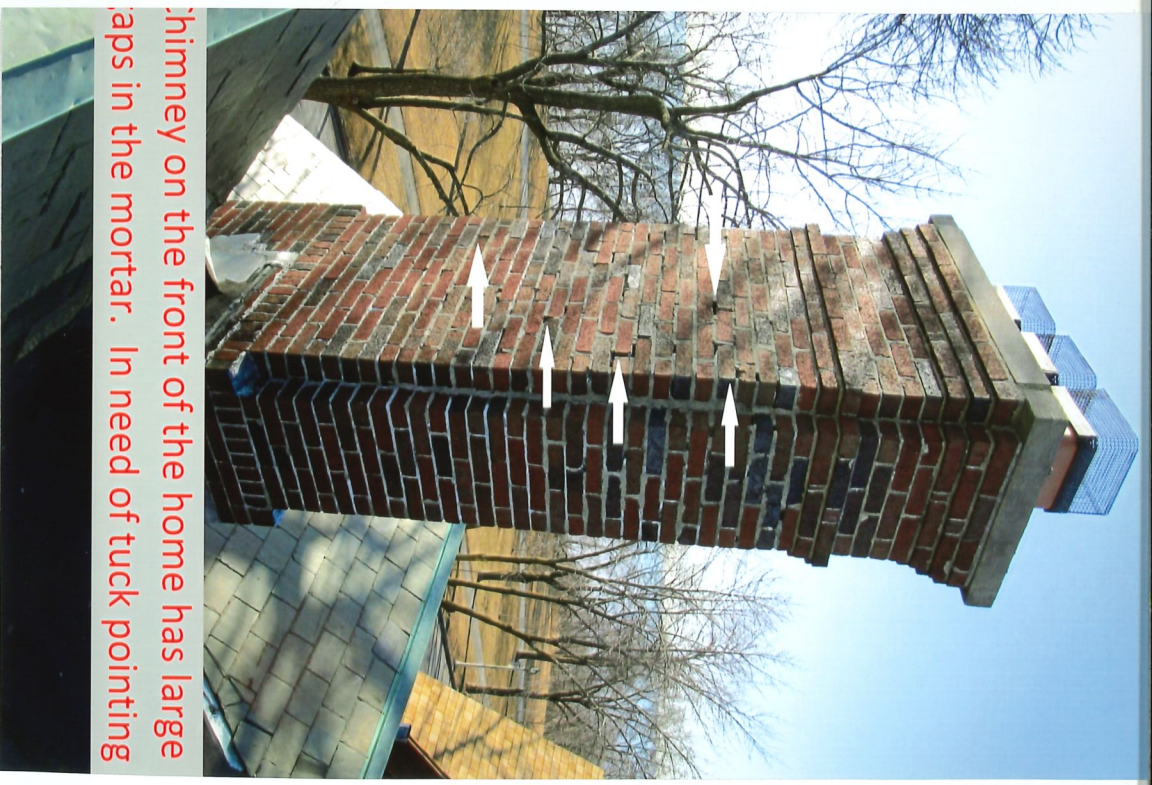
Chimney on the front of the home has large gaps in the mortar. In need of tuck pointing

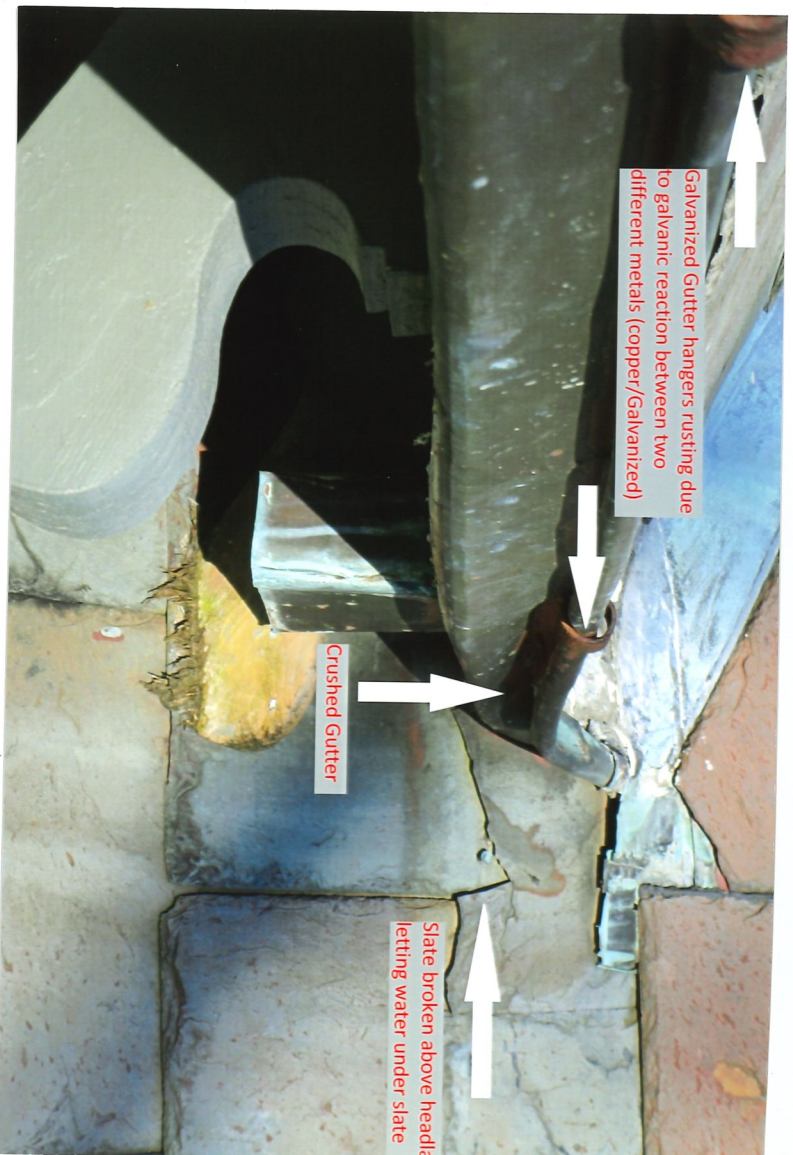
Galvanized gutter hangers rusting due to galvanic reaction between two different metals (copper/Galvanized)

Crushed Gutter

Slate broken above headliner letting water under slate

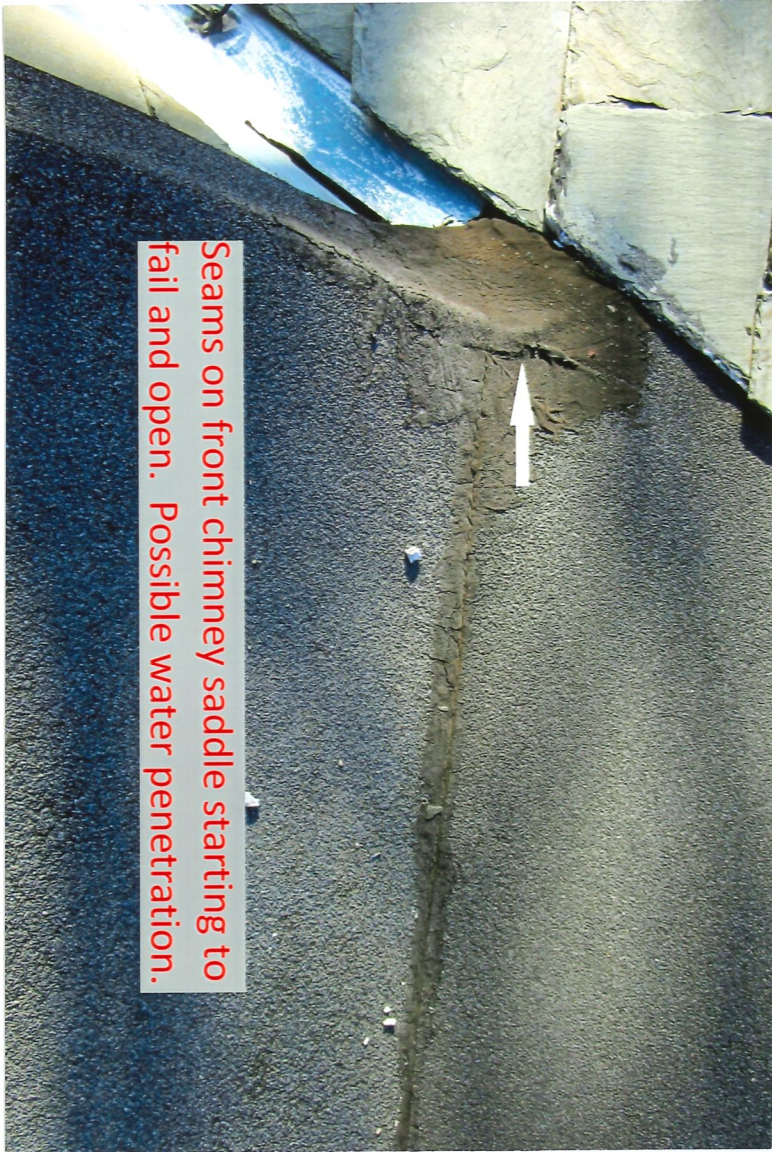
Seams on front chimney saddle starting to fail and open. Possible water penetration.

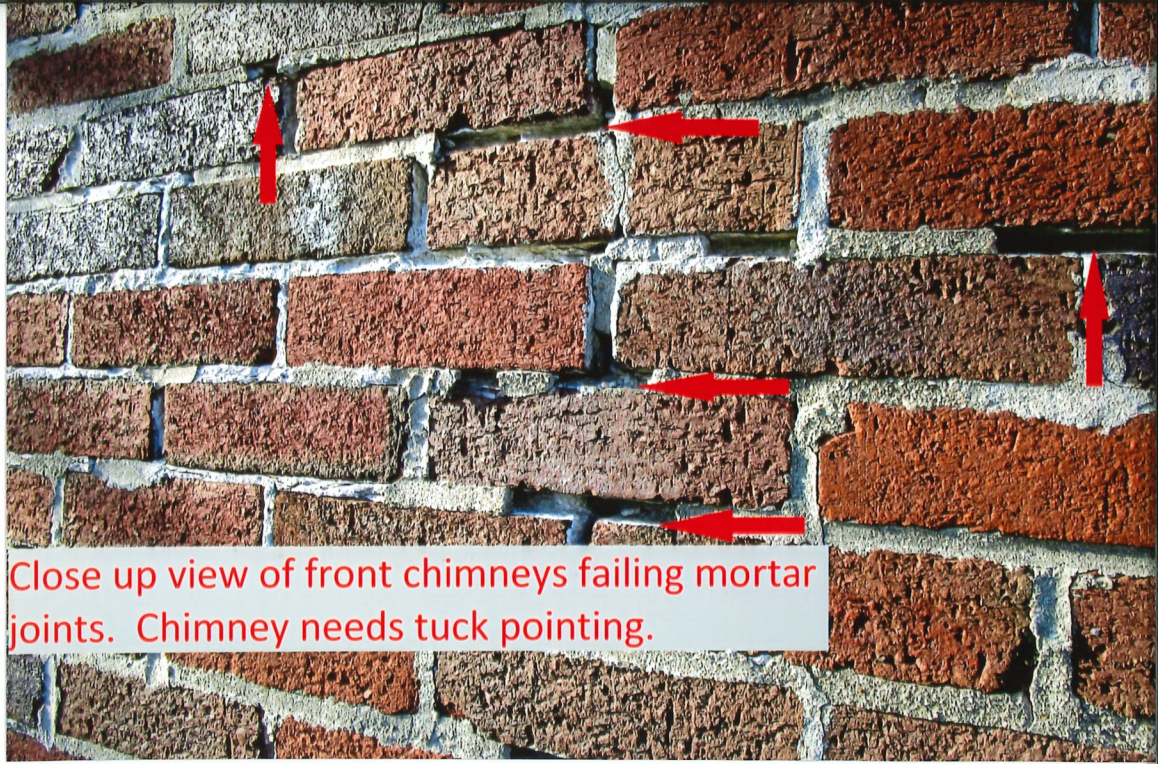
Close up view of front chimneys failing mortar joints. Chimney needs tuck pointing.

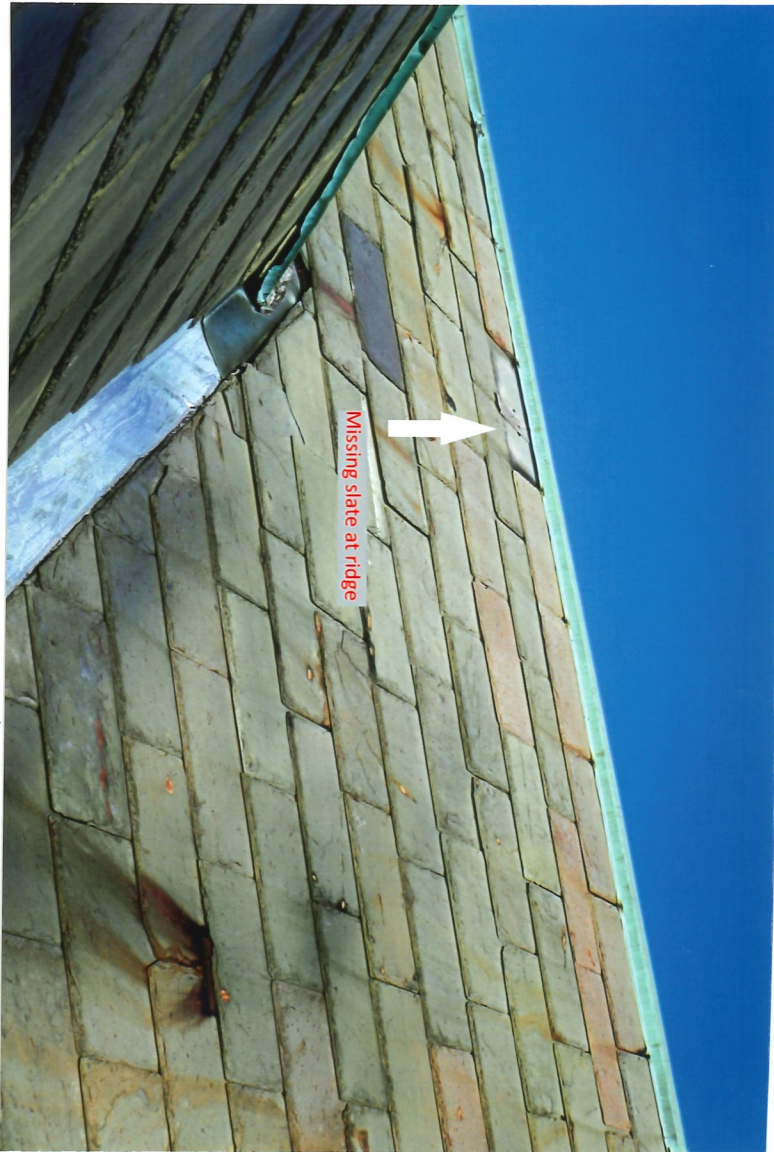
Missing slate at ridge

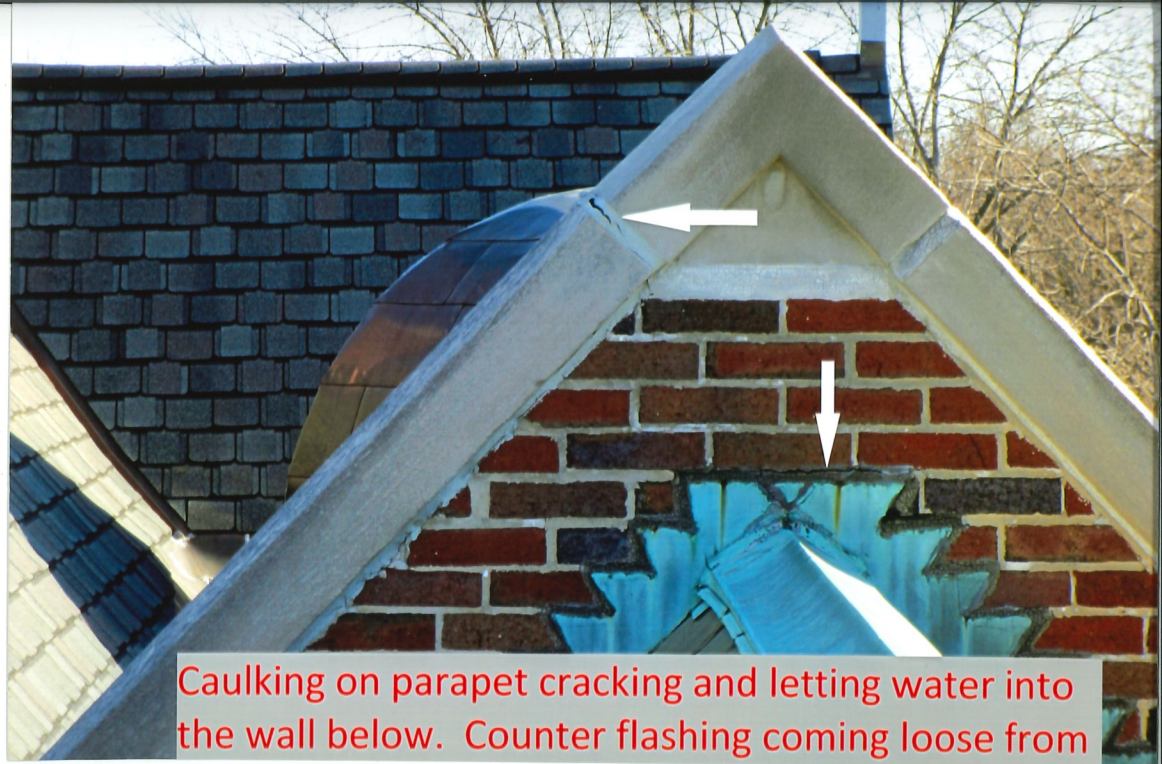
Caulking on parapet cracking and letting water into the wall below. Counter flashing coming loose from

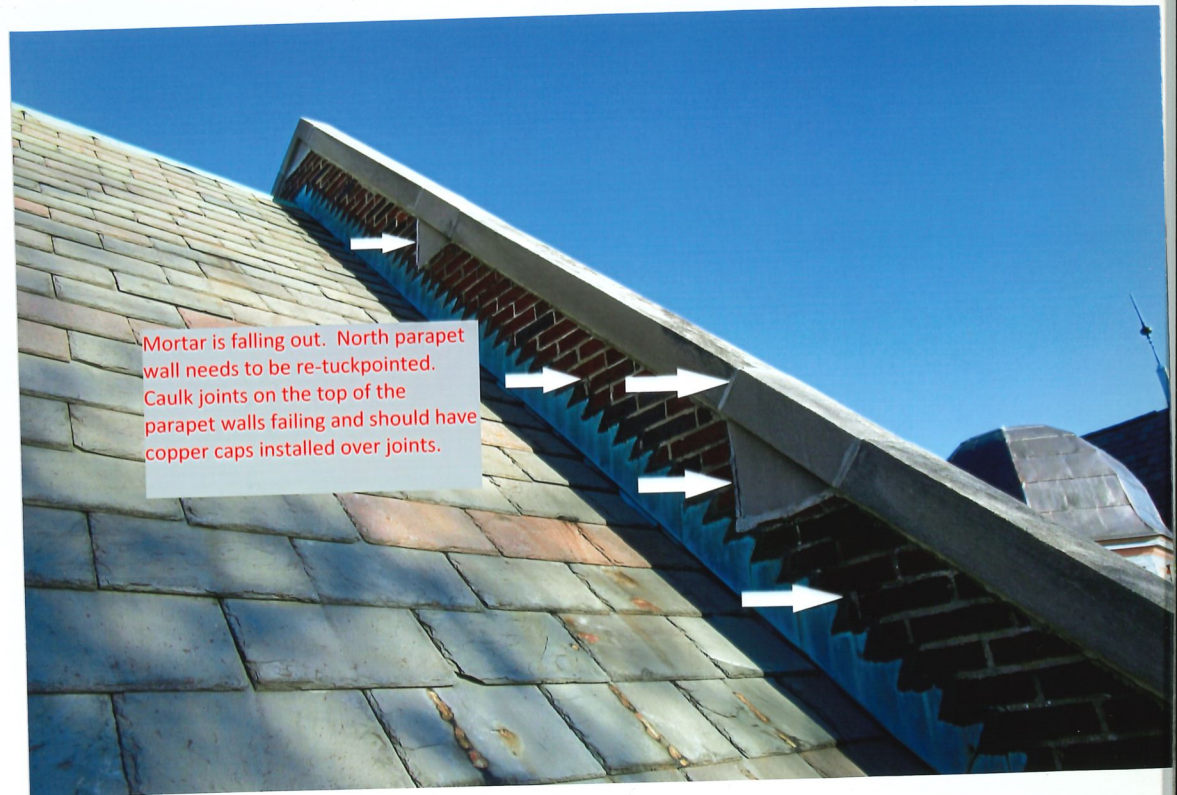
Mortar is falling out. North parapet wall needs to be re-tuckpointed. Caulk joints on the top of the parapet walls failing and should have copper caps installed over joints.

Lead soil stack flashing has been eaten by animal allowing water to gain access to attic.

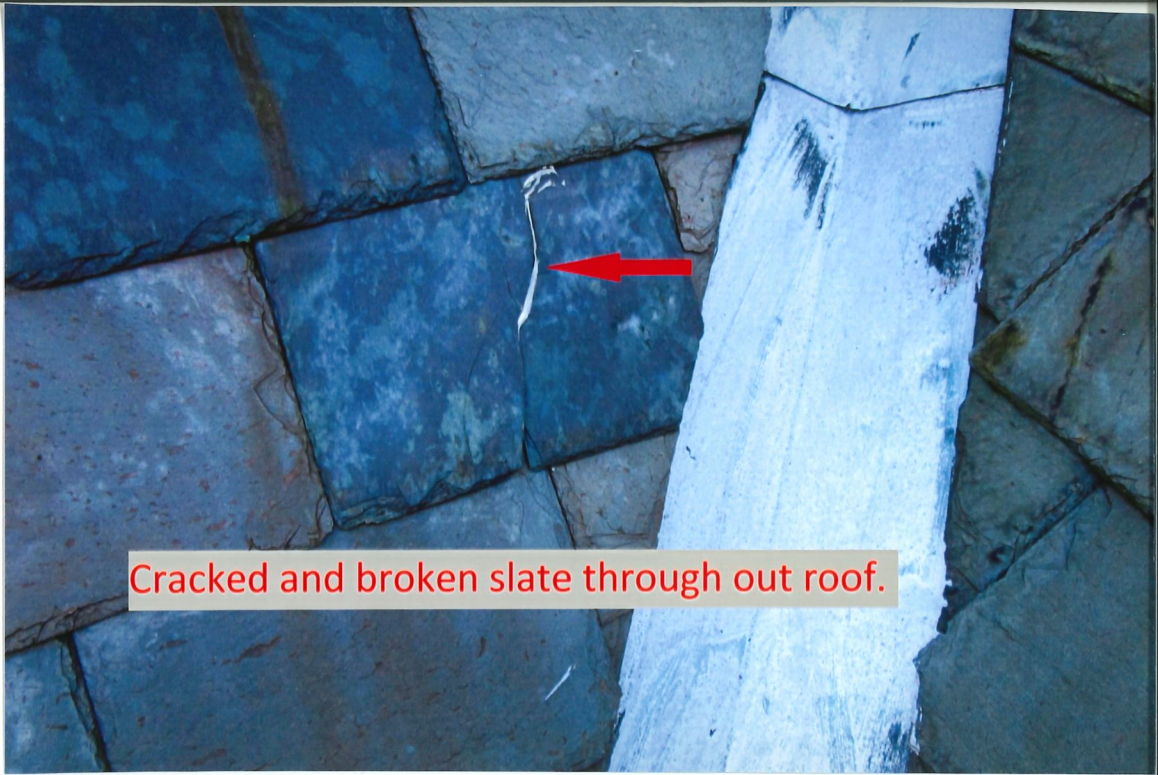
Broken and missing slate though out roof.
