READ INVESTMENT CO. BUILDING

2565-77 N. DOWNER AVE, MILWAUKEE, WI

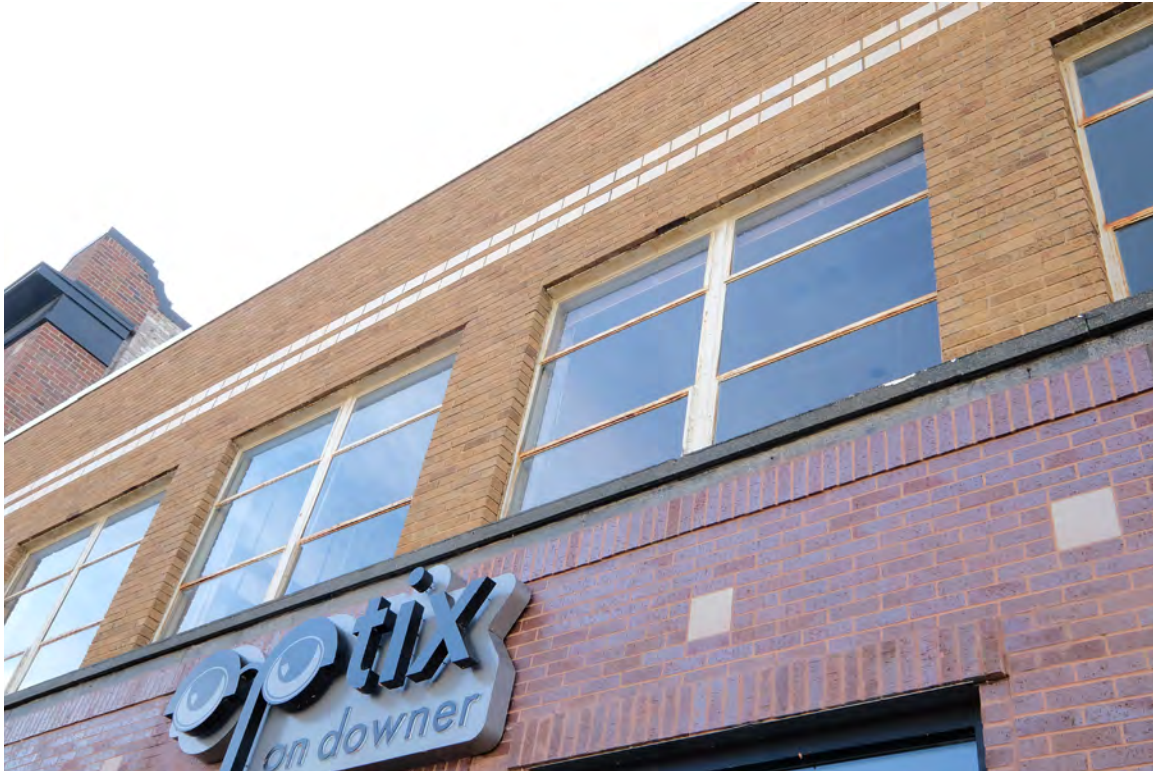
IMAGE 3: Typical east elevation second floor windows. Corrosion is evident throughout. Preserve, LLC 2021.

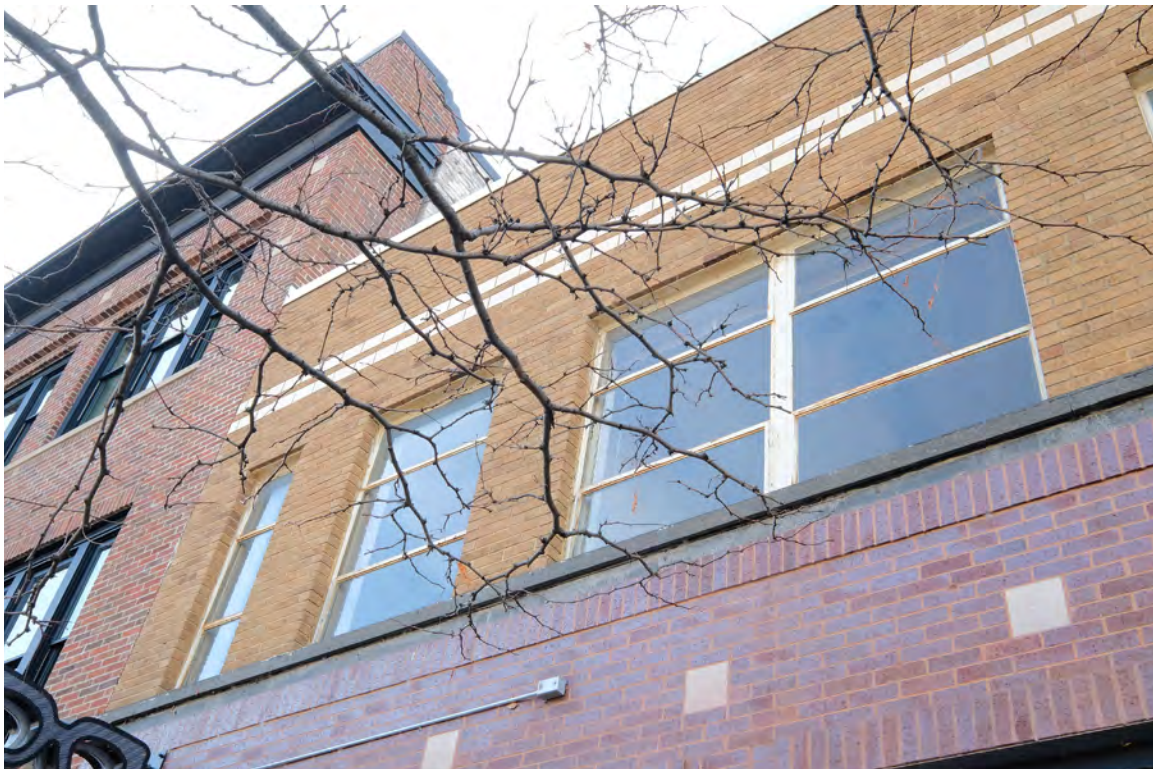
IMAGE 4: South end window units on the second floor. The south end matches the north end units. Preserve, LLC 2021.

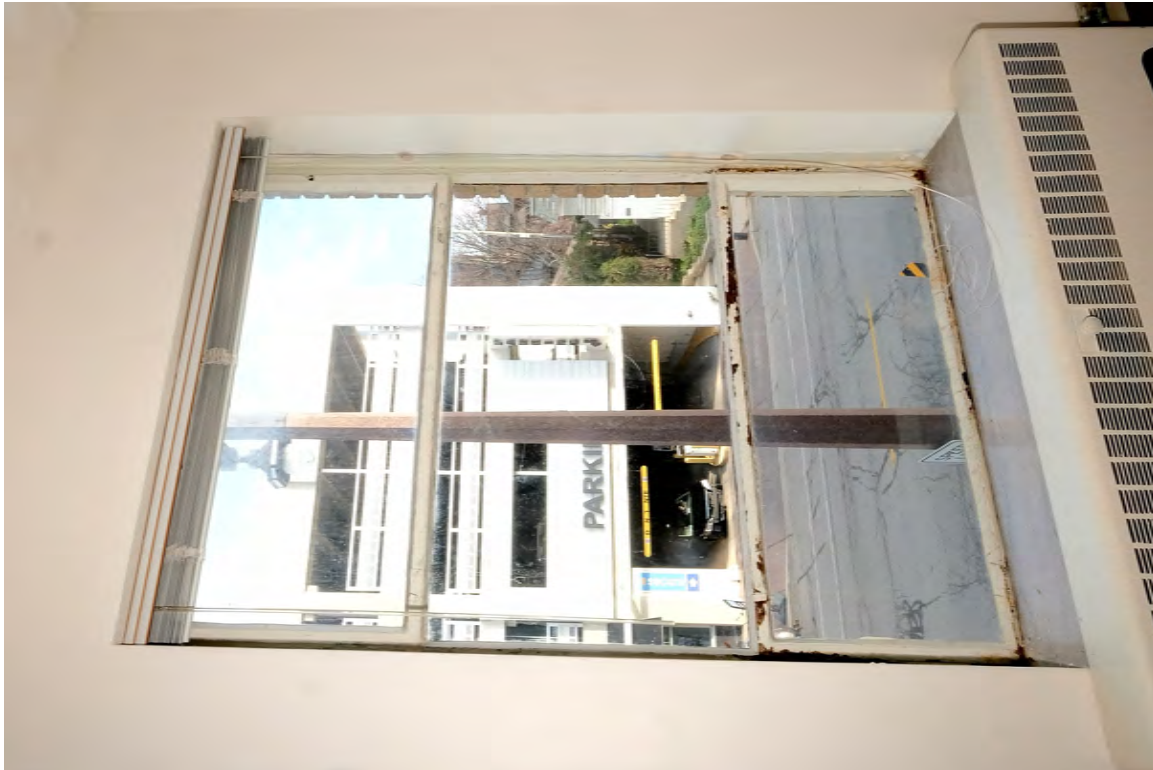
IMAGE 5: Corrosion is typical on the interior side of units. Window units have been painted closed. Preserve, LLC 2021.

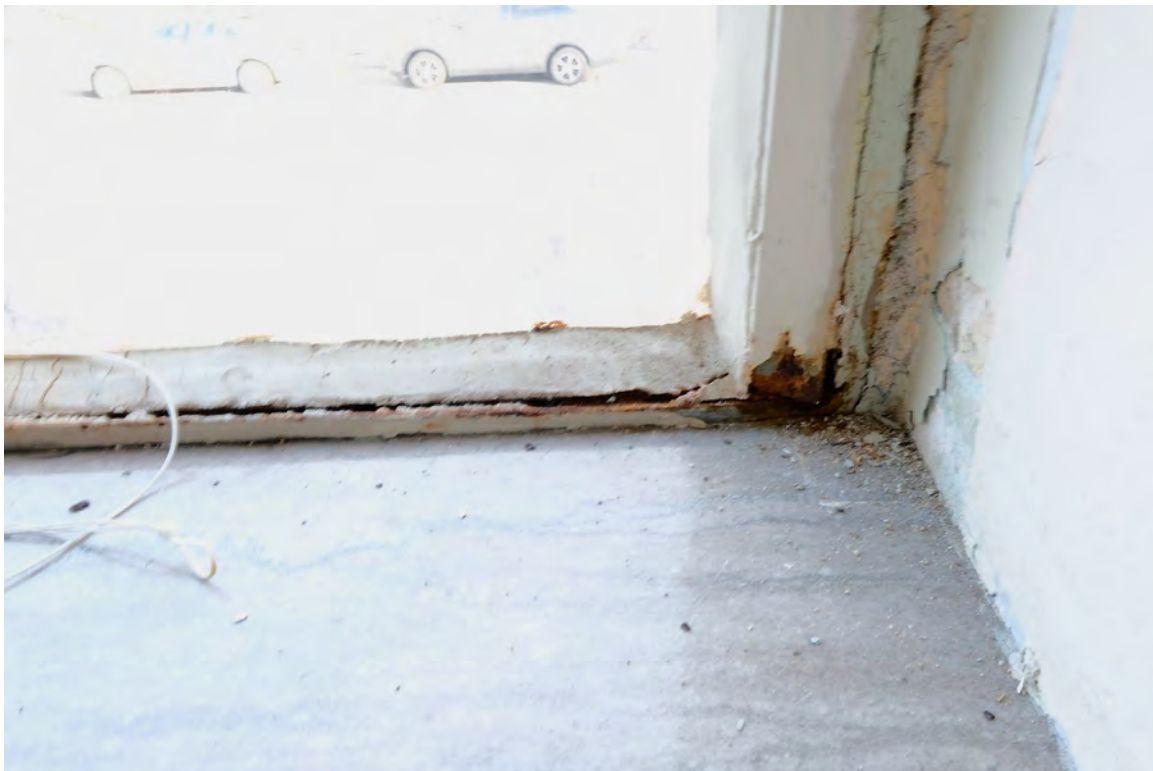
IMAGE 6: Typical corrosion location at the frame corners. Also note expansion cracks at frame and cracked sealant. Preserve, LLC 2021.

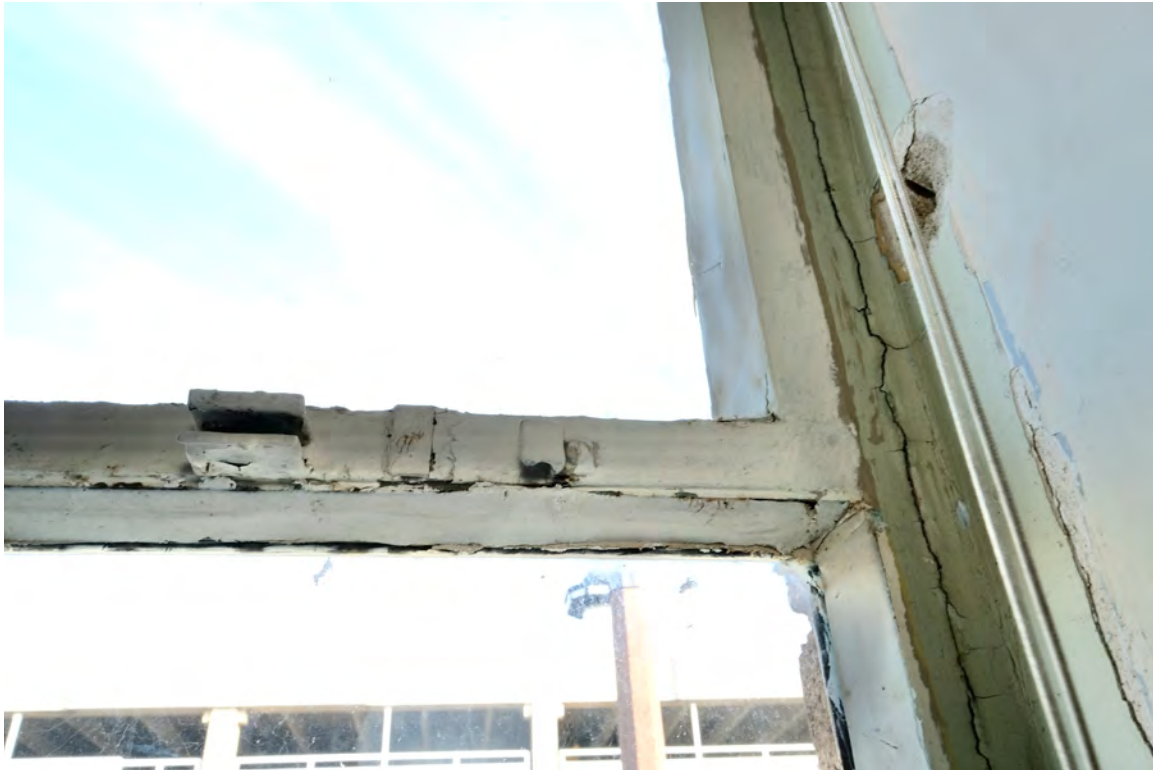
IMAGE 7: View of operable sash. Sashes are painted closed and cranks and hardware has been removed at spot locations throughout. Preserve, LLC 2021.

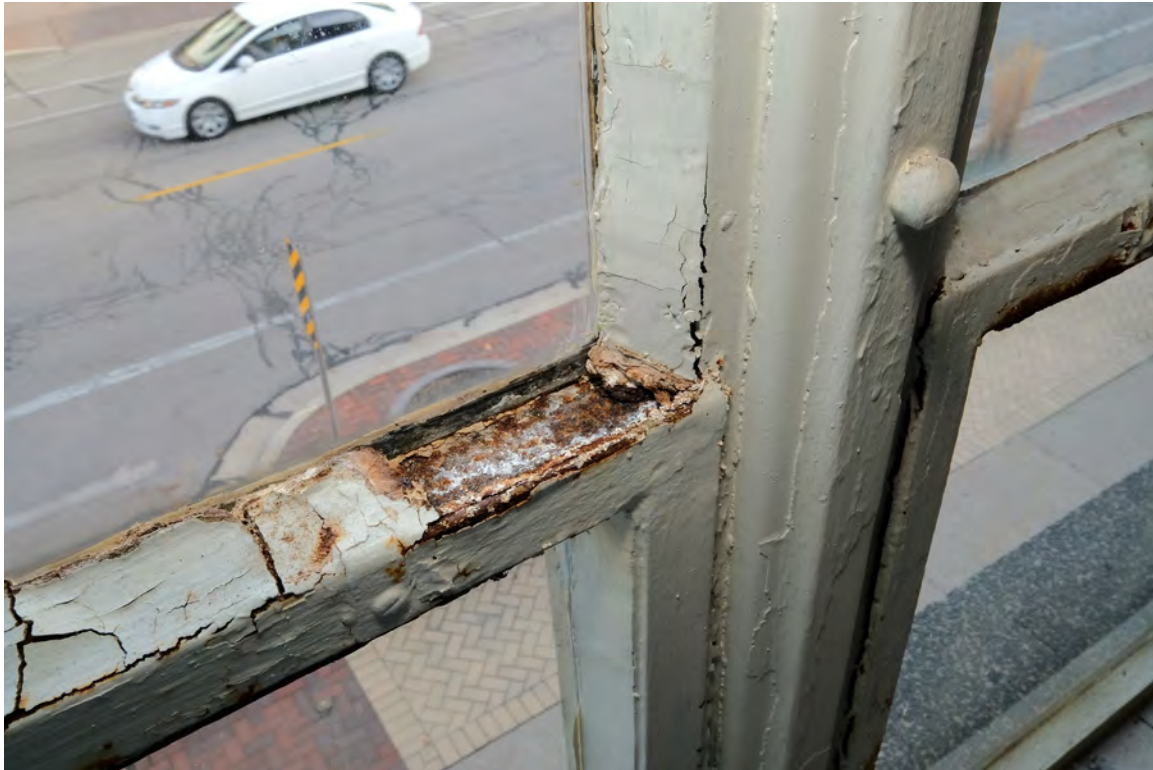
IMAGE 9: Corrosion typical at mullions. Preserve, LLC 2021.

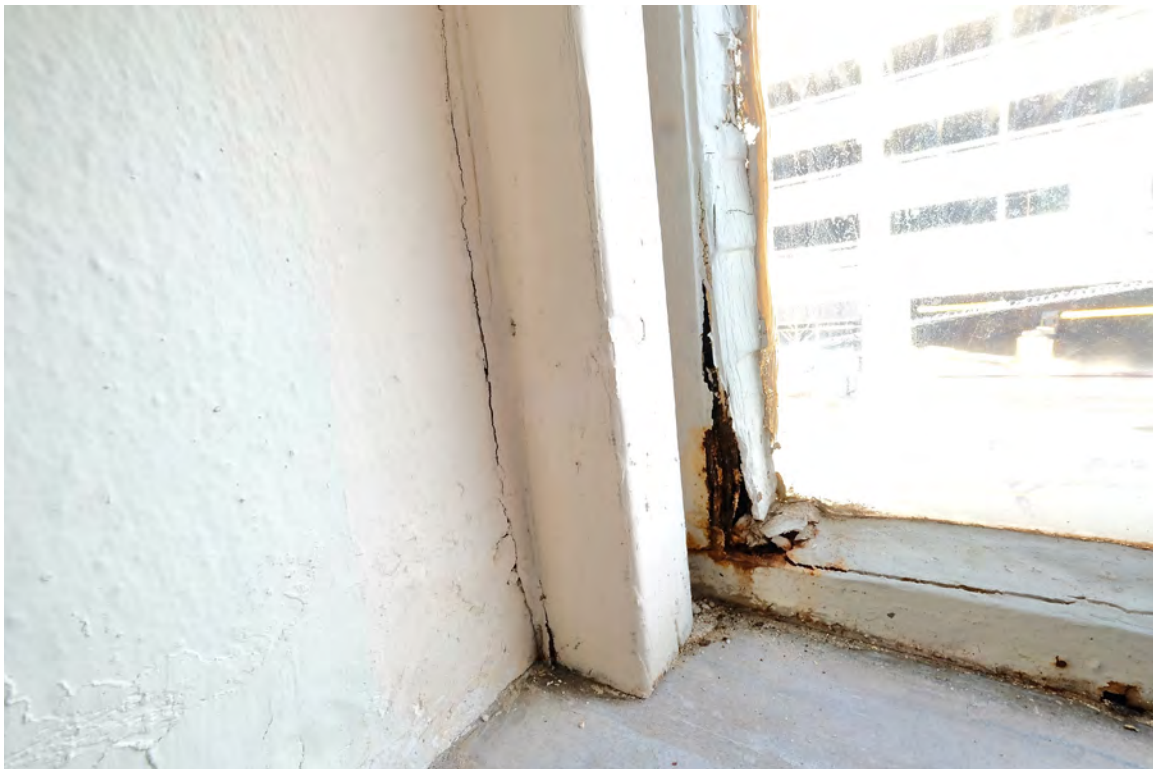
IMAGE 10: Corrosion typical at frame corners. Select units have interior storms installed. Preserve, LLC 2021.

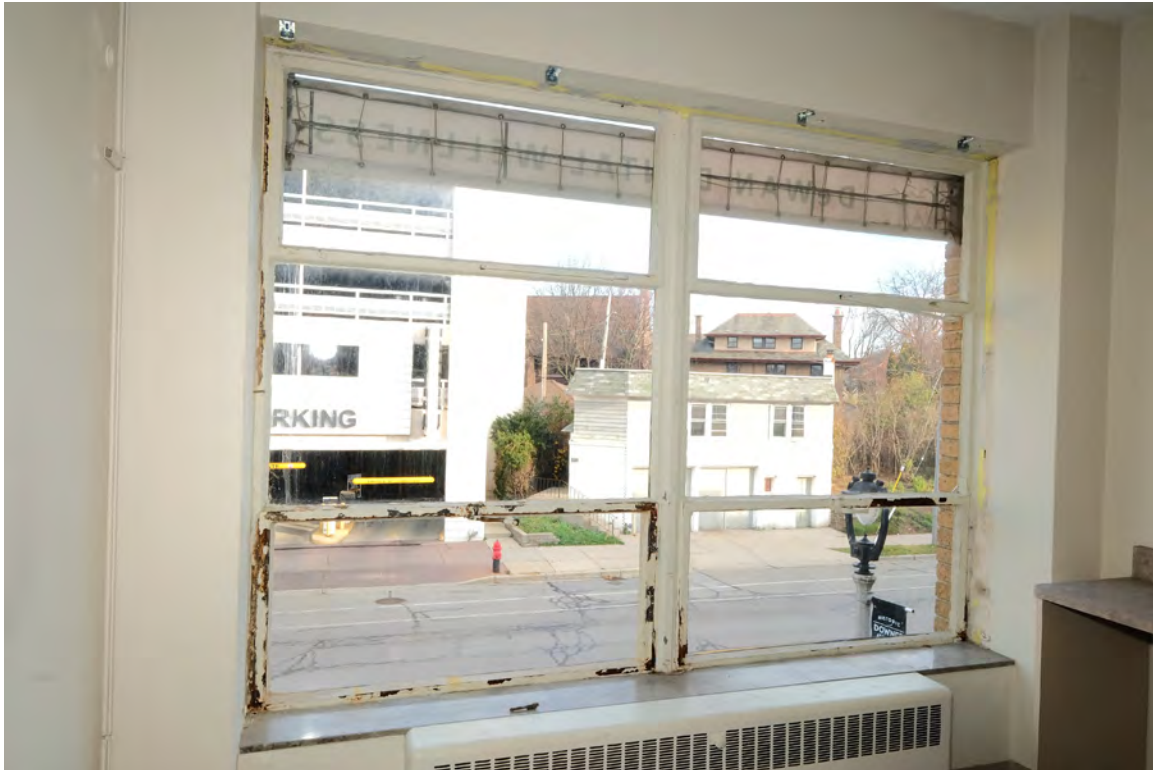
IMAGE 11: Interior view of a typical second-floor unit with typical corrosion throughout. Preserve, LLC 2021.

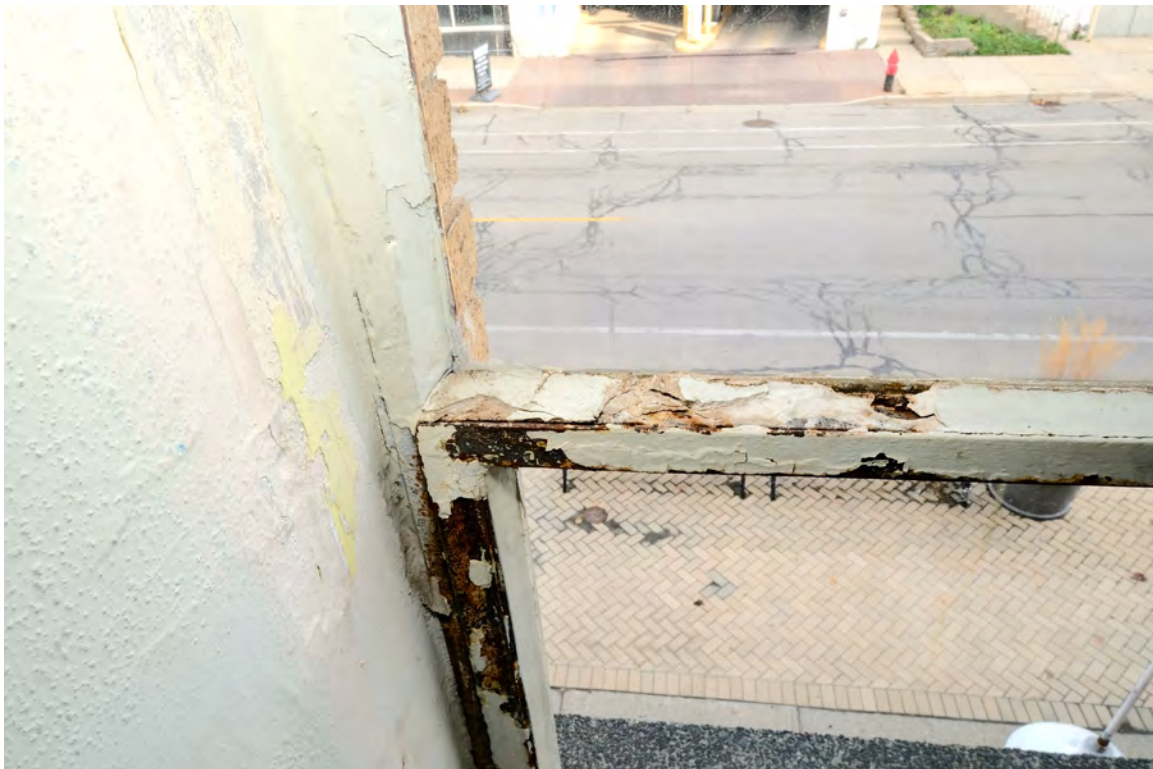
IMAGE 12: View of corrosion at ventilator frame. Seized frames, corrosion, paint, and missing hardware prevent window units from operating. Preserve, LLC 2021.

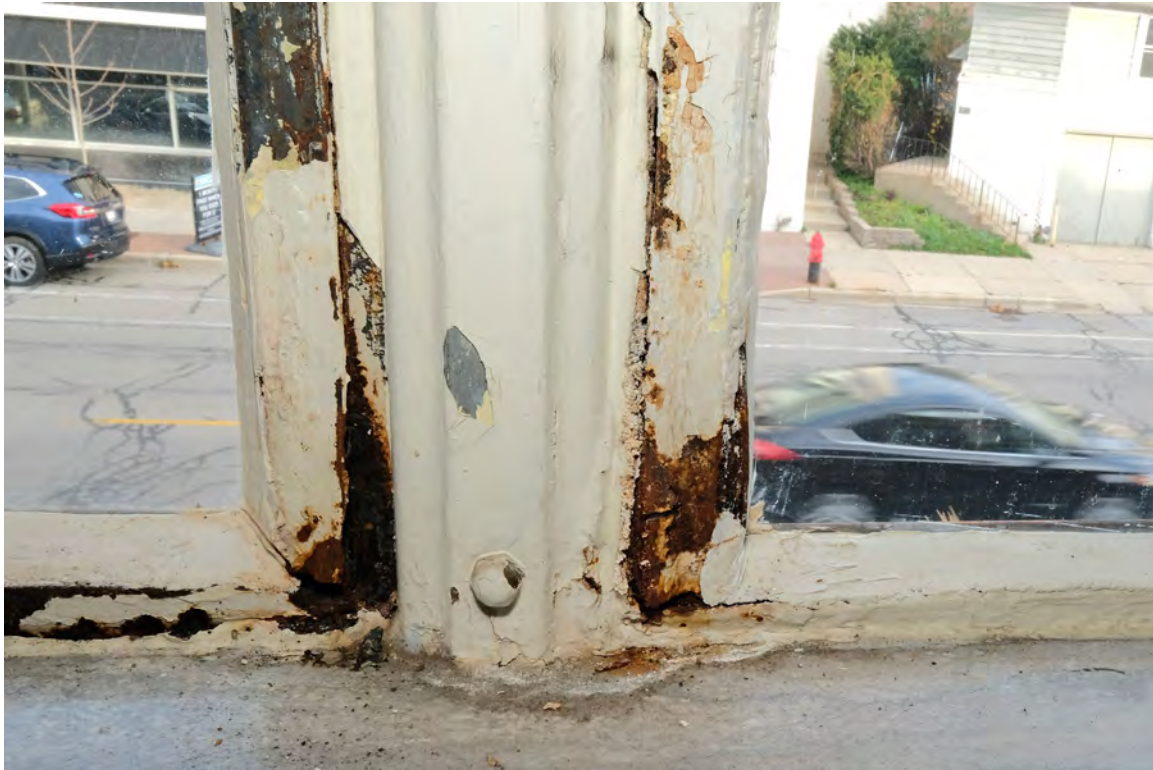
IMAGE 13: View of typical corrosion at window frame corners at center mullion. Preserve, LLC 2021.

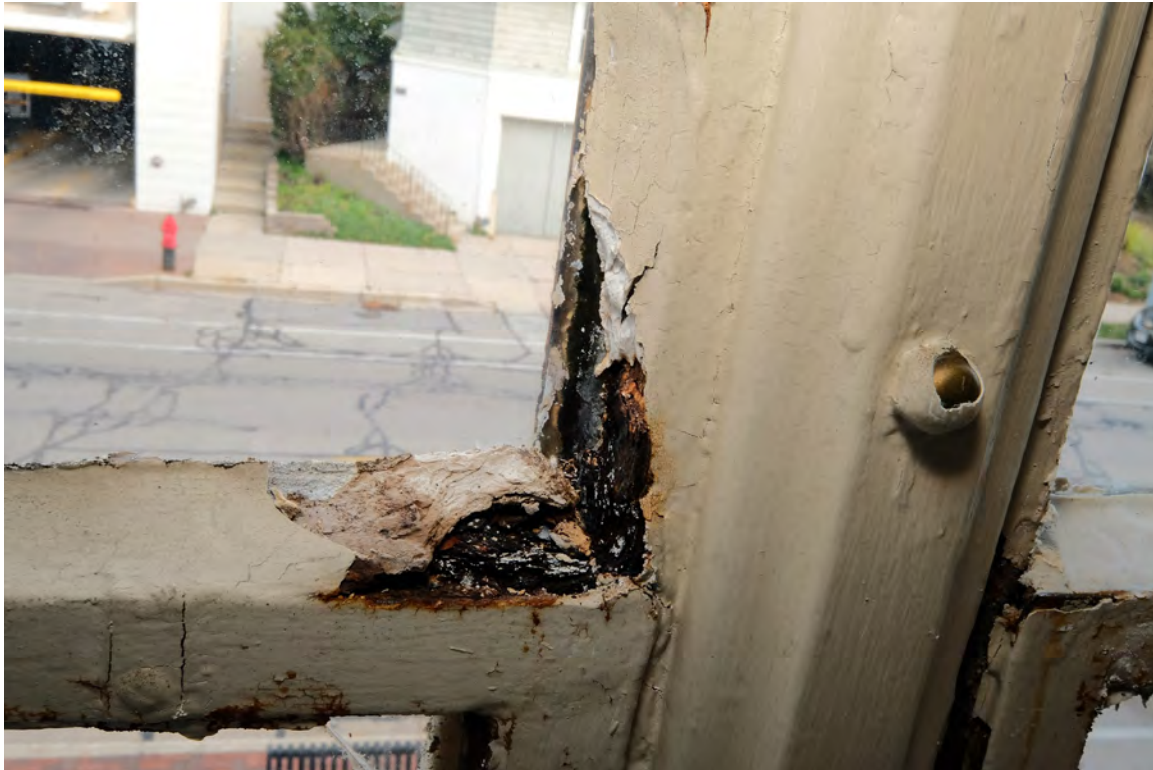
IMAGE 17: View of more severe corrosion at operable sash corner. Preserve, LLC 2021.

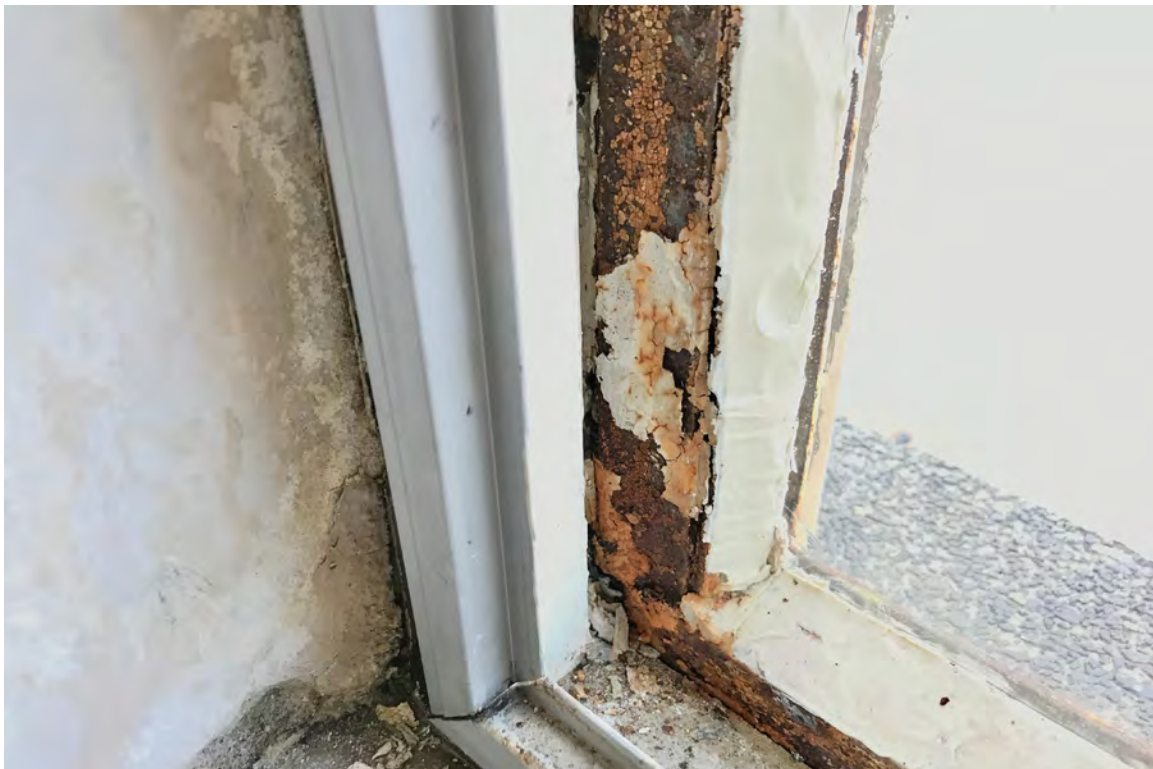
IMAGE 18: View of heavily deteriorated and corroded corner of window frame. Preserve, LLC 2021.

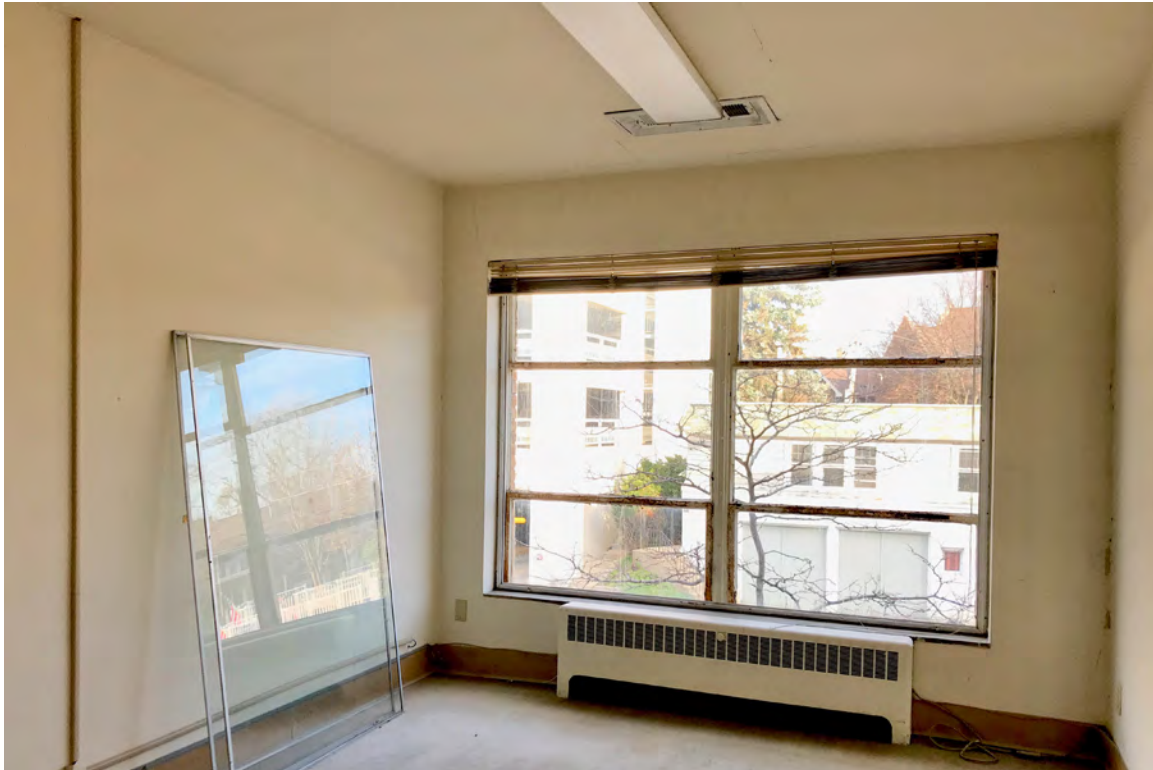
IMAGE 19: View of typical window unit. Corrosion is heaviest at the operable sash. Preserve, LLC 2021.

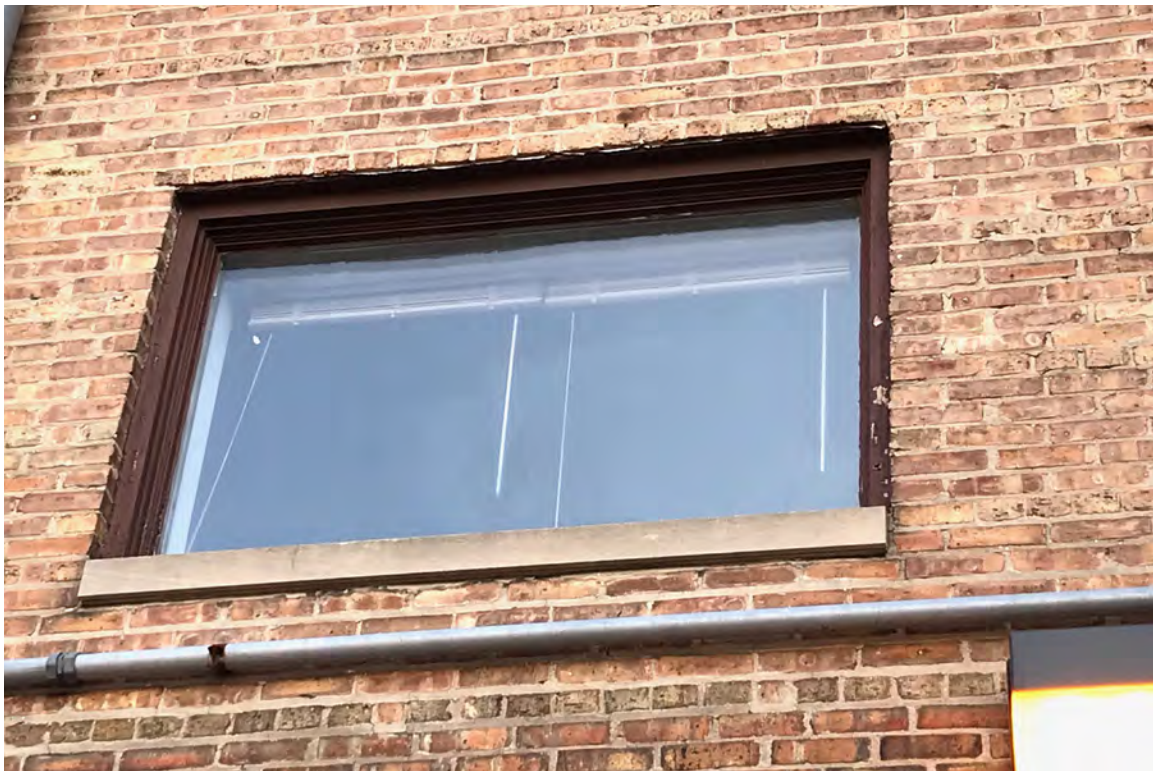
IMAGE 24: View of unit without frost buildup. Approximately half of all units have ice between the panes. Preserve, LLC 2021.

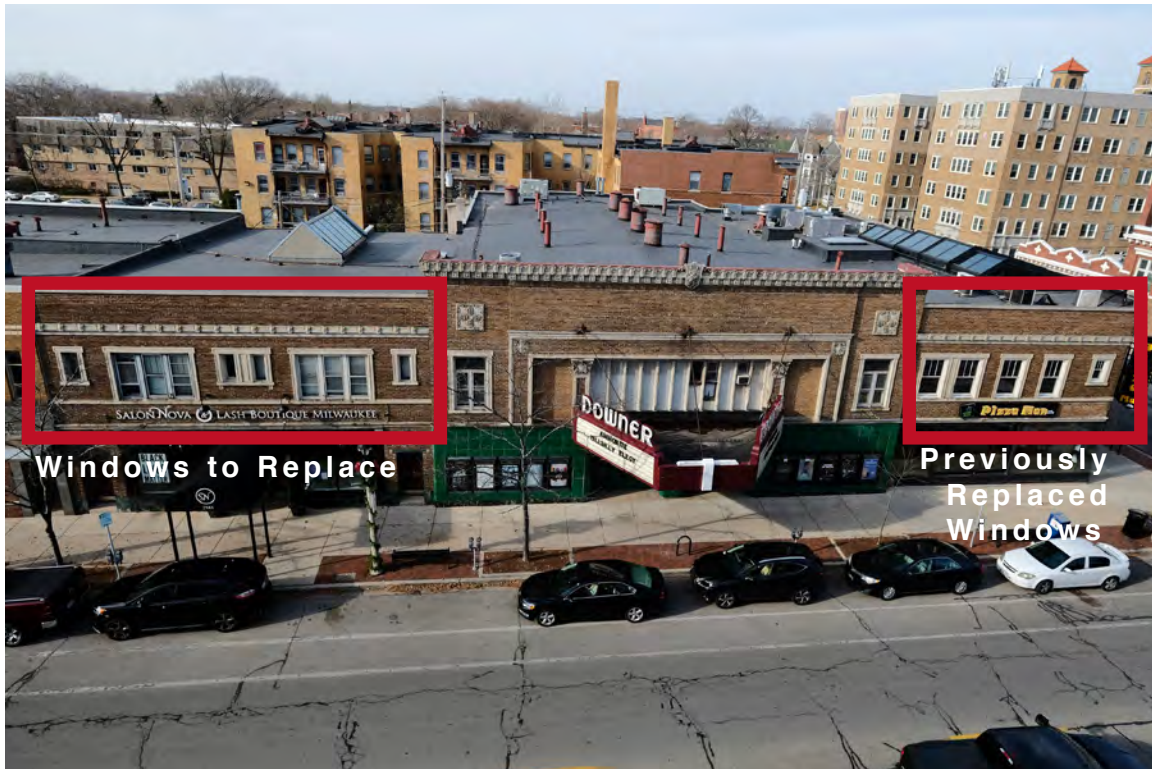
IMAGE 31: View of the Downer Theater building from across North Downer Avenue. The new windows on the south apartments will match the existing units in configuration. Preserve, LLC 2021.

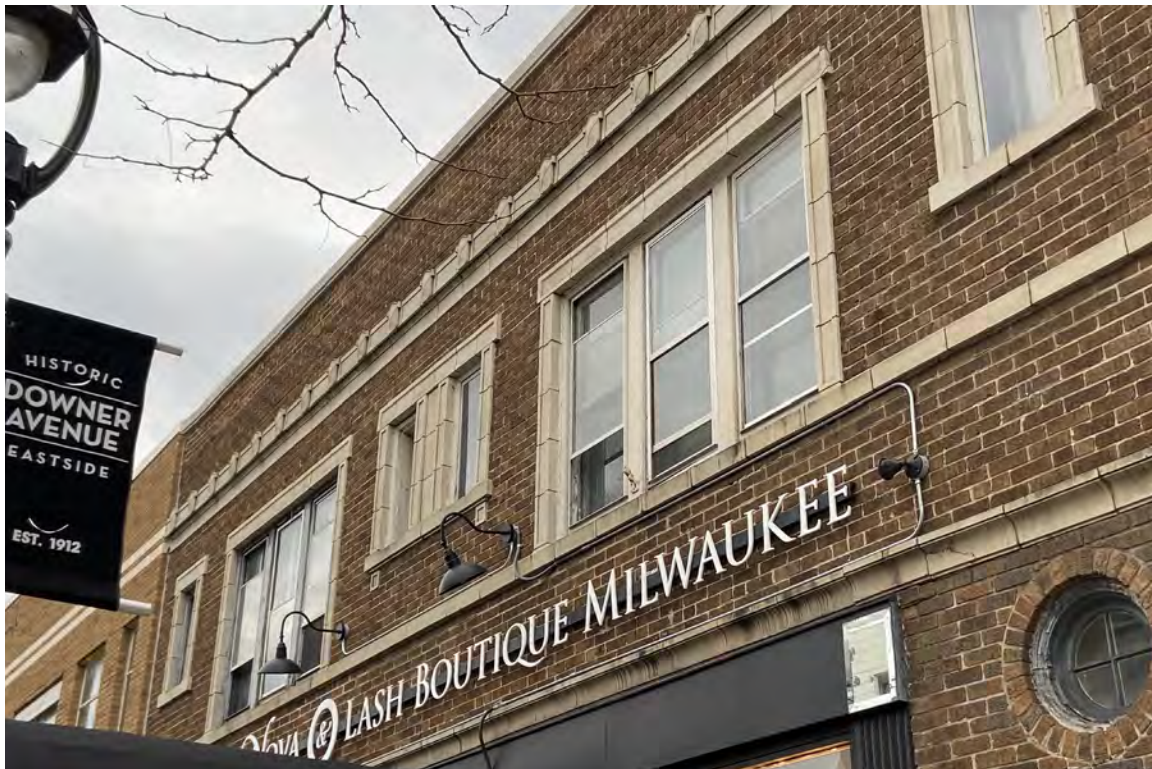
IMAGE 32: View of windows to be replaced on the second floor of the Downer Theater. Preserve, LLC 2021.

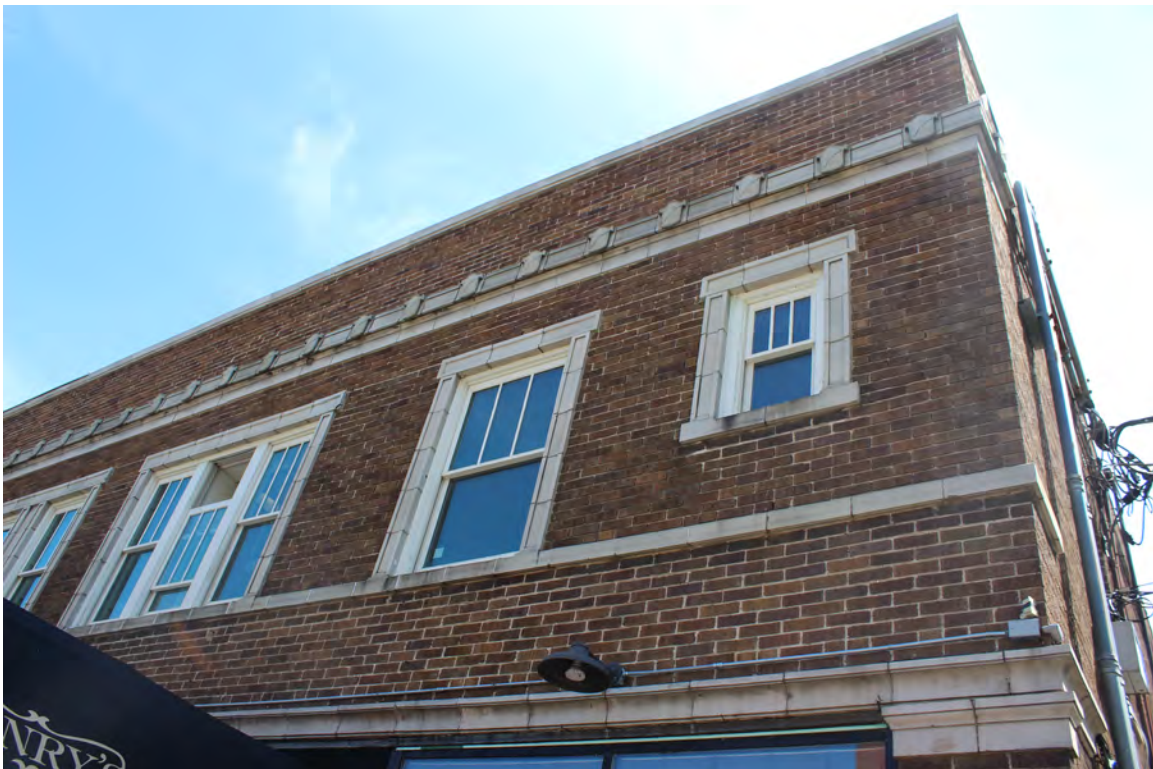
IMAGE 34: Close-up view of replacement window units at the Pizza Man restaurant. The new windows will coordinate with those already replaced on the building. Preserve, LLC 2021.
