CERTIFICATE OF APPROPRIATENESS APPLICATION FORM

Charles Allis Art Museum (Charles Allis House) - 1801 North Prospect, Milwaukee

■
January 15, 2016

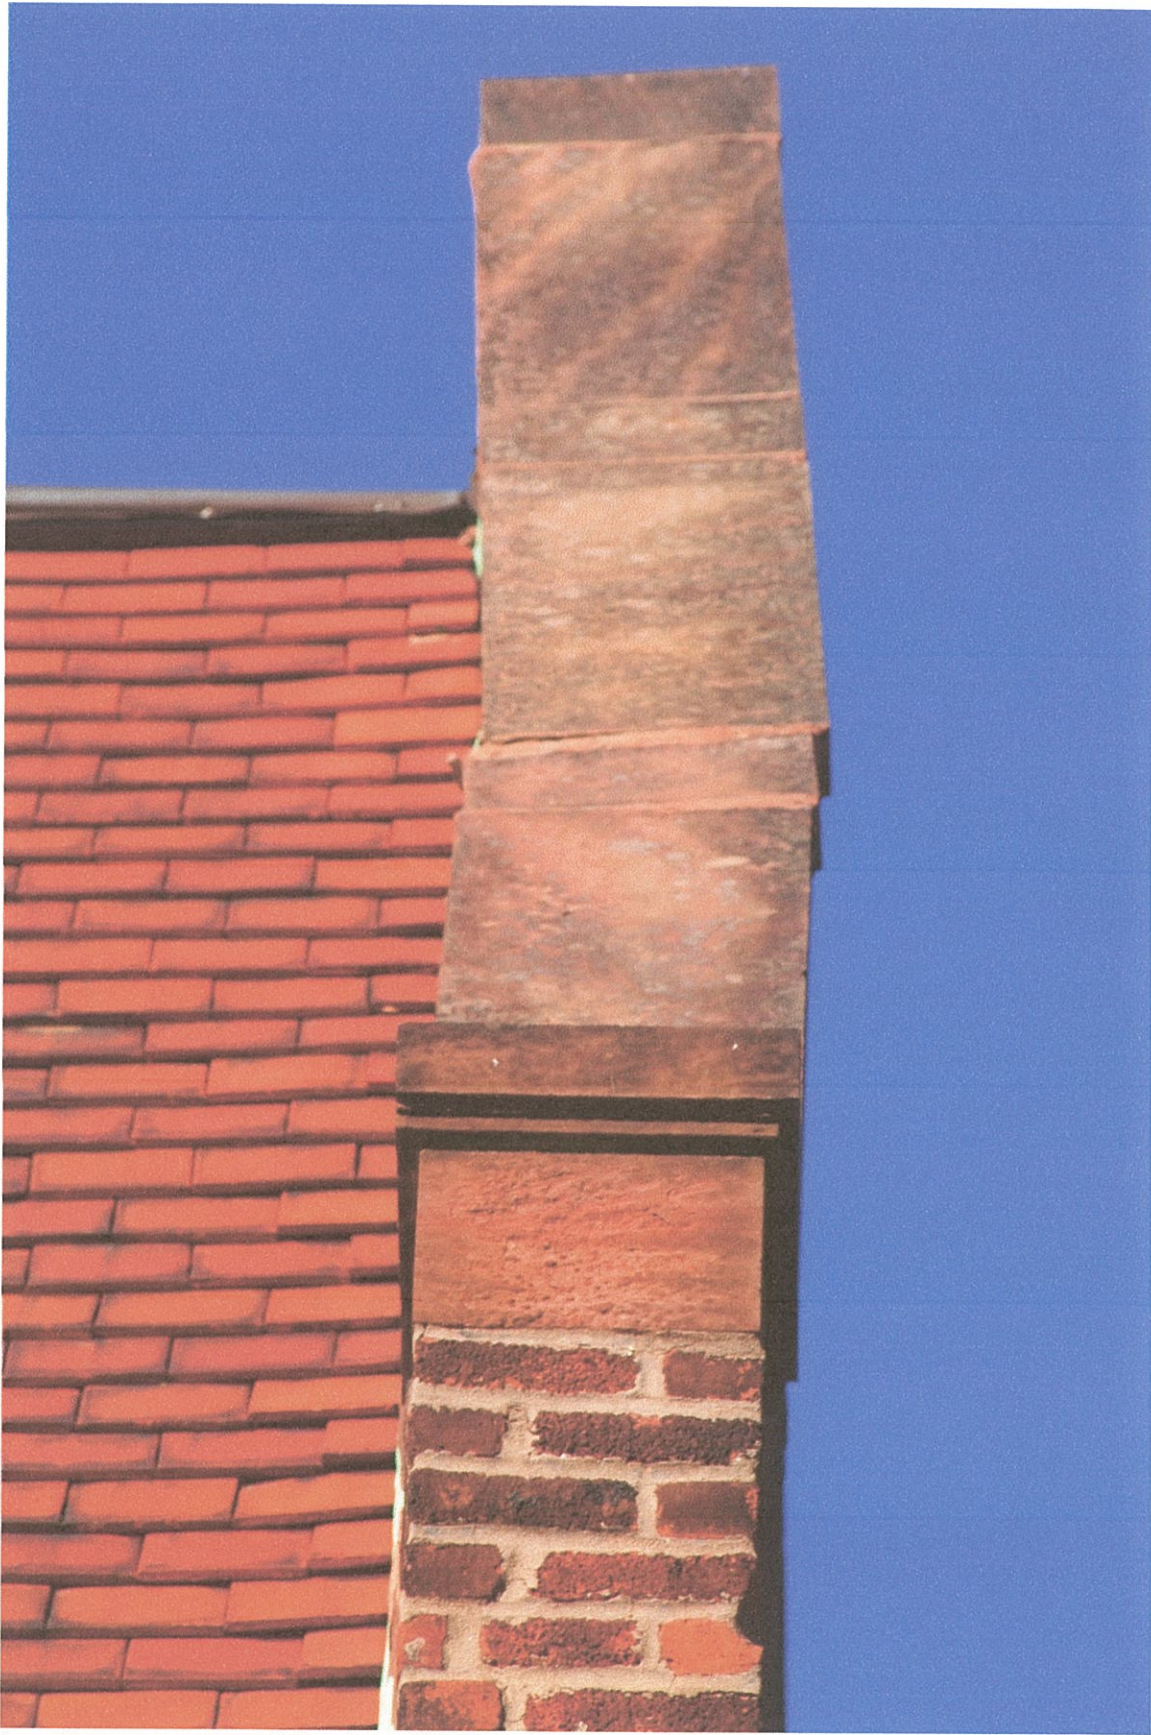
Leaning parapet and displaced gable coping – NE corner – Charles Allis House.
Condition is typical to all of the gables, but to varying degrees.

- At indicated house and garage gables, remove existing upper portion of gables and gable parapet walls down to sound masonry and reconstruction using salvaged face brick and new backup brick. Reset stone copings, providing stainless steel anchors at coping keystones. Repoint remaining portion of gable.

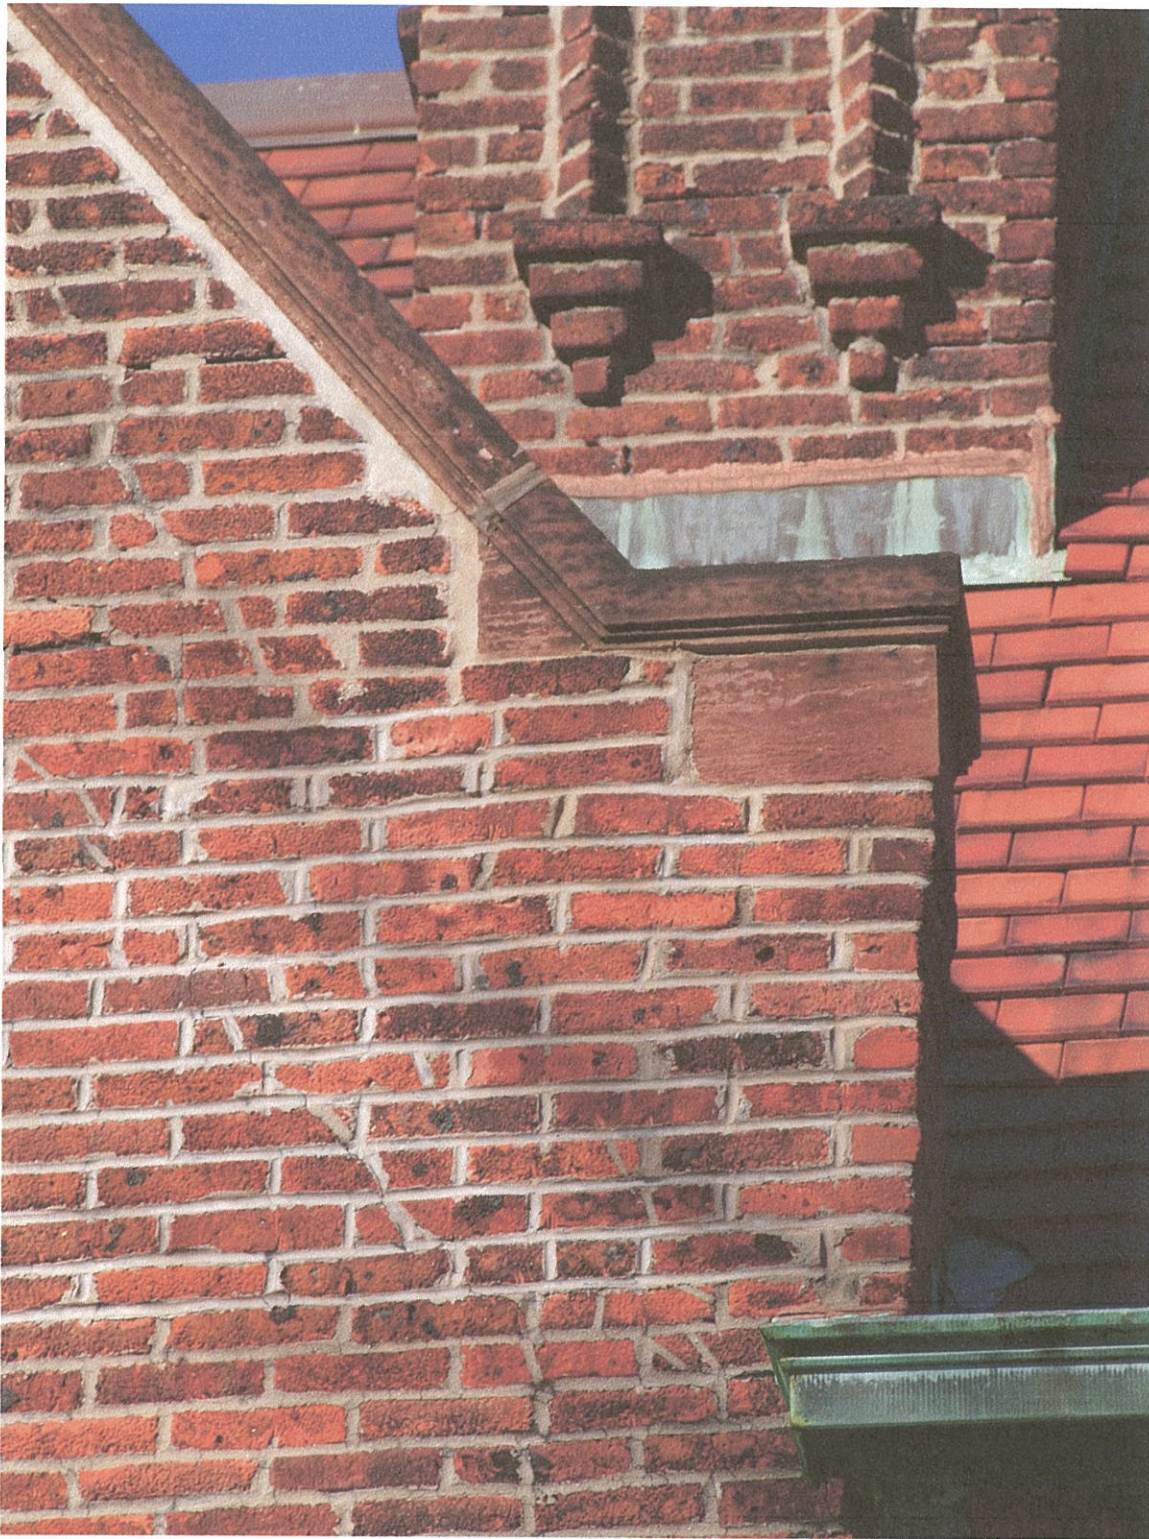
Cracked gable parapet walls – East Elevation, Charles Allis House. Condition is typical of all gables but to varying degrees. Note repaired cracks have re-cracked. Note condition of chimney in background.

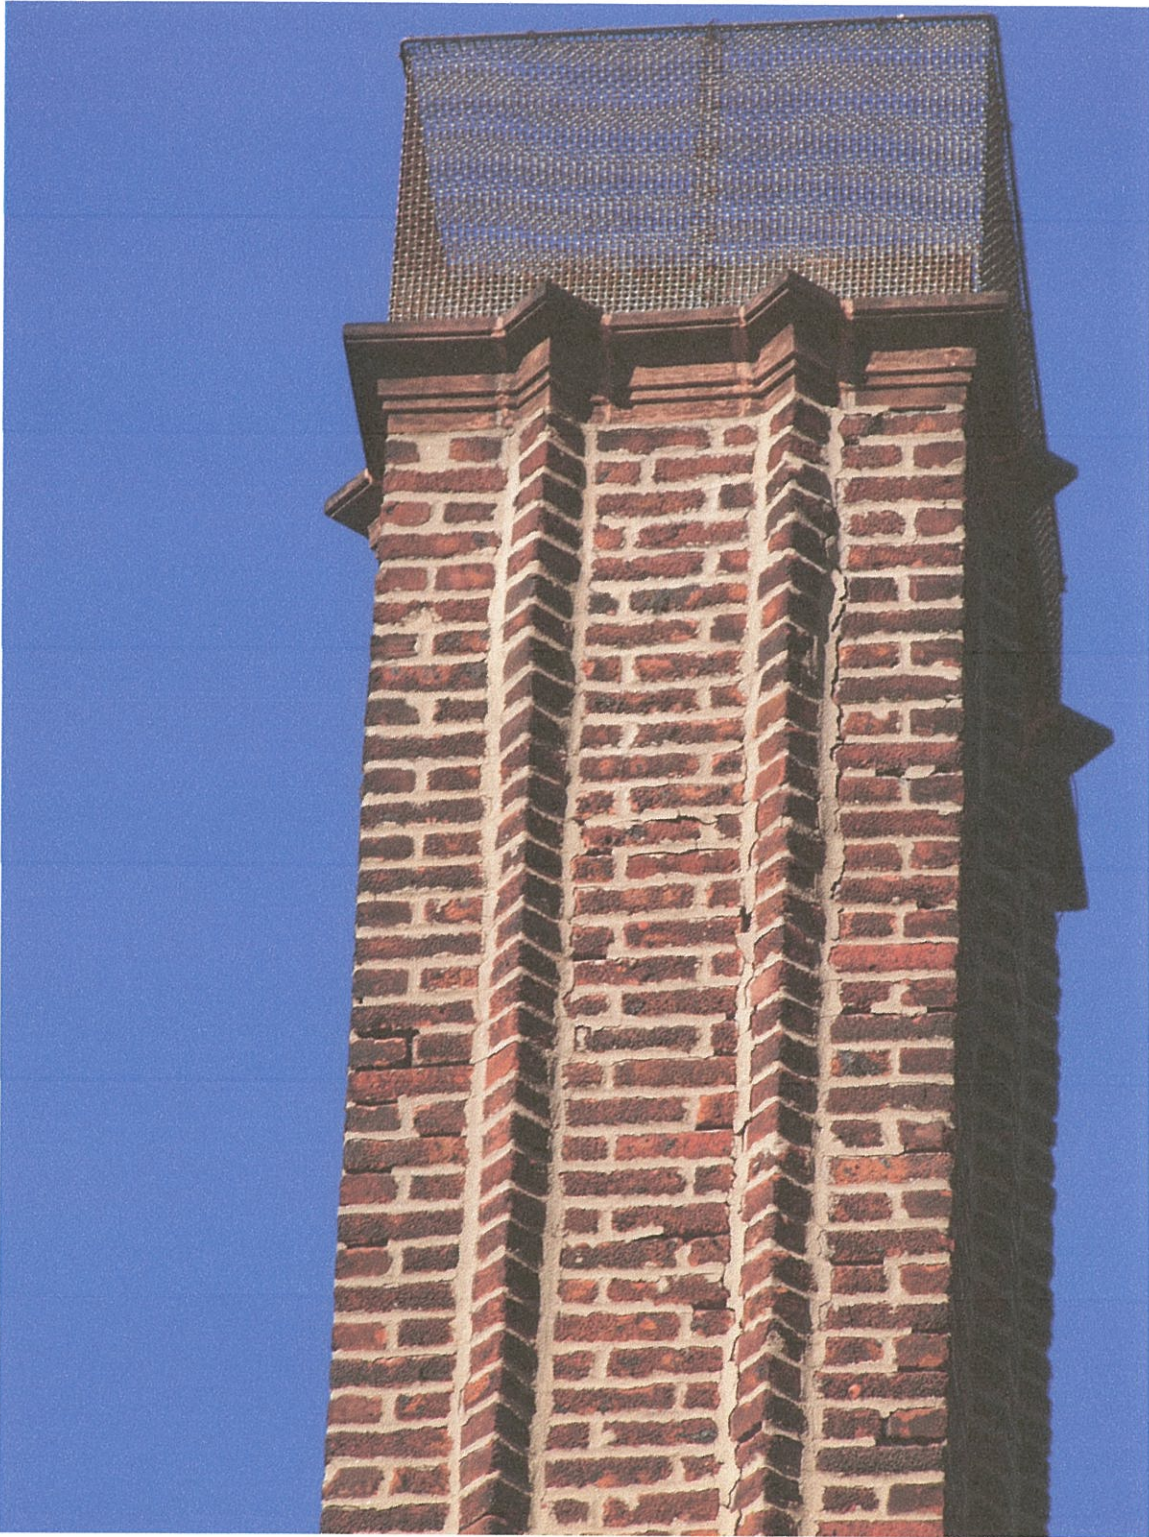
Typical Chimney Condition – East Chimney, East Elevation – Charles Allis House. Excessive spalling of hard grey pointing mortar and join cracking with brick displacement of stacked rotated brick accents.

- At house, repoint and repair the above roof portion of chimneys. Remove metal cages from chimneys and provide lead coated copper covers over chimney caps and vented caps over the unused flues.

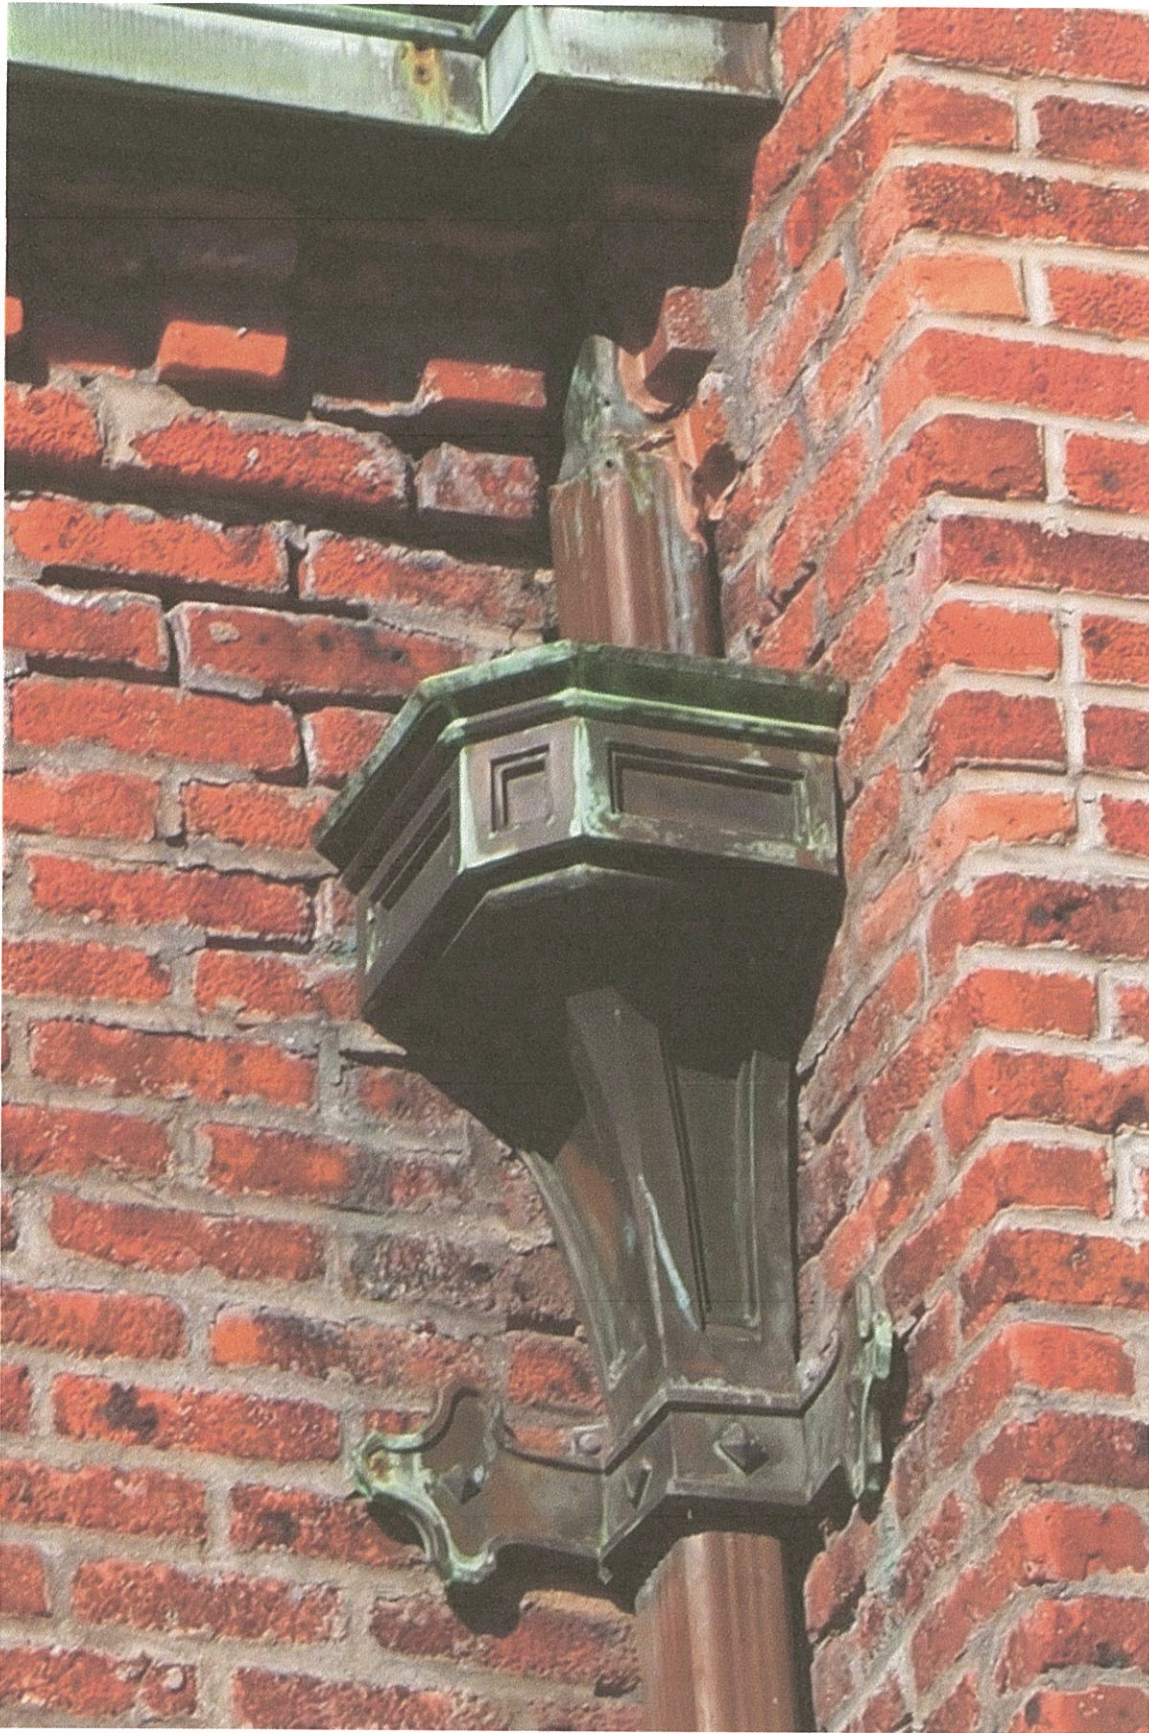
Mortar Deterioration at Downspouts, South Elevation – Charles Allis House. Typical at all downspouts.

- At house and garage, repoint brick immediately behind downspouts while downspouts are temporarily removed for repairs or replacement.
- At the garage, repoint, repair, or reconstruct the parapet walls surrounding the flat roof.

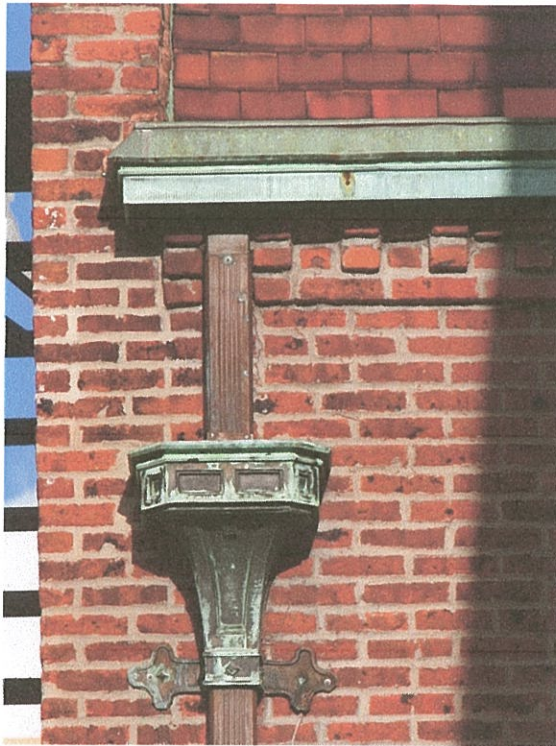
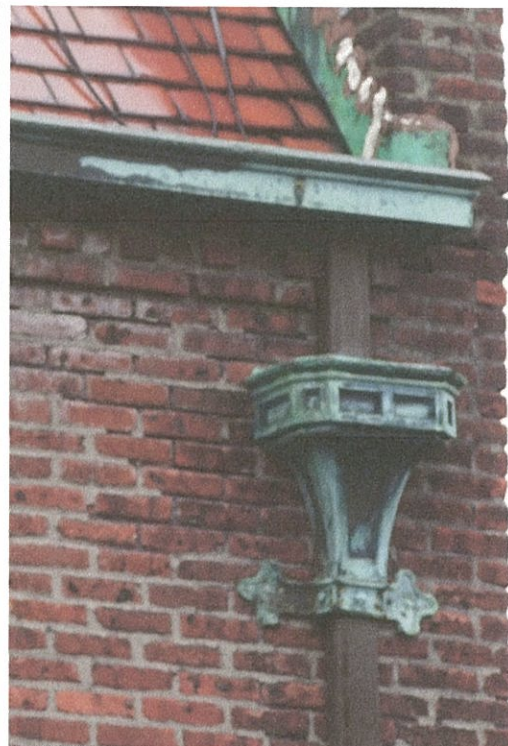
Existing Gutters – SE & NW Corners of Charles Allis House. It is proposed to raise the outer lip of the remaining unrepaired gutters to reduce the occurrence of rain runoff overflows which are contributing to the deterioration of the masonry immediately below and further downstream of the gutters. The previous gutter work was accomplished in the 1990s as part of the previous restoration work.

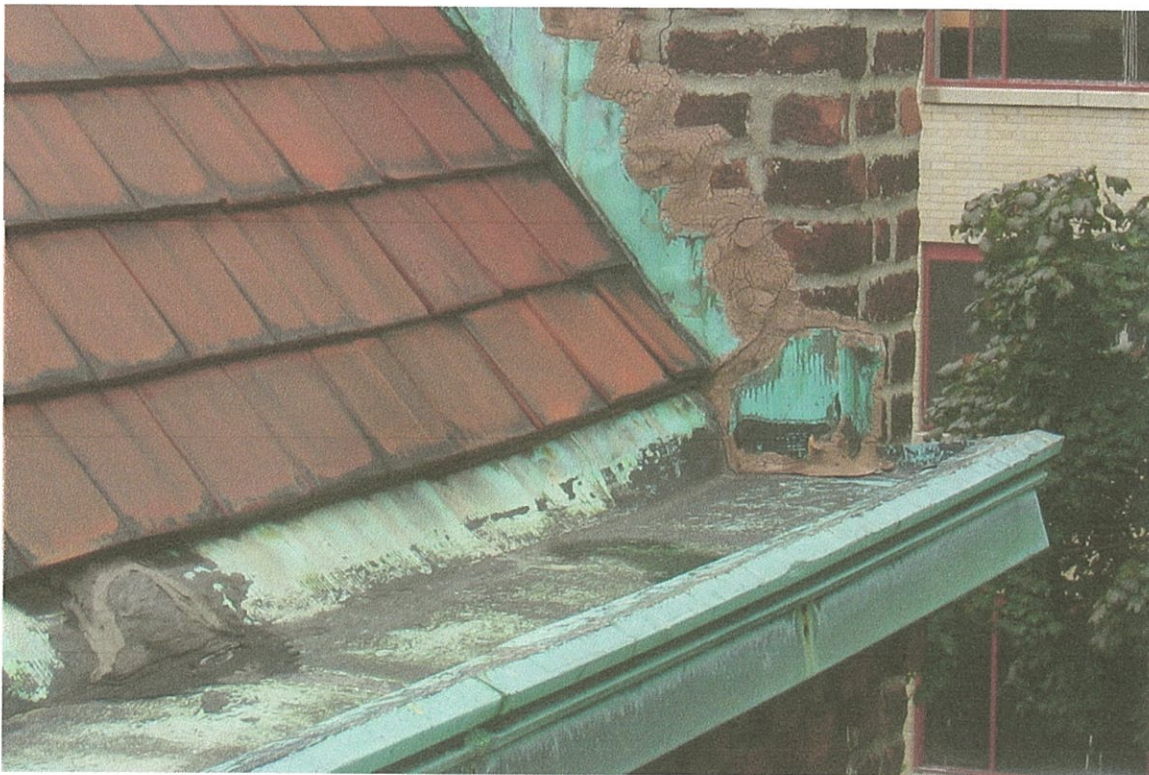
1.5" Deep Gutter at Termination - East Elevation, Charles Allis House

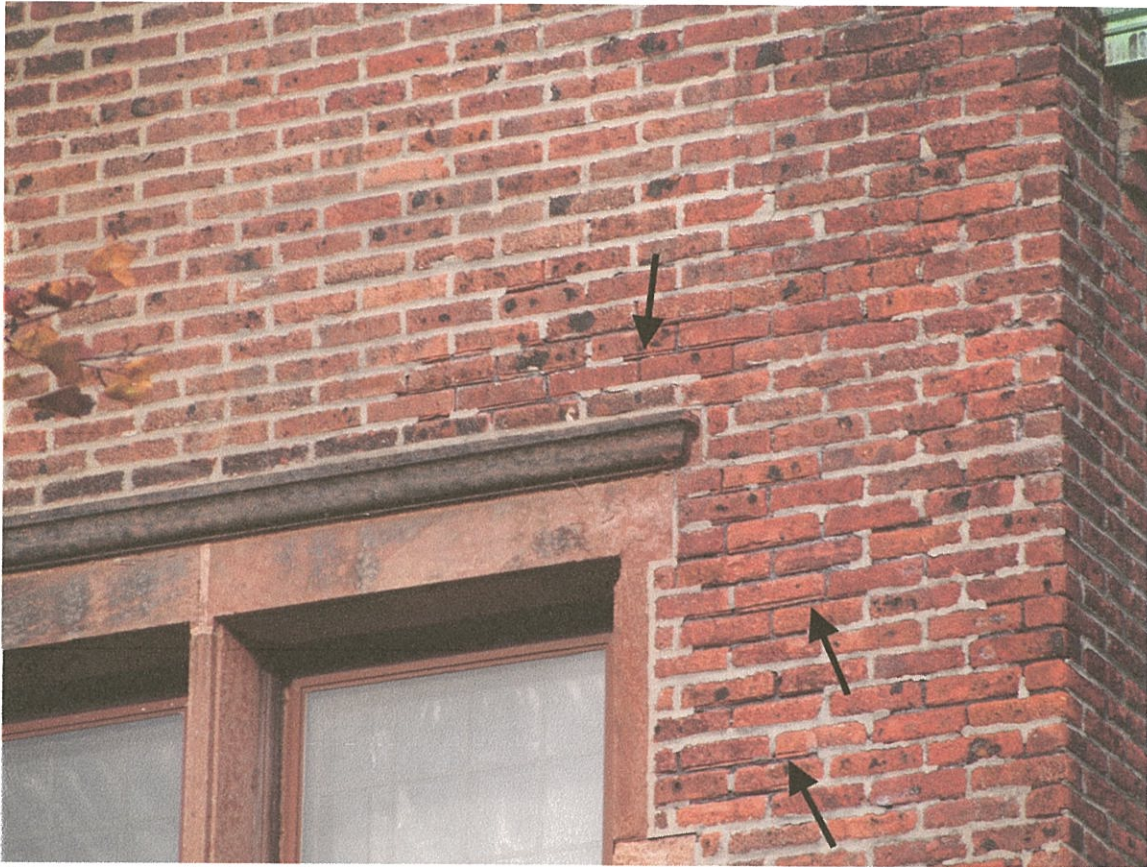
SE Corner – Charles Allis House. Wind blown runoff has repeatedly deteriorated the masonry in this area. Note the overcut bricks from a previous repointing project.

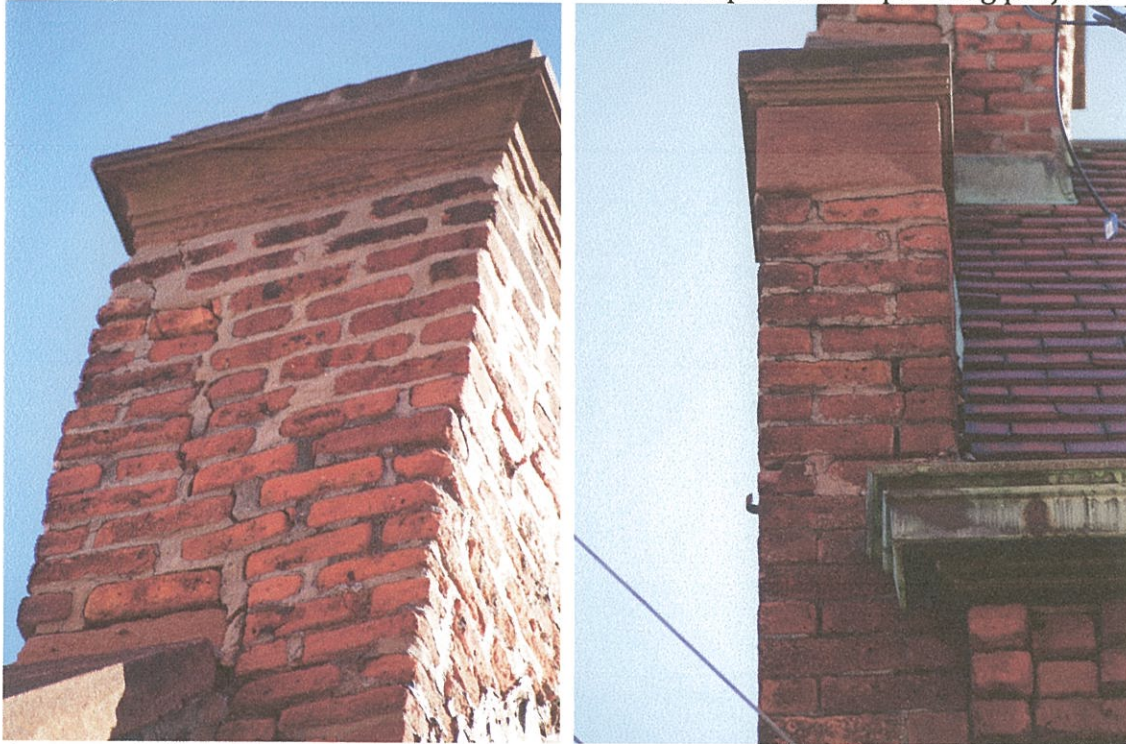
Garage North Gable & Chimney Deterioration – Charles Allis House. The leaning of the gable and chimney, along with the cracks, brick displacement required reconstruction of these elements.

- At garage north elevation, remove existing upper portion of gable, gable parapet wall, and chimney down to sound masonry and reconstruction using salvaged face brick and new backup brick. Reset stone copings, providing stainless steel anchors at coping keystones. At the reconstructed chimney, provide lead coated copper covers over chimney caps and vented caps over the unused flues.

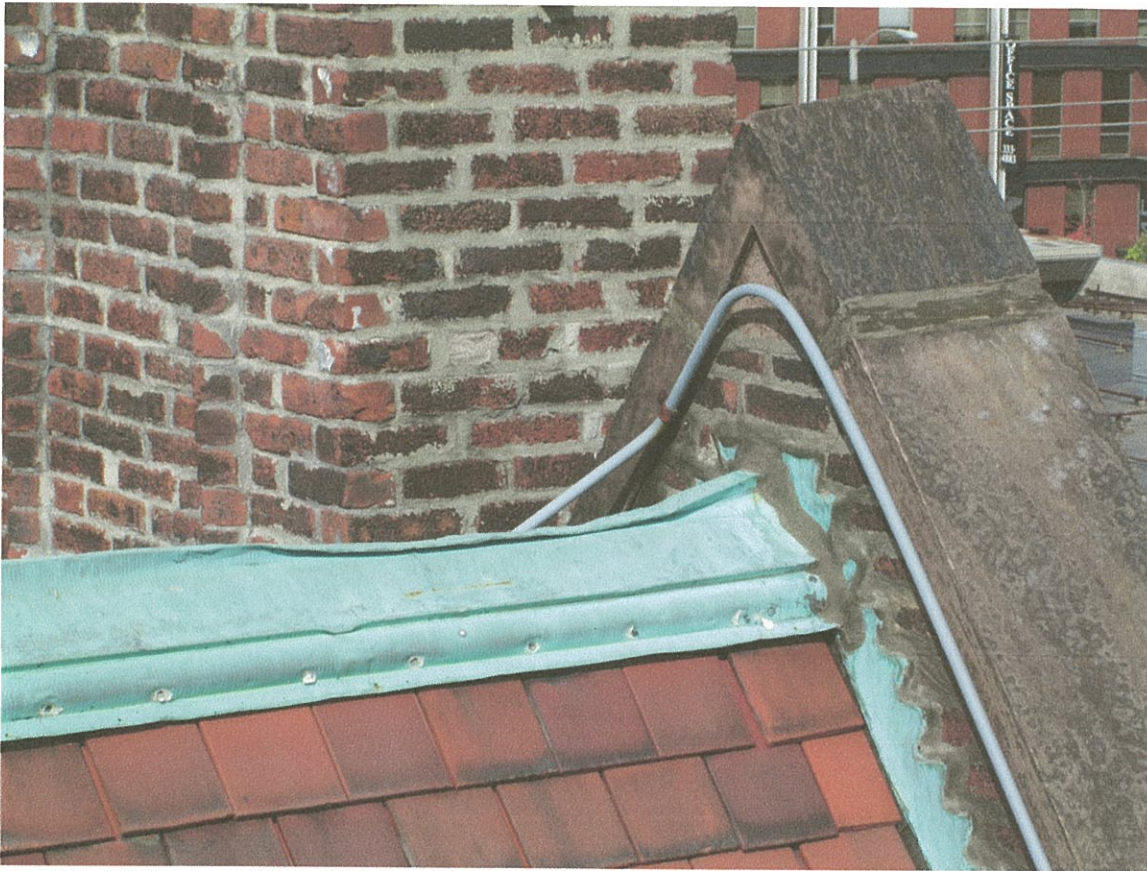
Crushed & Loose Ridge Cap – NW corner of Charles Allis House. Note excessive use of sealant on flashing, brick, and coping.

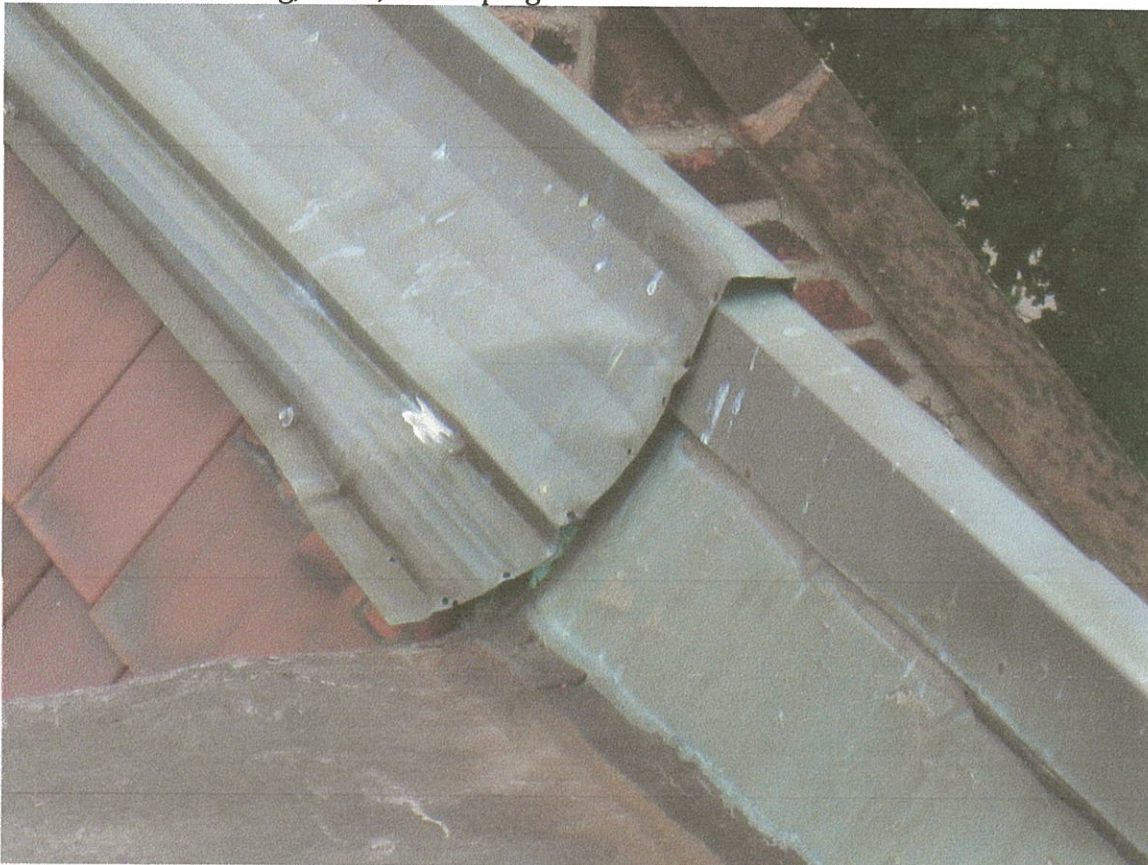
Loose Ridge Cap – NE Corner of Charles Allis House. A previous replacement, this cap was subsequently peeled open by wind or roof tile repair.
