Re: Pabst Sign Support Bridge Structure Review
Milwaukee, WI

Pierce Engineers, Inc., (PE) performed a site visit of the **Pabst Sign** support bridge over West Juneau Avenue at North 10th Street in Milwaukee, Wisconsin on May 19, 2025. The purpose of the site visit was to review visually the sign supporting steel truss bridge, decking, connections, and supports to provide our opinion regarding the condition of the structure and determine necessary repair work to preserve the structural integrity of the structure.

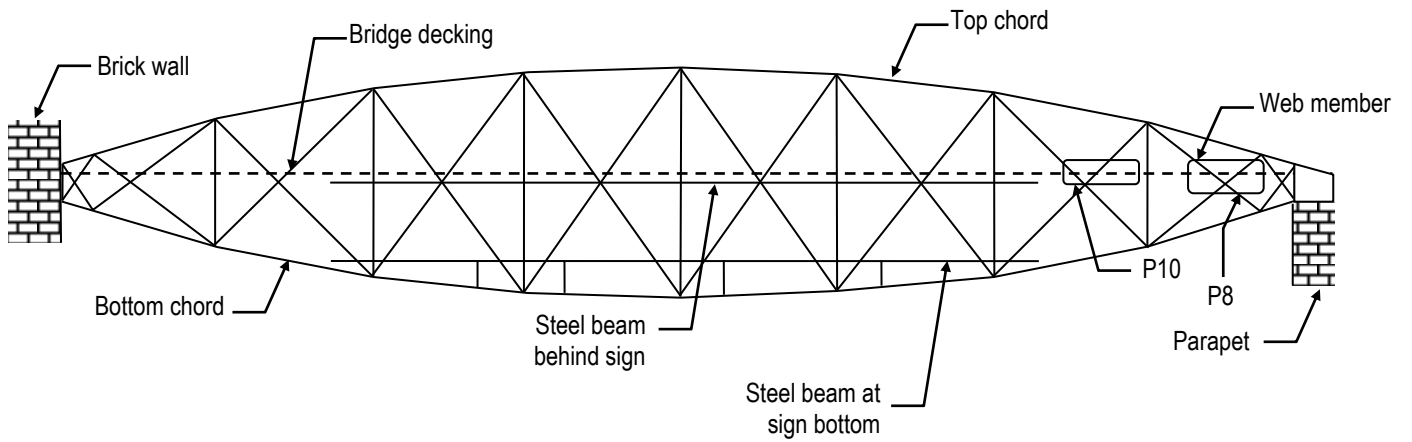
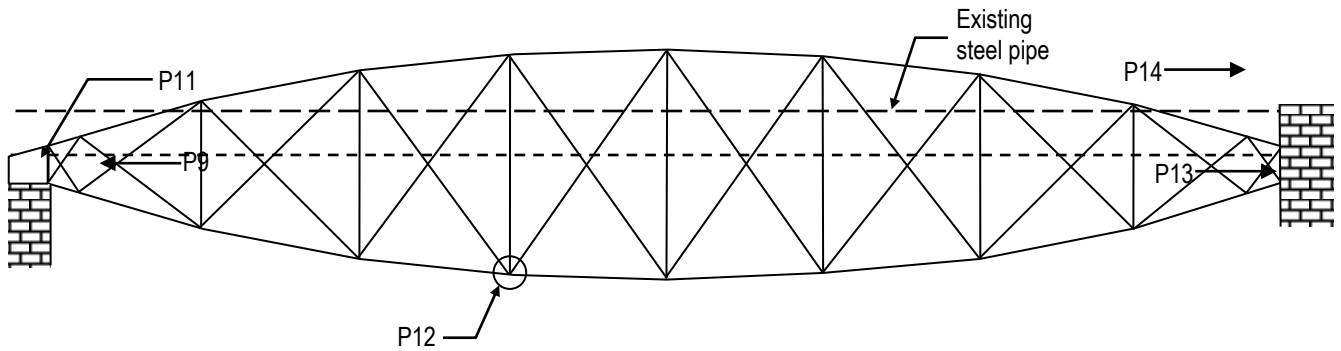
Figure 2: Pabst sign supporting longitudinal trusses

The existing bridge framing consists of 2 longitudinal steel trusses in the north-south direction connected by short transverse open-web steel joists in the east-west direction. These transverse open web steel joists support longitudinal steel beams that support wood beams and decking. Horizontal bracing in the form of rods with turnbuckles (below decking) and angle members (at the bridge bottom level) are provided for the lateral stability of the bridge. The schematics of the longitudinal trusses are provided in Figure 2.

with new plywood. Attached photographs P3, P4, and P5 illustrate these observations. Deck supporting wood joists have end decays at random locations. This observation is exhibited in the attached photographs P8 and P9. The cause of wood decay could be attributed to dry and wet states (related to moisture) due to their exposed condition. Some of the wood joists were noted with reinforcement in the form of wood side plates. These side plates are noted warping and detaching from the main joists. All joists are painted. This observation is shown in photograph P10. Overall, the wood decking and wood joists are in satisfactory condition. The locations of the above observations with corresponding photograph numbers are provided in the truss schematics in Figure 2.

Back-to-back double angles were used for both chord and web members in the construction of steel longitudinal trusses. In general, existing steel longitudinal trusses are in satisfactory condition with some minor issues, e.g., minor paint loss and member imperfections (bent angle legs) at random locations. These issues are shown in photographs P11 and P12. The Pabst Sign is supported on the east truss. A continuous pipe from Building 21 to Building 25 is supported along the west truss. The locations of the above observations with corresponding photograph numbers are provided in the truss schematics in Figure 2.

a) East truss (looking west)

b) West truss (looking east)

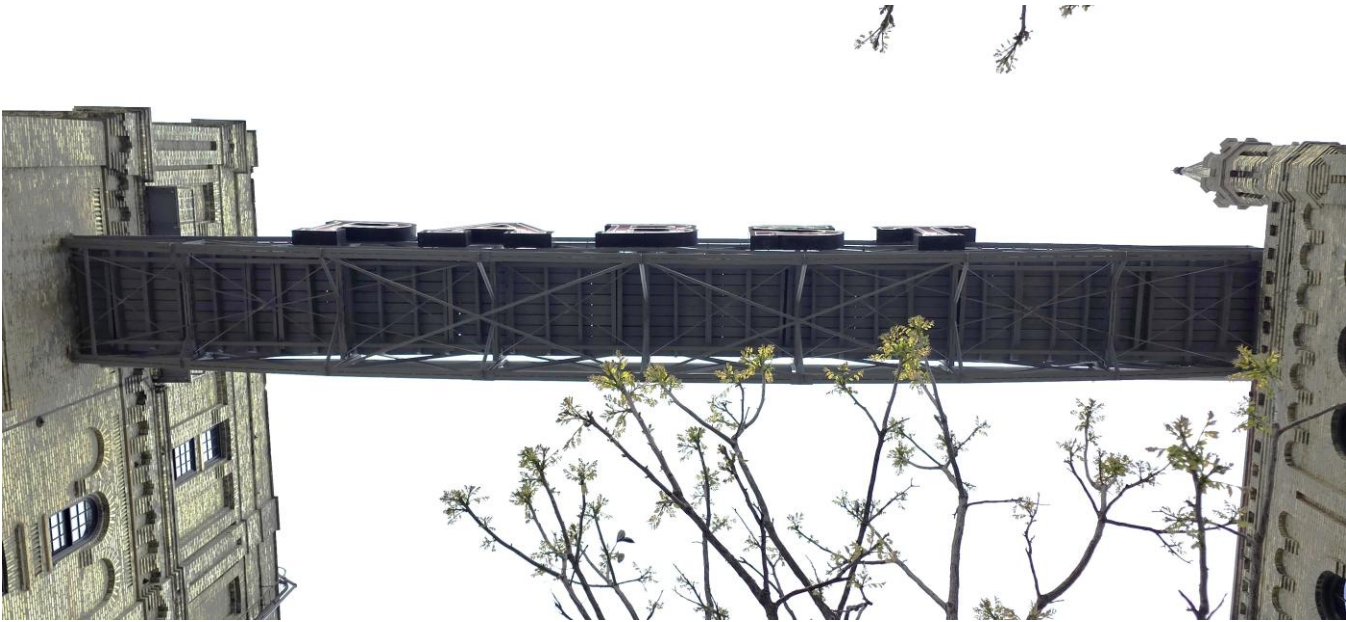
Existing wood decking spans in the north-south directions and is supported by the wood joists resting on steel beams. See attached photograph P4 showing the bridge framing construction. The wood decking previously noted with decay appeared to have been removed and replaced. The wood decking was noted with new paint and topped

P3 Pabst sign bridge (bottom view).

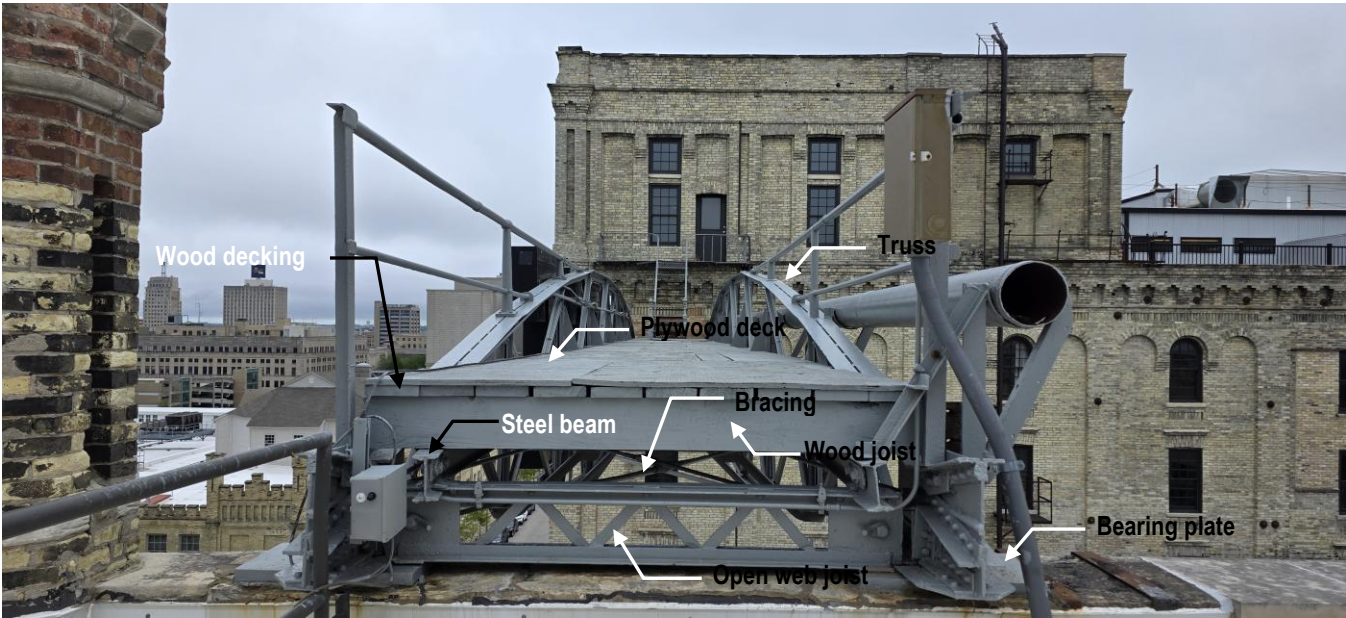
The top and bottom chords of the existing transverse open web steel joists spanning in the east-west direction were constructed using double angles (back-to-back). Steel bars were used as web members in these trusses (see photograph P4). These joists were noted with new paint. In general, these existing steel transverse joists are in satisfactory condition.

P4 Pabst sign bridge decking (looking south).

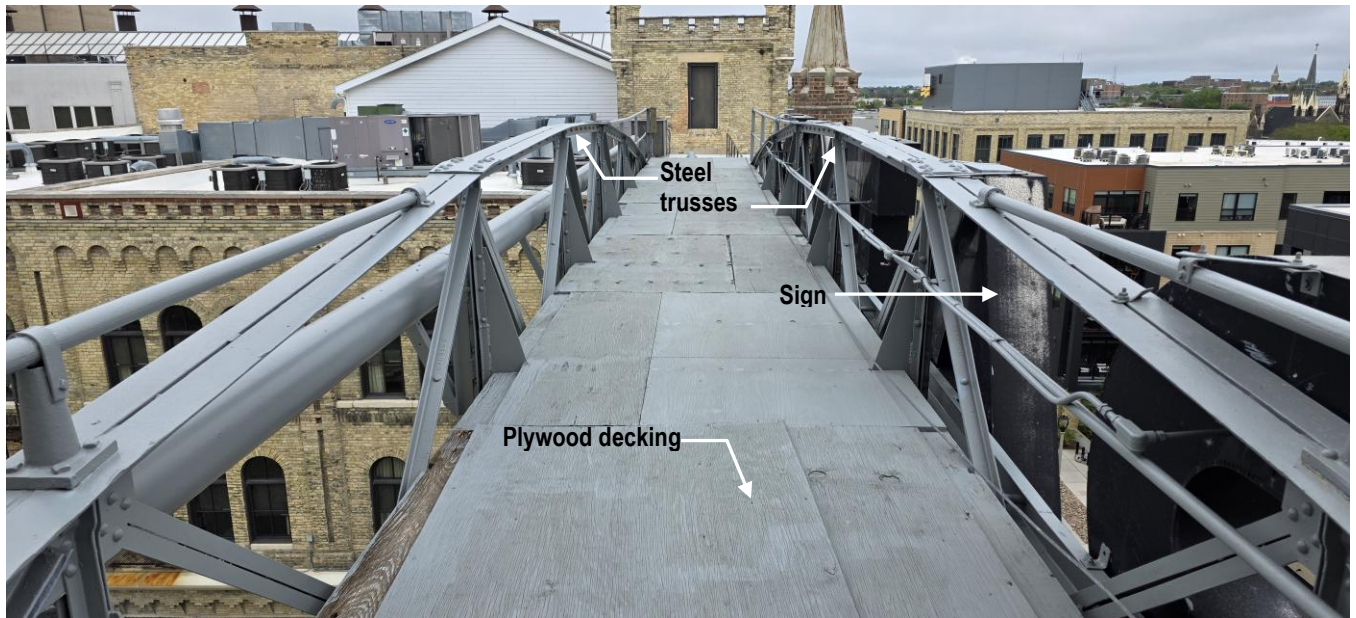
P5 Pabst sign bridge decking (looking north).

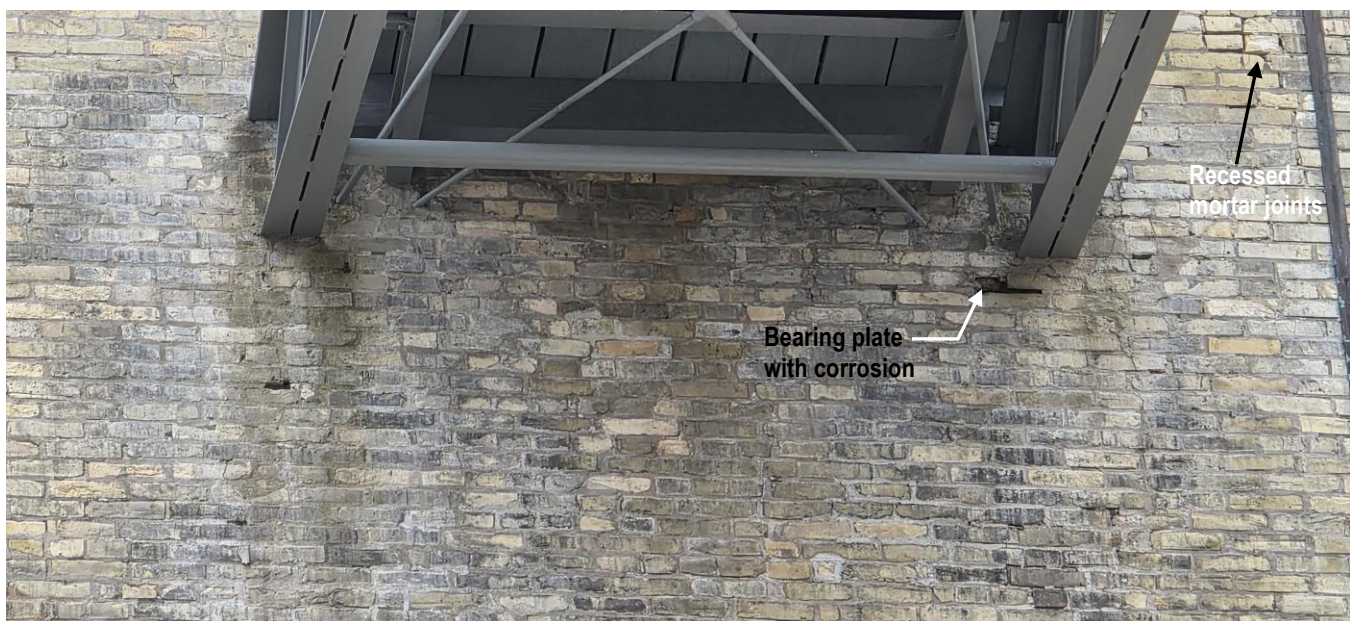
The south ends of the bridge trusses are embedded into existing exterior brick masonry. Mortar loss, minor cracks, and minor corrosion in steel bearing plate were noted in this wall and is shown in attached photographs P6 and P13. The north ends of the trusses are resting on steel bearing plates installed over the parapet stone coping (see photograph P7). Failing sealant was noted over the cracked joints. See attached photograph P11. The existing metal stair at the south end of the bridge rests on the bridge decking. This stair has missing and failing treads. Also noted was the corrosion in these remaining treads. This observation is illustrated in photograph P14.

P6 Pabst sign bridge south support end

Tuck pointing is recommended for the south wall area identified in photographs P6 and P13 supporting the south ends of the trusses. Prior to tuck pointing, remove all existing deteriorated and loose mortar up to one" in depth in the brick joints and clean. The tuck pointing detail is provided at the end of this report. At the north truss supporting ends, remove failing sealant, clean, and install new sealant at existing skyward stone cracks and mortar cracks. This repair will prevent moisture infiltration into the building wall.

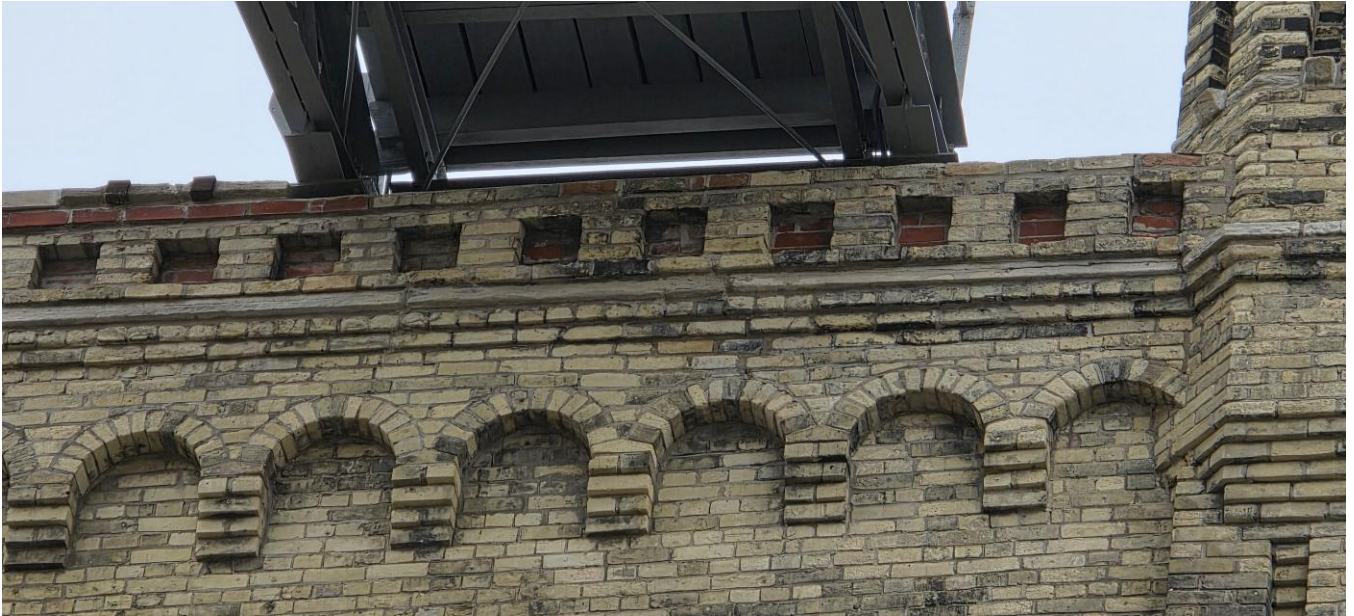
The different views (sides, bottom, and top) of bridge are provided in photographs P1 through P5. Note that the south ends of the bridge trusses are embedded into the exterior wall of building 25 and the north ends are resting on the parapet of building 21 as shown in Figure 2. Attached photographs P6 and P7 further illustrate these conditions.

P7 Pabst sign bridge north support end.

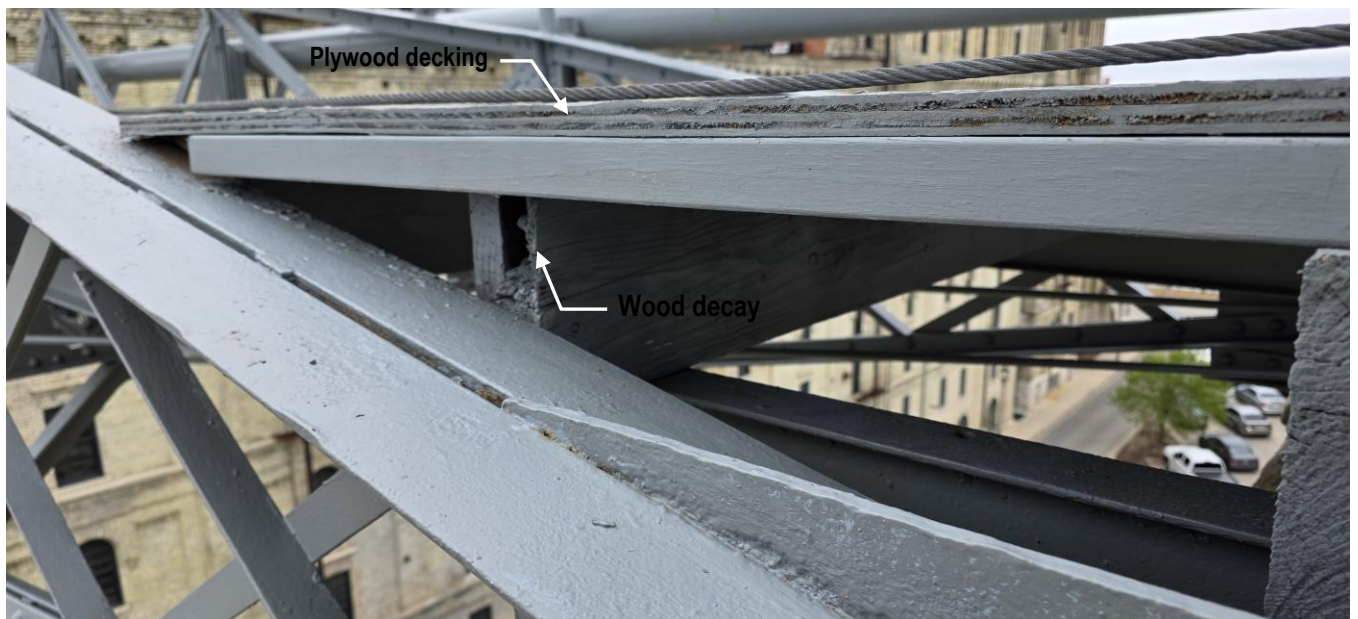
P8 Pabst sign bridge with end rotted wood joist (east elevation).

In general, the wood decking and joists are in satisfactory condition. Only monitoring for the decay growth is recommended for the joists with end decays.

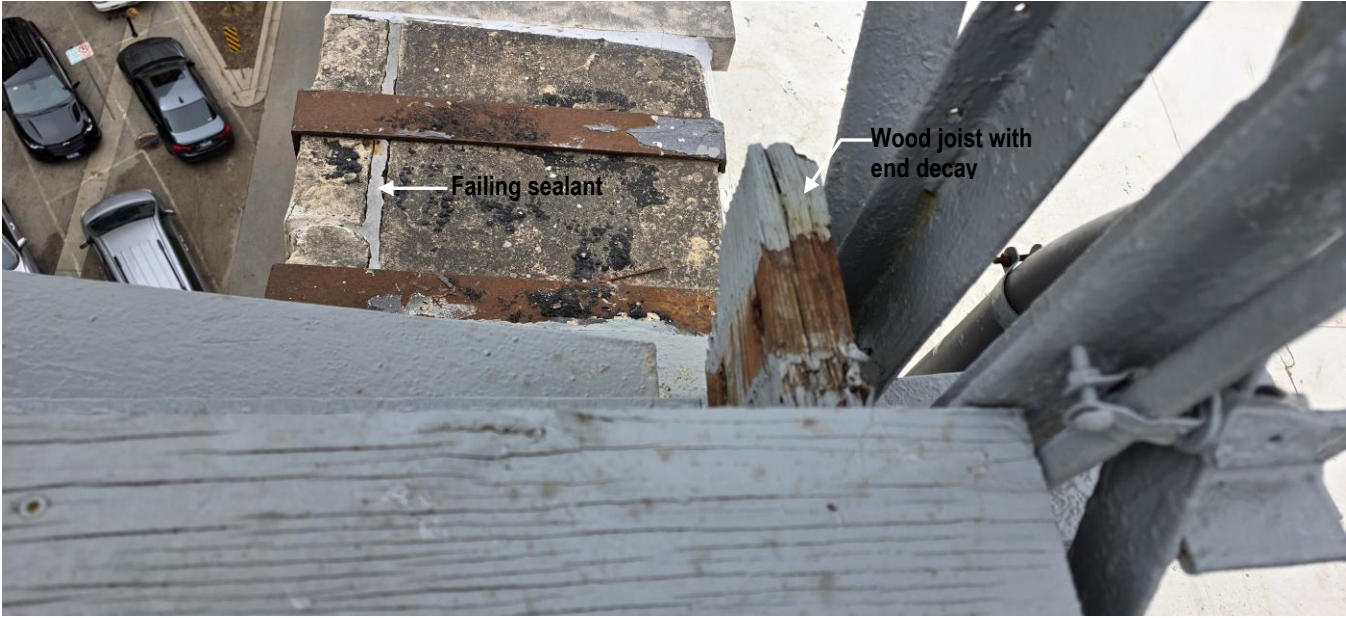
P9 Pabst sign bridge with end rotted wood joist (west elevation).

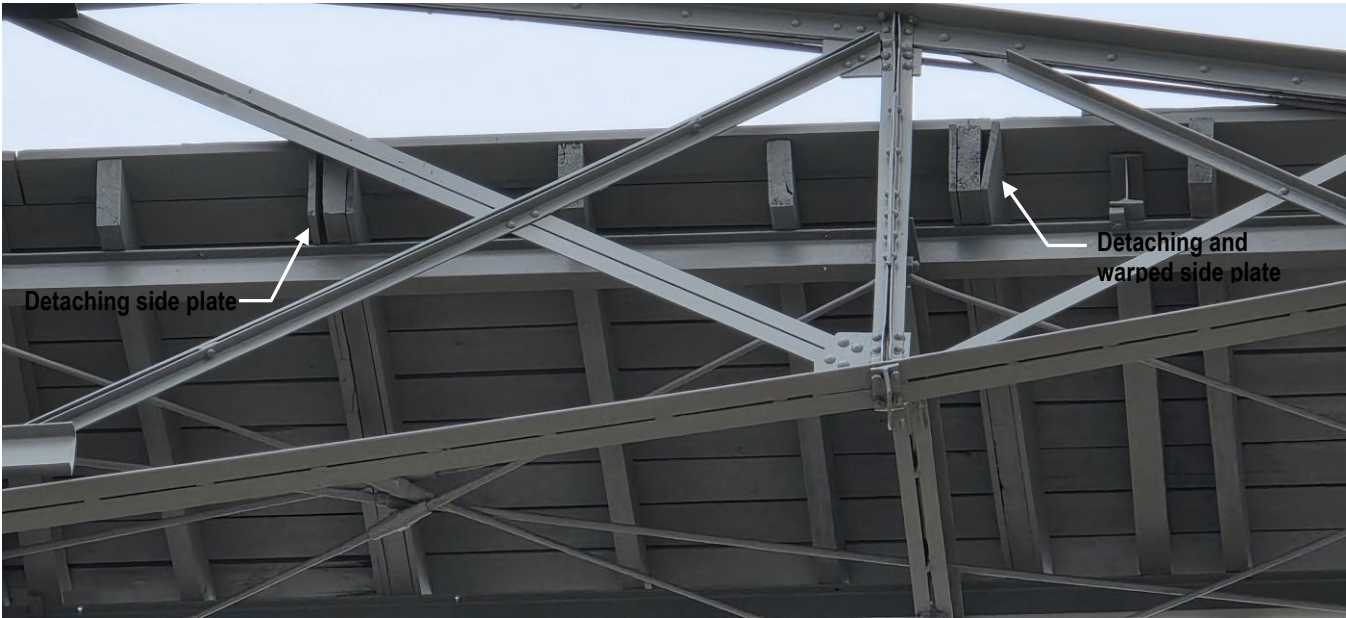
P10 Pabst sign bridge with detaching wood plates in wood joists.

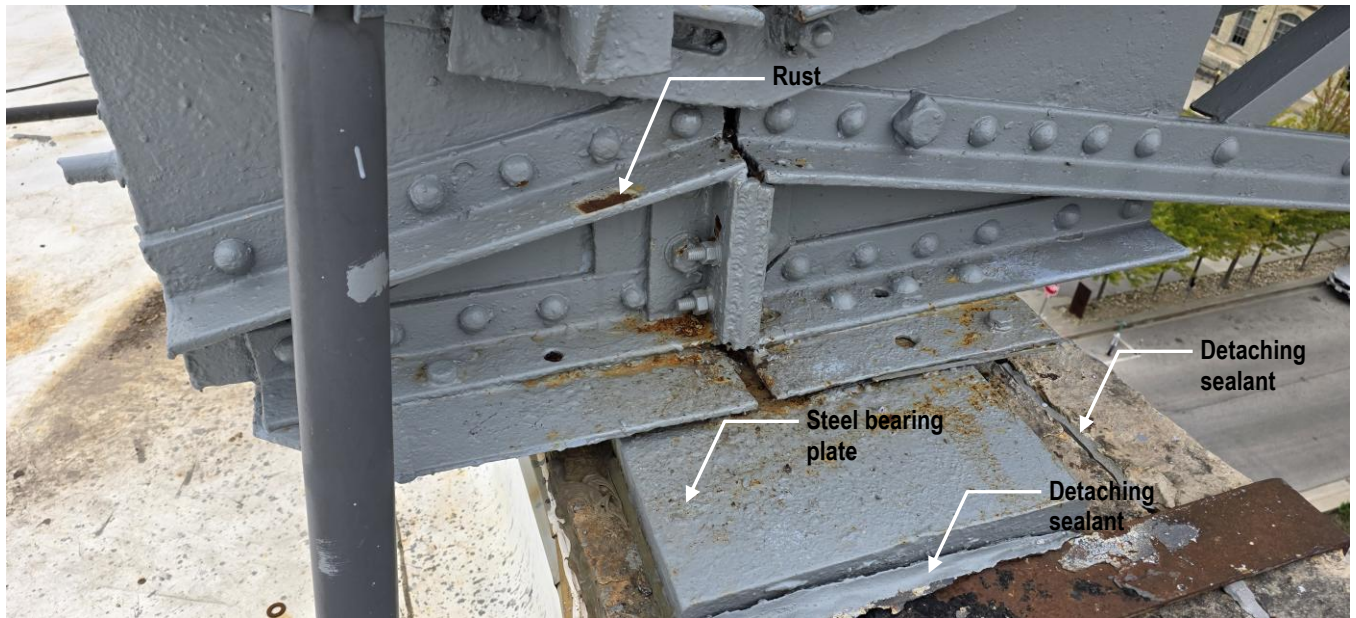
P11 Pabst sign bridge end support with a minor paint loss (north end).

All the main steel trusses and transverse open web joists including welded joints appeared to have been painted. A touch-up painting is only recommended where paint is lost or missed. Also, recommendation is made to clean the

loose rust deposits as shown in the photographs P11 and P12. If the existing south stair is still in use, this stair needs to be repaired. The repair will consist of removing and replacing failing treads, proper stringer connections to the deck, and reviewing existing landing framing for condition and adequacy. Cleaning and painting are also recommended.

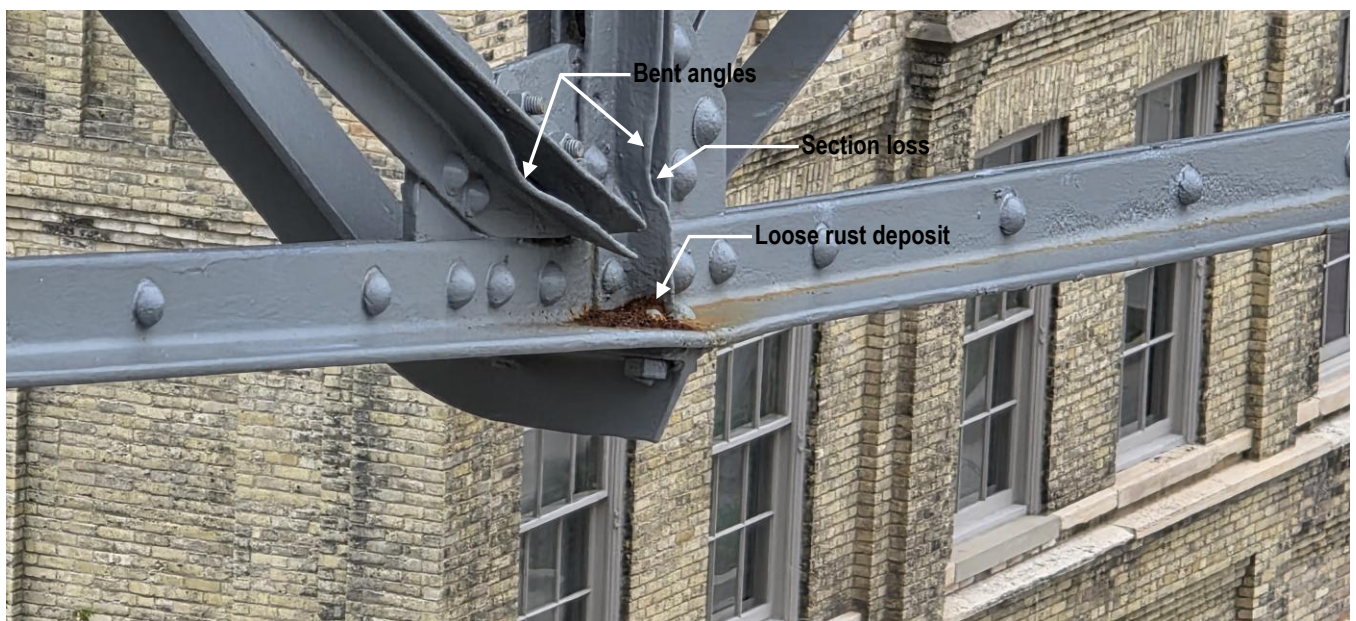
P12 Pabst sign bridge truss joint with bent angles, section loss, and loose rust.

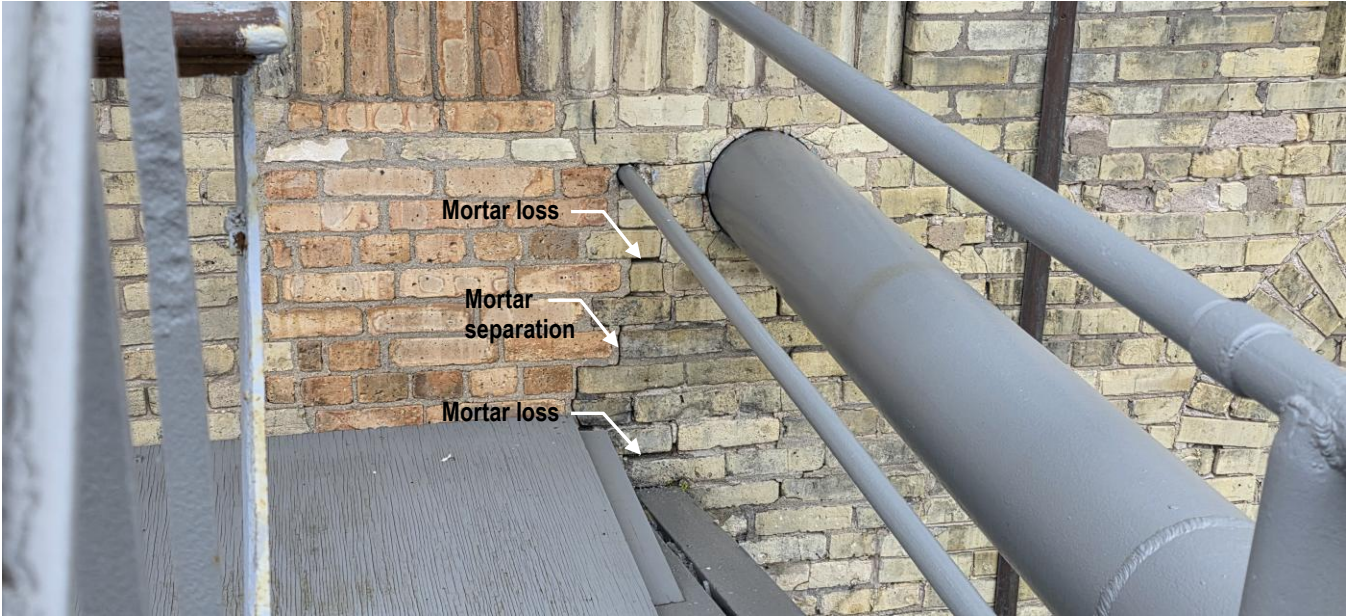
P13 Pabst sign bridge support with cracked and detached mortar joints (south end).

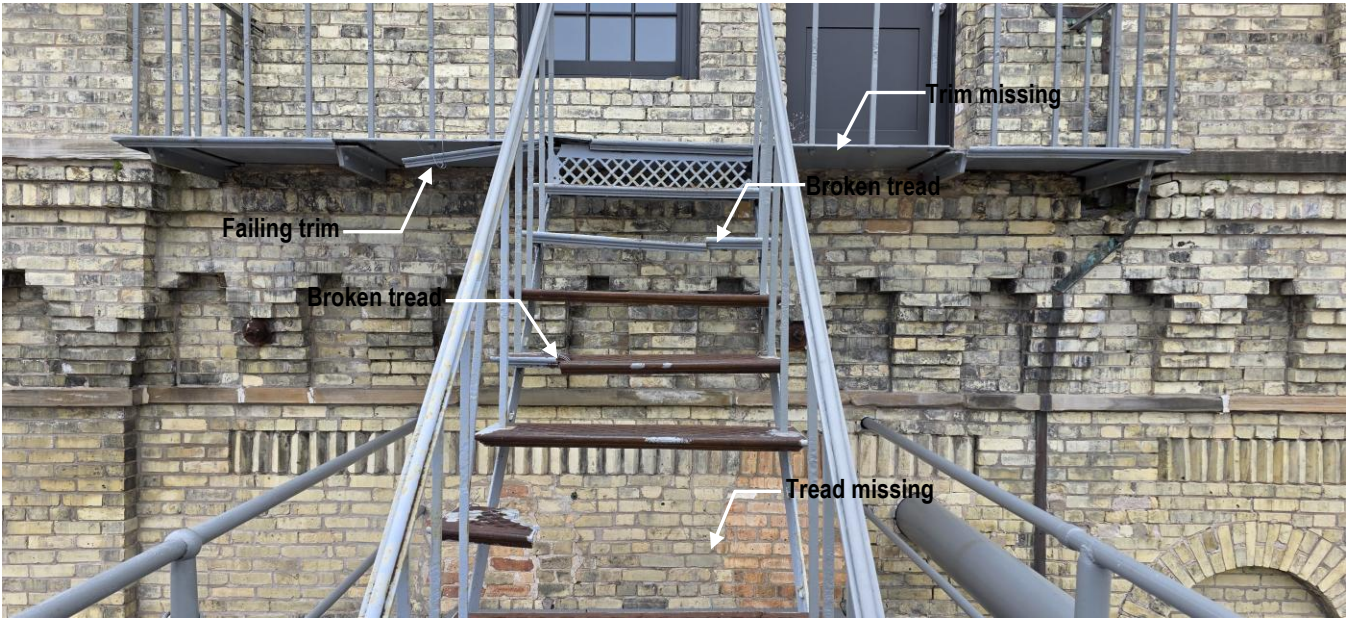
P14 Stair with missing and failing treads (south end).
