## Project Background

## Emergency Repair Projects South Elevation, West Gable

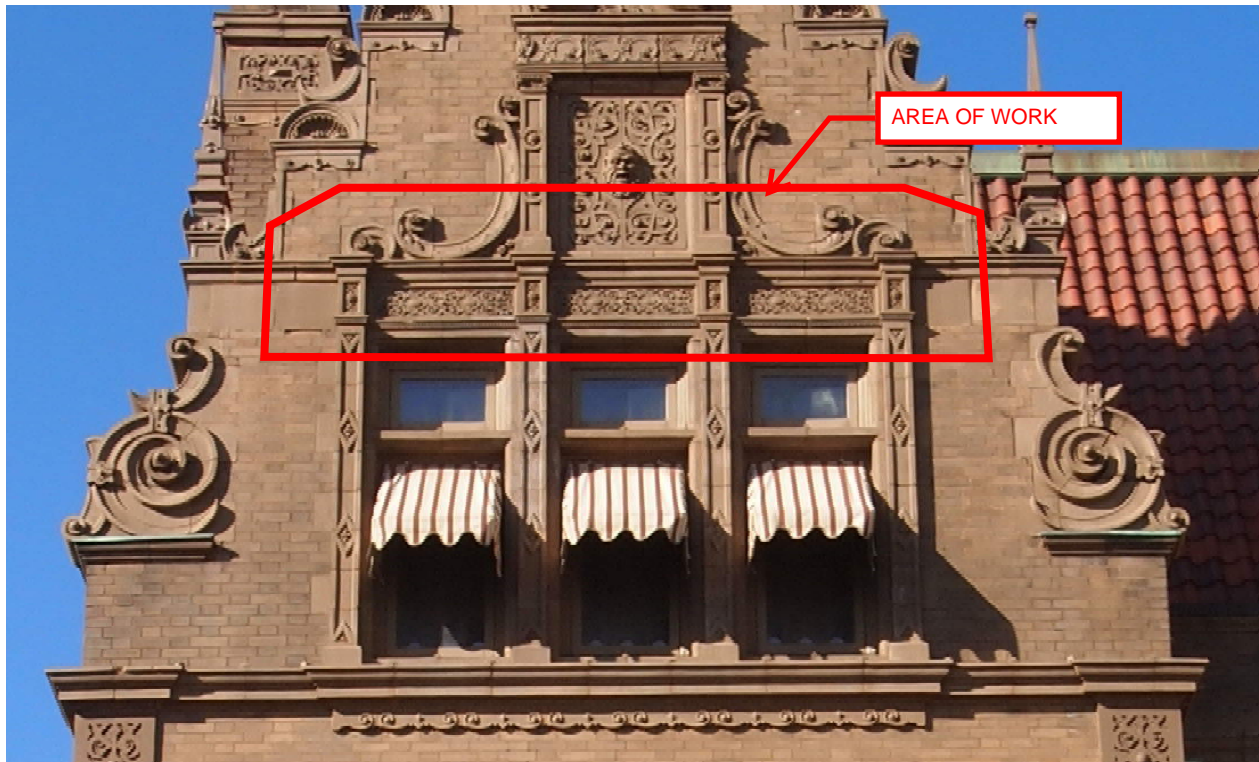
Goal: Stop water infiltration through masonry and wood brickmold over and around windows.

Tasks: Repoint terra cotta and brick at all exposed faces within indicated zone. Replace all damaged and failing sealant at brick mold around transom windows and at head of window below.

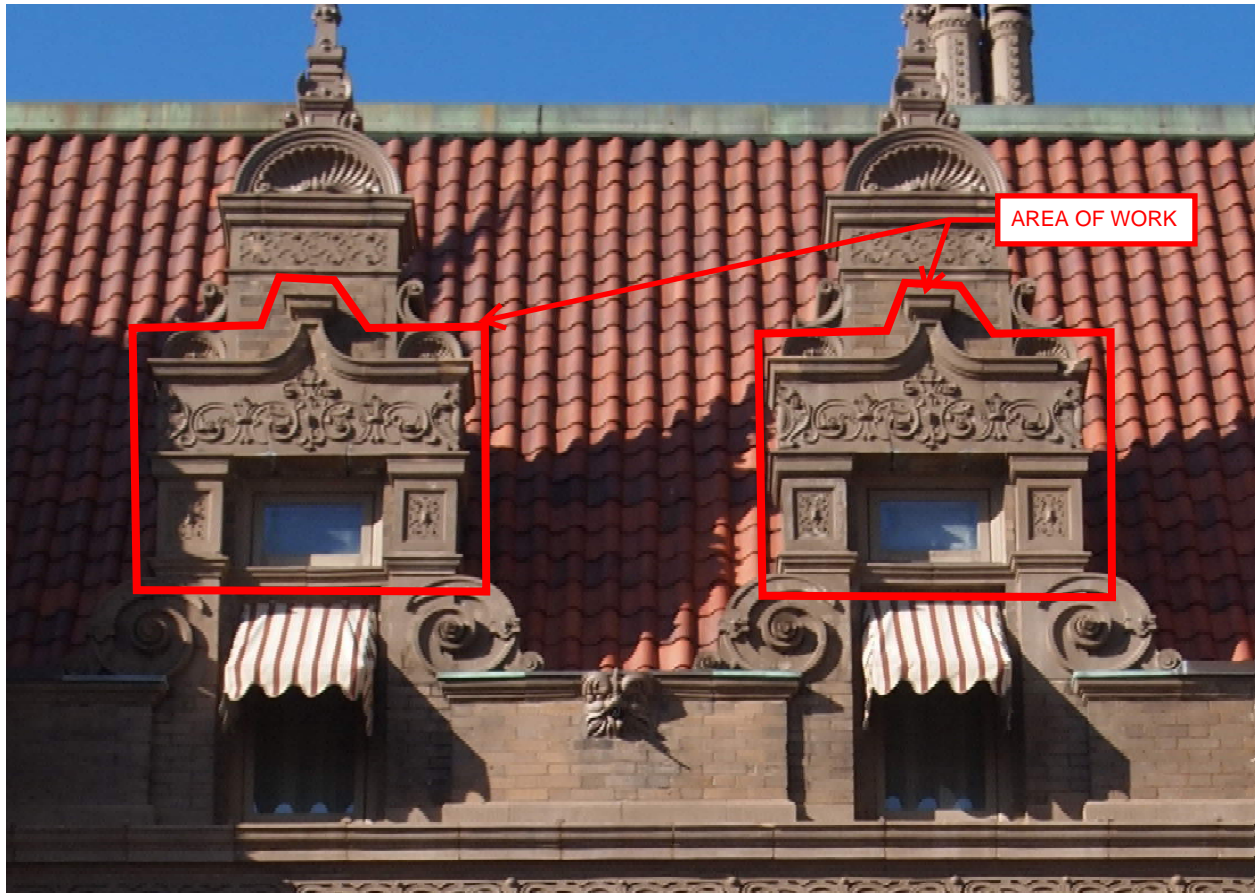
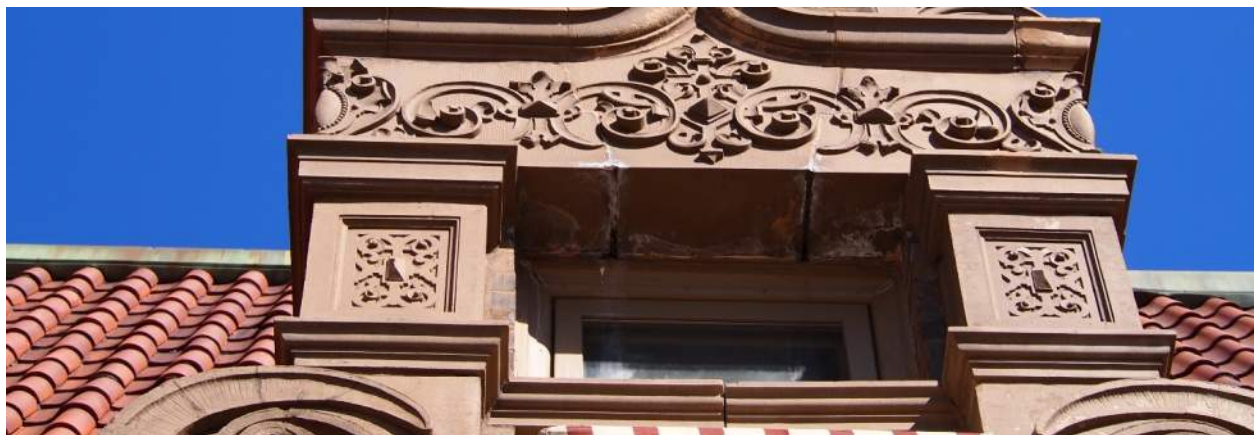
**South Elevation, Central Bay Dormers**

Goal: Stop water infiltration through masonry and wood brickmold over and around windows.

Tasks: Repoint terra cotta and brick at all exposed faces within indicated zone. Repoint open head joint at horizontal mullion providing elastomeric polyurethane with release tape backer to finish off repointed skyward joint. Replace all damaged and failing sealant at brick mold around transom windows and at head of window below.

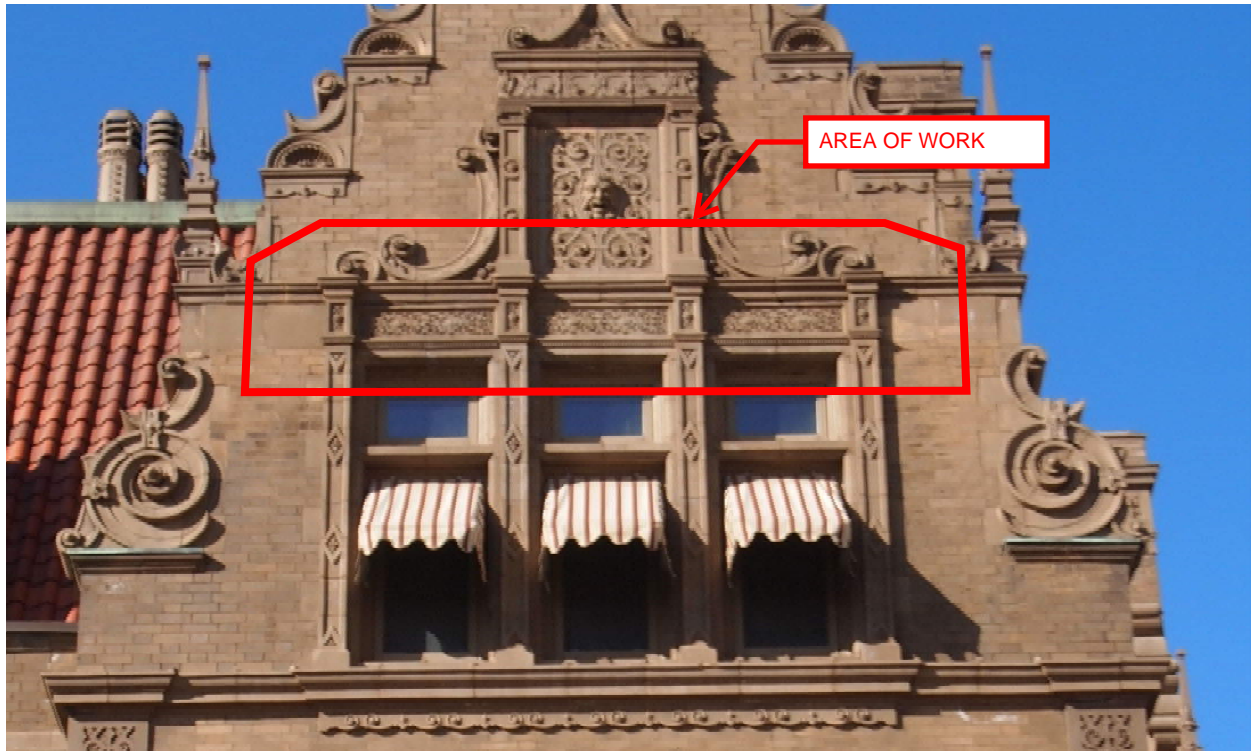
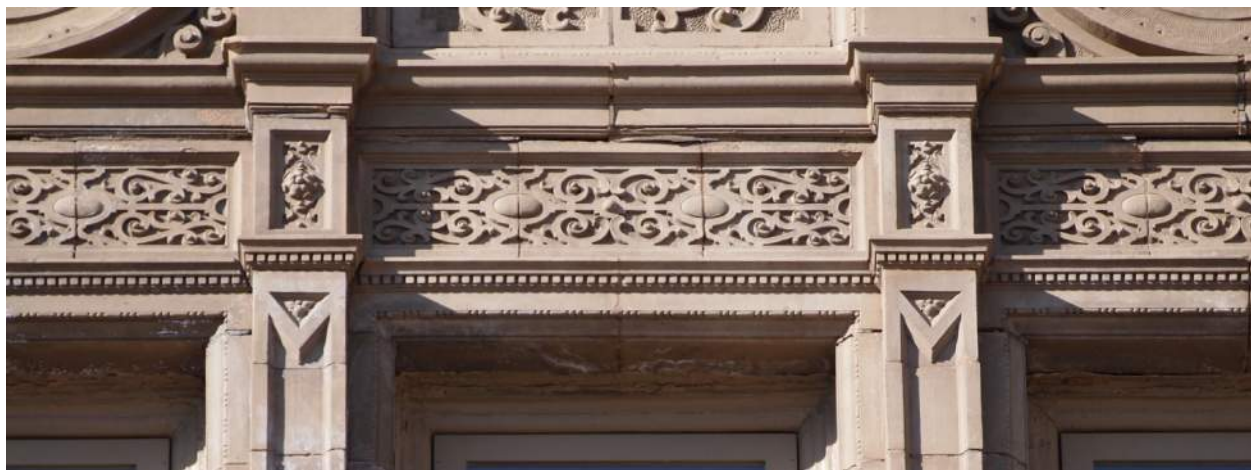
**South Elevation, East Gable**

Goal: Stop water infiltration through masonry and wood brickmold over and around windows.

Tasks: Repoint terra cotta and brick at all exposed faces within indicated zone, providing elastomeric polyurethane with release tape backer to finish off repointed skyward joints of belt course. Replace all damaged and failing sealant at brick mold at window heads.

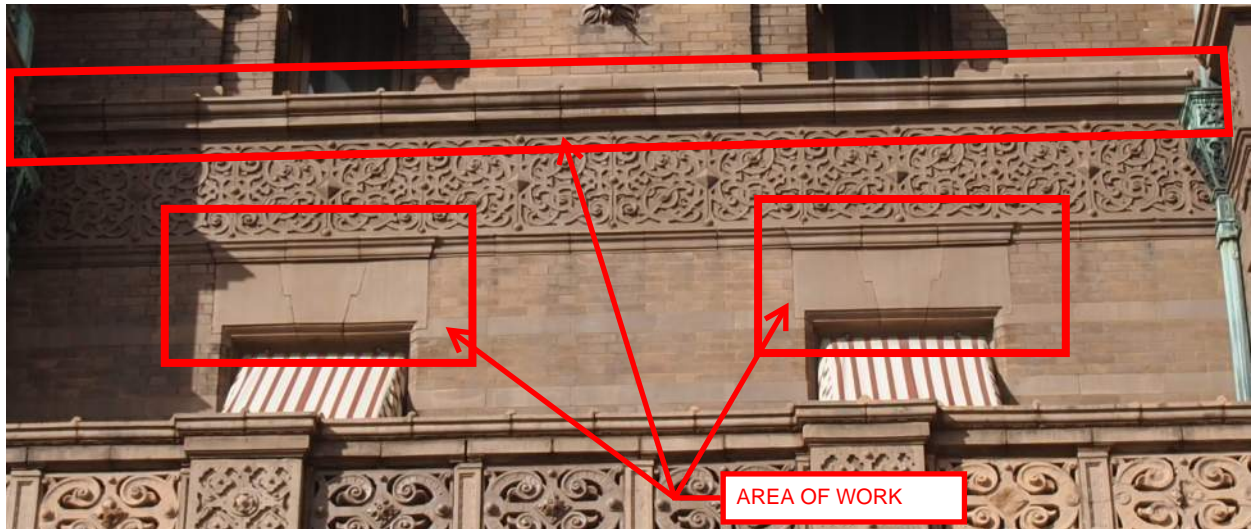
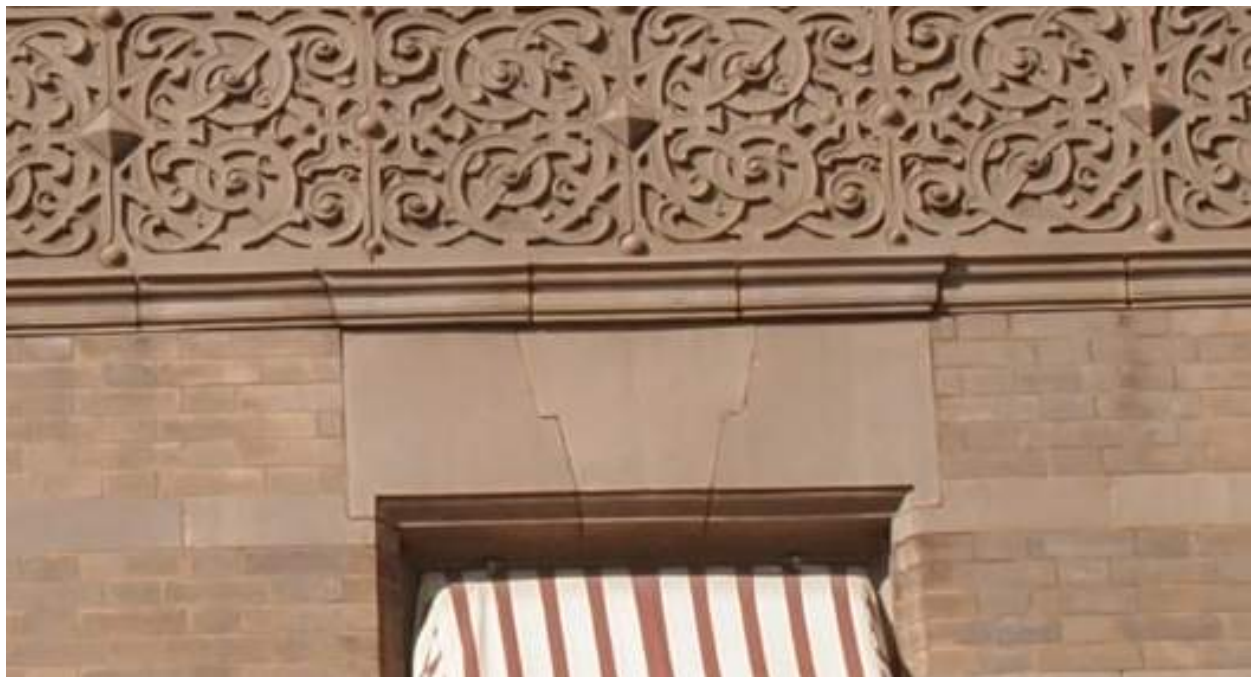
**South Elevation, Second Floor Center Bay Windows**

Goal: Stop water infiltration through masonry and wood brickmold over and around windows.

Tasks: Repoint terra cotta and brick at all exposed faces within indicated zone, providing elastomeric polyurethane with release tape backer to finish off repointed skyward joints of belt course. Replace all damaged and failing sealant at brick mold around single hung window heads and upper jambs.

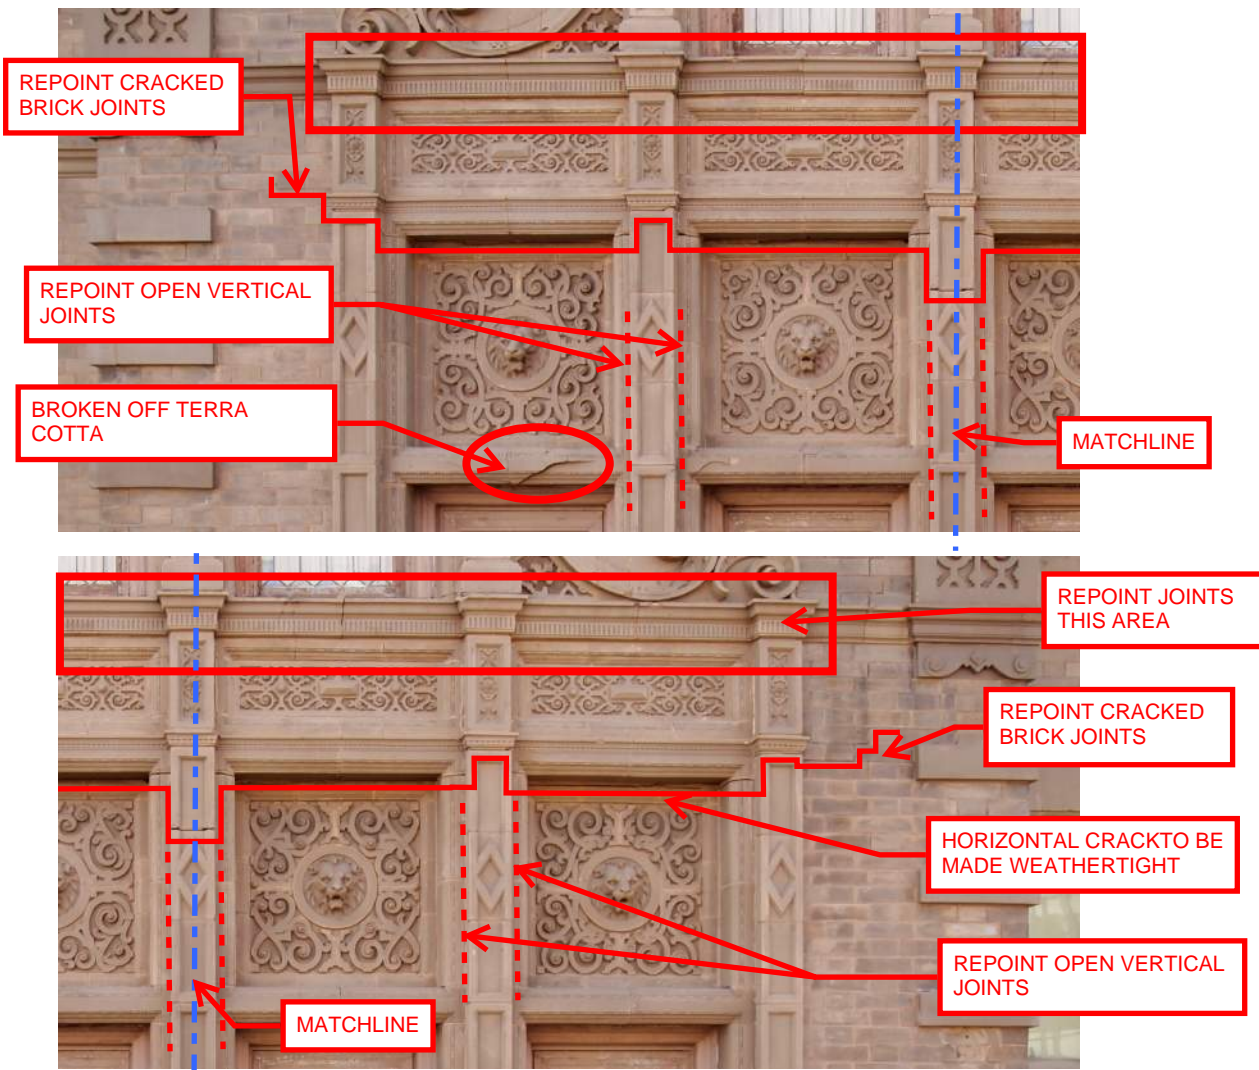
**West Elevation, Center Bay, Second & Third Floor**

Goal: Temporarily protect exposed steel and interior wall construction from elements, temporarily secure broken off terra cotta face at horizontal mullion in a manner to protect the exposed interior construction from weather and repointing open joints in terra cotta belt/sill course.

Tasks: Provide temporary repointing or closed cell backer rod supported elastomeric sealant joint at horizontal crack in terra cotta, color to be selected from manufacturer's standard colors; repoint adjacent cracked brick joints; repoint deteriorated and cracked joints at stacked terra cotta mullion pieces below crack; repoint deteriorated joints at terra cotta belt/sill course above crack, providing elastomeric polyurethane pointing with release tape backer to finish off repointed skyward head joints.

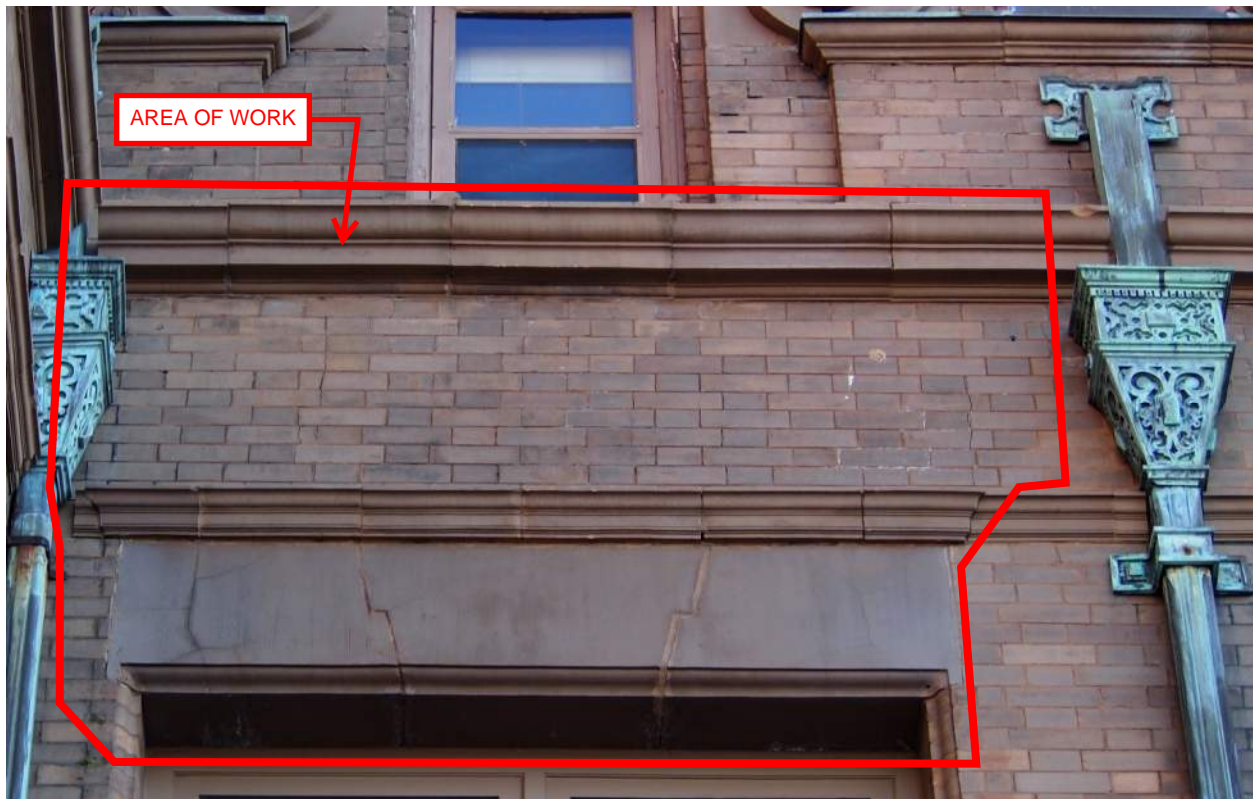
**North Elevation, Airing Porches, Second & Third Floor**

**Goal:** Stop water infiltration through brick masonry and terra cotta at second floor Ironing Porch.

**Tasks:** At areas indicated, repoint all terra cotta and brick joints, providing elastomeric polyurethane with release tape backer at skyward joints. Inspect cracked brick between porch lintel and 3<sup>rd</sup> floor window sill belt course and determine appropriate action to either replace cracked brick (from owner's supply) or repair cracks with mortar or closed cell backer rod and elastomeric polyurethane sealant with color selected from manufacturer's standard colors and proceed with action following owner review. At east (left) end of 3-piece terra cotta lintel, inspect cracked terra cotta unit and determine appropriate crack repair for unit and proceed with action following owner review.

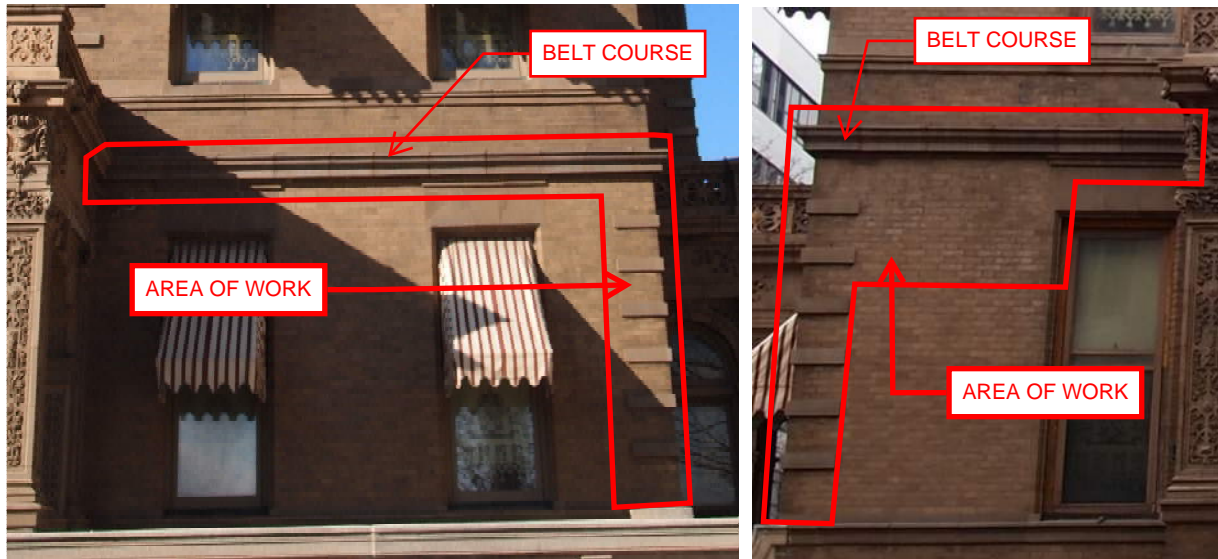
**Southeast Corner, Balustrade Up Thru Belt Course**

Goal: Stop water infiltration through wall of Music Room where embossed wallcovering is peeling.

Tasks: At areas indicated, inspect terra cottas and brick joints within area indicated and repoint cracked or deteriorated joints as required. Provide elastomeric polyurethane with release tape backer at all skyward joints at the belt course within the area indicated.
