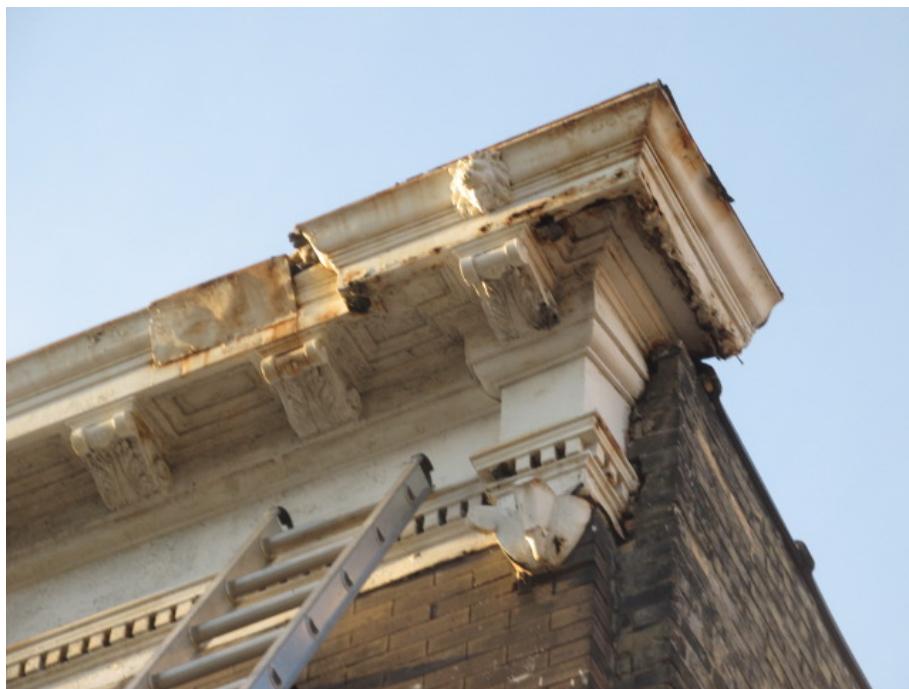
Photo 1

Upper Cornice – West End - improper repair - rusted holes in metal

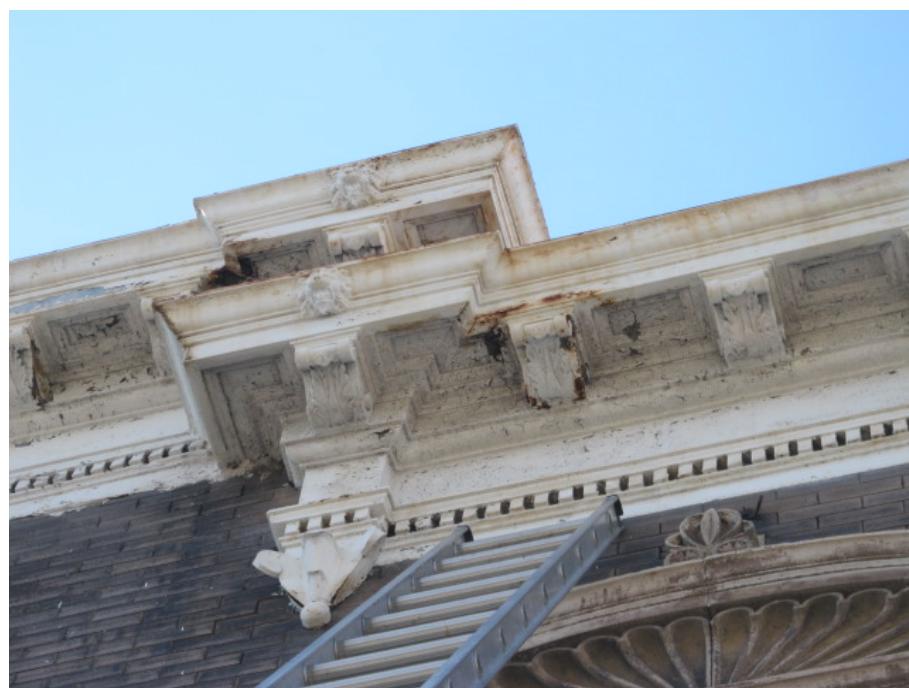
Photo 2

Upper Cornice – rusted holes in metal

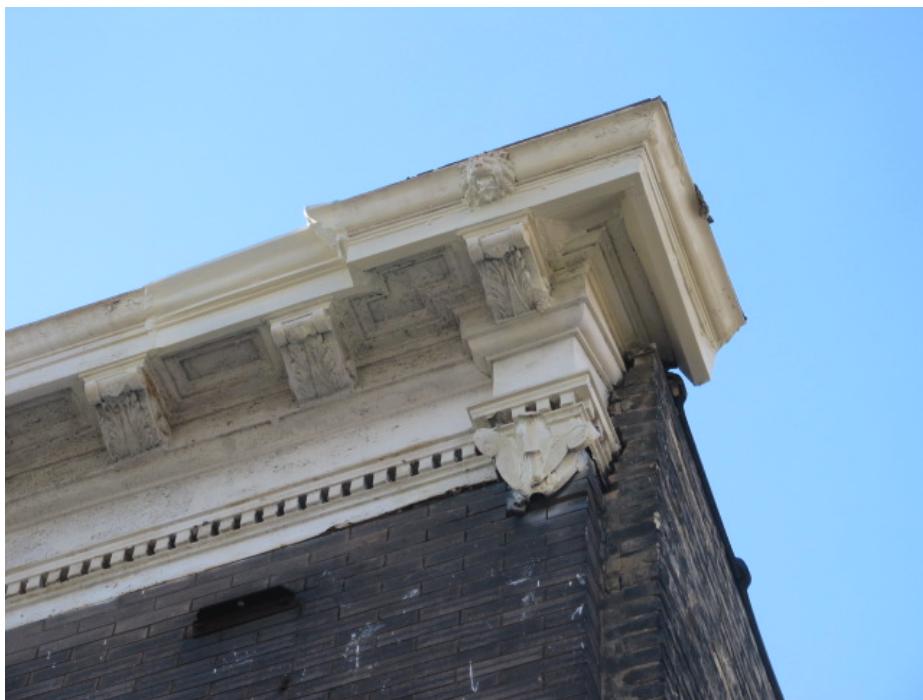
Photo 3

Upper Cornice – West End – repaired with formed sheet metal

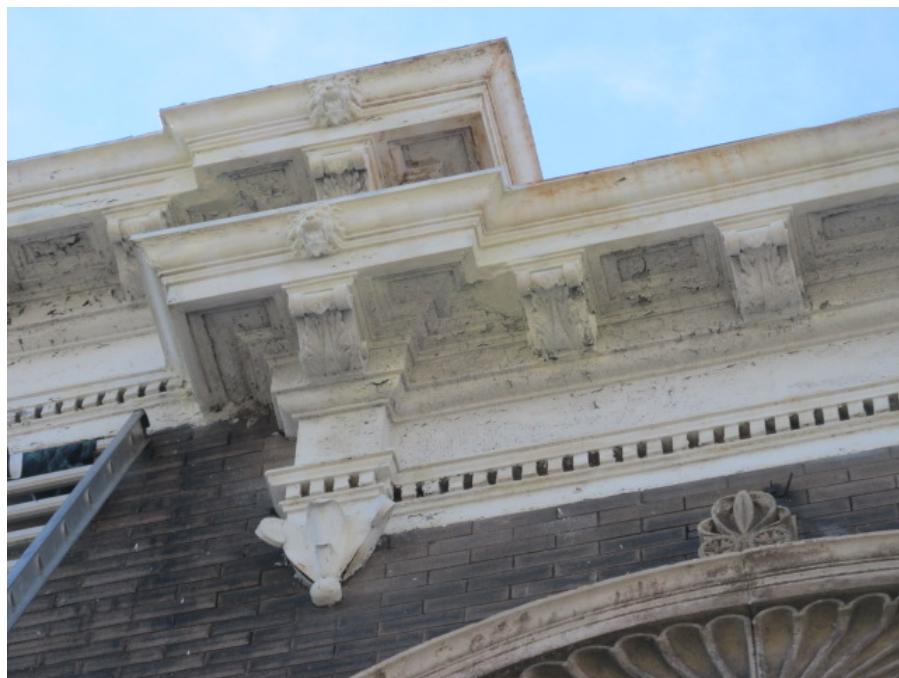
Photo 4

Upper Cornice – repaired with formed sheet metal
