Re: Pabst Sign Support Structure Review
Milwaukee, WI

PIERCE ENGINEERS, INC., (PE) performed site visit of the **Pabst Sign** support bridge over West Juneau Avenue at North 10th Street in Milwaukee, Wisconsin on August 8, 2018. The purpose of site visit was to review visually the sign supporting steel truss bridge, decking, connections, and supports to provide our opinion regarding the condition of the structure and determine necessary repair work to preserve the structural integrity of the structure.

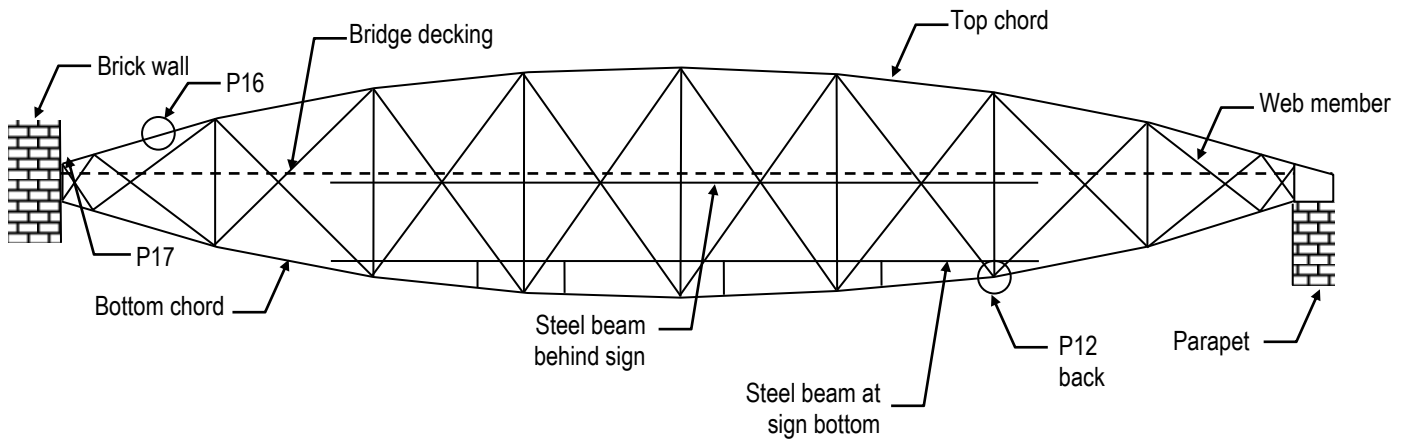
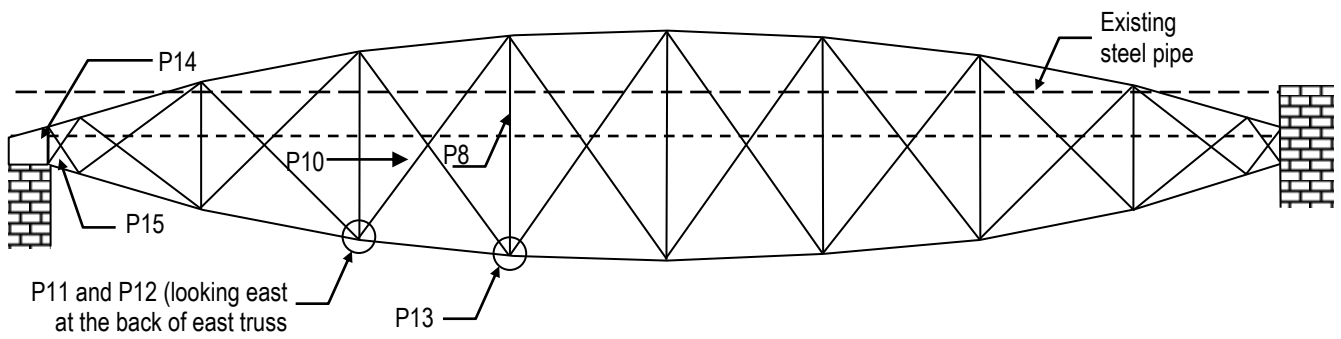
Figure 2: Pabst sign supporting longitudinal trusses

Back-to-back double angles were used for both chord and web members in the construction of steel longitudinal trusses. In general, existing steel longitudinal trusses are in satisfactory condition with some minor issues, e.g., steel corrosion, steel section loss, and member imperfections (bent angle legs) at random locations. These issues are shown in photographs P11, P12, and P13. The Pabst Sign is supported along the east truss. A continuous pipe from Building 21 to Building 25 is supported along the west truss. At the north end of these trusses, some missing bolts and detached steel splice plates were noted. This observation is depicted in photographs P14 and P15. A cracked steel connector of the guardrail is spotted on the top chord of the east truss at the south end. This observation is shown in photograph P16. The locations of the above observations and corresponding photographs are also provided in the truss schematics in Figure 2.

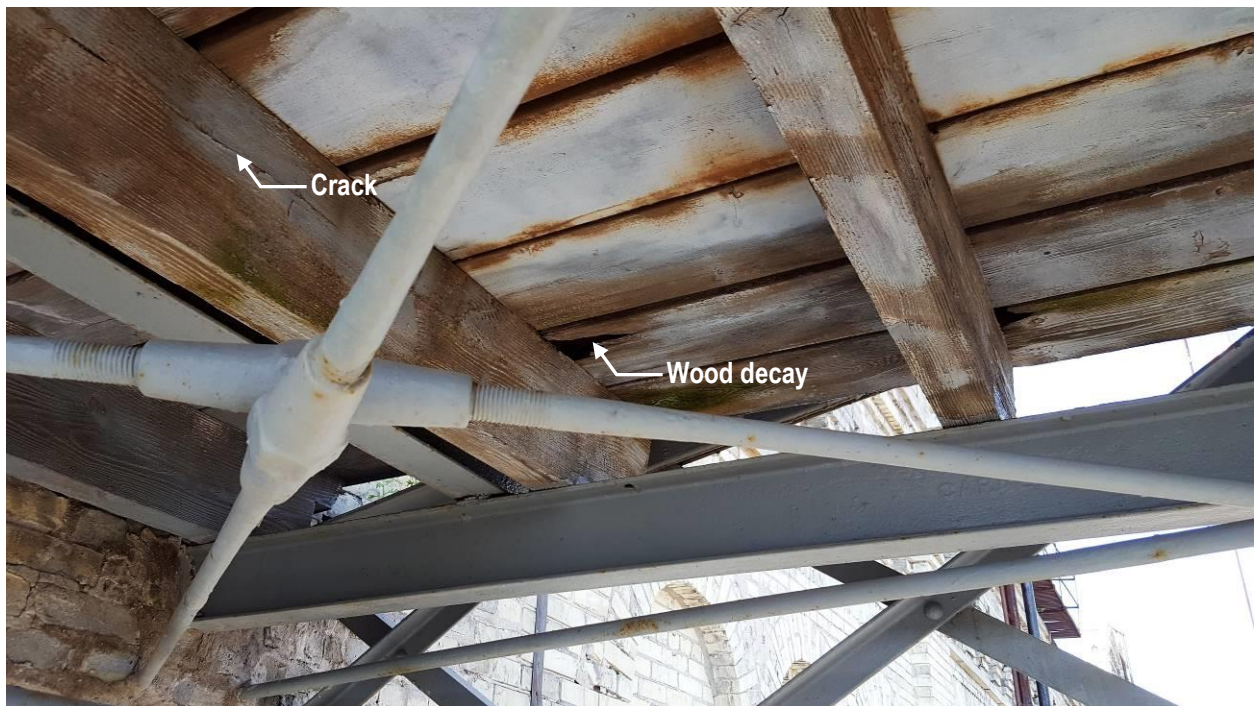
Existing wood decking spans in the north-south directions and is supported on wood joists resting on steel beams. See attached photographs P4 and P5. Wood decay was noted visually in decking and the top of wood beams at random locations. Cracks were also seen in wood joist at random locations. Attached photographs P6 and P7 depict

this observation. The cause of wood decay and crack could be attributed to dry and wet states (related to moisture) due to their exposed condition.

P6 Pabst sign bridge with cracked wood joist decay in wood decking

All existing wood decking and beams should be reviewed for decay in future. All wood members (both deck and joists) with decay should be replaced with new wood members of same size and strength. Until such compromised members are replaced, a temporary protection measure (e.g., barricade, plywood, etc.) should be undertaken as a safety measure.

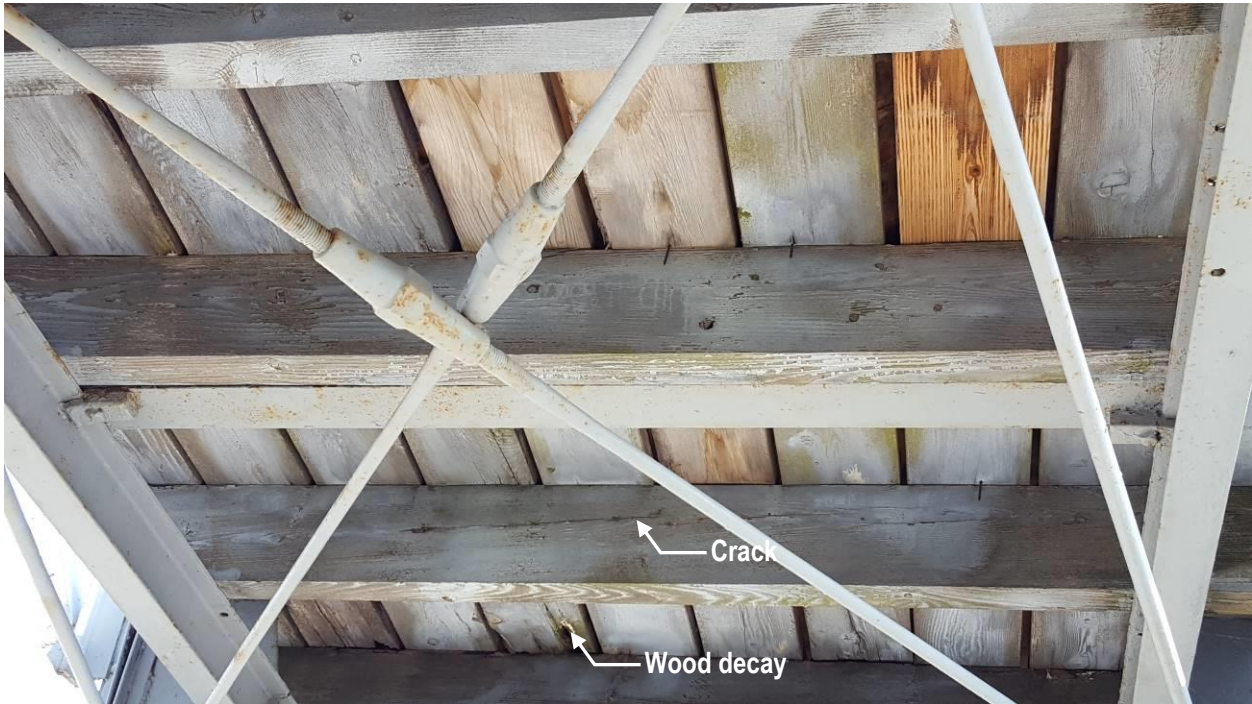
P7 Pabst sign bridge with cracked wood joist and decay in decking.

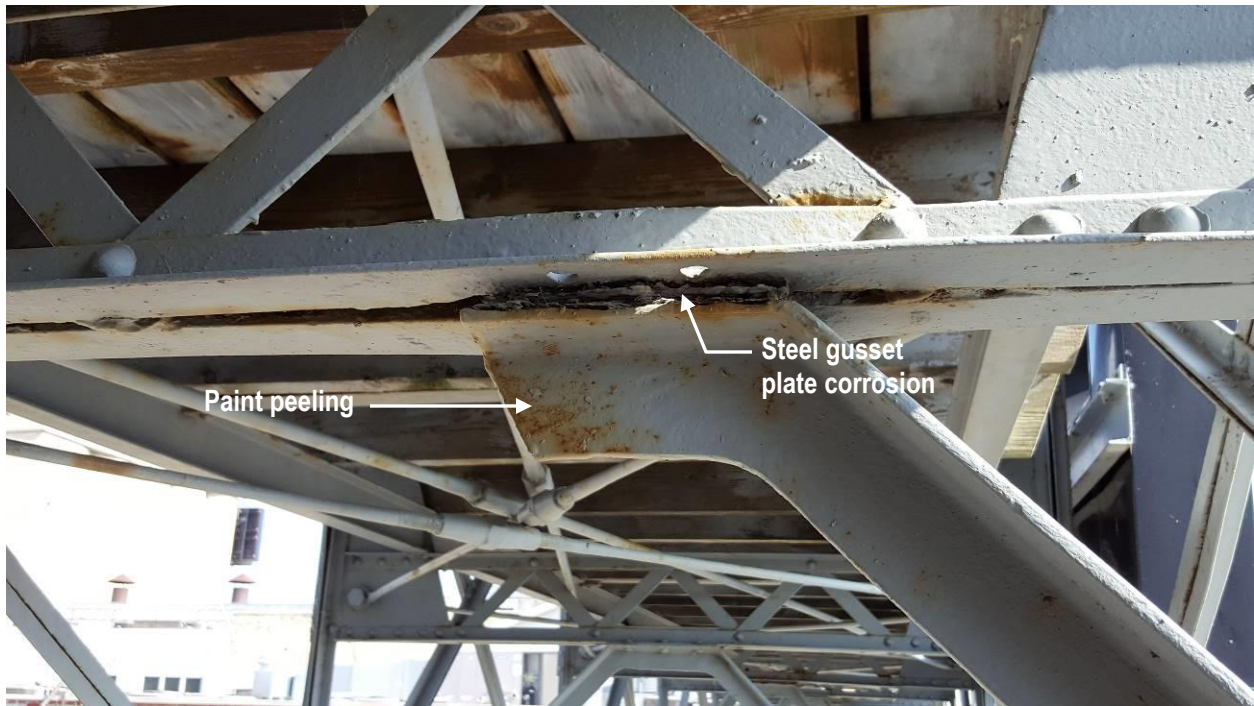
The top and bottom chords of the existing transverse open web steel joists spanning in the east-west direction were constructed using double angles (back-to-back). Steel bars were used as web members in these trusses (see photograph P8). In general, these existing steel transverse joists are in satisfactory condition with some steel corrosion at random locations. Attached photographs P9 and P10 illustrate this observation. Majority of corrosion noted was in the steel gusset plates between angles. Paint peeling or missing was also noted at some steel members in these joists (see photographs P9 and P10).

P9 Pabst sign bridge with corrosion at interior transverse open web steel joist support.

All main steel trusses and transverse open web joists including welded joints should be cleaned to remove rust and coated with rust inhibitive paint (minimum 2 coats). A new steel member or steel reinforcement is recommended for the existing sign supporting member with a section loss shown in photographs P12 and P13. Similar recommendation is also made for the truss panel point shown in photograph P11. The trusses bearing condition at the north end requires further review from the roof of Building 21 to determine the cause of splice plate detachment and missing rivets. Plug weld is recommended at the missing rivets. The cracked connector in guardrail connection should be removed and replaced or apply new welds. Cleaning and painting is also recommend to existing stair at the south end with corrosion.

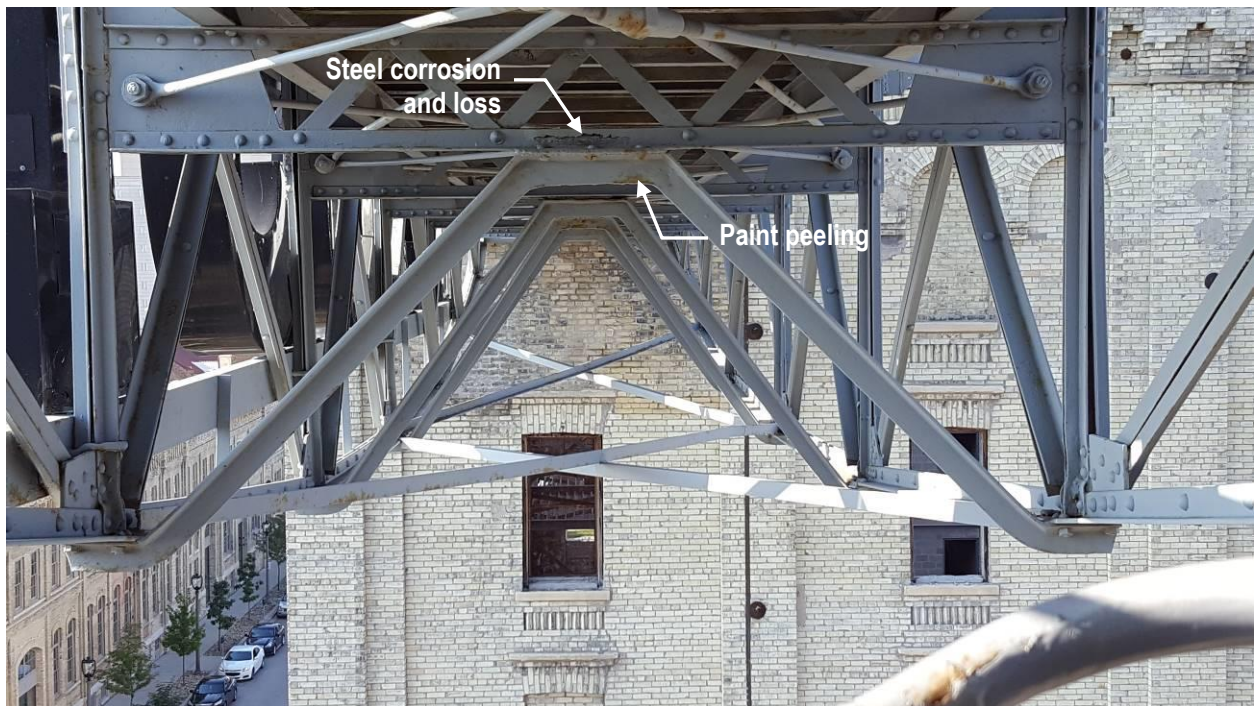
P10 Pabst sign bridge with steel corrosion and loss at interior transverse open web steel joist support

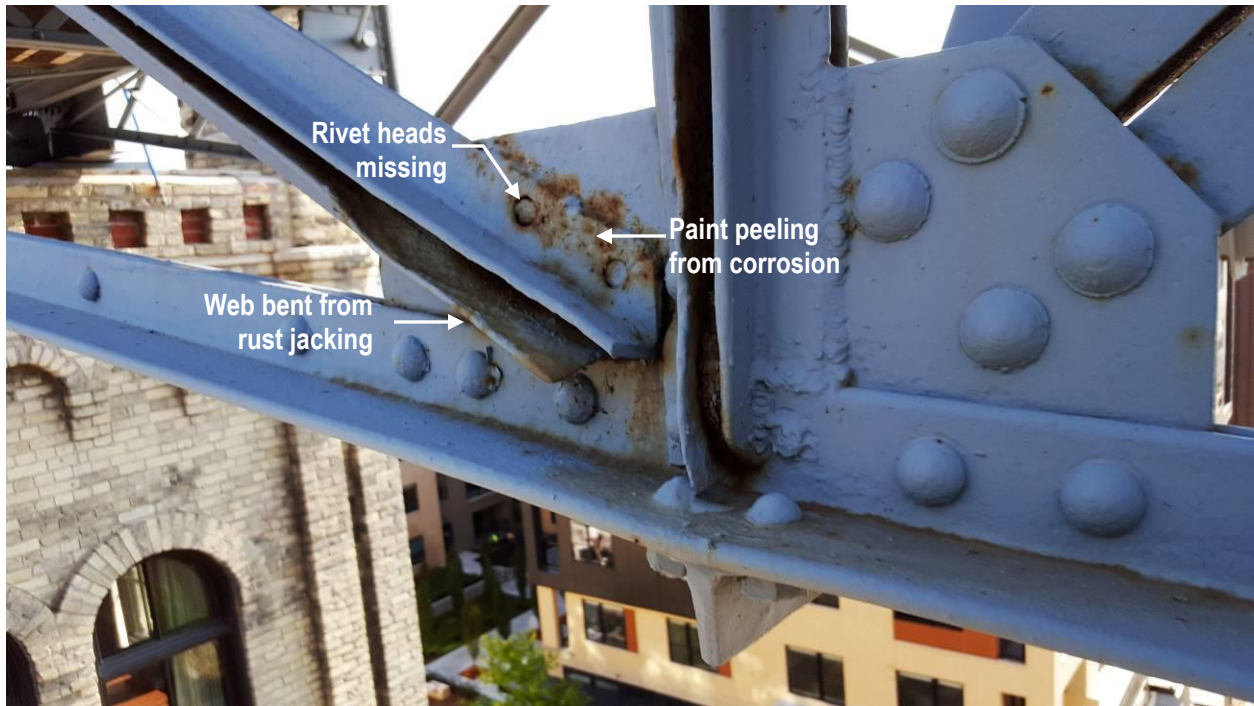
P11 Pabst sign bridge with steel corrosion (west truss).

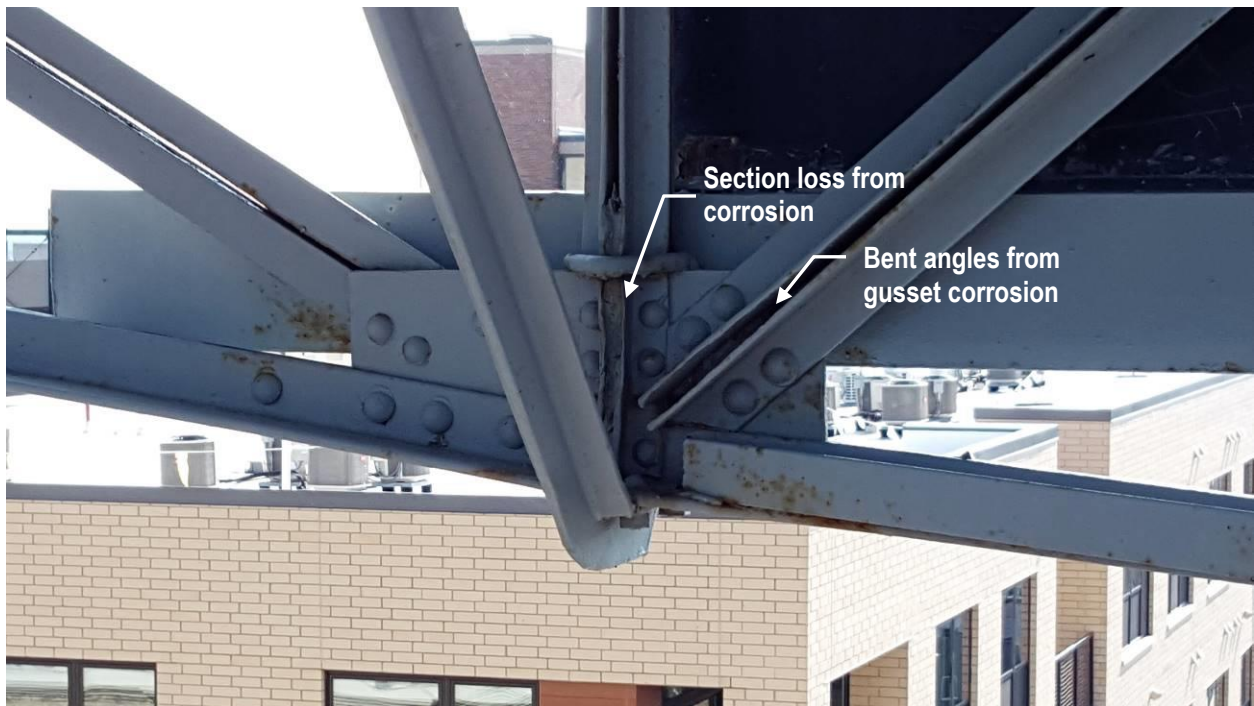
P12 Pabst sign bridge with bent steel angles and section loss from corrosion at panel point (east truss).

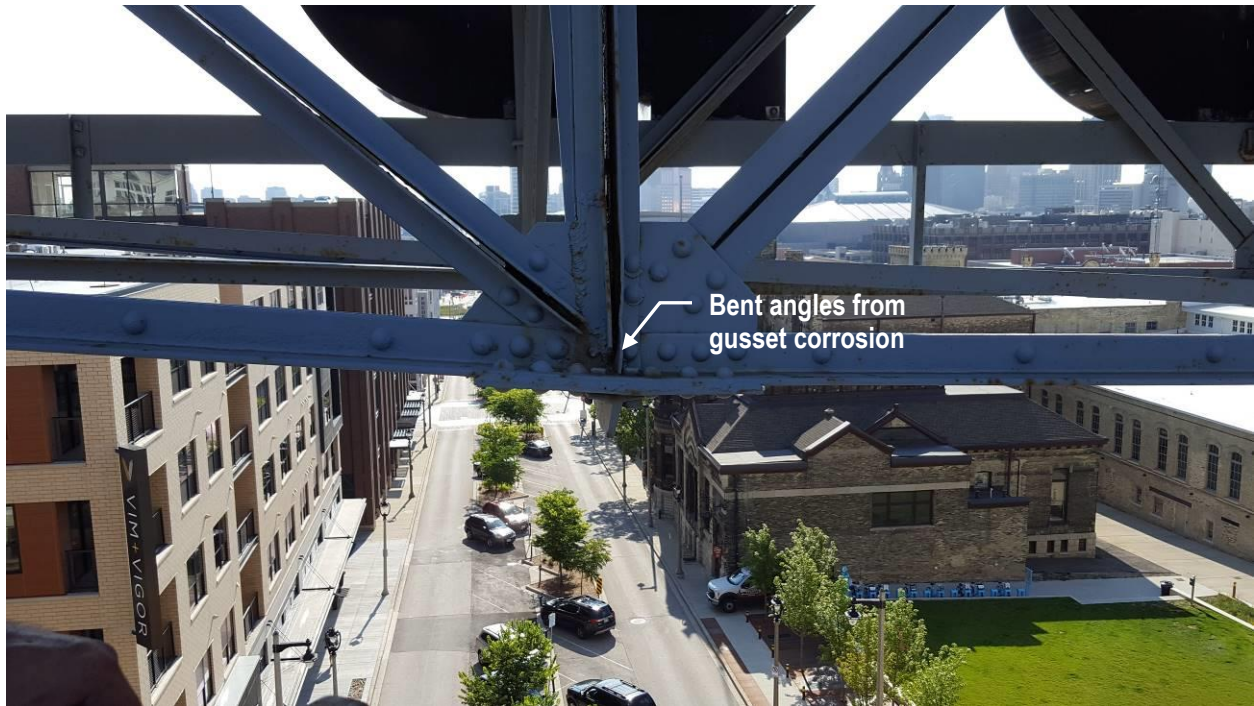
P13 Pabst sign bridge with bent steel angles and section loss from corrosion at panel point (east truss).

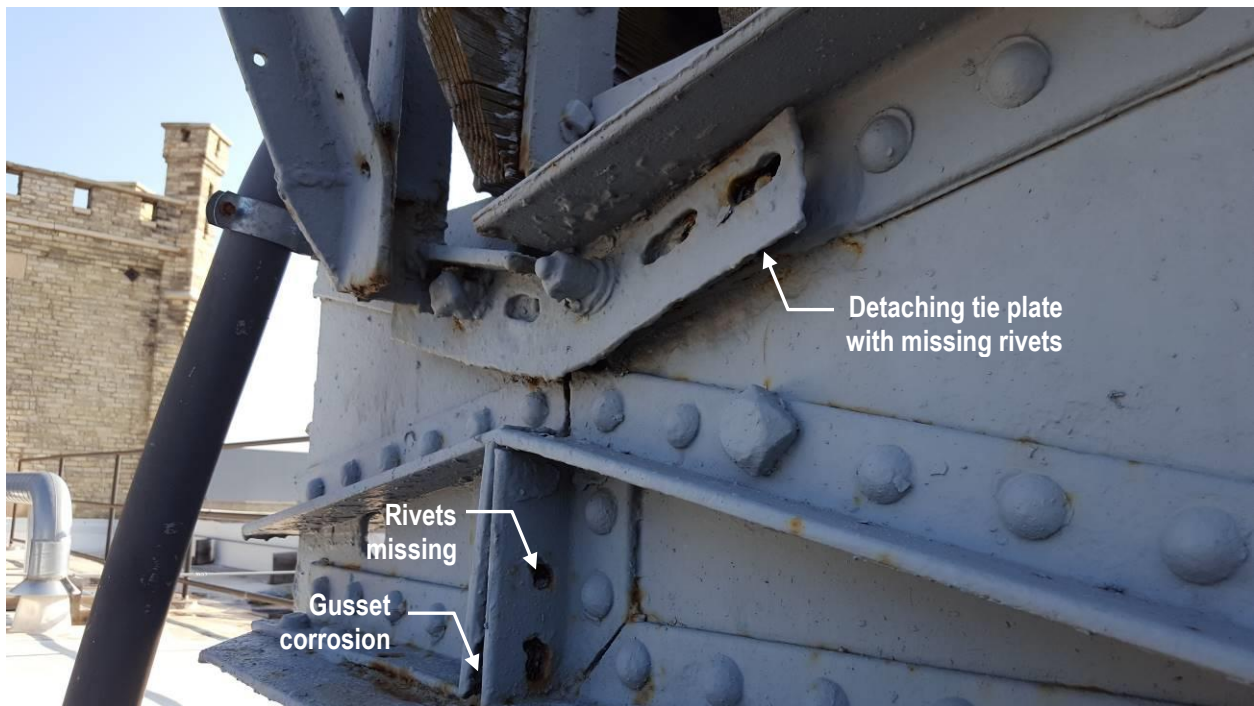
P14 Pabst sign bridge support end with detaching plate and missing rivets (north end).

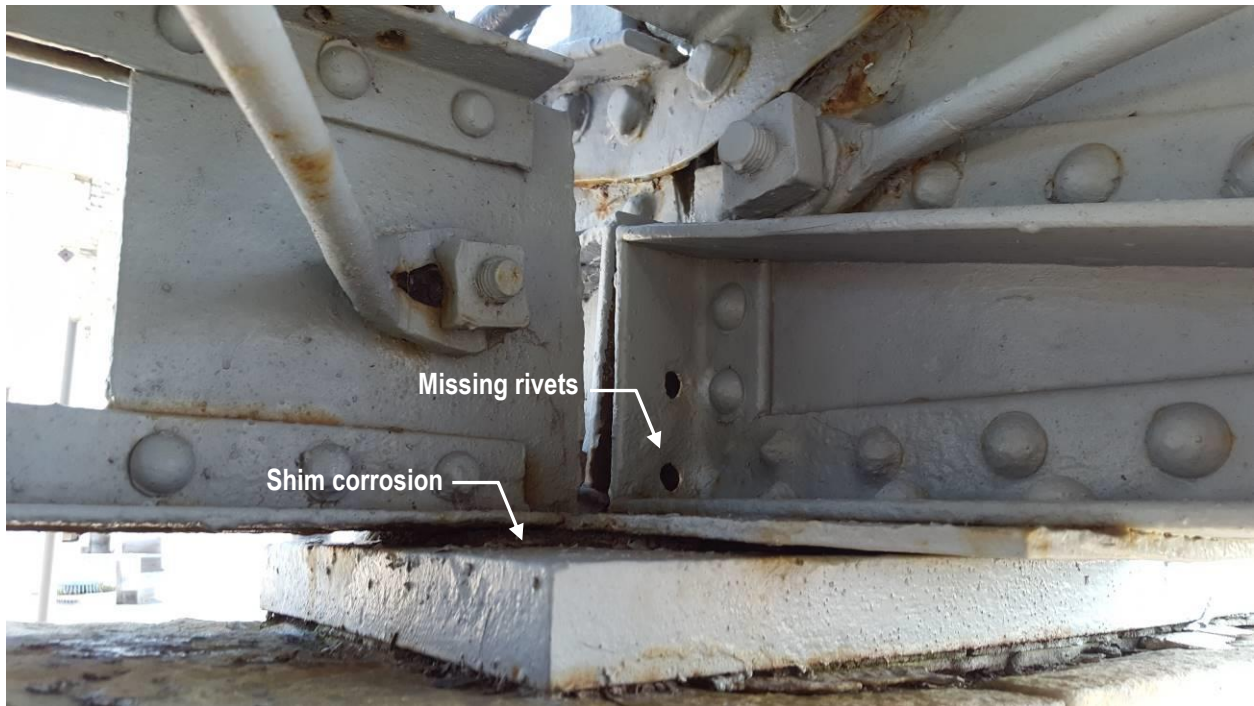
P15 Pabst sign support strut with missing rivets at east truss (north end).

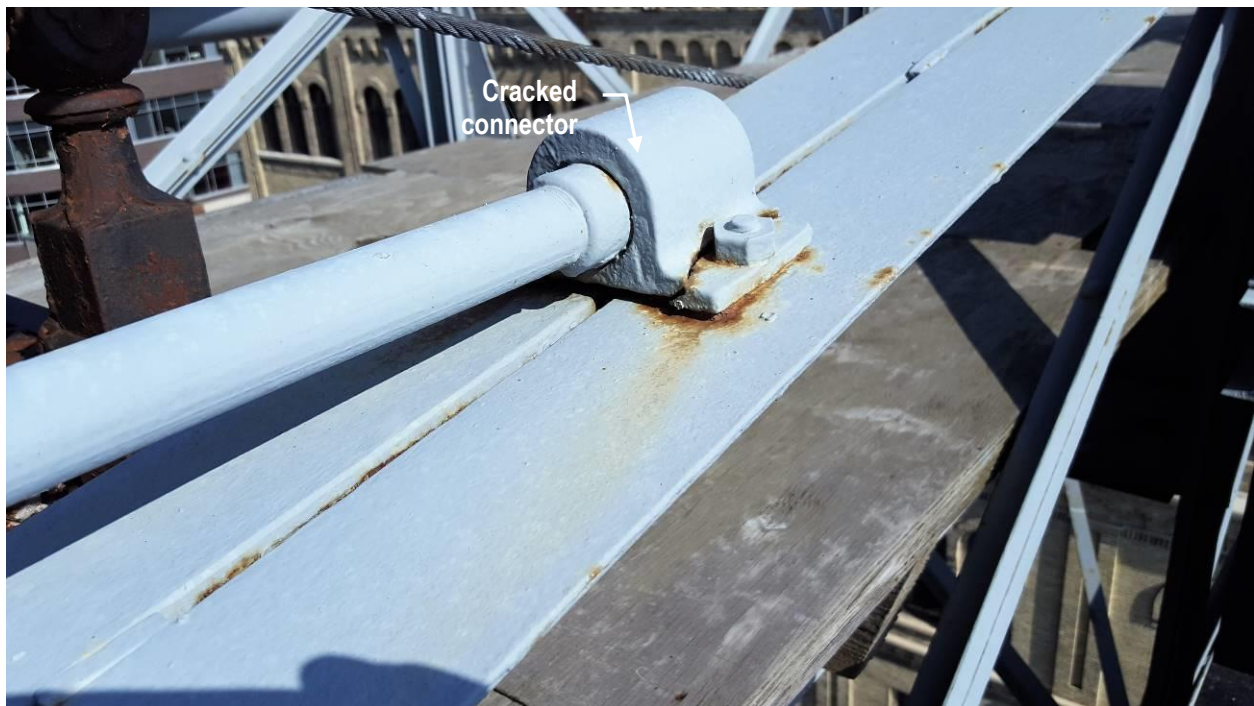
P16 Pabst sign bridge with cracked steel connector at guard rail (east truss).

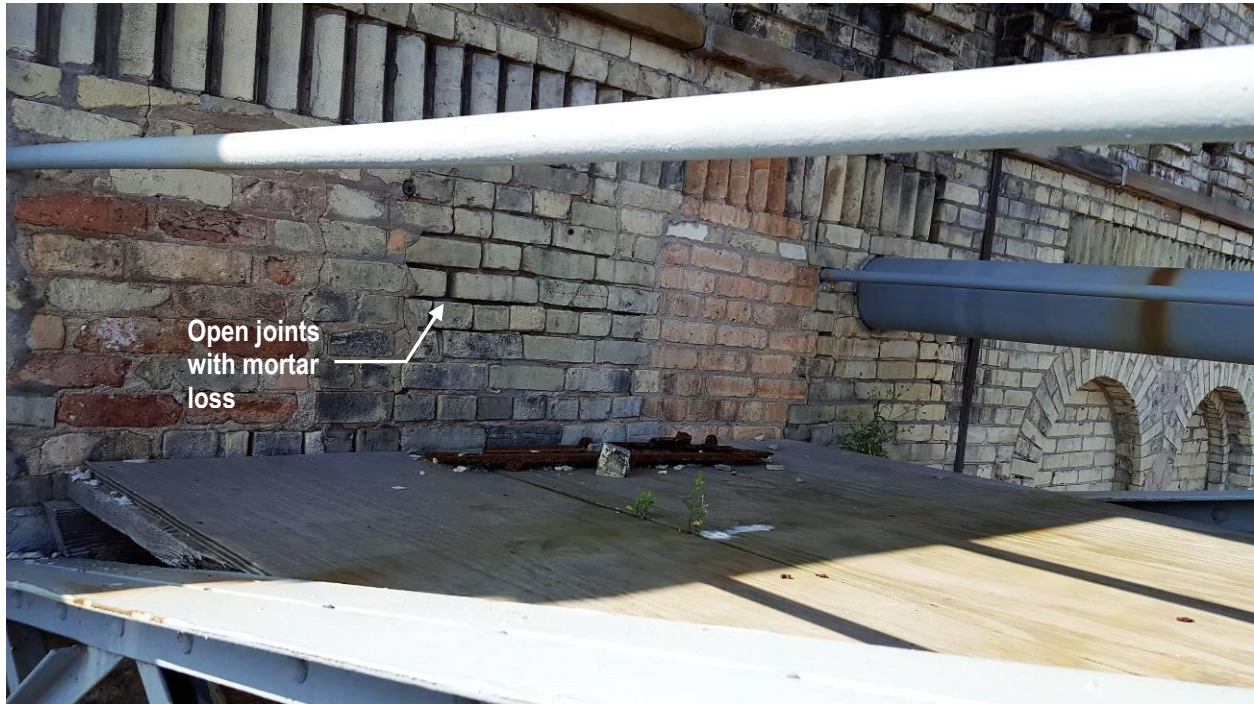
The south ends of the trusses are embedded into existing exterior brick masonry wall. Mortar loss was noted in this wall and is shown in attached photograph P17. The north ends of the trusses are resting on steel bearing plates installed over the parapet stone coping. Cracks were noted in the stone coping and cement mortar. See attached photographs P18 and P19. The existing metal stair at the south end of the bridge rests on the decking support framing. This stair has some corrosion. This observation is illustrated in photograph P20.

P17 Open joints with mortar loss at Pabst sign bridge south support end.

Tuck pointing is strongly recommended in the existing building wall area identified in photograph P17 supporting the south ends of the trusses. Prior to tuck pointing, remove all existing deteriorated and loose mortar up to 1" in depth in the brick joints and clean. At the north truss supporting ends, sealing existing cracks in stone coping, pointing loose and cracked mortar (by removing loose mortar and cleaning) are also priority repair items. This repair will stop any moisture infiltration into existing building wall.

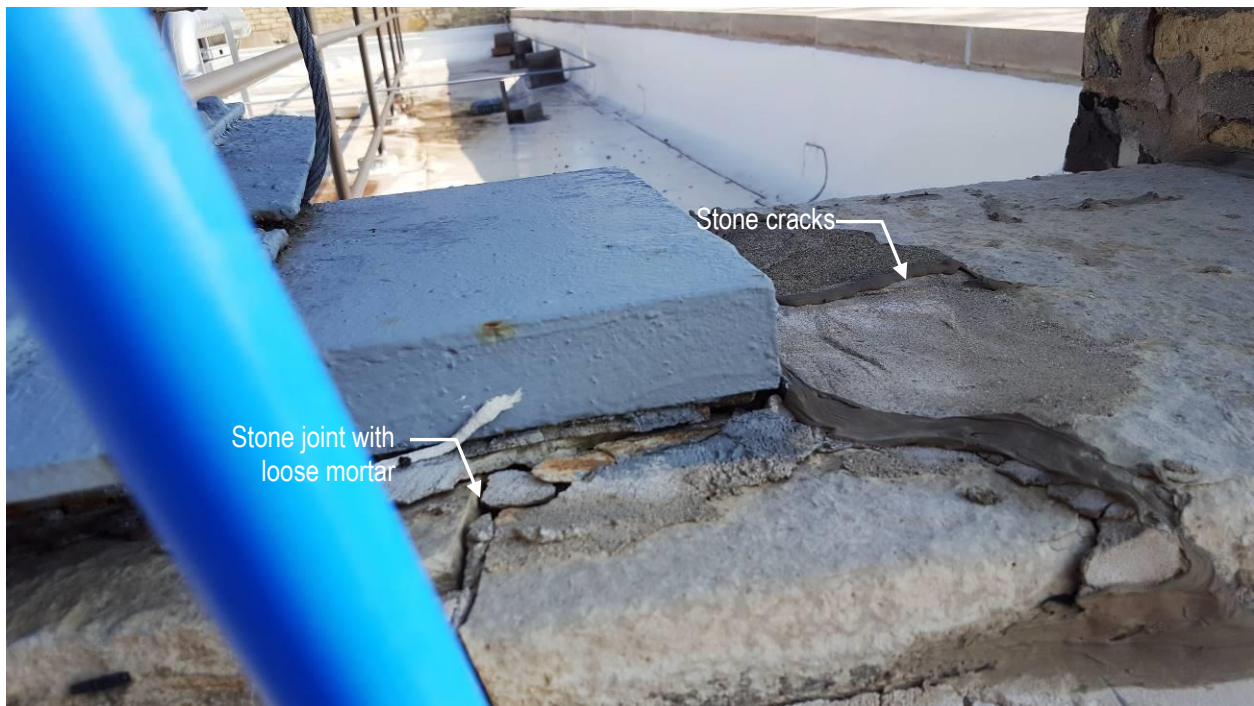
P18 Cracked and loose stone joints Pabst sign bridge (north support end).

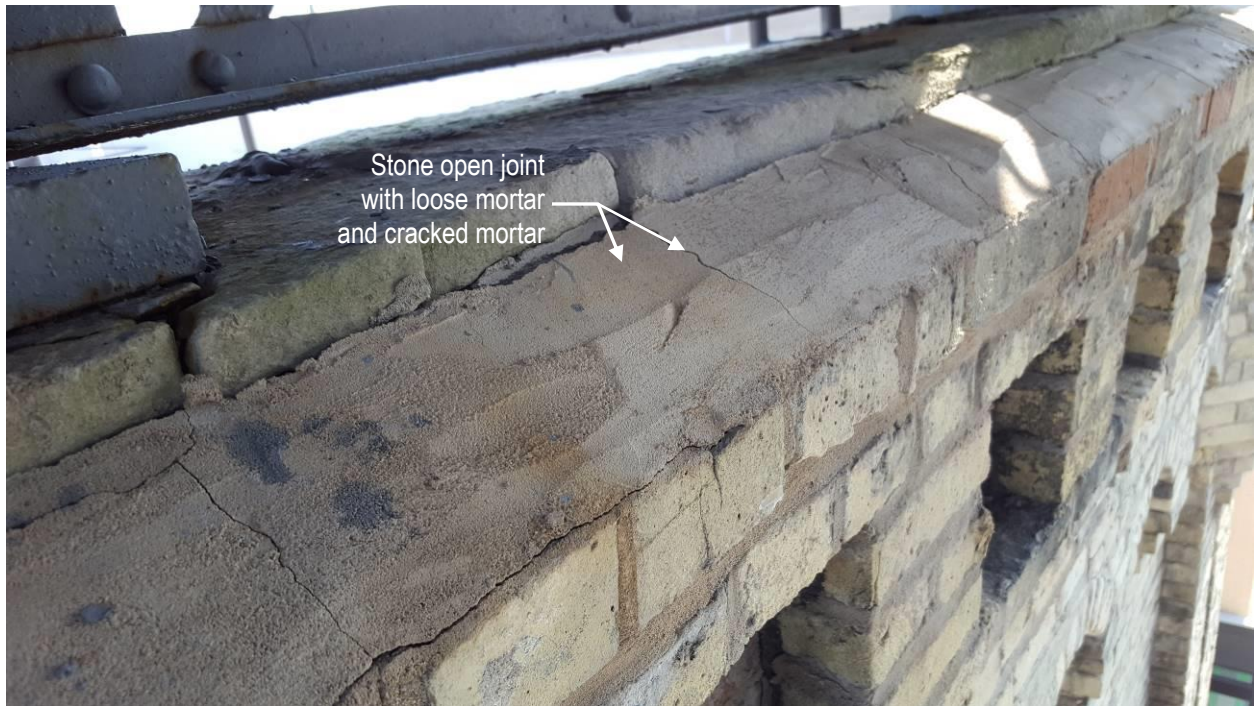
P19 Cracked and loose mortar grouts (north support end).

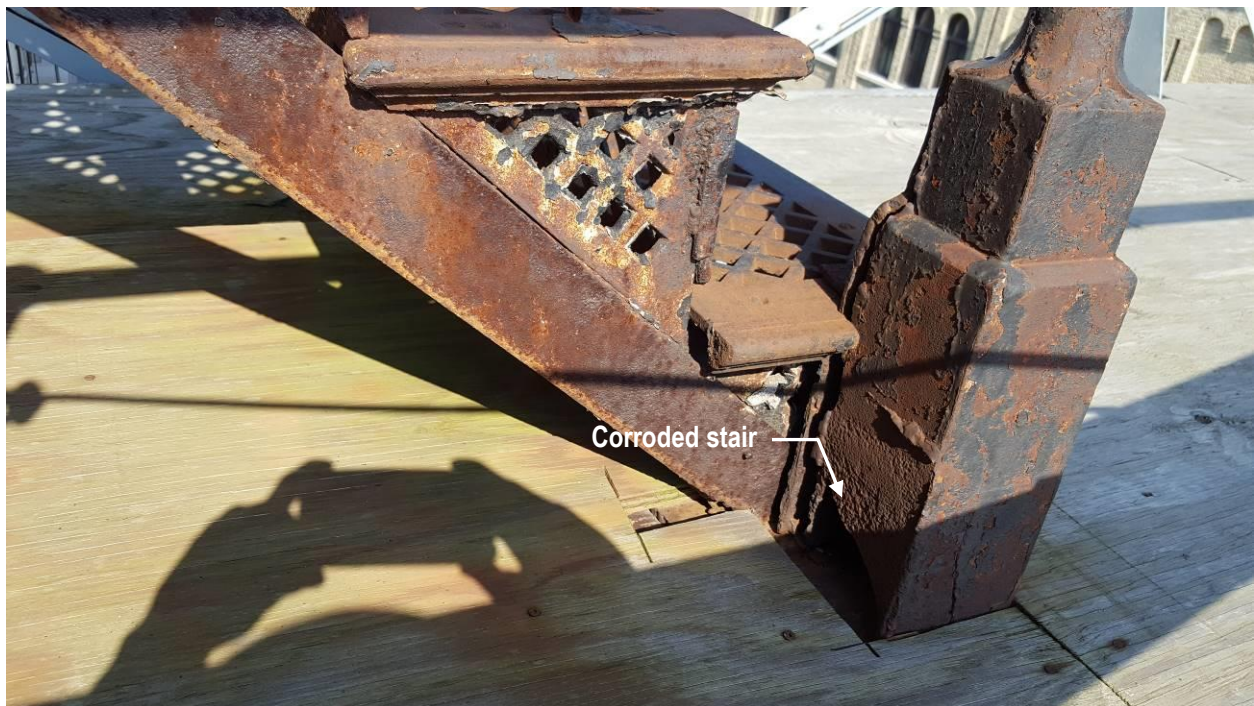
P20 Metal stair with corrosion at south end.
