ORD-20-06383
CCF #201536

Certificate of Appropriateness

Property 961 N. 33RD ST. Concordia
Description of work An assortment of code-mandated repairs per conditions below and the description on the following pages.
Date issued 7/26/2021 PTS ID 115111 COA: REQUIRED REPAIRS

PROPOSED WORK AND PHOTOS ASSOCIATED WITH THE LIST OF VIOLATIONS—961-967 N. 33rd Street

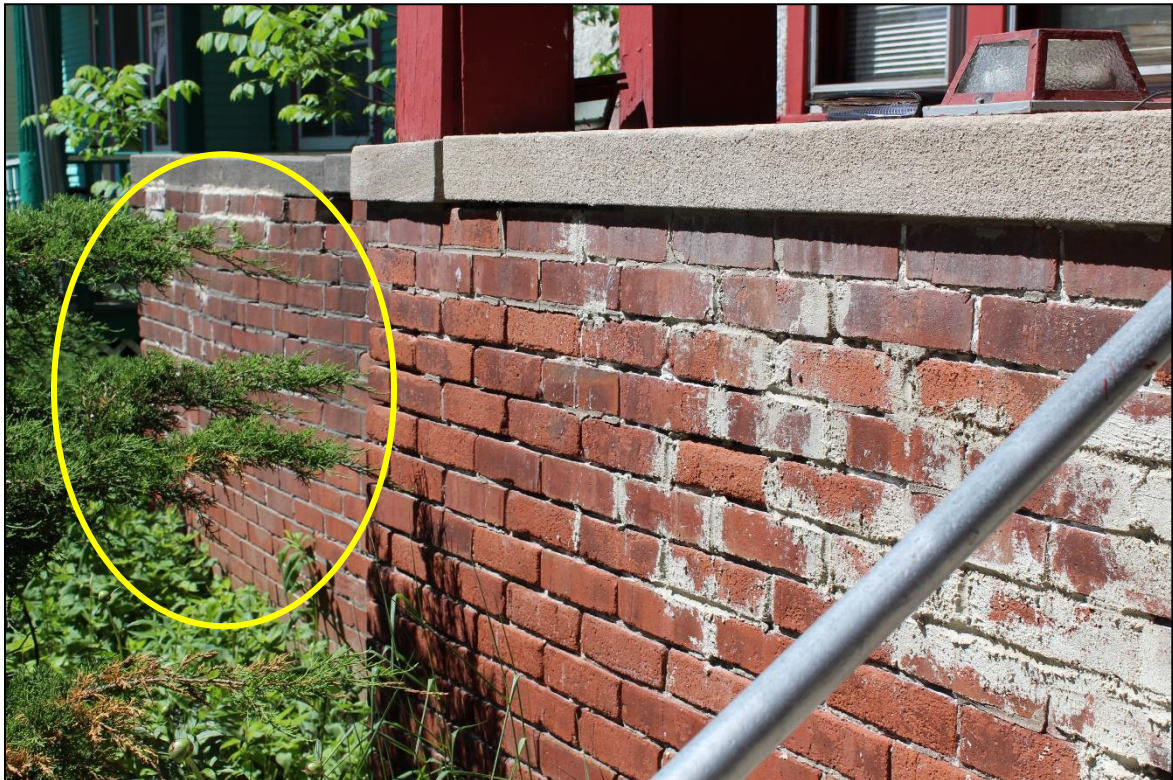
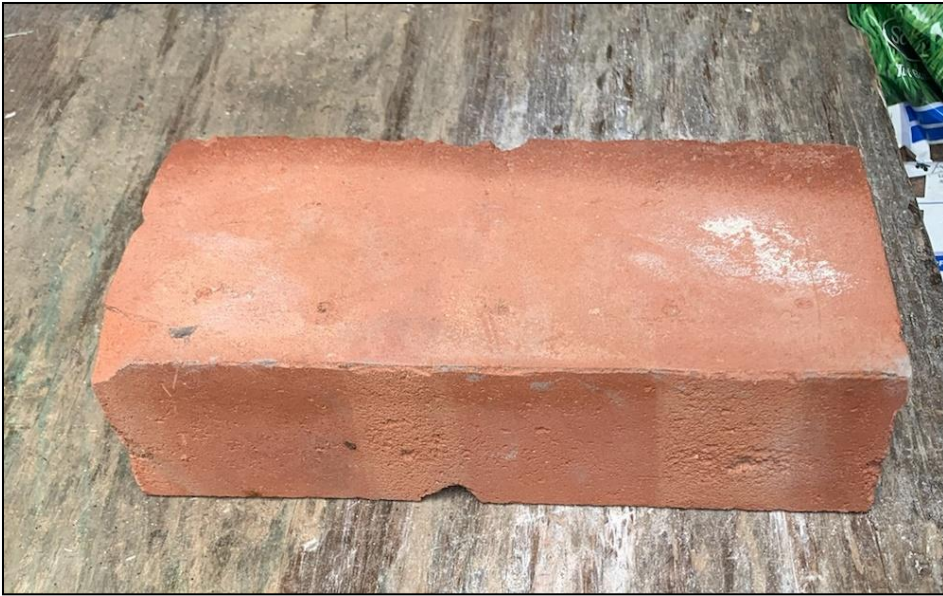
2) ***East Side of House: Replace mortar missing from exterior wall (tuckpoint) porch retaining wall.***

Matching mortar will be replaced (repointing) and contrasting mortar (tuckpointing) will be completed along the defective portions of the porch. Also, following further recent inspection by the property owner, the south portion of the porch wall (circled in yellow) will be rebuilt due to bowing. Existing brick will be re-used if possible. If too damaged, similarly colored and same-sized brick (planning to use reclaimed but may have to use some new) obtained from The Brickyard, Inc. (3351 S. Clement Avenue, Milwaukee) will be used.

Reclaimed brick 3 ¾" x 2 ½" x 8 ½ "

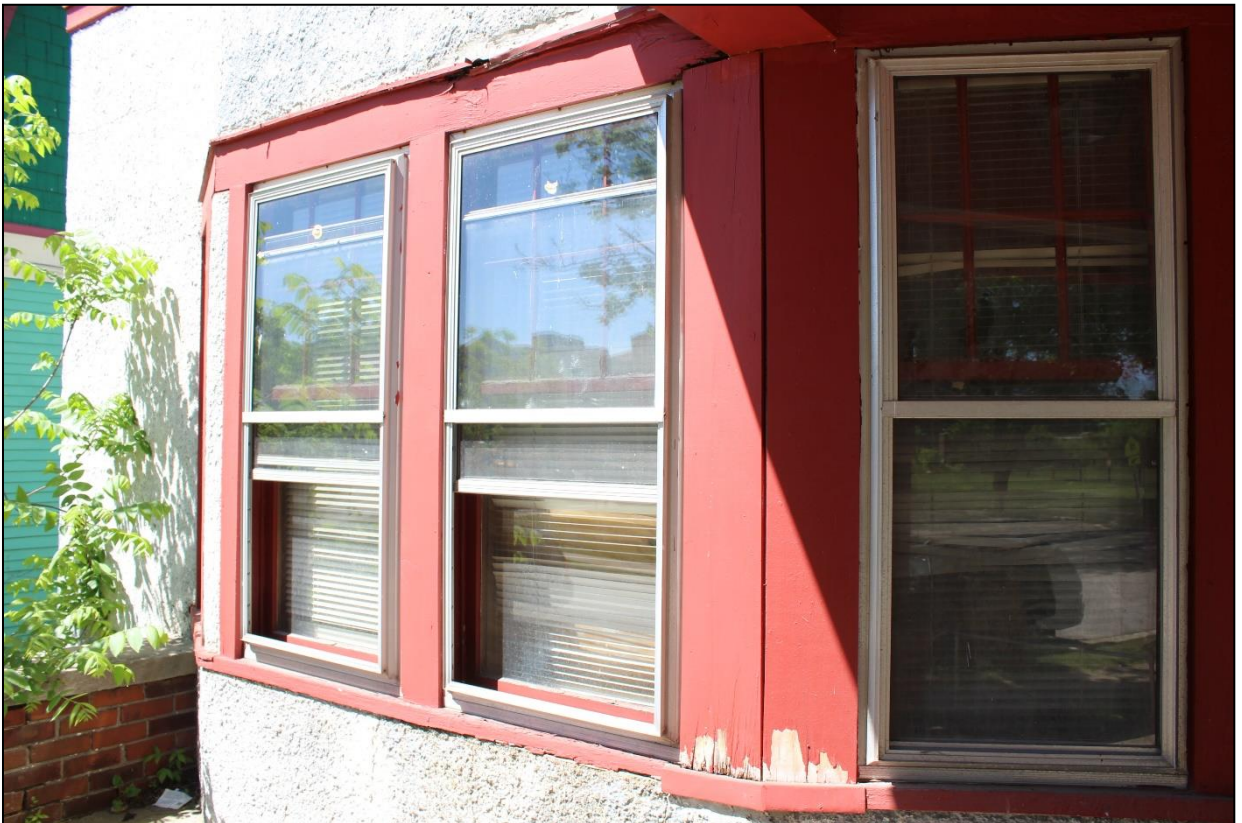
3) East Side of House: Repair or replace defective first-floor window frame.

Wooden window frame will be removed and replaced with new, pressure treated lumber of the same dimension as the existing obtained from Bliffert lumber. Following installation, it will be painted the same color as the existing trim.

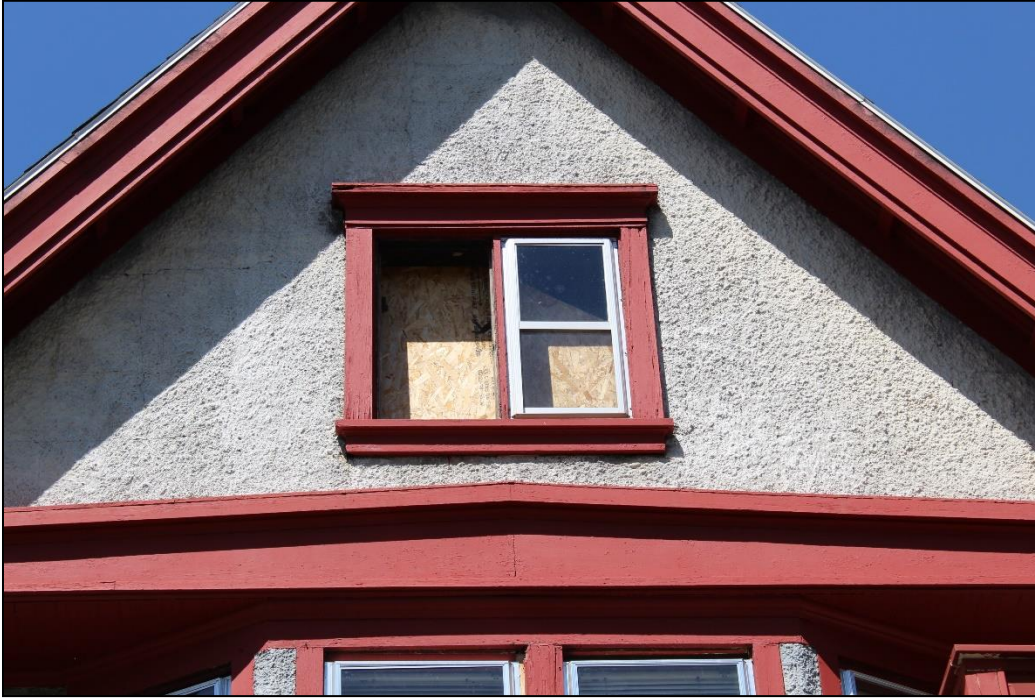
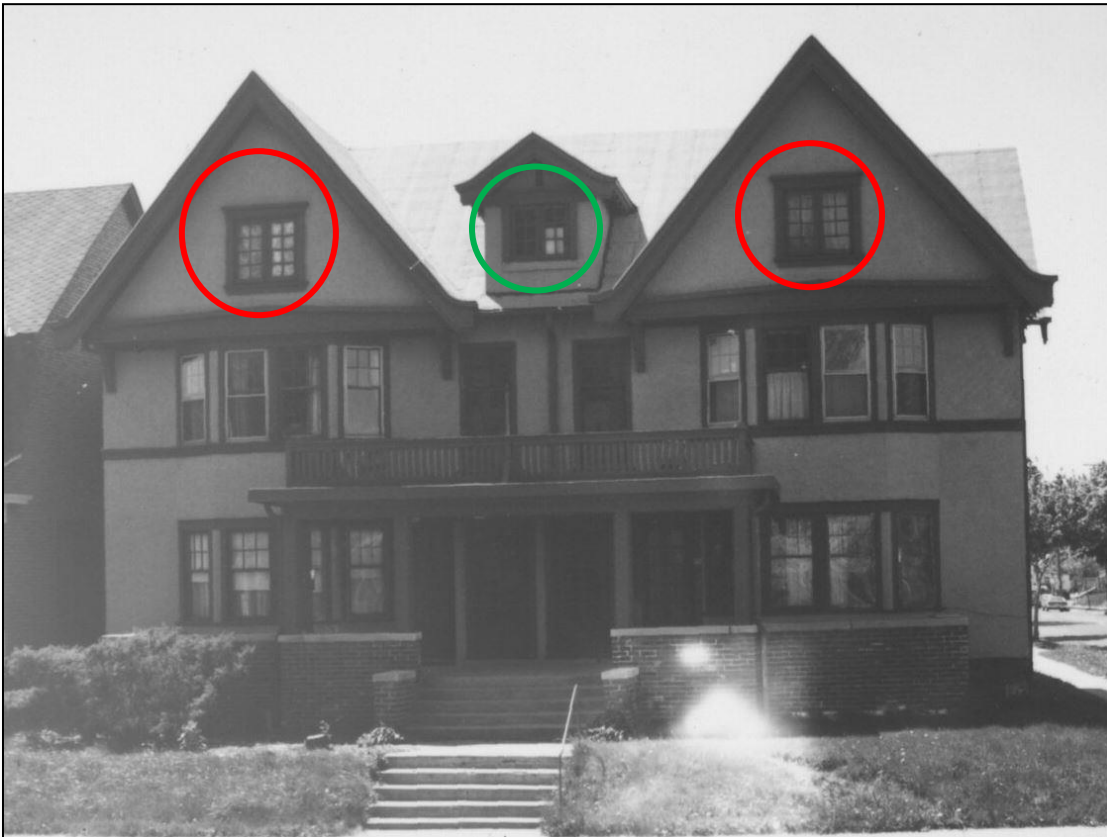
4) East Side of House: Replace missing window panes in attic.

If none are available in their inventory, new wood-frame windows of the same size will be made by Lisbon Storm, Screen & Door (5006 W. Lisbon Avenue, Milwaukee) and installed where none currently exist. Lighting of windows will match the original windows as seen in a 1980 photo of the house (see photo to follow).

Windows within the attic gables (red circles) will be eight-light, wood-frame examples, while the smaller windows within the roof dormer (green circle) will be six-light, wood-frame windows. It has

yet to be fully determined if the attic windows need to be operable or if fixed windows can be installed (we are checking with the inspector but it is believed they do not have to be operable since the attic story does not include living quarters).

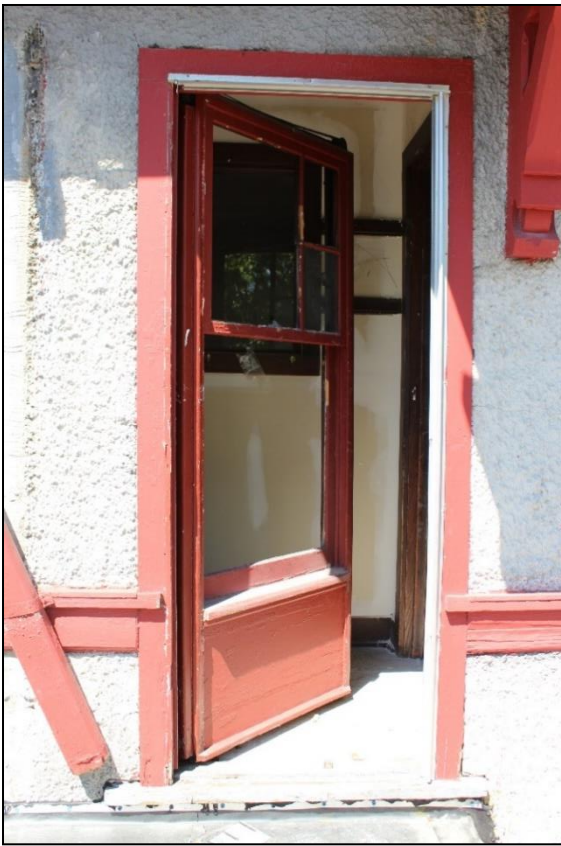
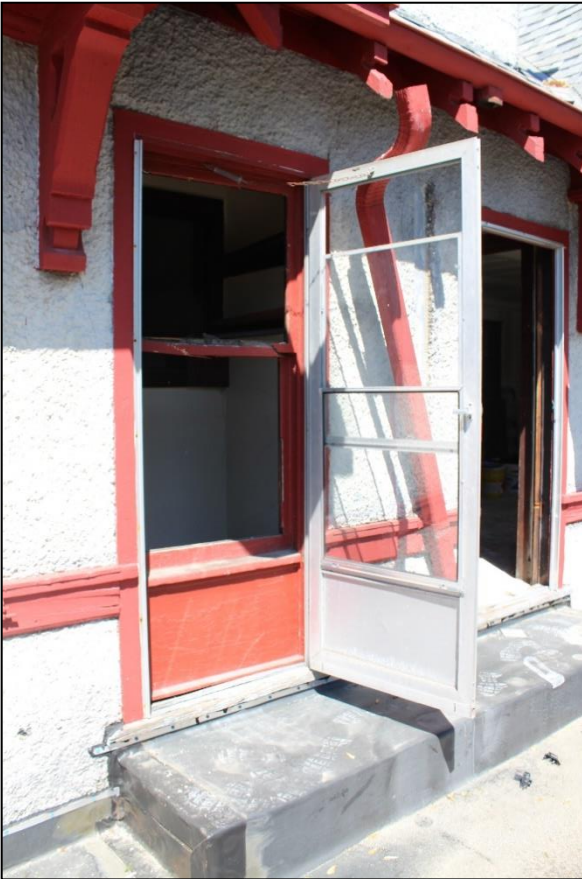
5) East Side of House: Repair or replace defective porch door on 2nd floor.

Although one door is identified as defective, both are missing their 6-light sash at the top. The door to the north (below: left) will be repaired (to include the six-light window), while a new, matching, wood door (with six-light upper pane) will be made by Lisbon Storm, Screen & Door and installed on the south (below: right).

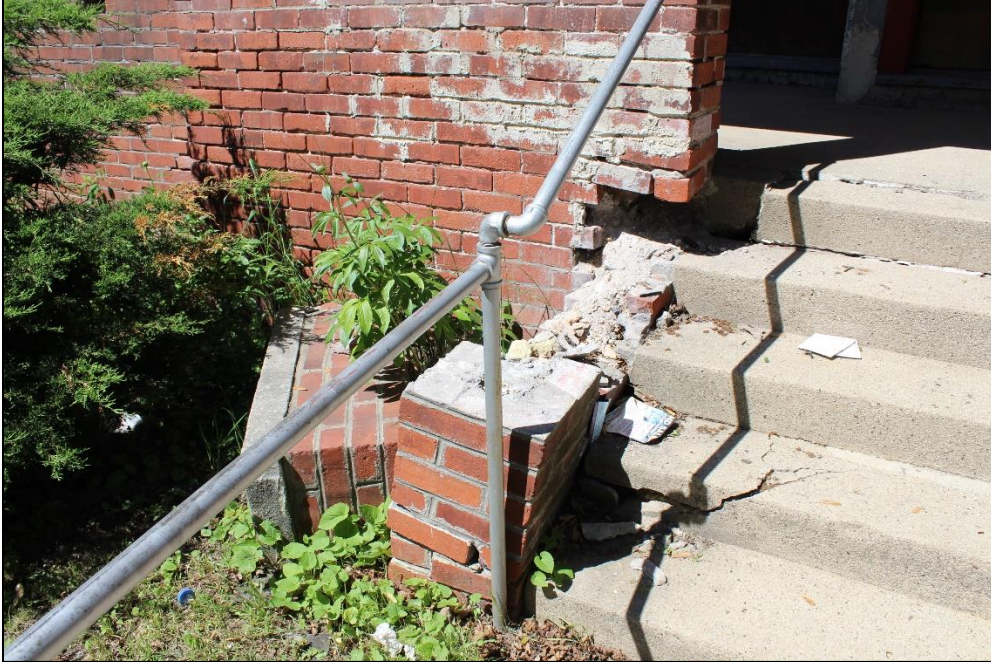
6) East Side of House: Replace defective buttress.

Brick cheek wall (or buttress, as identified per the inspection) to be rebuilt with similar-colored, reclaimed brick identified under #2 above and topped with a concrete cap.

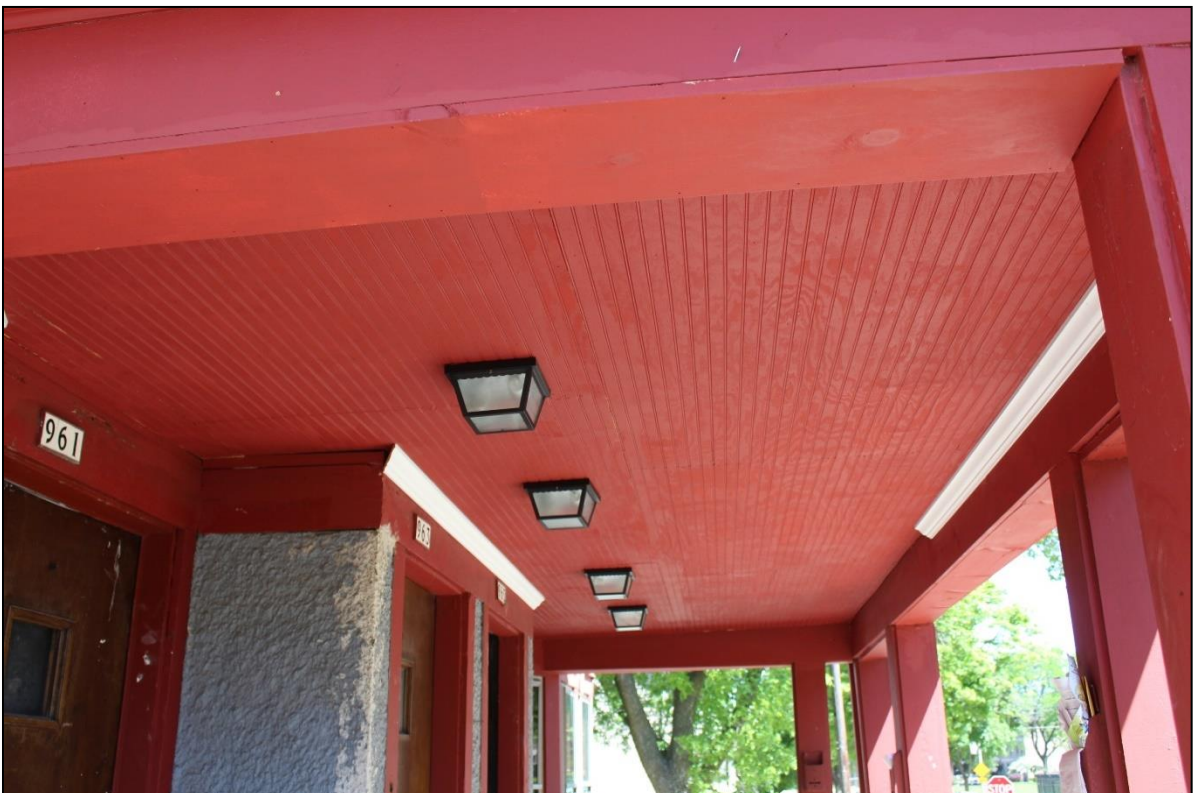
7) East Side of House: Replace defective board in porch ceiling.

This work was already completed prior to a stop work order being issued due to not having obtained a COA for the work. As seen in the photo, matching beadboard was obtained and the defective board replaced.

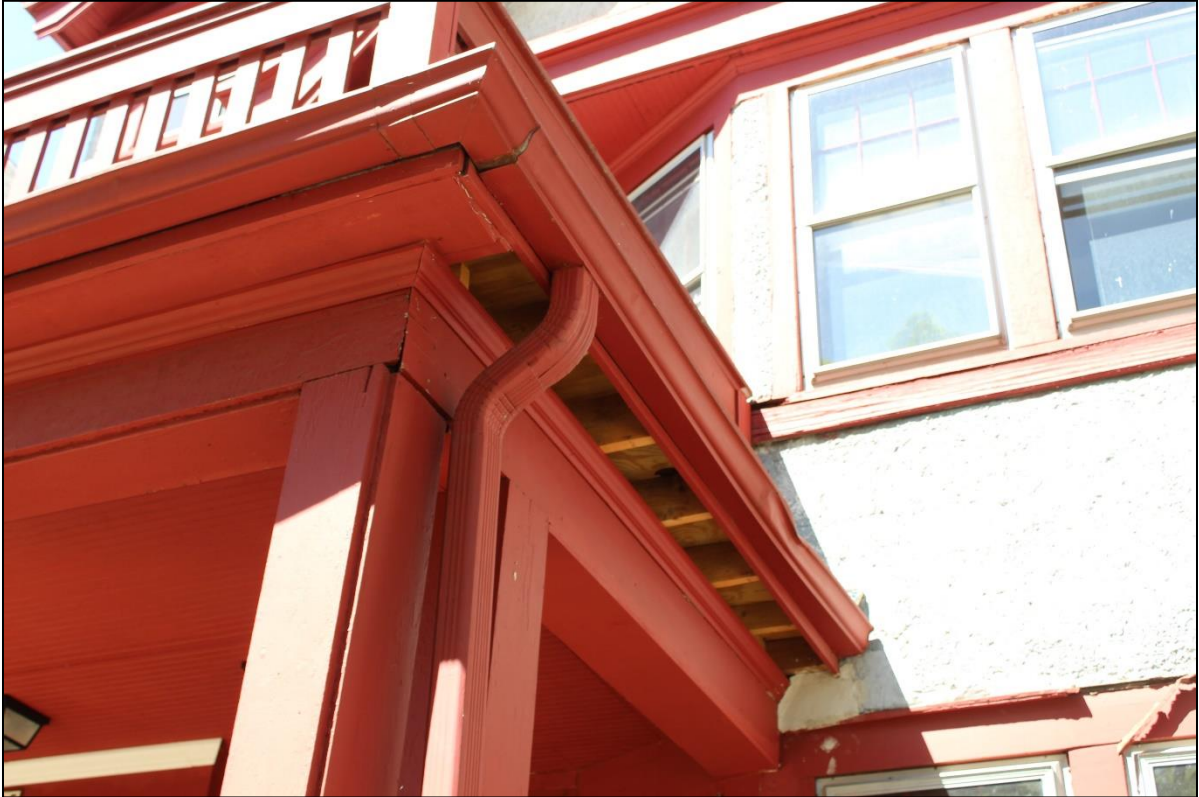
- 8) ***East Side of House: Repair or replace defective trim boards on porch (soffit between 1st and 2nd floor porch).***

Missing trim board to be replaced with wood to match existing board and painted to match trim.

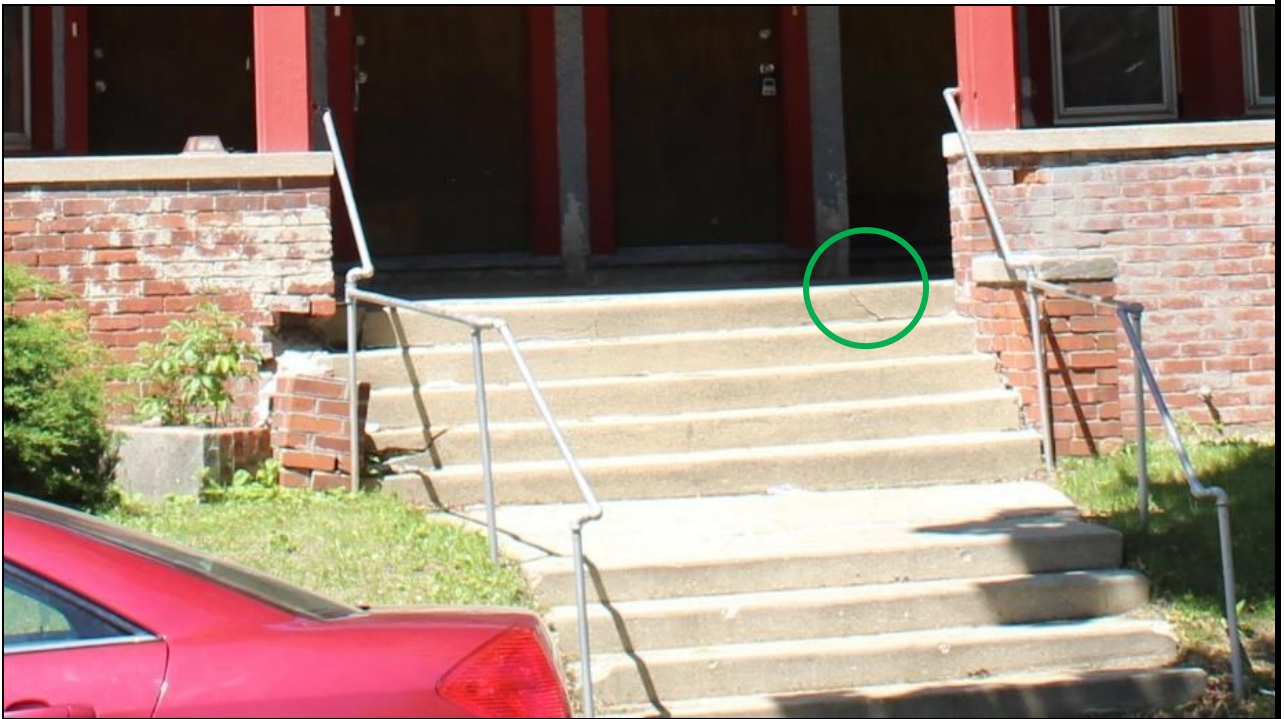
- 9) ***East Side of House: Repair or replace defective concrete or masonry porch steps.***

The upper set of concrete stairs will be removed and new concrete stairs poured. Repair will also be made to top step/porch base as seen at the far right (green circle).

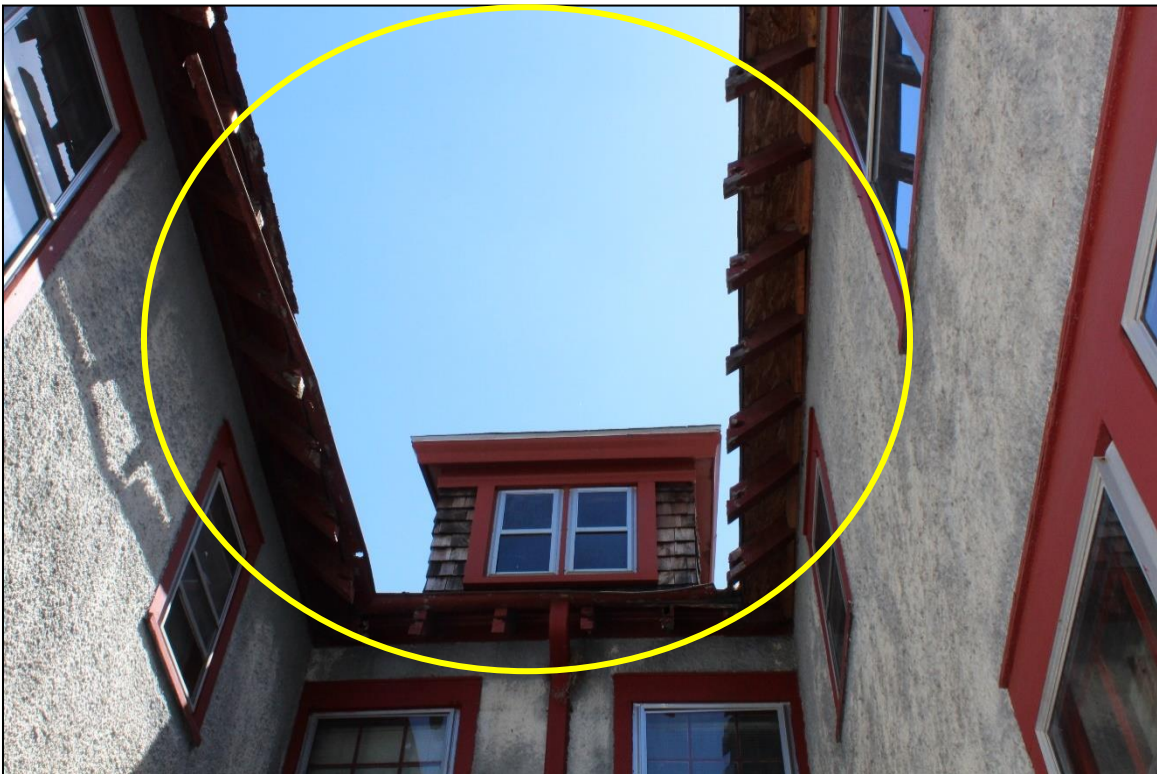
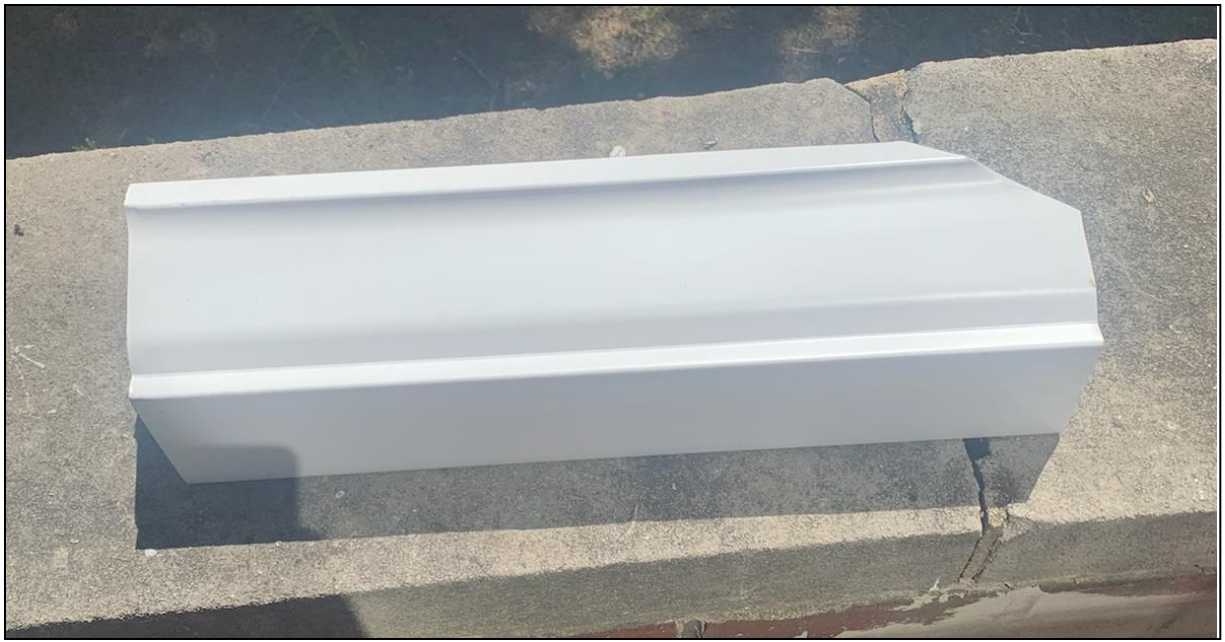
10) West Side of House: Repair or replace defective rain gutters.

Gutters are largely missing in a number of places (one example is below). New gutters will be installed throughout the entire house. Gutters to be obtained from and installed by The Gutter Company (4668 W. Electric Avenue, Milwaukee). The new gutters will be 6" aluminum K-style (see photo to follow) with 3" x 4" downspouts and will be painted to match the existing trim on the house.

6" aluminum K-Style gutters to be installed throughout the house and painted red to match the house trim.

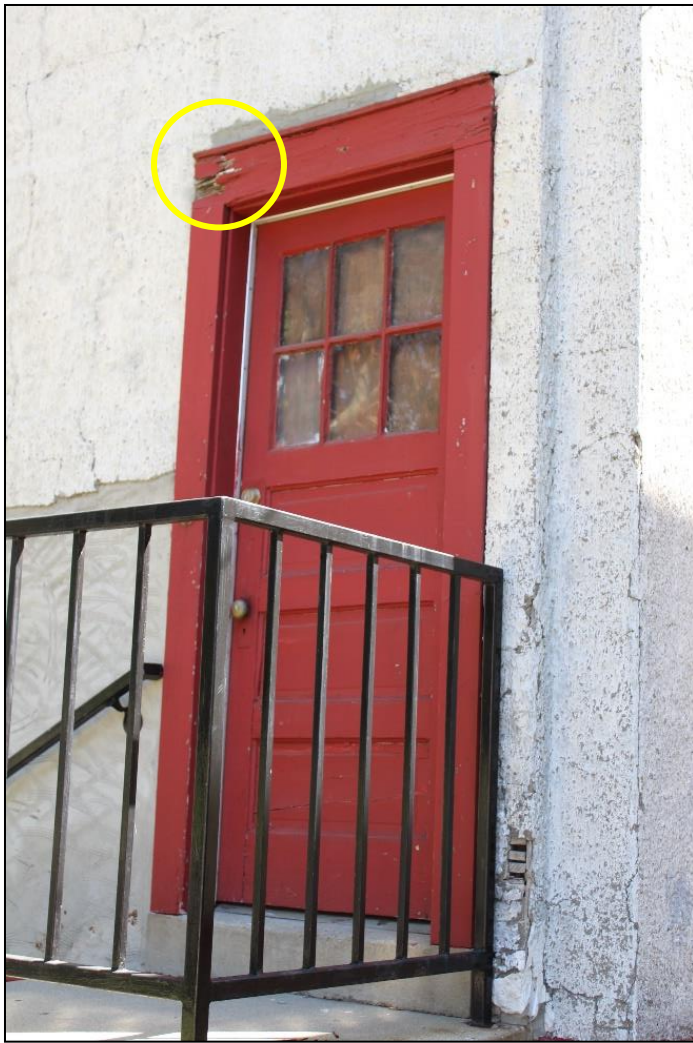
11) West Side of House: Repair or replace defective door frame (northwest side).

Abatron epoxy filler will be used to repair the corner of the defective door frame.

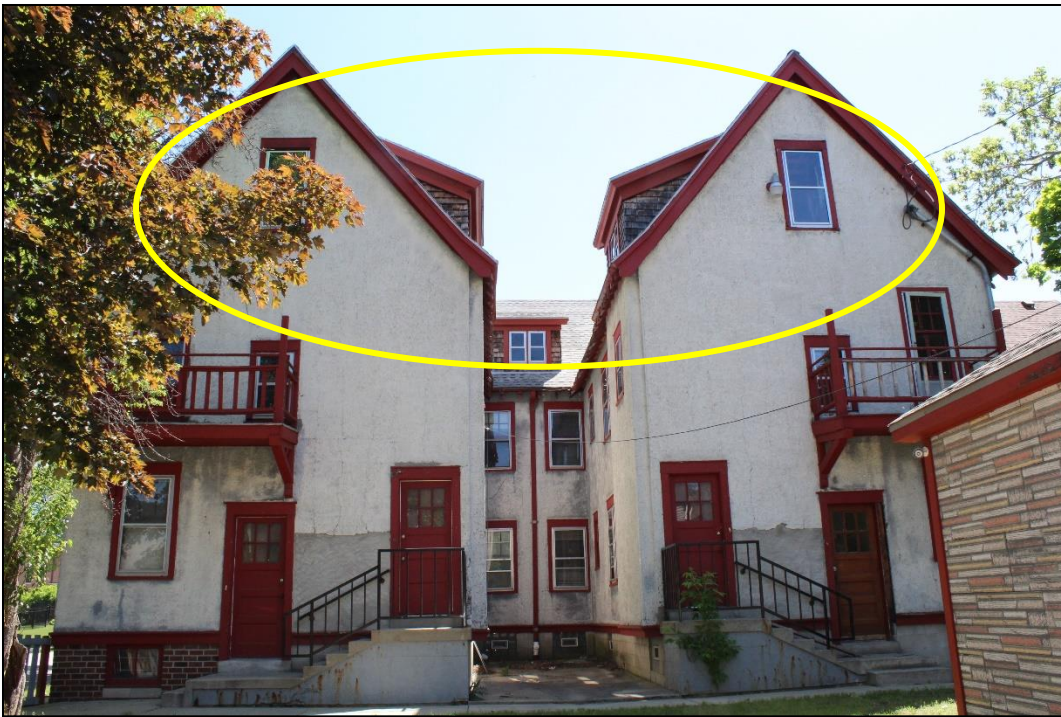
12) West Side of House: Replace missing window panes in attic.

All missing attic windows will be either obtained from or custom-made by Lisbon Storm, Screen, and Door to match what was there historically. Although there are no historic images of the rear of the house, the lighting of the new windows will match what is seen on the front of the house (8-light wood-frame windows in the attic gables, with six-light windows in the roof dormers).

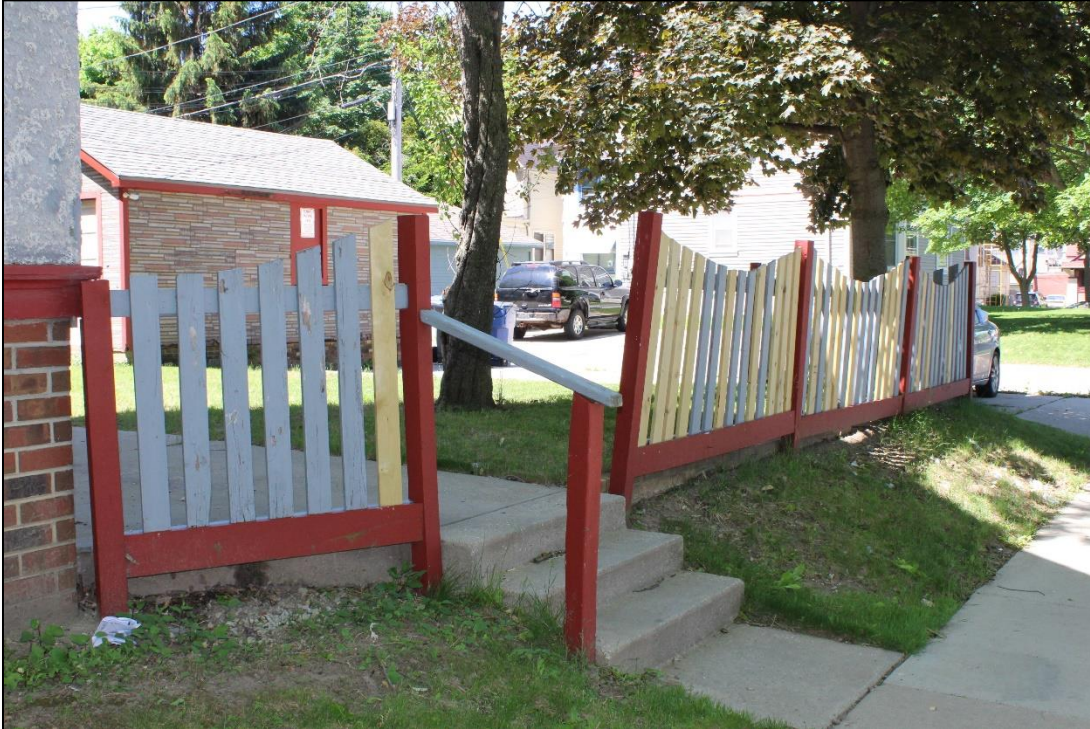
13) West Side of House: Repair, replace or remove the defective fence.

This work was already completed prior to a stop work order being issued due to not having obtained a COA for the work. As seen in the photo, the defective boards of the fence were replaced in kind but have not yet been painted.

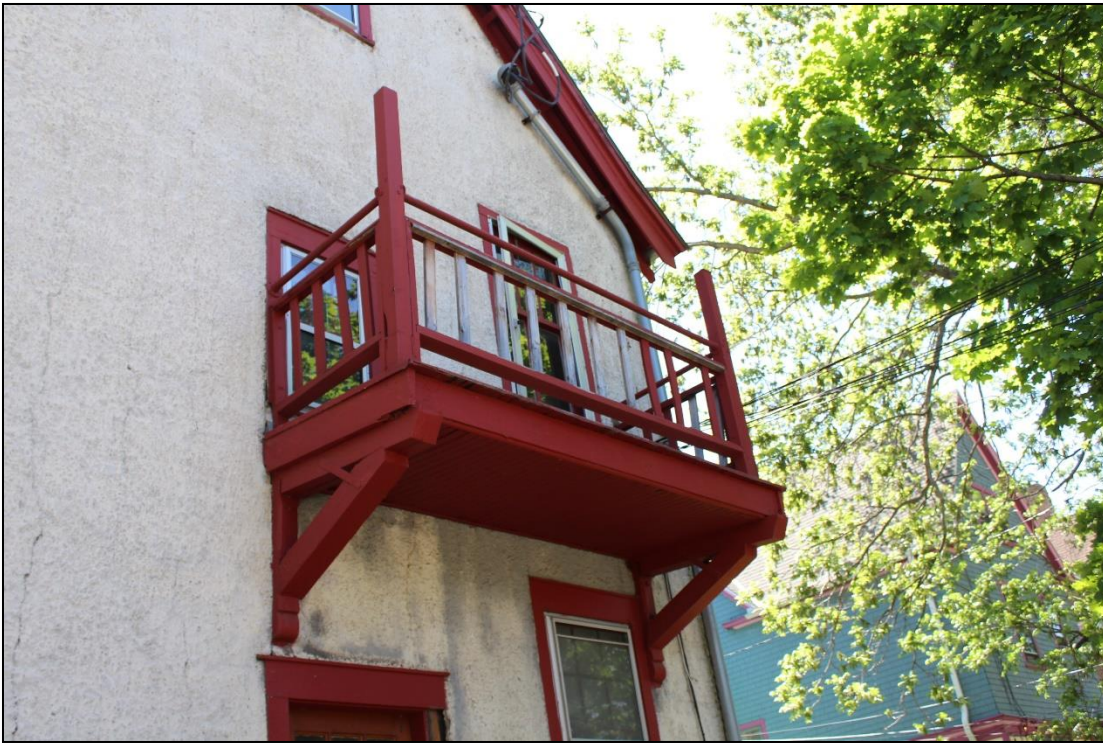
14) West Side of House: Porch support structure has failed. Restore the porch to a safe condition (southwest side).

The porch supports will be replaced with wood of the same dimension and in the same style/manner as the original. It will then be painted the same color as the existing trim. The portion of the railing that is not painted will also be painted.

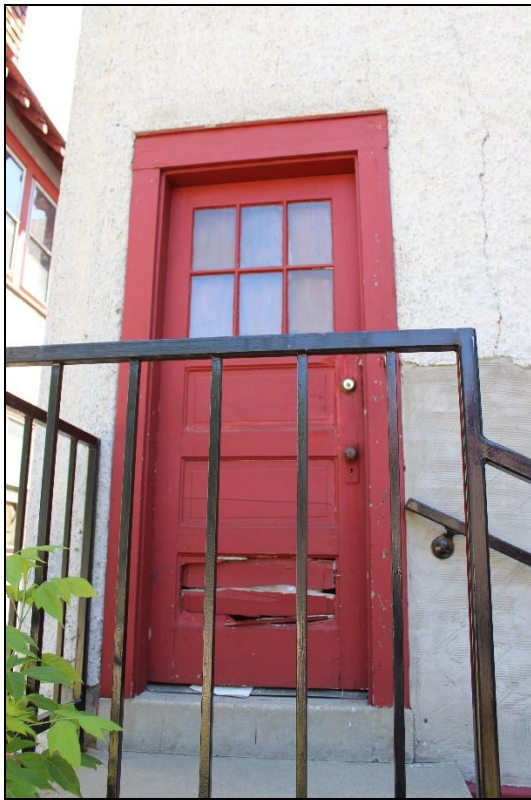
15) West Side of House: Repair or replace defective door.

The defective lower panel of this door will be repaired by Lisbon Storm, Screen & Door and painted to match the existing doors and trim.

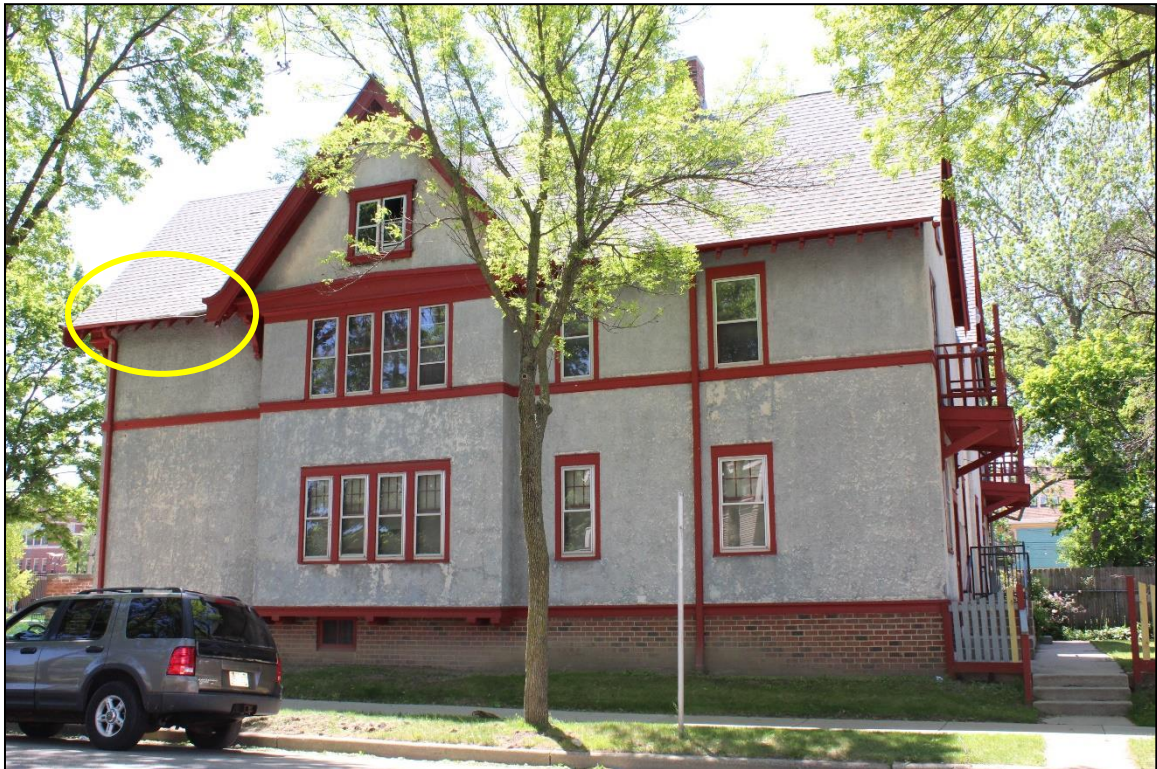
16) North Side of House: Replace defective gutters.

New gutters—6" Aluminum K-Style--will be installed throughout the entire house to replace the defective gutters.

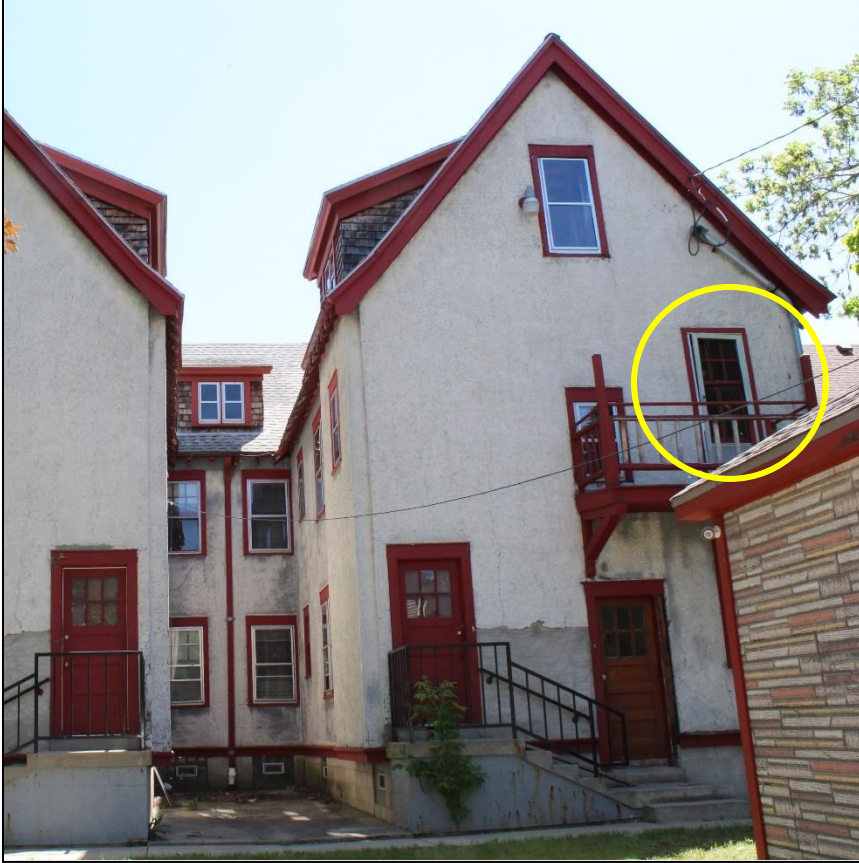
17) West Side of House: Repair or replace defective porch door on the southwest side, 2nd floor.

The existing, defective wood porch door will be taken to Lisbon Storm, Screen & Door for repair.

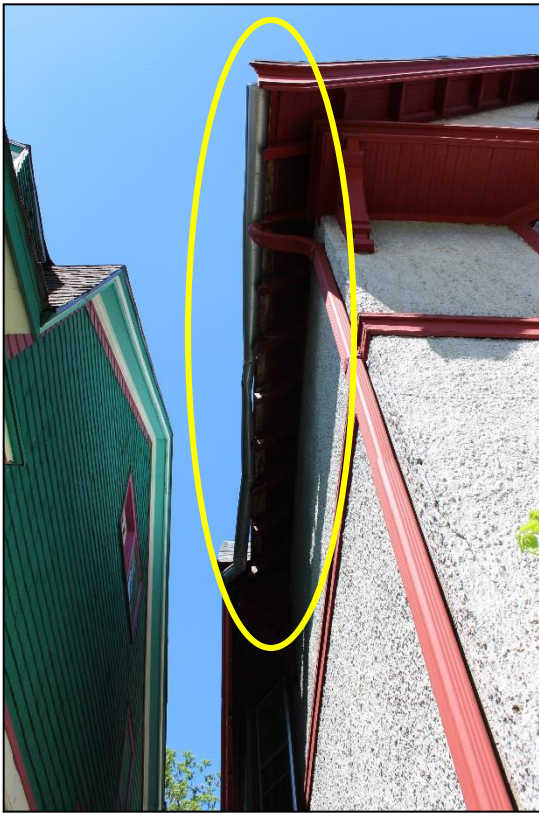
18) South Side of House: Replace defective rain gutters.

Like the rest of the house, gutters will be replaced at this location (and throughout the entire house)—
6" Aluminum K-Style.

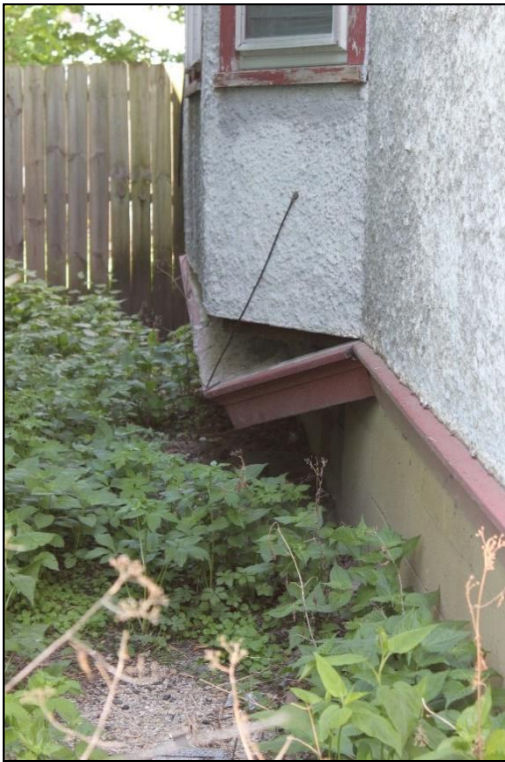
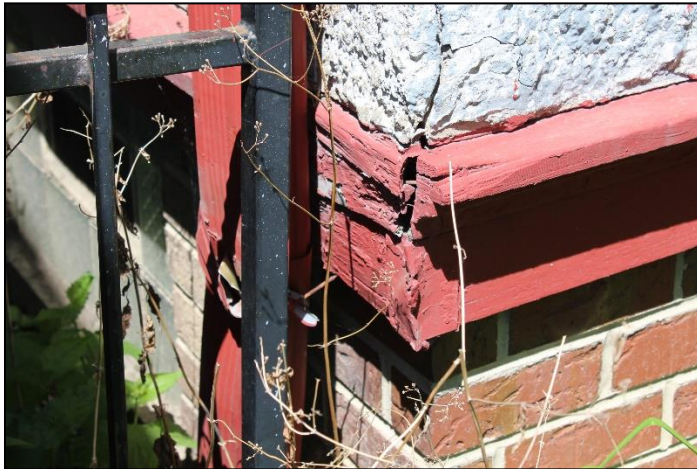
19) South Side of House: Replace defective trim boards on exterior walls above foundation.

Trim boards that have pulled away from the bottom of the bay will be reattached if still in salvageable condition. If not, they will be replaced with wooden boards of the same size and dimension, along with matching trim. Defective trim board at the immediate southeast corner will be replaced with a wooden trim board of the same size and dimension.

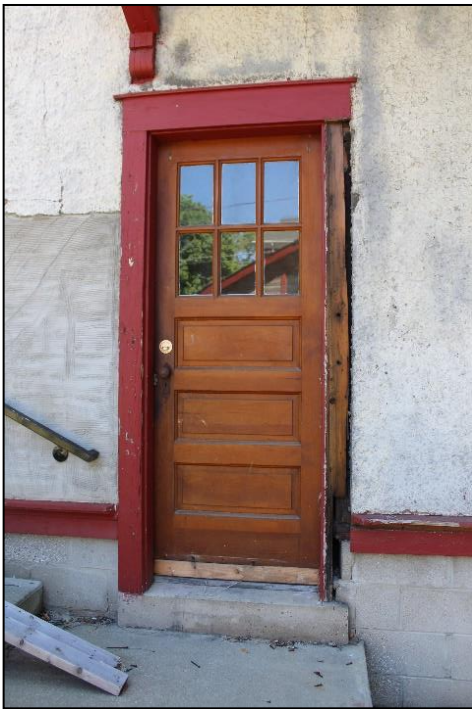
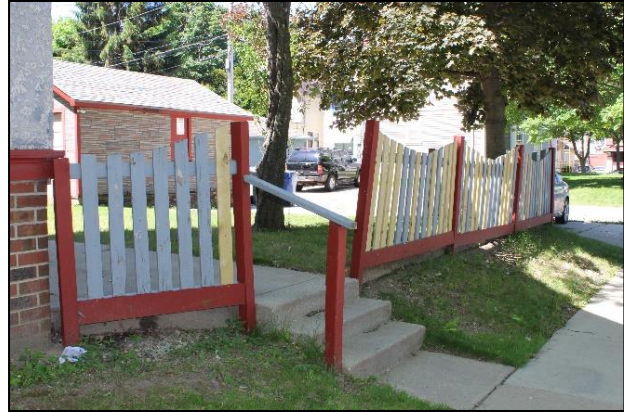
20) *Paint previously painted surfaces in a workmanlike manner.*

As indicated in other discussions, all new wood trim on the house will be painted to match the home's existing red trim color. Additionally, the replacement door below will be painted red as the others and the new boards of the fence will be painted grey like the previous boards.

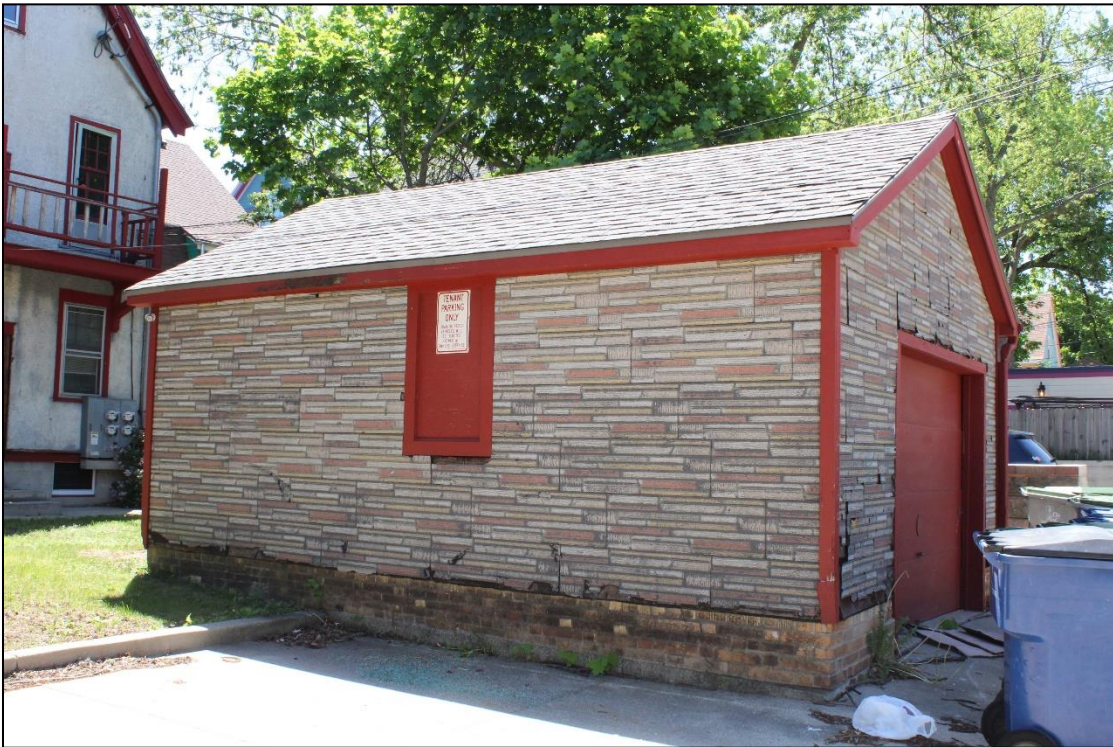
21) Garage: Replace defective siding on exterior walls.

1" x 6", smooth cedar siding will be installed over the existing asphalt siding. It will then be painted to match the house (off white/grey).

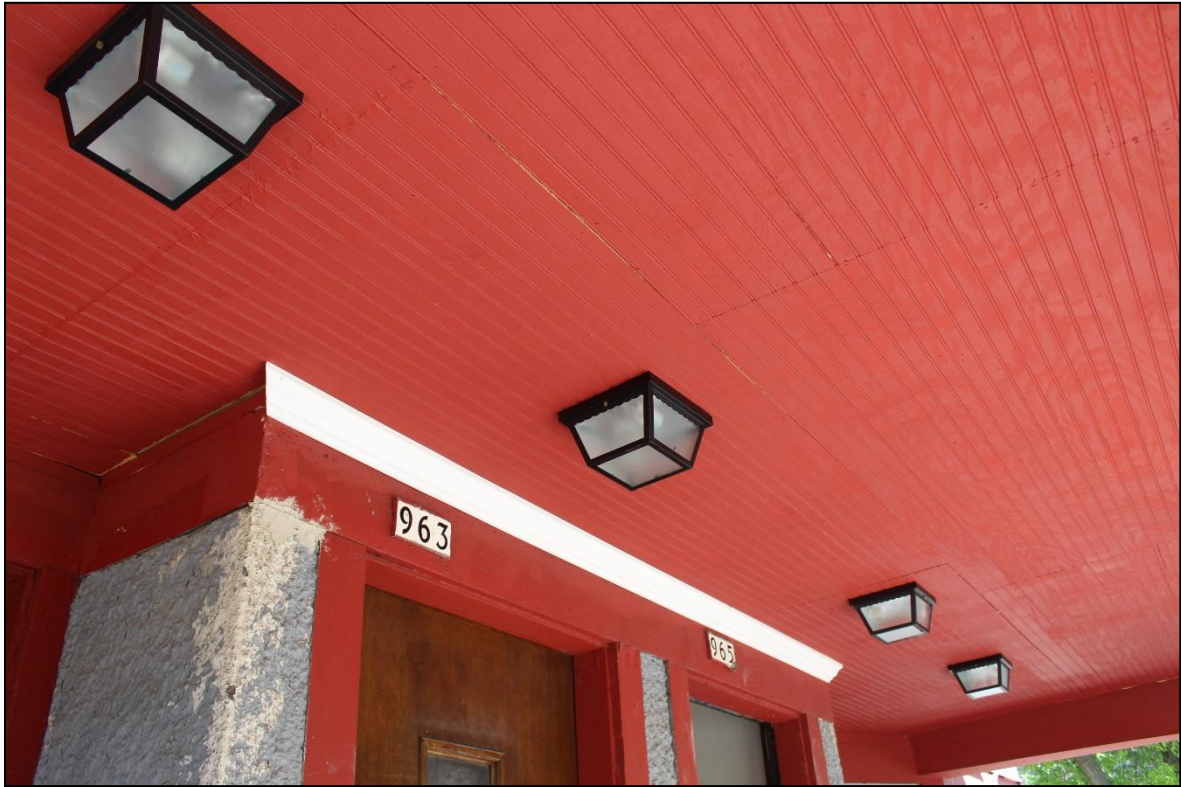
22) East Side of House: Repair or remove defective electrical fixture on the porch.

This work was already completed prior to a stop work order being issued due to not having obtained a COA for the work. As seen in the photo, all four porch light fixtures have been replaced with the same fixture that was there previously (the black trim on the lights were previously painted red to match the ceiling and house trim).
