PROPOSED WORK AND PHOTOS ASSOCIATED WITH THE LIST OF VIOLATIONS—961-967 N. 33rd Street

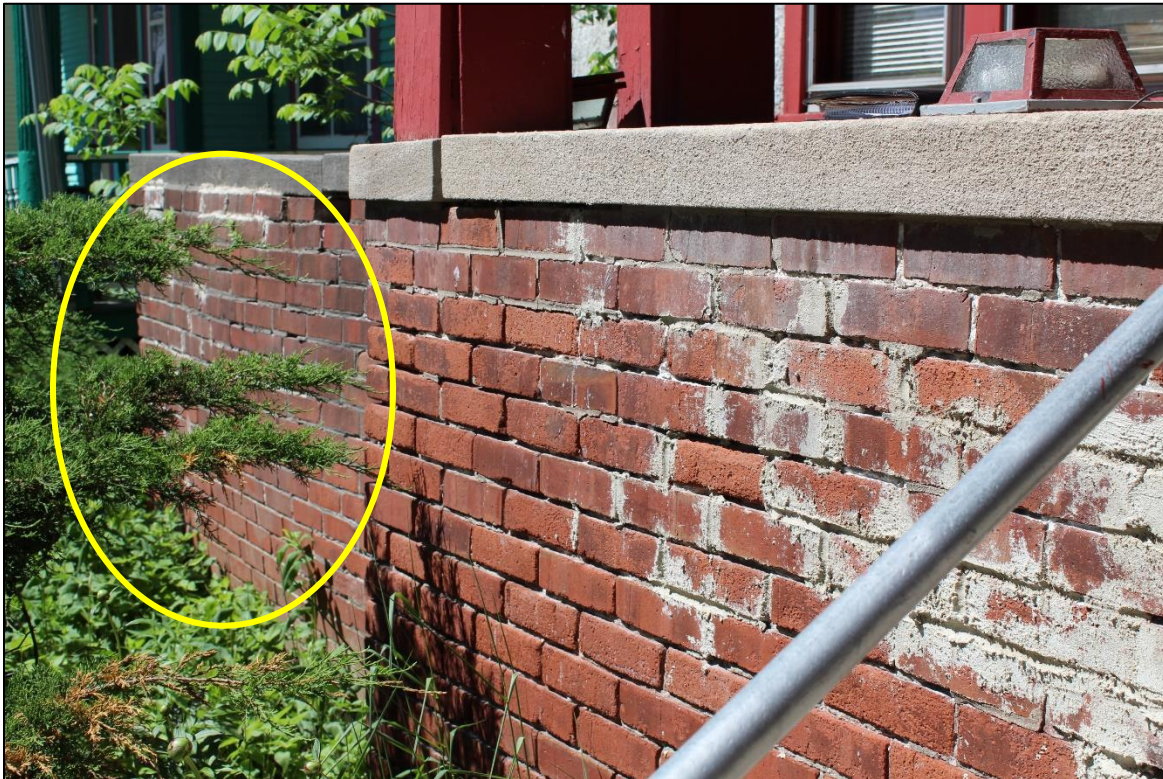
2) **East Side of House: Replace mortar missing from exterior wall (tuckpoint) porch retaining wall.**

Matching mortar will be replaced (repointing) and contrasting mortar (tuckpointing) will be completed along the defective portions of the porch. Also, following further recent inspection by the property owner, the south portion of the porch wall (circled in yellow) will be rebuilt due to bowing. Existing brick will be re-used if possible. If too damaged, similarly colored and same-sized brick (planning to used reclaimed but may have to use some new) obtained from The Brickyard, Inc. (3351 S. Clement Avenue, Milwaukee) will be used.

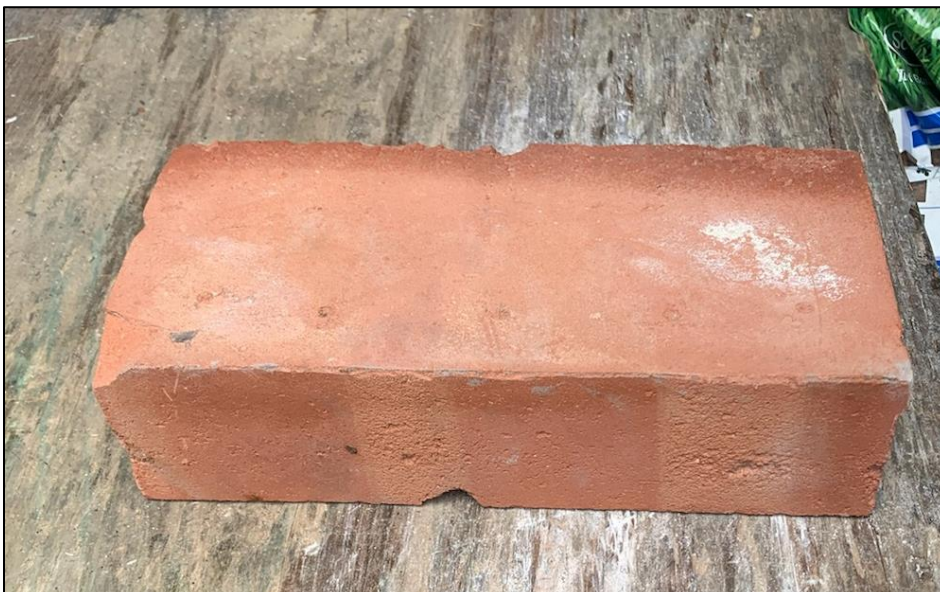
Reclaimed brick 3 ¾" x 2 ½" x 8 ½"

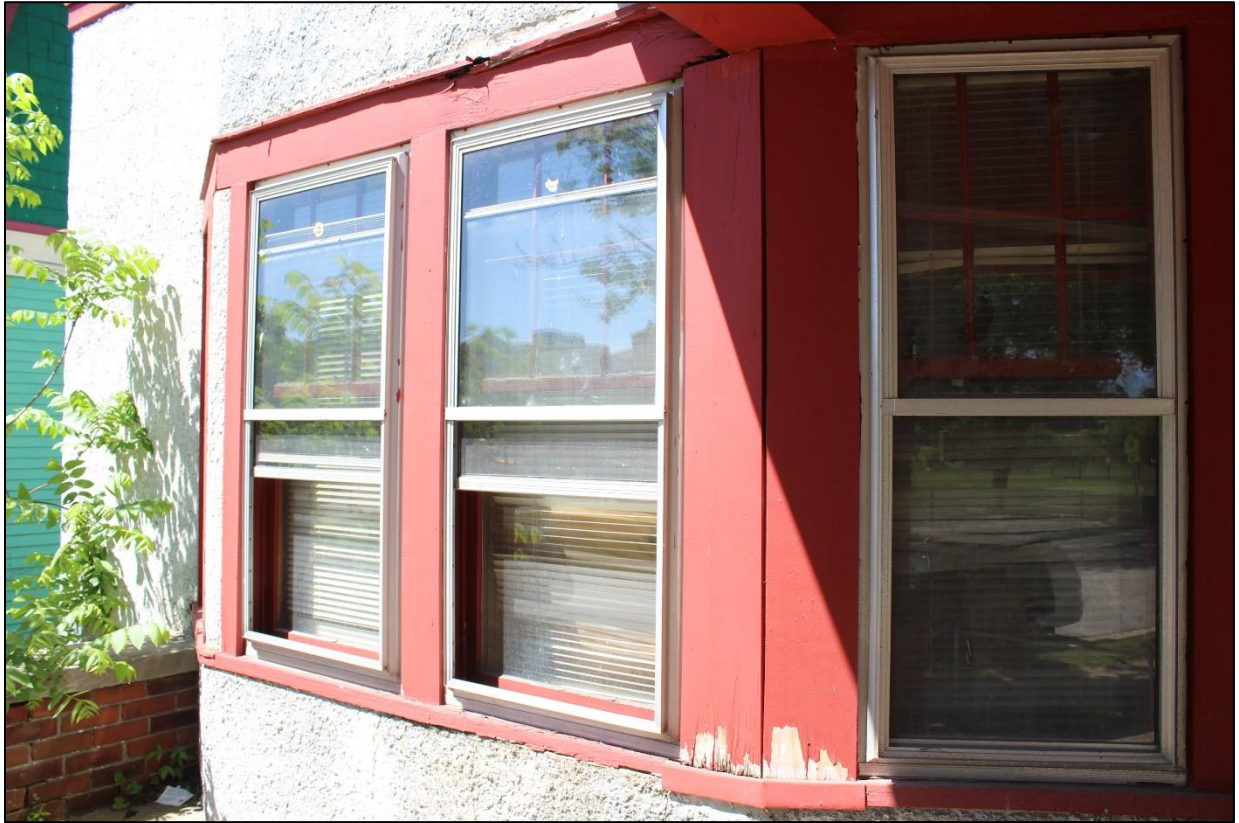
3) East Side of House: Repair or replace defective first-floor window frame.

Wooden window frame will be removed and replaced with new, pressure treated lumber of the same dimension as the existing obtained from Bliffert lumber. Following installation, it will be painted the same color as the existing trim.

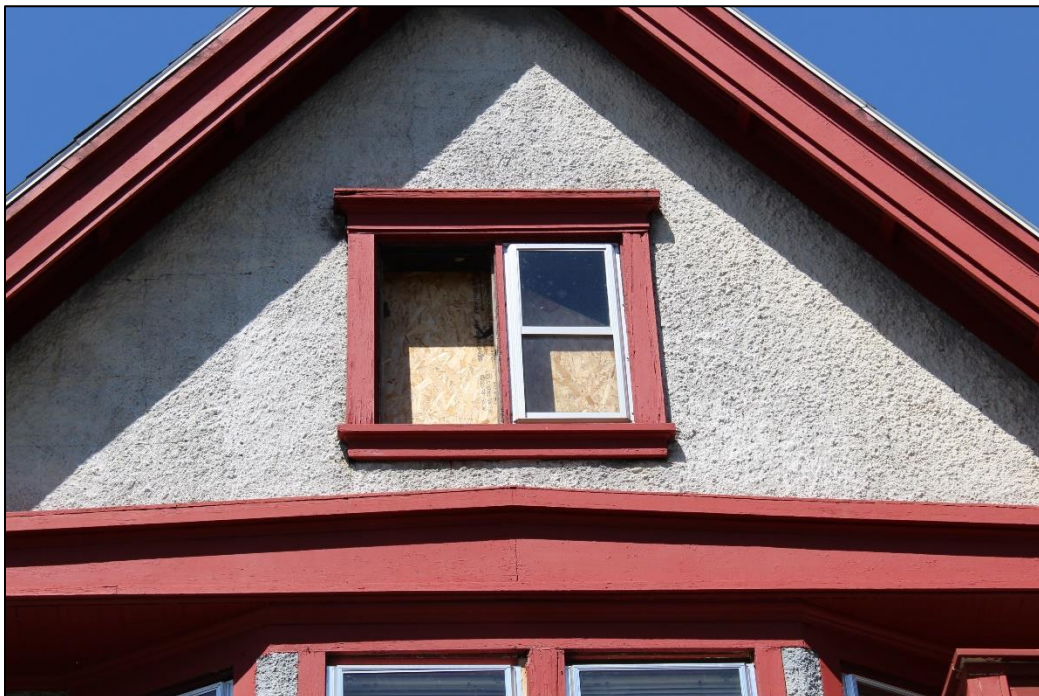
4) East Side of House: Replace missing window panes in attic.

If none are available in their inventory, new wood-frame windows of the same size will be made by Lisbon Storm, Screen & Door (5006 W. Lisbon Avenue, Milwaukee) and installed where none currently exist. Lighting of windows will match the original windows as seen in a 1980 photo of the house (see photo to follow).

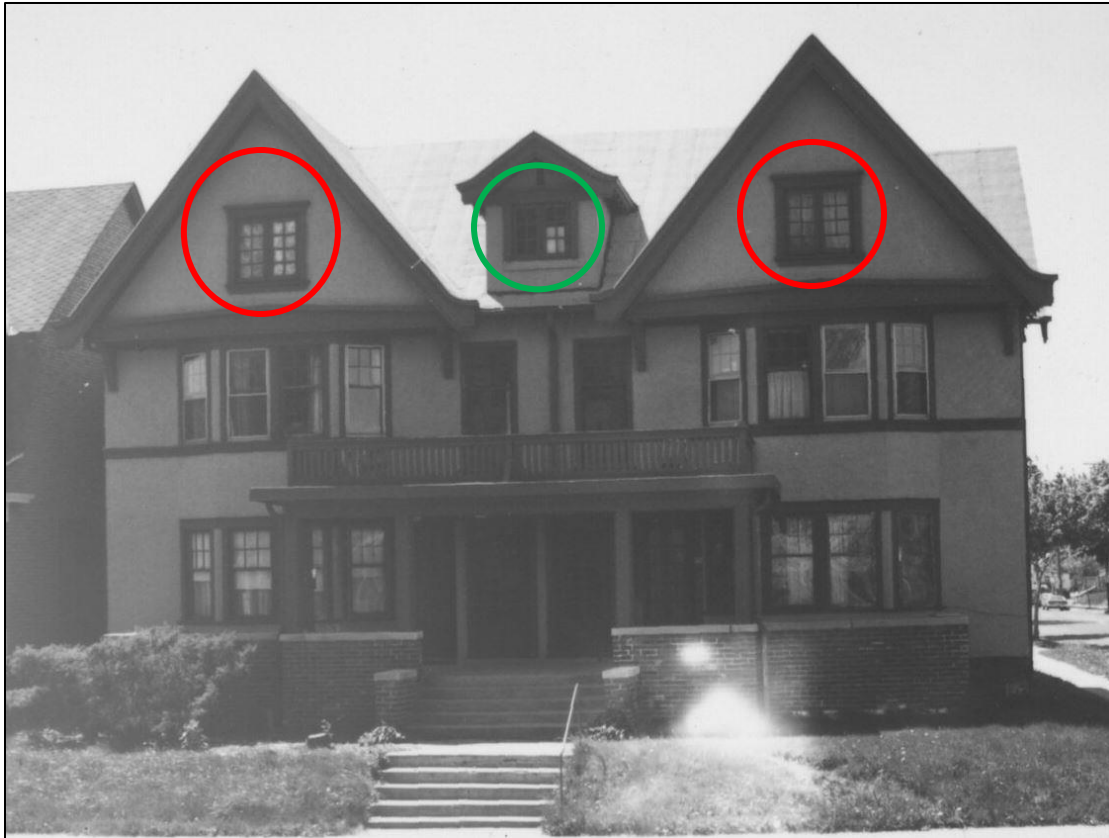
Windows within the attic gables (red circles) will be eight-light, wood-frame examples, while the smaller windows within the roof dormer (green circle) will be six-light, wood-frame windows. It has yet to be fully determined if the attic windows need to be operable or if fixed windows can be installed (we are checking with the inspector but it is believed they do not have to be operable since the attic story does not include living quarters).

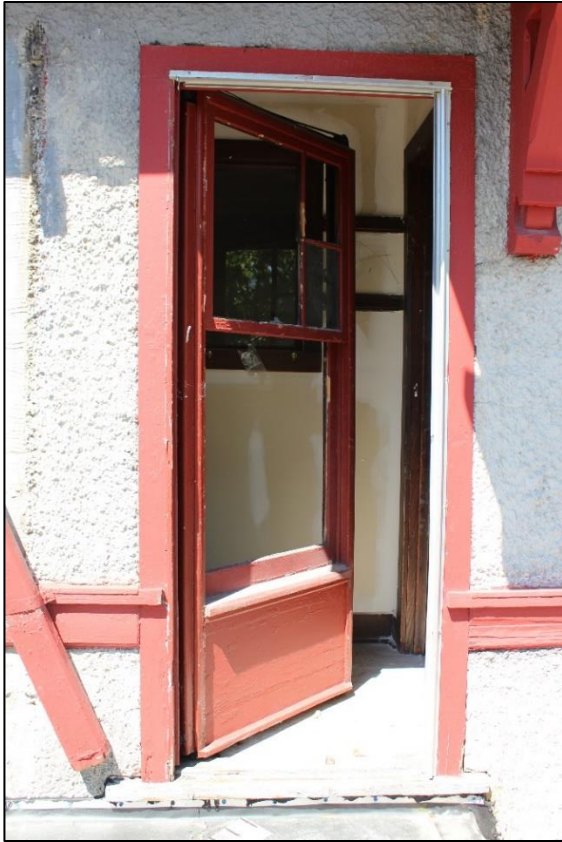
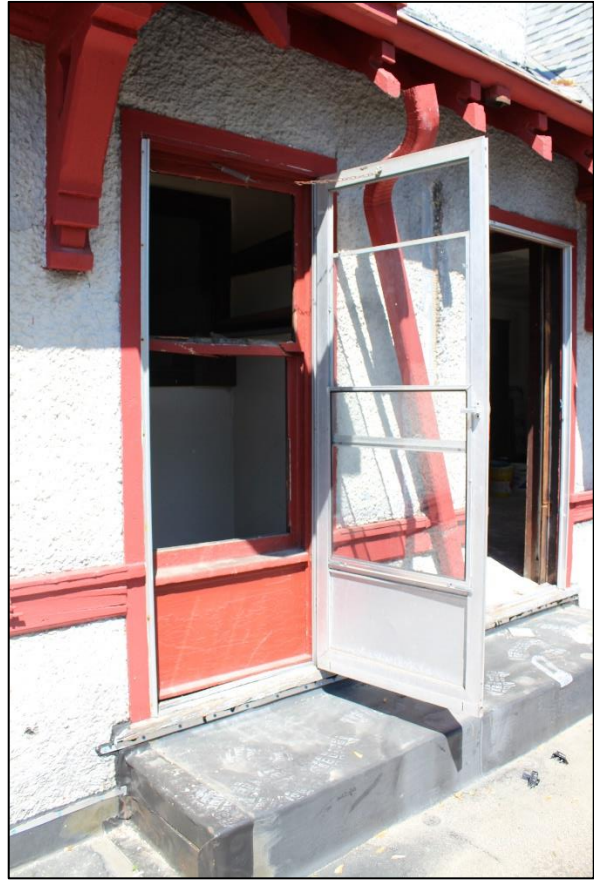
5) East Side of House: Repair or replace defective porch door on 2nd floor.

Although one door is identified as defective, both are missing their 6-light sash at the top. The door to the north (below: left) will be repaired (to include the six-light window), while a new, matching, wood door (with six-light upper pane) will be made by Lisbon Storm, Screen & Door and installed on the south (below: right).

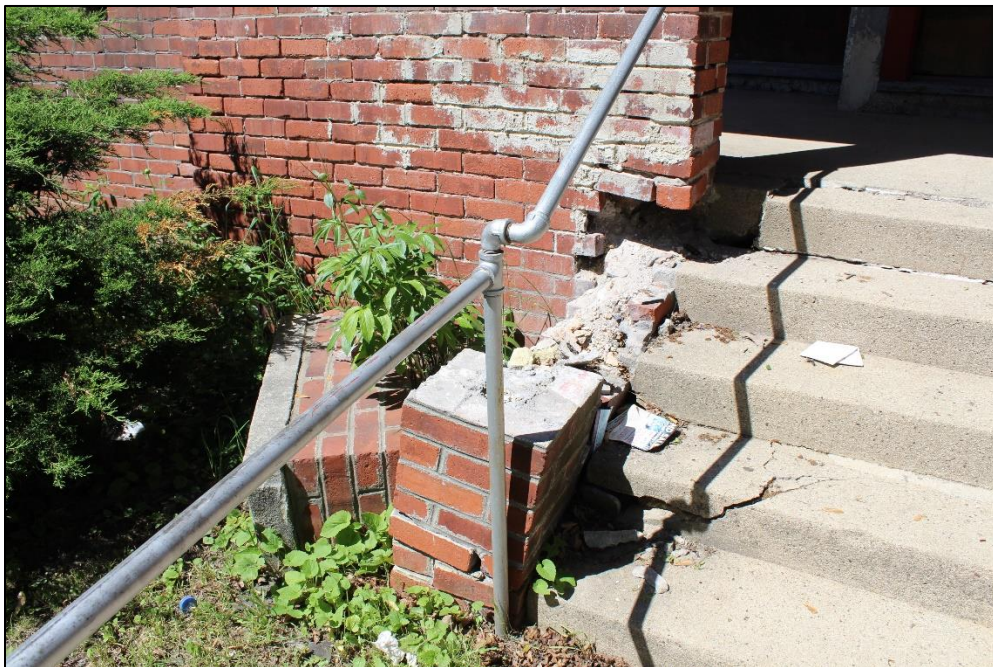
6) East Side of House: Replace defective buttress.

Brick cheek wall (or buttress, as identified per the inspection) to be rebuilt with similar-colored, reclaimed brick identified under #2 above and topped with a concrete cap.

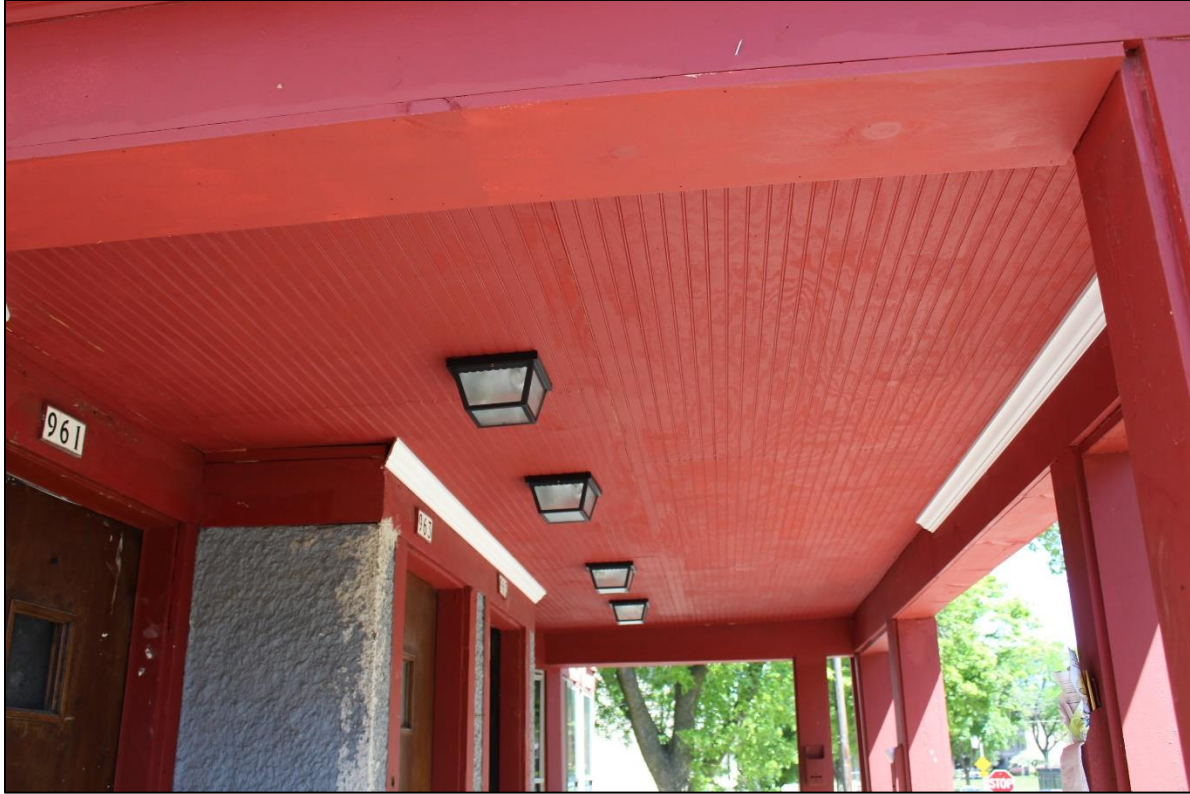
7) East Side of House: Replace defective board in porch ceiling.

This work was already completed prior to a stop work order being issued due to not having obtained a COA for the work. As seen in the photo, matching beadboard was obtained and the defective board replaced.

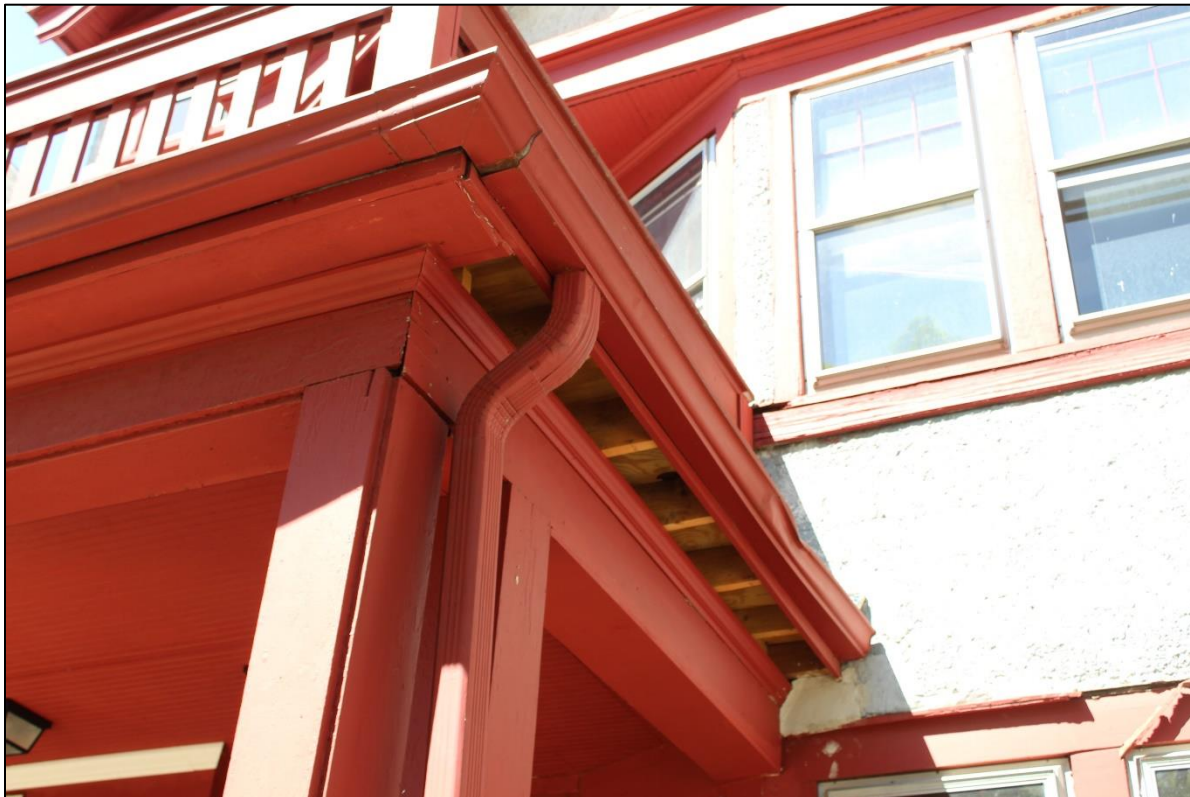
8) East Side of House: Repair or replace defective trim boards on porch (soffit between 1st and 2nd floor porch).

Missing trim board to be replaced with wood to match existing board and painted to match trim.

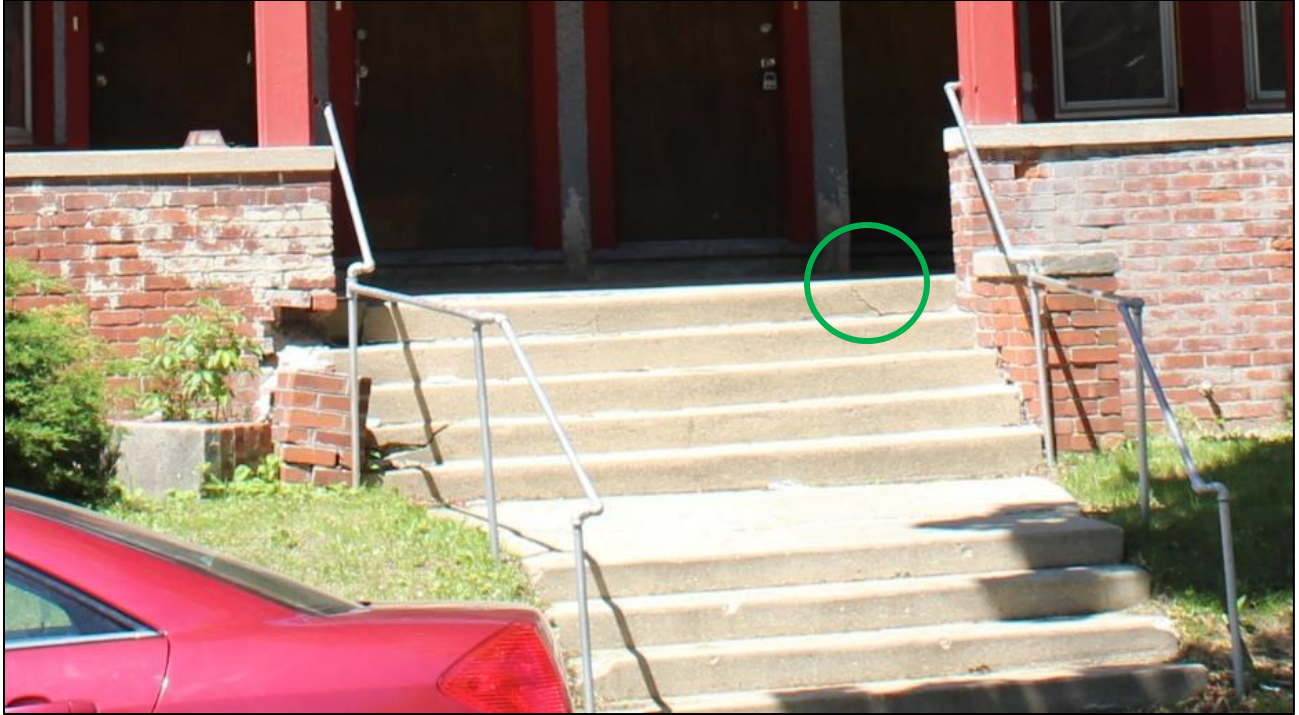
9) East Side of House: Repair or replace defective concrete or masonry porch steps.

The upper set of concrete stairs will be removed and new concrete stairs poured. Repair will also be made to top step/porch base as seen at the far right (green circle).

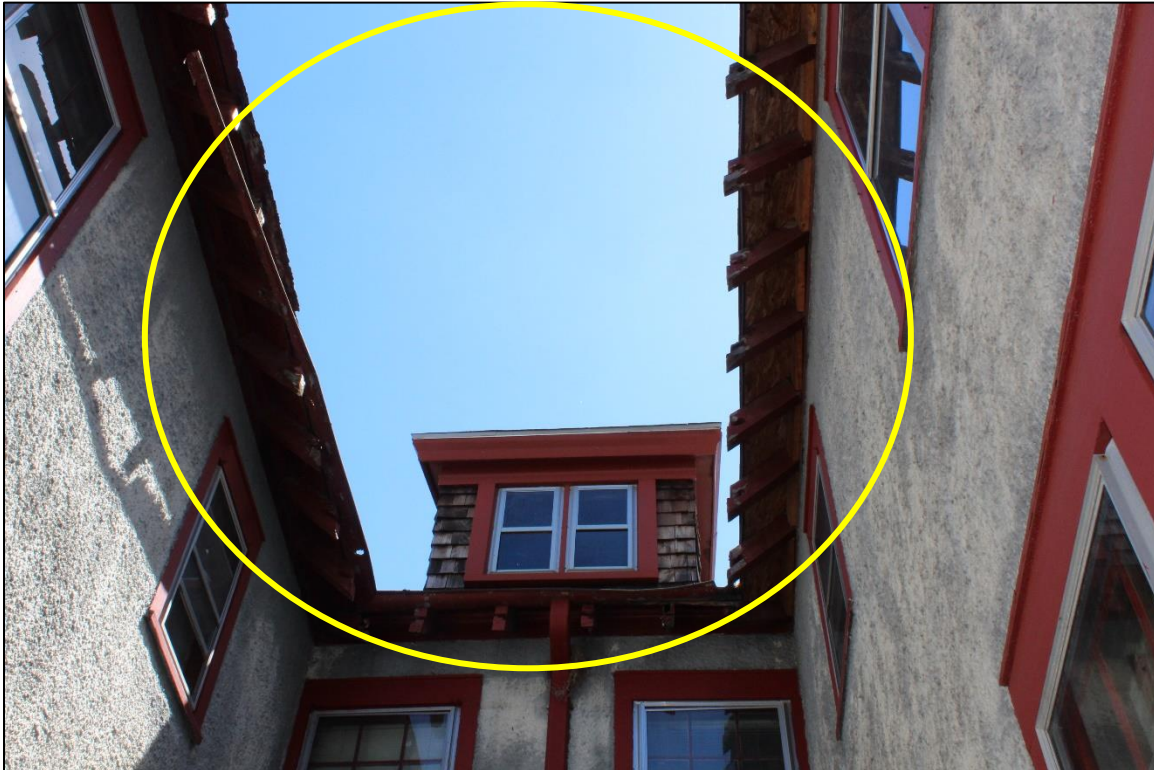
10) West Side of House: Repair or replace defective rain gutters.

Gutters are largely missing in a number of places (one example is below). New gutters will be installed throughout the entire house. Gutters to be obtained from and installed by The Gutter Company (4668 W. Electric Avenue, Milwaukee). The new gutters will be 6" aluminum K-style (see photo to follow) with 3" x 4" downspouts and will be painted to match the existing trim on the house.

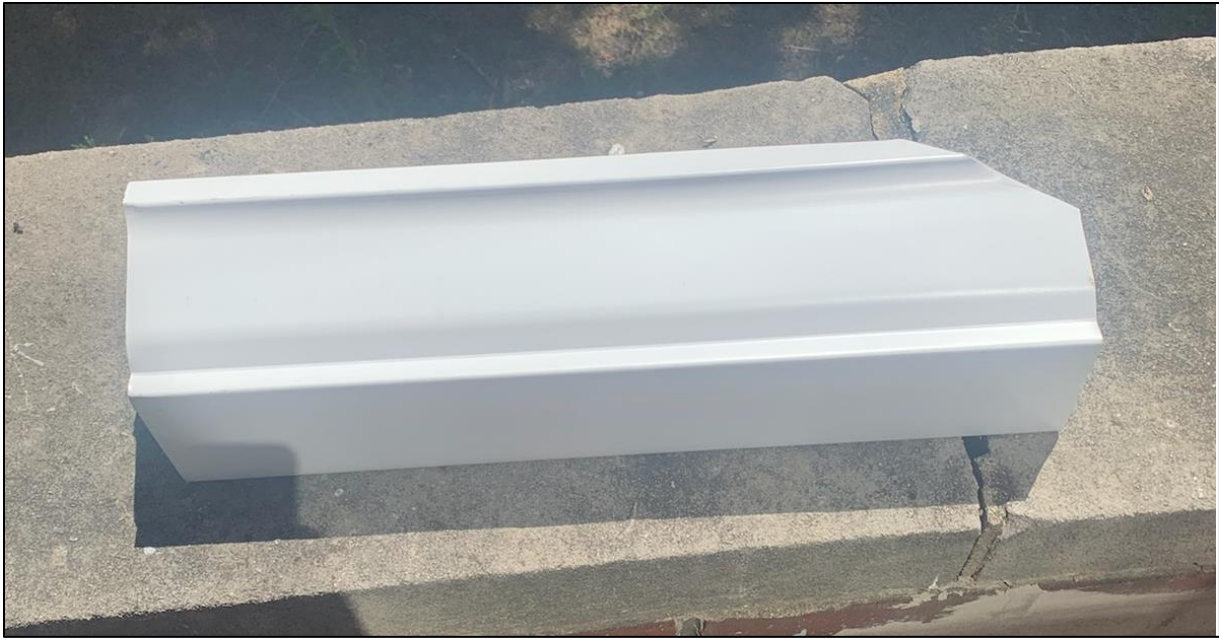
6" aluminum K-Style gutters to be installed throughout the house and painted red to match the house trim.

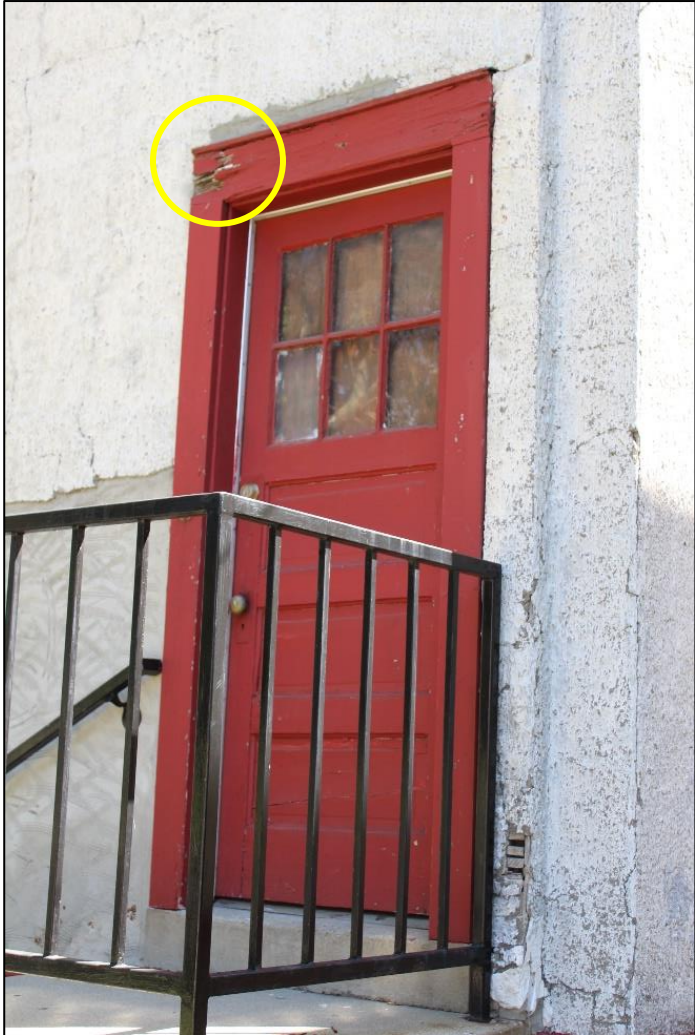
11) West Side of House: Repair or replace defective door frame (northwest side).

Abatron epoxy filler will be used to repair the corner of the defective door frame.

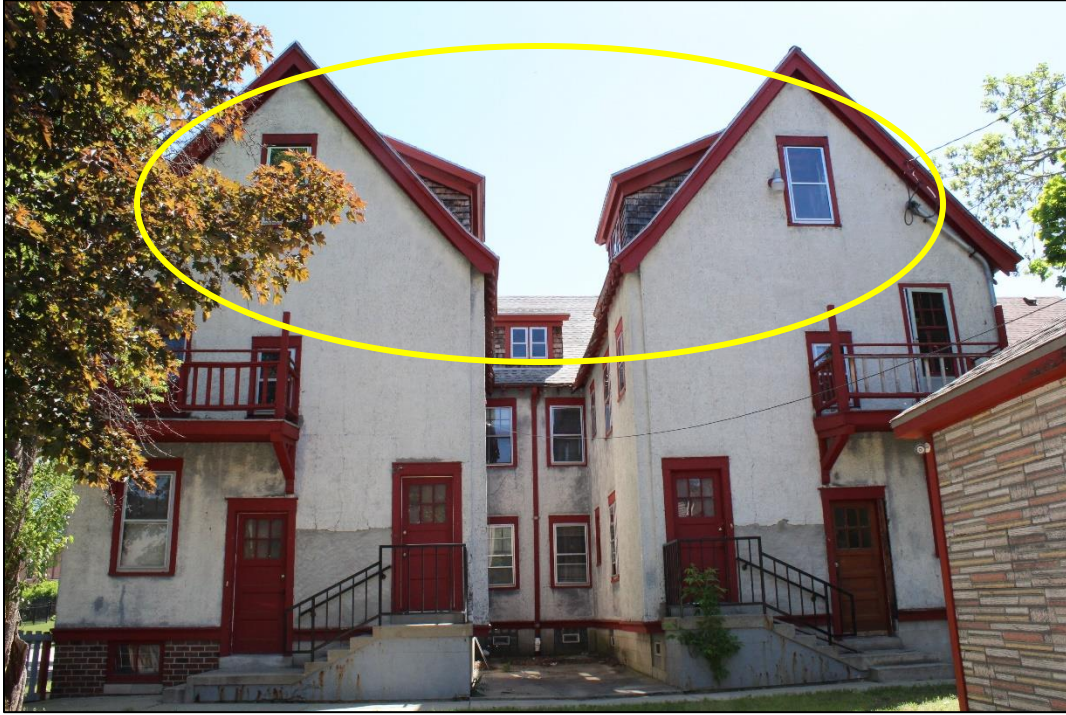
12) West Side of House: Replace missing window panes in attic.

All missing attic windows will be either obtained from or custom-made by Lisbon Storm, Screen, and Door to match what was there historically. Although there are no historic images of the rear of the house, the lighting of the new windows will match what is seen on the front of the house (8-light wood-frame windows in the attic gables, with six-light windows in the roof dormers).

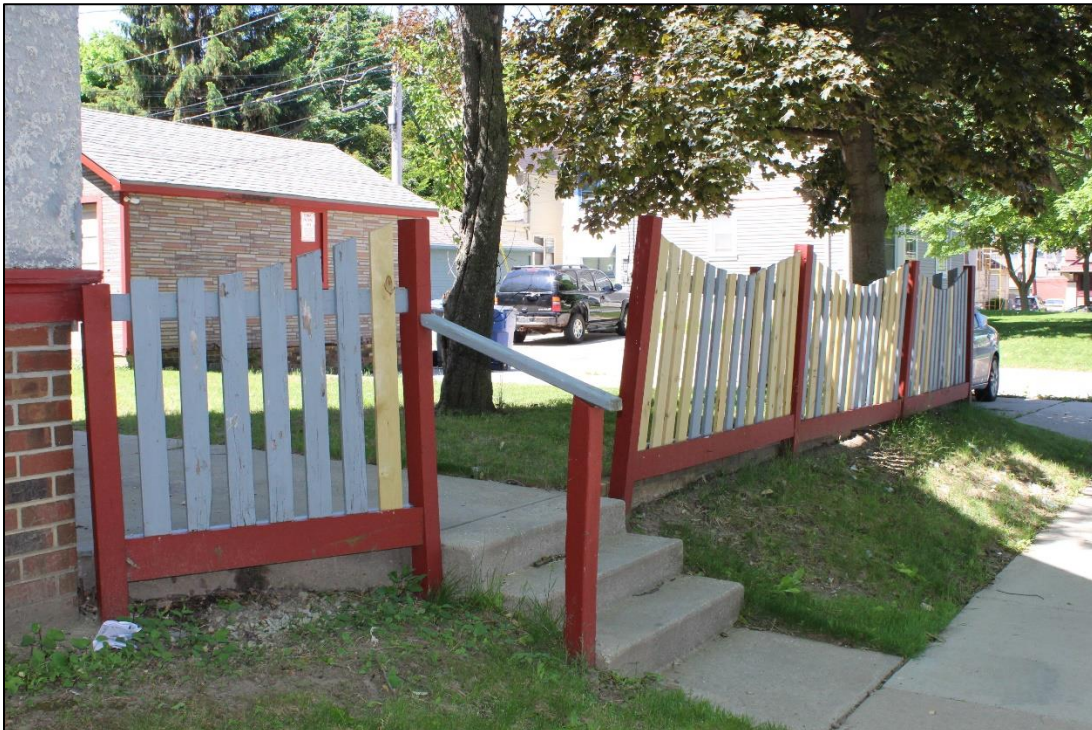
13) West Side of House: Repair, replace or remove the defective fence.

This work was already completed prior to a stop work order being issued due to not having obtained a COA for the work. As seen in the photo, the defective boards of the fence were replaced in kind but have not yet been painted.

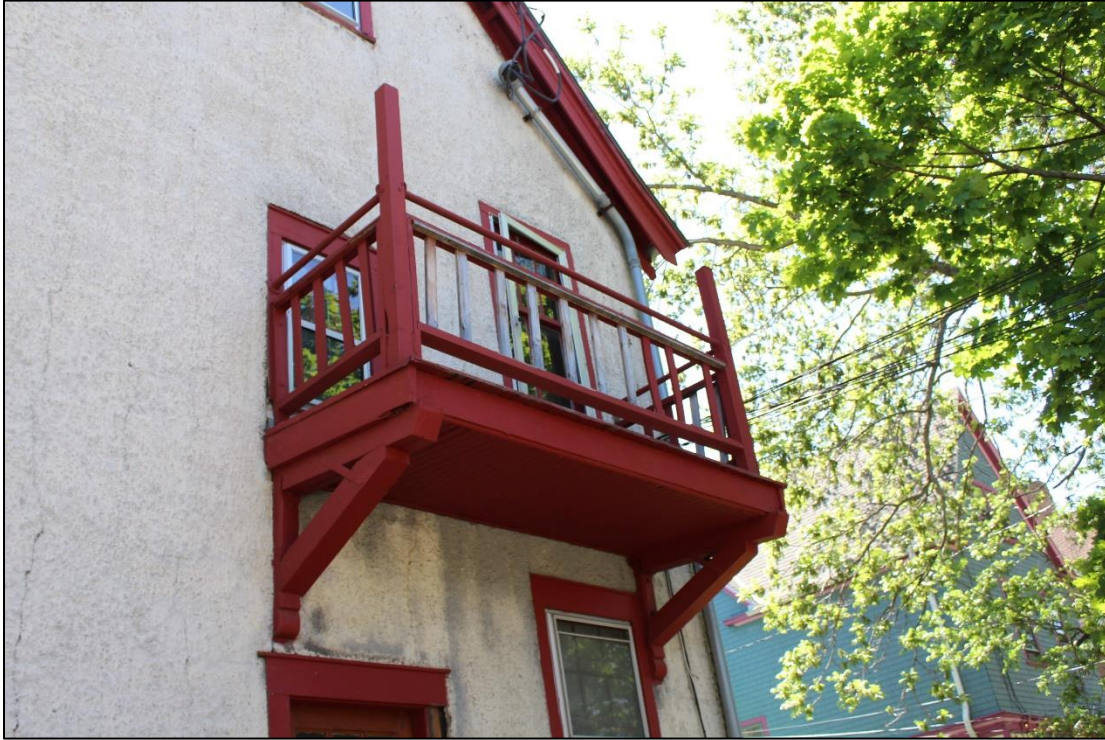
14) West Side of House: Porch support structure has failed. Restore the porch to a safe condition (southwest side).

The porch supports will be replaced with wood of the same dimension and in the same style/manner as the original. It will then be painted the same color as the existing trim. The portion of the railing that is not painted will also be painted.

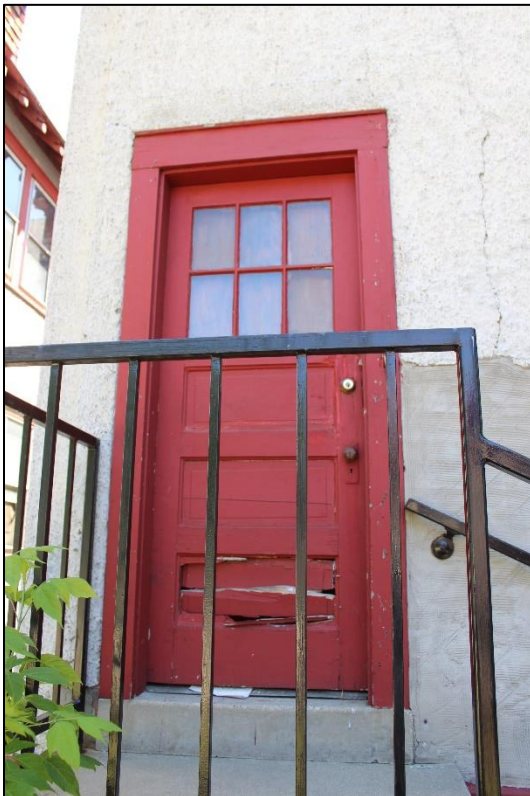
15) West Side of House: Repair or replace defective door.

The defective lower panel of this door will be repaired by Lisbon Storm, Screen & Door and painted to match the existing doors and trim.

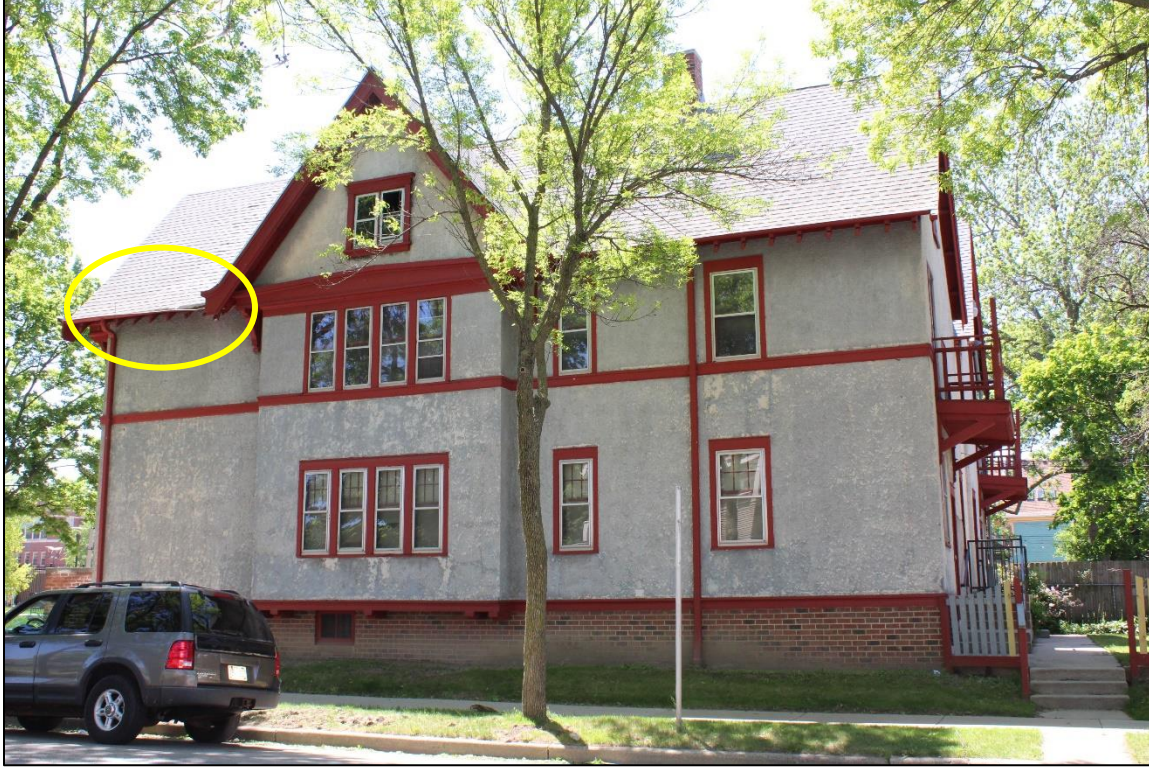
16) North Side of House: Replace defective gutters.

New gutters—6" Aluminum K-Style--will be installed throughout the entire house to replace the defective gutters.

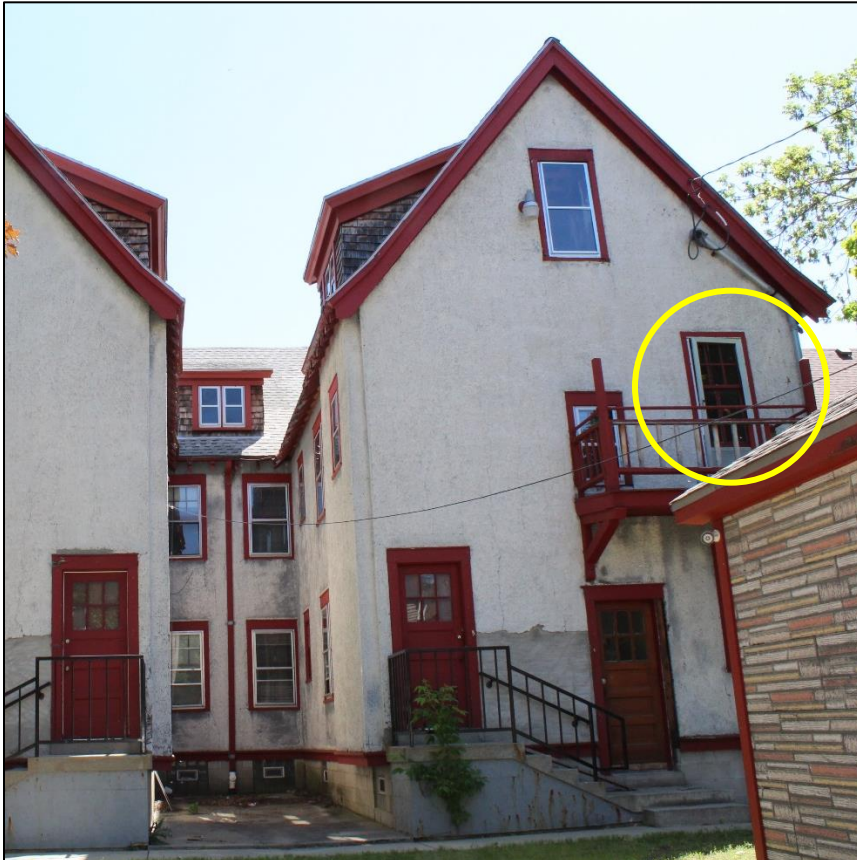
17) West Side of House: Repair or replace defective porch door on the southwest side, 2nd floor.

The existing, defective wood porch door will be taken to Lisbon Storm, Screen & Door for repair.

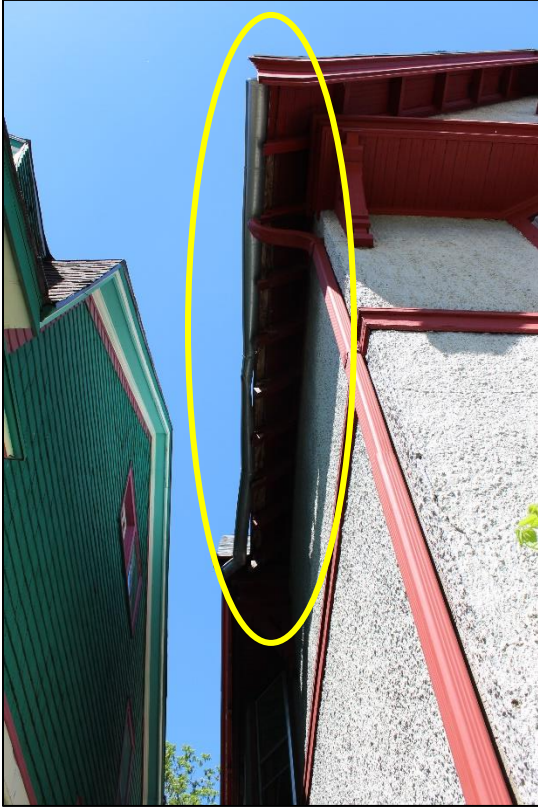
18) South Side of House: Replace defective rain gutters.

Like the rest of the house, gutters will be replaced at this location (and throughout the entire house)—6" Aluminum K-Style.

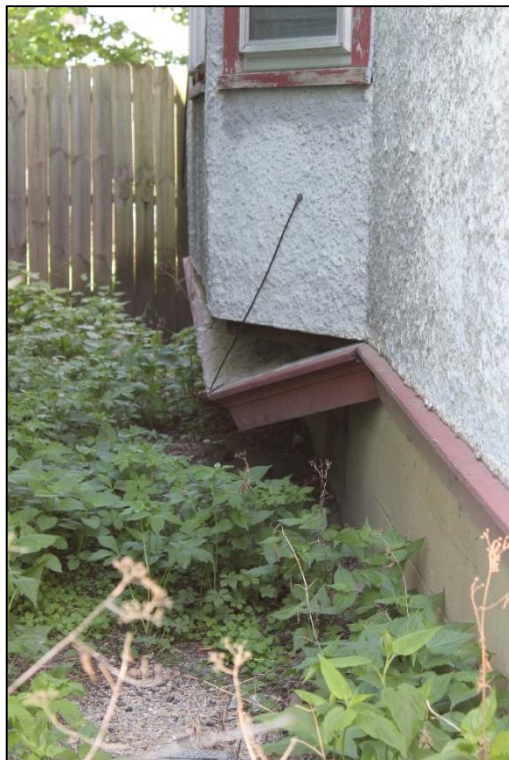
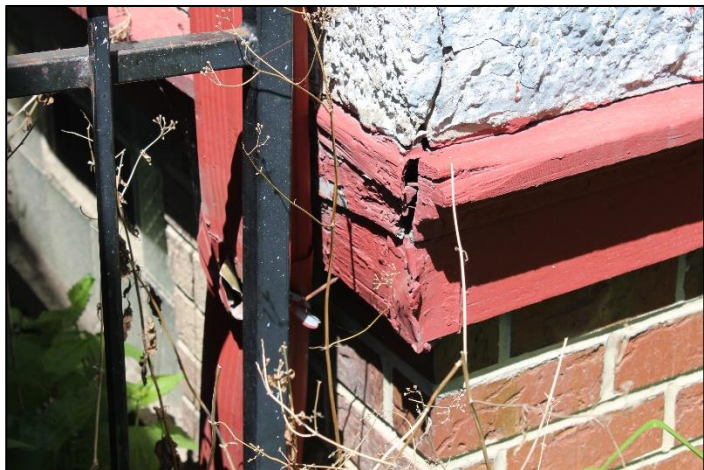
19) South Side of House: Replace defective trim boards on exterior walls above foundation.

Trim boards that have pulled away from the bottom of the bay will be reattached if still in salvageable condition. If not, they will be replaced with wooden boards of the same size and dimension, along with matching trim. Defective trim board at the immediate southeast corner will be replaced with a wooden trim board of the same size and dimension.

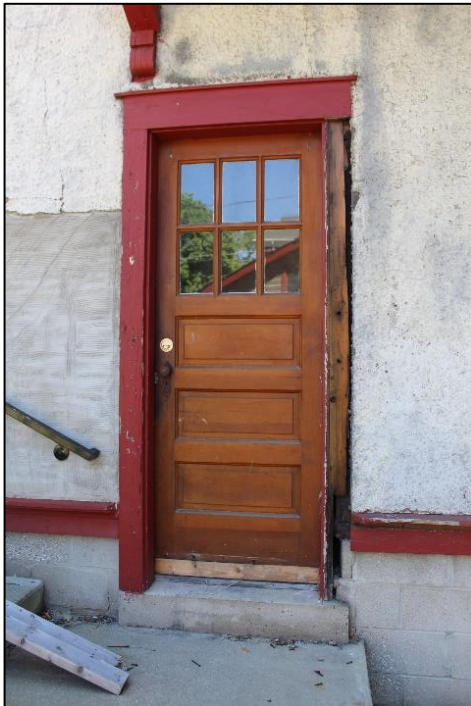
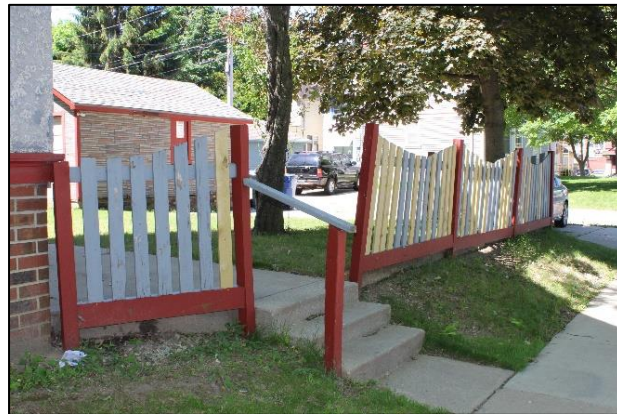
20) Paint previously painted surfaces in a workmanlike manner.

As indicated in other discussions, all new wood trim on the house will be painted to match the home's existing red trim color. Additionally, the replacement door below will be painted red as the others and the new boards of the fence will be painted grey like the previous boards.

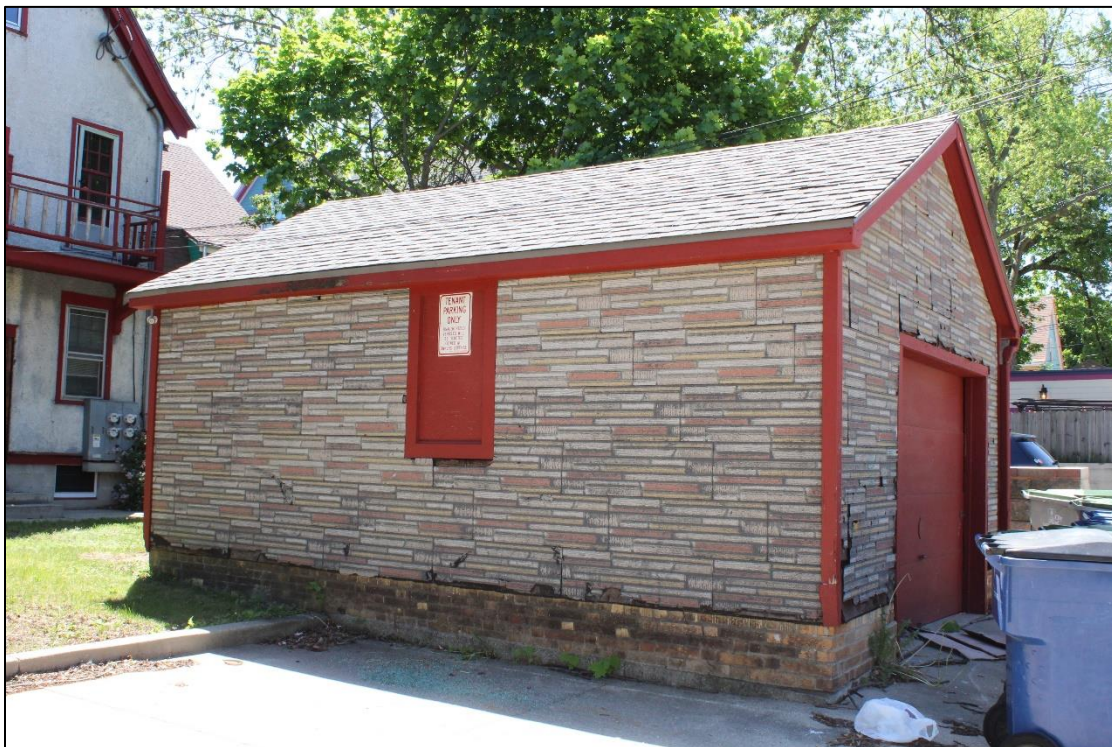
21) Garage: Replace defective siding on exterior walls.

1" x 6", smooth cedar siding will be installed over the existing asphalt siding. It will then be painted to match the house (off white/grey).

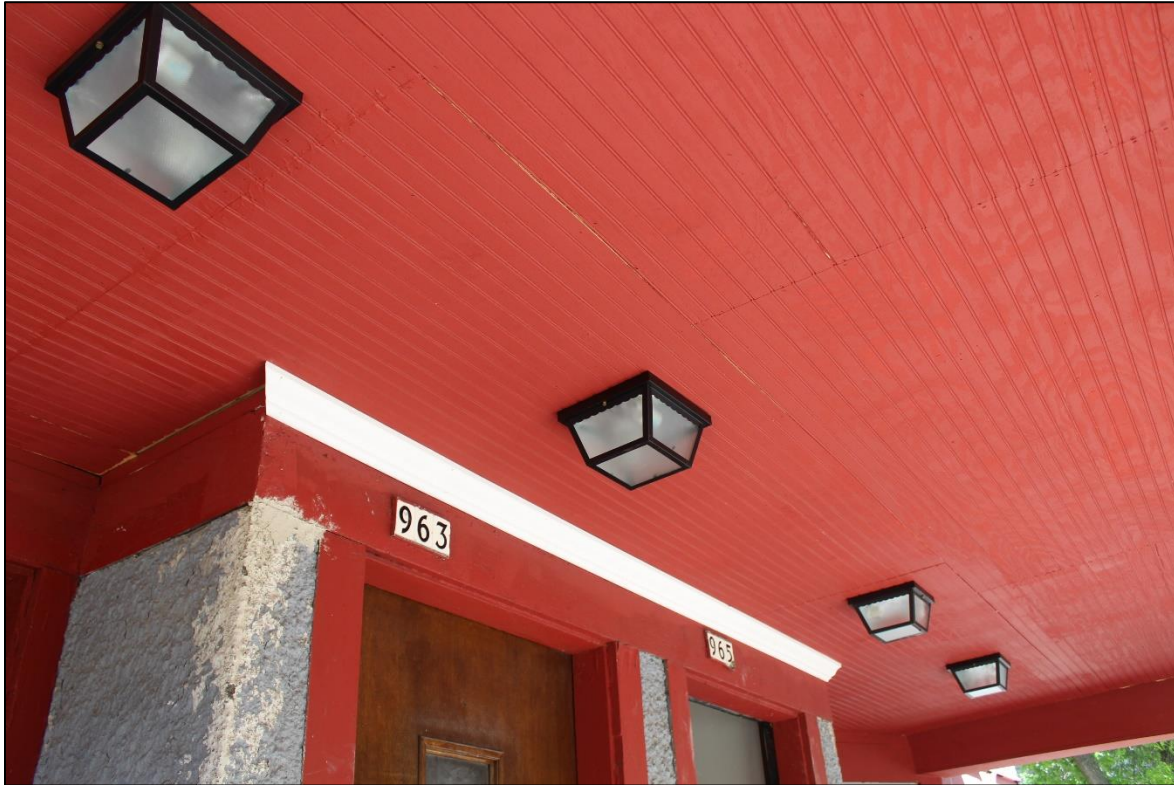
22) East Side of House: Repair or remove defective electrical fixture on the porch.

This work was already completed prior to a stop work order being issued due to not having obtained a COA for the work. As seen in the photo, all four porch light fixtures have been replaced with the same fixture that was there previously (the black trim on the lights were previously painted red to match the ceiling and house trim).
