# WGEMA CAMPUS WGETTHTA BUILDINGS EXTERIOR STABILIZATION

BID PACKAGE NO. 1

DATE: MAY 29, 2015

PROJECT NUMBER: 15014.01

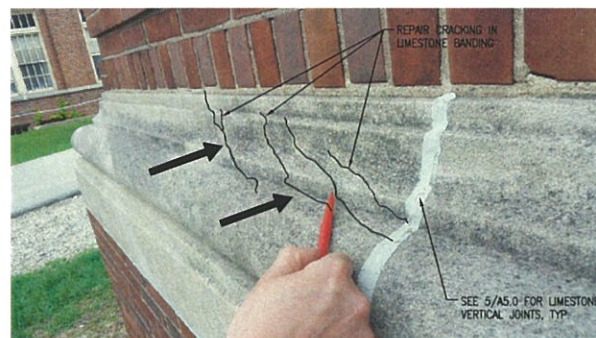
1 LIMESTONE CRACKING  
SCALE: N.T.S.

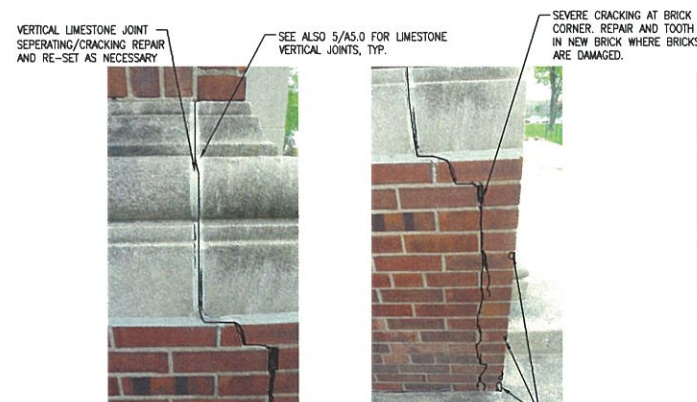
2 BRICK AND LIMESTONE CRACKING  
SCALE: N.T.S.

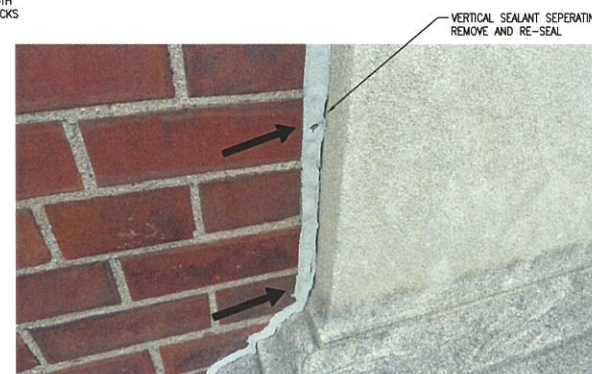
3 VERTICAL SEALANT JOINTS @ COLUMNS, TYP.  
SCALE: N.T.S.

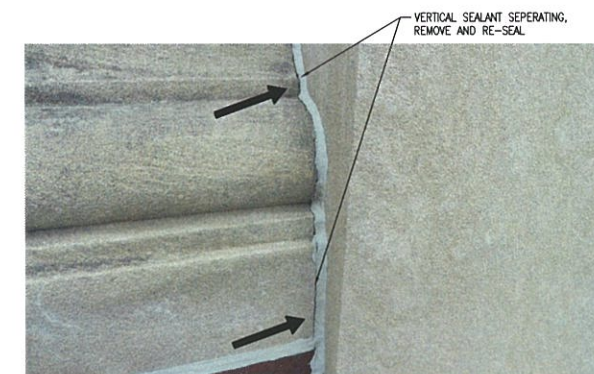
4 VERTICAL SEALANT JOINTS @ COLUMNS, TYP.  
SCALE: N.T.S.

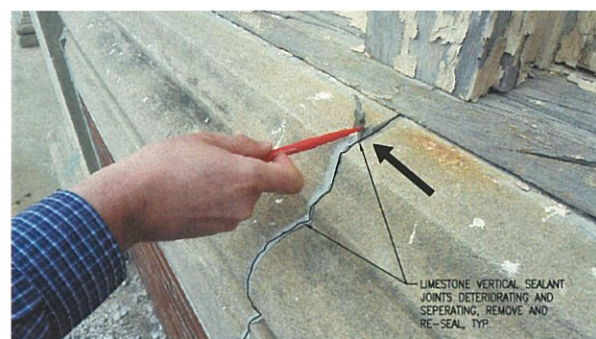
5 VERTICAL SEALANT JOINTS @ LIMESTONE BANDING  
SCALE: N.T.S.

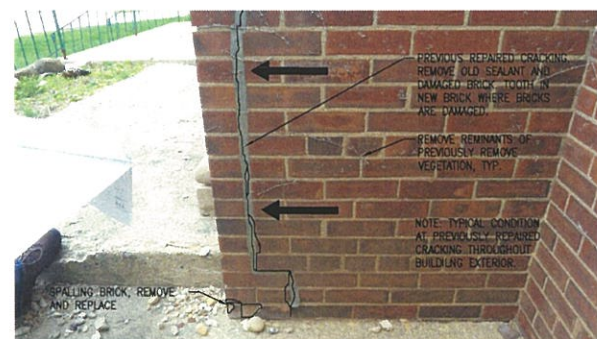
6 BRICK CRACKING AND SPALLING  
SCALE: N.T.S.

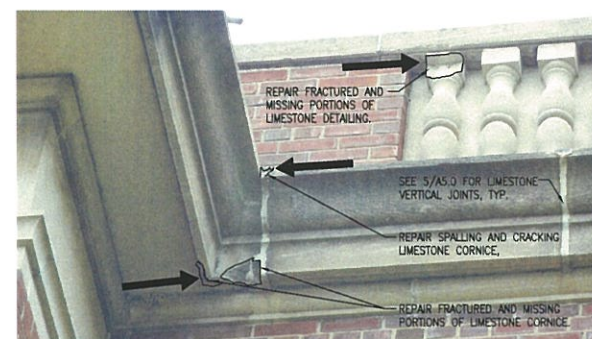
7 FRACTURED LIMESTONE ELEMENTS  
SCALE: N.T.S.

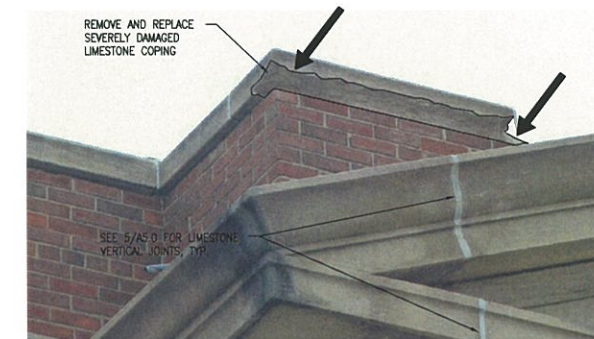
8 DAMAGED LIMESTONE COPING  
SCALE: N.T.S.

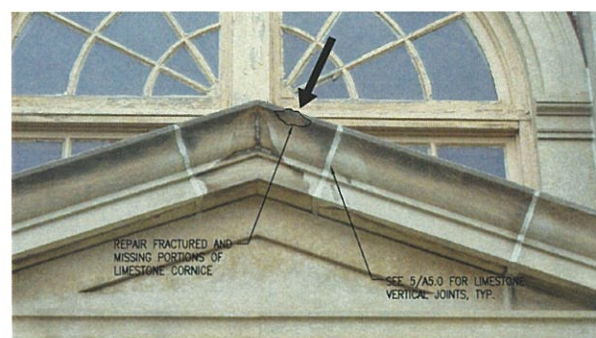
9 FRACTURED LIMESTONE ELEMENTS  
SCALE: N.T.S.

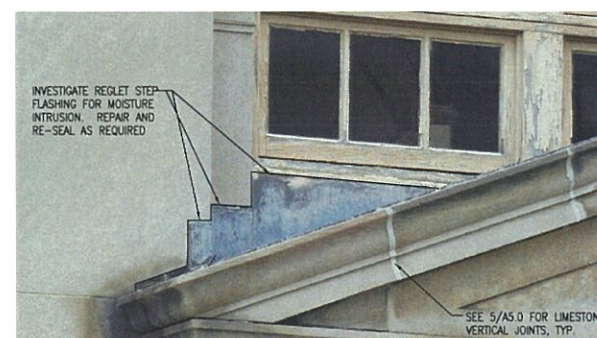
10 EXISTING REGLET FLASHING  
SCALE: N.T.S.

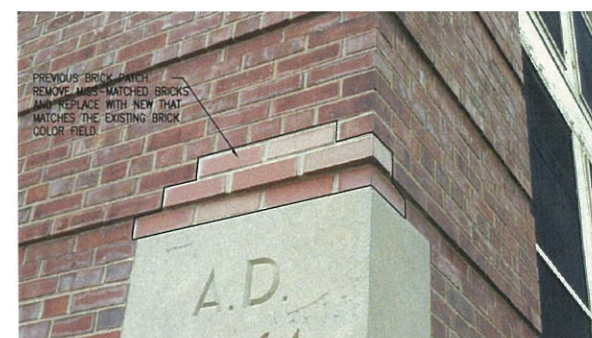
11 NON-MATCHING BRICK PATCH, TYP.  
SCALE: N.T.S.

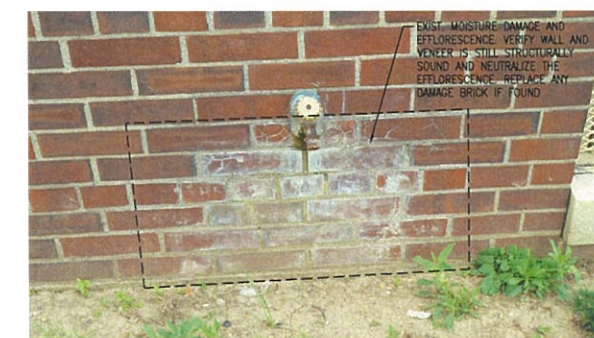
12 BRICK EFFLORESCENCE / WATER DAMAGE  
SCALE: N.T.S.

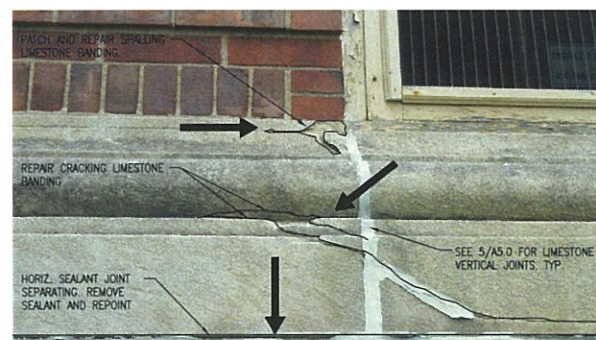
13 LIMESTONE BANDING CRACKING/SPALLING  
SCALE: N.T.S.

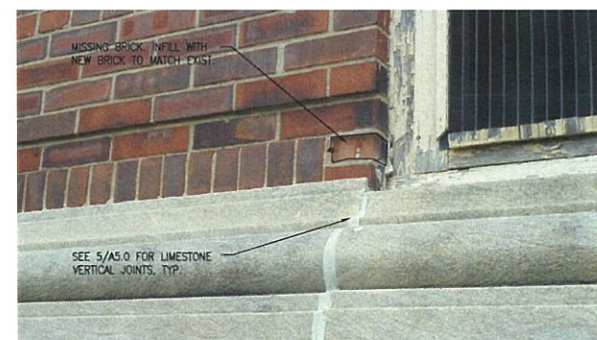
14 MISSING BRICK  
SCALE: N.T.S.

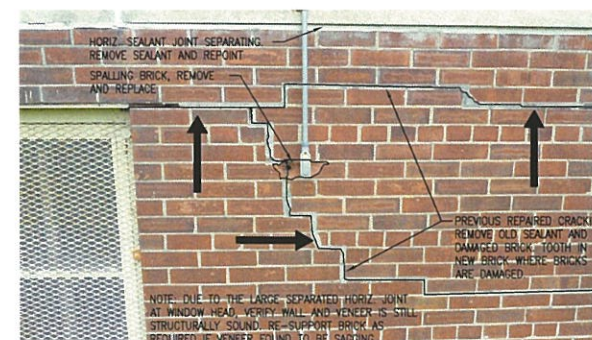
15 TYPICAL STEP-CRACKING IN BRICK  
SCALE: N.T.S.

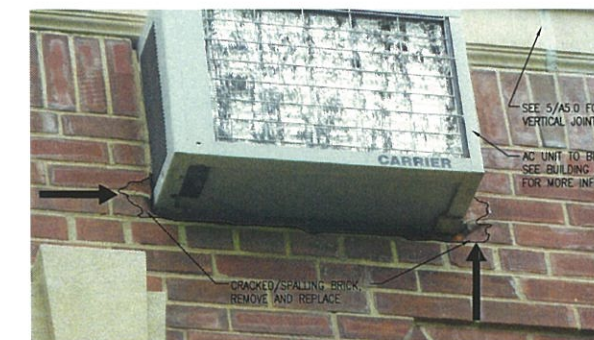
16 CRACKING/SPALLING BRICK AT A.C. UNITS, TYP.  
SCALE: N.T.S.

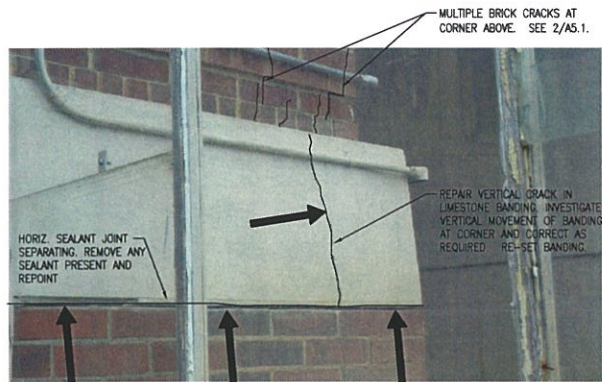
**1 CRACKING AT LIMESTONE BANDING**  
 SCALE: N.T.S.

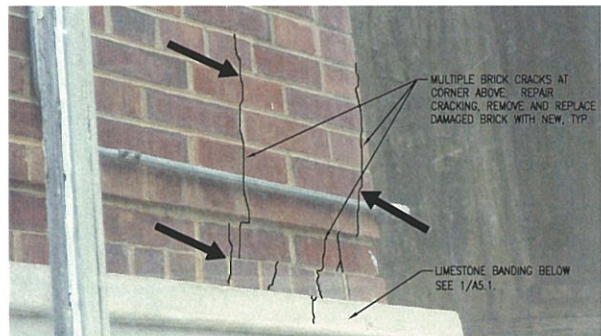
**2 CRACKING AT BRICK CORNER**  
 SCALE: N.T.S.

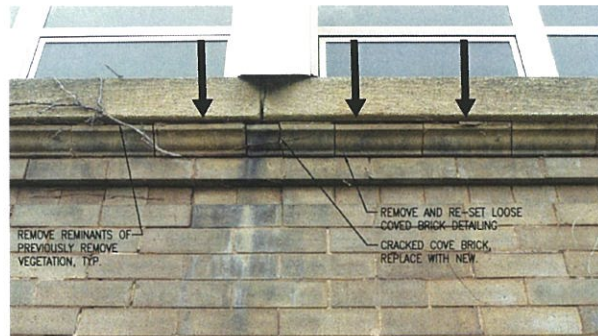
**3 LOOSE AND CRACKING COVERED BRICK, TYP.**  
 SCALE: N.T.S.

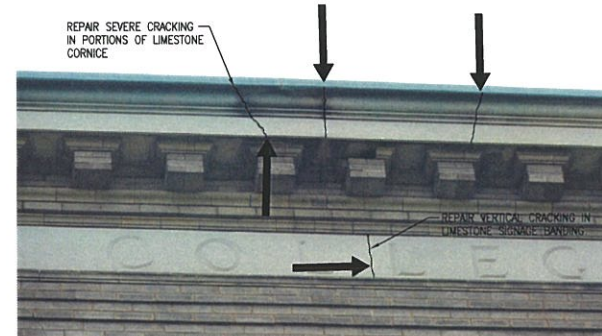
**4 LIMESTONE BANDING AND CORNICE CRACKING, TYP.**  
 SCALE: N.T.S.

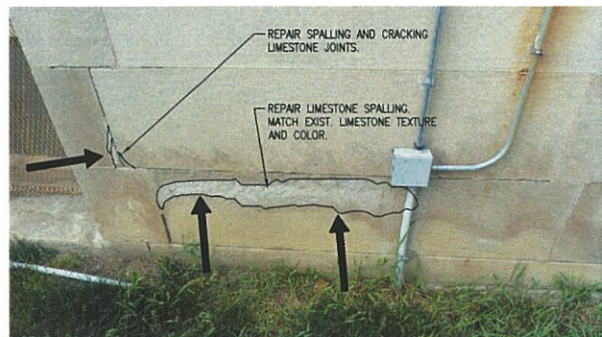
**5 SPALLING AND CRACKING AT LIMESTONE**  
 SCALE: N.T.S.

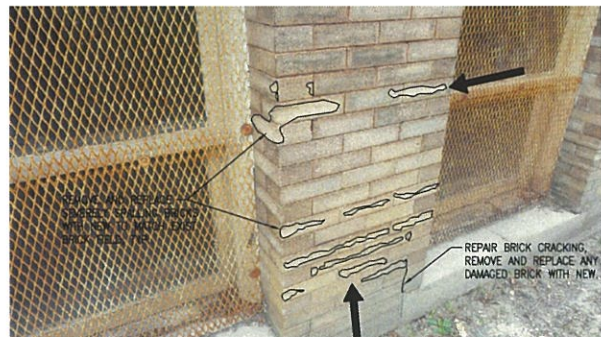
**6 SPALLING AT BRICK, TYP.**  
 SCALE: N.T.S.

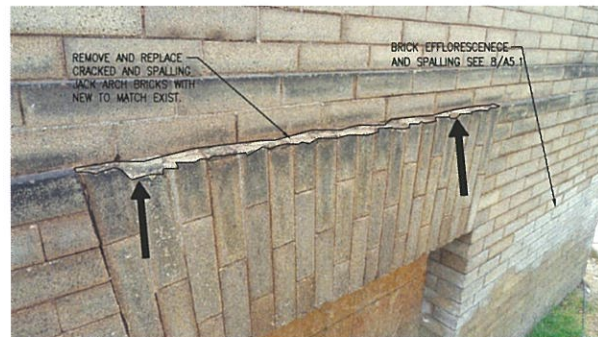
**7 JACK ARCH CRACKING AND SPALLING, TYP.**  
 SCALE: N.T.S.

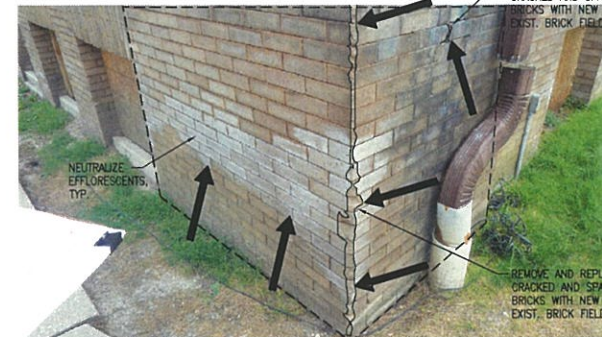
**8 BRICK EFFLORESCENCE AND SPALLING**  
 SCALE: N.T.S.

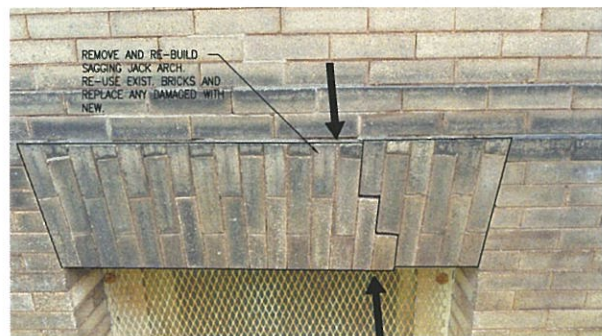
**9 JACK ARCH SAGGING**  
 SCALE: N.T.S.

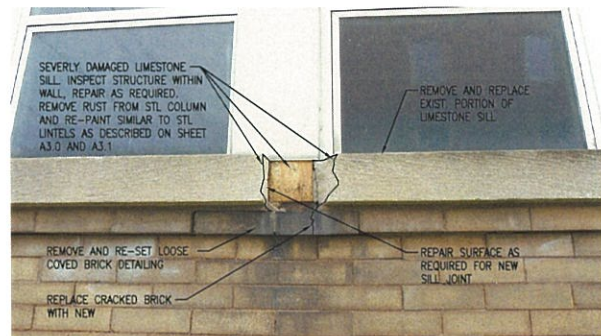
**10 SEVERELY DAMAGED LIMESTONE SILL**  
 SCALE: N.T.S.

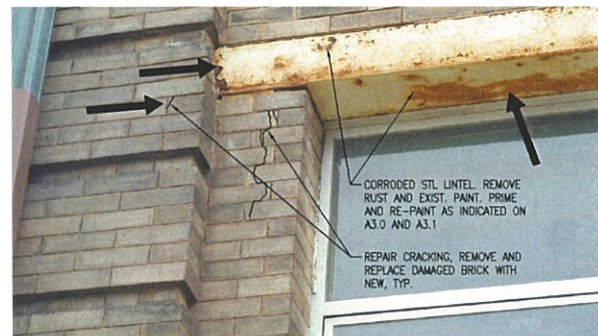
**11 CORRODED STEEL LINTEL, TYP.**  
 SCALE: N.T.S.

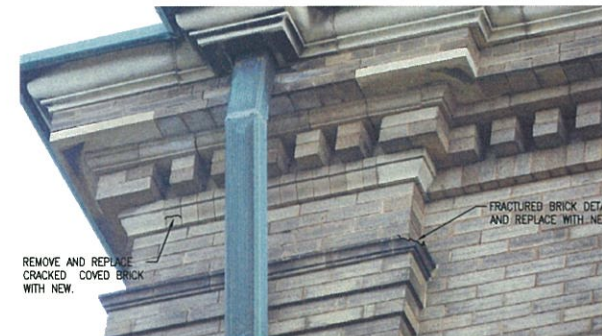
**12 BRICK CRACKING**  
 SCALE: N.T.S.

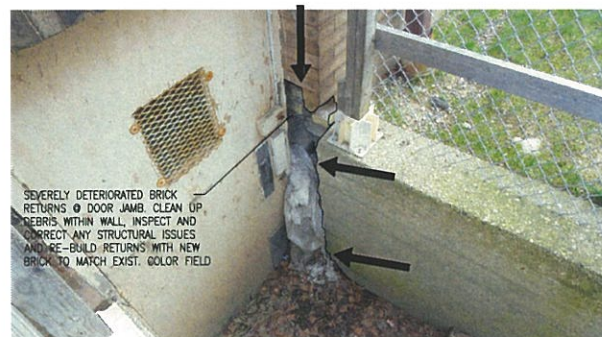
**13 DOOR JAMBS DETERIORATED**  
 SCALE: N.T.S.

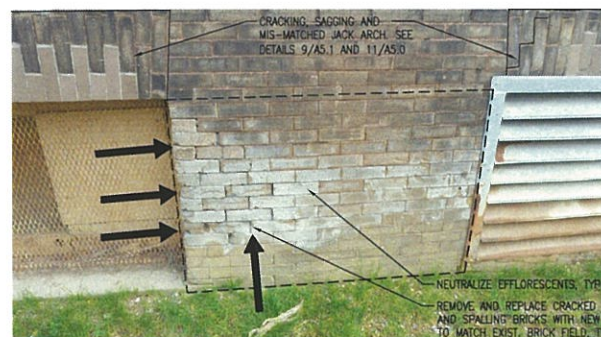
**14 BRICK EFFLORESCENCE AND SPALLING**  
 SCALE: N.T.S.

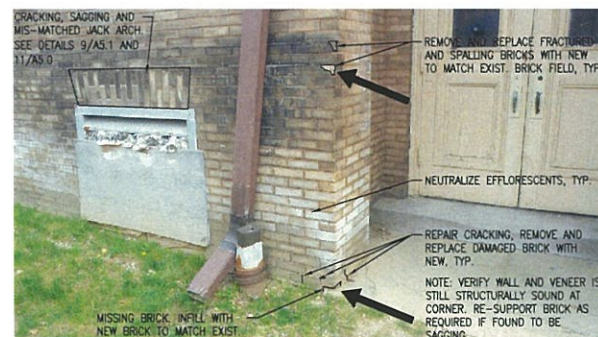
**15 BRICK EFFLORESCENCE AND SPALLING**  
 SCALE: N.T.S.

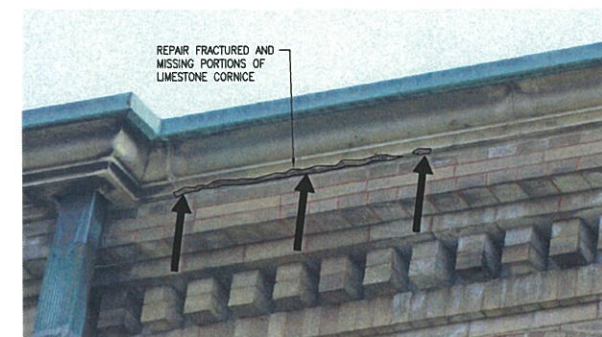
**16 LIMESTONE CORNICE FRACTURED**  
 SCALE: N.T.S.

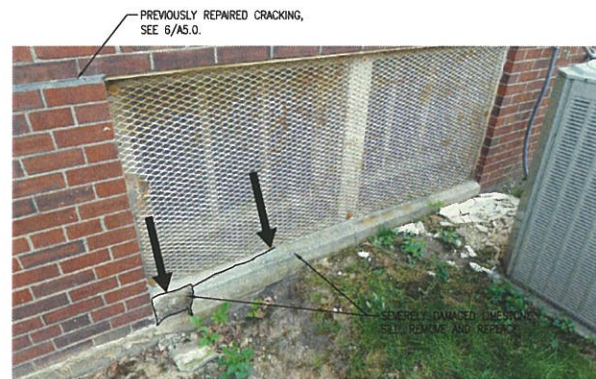
**1 DETERIORATED LIMESTONE SILL**  
 SCALE: N.T.S.

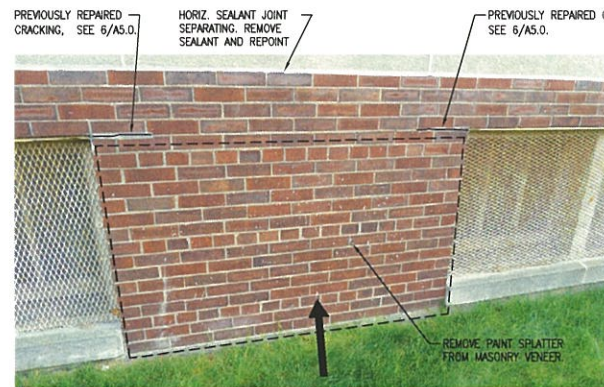
**2 PAINT SPLATTER ON MASONRY, TYP.**  
 SCALE: N.T.S.

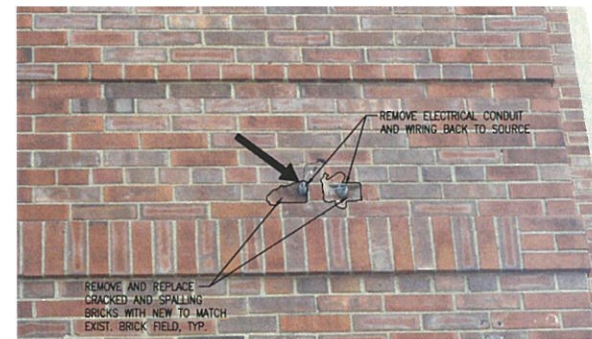
**3 BRICK SPALLING AND EXPOSED CONDUIT**  
 SCALE: N.T.S.

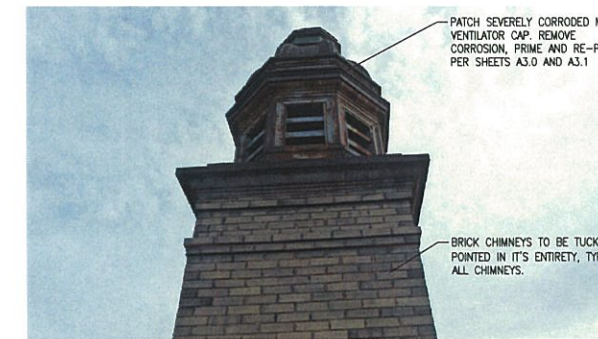
**4 ROOF CHIMNEYS AND VENTILATORS**  
 SCALE: N.T.S.

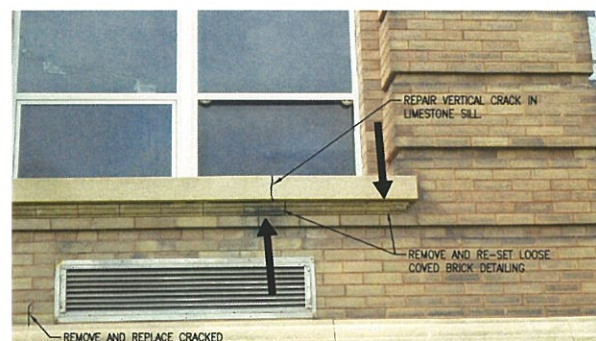
**5 LIMESTONE SILL CRACKING, TYP.**  
 SCALE: N.T.S.

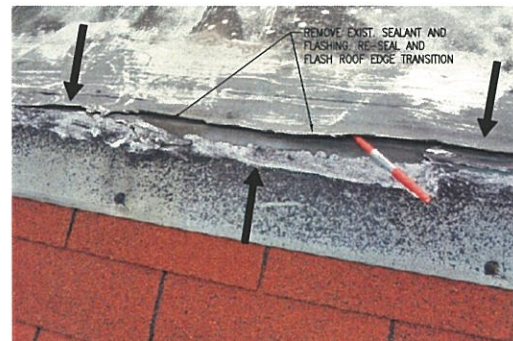
**6 ROOF TRANSITION AND FLASHING**  
 SCALE: N.T.S.

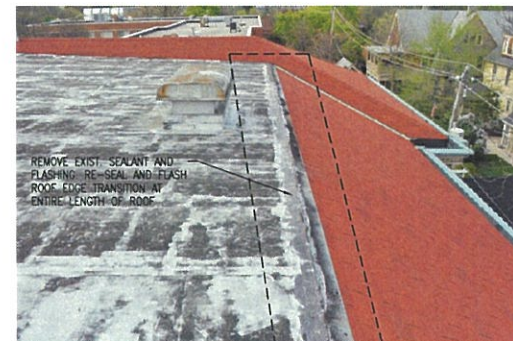
**7 ROOF TRANSITION AND FLASHING**  
 SCALE: N.T.S.

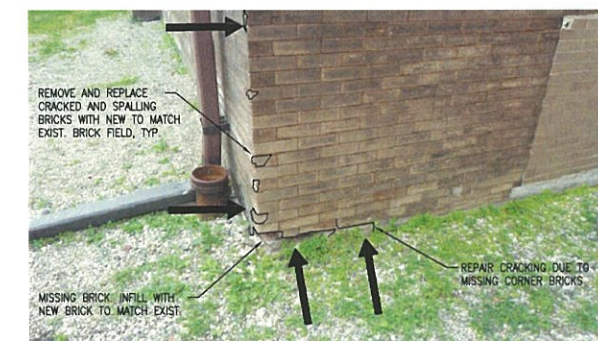
**8 BRICK CORNER DAMAGE**  
 SCALE: N.T.S.
