MPS - Existing Window Condition

MPS - NE Tower Window Condition

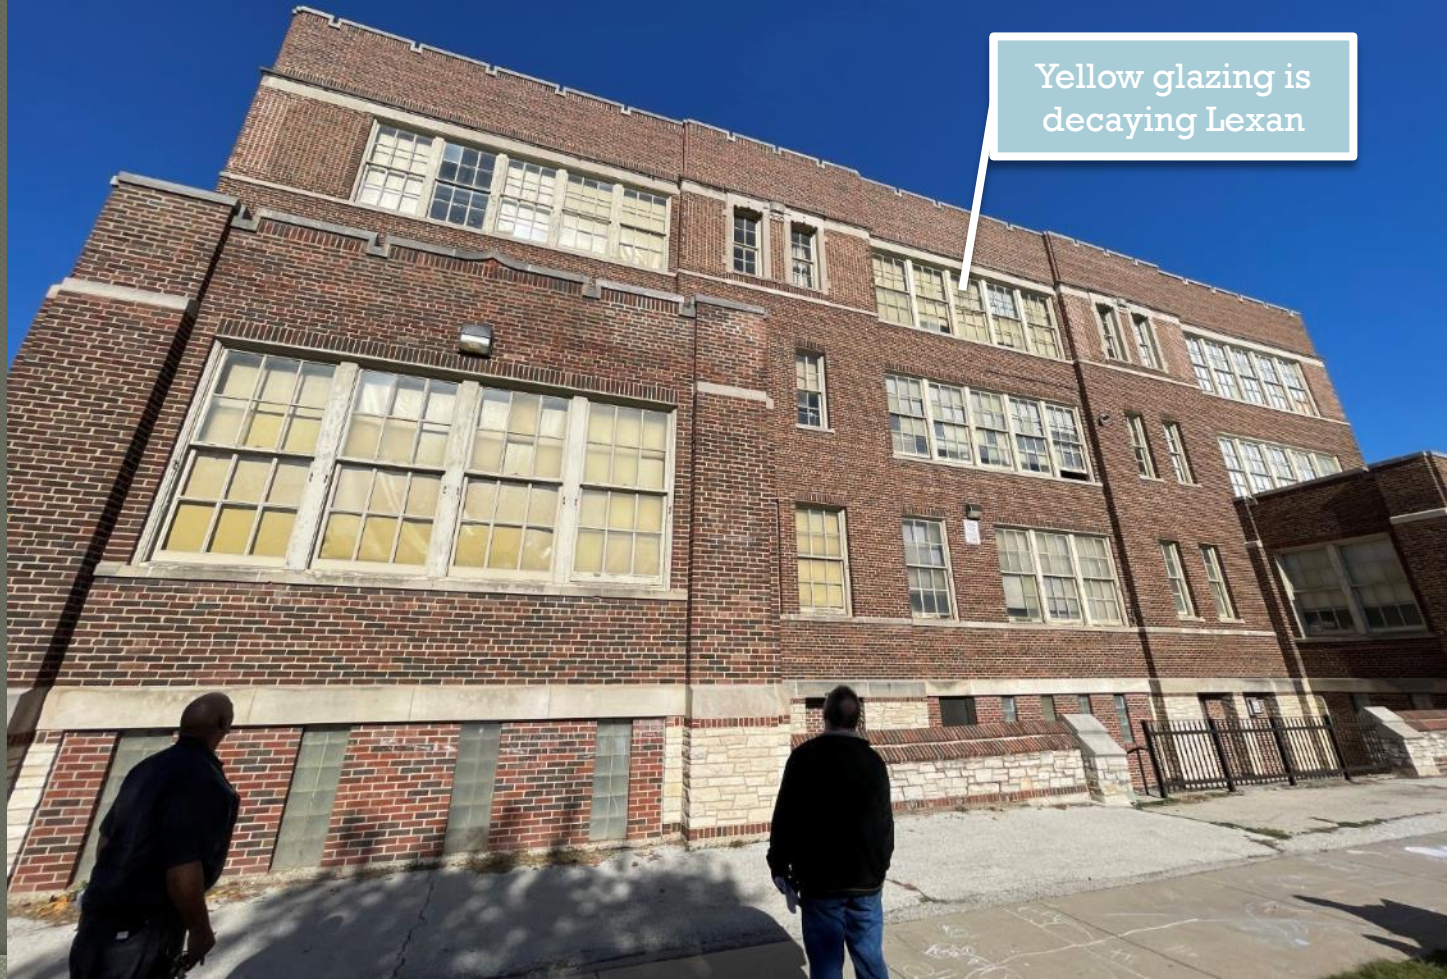
Yellow glazing is
decaying Lexan

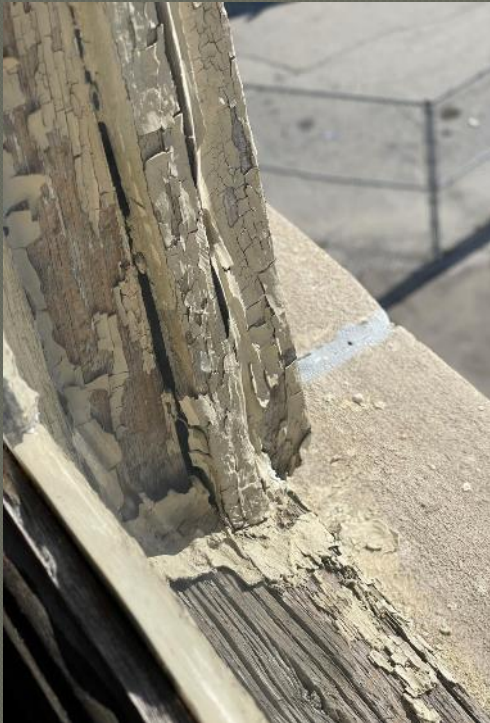
Existing window deterioration

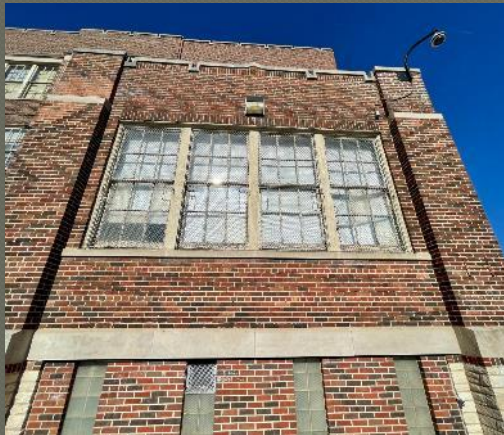
View of exterior existing window

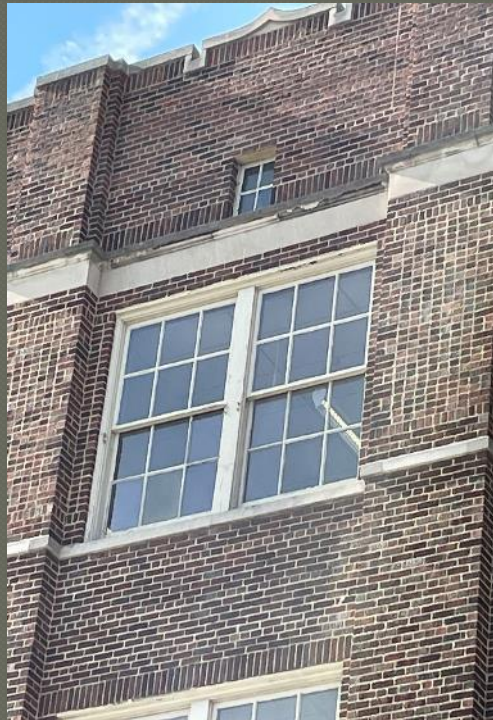
View of exterior existing window

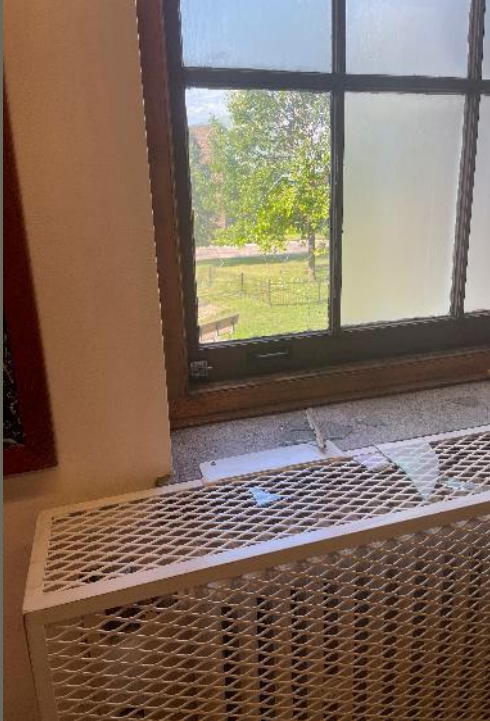
Interior view broken window

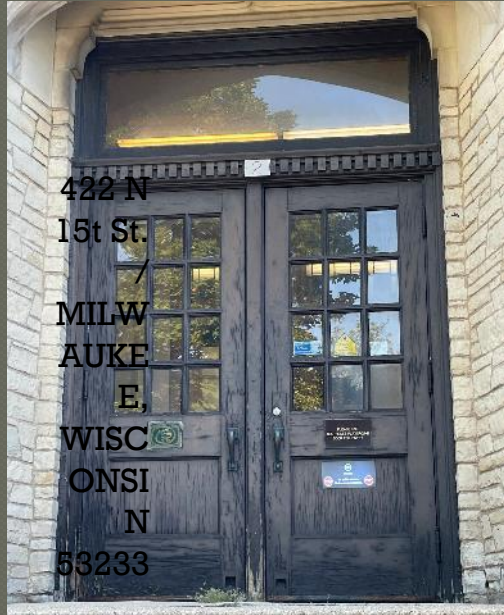
Existing entry doorway

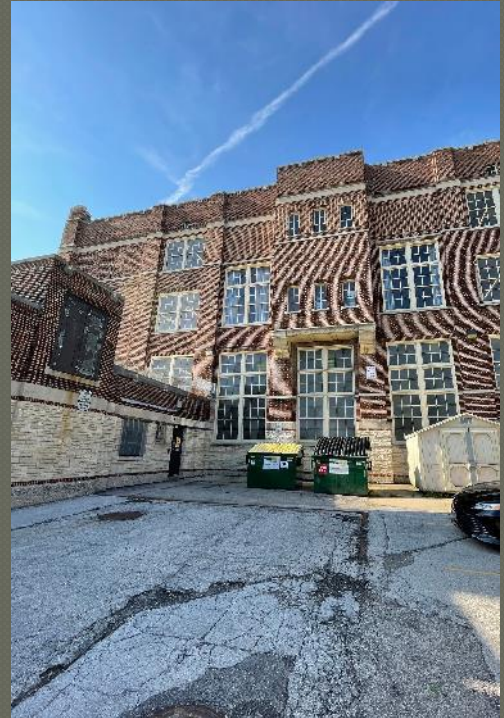
North elevation exterior view

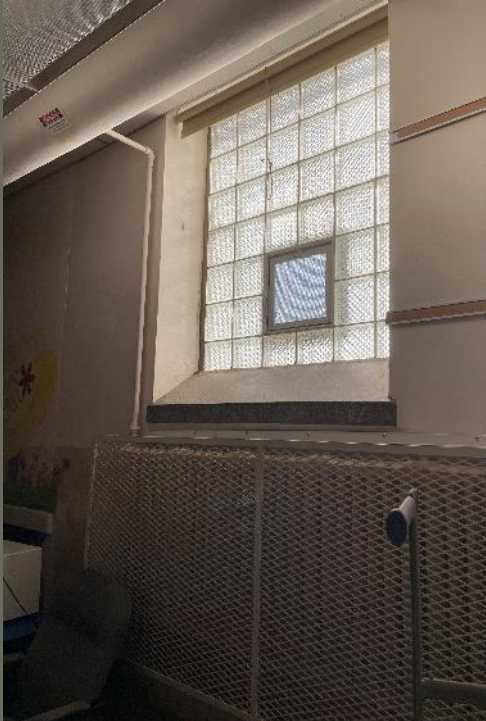
Interior view glass block window

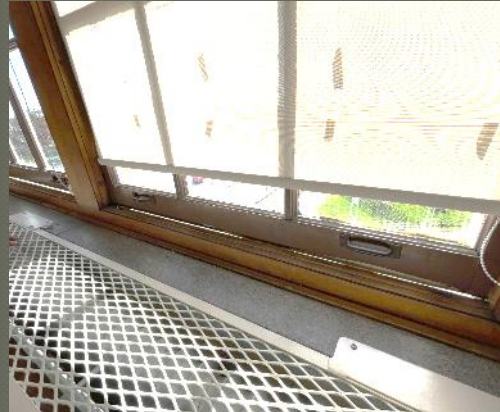
Interior view existing window

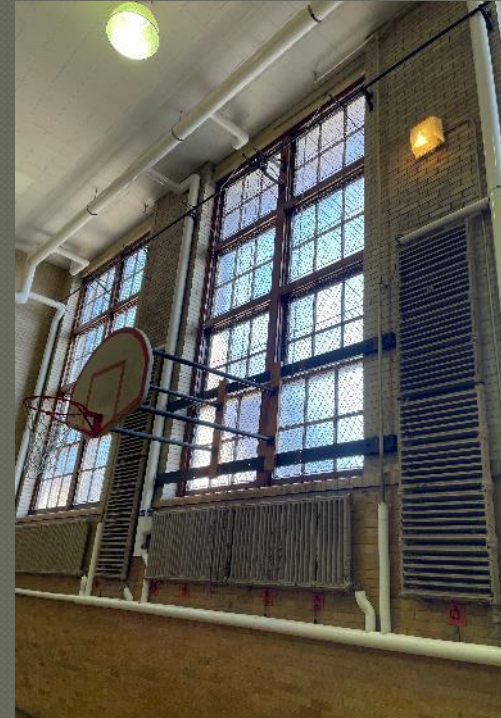
Interior view gym windows

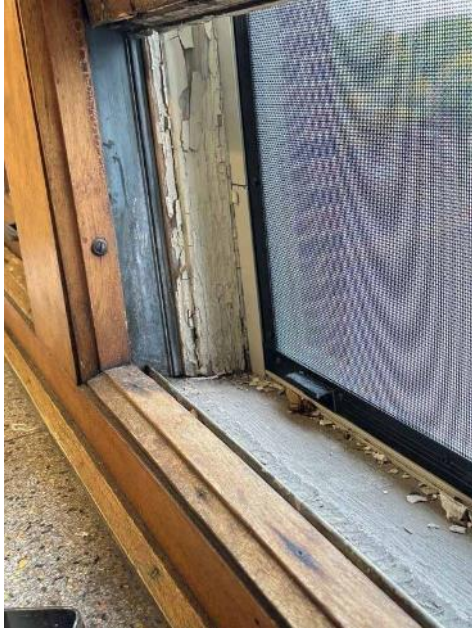
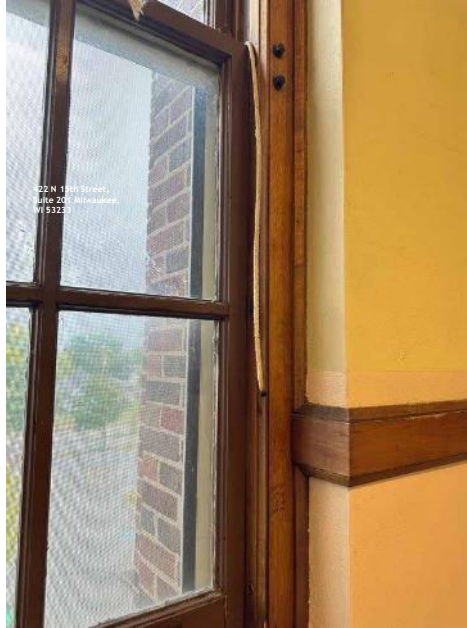
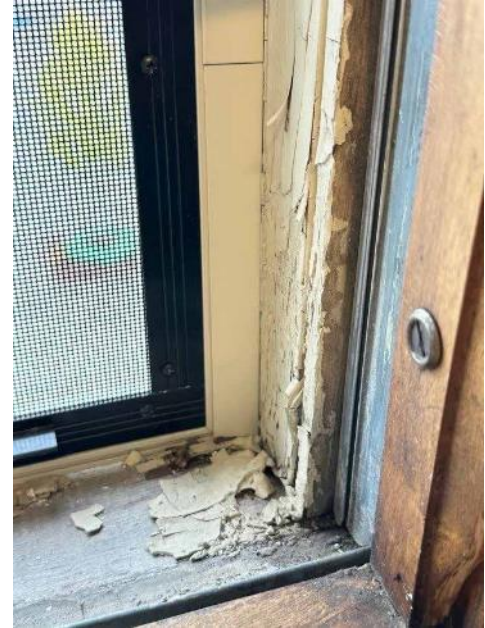
Note: That while all windows in the towers were originally designed to be operable, some are no longer functional due to their current condition.

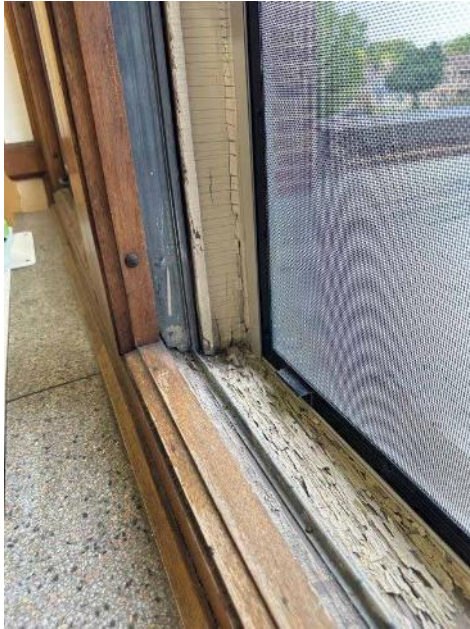
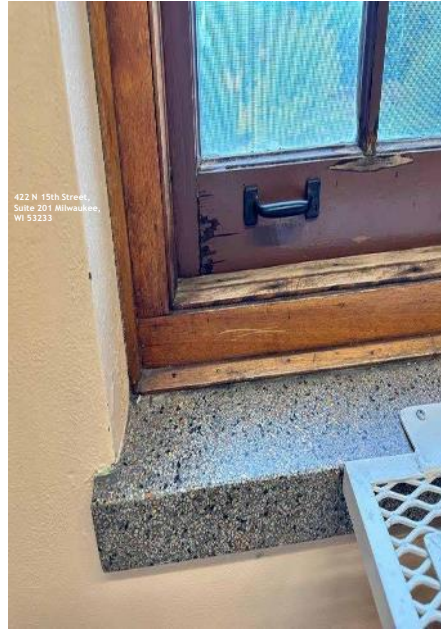
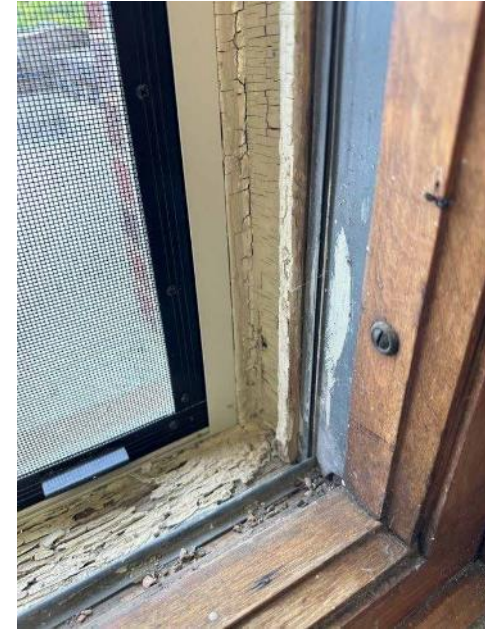
MPS - NE Tower Window Condition

Note: That while all windows in the towers were originally designed to be operable, some are no longer functional due to their current condition.

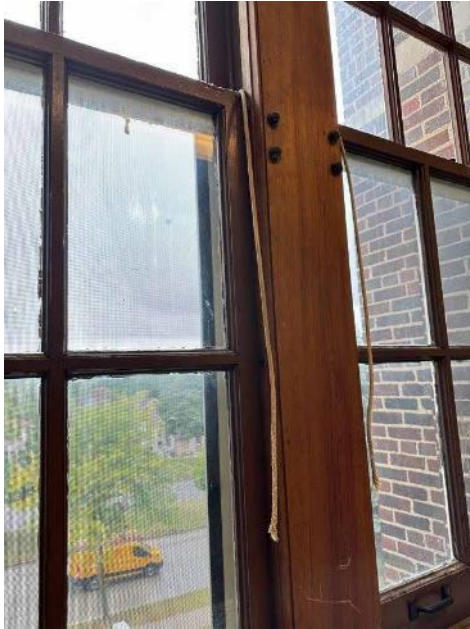
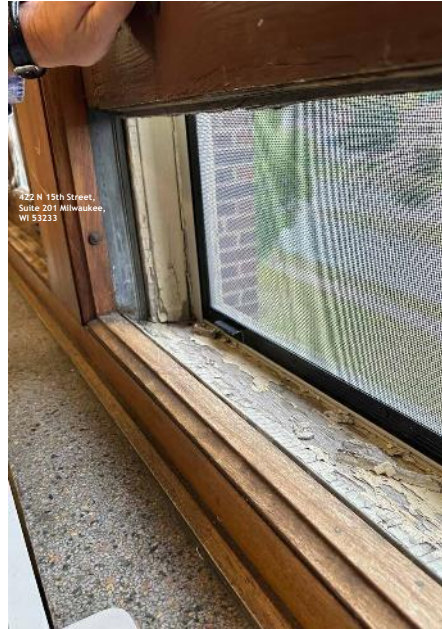
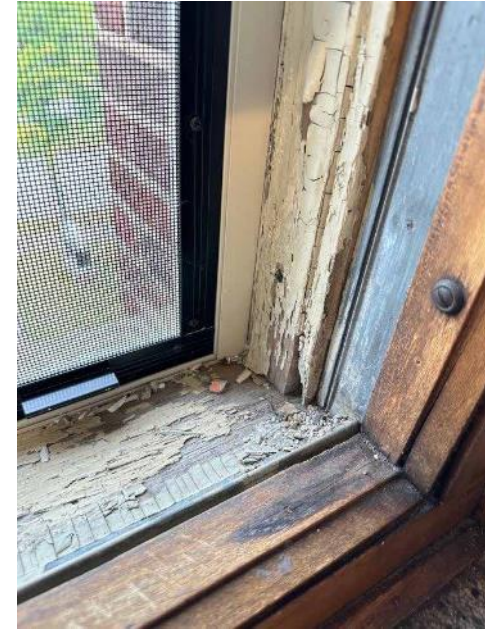
MPS - NW Tower Window Condition

Note: That while all windows in the towers were originally designed to be operable, some are no longer functional due to their current condition.

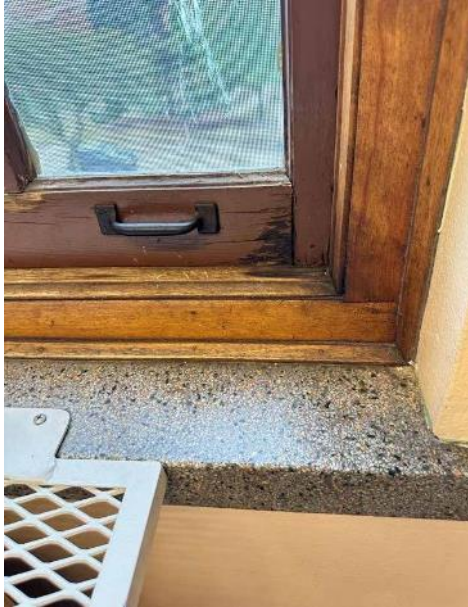
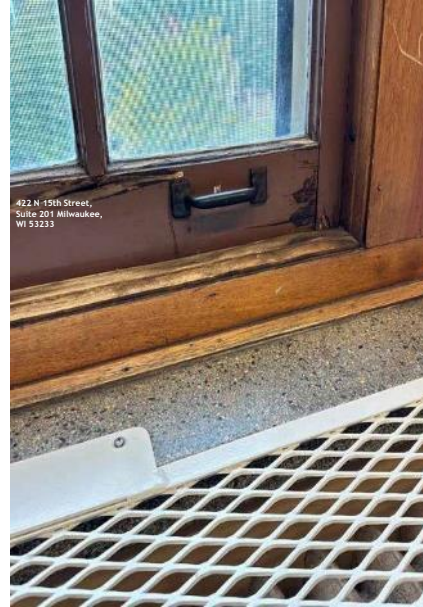
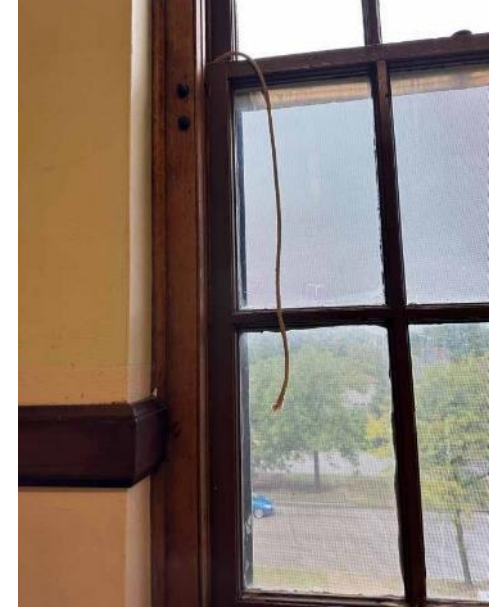
MPS - NW Tower Window Condition

Note: That while all windows in the towers were originally designed to be operable, some are no longer functional due to their current condition.

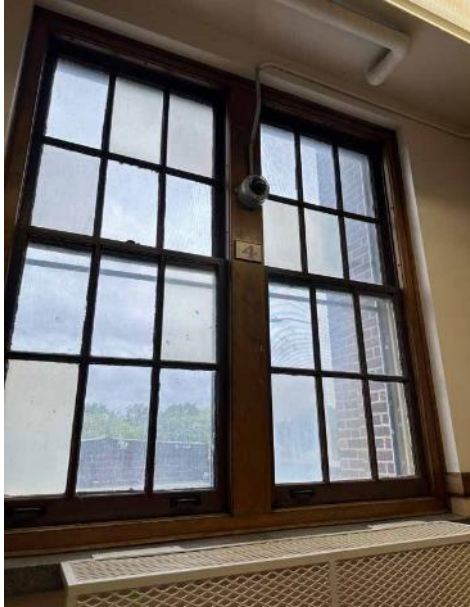
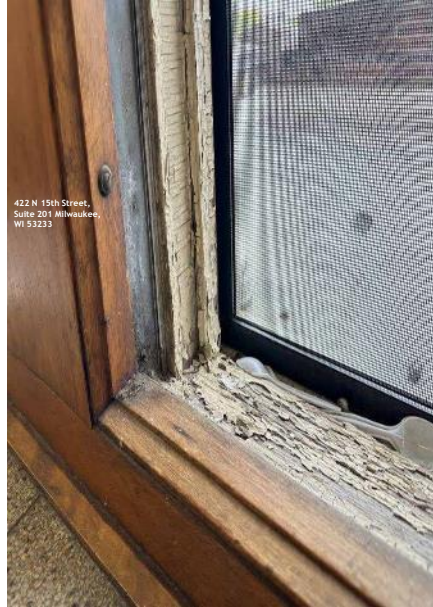
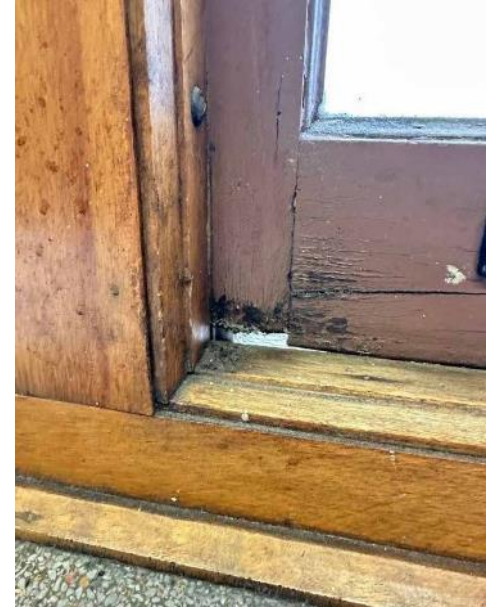
MPS - SE Tower Window Condition

Note: That while all windows in the towers were originally designed to be operable, some are no longer functional due to their current condition.

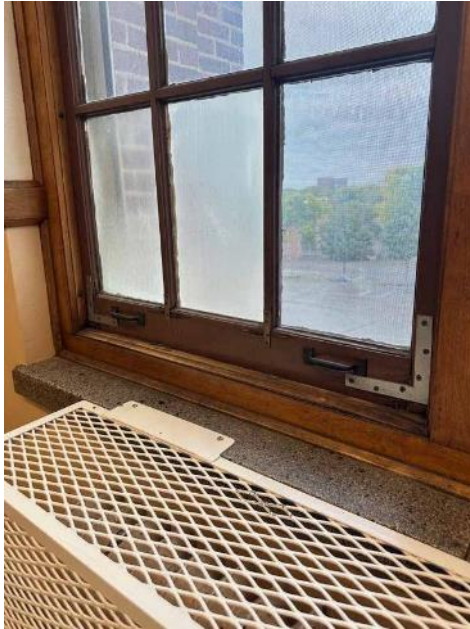
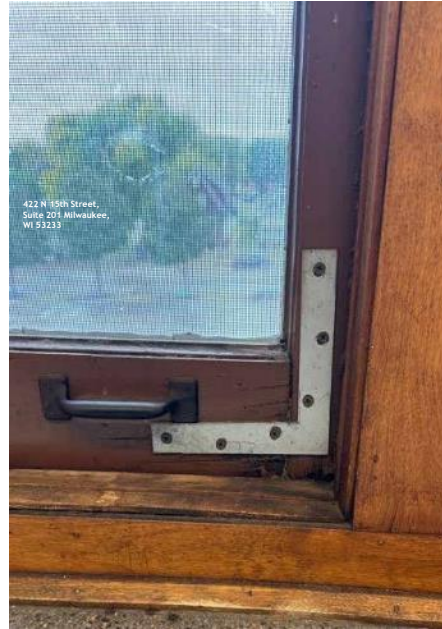
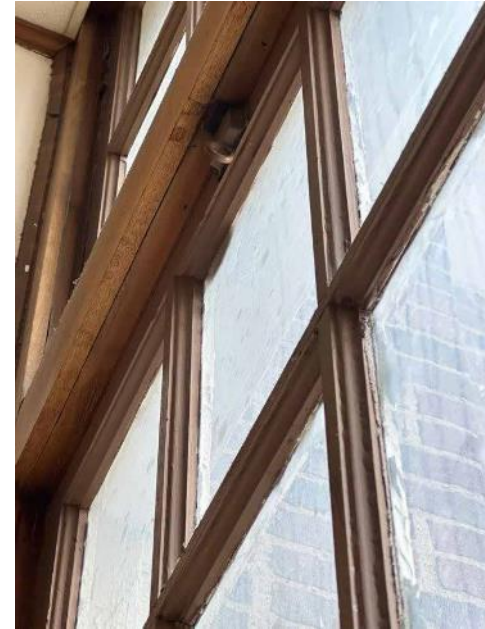
MPS - SE Tower Window Condition

Note: That while all windows in the towers were originally designed to be operable, some are no longer functional due to their current condition.

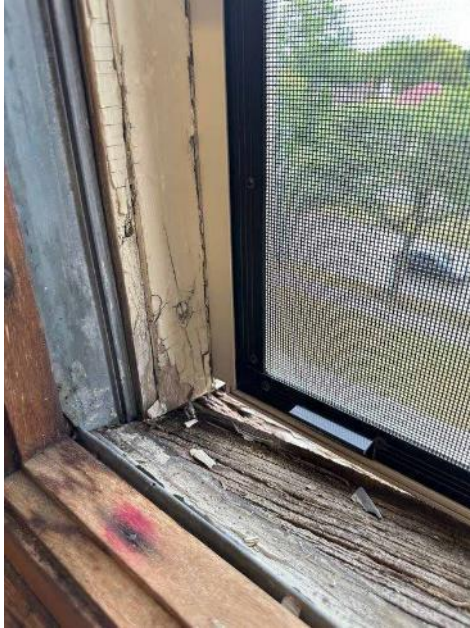
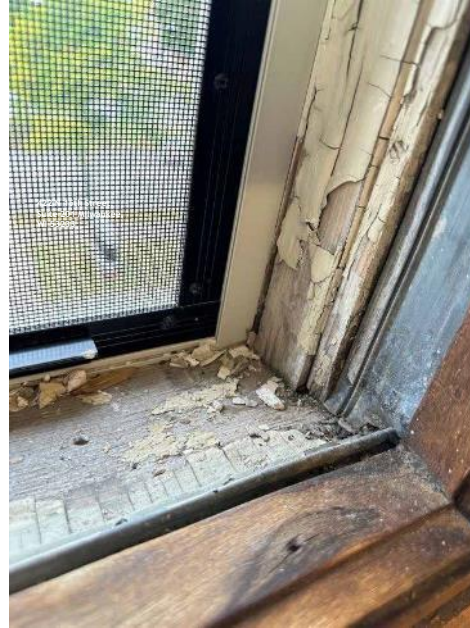
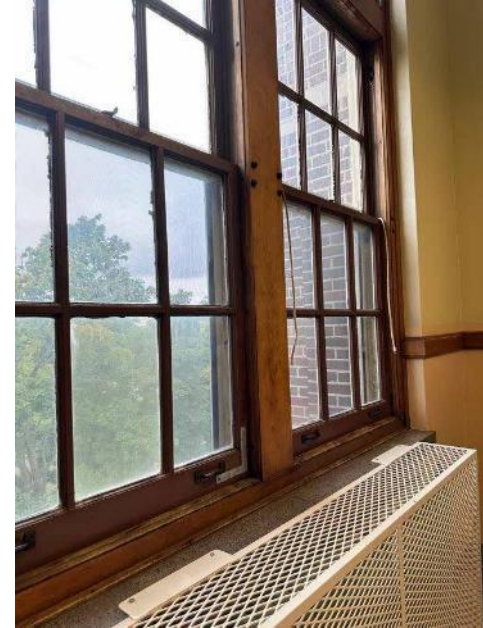
MPS - SW Tower Window Condition

Note: That while all windows in the towers were originally designed to be operable, some are no longer functional due to their current condition.

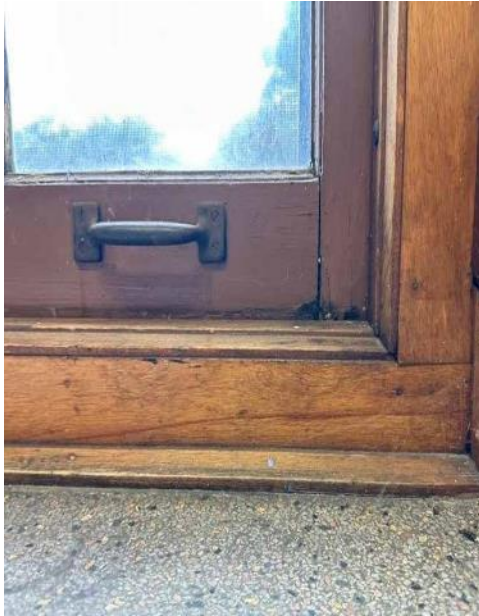
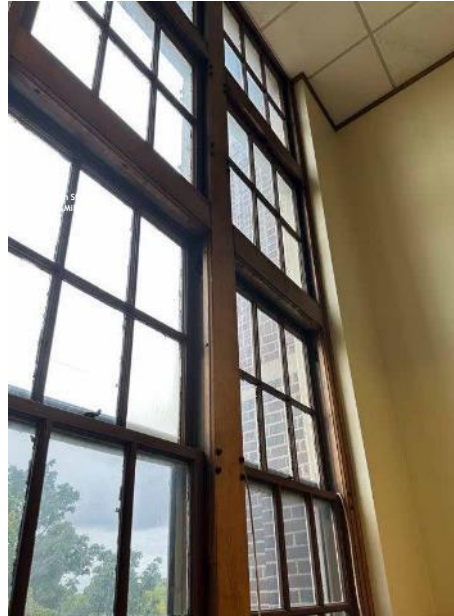
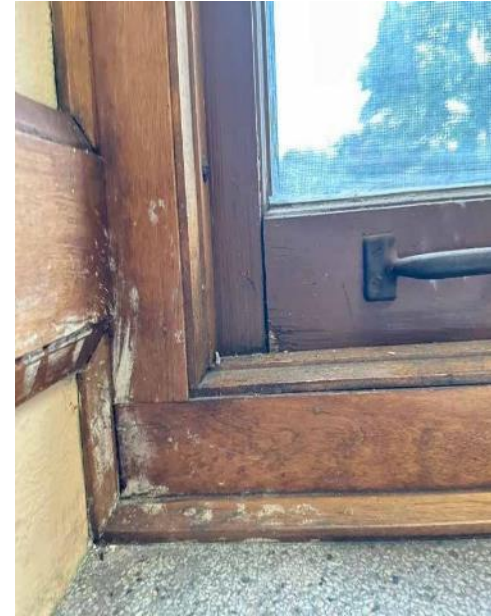
MPS - SW Tower Window Condition

Note: That while all windows in the towers were originally designed to be operable, some are no longer functional due to their current condition.

- Approve replacement of all ordinary, two-sash double-hung windows, all glass block windows, filled-in windows, ground floor windows, and attic windows
- Tower windows appear to be readily repairable
