Leslie McCormick
2618 N Hackett, Milwaukee, WI Wisconsin United
States, 2618 N Hackett, Milwaukee, WI, WI
53211

INSPECTION

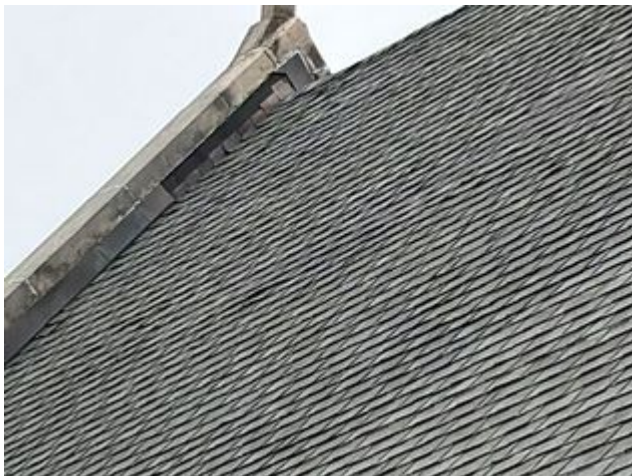
Damage from storm. In Claim the insurance company references replacing the copper step flashing but I do not see a line item for replacing the copper counter flashing over the step flashing which is absolutely needed. I found 202' of each.

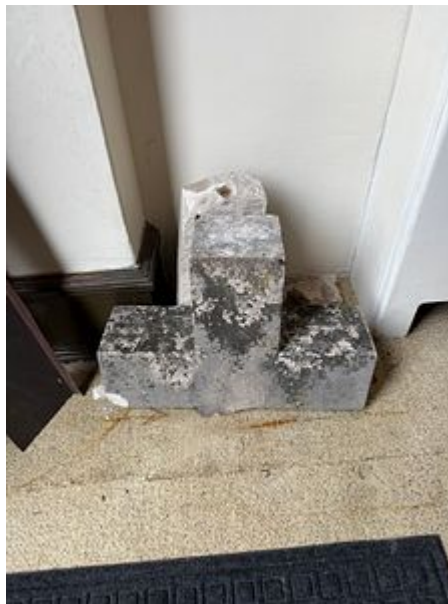
Picture shows the cross that was knocked off of the East end of the church and fell down the roof down onto the ground.

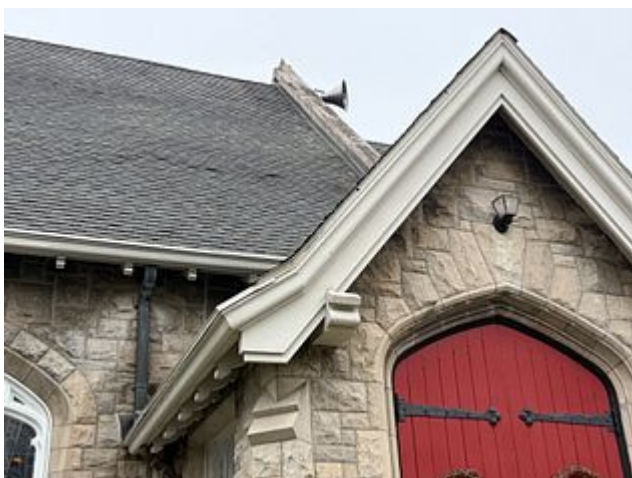
Overview of where the cross was originally at the peak of the East end of the church

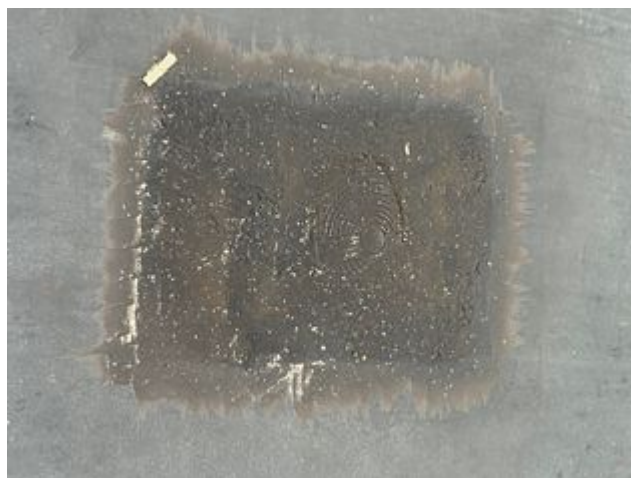
Large section of the rubber roof on South-East corner of the church was damaged by the concrete cross.

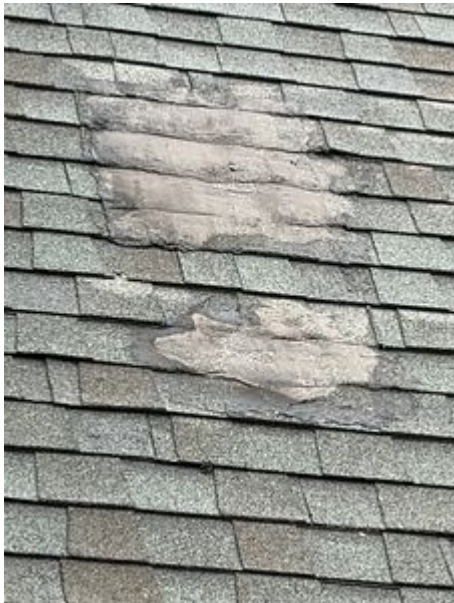
Section of the roof on the South-East roof facet that was damaged by the falling concrete cross

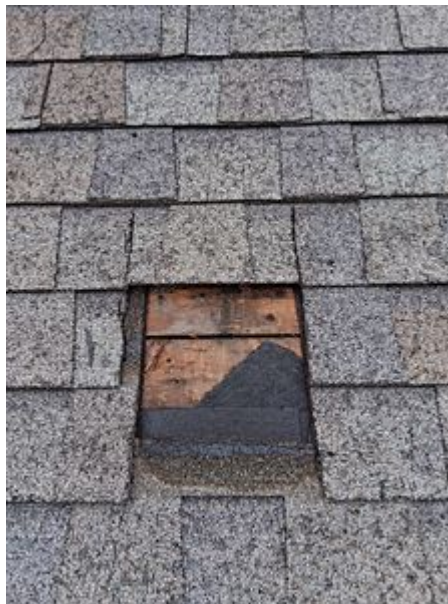
1 layer of asphalt roofing was found to be on the church currently.

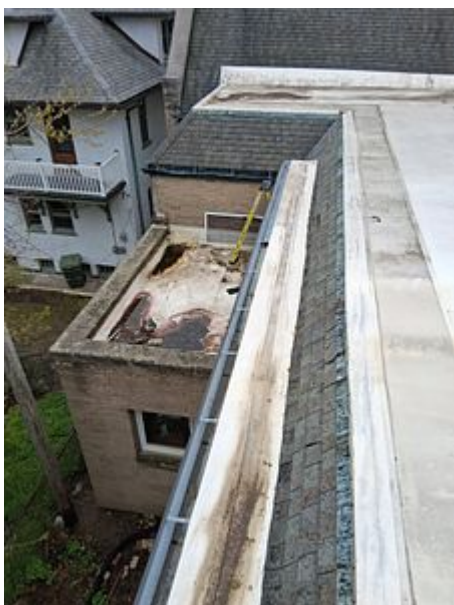
North-East roof facet that we will need to remove termination bar, fix roof, install new copper apron, and then reattach the existing termination bar. Did not see this scope of work in the insurance claim around copper apron work needed.

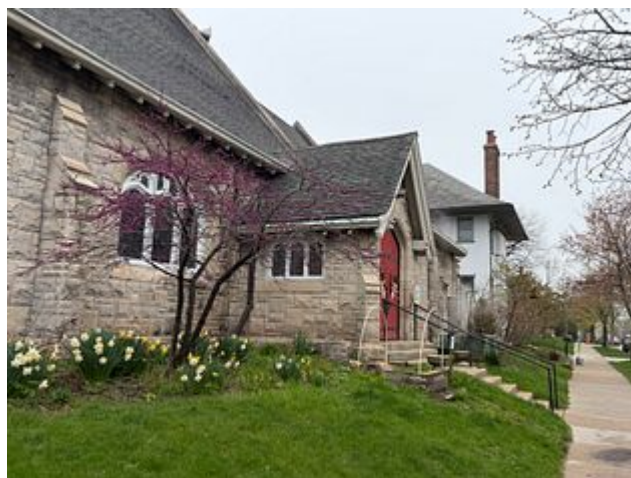
Pic shows new counter flashing system along roof wall intersection that I think was missed in overview of total feet of step flashing and counter flashing needed on the project. I have 202' in total of each on the project.
