MILWAUKEE CITY HALL

Evaluation of Distressed Terra Cotta

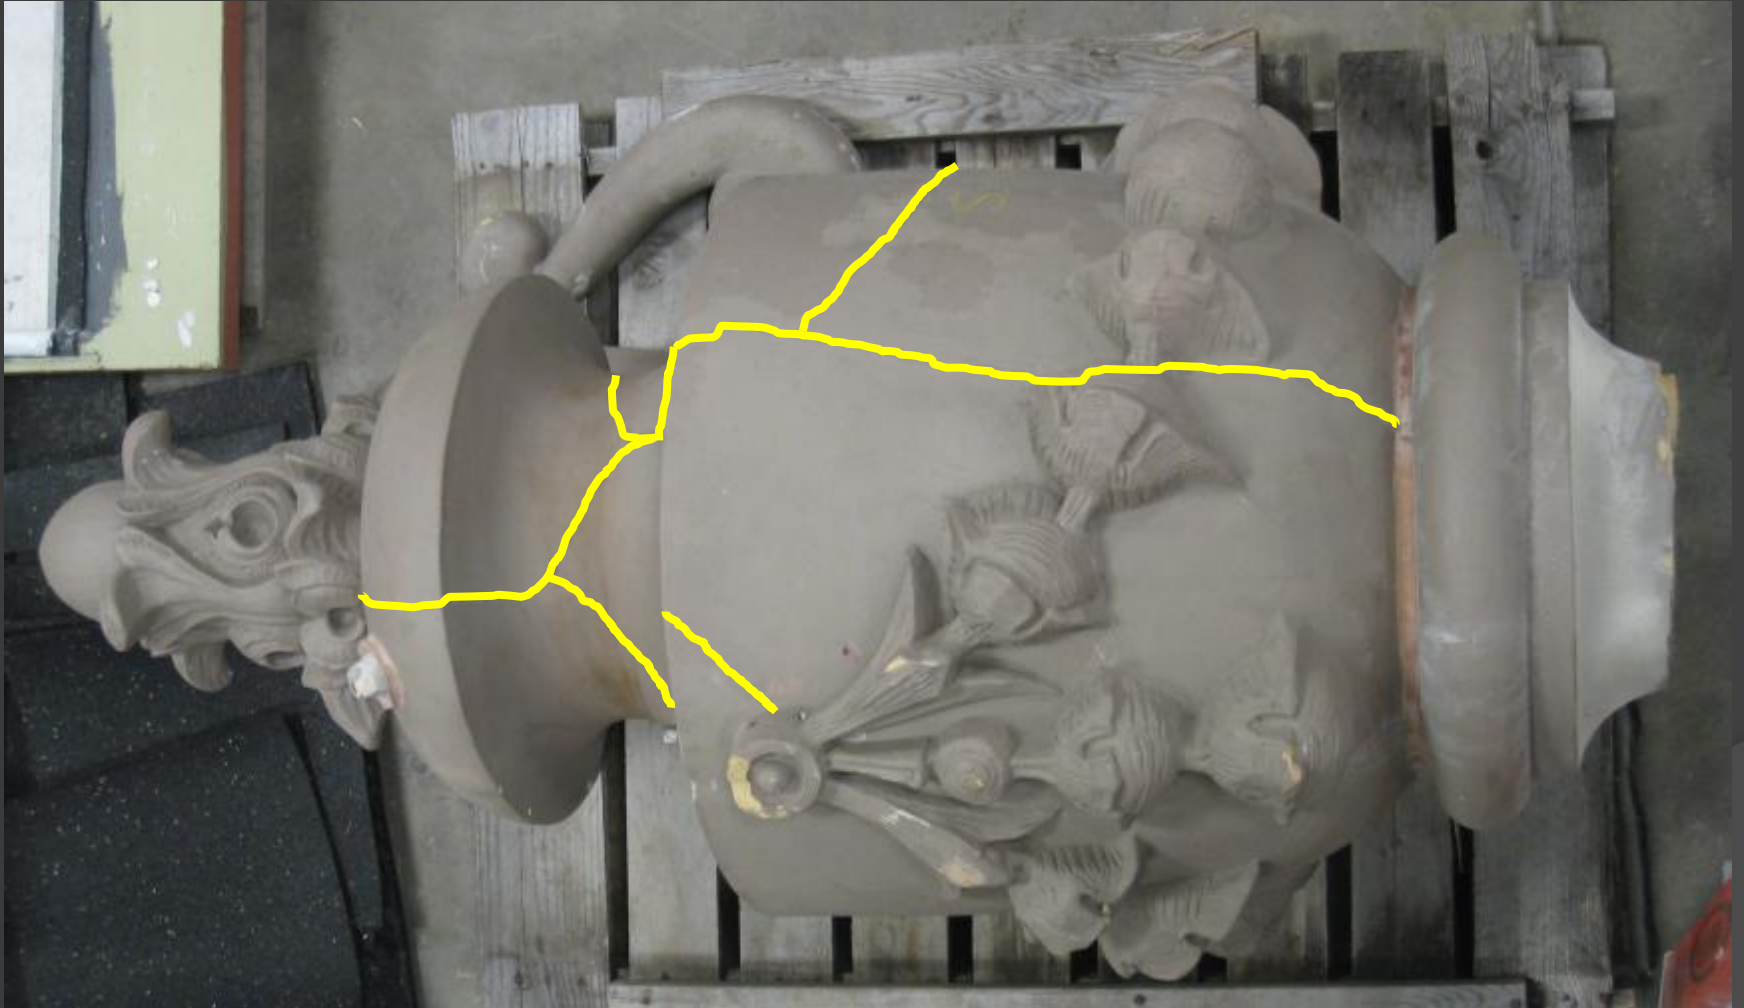
Urn Distress

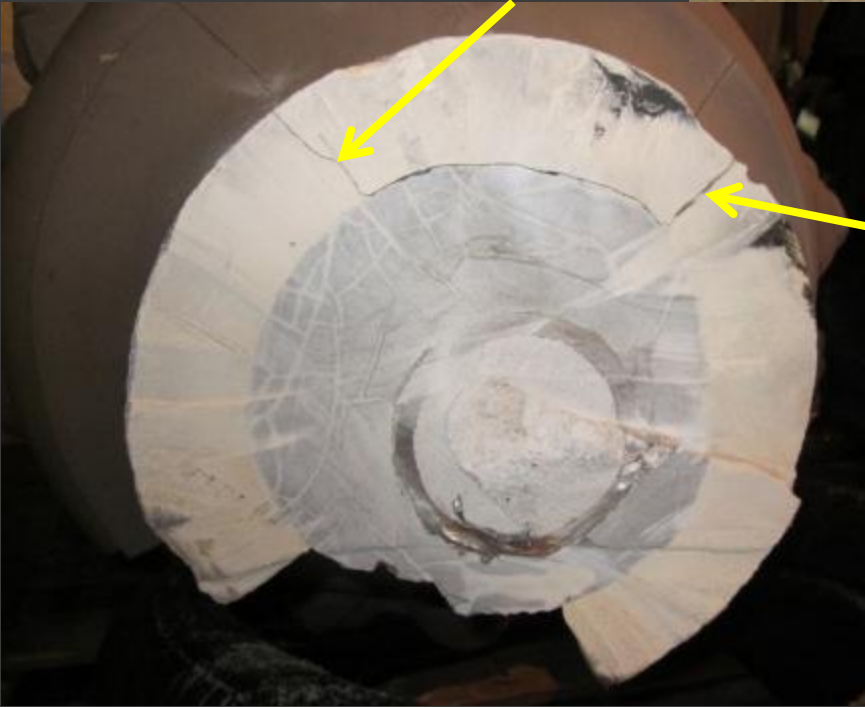
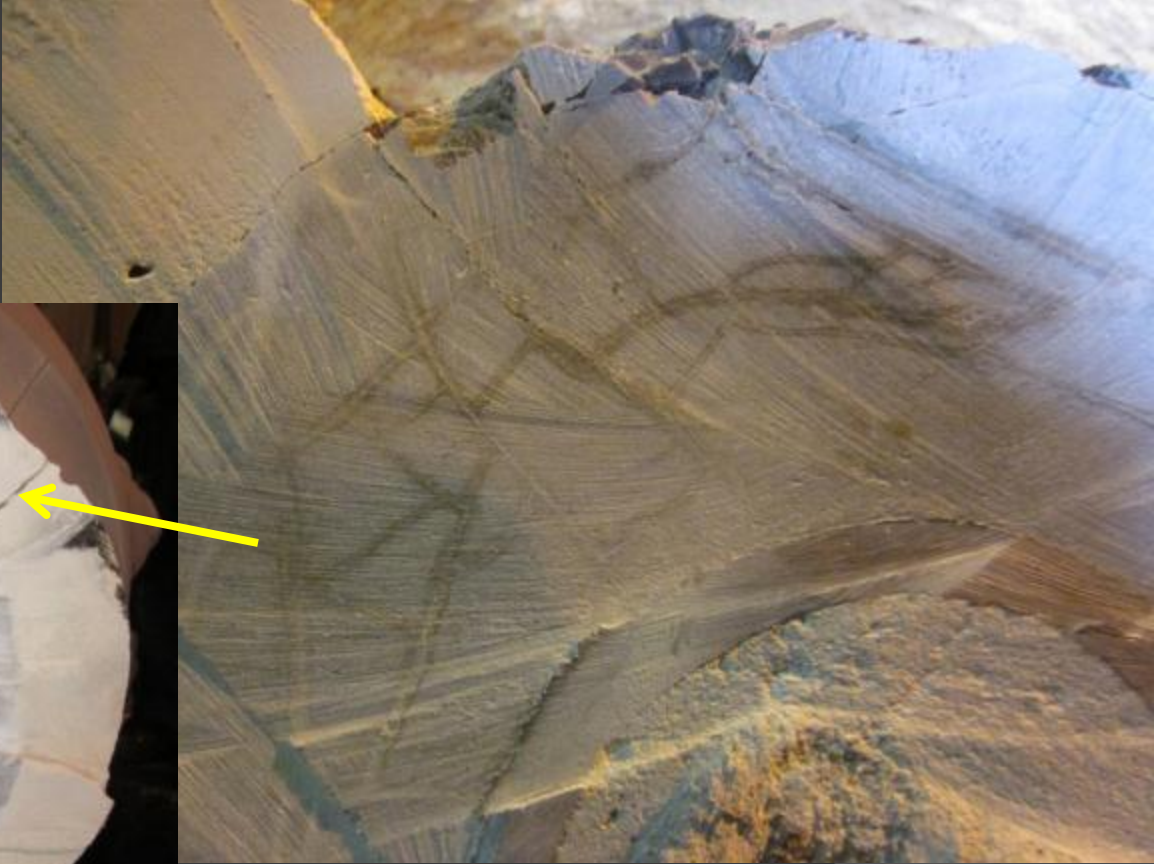
Observations - Urns

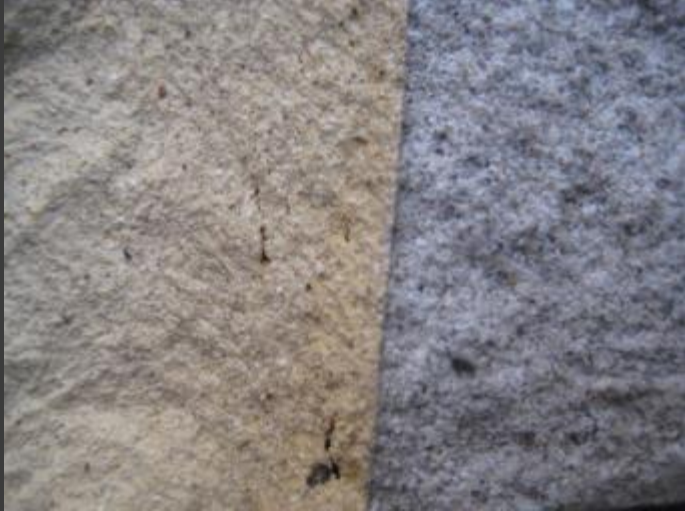
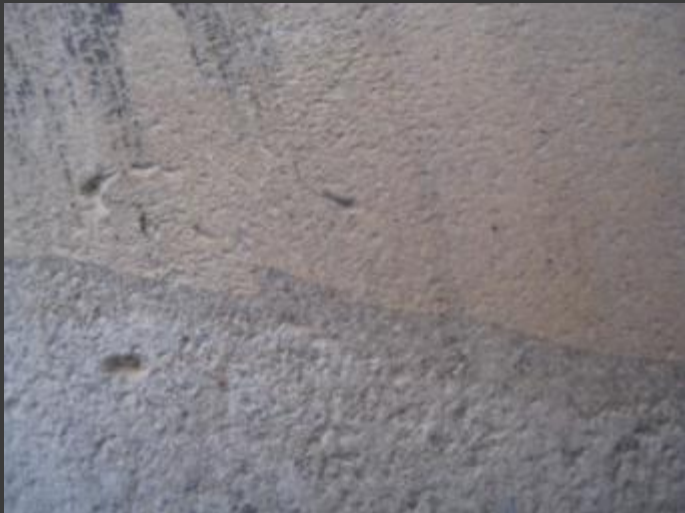
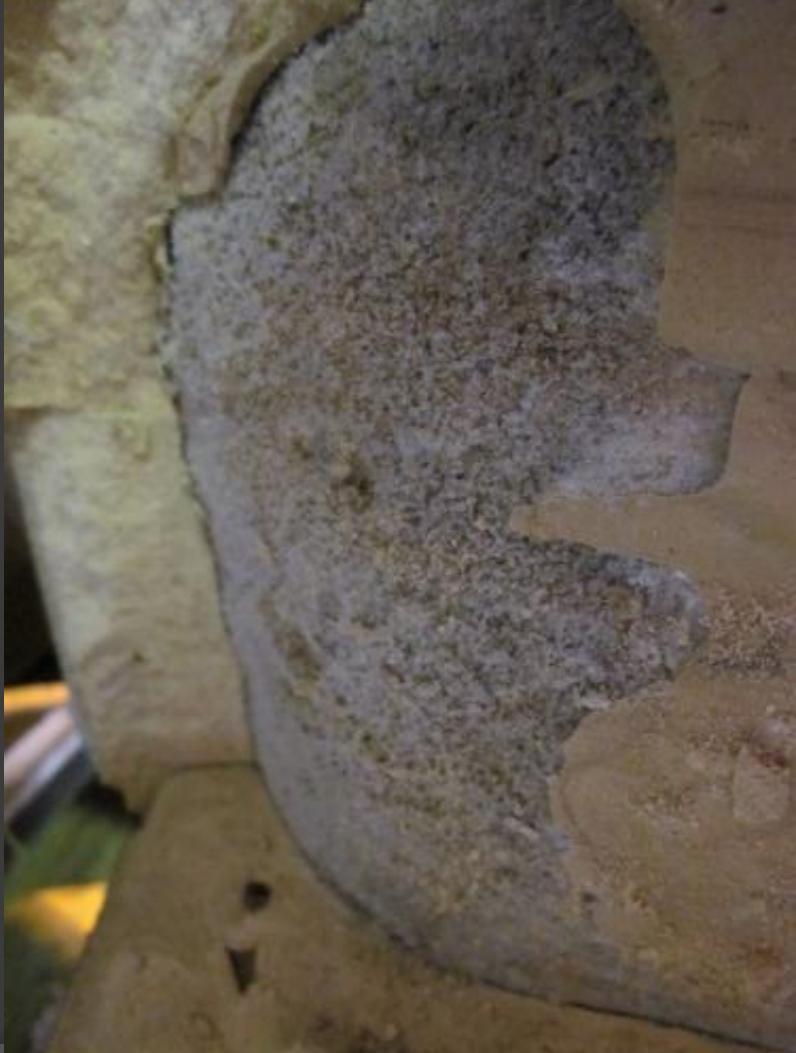
Observations - Urns

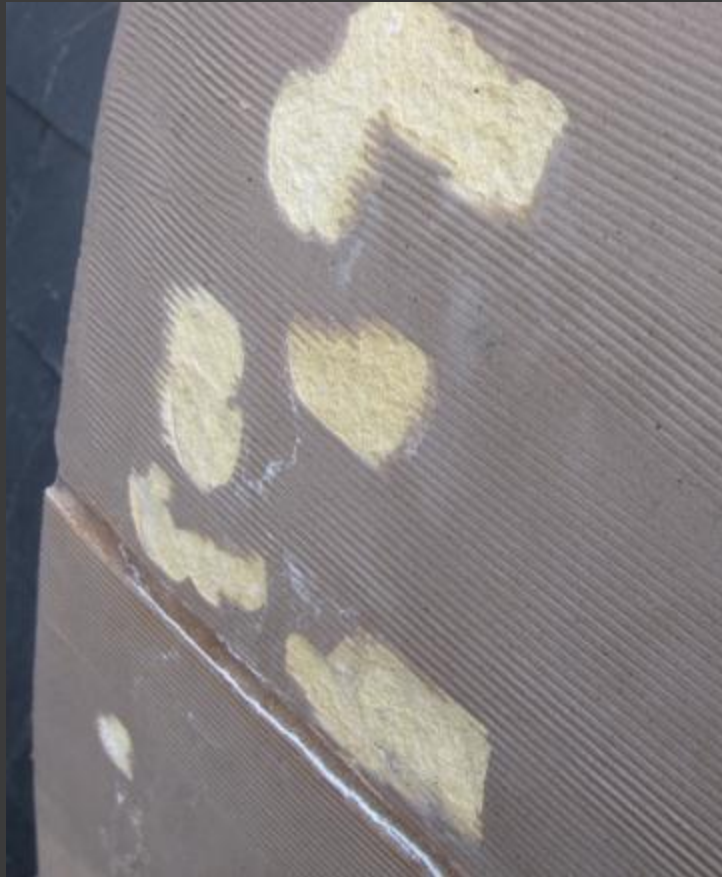
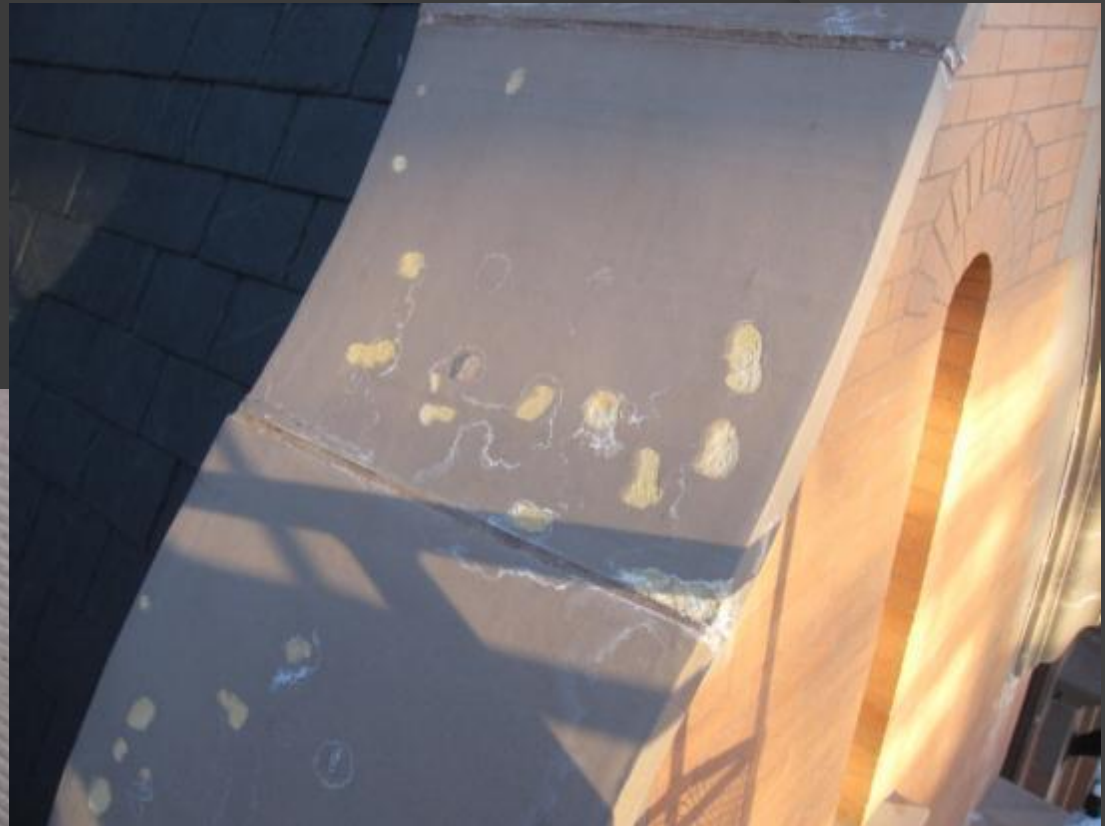
Dormer & cross
gable copings

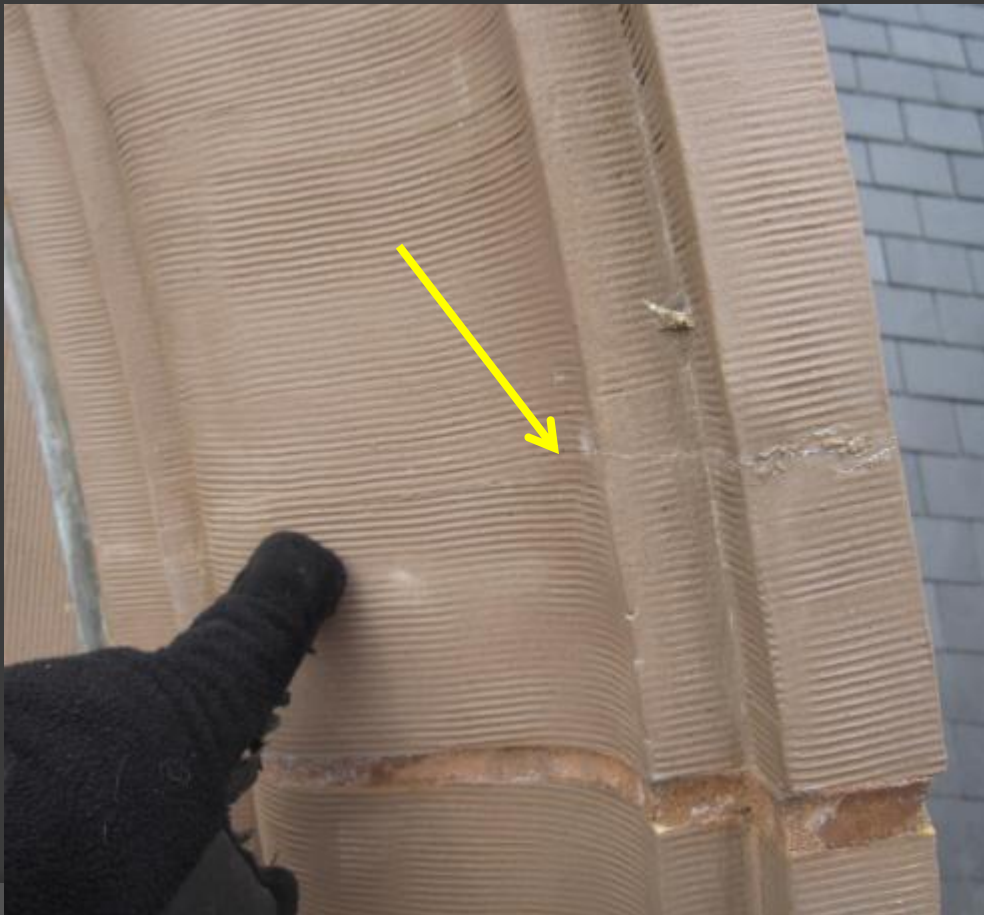
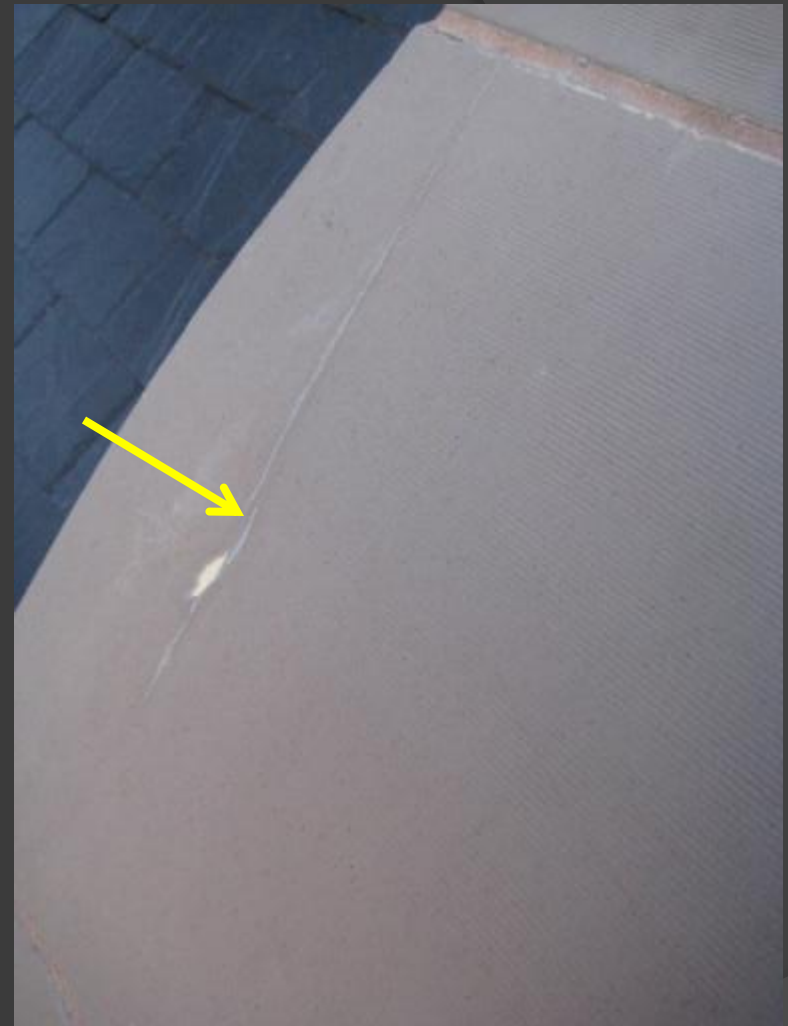
Dormer and cross
gable copings

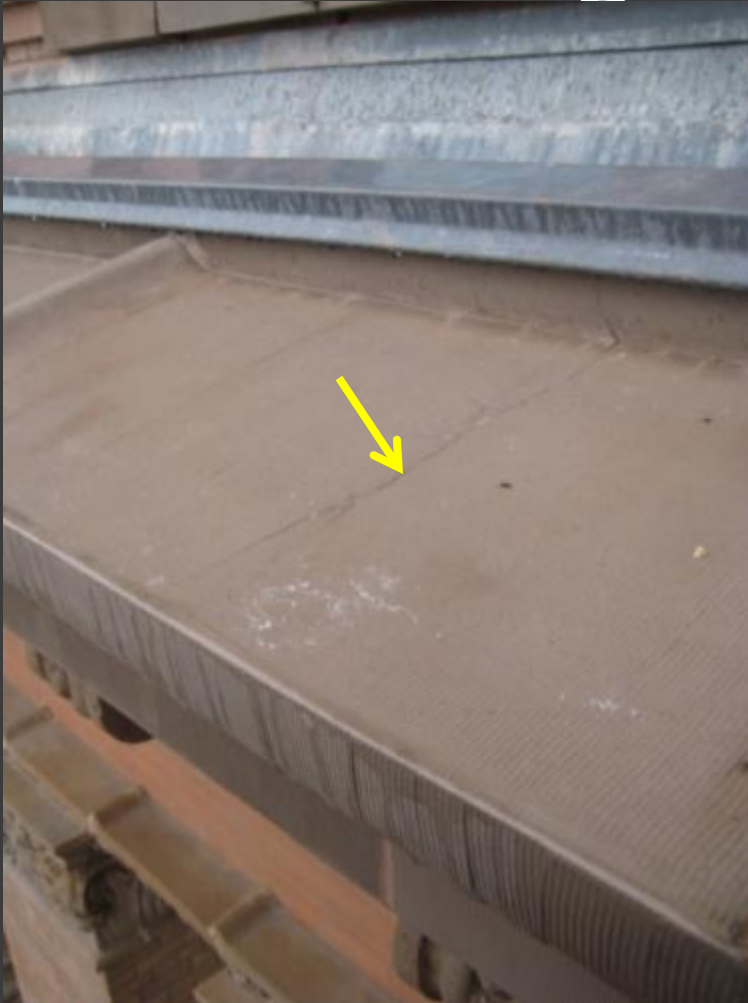
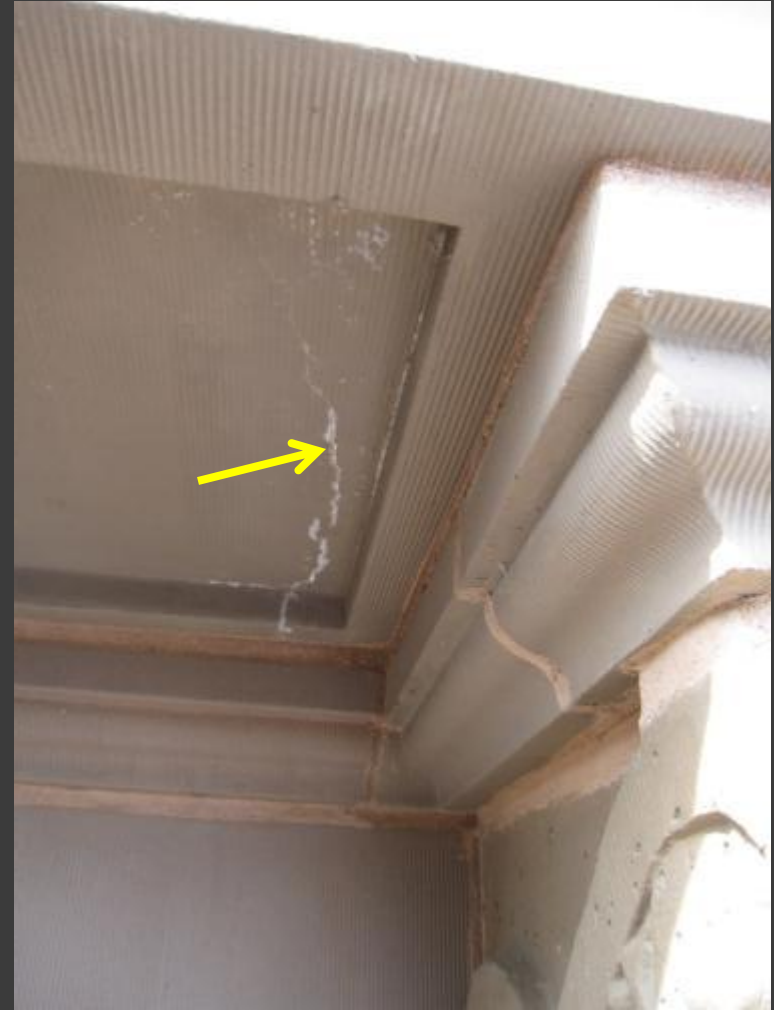
8th floor water table

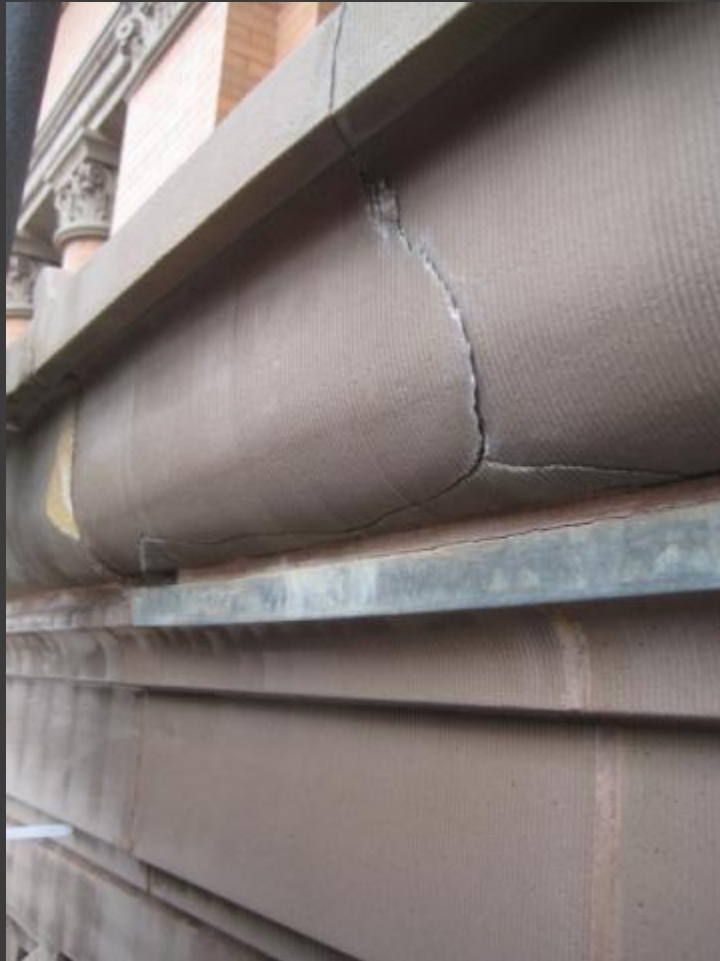
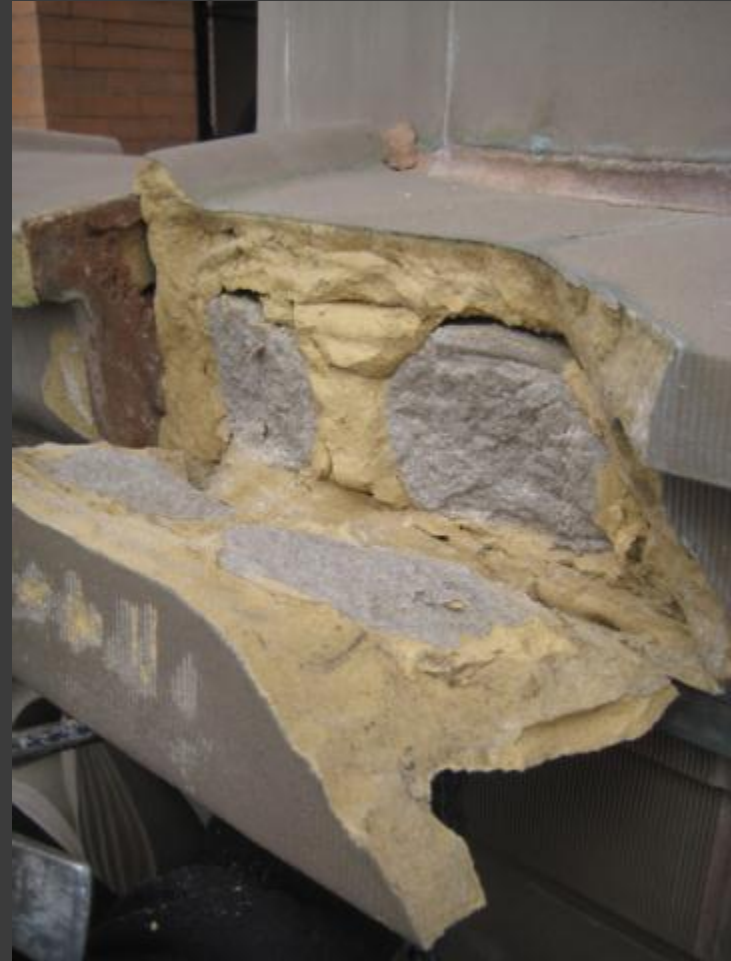
12th floor balustrade

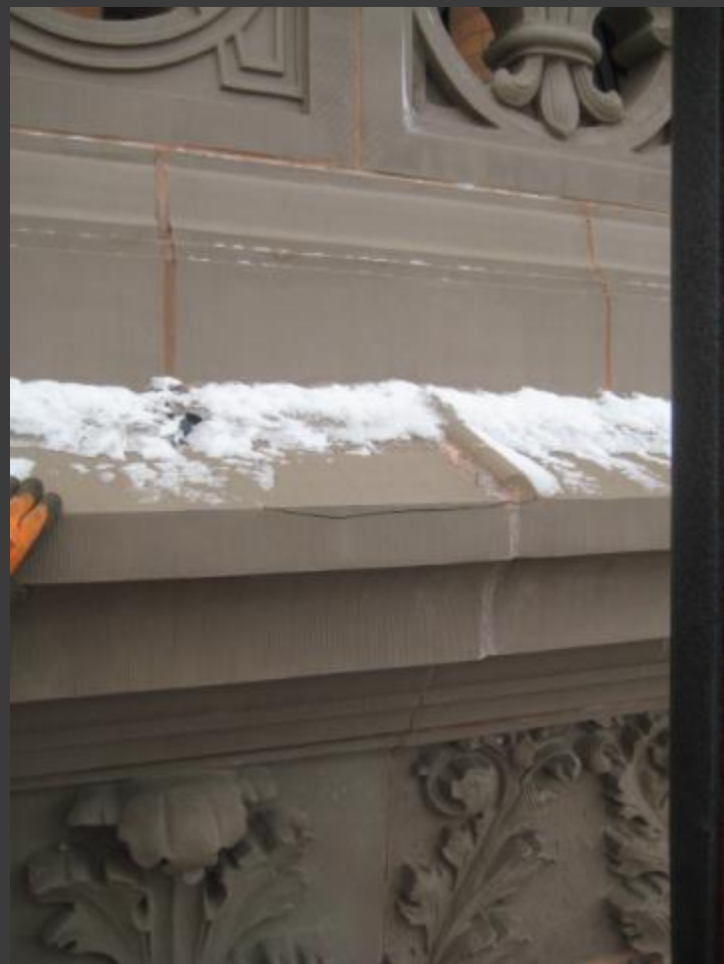
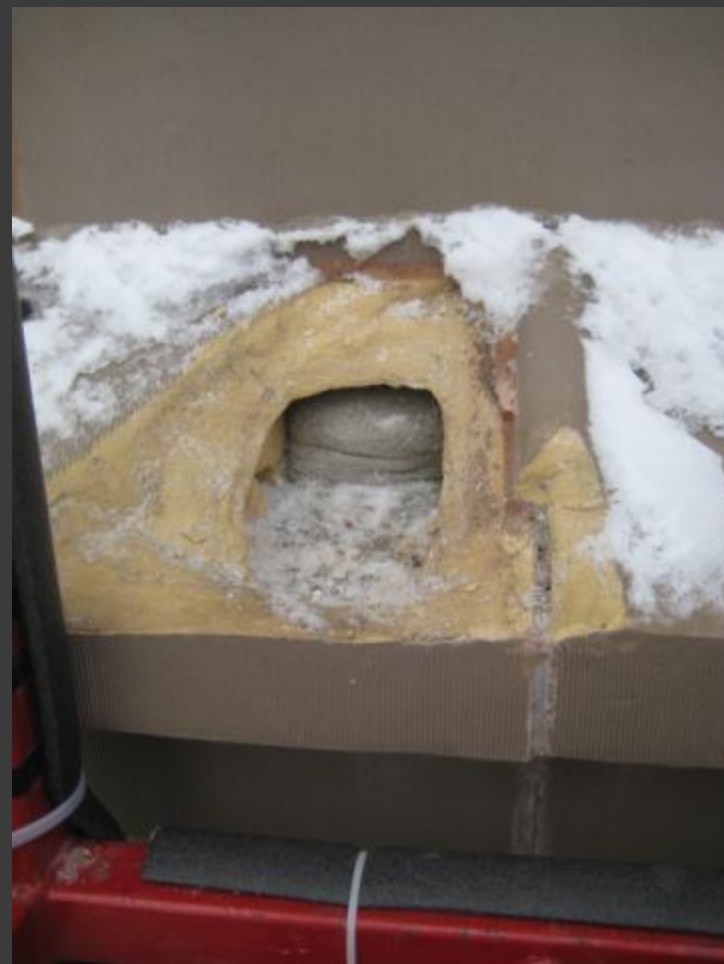
12th floor balustrade

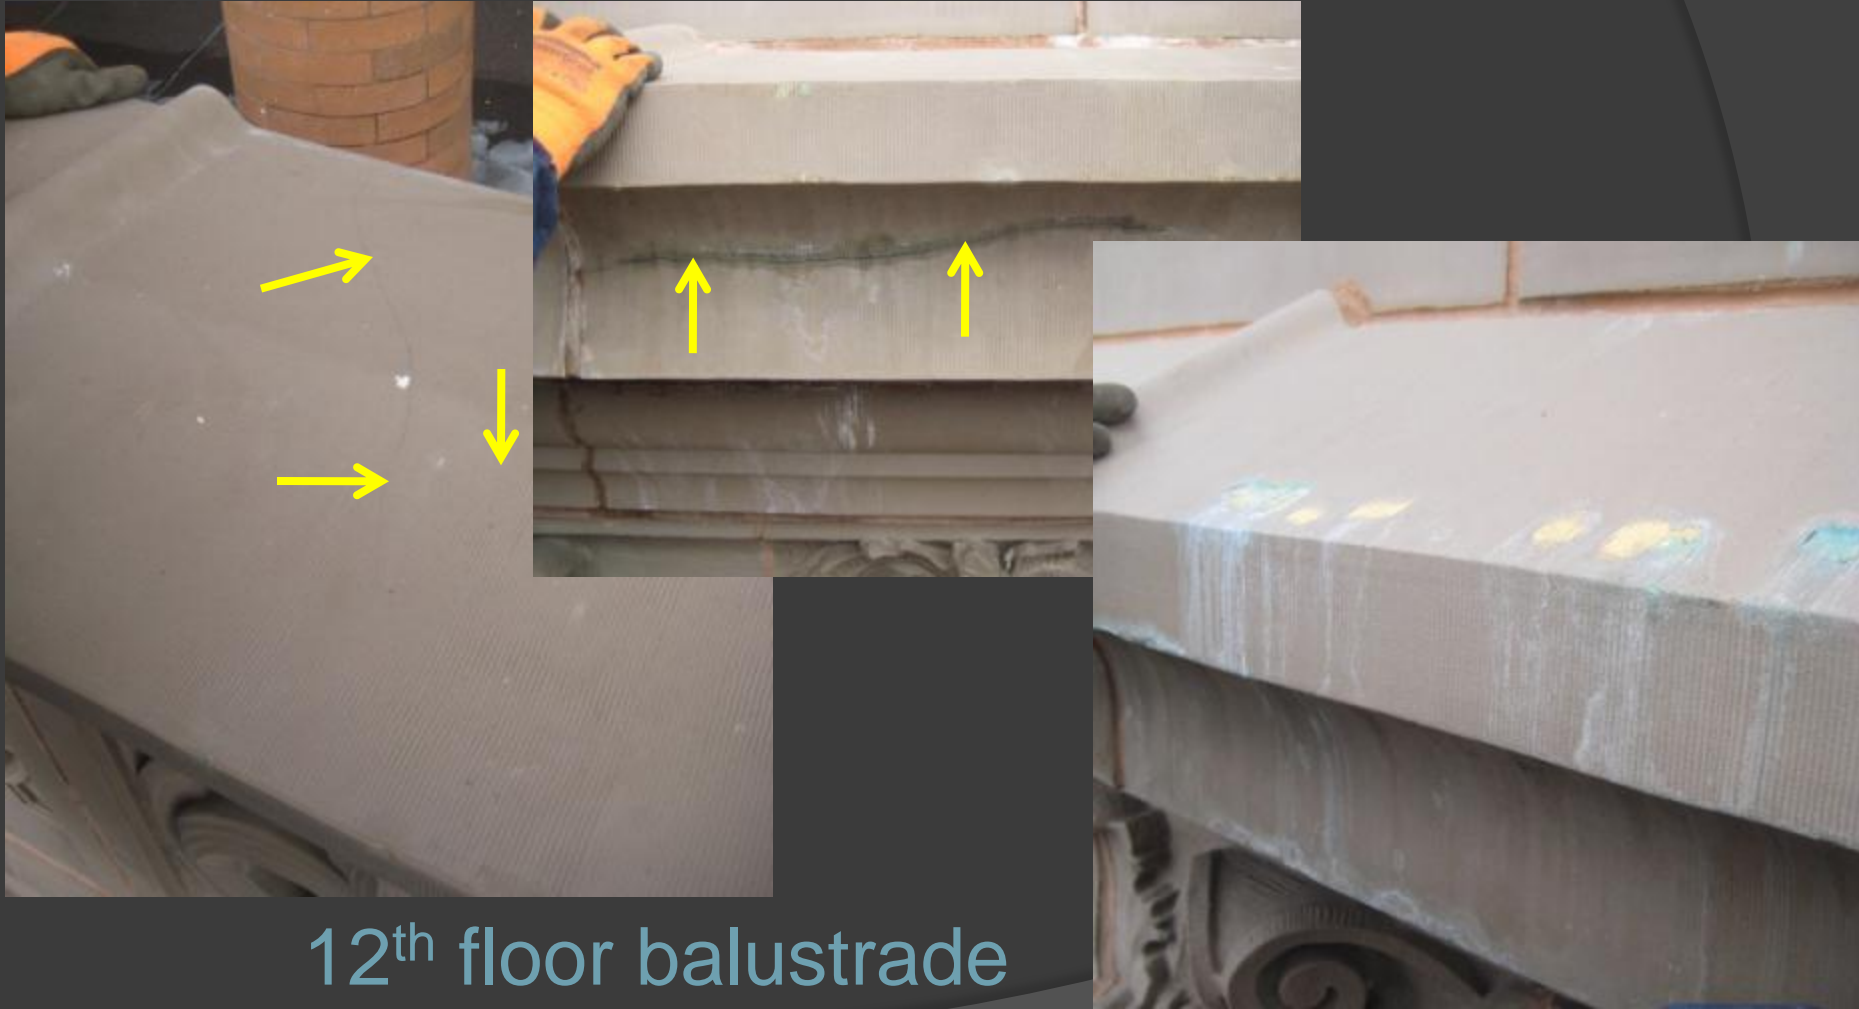
12th floor balustrade

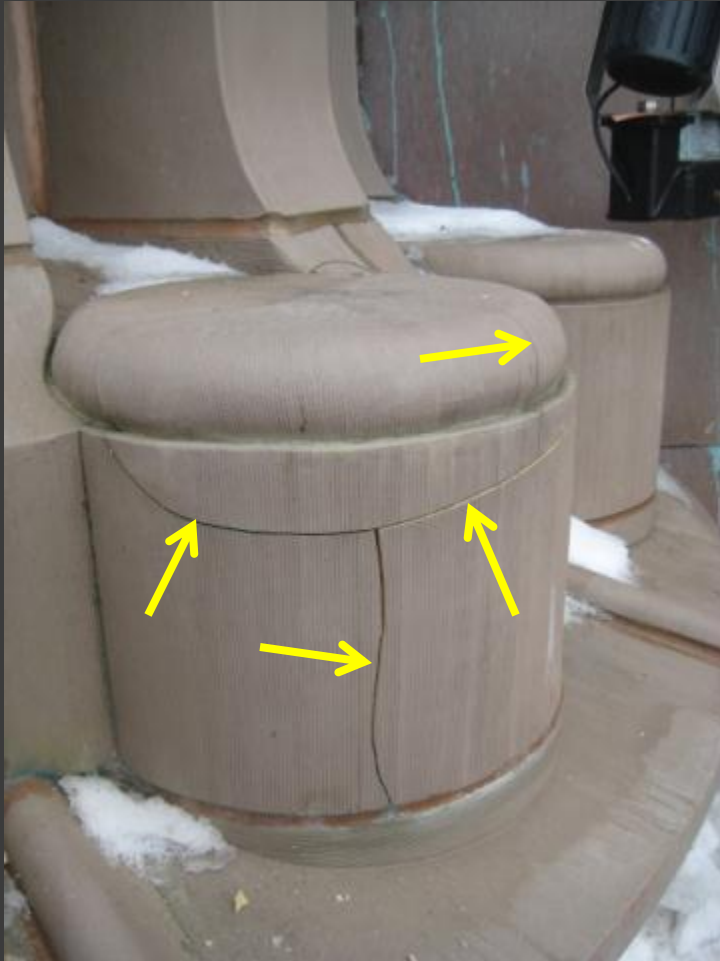
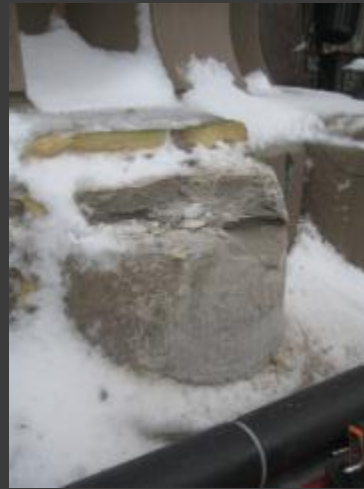
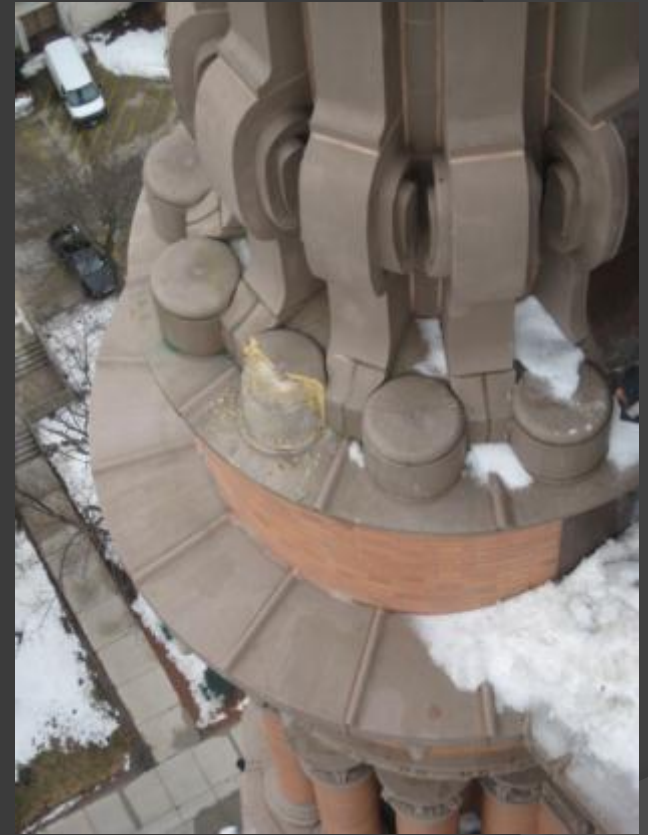
Turret urn bases

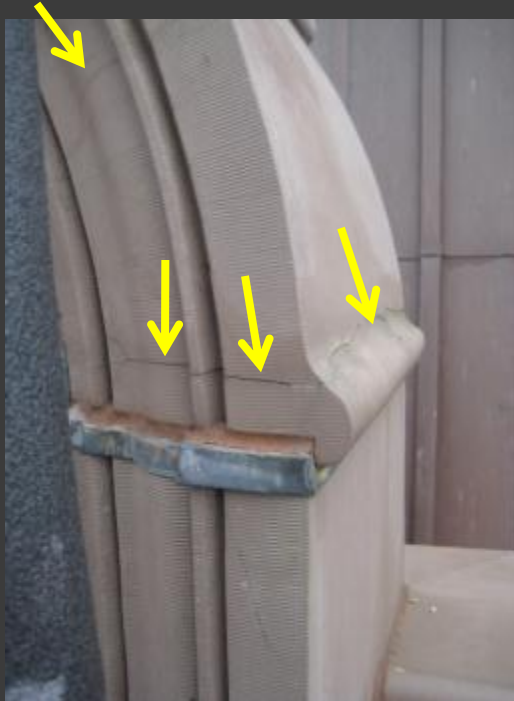
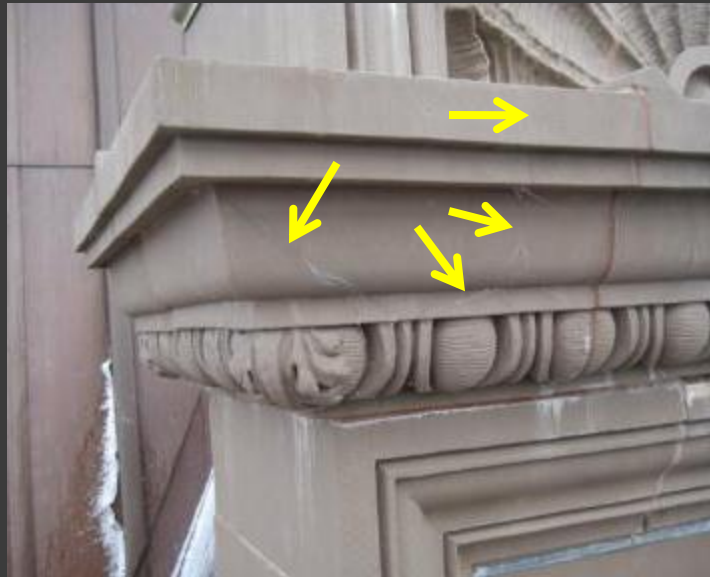
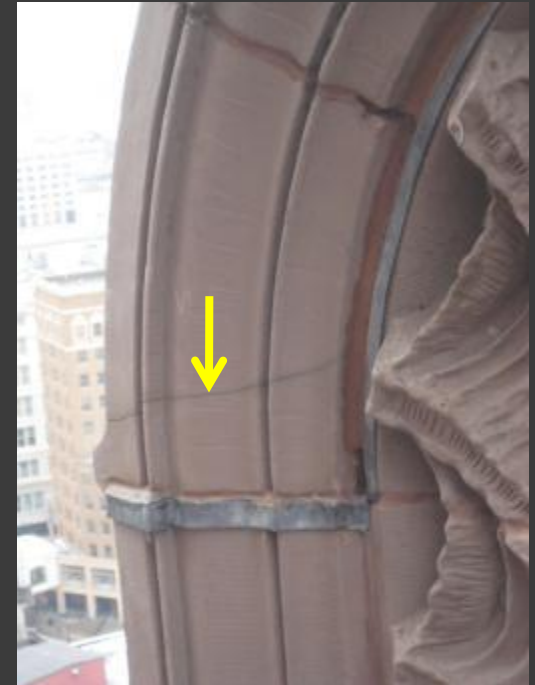
Finial bases
