# FREDERIC PALMER RUGEE HOUSE

2603 NORTH LAKE DRIVE, MILWAUKEE, WI

## Certificate of Appropriateness Application

19 JANUARY 2024

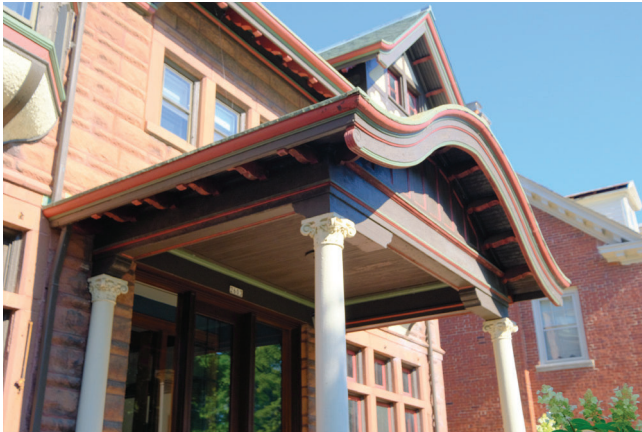
IMAGE 1: Bell-shaped roof above the east elevation's main entry.

The elegant bell-curved roof is above the main east elevation entry (**Image 1**). The protective paint finish on this roof is severely peeling resulting in metal corrosion (**Image 2**). Flakes of metal corrosion are abundant in the built-in gutters. Wall flashing is surface applied with no counterflashing nor reglet evident.

- Once the existing materials are removed, the exposed structure will be inspected. Only as needed, rotted and/or missing materials will be replaced in kind as necessary;
- Install ice and water shield membrane to the exposed decking and structure;
- Install new custom-fabricated galvalume drip edge;
- Install new custom-fabricated galvalume standing seam roof;
- Repair and reline all deteriorated built-in gutters with galvalume;
- Install new custom-fabricated galvalume sawtooth reglet-cut counter flashings;
- Install new pre-finished aluminum 4" x 3" downspouts.

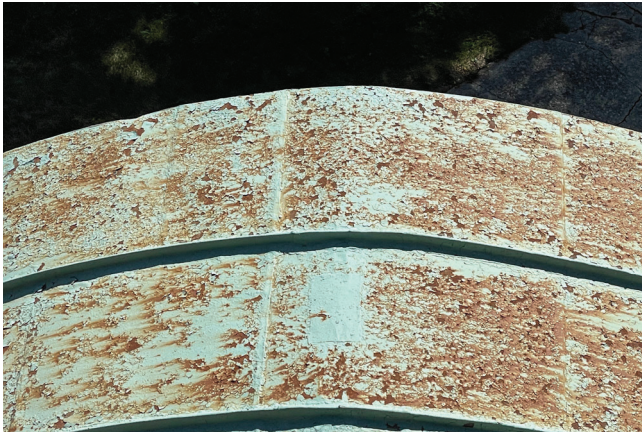
IMAGE 2: Metal corrosion on east bell-shaped roof.

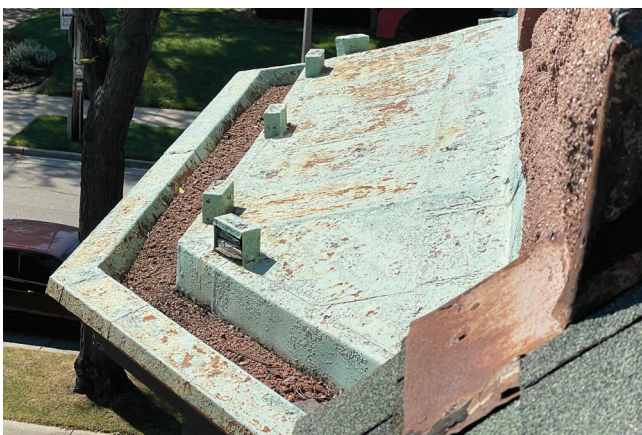
IMAGE 3: Surface corrosion on east bay roof, along with debris build up in the gutters. Note the box forms that once supported a decorative railing.

The east bay roof is clad with painted-sheet metal. Paint is worn away resulting in surface corrosion (**Image 3**). This roof lacks proper drip edges. The seven box forms along the built-in gutter are mounting blocks for a decorative railing that was once located here. The built-in gutter is full of debris, which appears to be from the masonry above this roof.

Gutters are built-in and sheet metal lined. Built-in gutters show signs of peeling paint, moderate to significant corrosion, and accumulated debris (**Images 3-4**). The west-flat roof built-in gutter was lined with copper in the modern era (copper is not original to the home).

- Once the existing materials are removed, the exposed structure will be inspected; rotted and/or missing materials will be replaced in kind as necessary;
- Install ice and water shield membrane to the exposed decking and structure;
- Install new custom-fabricated galvalume standing seam roofing;
- Repair and reline all deteriorated built-in gutters with galvalume;
- Install new custom-fabricated galvalume sawtooth reglet-cut counter flashings;
- Install new pre-finished aluminum 4" x 3" downspouts.

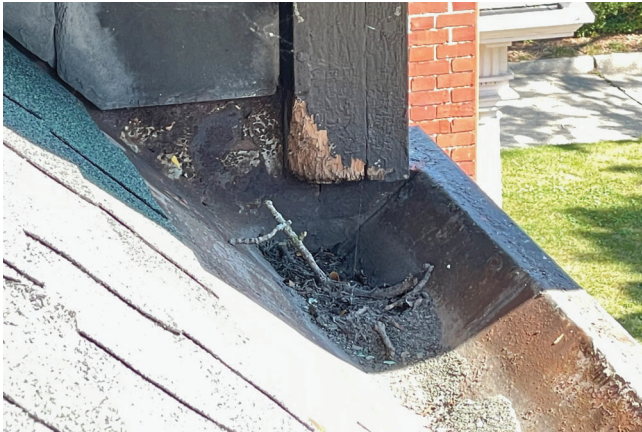
IMAGE 4: Debris and corrosion in built-in gutters.

- Repair and reline all deteriorated built-in gutters with galvalume.

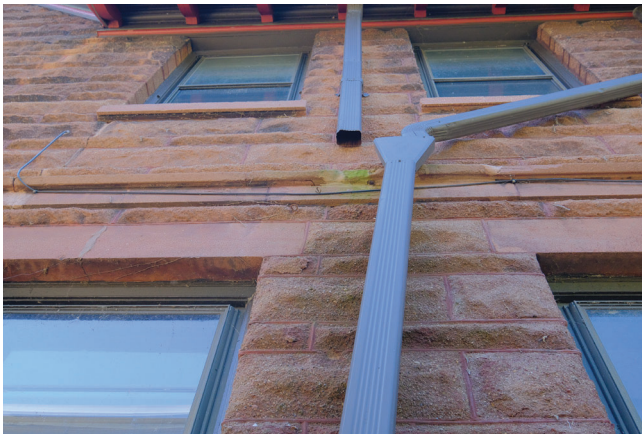
At the north elevation, the main mid-wall downspout consists of two connecting runs that join into a V at the second-floor line, coming together into one downspout at the first-floor level (**Image 5**). The V connection has dislodged, allowing run-off to saturate the masonry wall. A temporary aluminum downspout fix was executed in 2021 to reconnect the drainage runs. Active moisture and algae growth are present on the masonry (**Images 5-7**). The short downspout extensions at grade allow significant run-off to further saturate the foundation. In addition, the recessed window well created by the hardscaping approach further encourages moisture and run-off toward the north wall rather than away (**Image 6**).

IMAGE 5: Second-floor V connection of the downspout on north elevation. Note the algae growth present where moisture has collected at the disconnected junction of the downspouts.

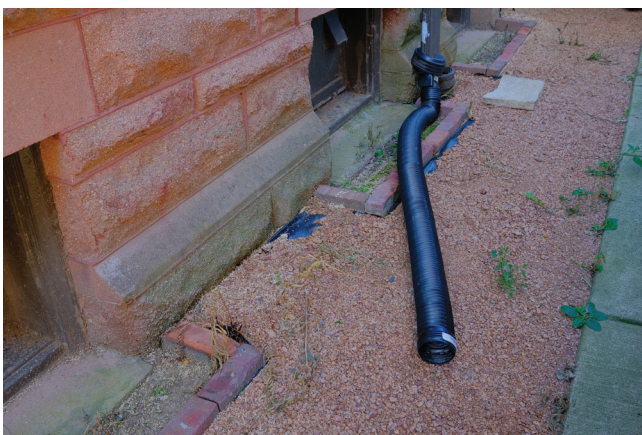
All downspouts are now disconnected from the storm sewer lines (executed in 2021 to halt basement flooding). Downspout extensions outlet within less than 3' from the foundation. This results in run-off being directed at the foundation rather than away down the sloping yard.

IMAGE 6: Recessed window wells on the north elevation. Downspout-extension outlets too close to the foundation, exacerbating moisture accumulation and algae growth.

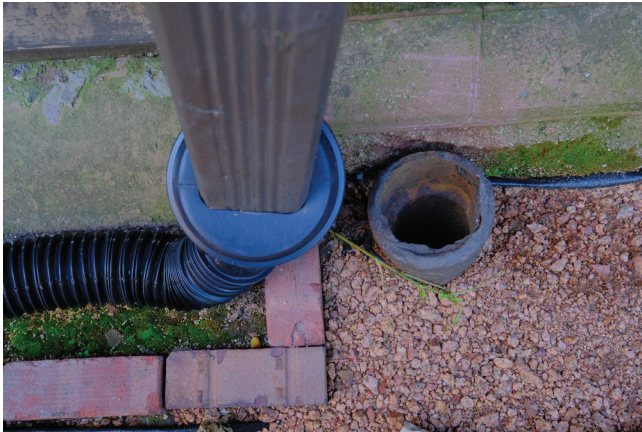
IMAGE 7: Algae growth at the base of the north elevation near downspout.

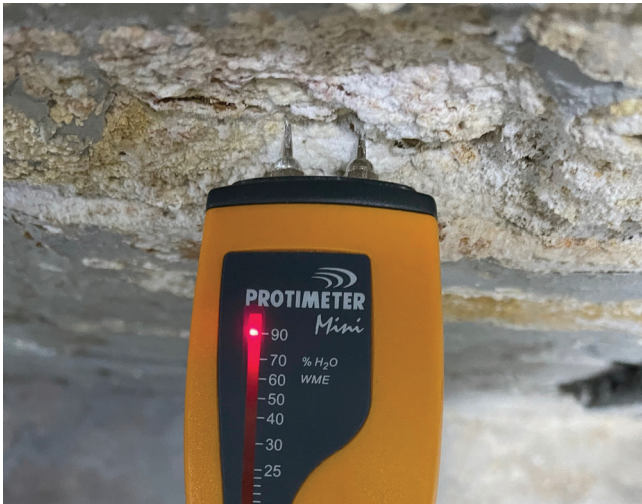
IMAGE 8: High moisture-meter readings along the perimeter walls in the basement.

Significant moisture is present within the basement at each rain event. This is due to several conditions:

- Lack of appropriate chimney hoods and flashing/counterflashing resulting in significant water running down into the north chimney and flooding the basement each time it rains.
- Lack of a breathable masonry foundation. Cementitious parging and multiple layers of non-permeable paint were added to the interior basement perimeter walls over its lifespan. The result is moisture trapped within the masonry walls with spalling stone and decomposed mortar. Moisture-meter readings range from 25% to 95% WME (wood-moisture equivalent)(**Image 8**).
- Broken exterior drain tiles. Spot excavation as executed at the northeast corner. A terra cotta drain tile was located in an approximately 5' length. The drain tile was fractured in several locations.

- Remove all paint and parging from stone perimeter foundation walls;
- Remove decomposed mortar back to sound material, allow walls to dry to 18% WME;
- Increase dehumidification measures by installing additional portable units;
- Install new mortar matching the historical composition once walls have reached a stable 18% WME maximum;
- Leave stone foundation walls exposed and uncoated .
- Refer to Roofing and Drainage above for chimney-related work.

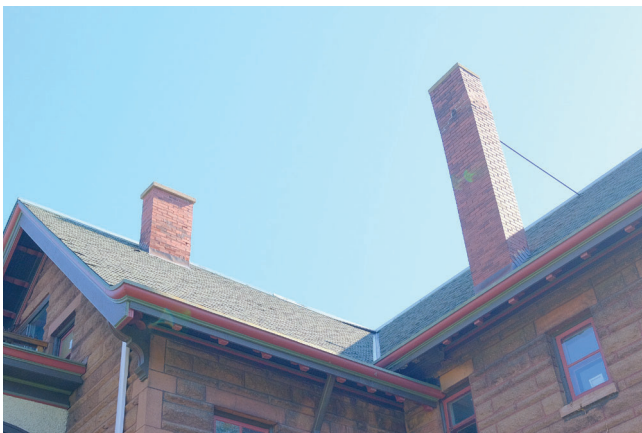
IMAGE 9: North and south chimneys with tie rod anchoring the south chimney.

South Chimney: The south chimney tilts significantly north and has one existing tie rod back to the roof structure (**Image 9**). Loose brick, decomposed mortar, and deep voids are visible for the upper nineteen-brick courses (**Image 10**).

- Rebuild the top nineteen brick courses of the south chimney;
- Rebuild the smaller north chimney down to the roof;
- Install new cast-in-place chimney caps with a 2" overhang and drip edges over chimney felt;
- Install new sheet metal caps with sidewall mesh to keep out weather and wildlife;
- Install proper flashing and counterflashing set into reglets at both north and south chimneys, including the installation of chimney saddles.

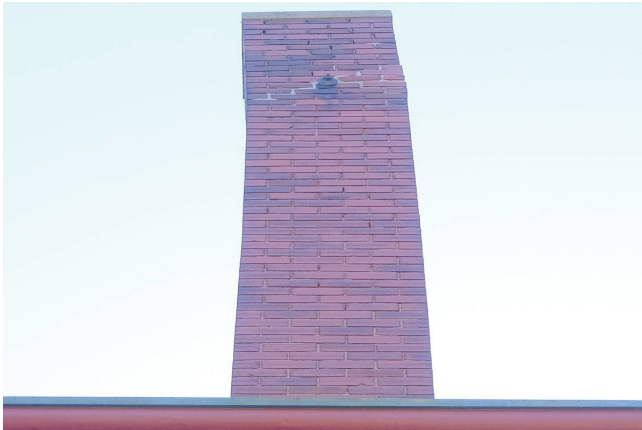
IMAGE 10: The south chimney has a noticeable northward tilt. Deterioration of the brick and mortar joints is visible from the ground.

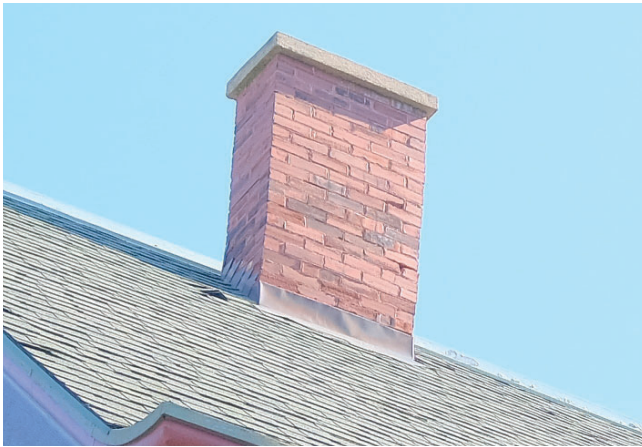
North Chimney: Loose brick and decomposed mortar are typical with deep voids visible from the ground the full height of this chimney on all four sides (**Image 11**).

IMAGE 11: Deterioration of the brick and mortar joints on the north chimney is visible from the ground.

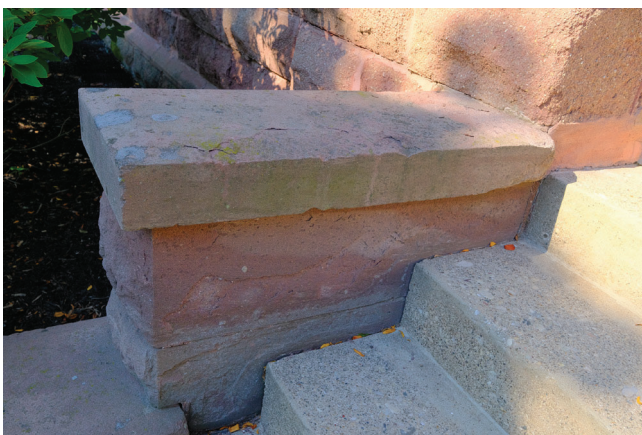
IMAGE 12: Previous repair and replacement attempts are visible on cheek walls. Spalling, cracking, and algae growth is also apparent.

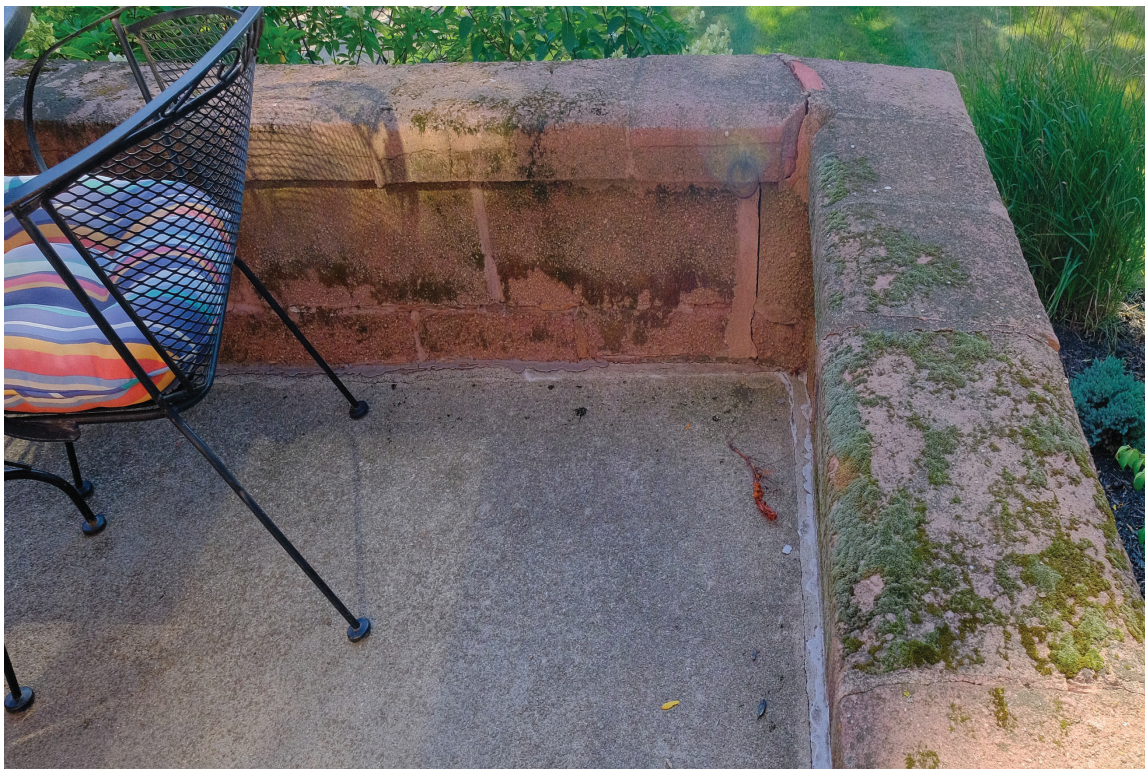
Significant portions of the east main porch were previously rebuilt. Cast stone units have been reset in new bedding mortar or replaced with non-matching modern cast stone units (**Images 13-14**). A few units at the stair-cheek wall have been replaced with sandstone. There are many areas of cracking, parging, shifting cast stone units, and spalling (**Images 12-15**). Several cast stone units are loose and out of plane with the wall. The cheek walls at concrete steps are also deteriorated with cracks and spalls (**Image 12**). The concrete porch floor levels slope away from floor drains, exacerbating masonry conditions (**Image 16**). Several through-slab cracks are present (**Image 17**).

IMAGE 13: Algae has begun to grow on some porch surfaces. Note the evidence of shifting cast stone units and cracking in floor slab. Previous repairs are also evident.

- Install temporary shoring to porch floor, roof, and columns;
- Prepare basement portion or porch for fill;
- Remove south and north windows and infill with face brick matching historical cast stone color (oversize units) set brick infill at the exterior wood jamb plane;
- Infill interior west doorway with CMU and waterproof on porch side;

- Remove the porch concrete slab and disassemble the cast stone units retaining any units suitable for repair and reuse;
- Apply foundation membrane (coating) to existing walls;
- Reinforce any deteriorated foundation;
- Geofill foundation area;
- Take apart porch walls down to foundation;
- Pour new foundation ledge for rebuild;
- Replace deteriorated cast stone with matching sandstone;
- Allowance of 50% of units to be replaced;
- Rebuild porch walls;
- Pour new concrete slab over gravel base ;
- Repoint joints in NHL 3.5 mortar color to match existing historical mortar.

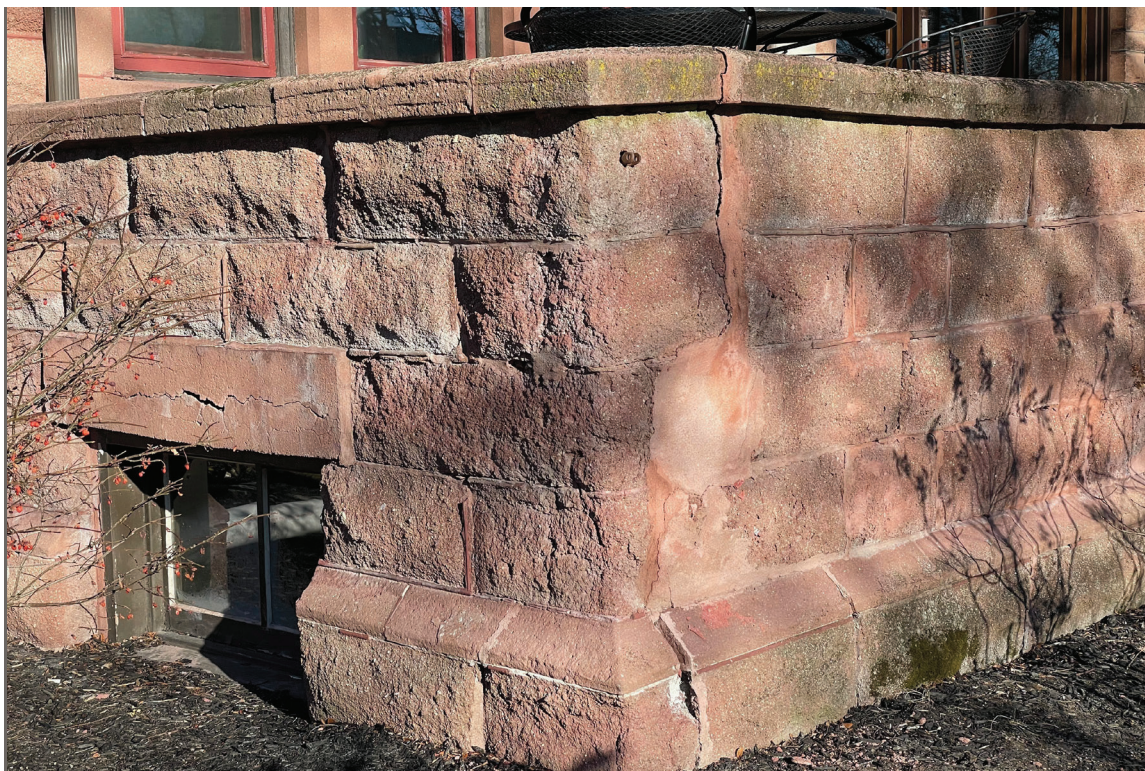
IMAGE 14: Some cast-stone units and open mortar joints have been replaced and attempts at repairs have been made. Shifting and algae growth are visible.

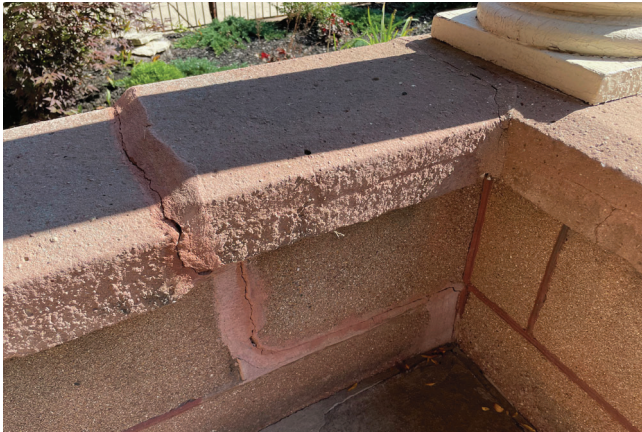
IMAGE 15: Cast-stone units have shifted significantly over time. Note the evidence of previous repairs.

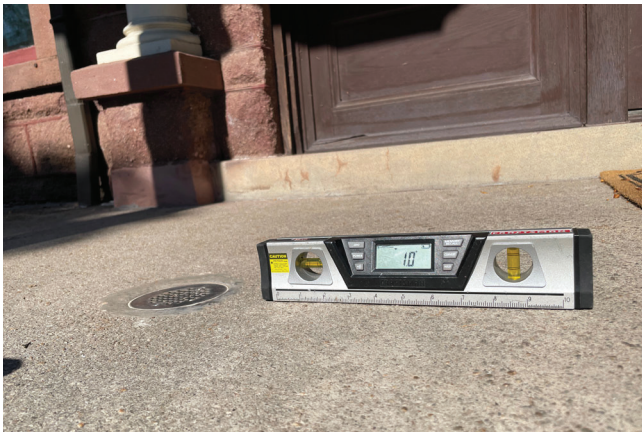
IMAGE 16: Concrete-porch floor slopes away from drain.

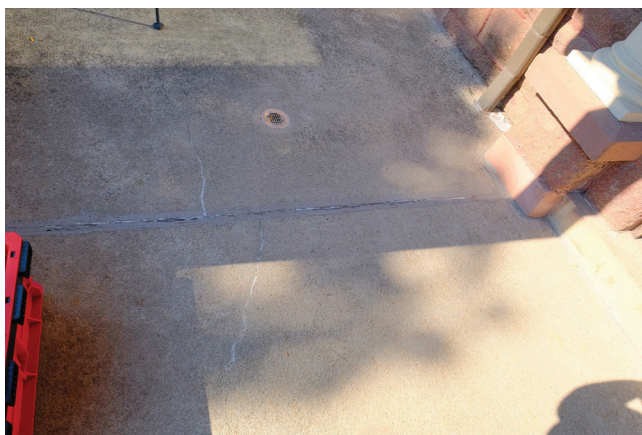
IMAGE 17: Cracking in the concrete-porch slab.

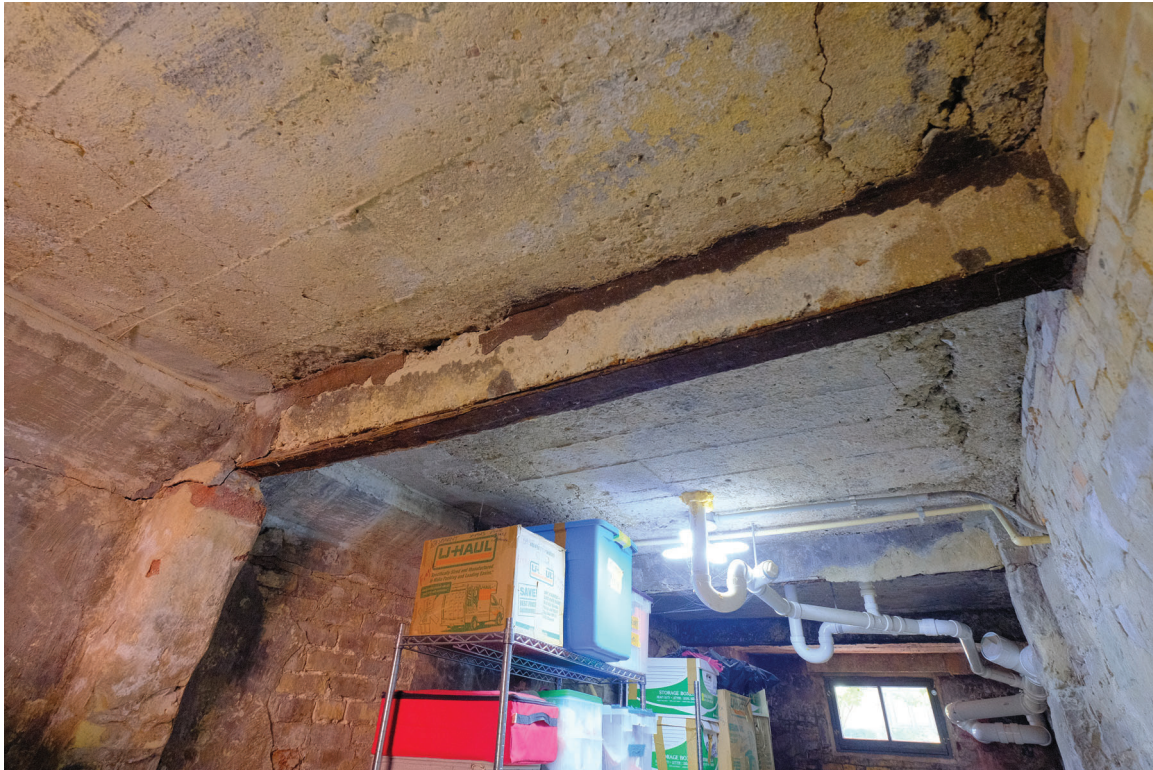
The underlying cause of the movement is the porch structure. Five east-west running cast iron I-beams carry the concrete deck load. Coatings protecting the cast iron are worn away. When the stone porch deck was replaced in the modern era with concrete, no waterproofing measures were added. As a result, the cast iron I-beams are severely corroded (**Images 18-19**). Structural evaluation indicates they can no longer support the deck load. Beam pockets are also severely decomposed and require rebuilding. Shifting cast stone units are visible in the basement.

IMAGE 18: Cast-iron beams in the basement are severely corroded.

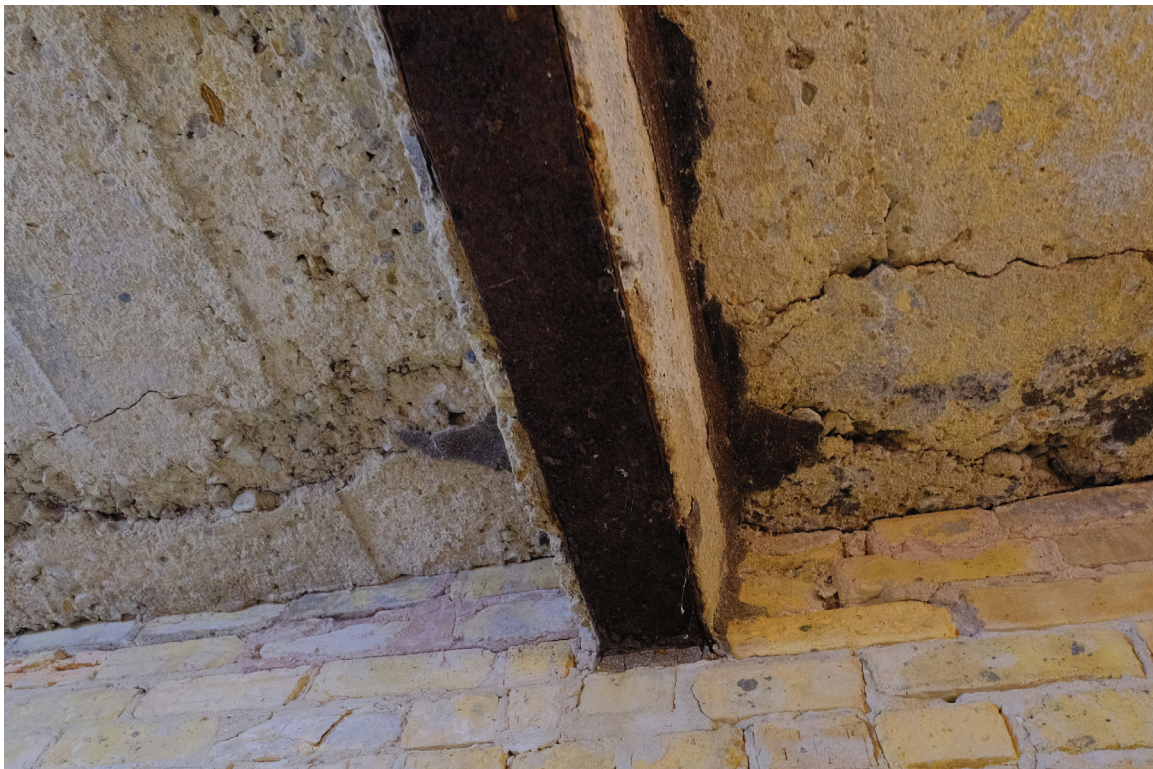
IMAGE 19: Close up image showing severe corrosion of an iron beam. Note the deterioration and cracking evident on the cast-in-place concrete ceiling.

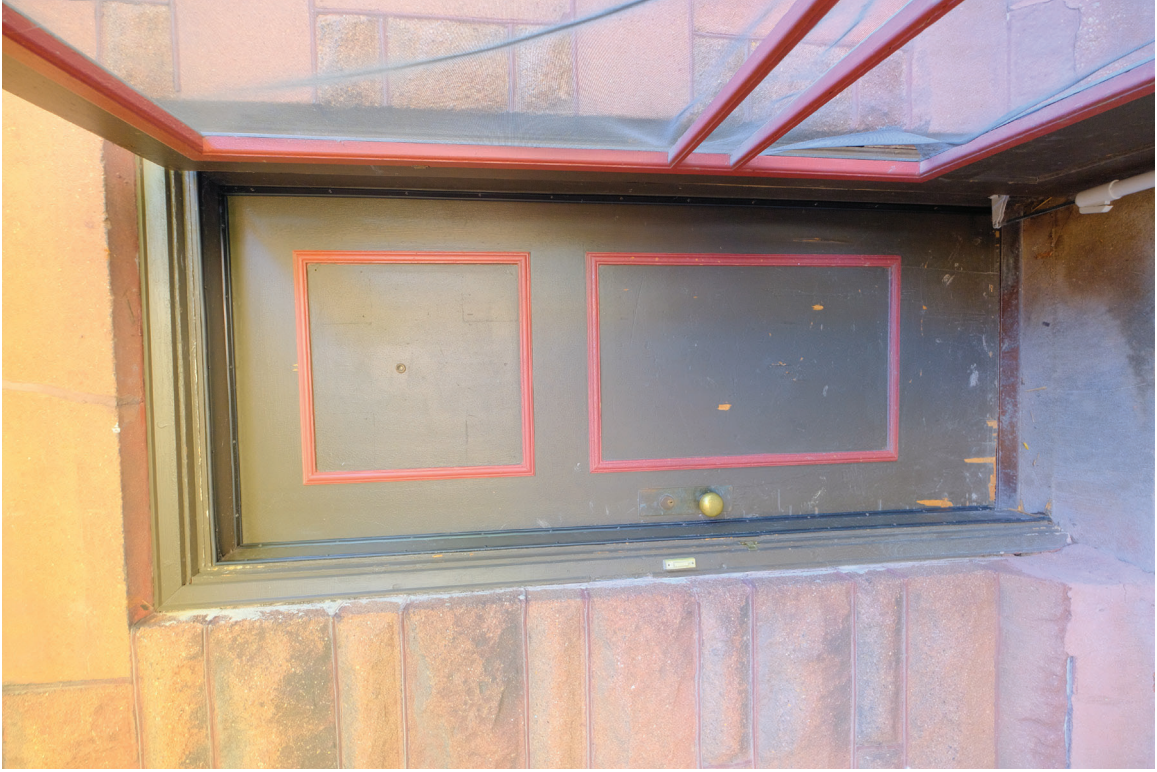
This modern era slab 2" wood door is in poor condition (**Image 20**). The leaf is delaminating at the bottom, has no sweep, is missing part of its bronze weather stripping, and allows noticeable daylight and wind through the gaps between the door and frame. The existing screen door has splitting wood veneer, peeling paint and is not configured for a glass insert for added winter thermal performance (**Image 21**).

IMAGE 20: West entry door is in poor condition.

Replace the west rear entry door with a solid exterior grade door in keeping with the style of other exterior doors on the home. Install proper weather stripping and sweeps. Door Specification: Simpson, 7114 Thermal Sash, fir with clear glass; painted finish; featuring two lower recessed panels and an upper light (**Image 22**).

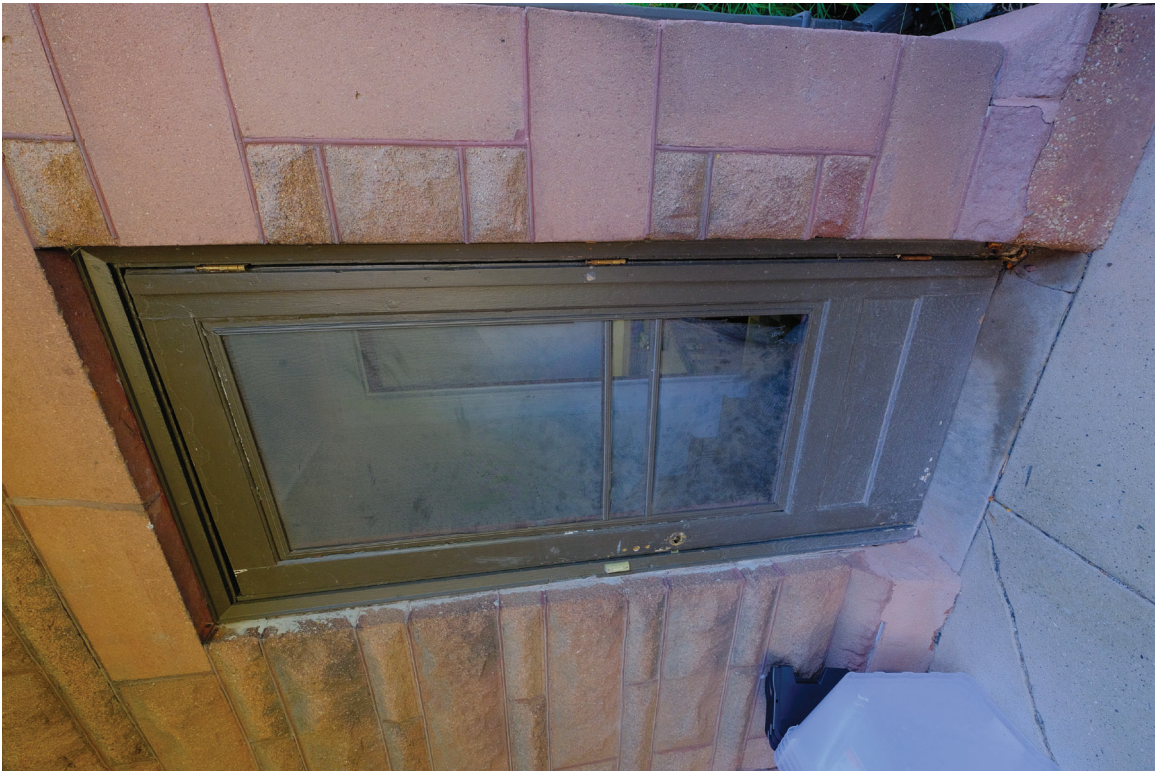
IMAGE 21: Screen door at west entry.

Replace the existing storm door with a powder-coated aluminum Larson Premier Classic Elegance EasyVent® (in color 'Sandstone') with Retractable Screen Away®, 2/3 glass doors with retractable Screen Away® design converts the storm door to a screen door with an unobstructed view (**Image 23**).
