INSPECTION REPORT AND ORDER TO CORRECT CONDITION

Re: 2424 W KILBOURN AV 1

I performed an exterior inspection of the property located at 947 N. 24<sup>th</sup> Street in Milwaukee, Wisconsin on January 31<sup>st</sup>, 2020. The residence is approximately 122 years old according to public records. The purpose of the inspection was to investigate a report of an existing stone foundation wall that was of concern to an existing neighbor. The stone wall was directly adjacent to a public alleyway that, according to the owner, is used frequently. Please reference the photos included in this report taken during the inspection. The only component of the structure observed is the existing stone foundation wall indicated in this report – no other part of the structure was observed.

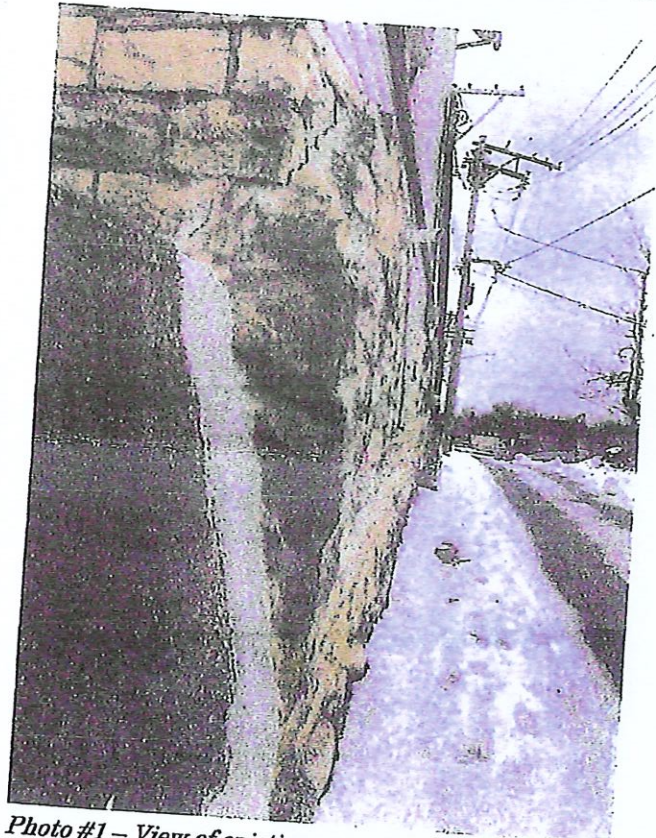
*Photo #1 – View of existing stone basement wall corner (NE)*

The existing stone basement wall is tipped outward significantly and there is cracking of old-tuck-pointed repairs that indicate that the wall is continuing to move laterally. The wall joints show significant deterioration especially at the base. In my opinion, the wall has functioned properly as a foundation wall for many years, however, the on-going movement and deterioration of the wall brings into question the overall stability of the wall as it exists in place. Typically walls of this construction that are in the process of failing and in the condition of this wall need to be re-built. In my opinion, to prescribe an

adequate repair, a licensed structural engineer should do a complete assessment of the wall from both the inside and outside. This must be done in order to determine the wall's overall condition and to determine how the wall currently supports the existing structure. At this time the wall may be a safety hazard for any people that are using the adjacent alley.

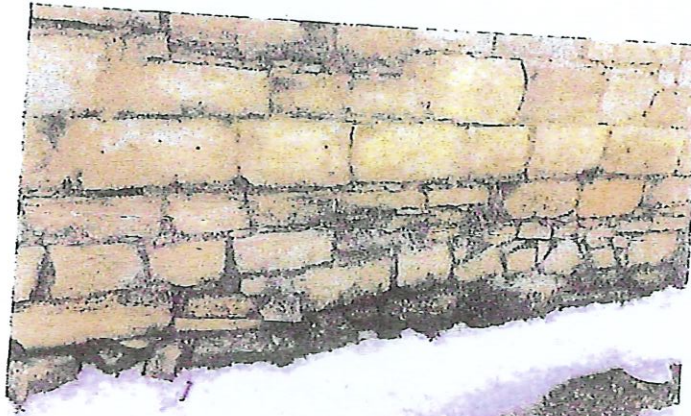
*Photo #2 - Base of Basement Wall*

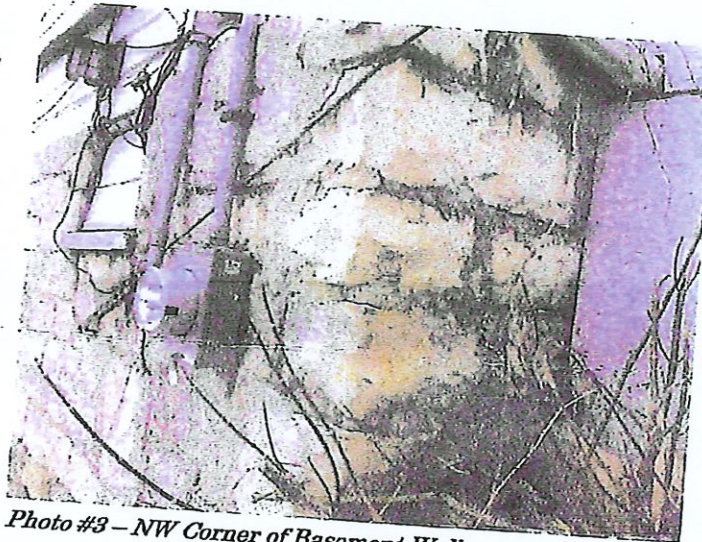
*Photo #3 - NW Corner of Basement Wall*
