Facilities Condition Assessment Program

Forestry and Sanitation Central HQ

Introduction

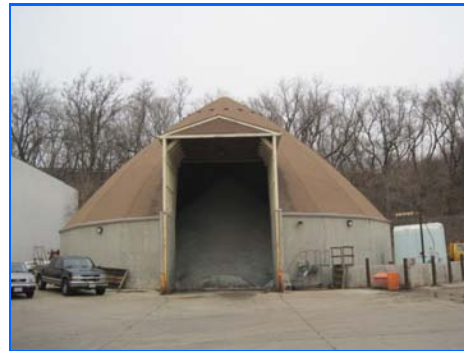
The salt dome at the Forestry and Sanitation Central HQ contains an asphalt shingle roof which comprises 13,392 SF. The soil dome roof comprises 2,000 SF of asphalt shingles. The roofs are in good overall condition.

Salt dome with asphalt shingle roof

The useful life of asphalt shingle roofs is up to 20 years. The City of Milwaukee anticipates replacement of the asphalt shingle roofs by 2021.

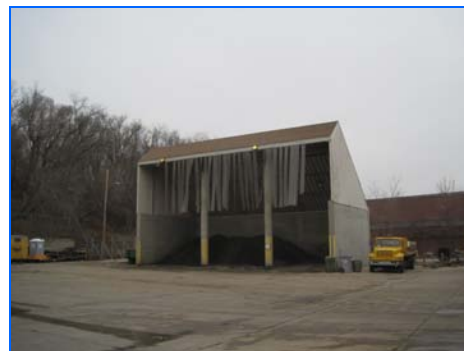
Soil shed with asphalt shingle roof

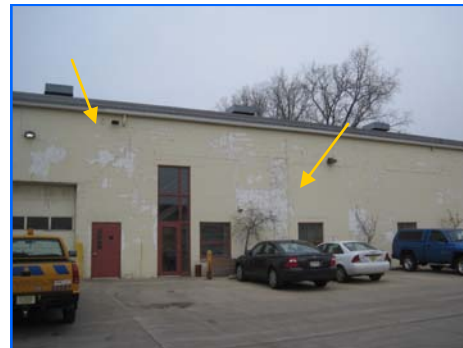
The condition of the paint finish at the Central HQ Building is fair/poor overall. The condition of the underlying masonry units is unknown due to the paint finish application. The condition of the masonry units at the vehicle garage is good, overall.

Paint finish deterioration at the Central HQ Building

The City of Milwaukee plans for exterior paint finishes and repairs. The repairs will include repointing and partial masonry unit replacement as necessary. The City of Milwaukee anticipates to conduct this capital improvement by 2013 and every 10 years thereafter.

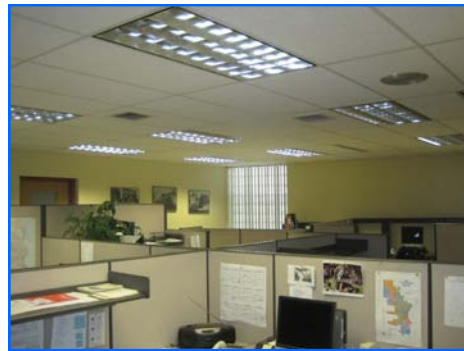
The Sanitation offices and locker rooms are located in the south portion and second floor of the Central HQ Building. The offices comprise approximately 5,400 SF of floor area and the condition of the finishes is good overall. The two locker rooms and associated rest rooms are in good condition.

Sanitation Offices

The City of Milwaukee plans to update the Sanitation Offices by 2017 and every 10 years thereafter. The Locker Rooms are planned for an update by 2027 in conjunction with subsequent office updates.

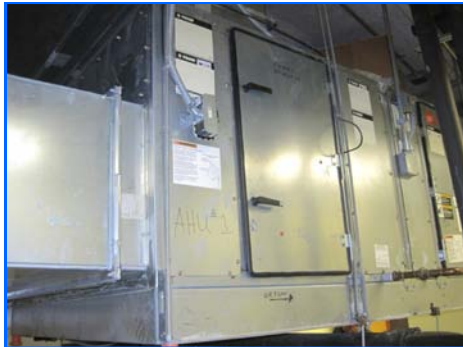
Sanitation AHU

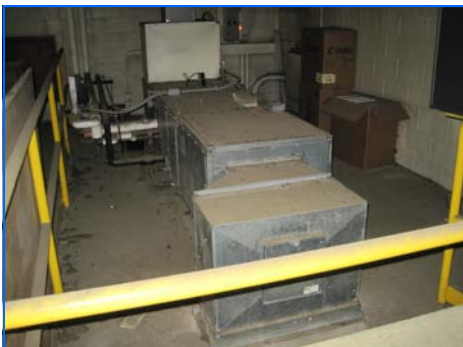
The Forestry and Sanitation Central HQ contains one AHU located atop the roof of the Forestry offices and one AHU within the Sanitation Building. The AHU at the Forestry section is in fair overall condition and the AHU at the Sanitation section is in good overall condition.

Forestry AHU

The useful life of AHUs in this capacity is up to 25 years. Based on condition and the desire to replace the AHUs along with building heat boilers, the City of Milwaukee anticipates near term replacement of the Forestry AHU by 2016. Replacement of the Sanitation AHU is projected by 2028.

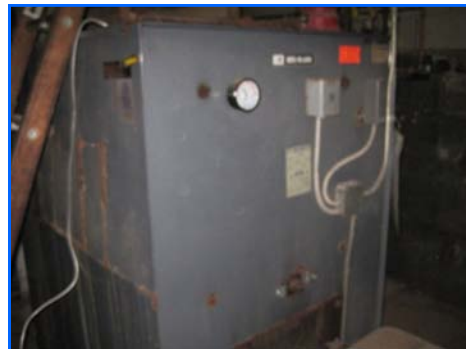
The Forestry AHU circulates heated air which is provided by the building heat boiler. The building heat boiler is in fair overall condition.

Building heat boiler

The useful life building heat boilers is up to 25 years. An energy audit conducted by Wilinski Associates, Inc. reveals that the building heat boiler is relatively inefficient. The City of Milwaukee anticipates replacement of the boiler by 2016.

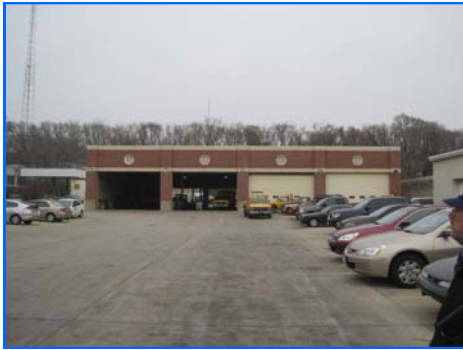
The Forestry and Sanitation Central HQ contains approximately 7,500 SF of on-grade concrete slab throughout the property. The condition of the concrete flatwork is good to fair.

Typical condition of concrete

Concrete flatwork has a useful life of up to 50 years. The City of Milwaukee anticipates partial replacements of up to 1,500 SF of concrete every 10 years beginning by 2018.

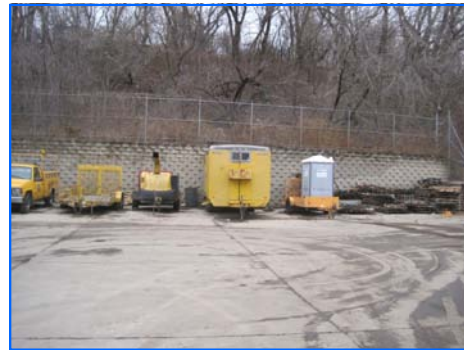
The perimeter of the Forestry and Sanitation Central HQ comprises a 1,070 LF chain link fence with barbed-wired. This quantity includes the vehicular gate at the south entrance. The fence and gate are in good overall condition.

Chain link fence with barbed wire
- note retaining wall

The useful life of chain link fences is up to 25 years. The City of Milwaukee anticipates replacement of this fence by 2026.

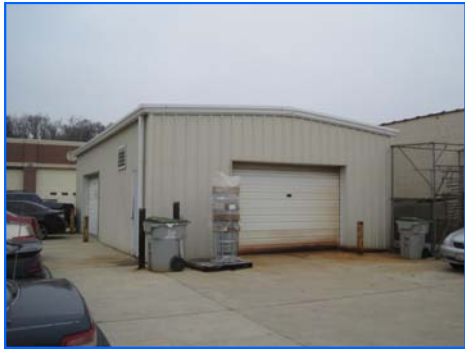
The Forestry and Sanitation Central HQ contains a 1,000 SF metal storage garage located at the east perimeter of the property. The garage is in fair overall condition.

Metal storage garage

The useful life of metal storage garage structures is up to 30 years. The City of Milwaukee plans replacement of the garage by 2022.

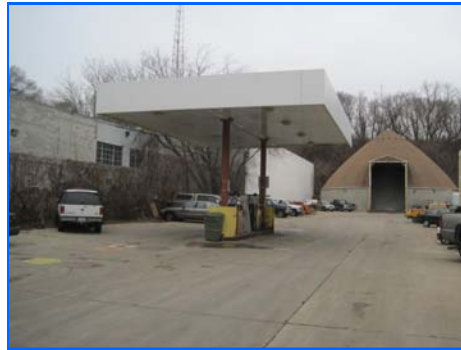
The Forestry and Sanitation Central HQ contains one fuel island structure. The condition of this structure is fair overall. Exterior, open air structures have a useful life of up to 40 years. Based on its current condition, the City of Milwaukee anticipates replacement of this fuel island by 2018.

Fuel Island

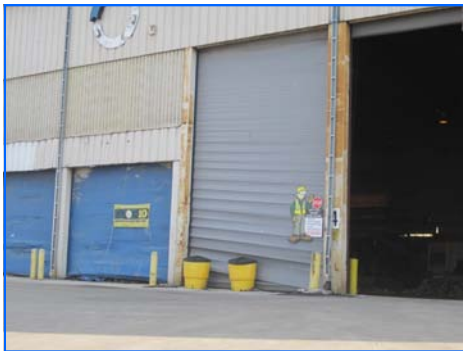
Garage door at west elevation is collapsed

The useful life of metal garage doors at the MRF is up to 20 years. The City of Milwaukee anticipates phased replacement of seven doors every four years beginning by 2014.

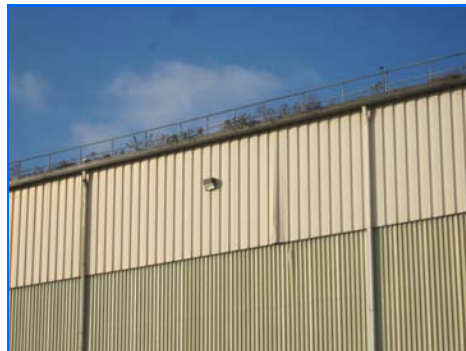
East elevation gutters contain organic growth

Subsequent phased replacements of the gutters and downspouts are likely every 19 years thereafter.

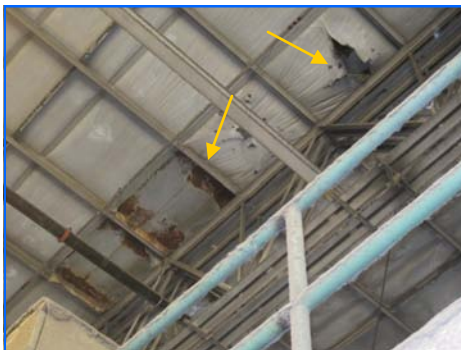
Torn insulation and rusted roof decking

Corrugated metal roofs have a useful life of up to 20 years. The City of Milwaukee anticipates replacement of the metal roofs every 19 years.

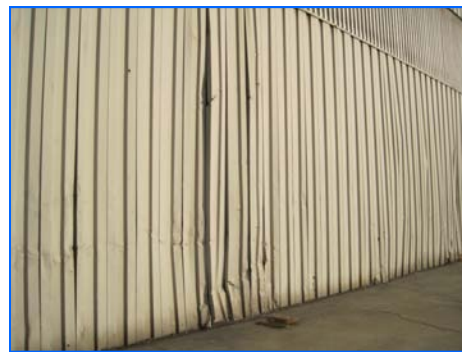
Damaged siding at south elevation

The useful life of metal and fiberglass siding is up to 35 years. Based on localized damage and varied conditions of the siding, the City of Milwaukee anticipates phased replacement of one-half of the siding by 2020 and the remaining half by 2028. Partial replacement of siding is funded by O+M.

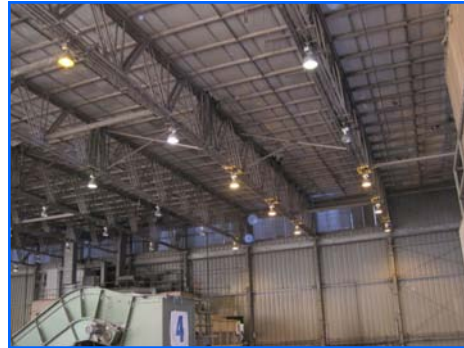
The 140 pendulum light fixtures within the warehouse portion of the MRF are in fair overall condition. Hanging pendulum light fixtures have a useful life of up to 35 years. The City of Milwaukee anticipates replacement of the light fixtures by 2017.

Typical pendulum light fixtures attached to roof truss

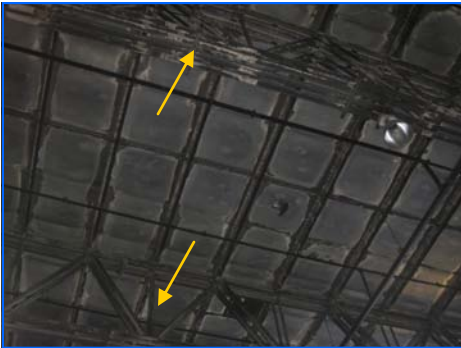
Evidence of deterioration at truss and roof stringers

The useful life for structural steel paint application in semi-exposed facilities is up to 40 years. At the recommendation of AME, Inc., the City of Milwaukee plans a paint finish application to the structural steel by 2013.

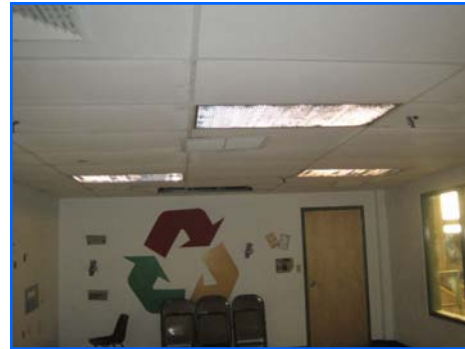
The condition of these components is fair overall. The City of Milwaukee plans the next interior update by 2016 and every 12 years thereafter.

Interior finishes

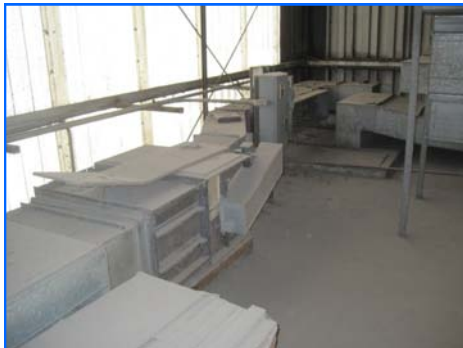
The AHU is in fair operational condition. The City of Milwaukee anticipates replacement of the AHU by 2013 and again by 2036. The near term AHU replacement is recommended to be done in conjunction with installation of AHU housing. AME, Inc. has recommended installation of the AHU housing.

AHU - note accumulation of particulate matter

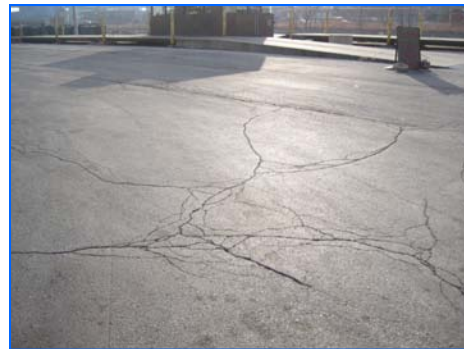
Large unsealed cracks at MRF asphalt pavement

Seal coat and repairs should be conducted every 3-5 years. The City of Milwaukee anticipates phased seal coat application of approximately 75% of the asphalt pavement in conjunction with phased asphalt pavement overlayment beginning by 2014 and every four years thereafter.

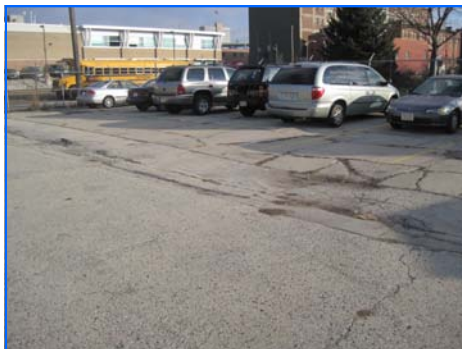
Localized failures and settled asphalt pavement

Based on the varied condition of the pavement at the MRF, the City of Milwaukee projects a phased overlayment of the asphalt pavement. The City of Milwaukee anticipates phased asphalt pavement overlayment of approximately 25% in conjunction with phased seal coat application beginning by 2014 and every four years thereafter.

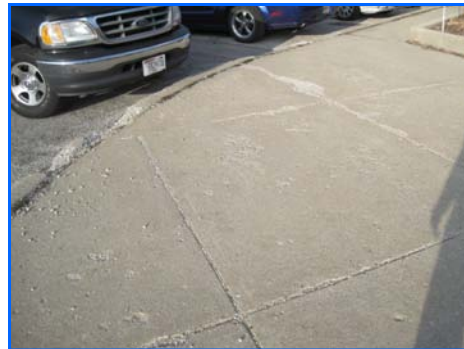
Deteriorated concrete and curbs

The useful life of concrete flatwork is up to 50 years. Based on the condition of the concrete flatwork, the City of Milwaukee anticipates partial replacements by 2012 and again by 2019.

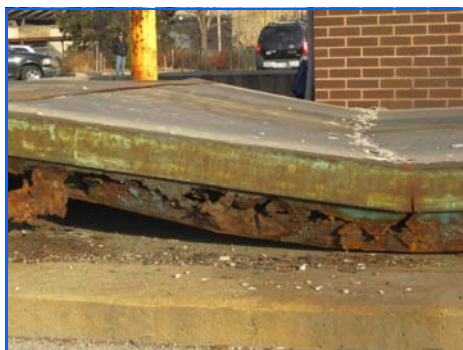
Damaged scale

The useful life of truck scales is up to 15 years. The City of Milwaukee should anticipate the next scale replacement by 2025.

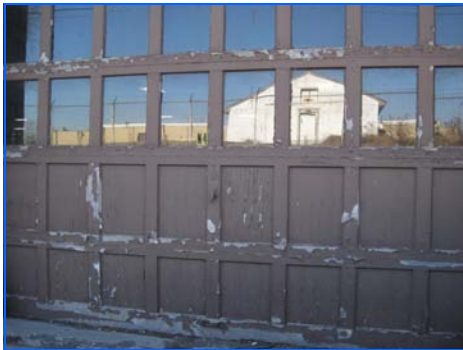
Typical garage door with paint finish deterioration

The useful life of exterior wood garage doors is up to 20 years with proper maintenance. Proper maintenance includes paint application every 3-5 years and interim repairs as required. The City of Milwaukee anticipates replacement of the garage doors by 2019.

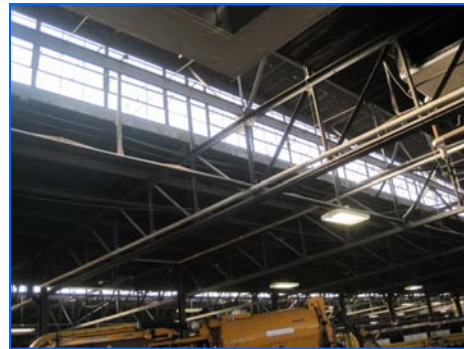
Clerestory windows

Wilinski and Associates, Inc. suggests the City of Milwaukee replace these windows in the future. For budgetary purposes, the City of Milwaukee projects for replacement of these windows in 2025.

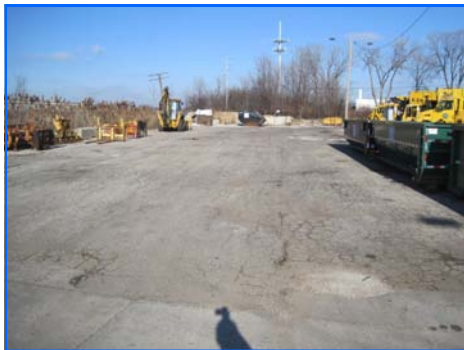
Pavement requires maintenance

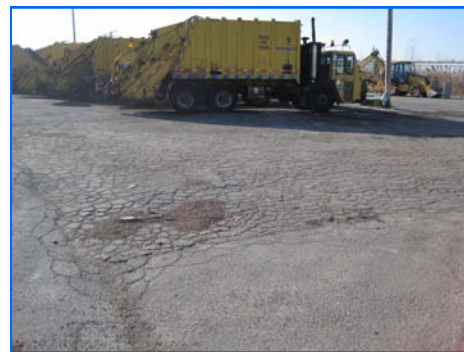
Failed pavement at west end of property

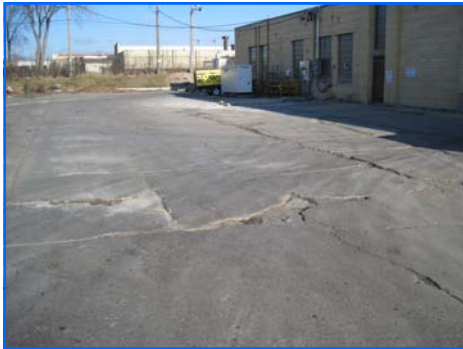
Deteriorated concrete at west end of garage
