# CERTIFICATE OF APPROPRIATENESS APPLICATION FORM

North Downer Avenue Commercial District: Mulkern's Building

**Re: 2650 N Downer Ave**

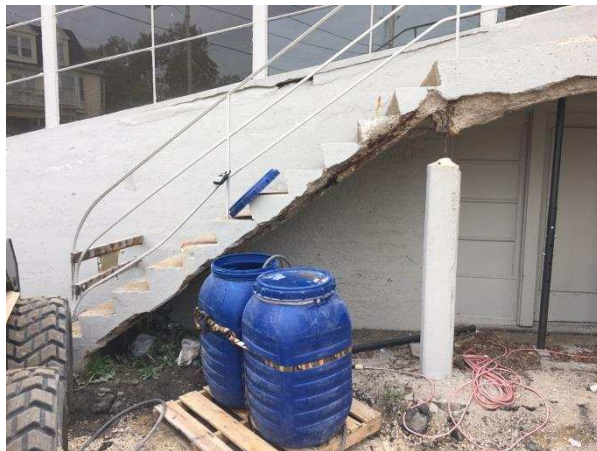
**Photo 'A': West Elevation of Stairs**

The stair is original to the building that is estimated to be 50 to 75 years old. The stair landing and risers consist of reinforced concrete slabs. The landing slab spans between the west wall of the building and an exterior concrete beam. The stair riser slab spans from grade to a concrete beam at the top. Both concrete beams span between walls of the building to a single concrete column. See photos "A" and "B" for the existing conditions.

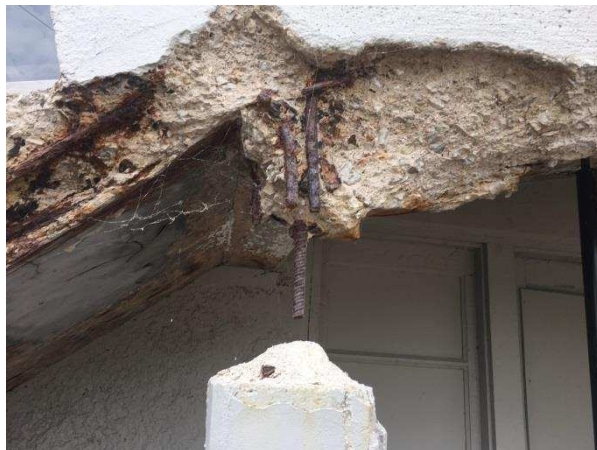
**Photo 'C': Top of Column**

The stairs are in very poor condition. The underside of the landing and stair slabs along with the edge beam have experienced substantial spalling and rebar corrosion as shown in photos "C" and "D". The concrete at the column to beam connection has completely spalled away and temporary steel shoring columns have been added to support the stairs.

While the stairs are in very poor condition, they can be repaired and reinforced to re-establish their structural integrity. For the concrete slabs and edge beam, the majority of the concrete that has spalled is the protective layer of concrete below the layer of reinforcing bars. This layer of concrete below the tensile reinforcement is not relied on for structural capacity, but none the less should be replaced. The concrete at the top of the column and at the edge beam are required for structural strength and stability. Repairs should be made to the stairs as shown in Detail "E".
