# Certificate of Appropriateness—Amended

910 N. OLD WORLD THIRD ST. Second Ward Savings Bank

## Description of work

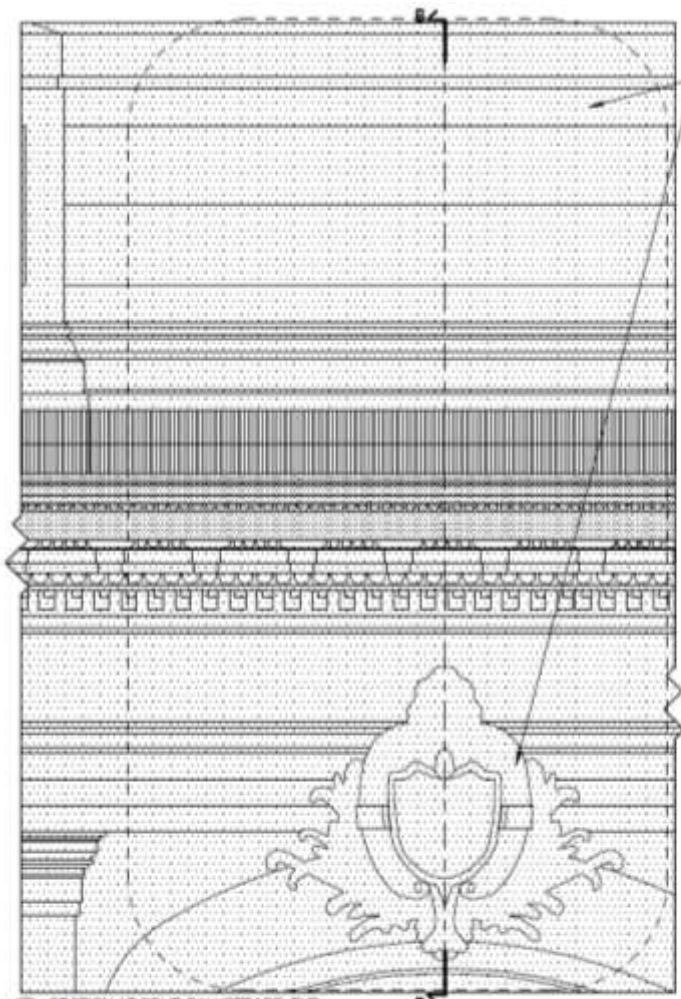
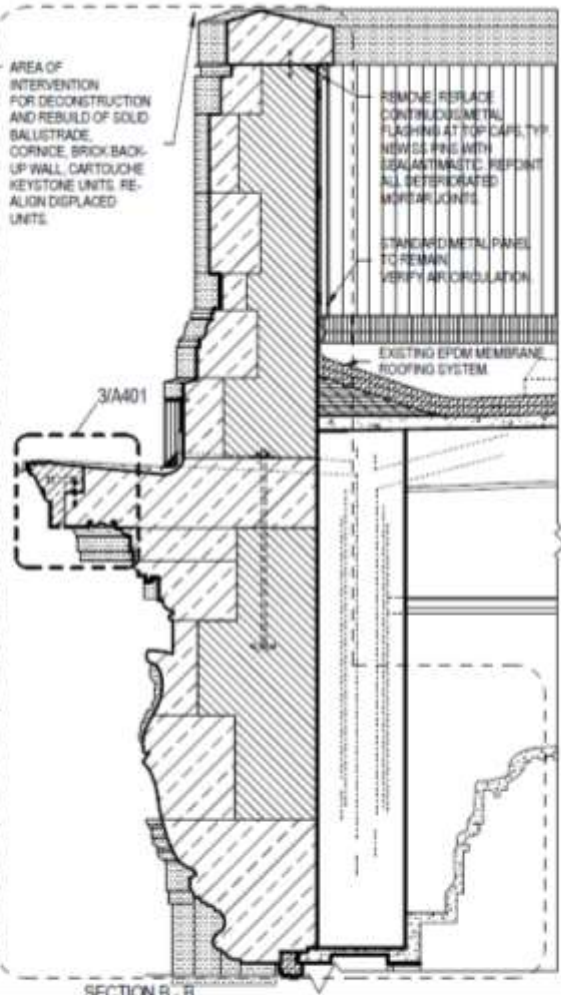
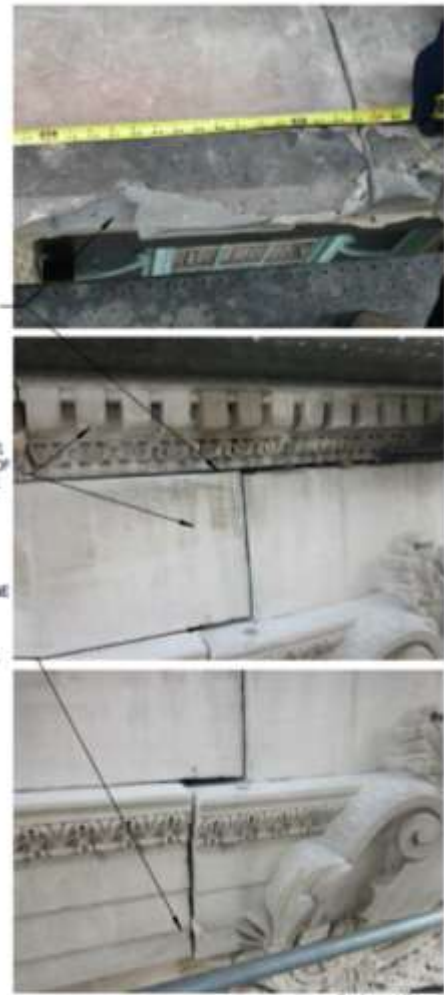
Drawing No.  
A301

The stone cladding of the solid balustrade will be re-pointed. The previously mortar-set cap stones will be pinned and have new, alloy-coated copper flashing. The balustrade brick back-up walls are protected by metal panels installed on hat channels. Air circulation was verified and so the existing metal panels will remain in place. (1/A301)

The re-alignment of the most displaced limestone cartouche will necessitate the complete deconstruction and rebuild of the wall's full-depth including the solid balustrade above. An assessment of the conditions necessitating the displacement will inform the subsequent stabilization of at least four of the remaining six cartouche assemblies. (Total of seven cartouche.) Alternatively, given that the assembly works as a true arch, a repair-in-place is feasible. Approximated life-span is 25 years. The visual displacement would remain. (1/A301)

EXISTING LIMESTONE CORNICE EDGE CONDITION WATER INFILTRATION AT COMMON BRICK BACK-UP WALL

WORST-CASE CONDITION AT ONE OF SEVEN CARTOUCHE LOCATIONS KEYSTONE UNITS SHIFTED DOWN AND OUT OF PLANAR ALIGNMENT.

CARVED LIMESTONE UNITS TO BE CLEANED OF EFFLORESCENCE AND DIRT AND GRIME, TYP.

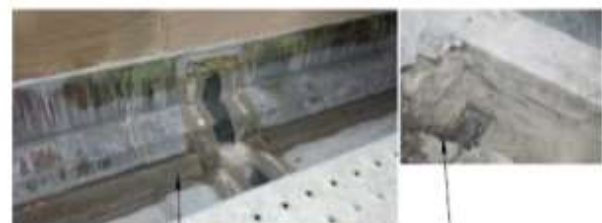
ACCUMULATED SEDIMENT, TYP.  
CONDUCTOR NOTCHED INTO STONE, LOW PITCH

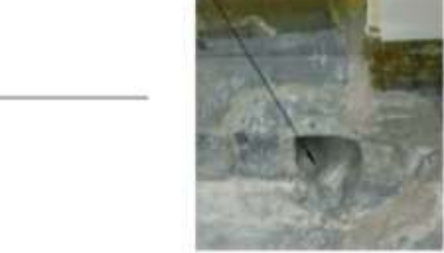
FLASHED-IN OPENING OF DRAINAGE CONDUCTOR. LONG-STANDING WATER FOUND AT ENTIRE PERIMETER.

The existing flashed-in cornice conductor opening will be replaced by sidewall drains to assure efficient drainage. The carved limestone units, below the projecting cornice, will be cleaned of all efflorescence and accumulated dirt and grime. (2/A401)

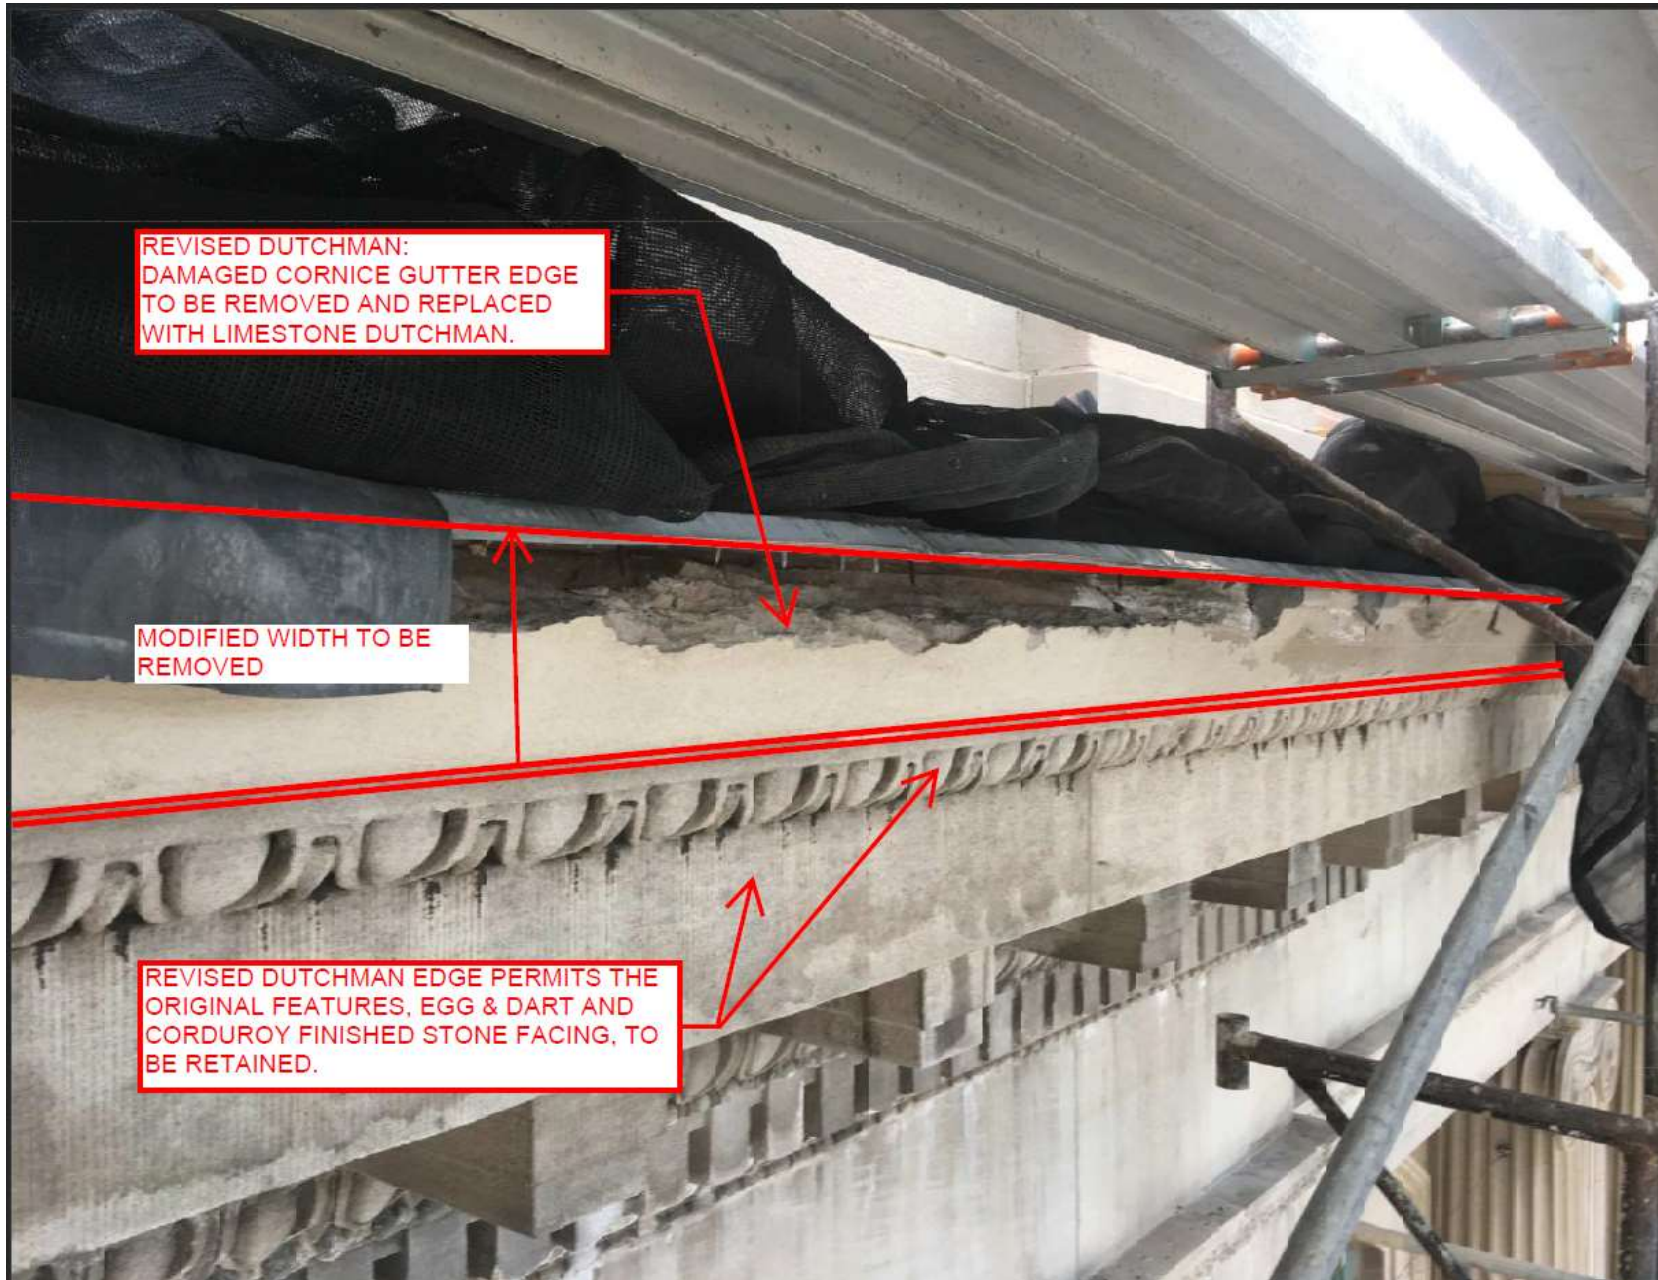
REVISED DUTCHMAN:  
DAMAGED CORNICE GUTTER EDGE  
TO BE REMOVED AND REPLACED  
WITH LIMESTONE DUTCHMAN.

MODIFIED WIDTH TO BE  
REMOVED

REVISED DUTCHMAN EDGE PERMITS THE  
ORIGINAL FEATURES, EGG & DART AND  
CORDUROY FINISHED STONE FACING, TO  
BE RETAINED.
