Certificate of Appropriateness

Milwaukee Historic Preservation Commission/841 N Broadway/Milwaukee, WI 53202/phone 414-286-5712

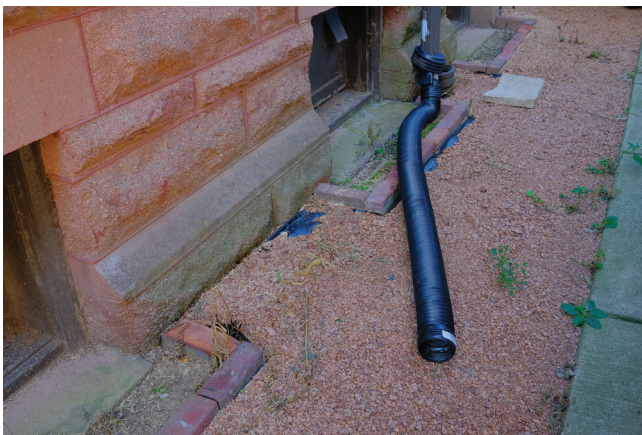
IMAGE 6: Recessed window wells on the north elevation. Downspout-extension outlets too close to the foundation, exacerbating moisture accumulation and algae growth.

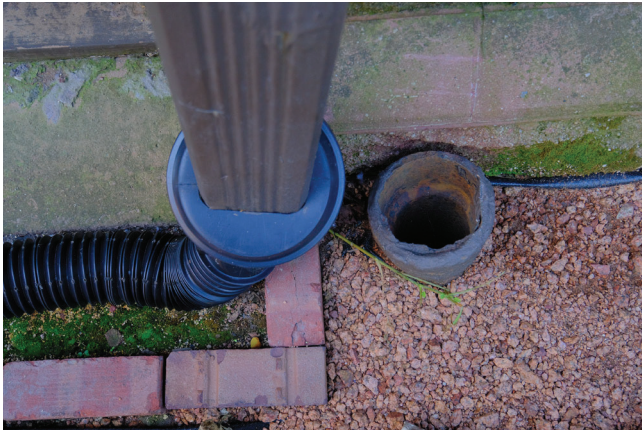
IMAGE 7: Algae growth at the base of the north elevation near downspout.

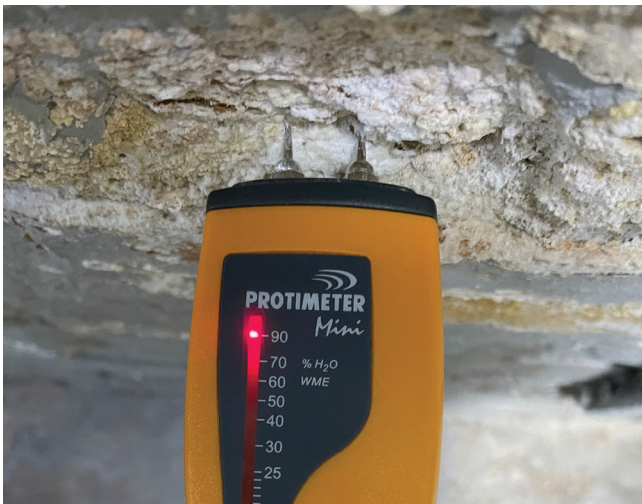
IMAGE 8: High moisture-meter readings along the perimeter walls in the basement.

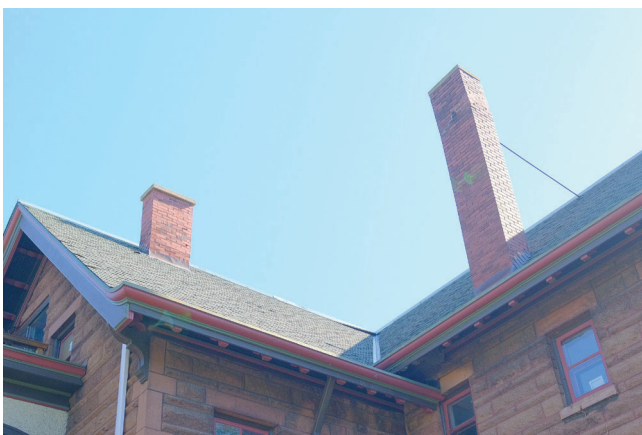
IMAGE 9: North and south chimneys with tie rod anchoring the south chimney.

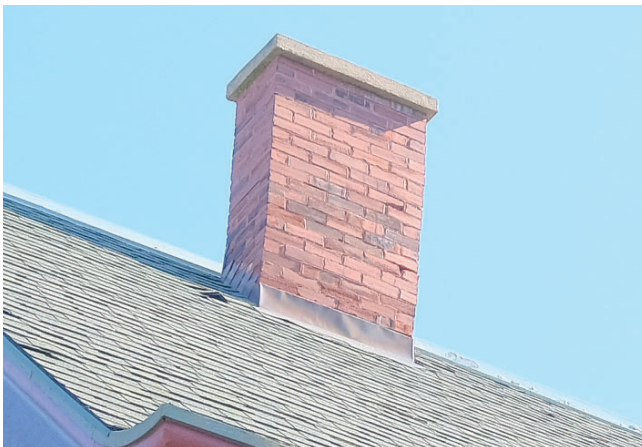
IMAGE 11: Deterioration of the brick and mortar joints on the north chimney is visible from the ground.

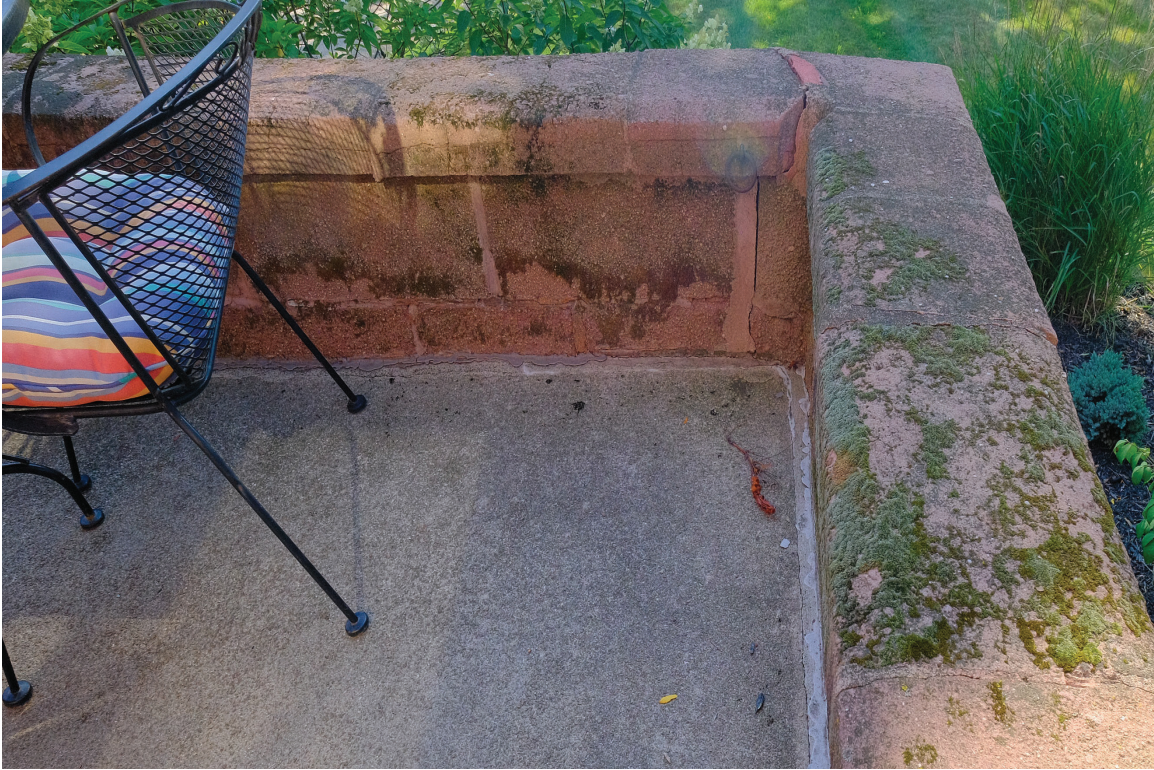
IMAGE 13: Algae has begun to grow on some porch surfaces. Note the evidence of shifting cast stone units and cracking in floor slab. Previous repairs are also evident.

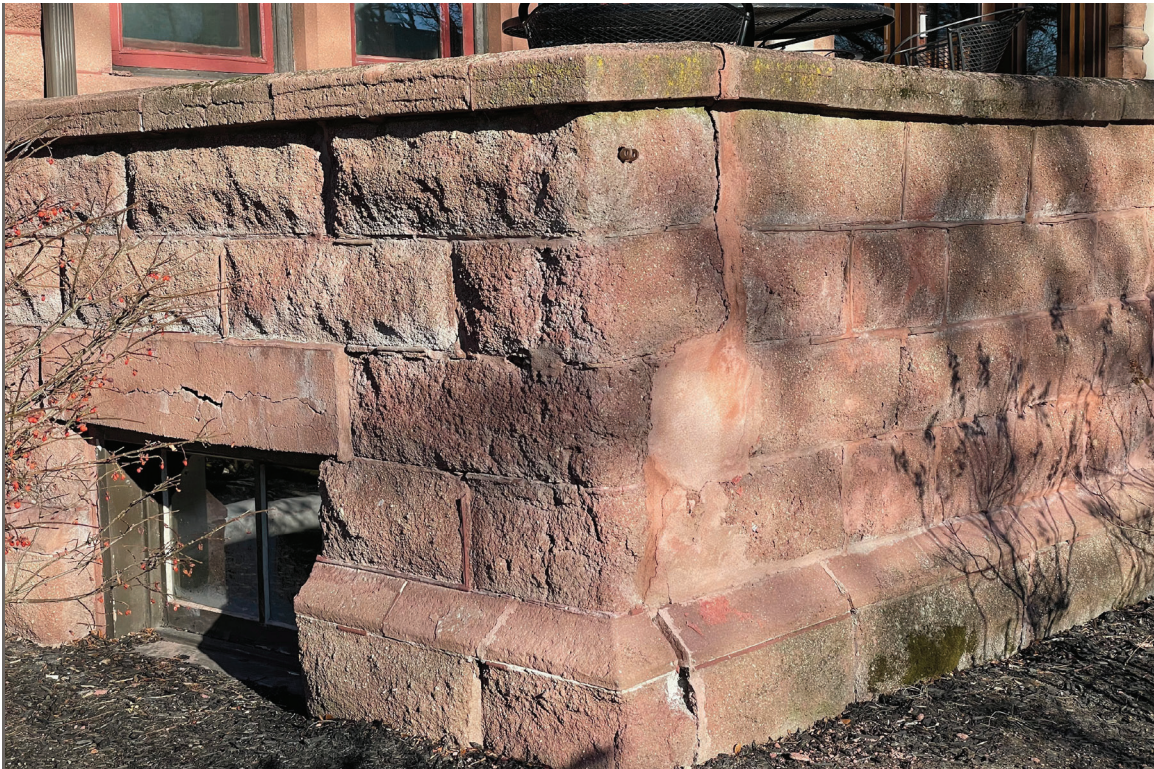
IMAGE 14: Some cast-stone units and open mortar joints have been replaced and attempts at repairs have been made. Shifting and algae growth are visible.

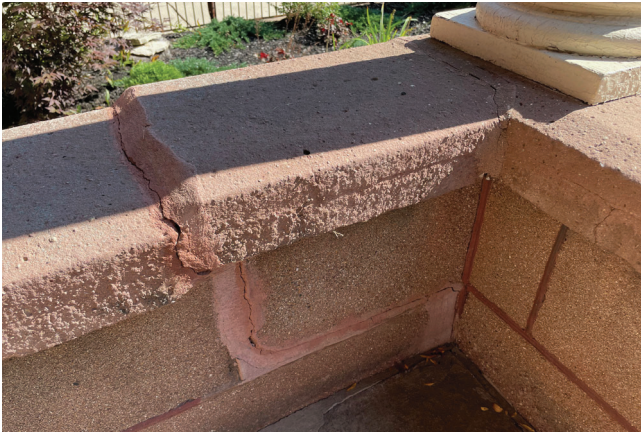
IMAGE 15: Cast-stone units have shifted significantly over time. Note the evidence of previous repairs.

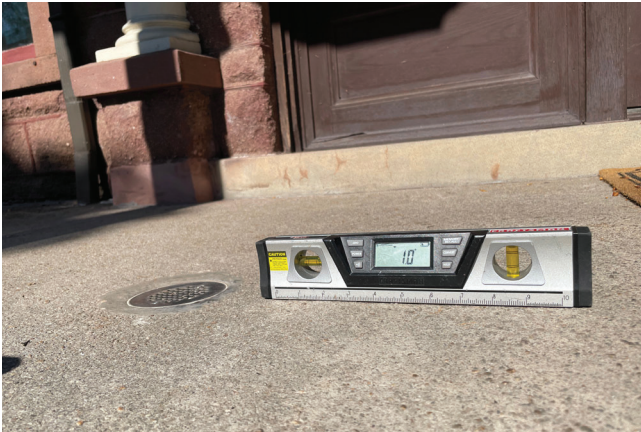
IMAGE 16: Concrete-porch floor slopes away from drain.

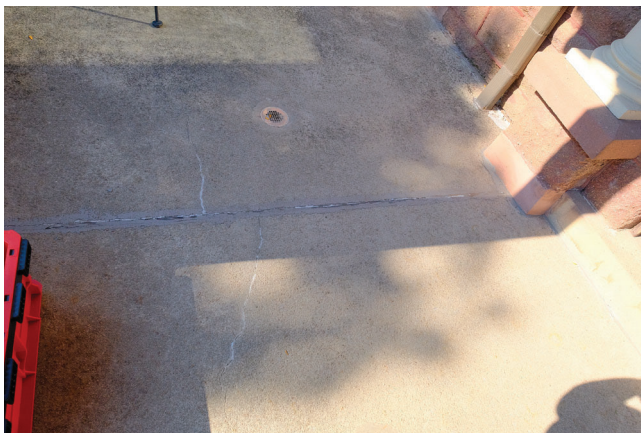
IMAGE 17: Cracking in the concrete-porch slab.

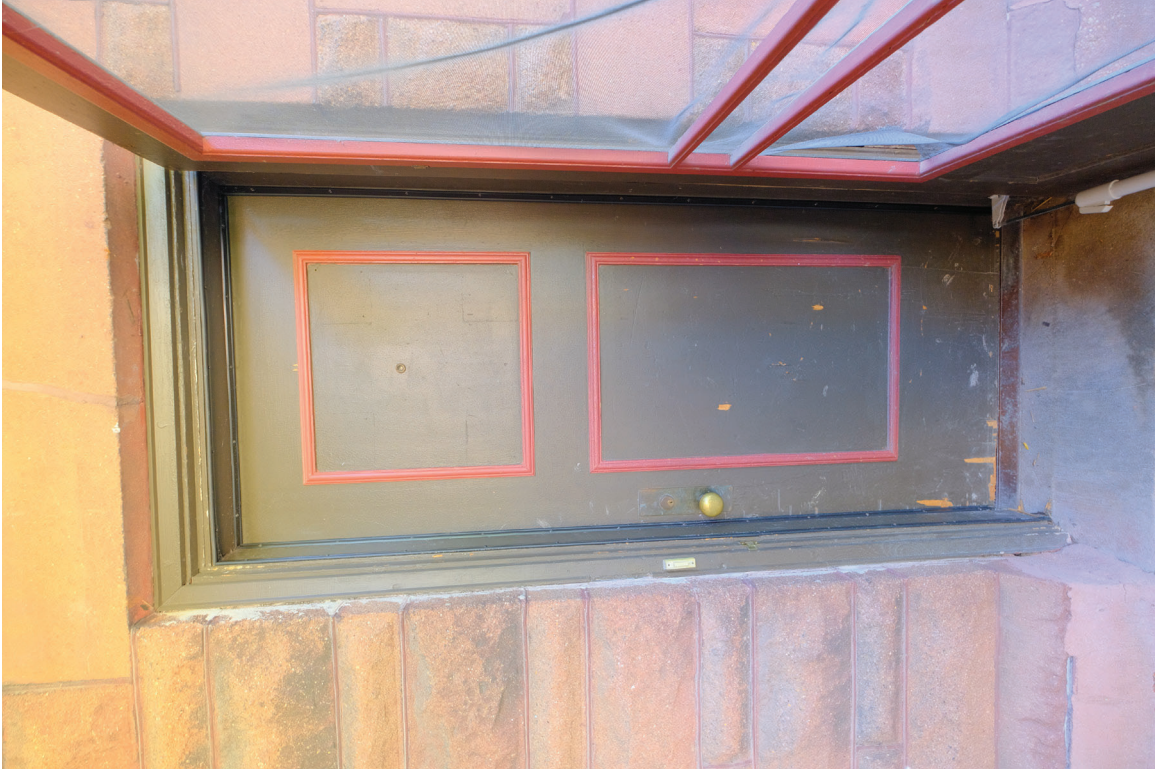
IMAGE 20: West entry door is in poor condition.

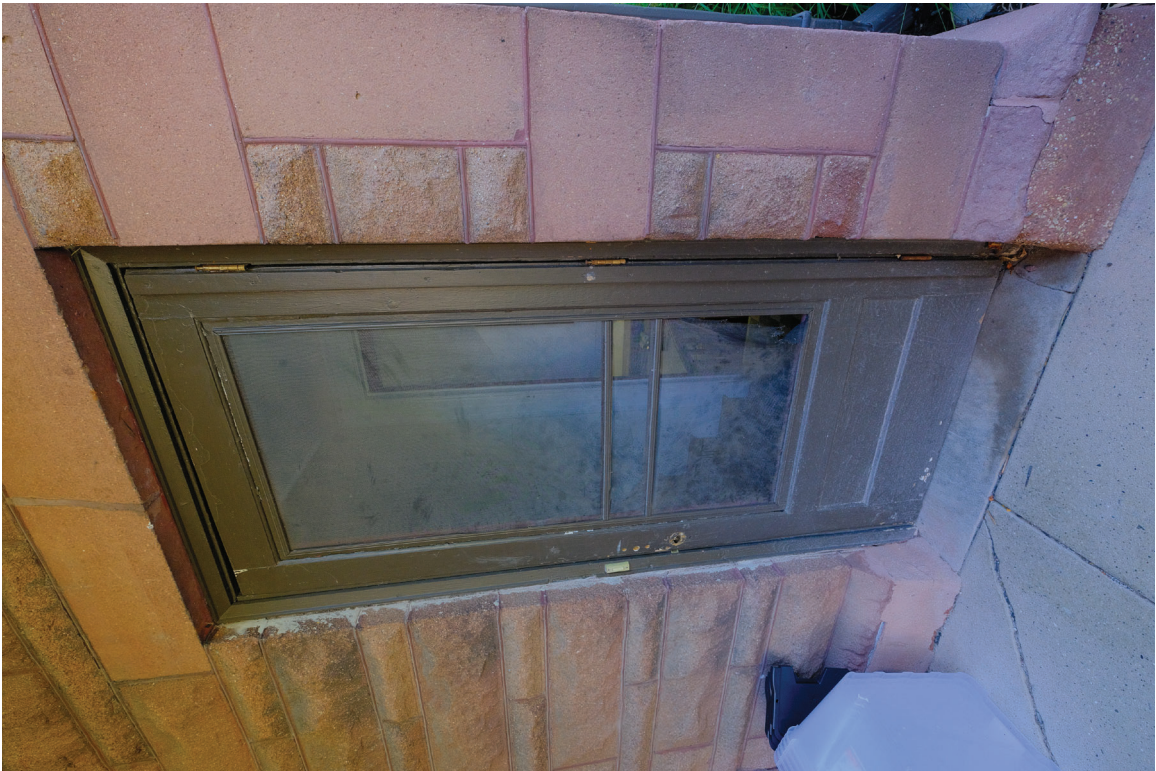
IMAGE 21: Screen door at west entry.

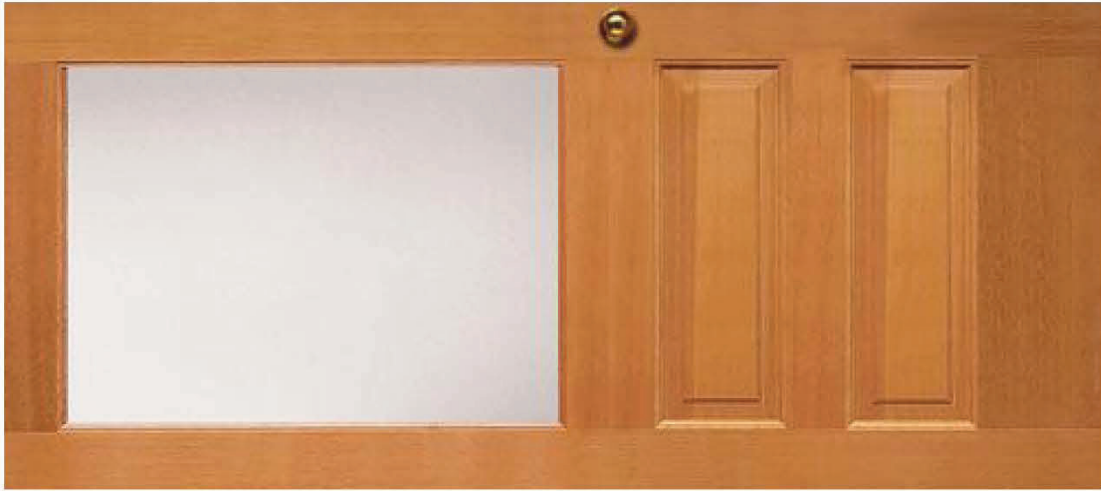
IMAGE 22: Replacement for west entry door.

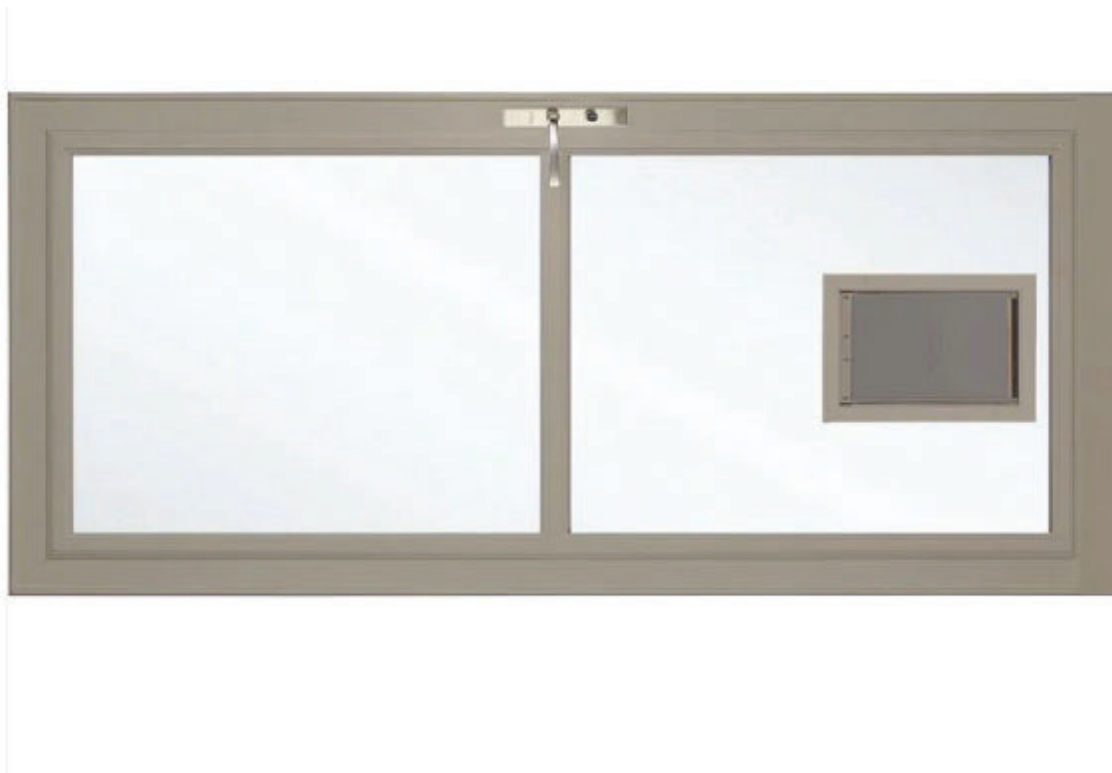
IMAGE 23: Replacement for west entry screen door.
