1 CAMPUS SITE PLAN
SCALE: N.T.S.

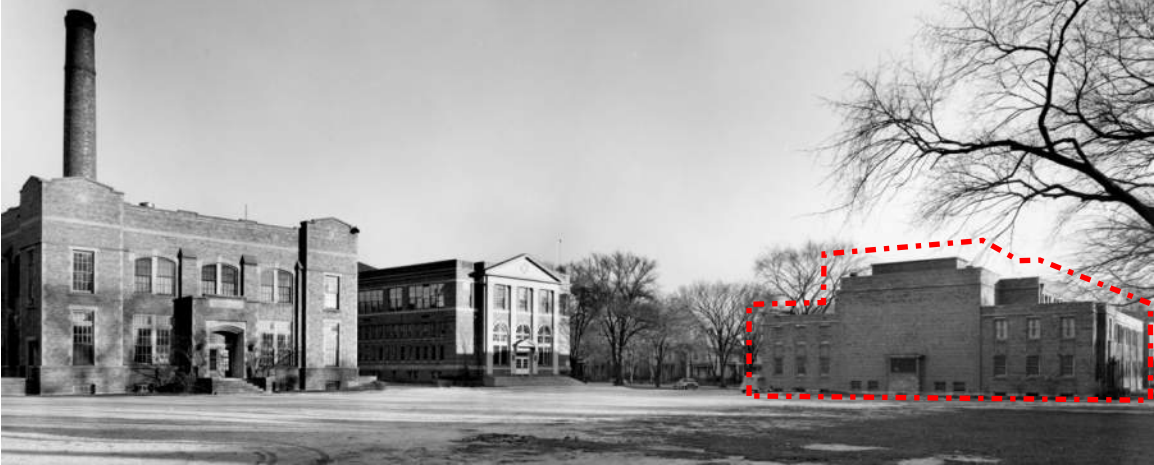
Photo 1 - Gymnasium Building prior to Pool Addition

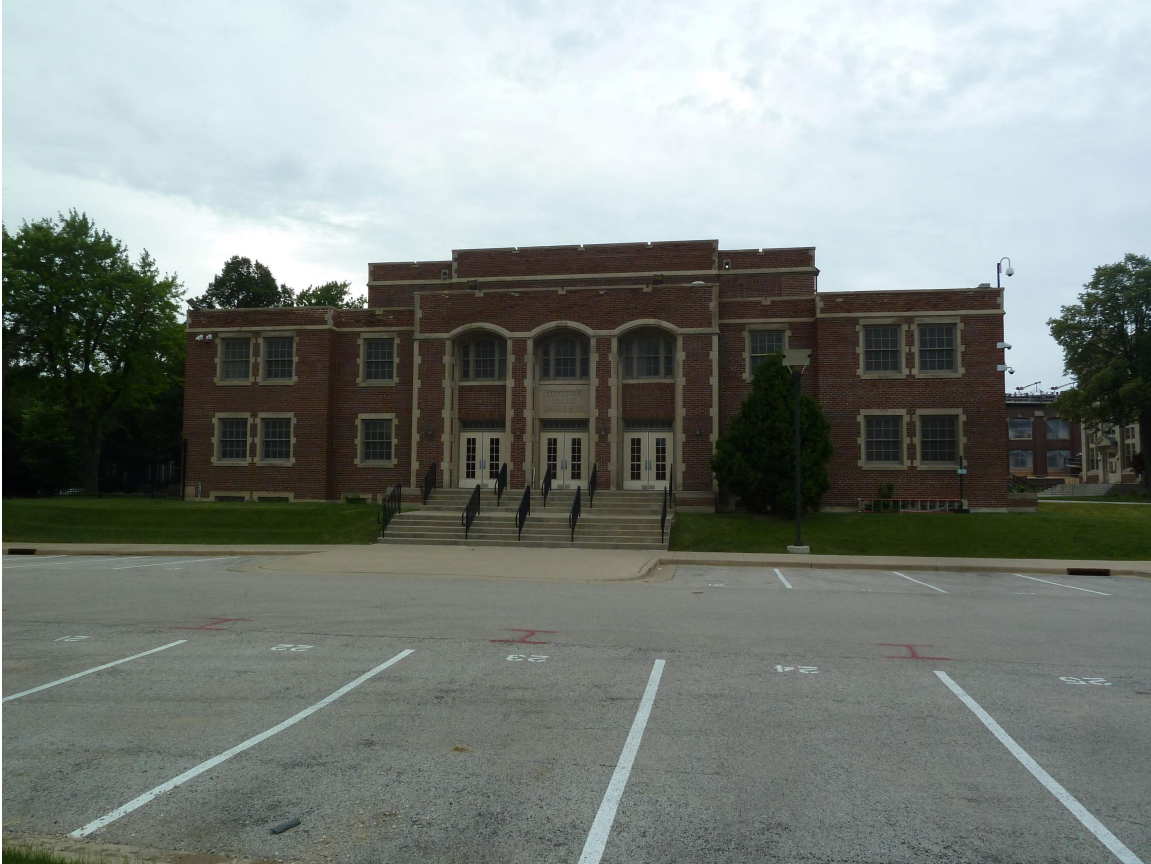
Photo 2 - South Overall at Gymnasium

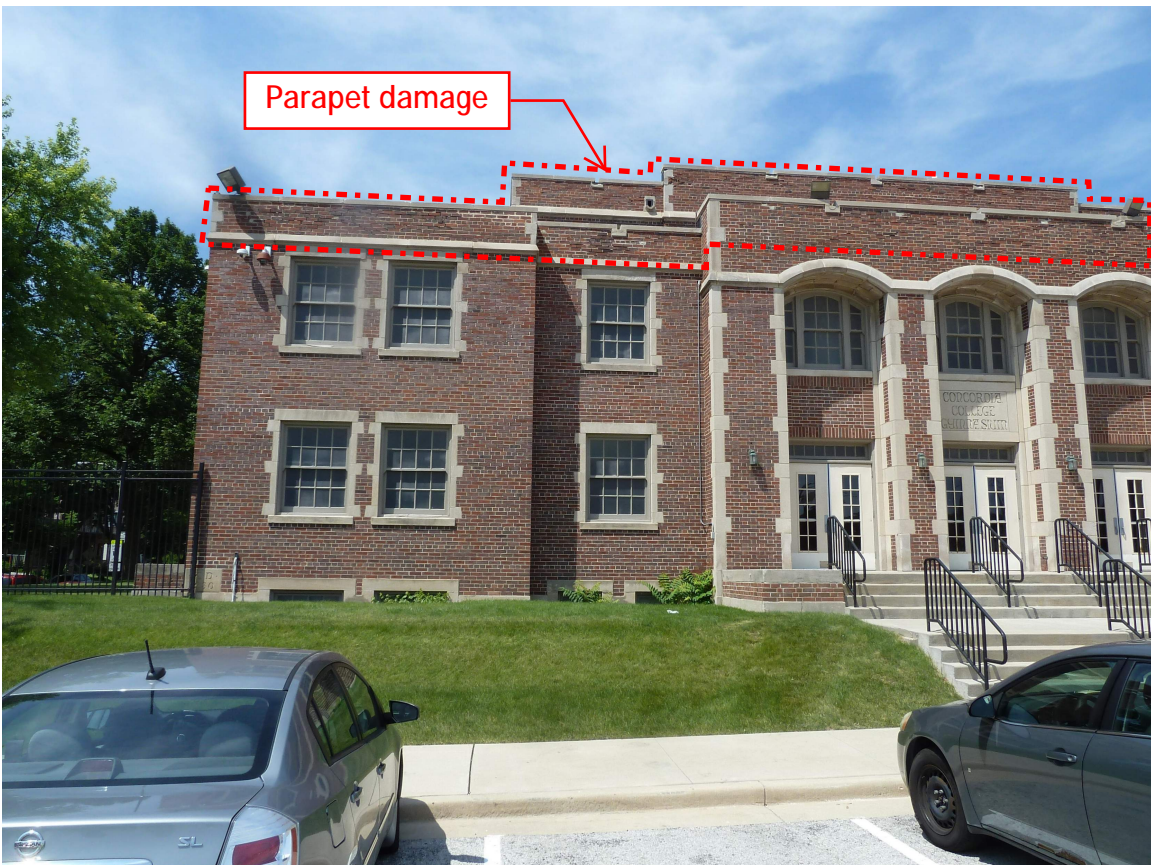
Photo 3 - South (western portion) at Gymnasium

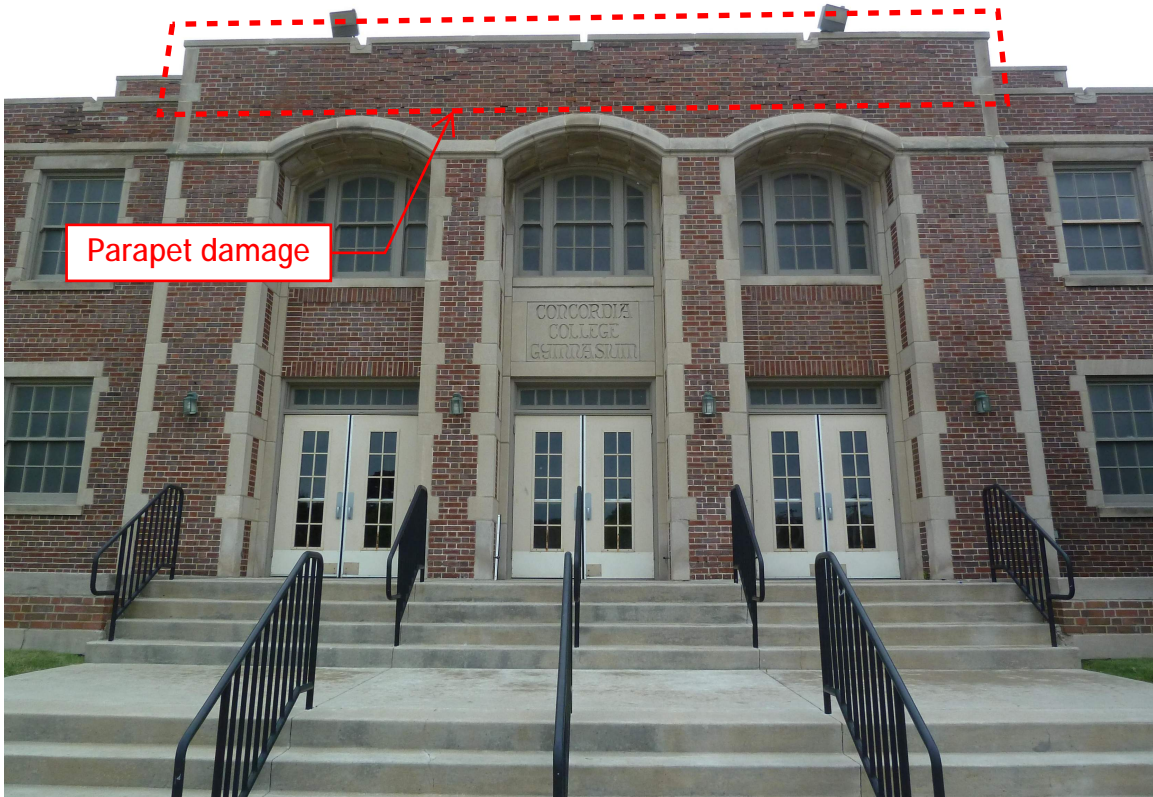
Photo 4 - South (central portion) at Gymnasium

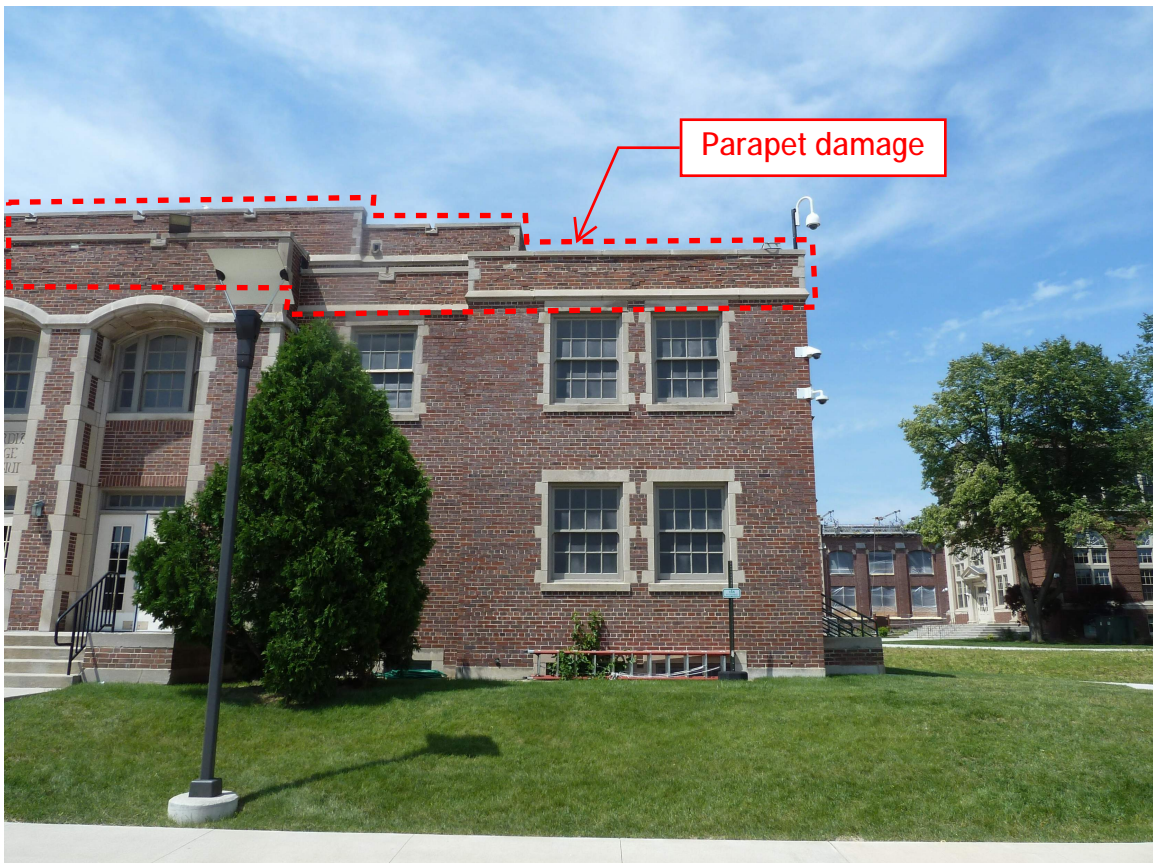
Photo 5 - South (eastern portion) at Gymnasium

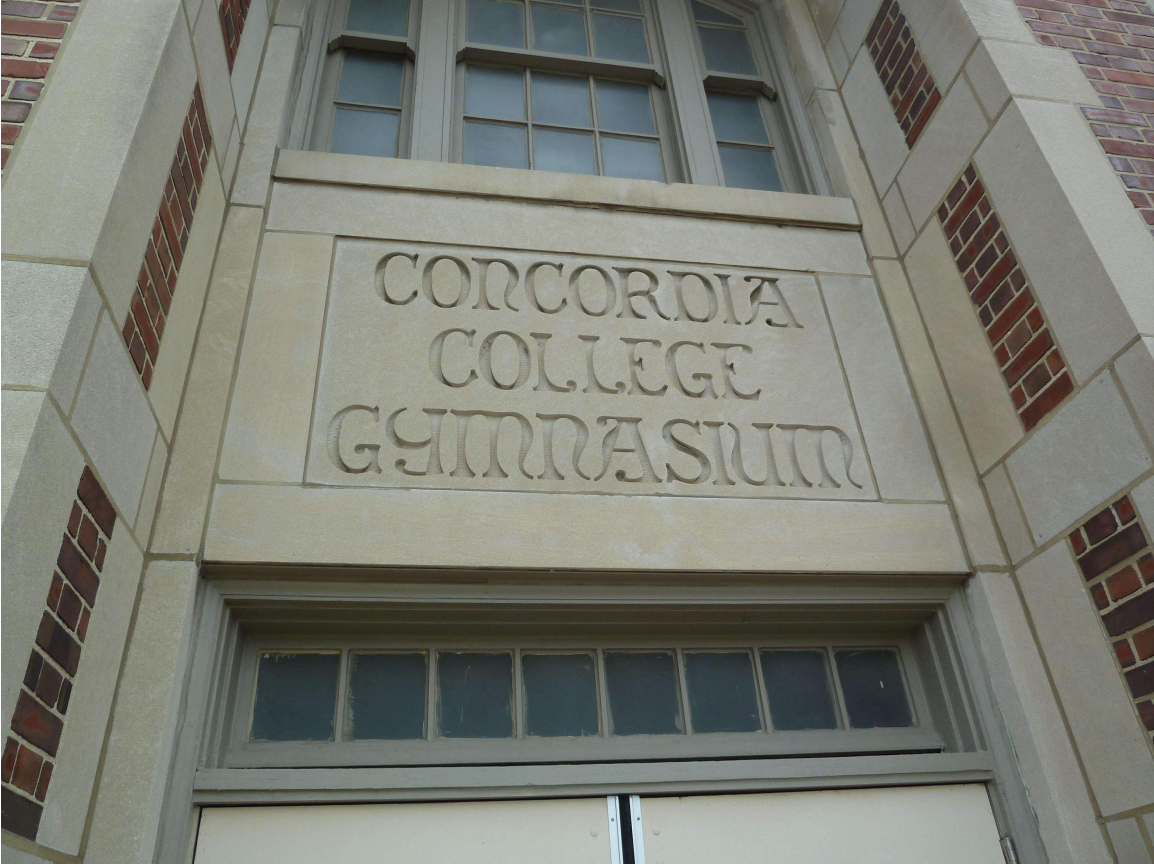
Photo 6 - South Entry Plaque at Gymnasium

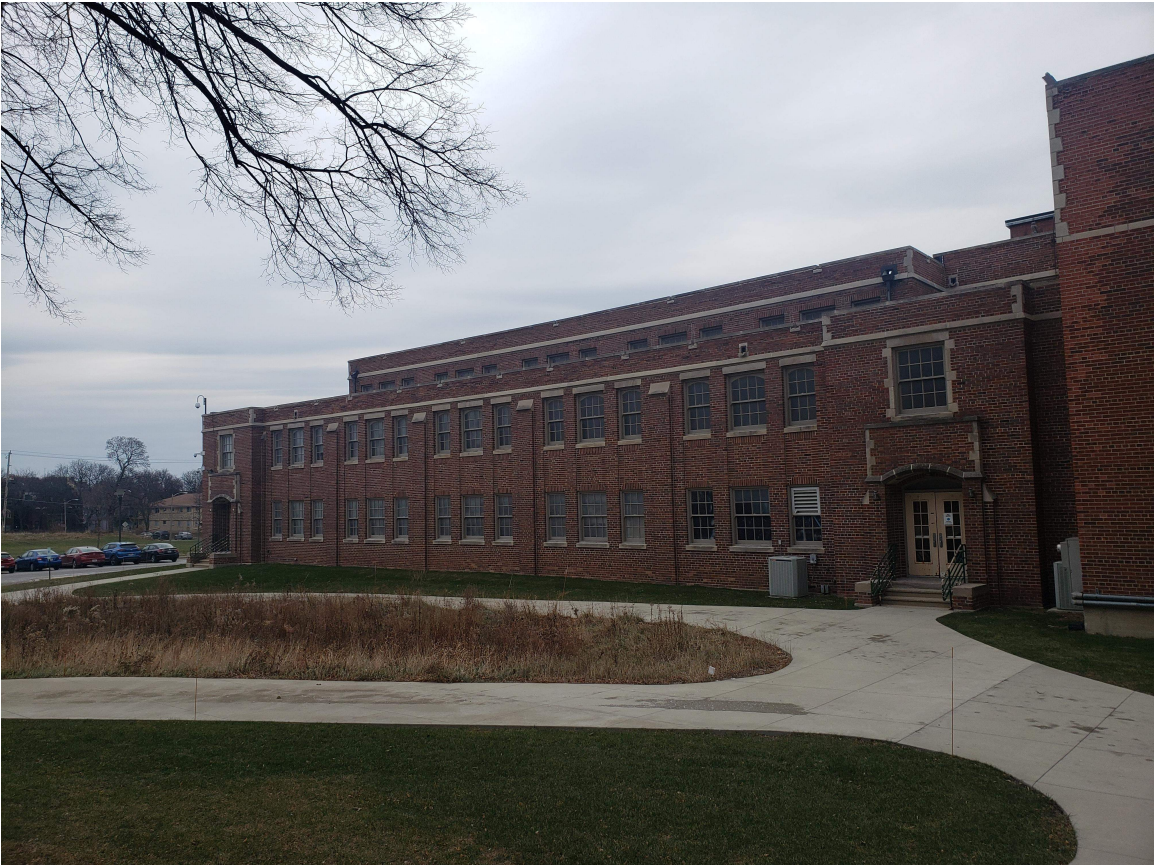
Photo 7 - East Overall at Gymnasium

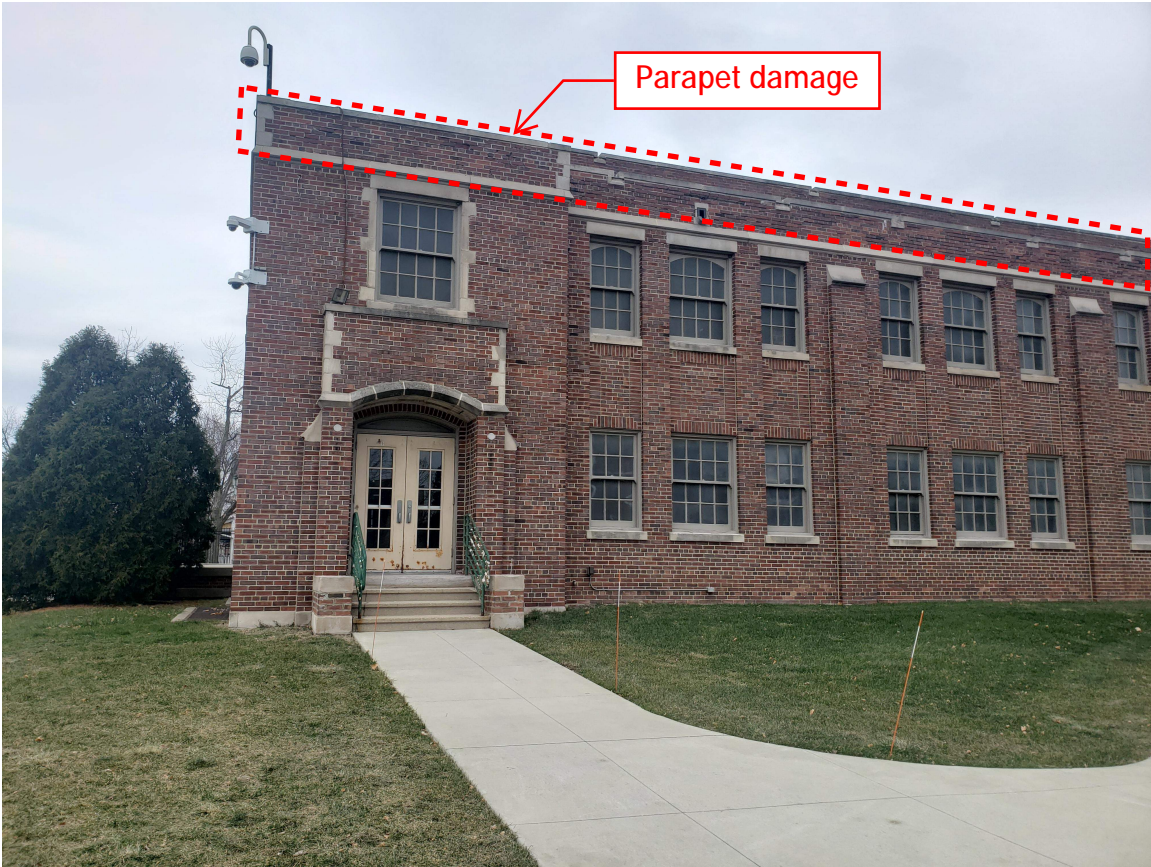
Photo 8 - East (southern portion) at Gymnasium

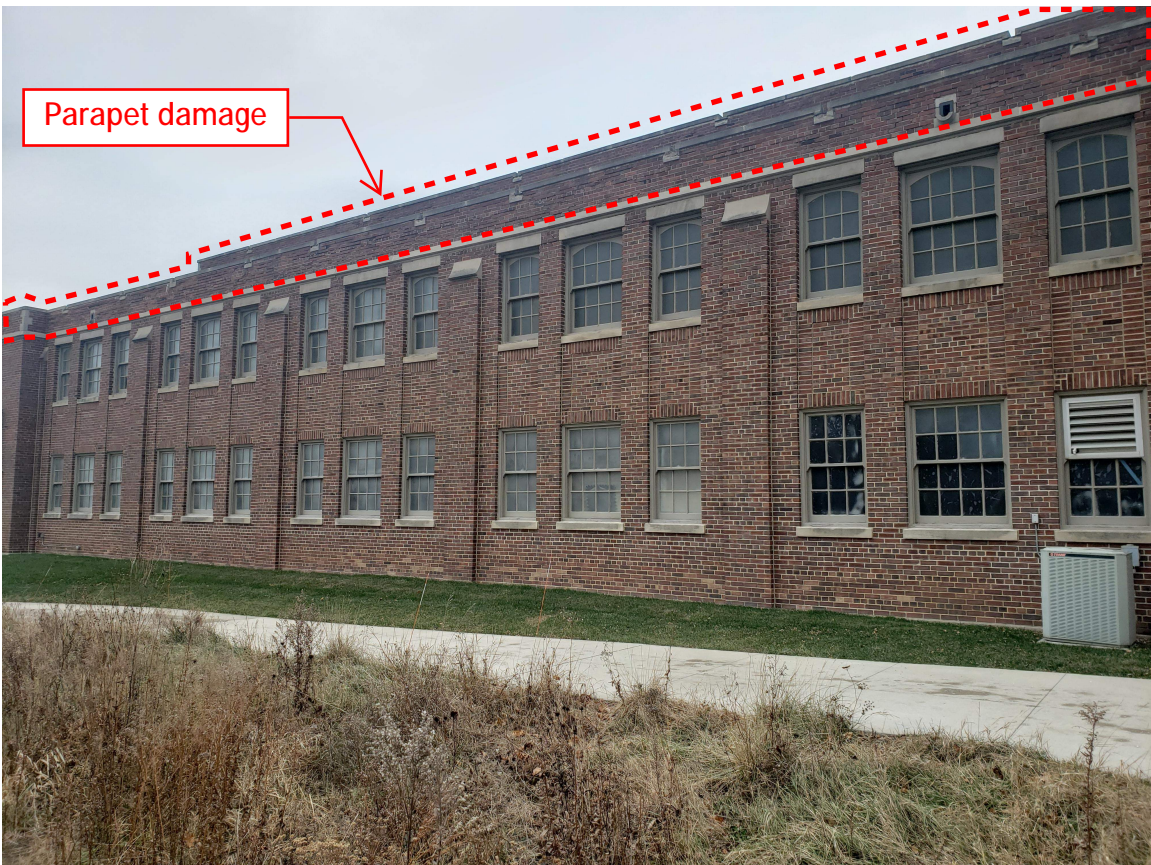
Photo 9 - East (central portion) at Gymnasium

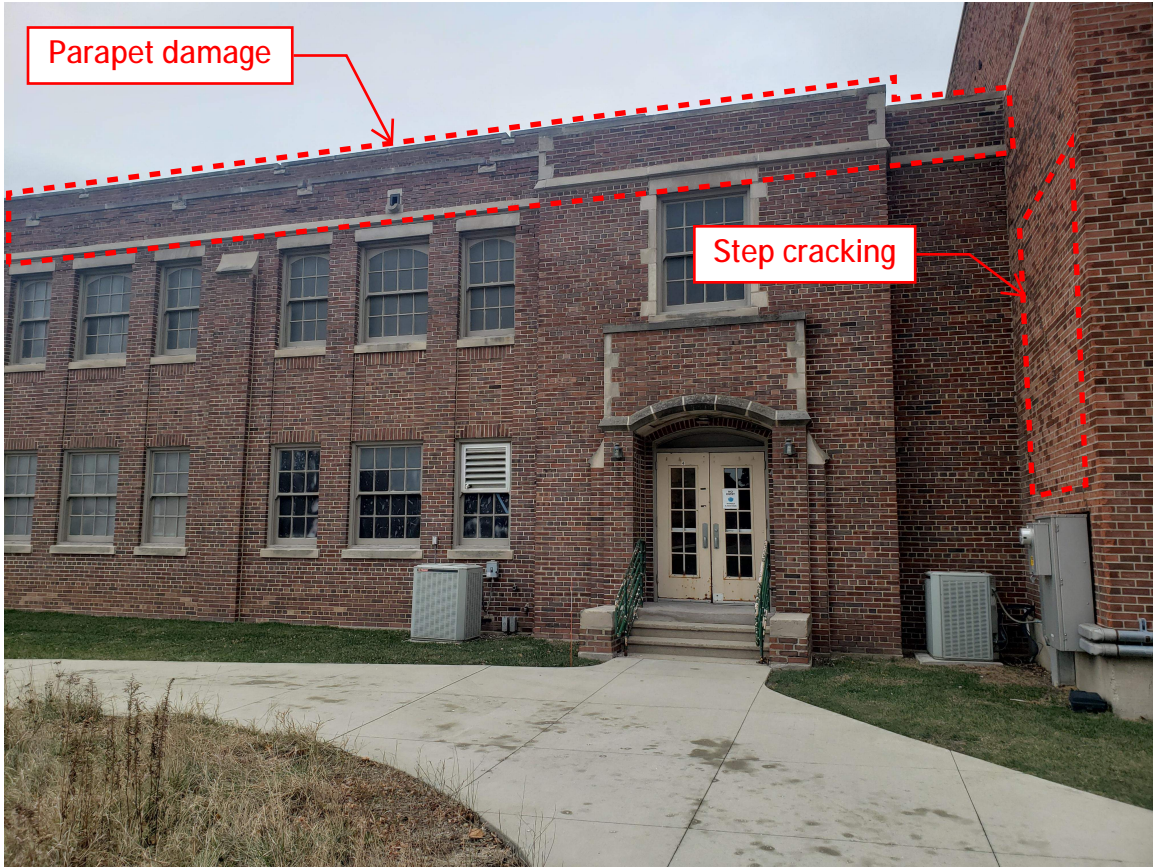
Photo 10 - East (northern portion) at Gymnasium

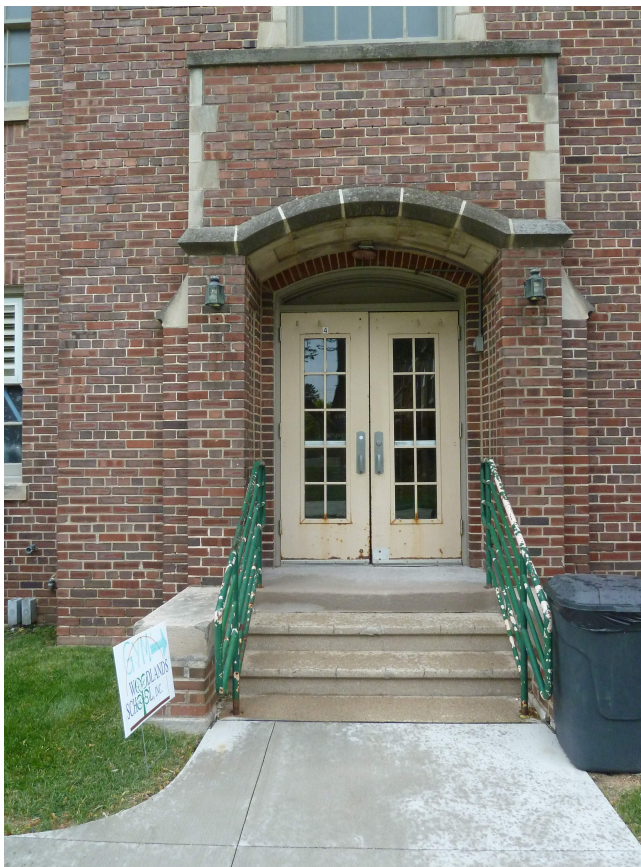
Photo 11 - East Entry (northern portion) at Gymnasium

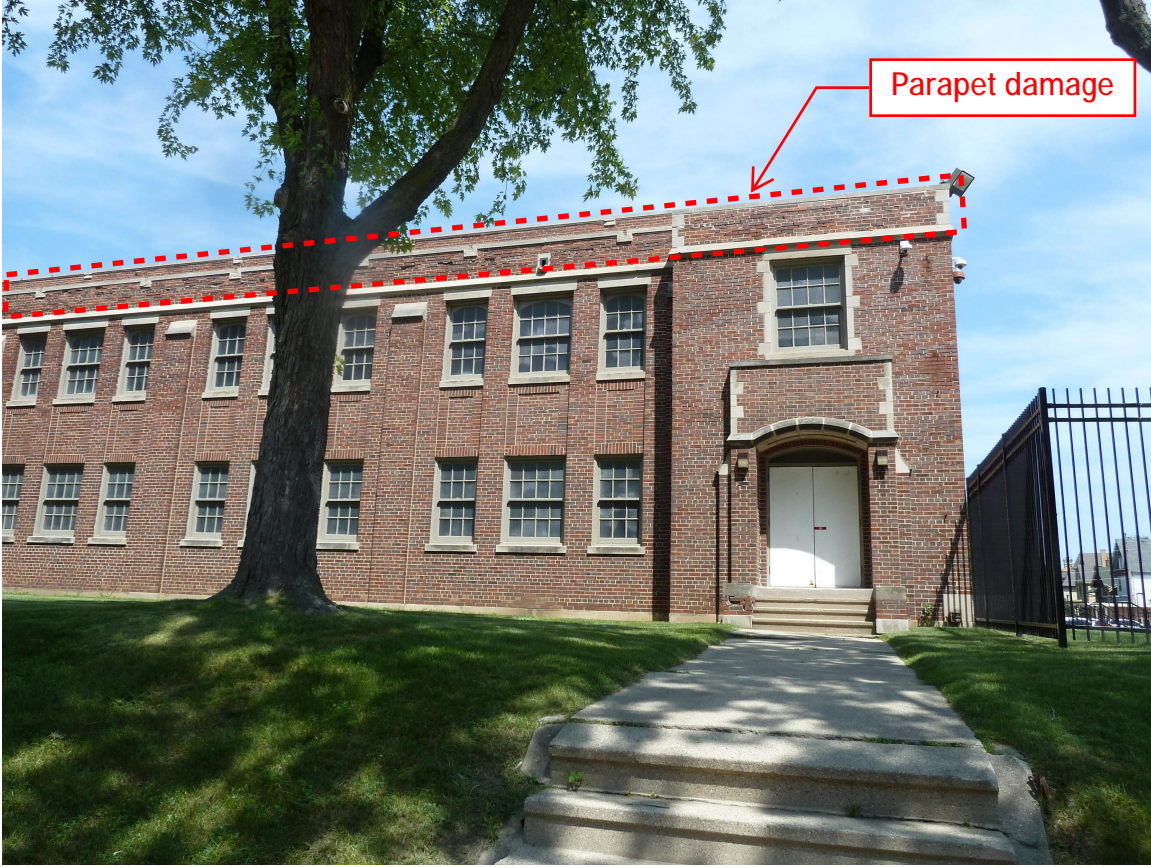
Photo 12 - West (southern portion) at Gymnasium

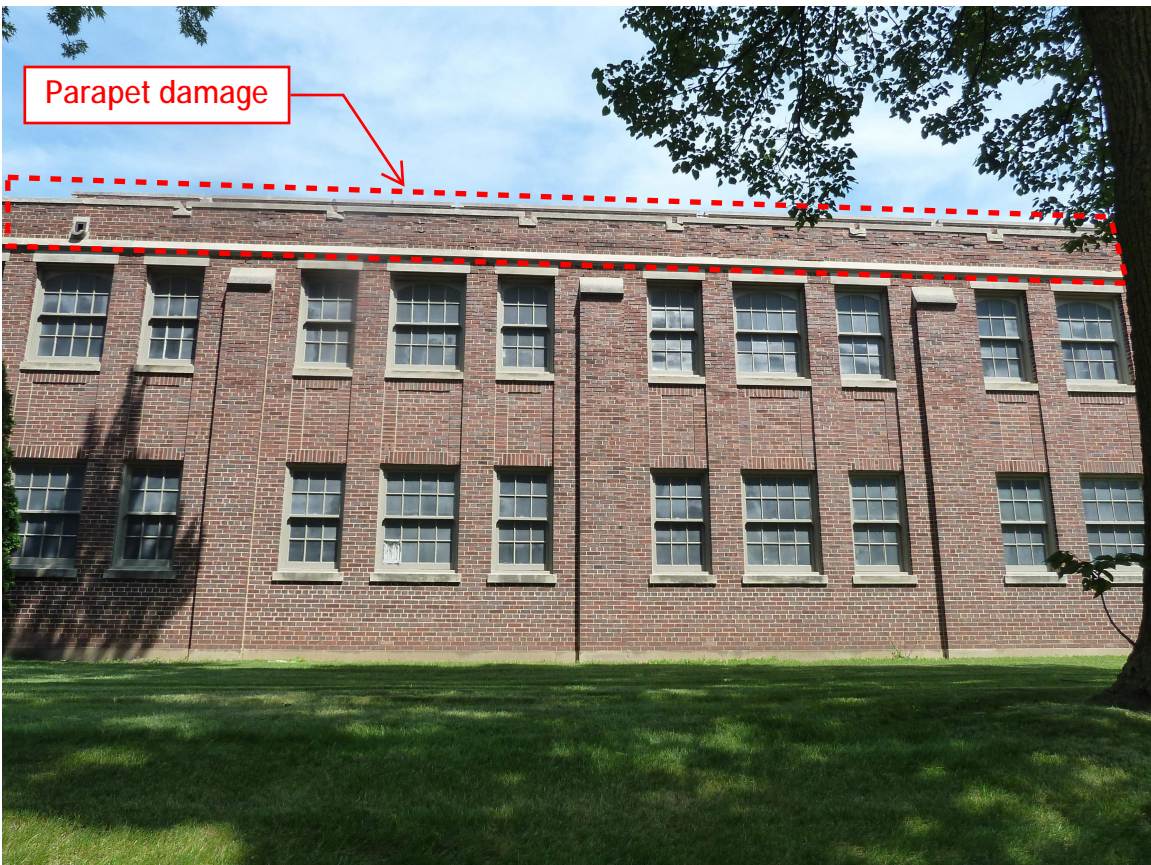
Photo 13 - West (central portion) at Gymnasium

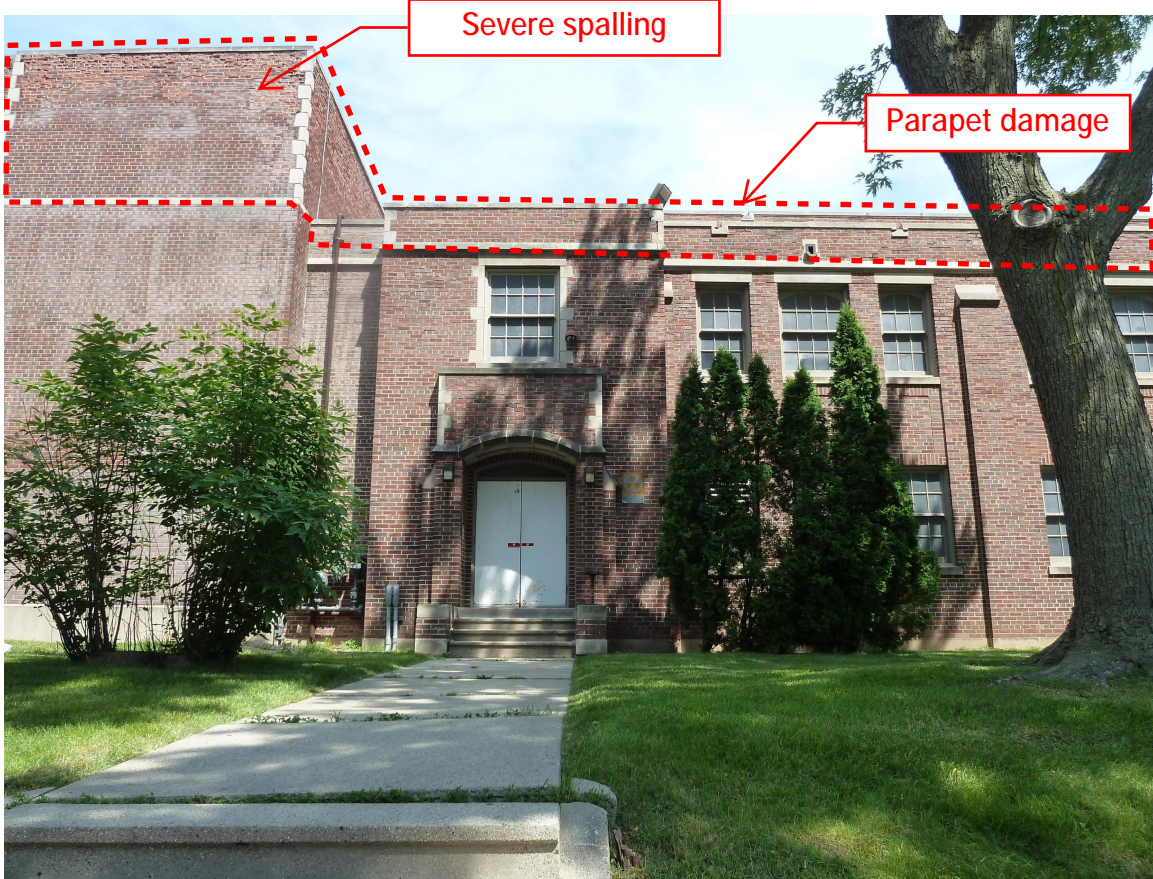
Photo 14 - West (northern portion) at Gymnasium

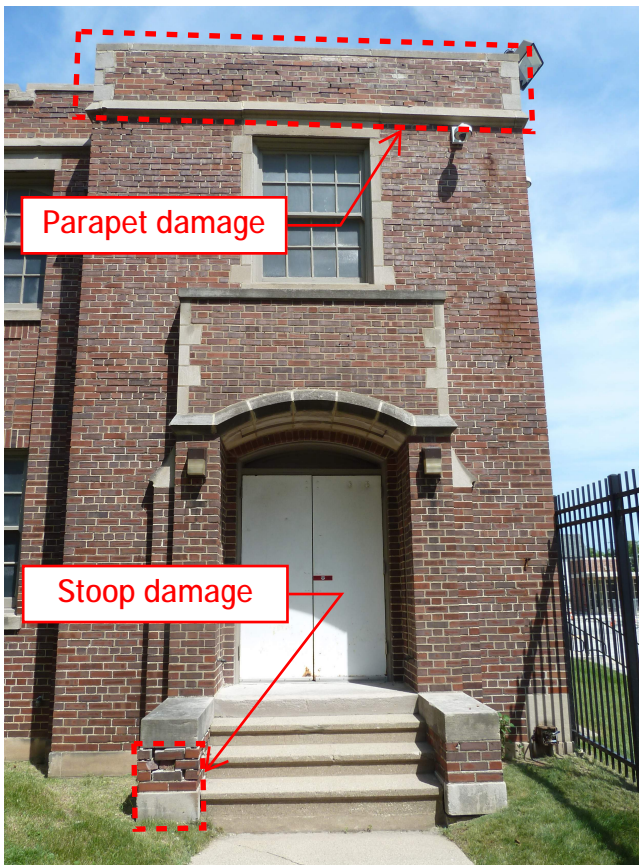
Photo 15 - West Entry (southern portion) at Gymnasium

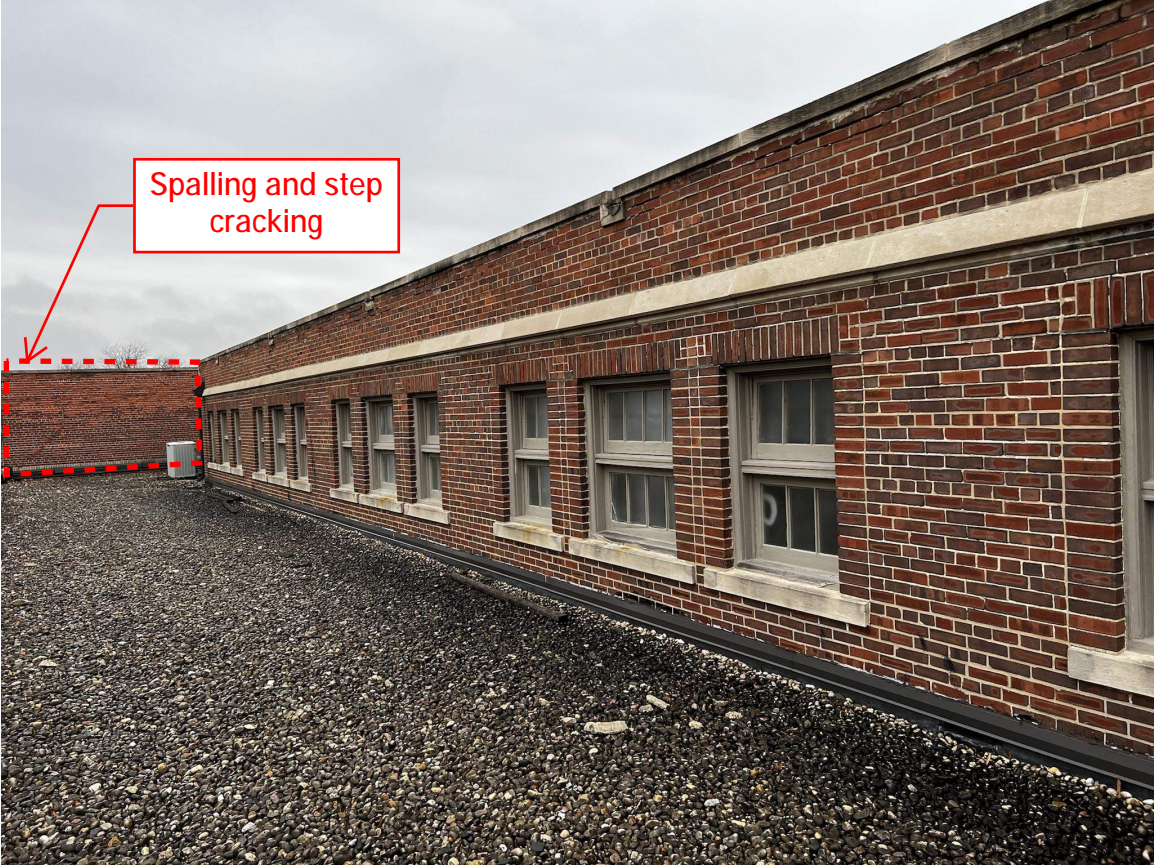
Photo 16 - Upper Windows at Gymnasium

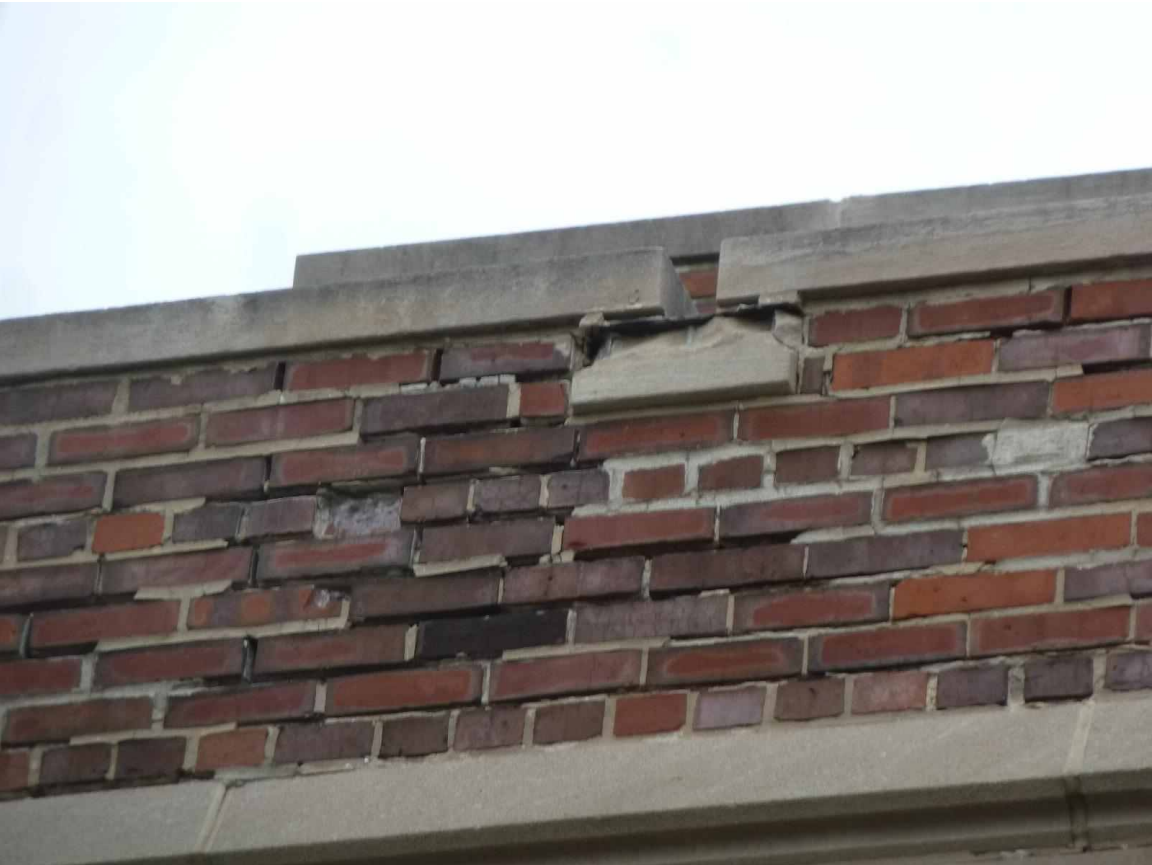
Photo 17 - South parapet damage at Gymnasium

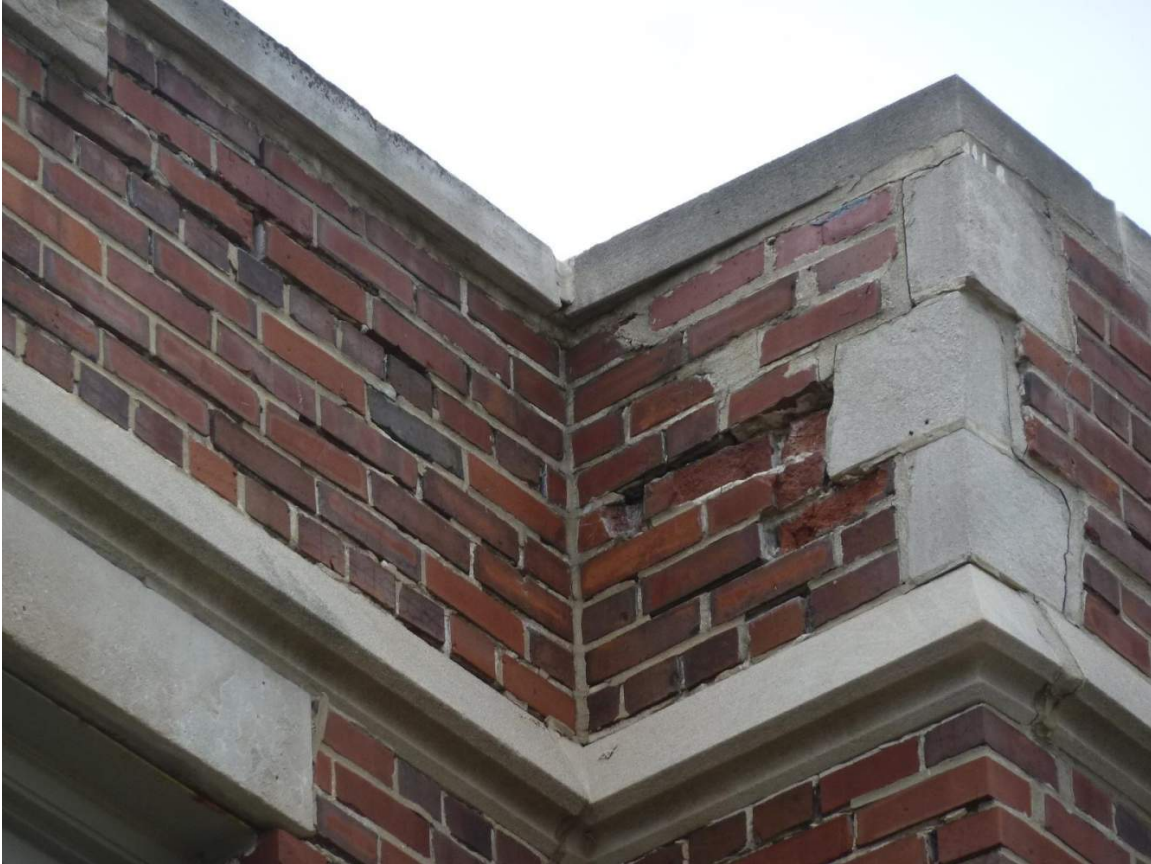
Photo 18 - East parapet damage at Gymnasium

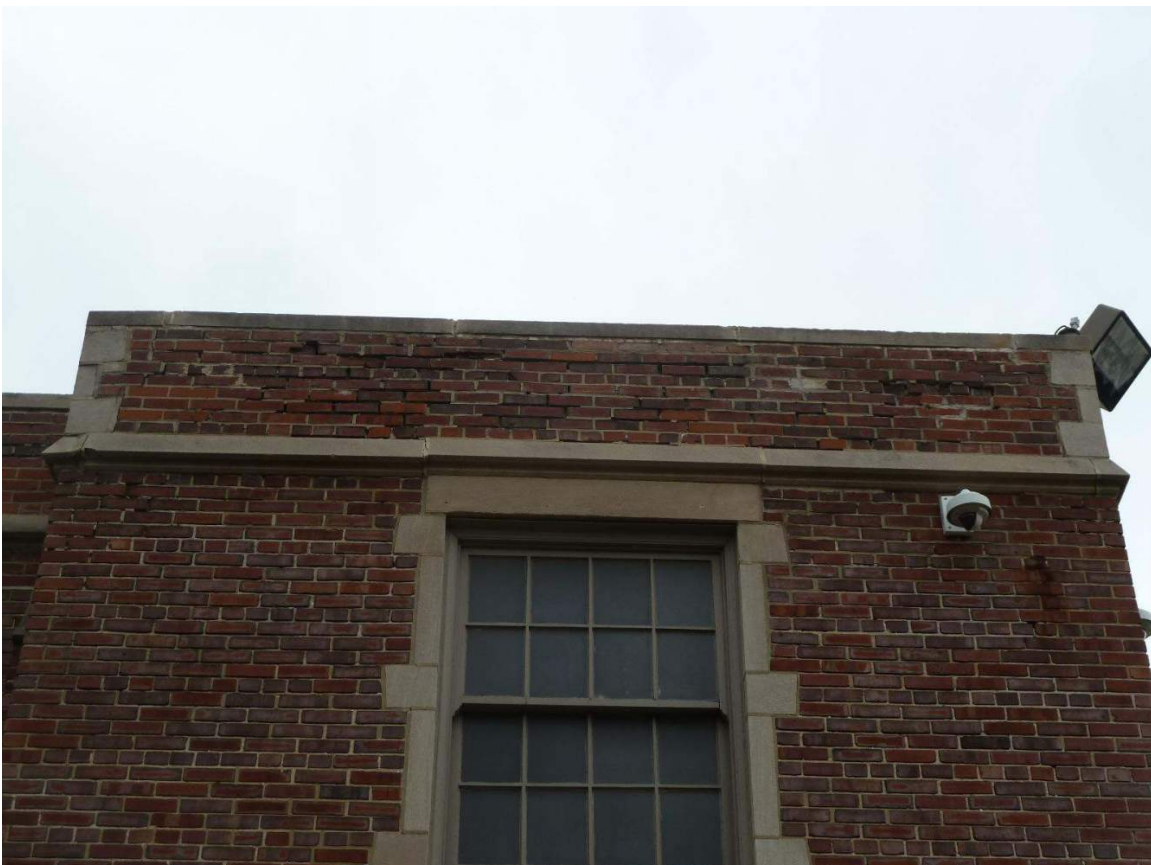
Photo 19 - West parapet damage at Gymnasium

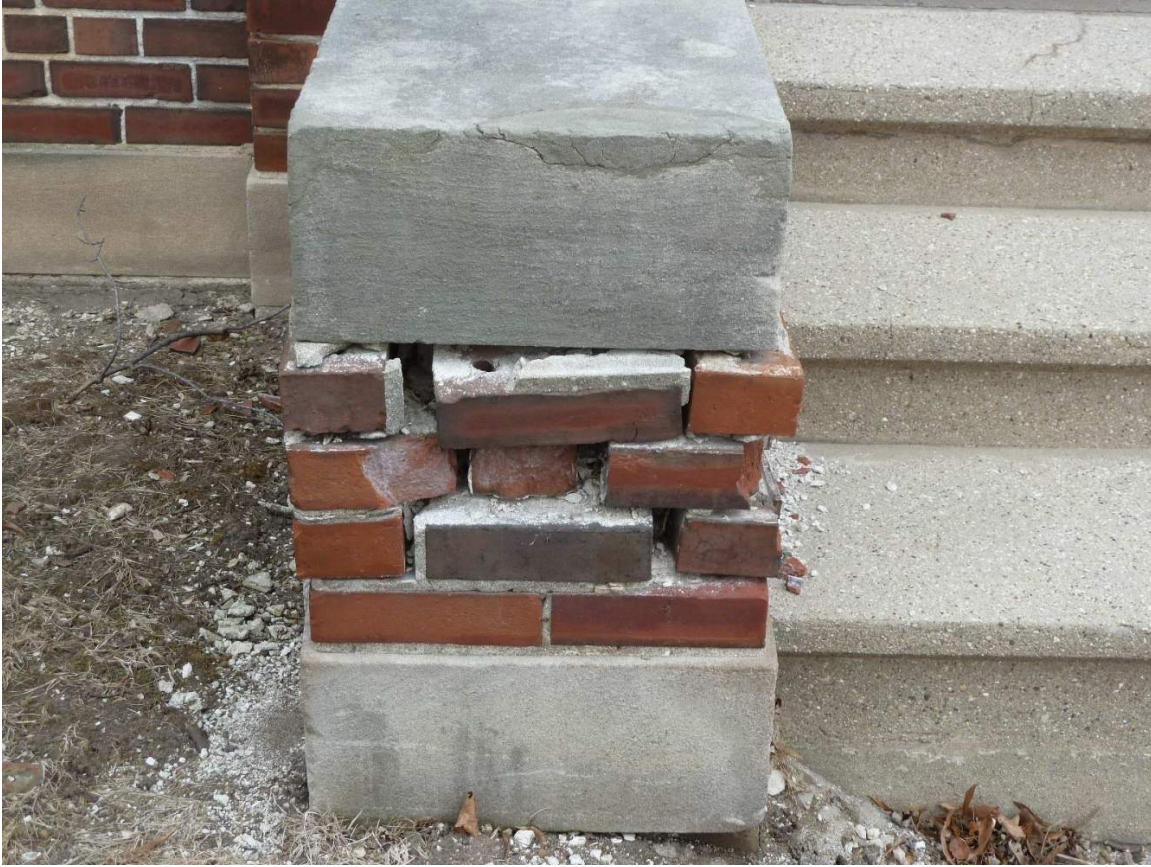
Photo 20 - West entry damage at Gymnasium

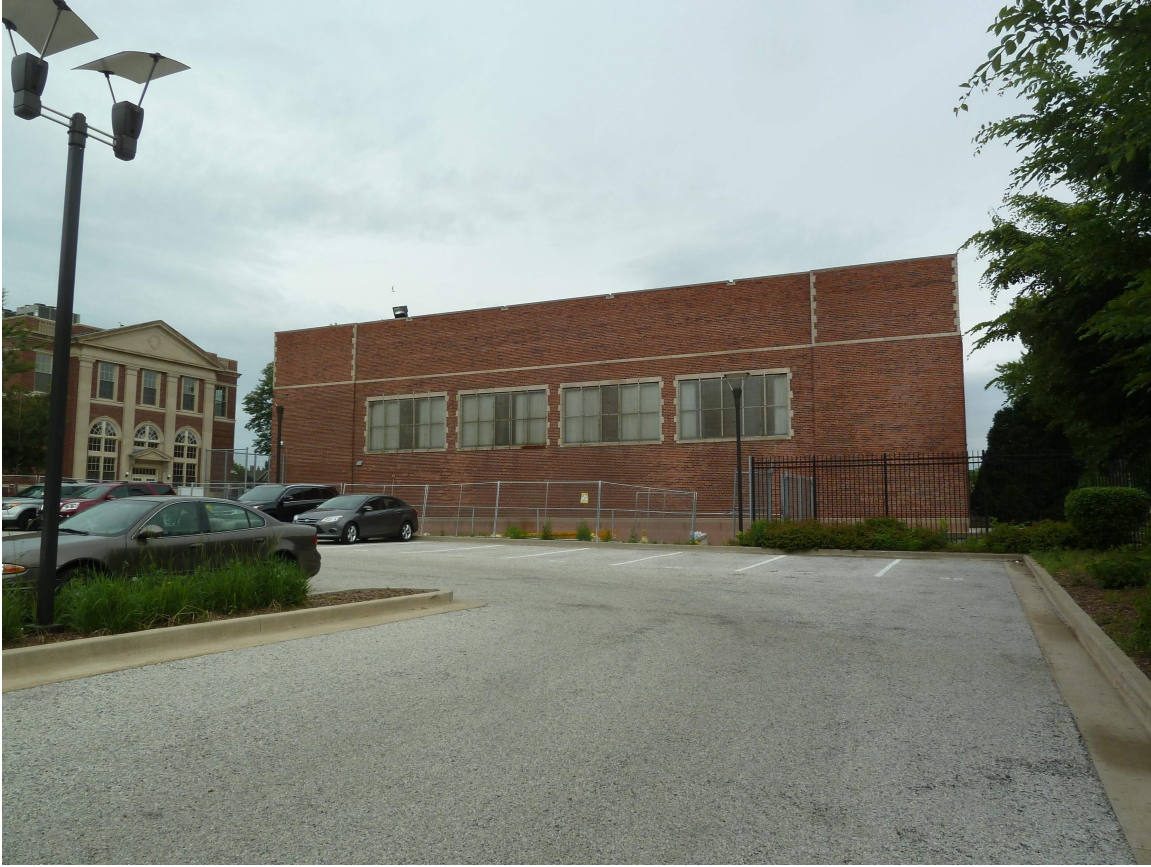
Photo 21 - North Overall at Pool Addition

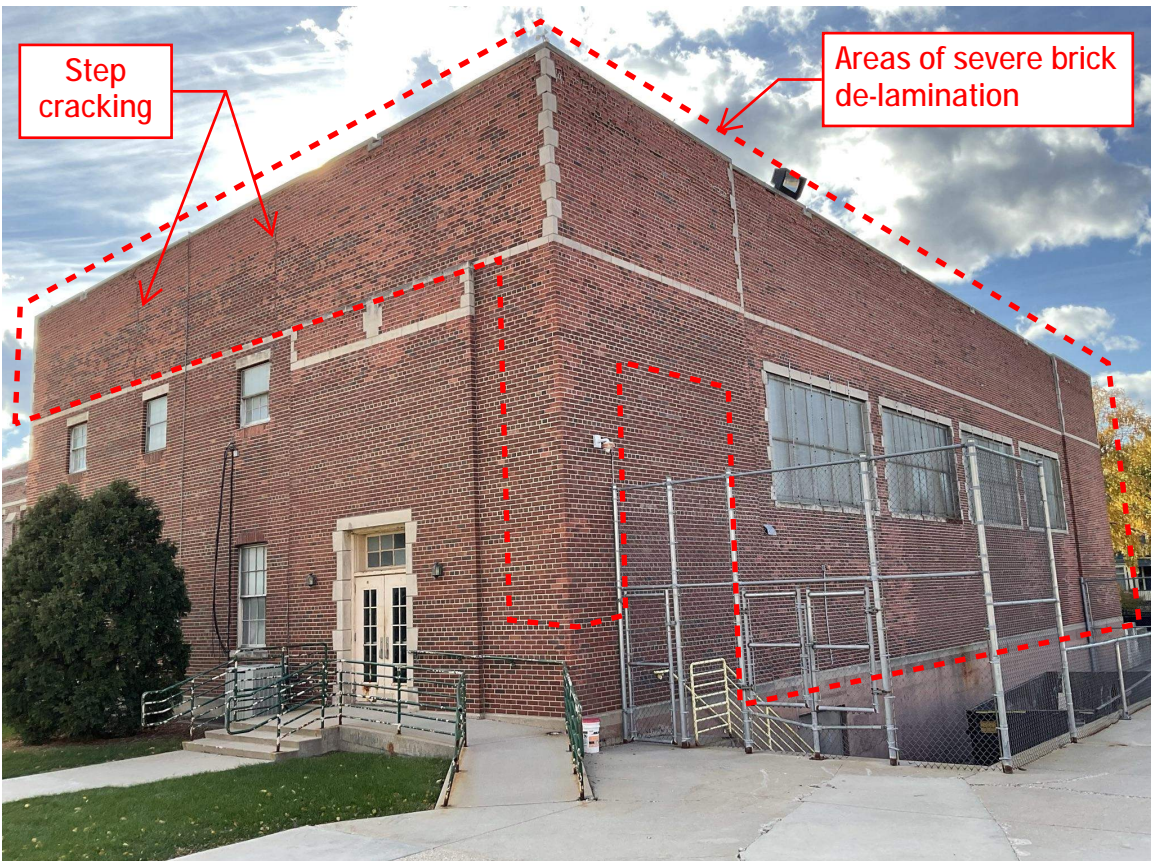
Photo 22 - North-east corner at Pool Addition

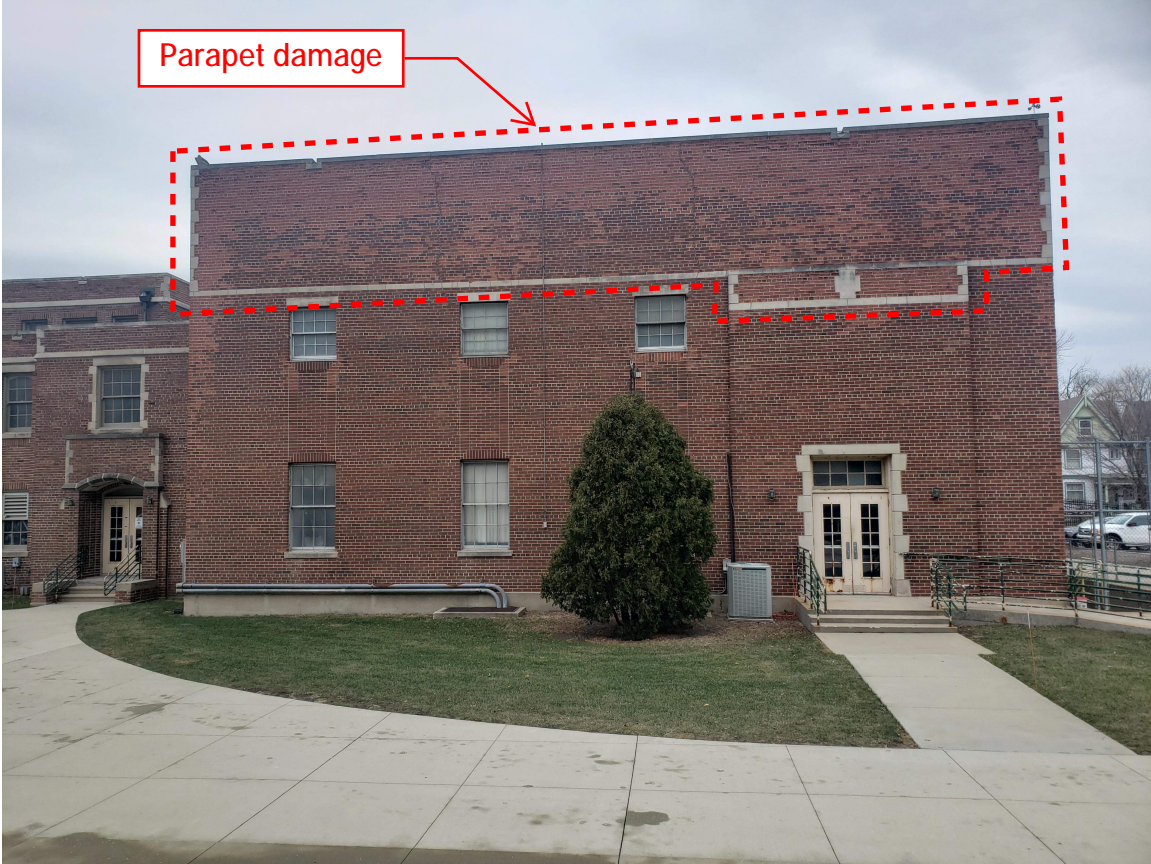
Photo 23 - East Overall at Pool Addition

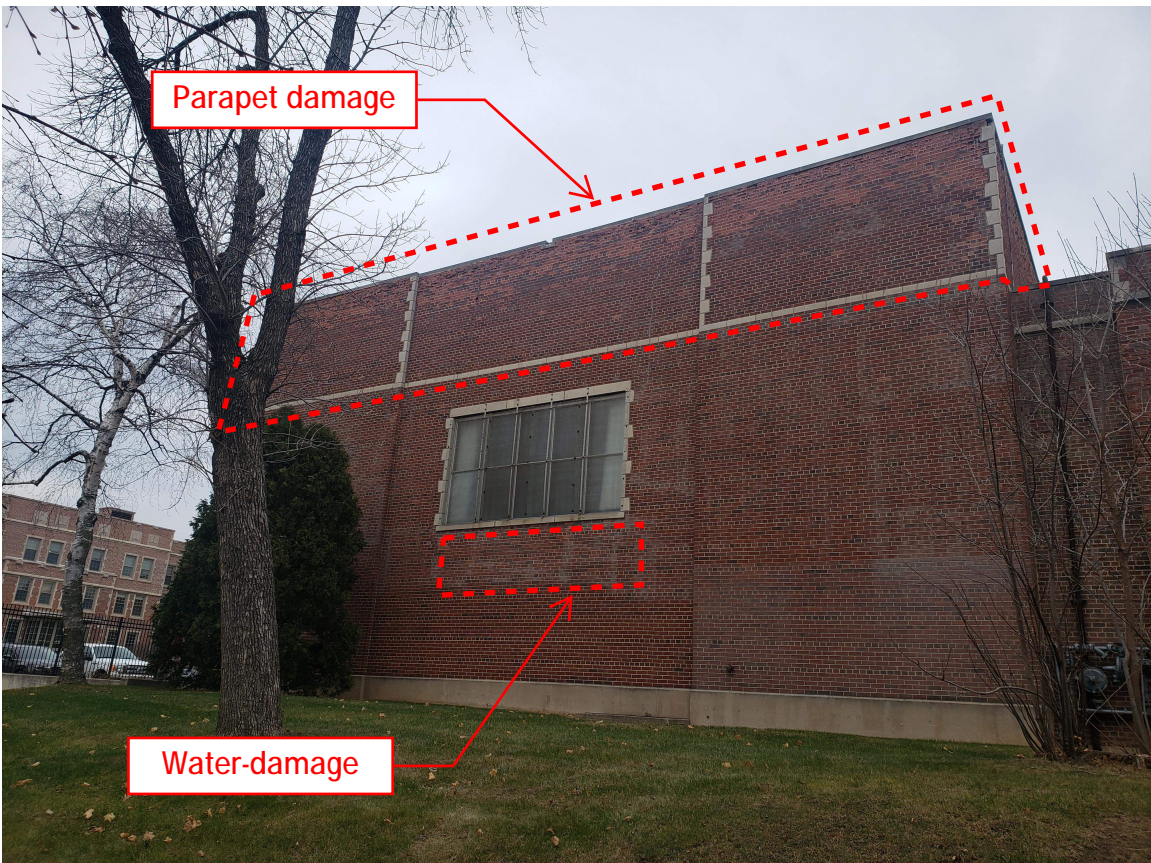
Photo 24 - West Overall at Pool Addition
