1 CAMPUS SITE PLAN
SCALE: N.T.S.

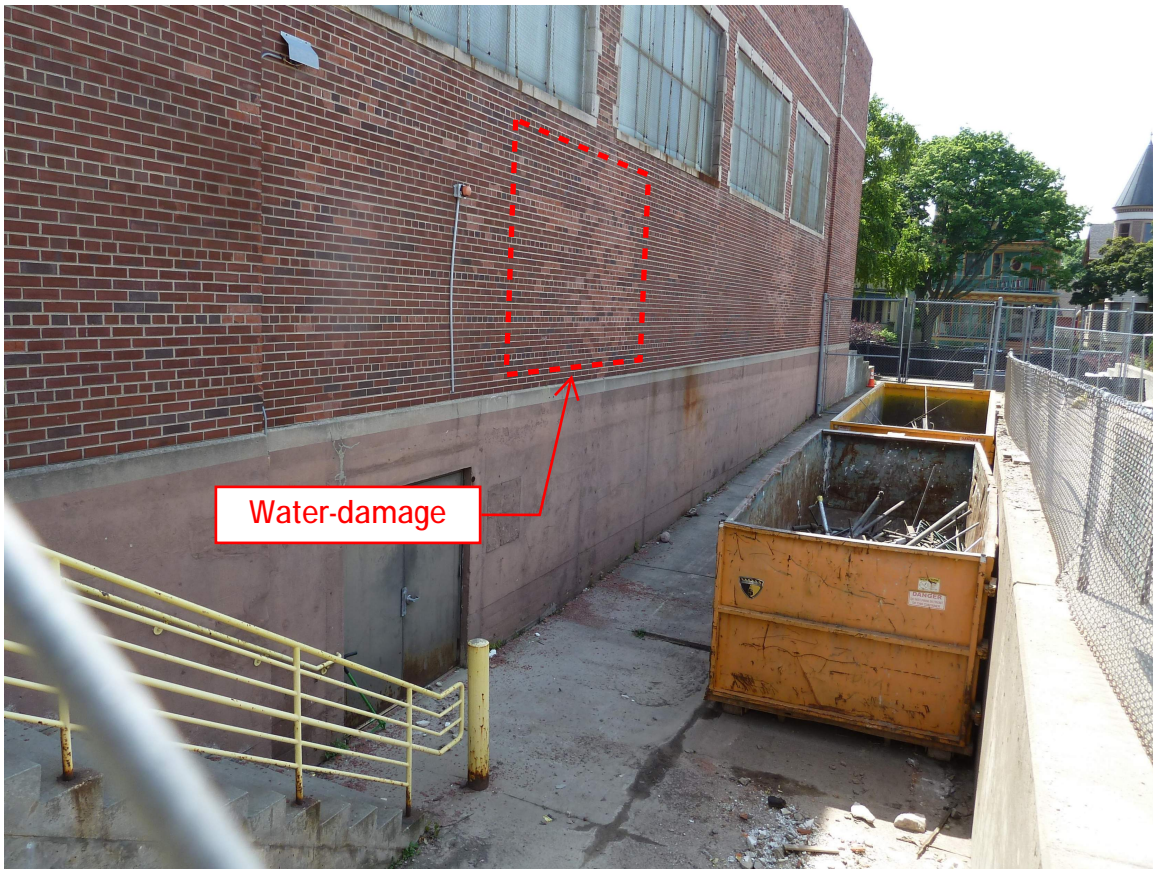
Photo 25 - North (loading dock) at Pool Addition

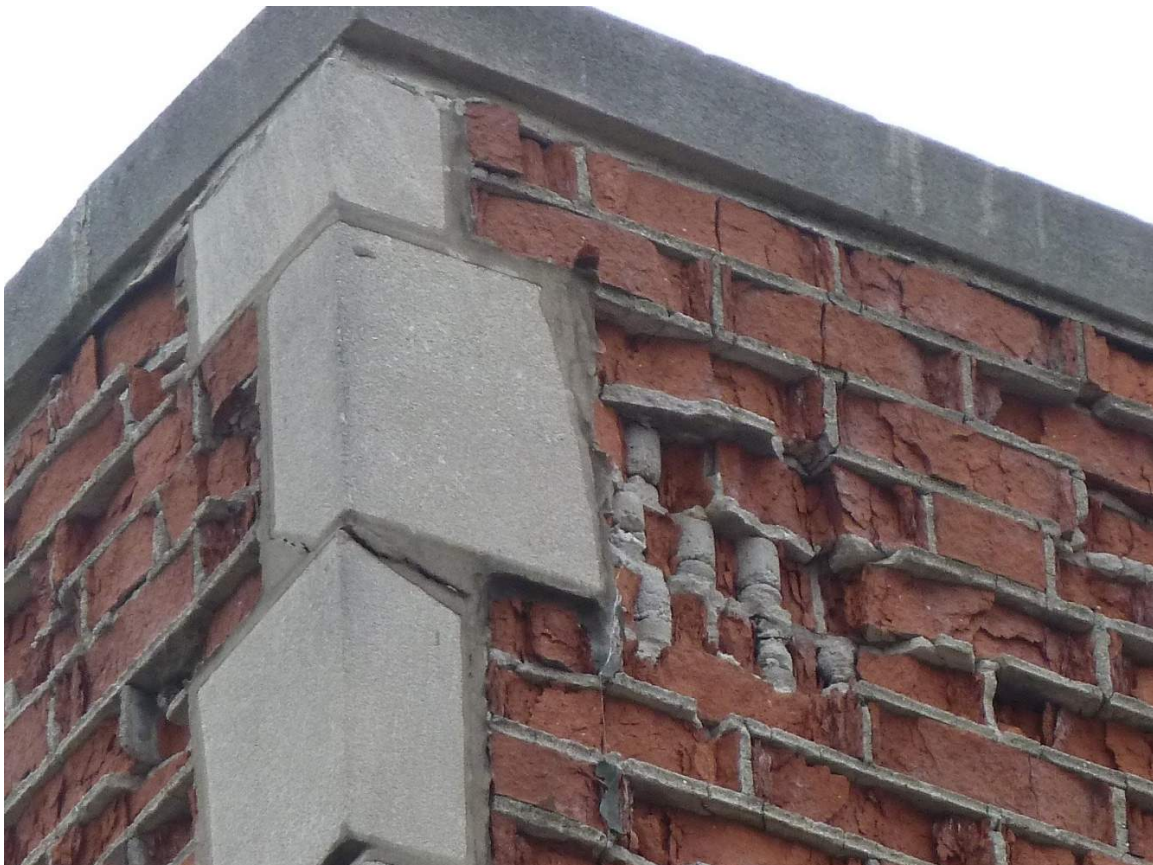
Photo 26 - North-east parapet damage at Pool Addition

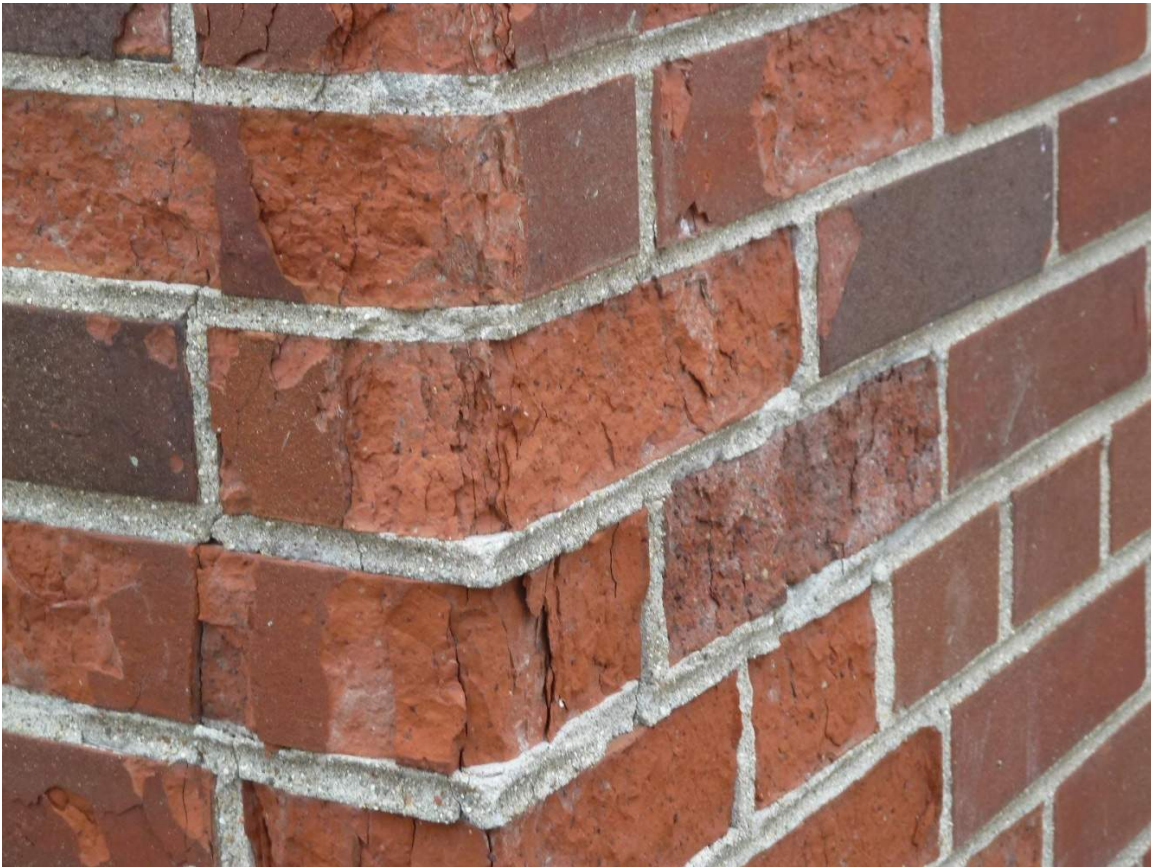
Photo 27 - North-east corner damage at Pool Addition

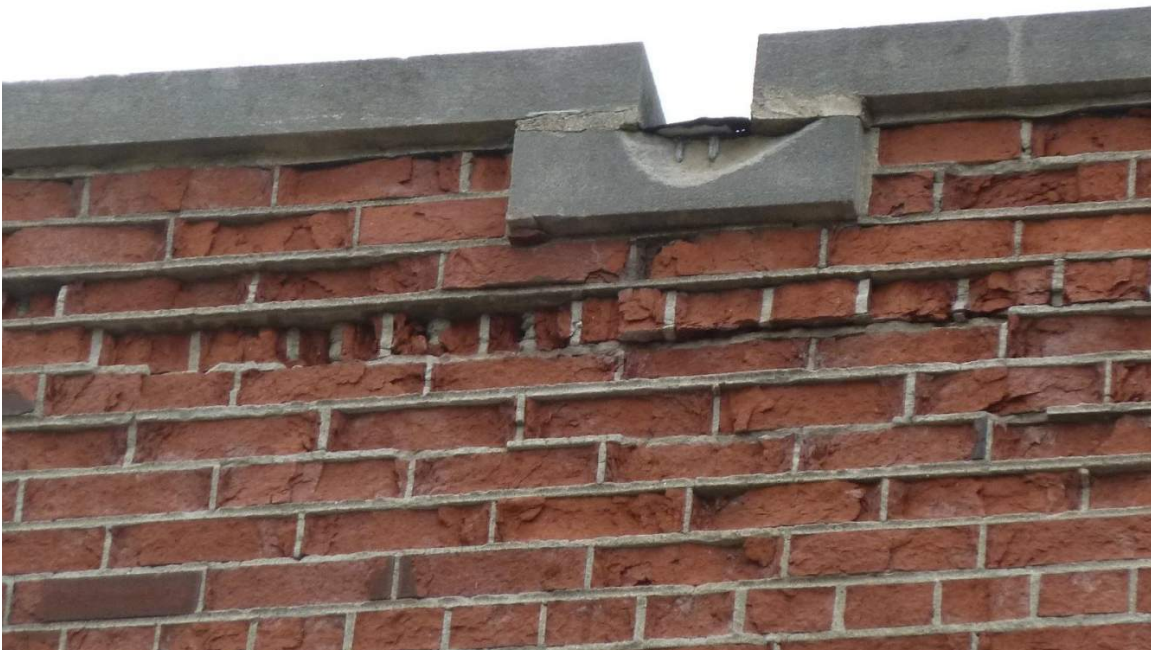
Photo 28 - East parapet damage at Pool Addition

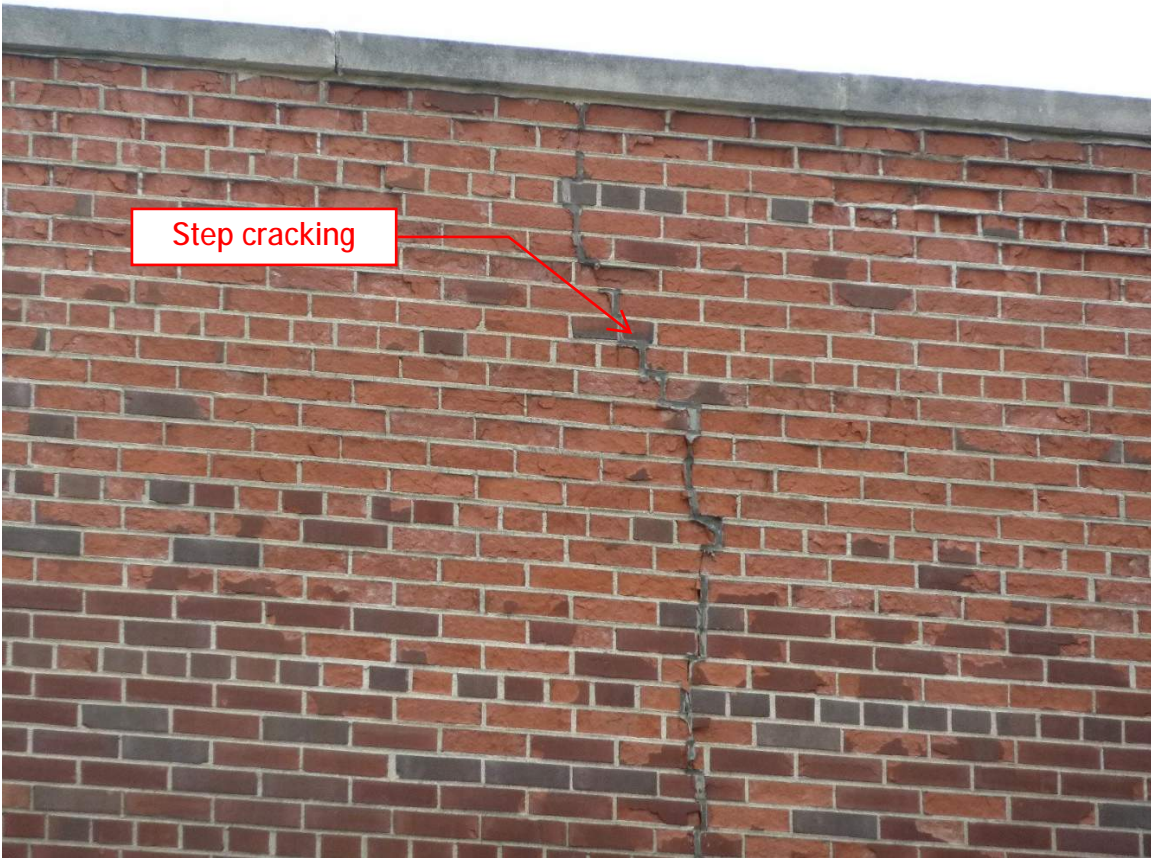
Photo 29 - East elevation cracking at Pool Addition

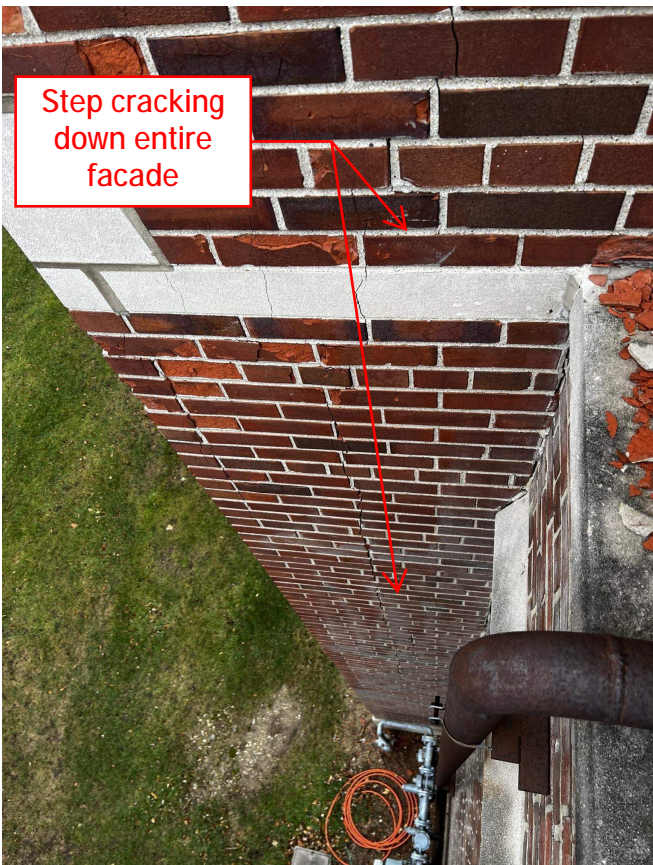
Photo 30 - South-west elevation cracking at Pool Addition

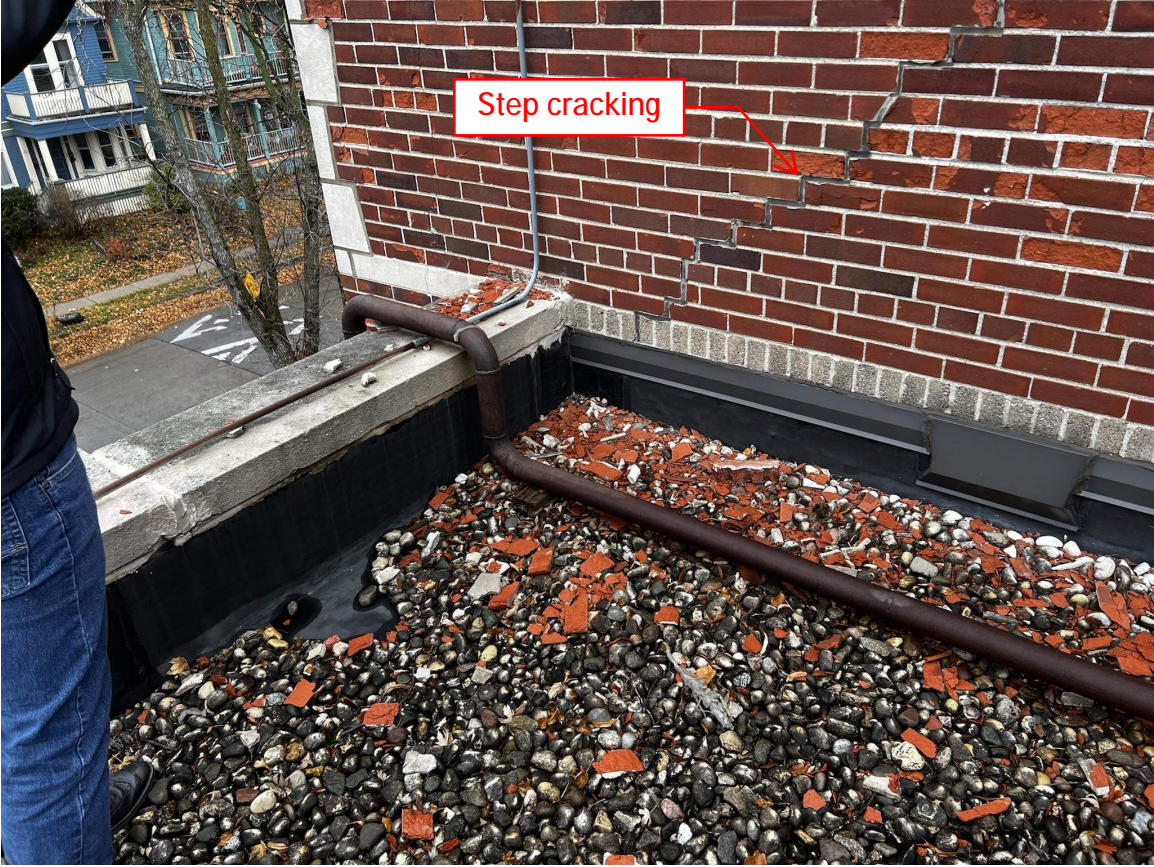
Photo 31 - South-west elevation cracking at Pool Addition

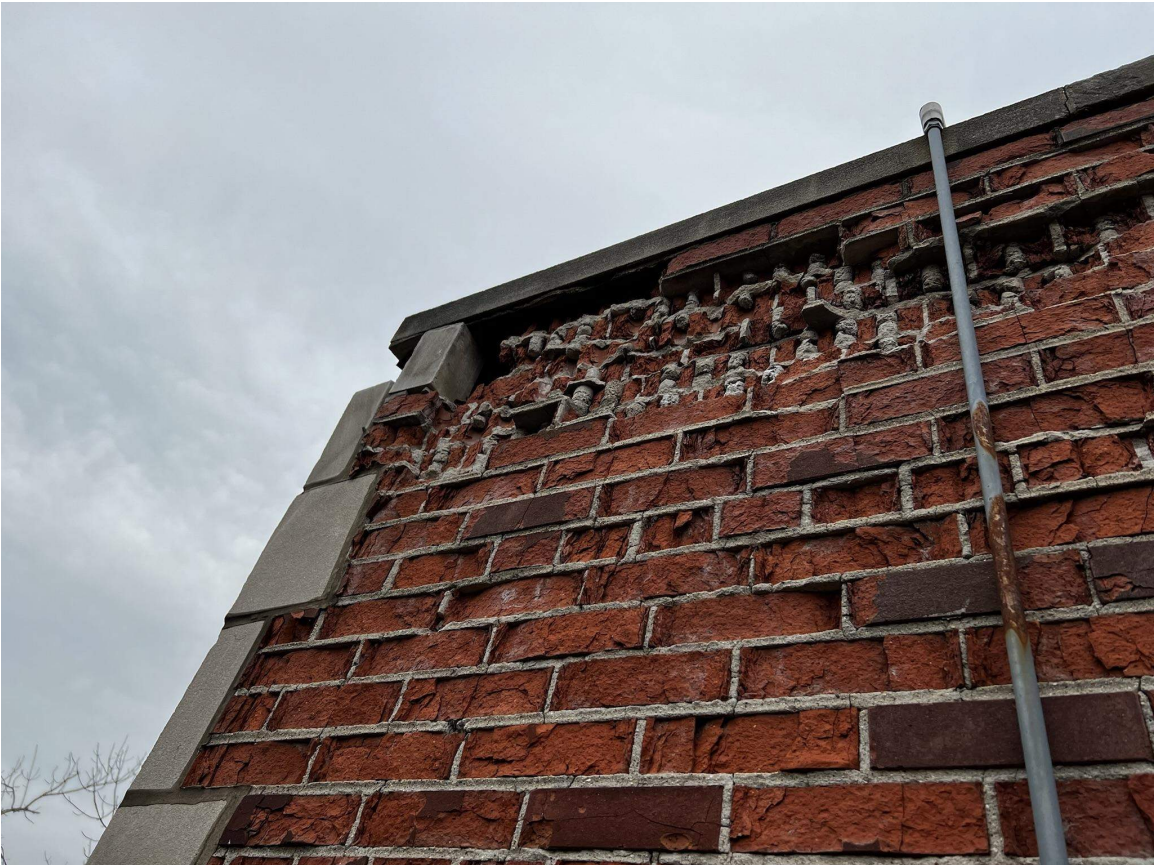
Photo 32 - South-west parapet damage at Pool Addition

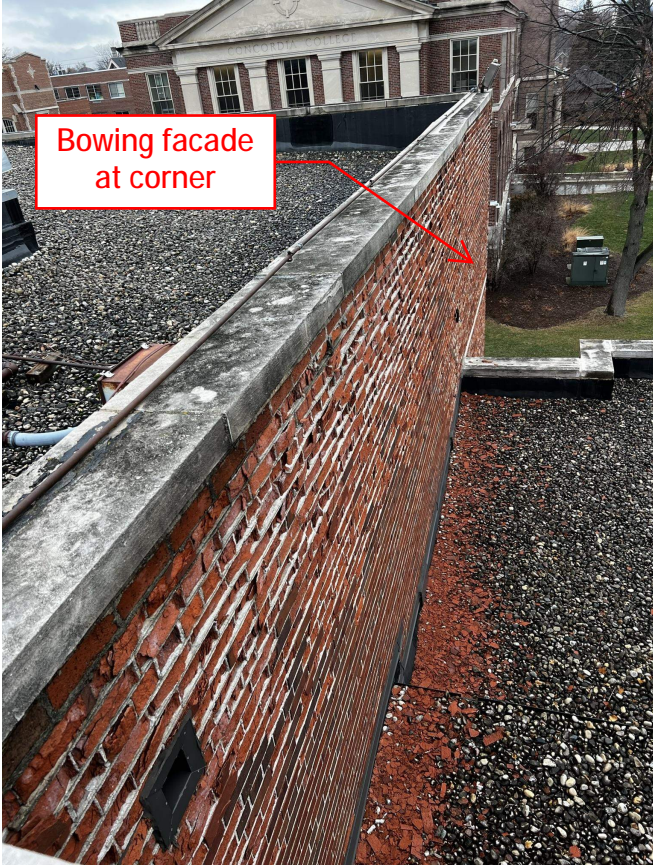
Bowing facade
at corner

Photo 33 - South elevation bowing and brick damage at Pool Addition

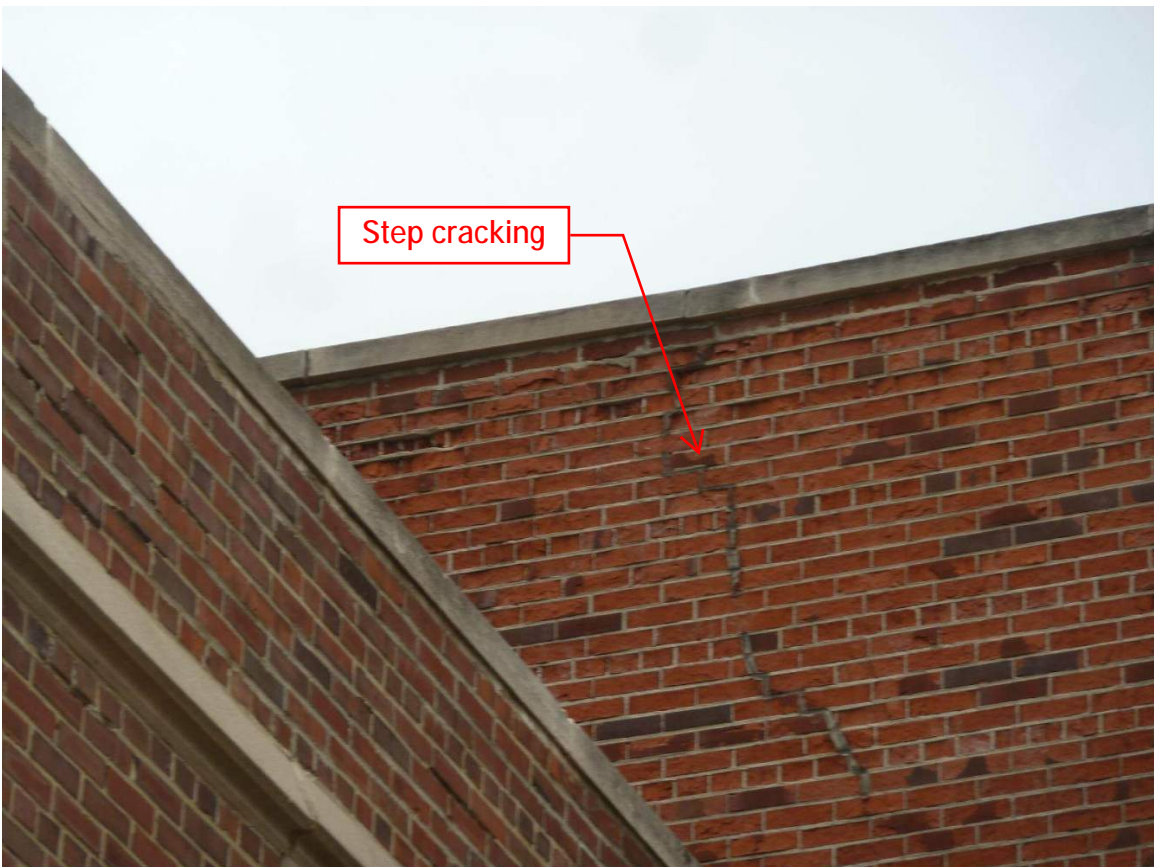
Step cracking

Photo 34 - South-east elevation cracking at Pool Addition

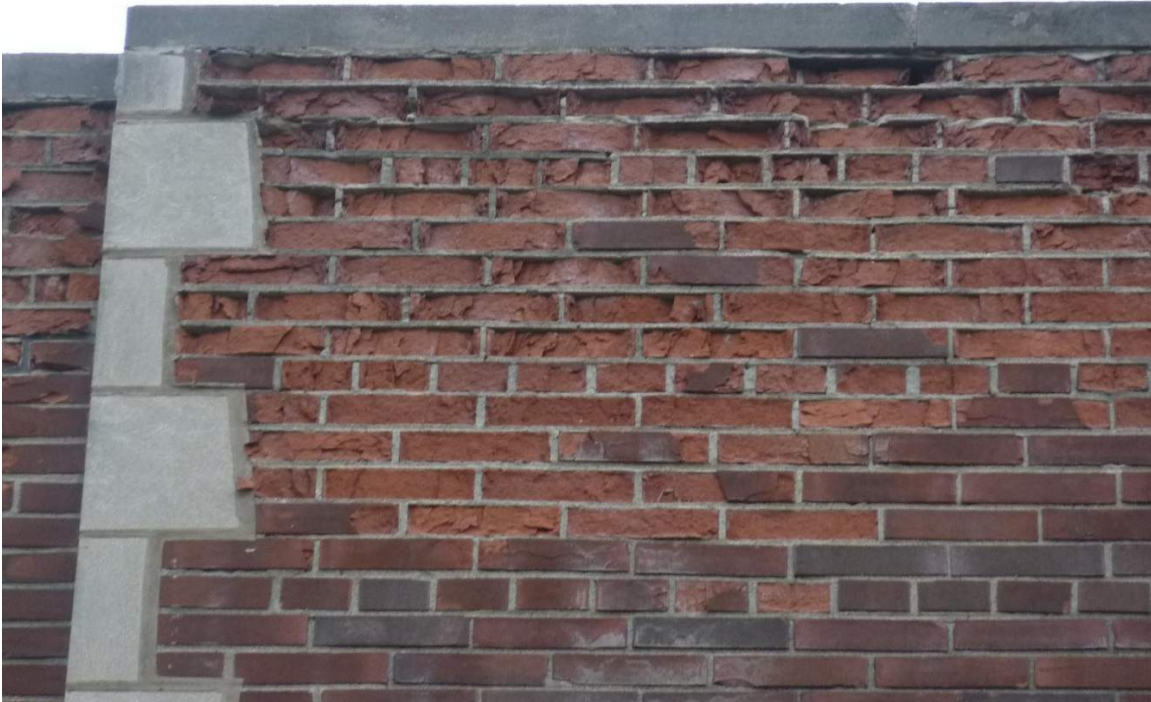
Photo 35 - West parapet damage at Pool Addition

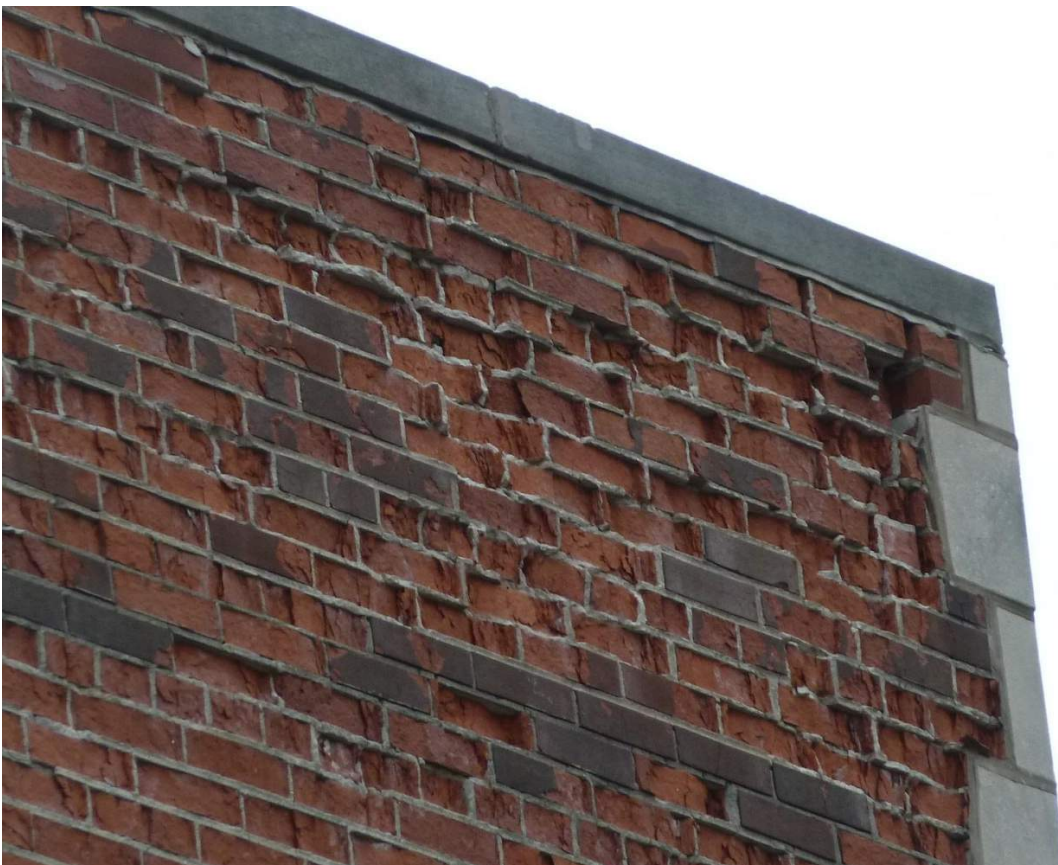
Photo 34 - North parapet damage at Pool Addition
