Certificate of Appropriateness-Corrected

Property	733 -737 W. HISTORIC MITCHELL ST.	Mitchell Street HD	
Description of work	Masonry repairs per conditions below and project narrative on following page.		
Date issued	8/10/2018; corrected 3/5/2019 and expiration date extended to 4/1/2020	PTS ID	114601 COA: masonry repairs

NORTH FACADE

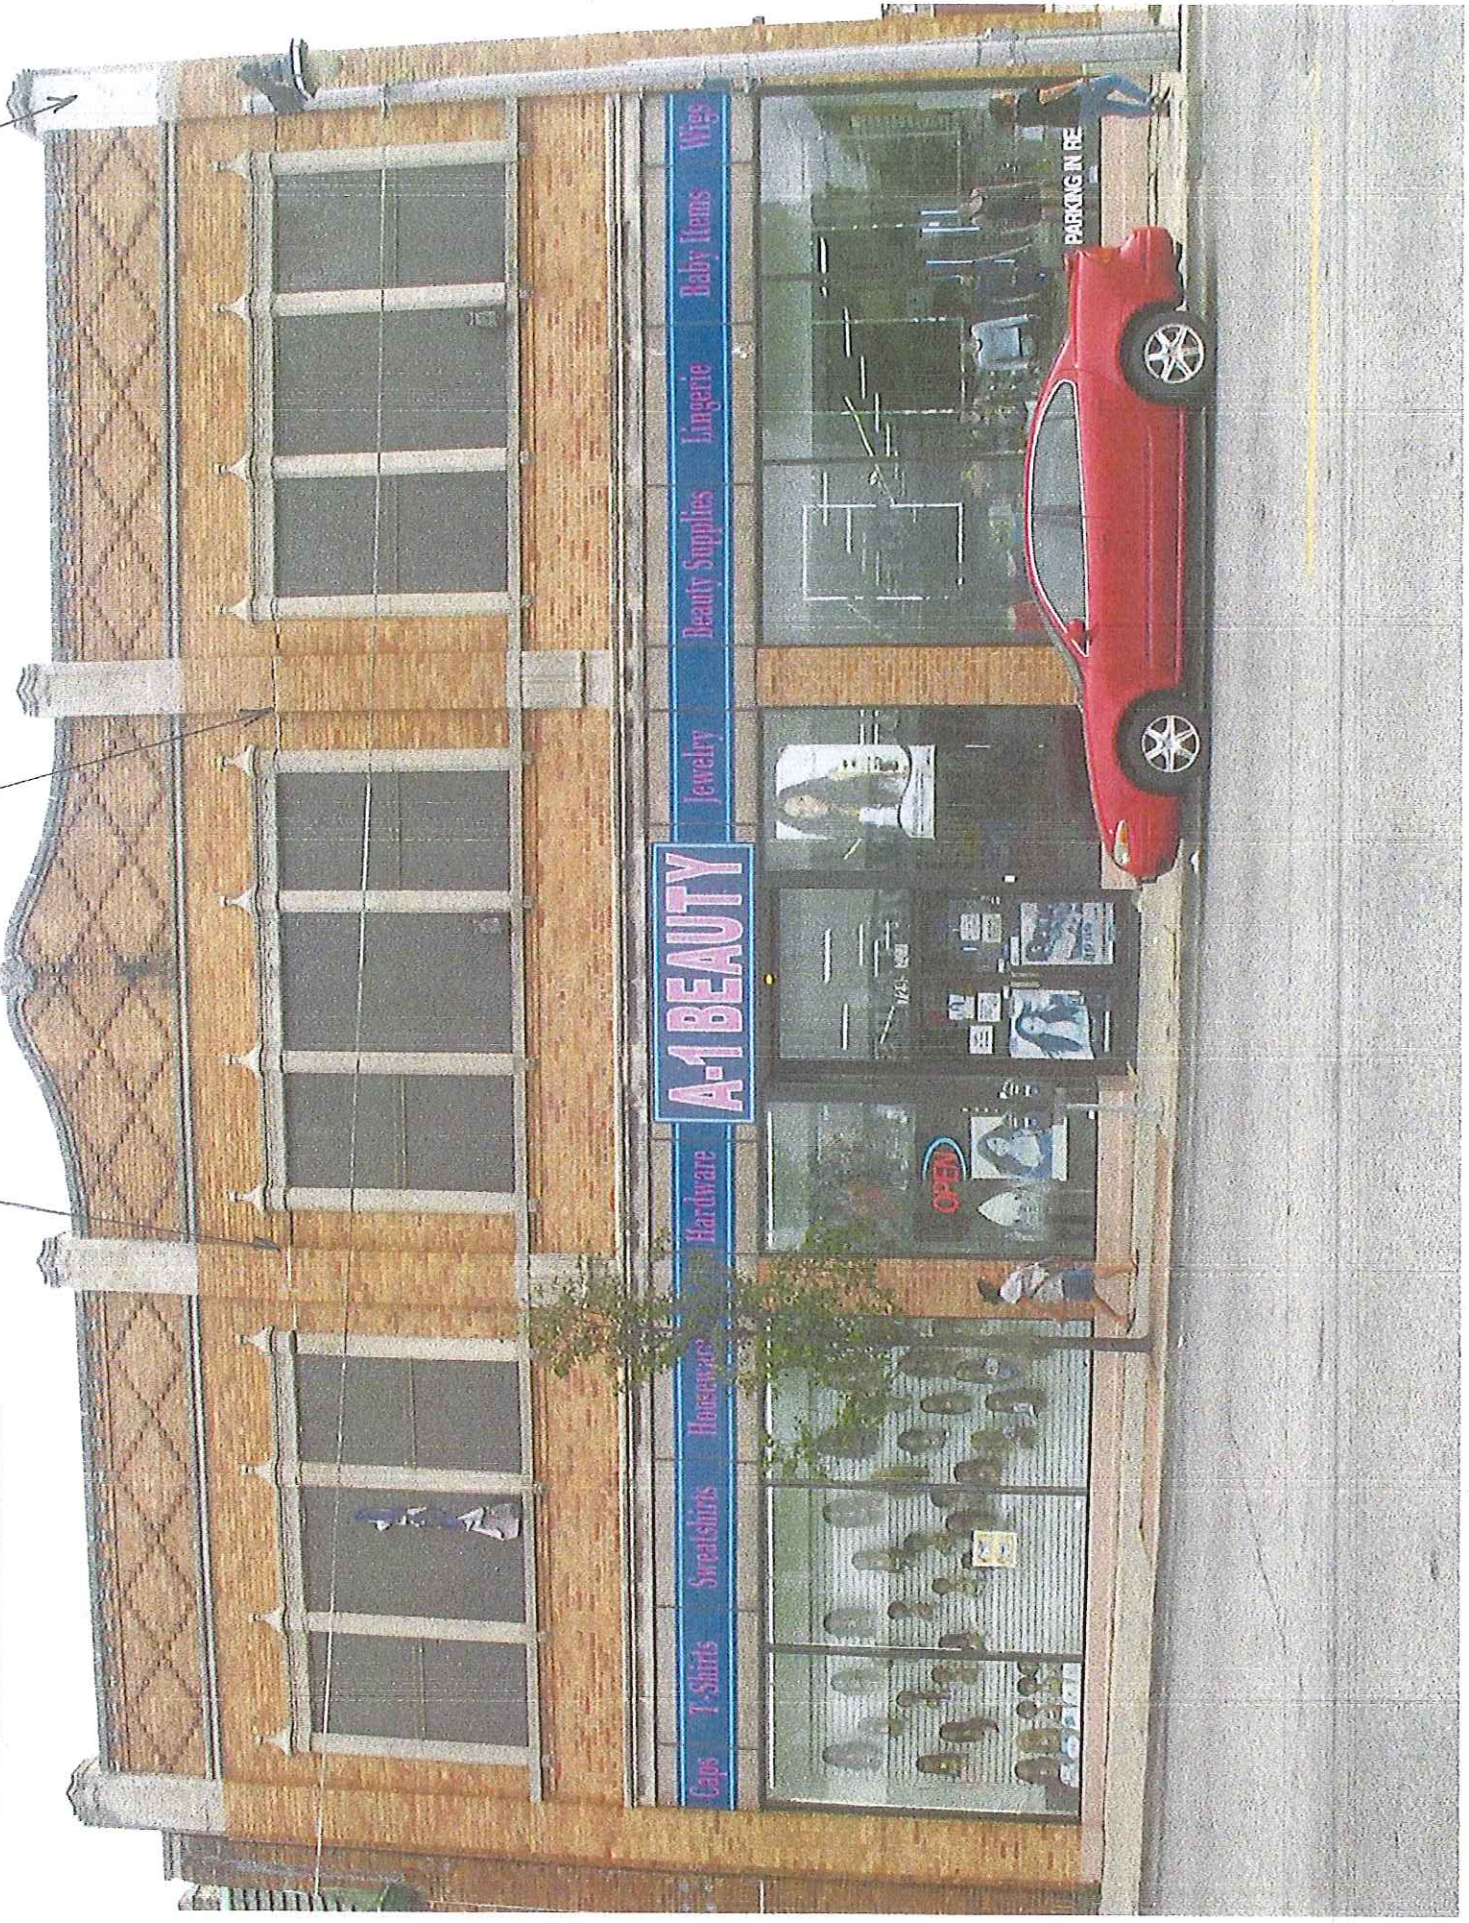
REPAIR PILASTERS

INSERT NEW PEDIMENT

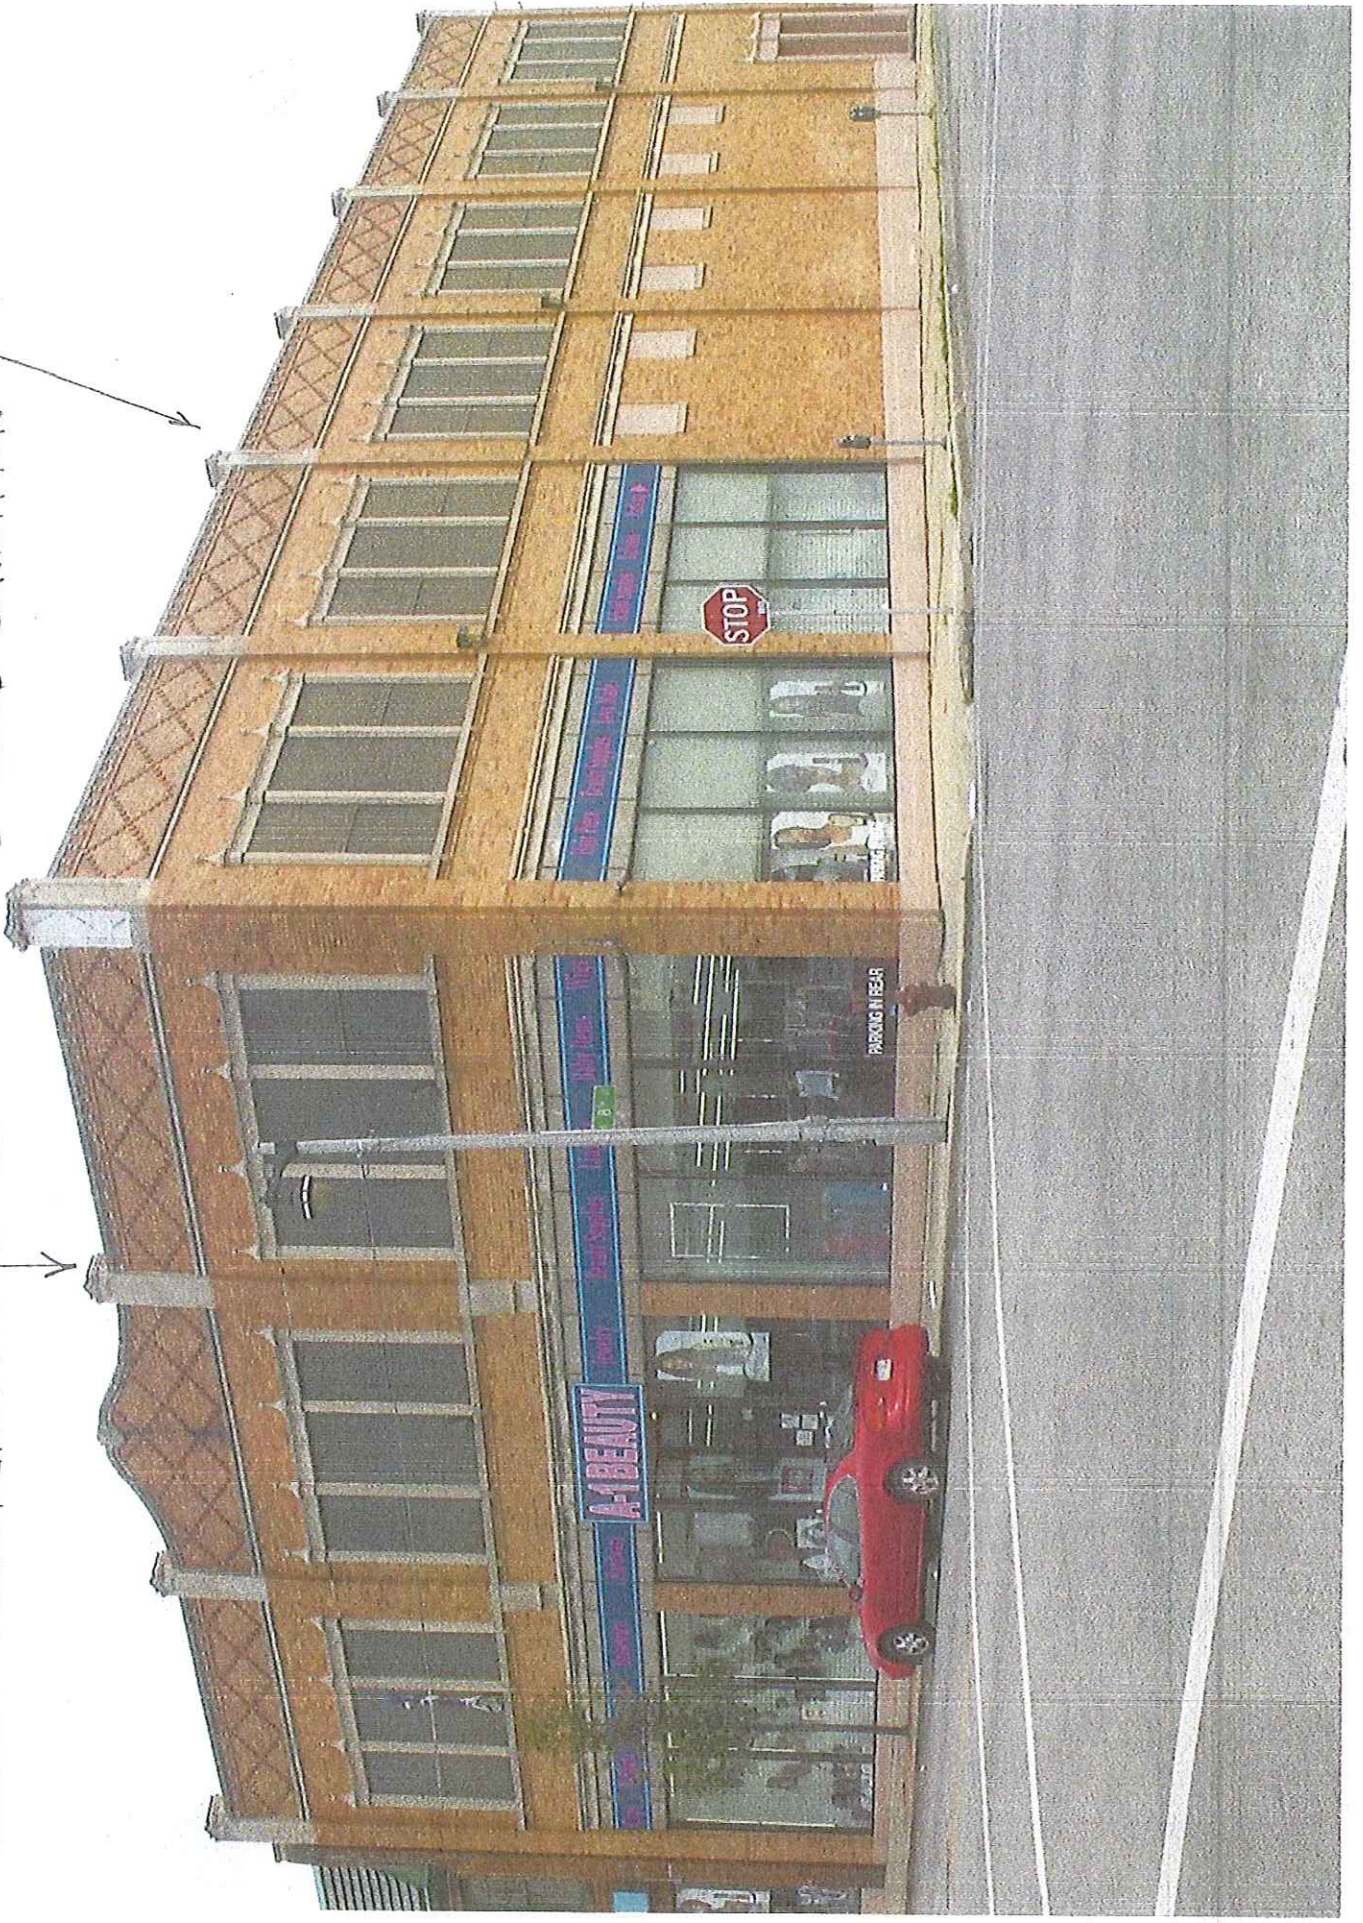
VIEW LOOKING SOUTHEAST
WEST (RIGHT) FACADE IS IN
GOOD CONDITION

NORTH (LEFT) FACADE IS IN
NEED OF REPAIR

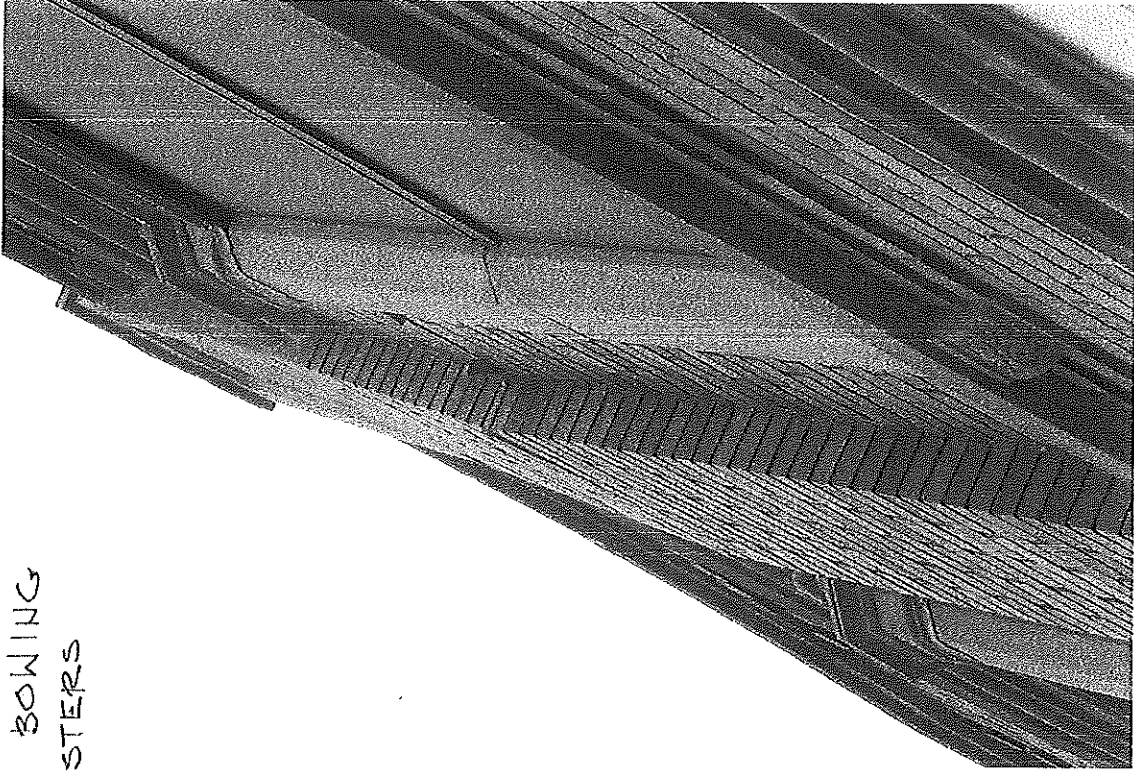
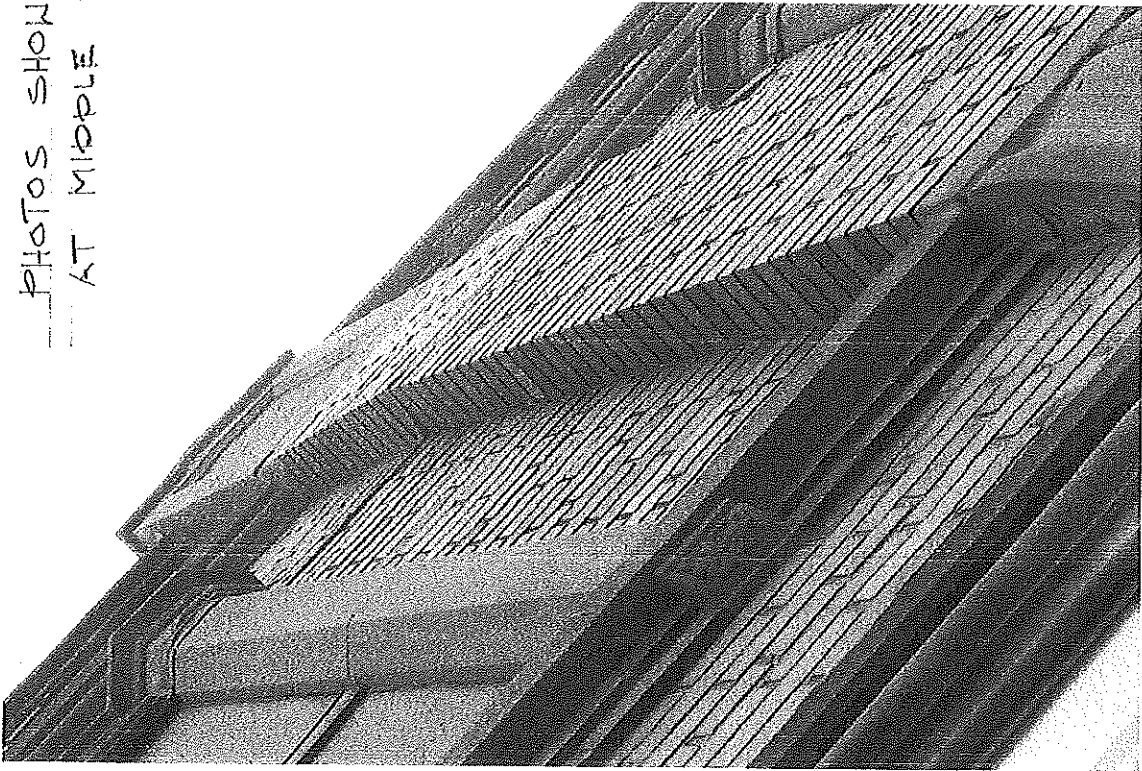
PHOTOS SHOWING BOWLING
AT MIDDLE PILASTERS

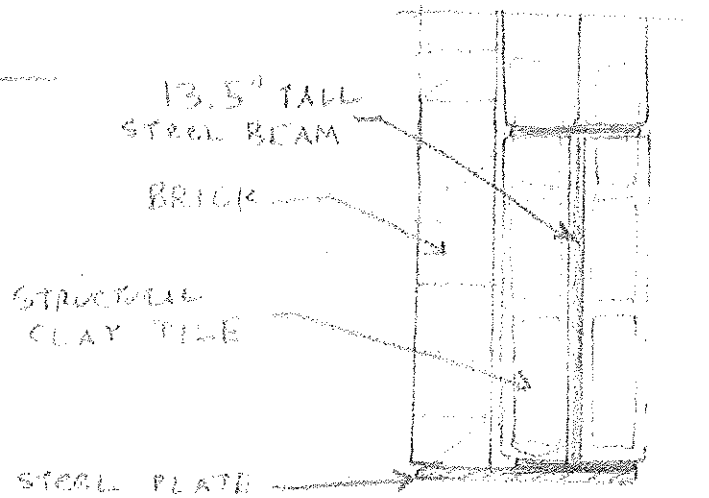
EXISTING CONDITIONS

* STEEL PLATE AND
BOTTOM FLANGES ARE
RUSTED SEVERELY ABOVE
WINDOWS.

* REMOVE RUSTED PORTION OF
STEEL BEAM (ONLY BETWEEN COLUMNS)

* INSTALL $6 \times 6 \times \frac{1}{4}$ " (MIN) ANGLE
PENDING MORE ACCURATE MEASUREMENT
OF HORIZONTAL MOVEMENT
(UP TO $L8 \times 8 \times \frac{3}{8}$ " MAY BE NEEDED)
