1. HISTORIC NAME OF PROPERTY OR HISTORIC DISTRICT: (if known)
Harry Berger House - North Point Historic District
ADDRESS OF PROPERTY:
2720 East Bradford Avenue

Replace roof.
Material to be used: Certain Teed Landmark
color: weathered wood
Refer to the attached documents.

Restoration of Roof System

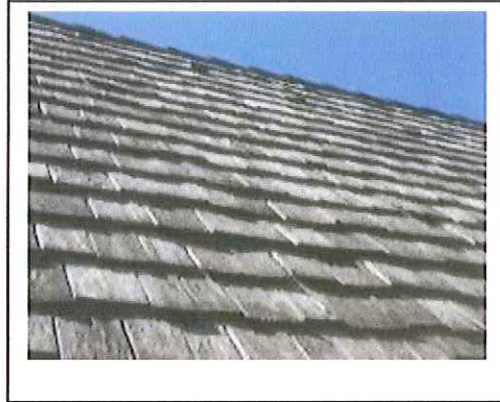
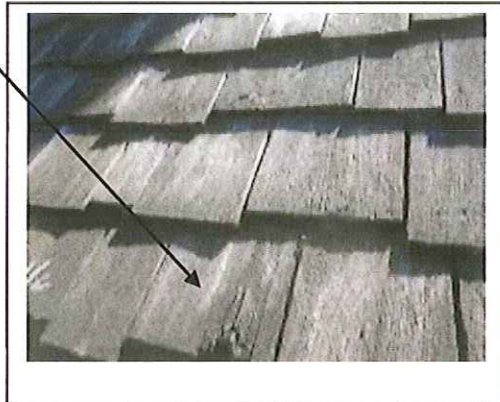
Observation # - Many of the north-facing shakes appeared sound but some defects, such as minor splitting and butt rot were still noted.

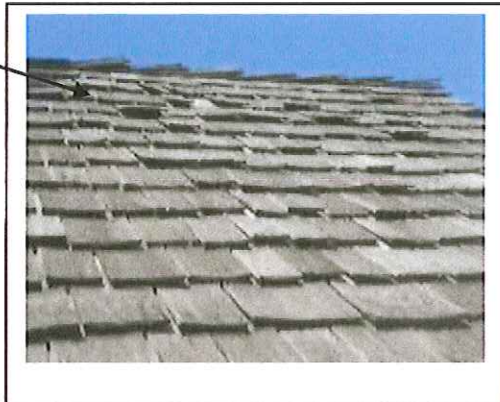
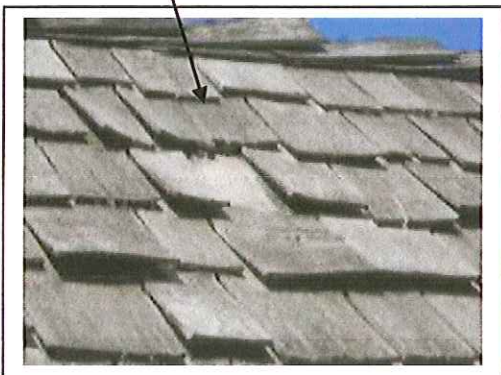
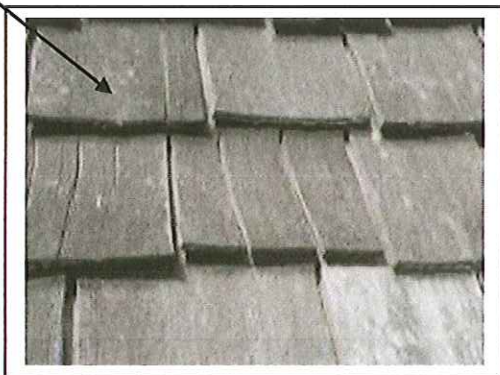
Observation # - More defects, such as lifting / curling, splitting and missing shakes were noted on the east- and west-facing slopes

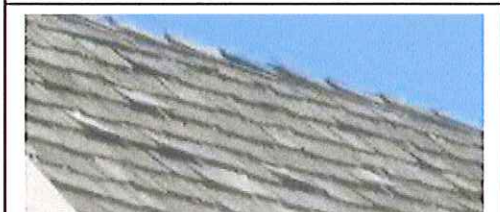
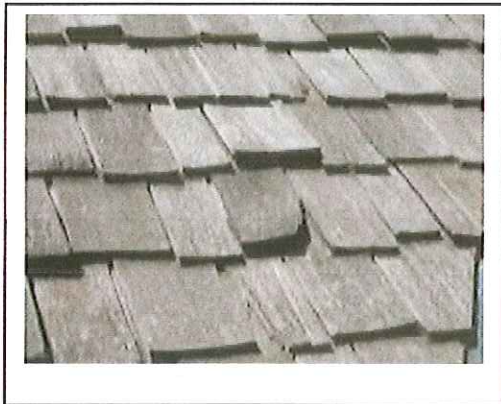
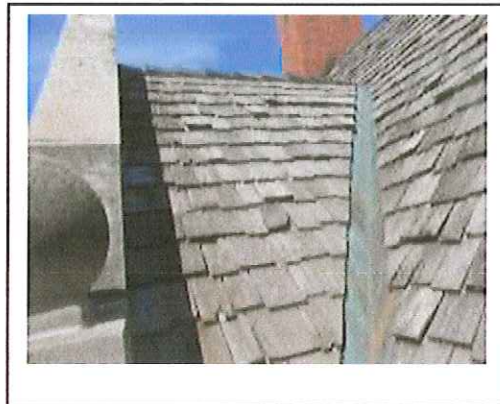
Observation # - The south-facing slopes had the most defects. There was more severe lifting and curling as well as splitting.

The existing copper valleys were weathered but sound. They would be replaced with a new

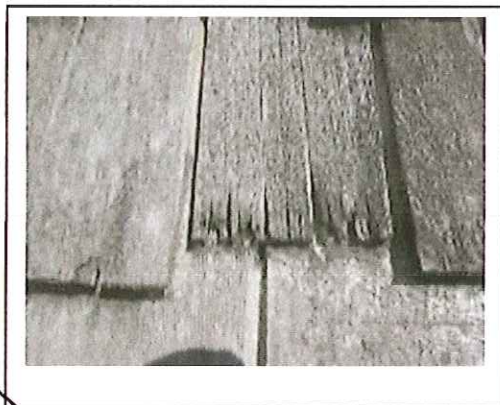
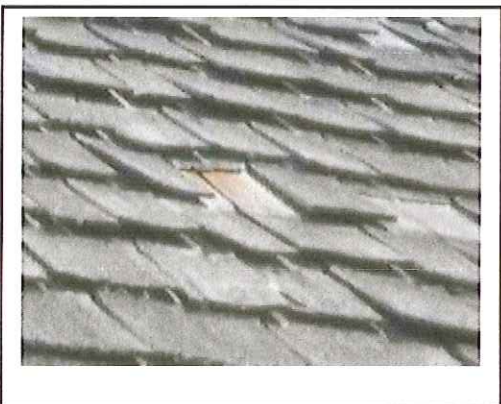
Observation # - Butt-rot, significant splitting and missing shakes were more prevalent on these south-facing slopes.

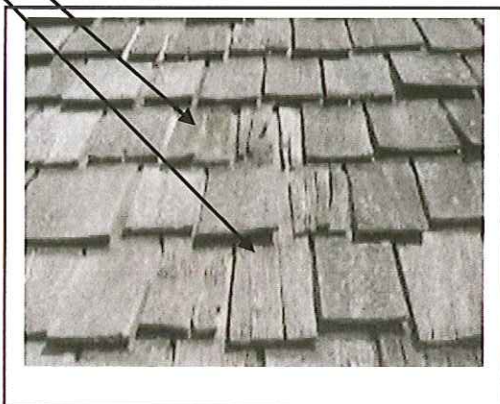
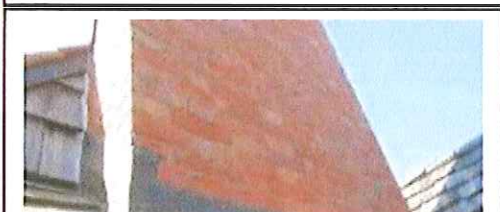
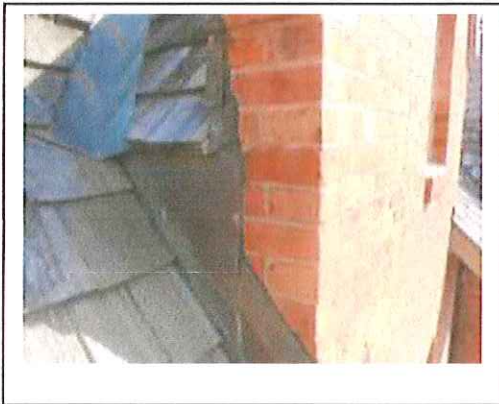
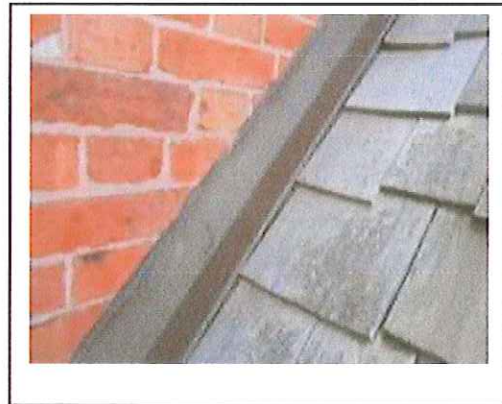
Observation # - The various newer copper flashings appeared sound and would, for the most part, be usable with a new roof.

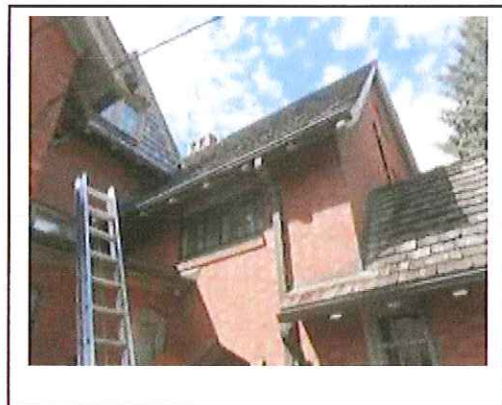
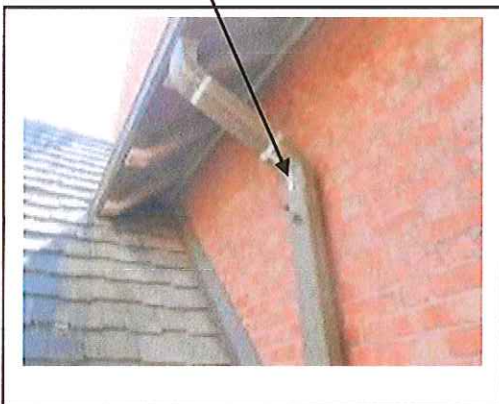
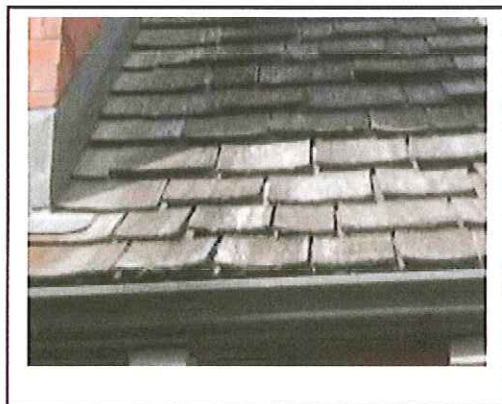
Observation # - The gutters and downspouts appeared generally sound with some minor repairs being required.

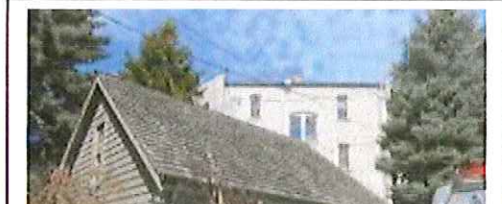
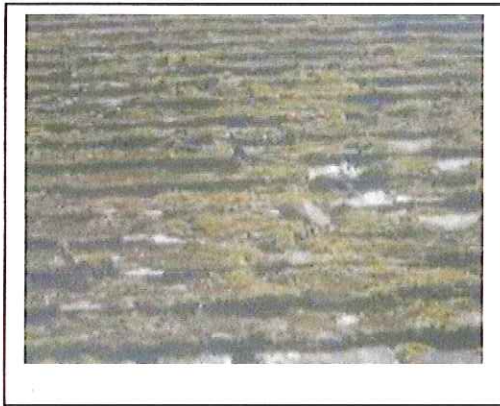
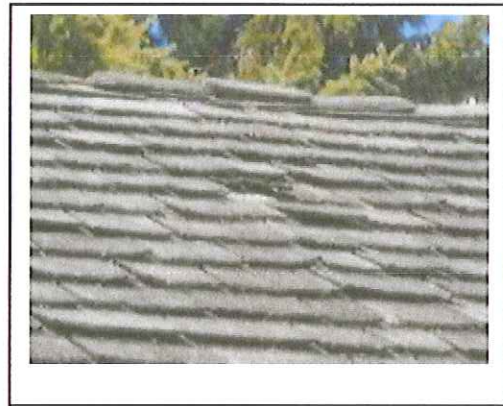
Observation # - The two sides of the garage roof also had their share of defects ranging from curled and missing shakes to fairly weathered moss-covered shakes.
