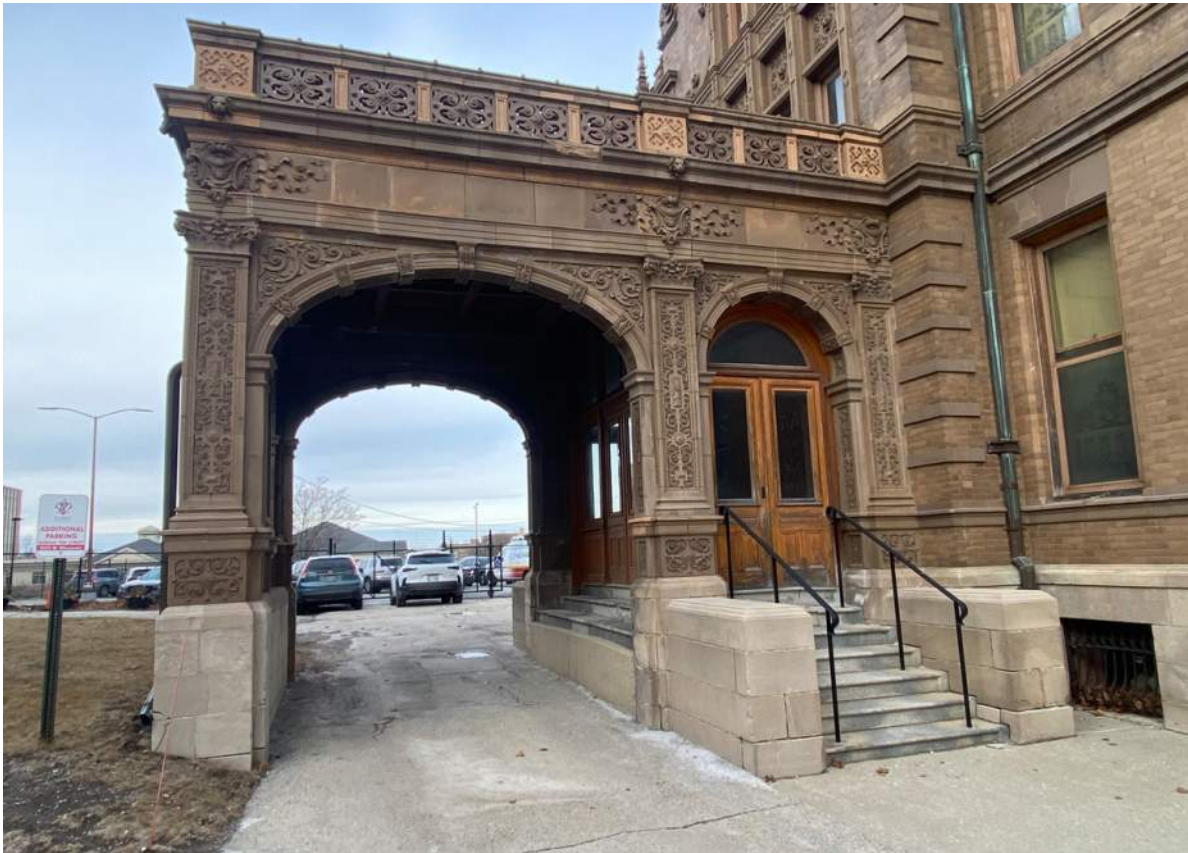
*Photo 03: South View of Porte Cochere showing drop in terra cotta arch stones and deterioration of entry steps.*

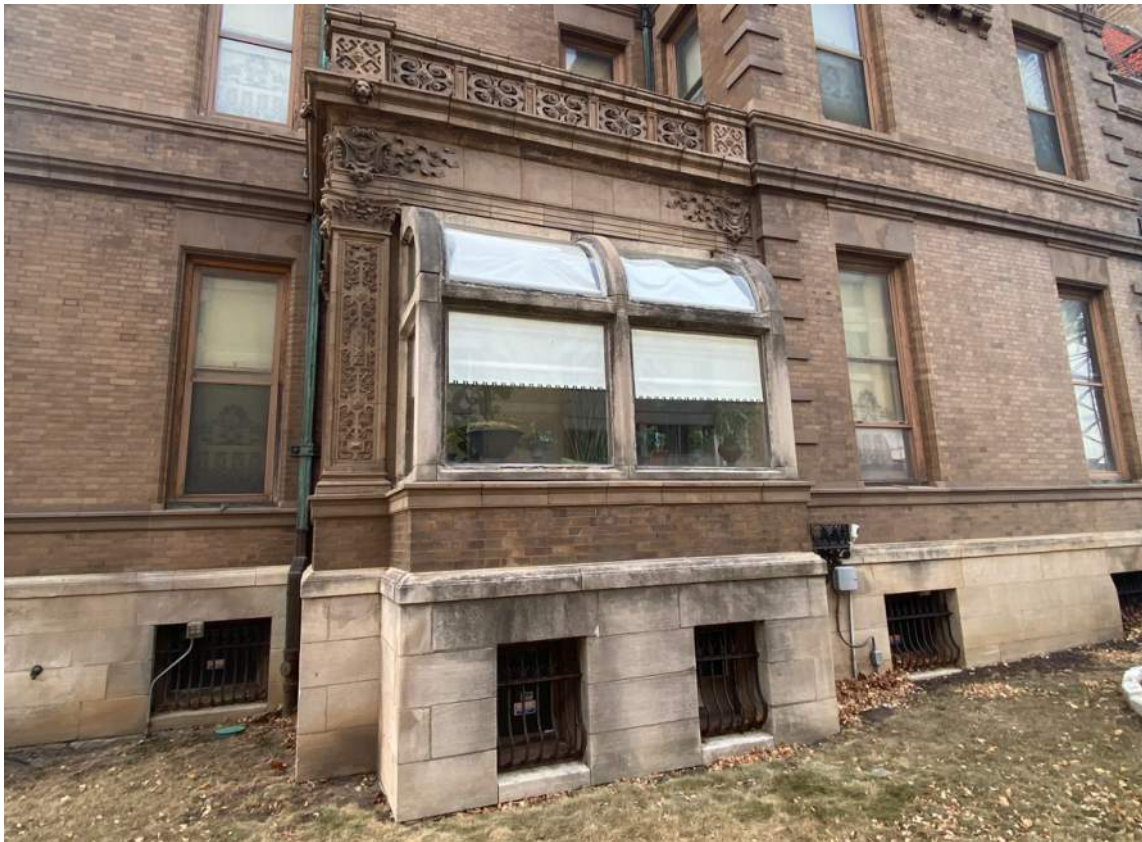
*Photo 06: Detail of Conservatory. Non-original stone window framing to be removed and replaced with new to match original.*

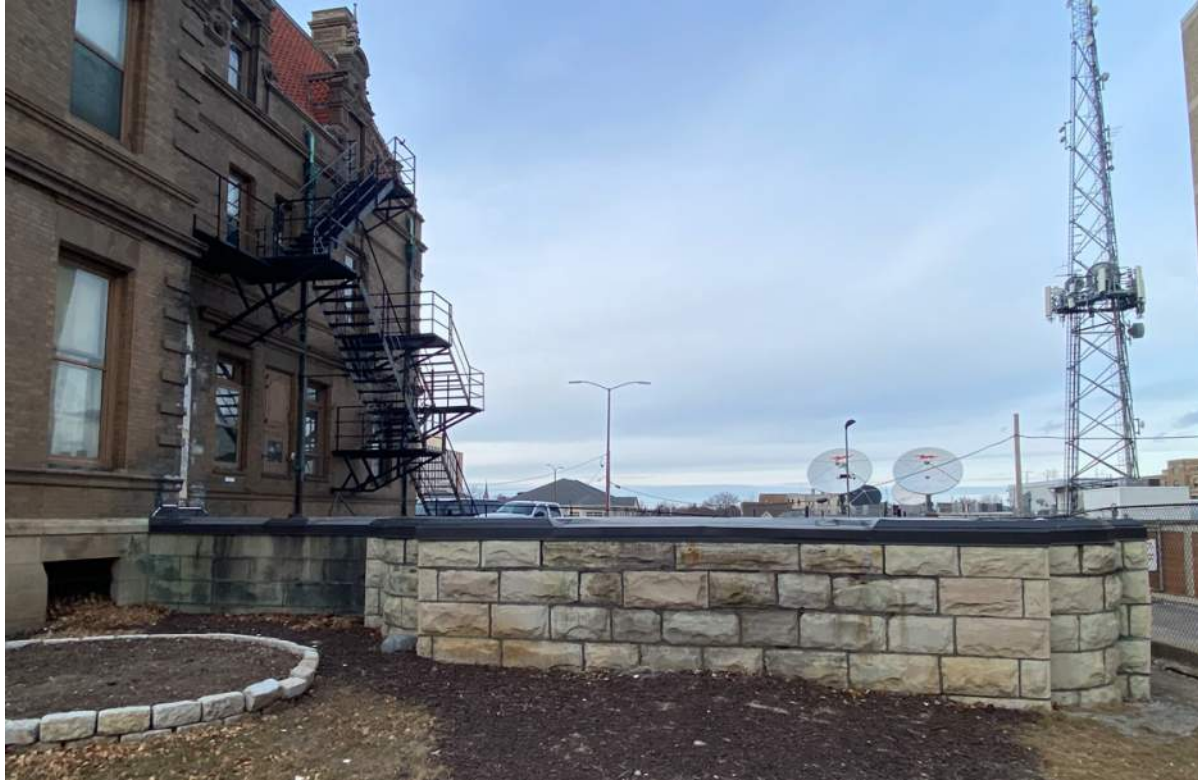
*Photo 07: East Side - Capped foundation at removed Pavilion*

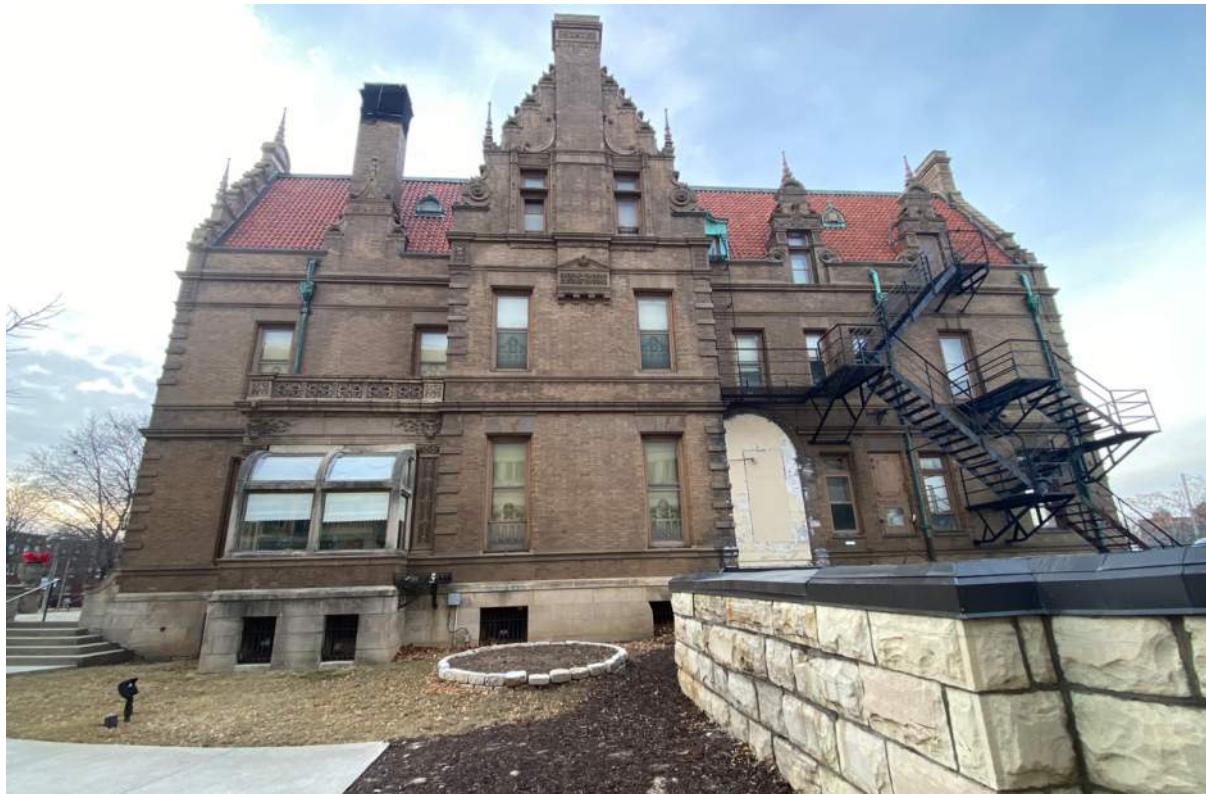
*Photo 08: East Exterior Elevation of Mansion - Fire Escape to be Removed*

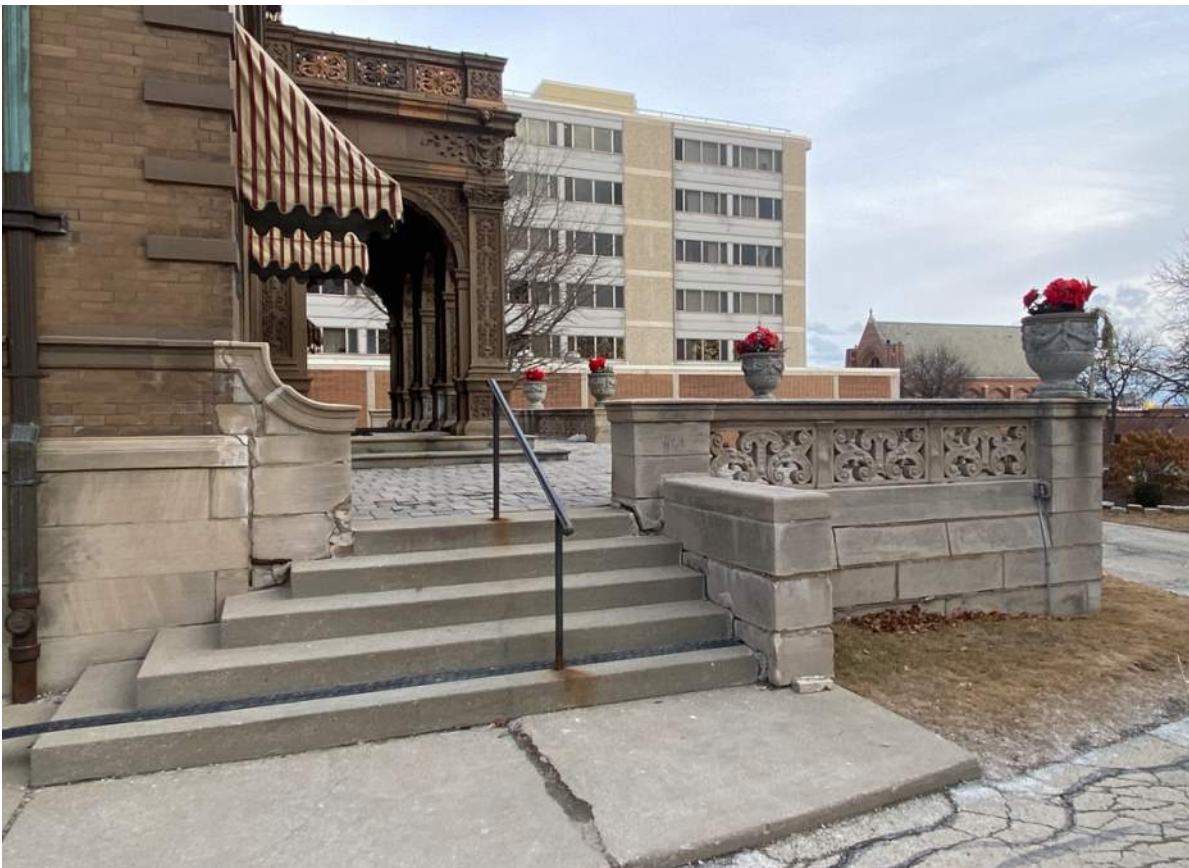
*Photo 12: West Side of South Entrance Terrace Showing Stone & Paver Deterioration*

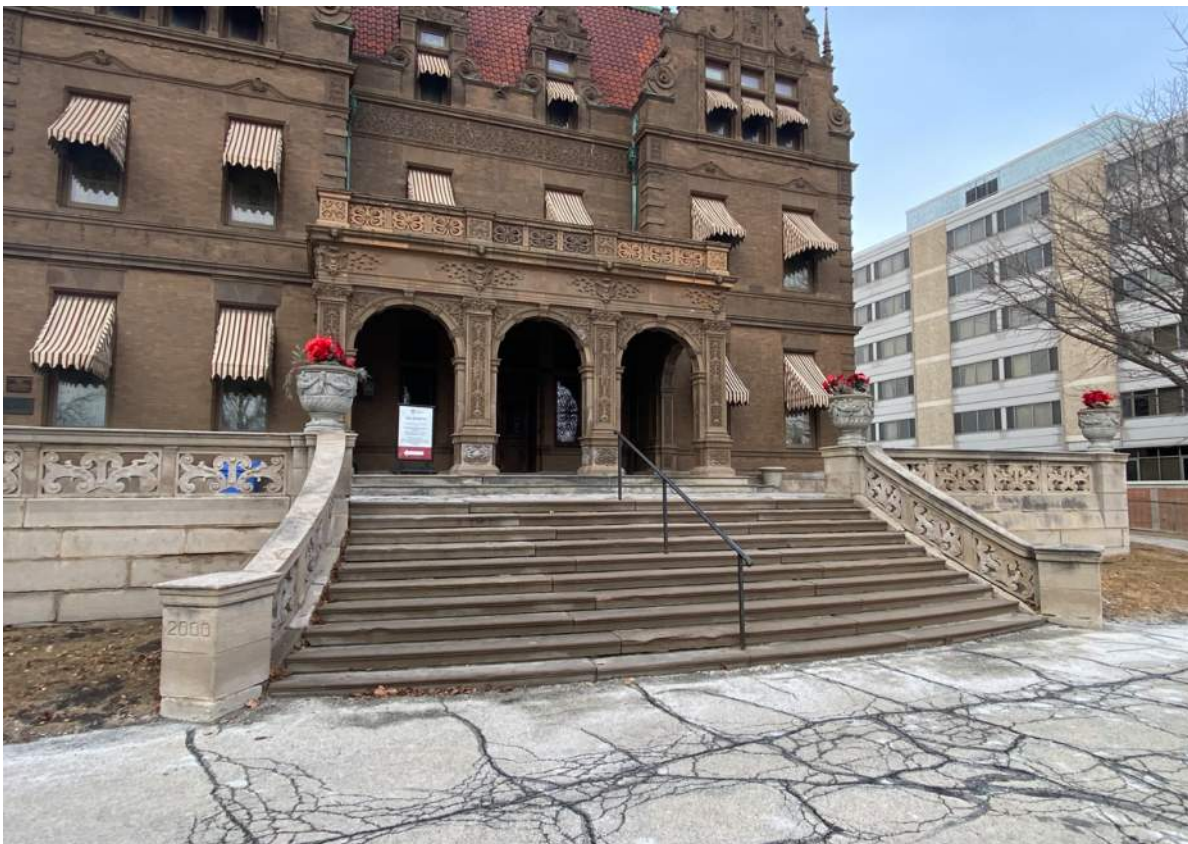
*Photo 14: South Side of South Entrance Terrace Showing Condition of Stair and Balustrade*
