Certificate of Appropriateness

910 N. OLD WORLD THIRD ST. Second Ward Savings Bank

Applicant proposes a substantial amount of facade restoration work delineated below:

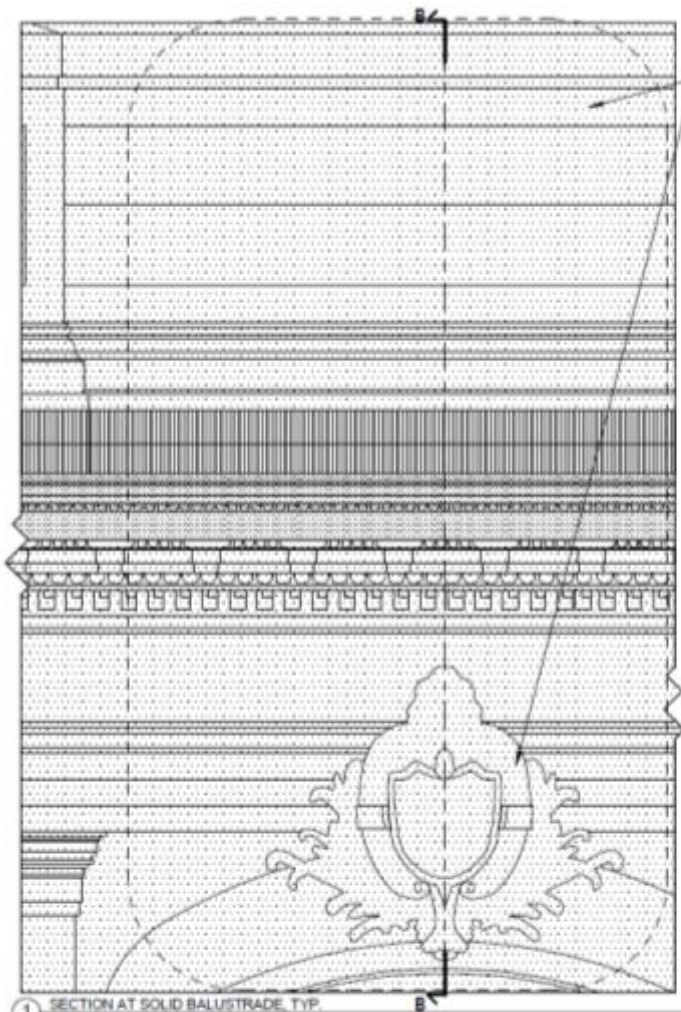
1 SECTION AT SOLID BALUSTRADE, TYP.
1/2" = 1'-0"

The stone cladding of the solid balustrade will be re-pointed. The previously mortar-set cap stones will be pinned and have new, alloy-coated copper flashing. The balustrade brick back-up walls are protected by metal panels installed on hat channels. Air circulation was verified and so the existing metal panels will remain in place. (1/A301)

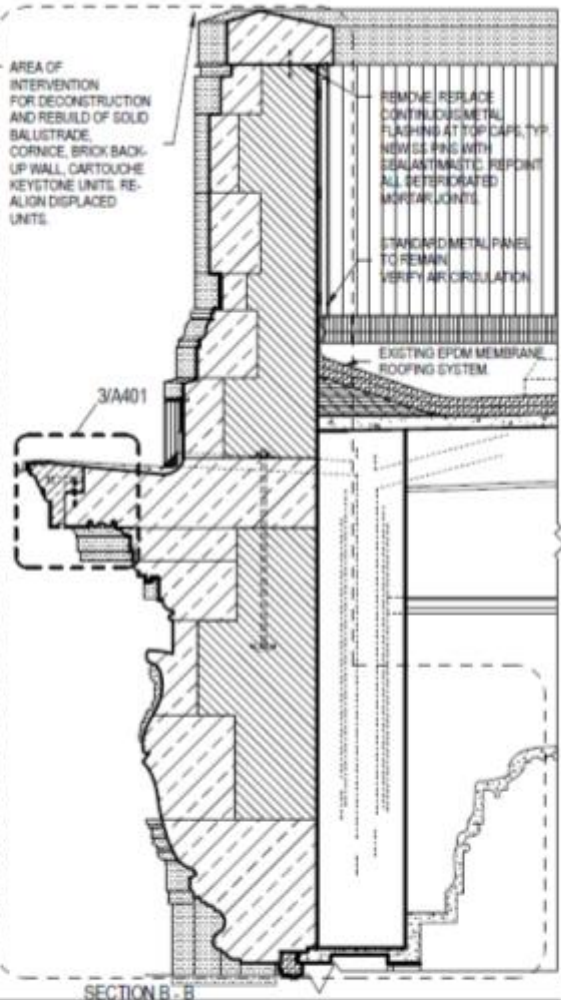
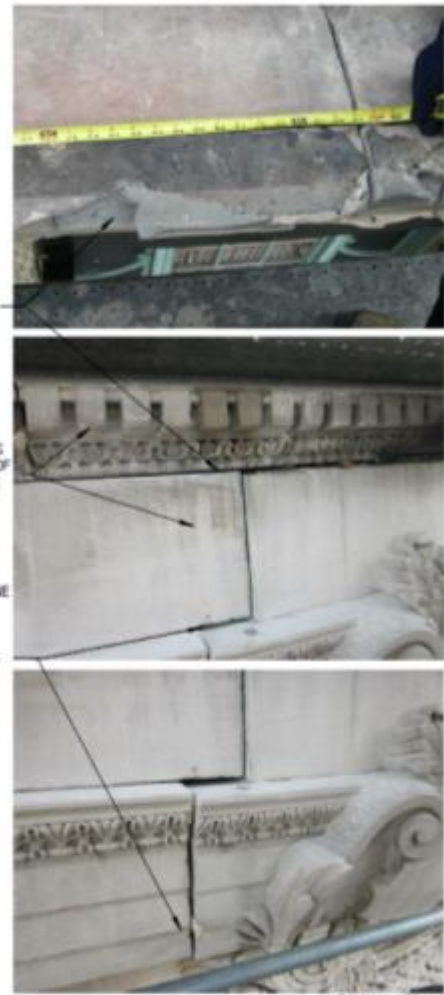
SECTION B - B

assessment of the conditions necessitating the displacement will inform the subsequent stabilization of at least four of the remaining six cartouche assemblies. (Total of seven cartouche.) Alternatively, given that the assembly works as a true arch, a repair-in-place is feasible. Approximated life-span is 25 years. The visual displacement would remain.
(1/A301)

EXISTING LIMESTONE CORNICE EDGE CONDITION WATER INFILTRATION AT COMMON BRICK BACK-UP WALL.

WORST-CASE CONDITION AT ONE OF SEVEN CARTOUCHE LOCATIONS. KEYSTONE UNITS SHIFTED DOWN AND OUT OF PLANAR ALIGNMENT.

The re-alignment of the most displaced limestone cartouche will necessitate the complete deconstruction and rebuild of the wall's full-depth including the solid balustrade above. An

AREA OF INTERVENTION FOR DECONSTRUCTION AND REBUILD OF SOLID BALUSTRADE, CORNICE, BRICK BACK-UP WALL, CARTOUCHE, KEYSTONE UNITS. REALIGN DISPLACED UNITS.

REMOVE REPLACE CONTINUOUS METAL FLASHING AT TOP CAPS, TYP. NOW USING WITH BALUSTRADE. REPOINT ALL DETERIORATED MORTAR JOINTS.

STANDARD METAL PANEL TO REMAIN. VERIFY AIR CIRCULATION.

CARVED LIMESTONE UNITS TO BE CLEANED OF EFFLORESCENCE AND DIRT AND GRIME, TYP.

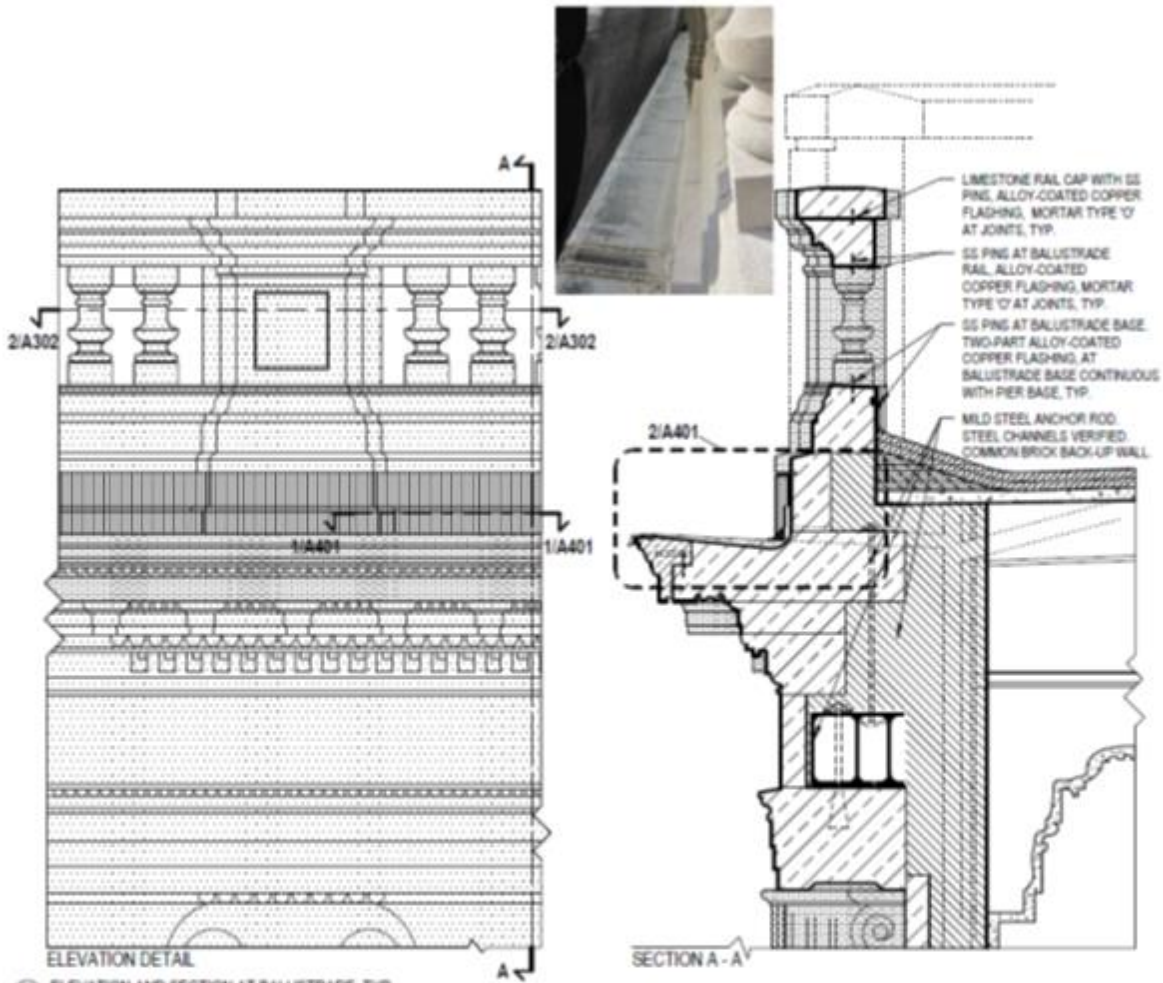
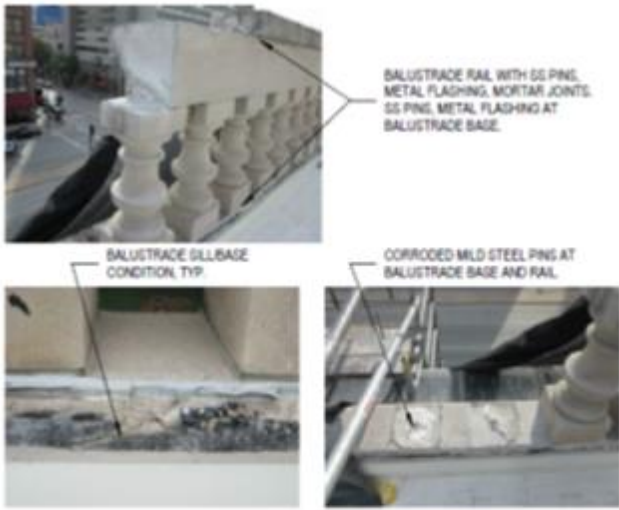
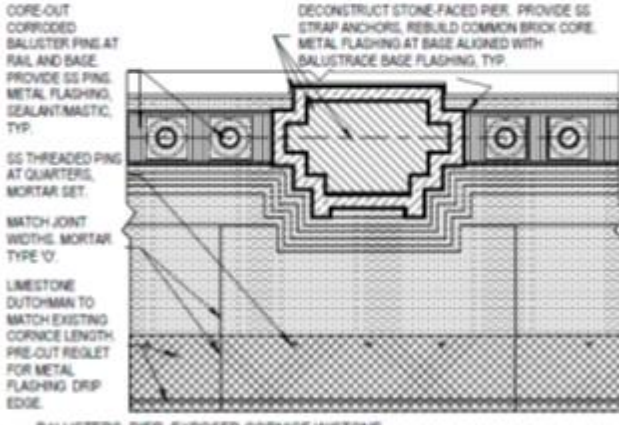
1 ELEVATION AND SECTION AT BALUSTRADE, TYP.
1/2" = 1'-0"

The missing and cracked balusters will be replaced by newly fabricated limestone balusters. The Masonry Contractor will remove an existing baluster. The Stone Contractor will use the removed baluster as a template for new limestone elements. The existing mild steel anchor pins will be cored-out at all balusters. Stainless steel pins shall be provided, with copper thimbles for flashing conditions. New alloy-coated copper flashing will safeguard the longevity of the limestone balusters. (A001, A101)

The solid masonry piers will be deconstructed and the limestone facing units, salvaged. All sixteen, individual piers shall have a new common brick core. The salvaged, cleaned limestone units will be the facing to the brick core. The pier's assembly shall be anchored by stainless steel masonry strap anchors.

The alloy-coated copper, adopted for the cornice gutter, will also flash the individual pier cap stones, balustrade cap stones and baluster base units (plinth). (1/A302)

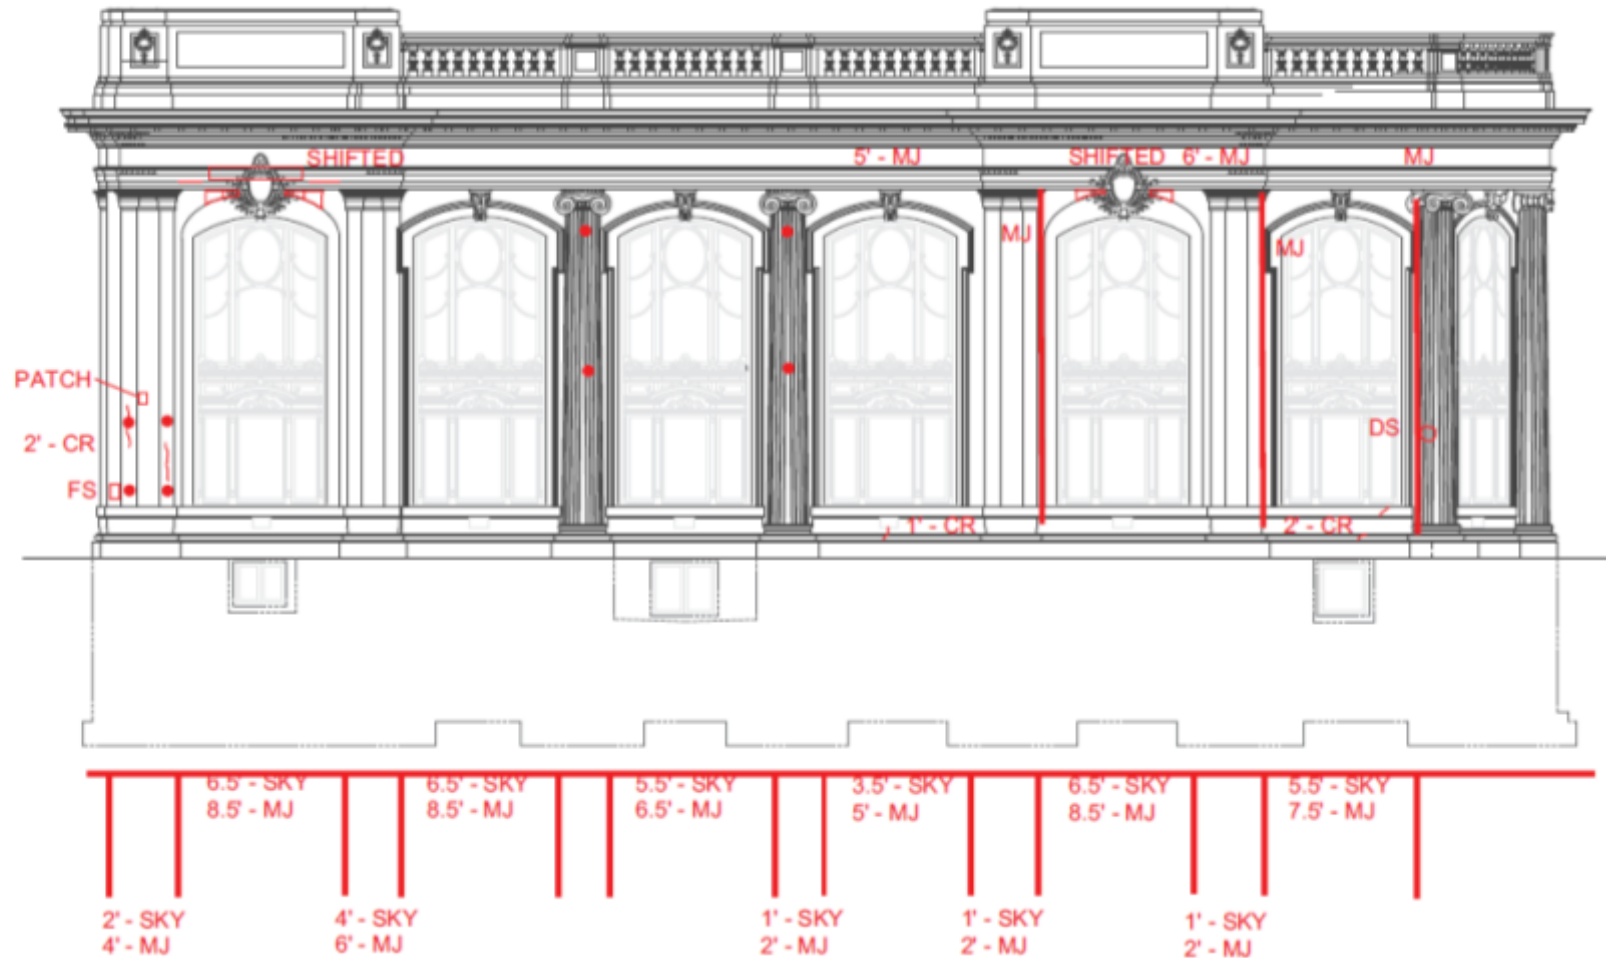
Kilbourn St. Elevation (SOUTH)

Limestone repairs in the facades include: the spalled, cracked units; failed mortar joints. The attached photographic narratives and annotated architectural drawings illustrate the conditions and the scope of the restorative interventions.
