C.I. File No:05-S-193

In the matter of: Damage to my personal vehicle at the City of Milwaukee Safety Academy

In the Matter of: Damage to Vehicles Parked in the Lot at the Police Academy

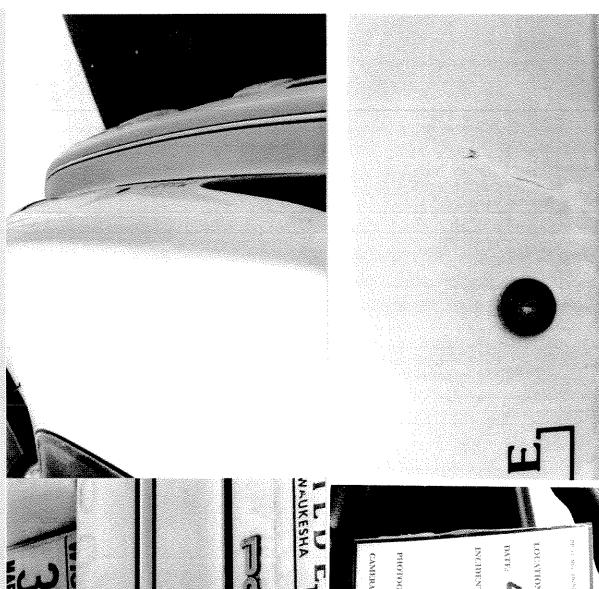
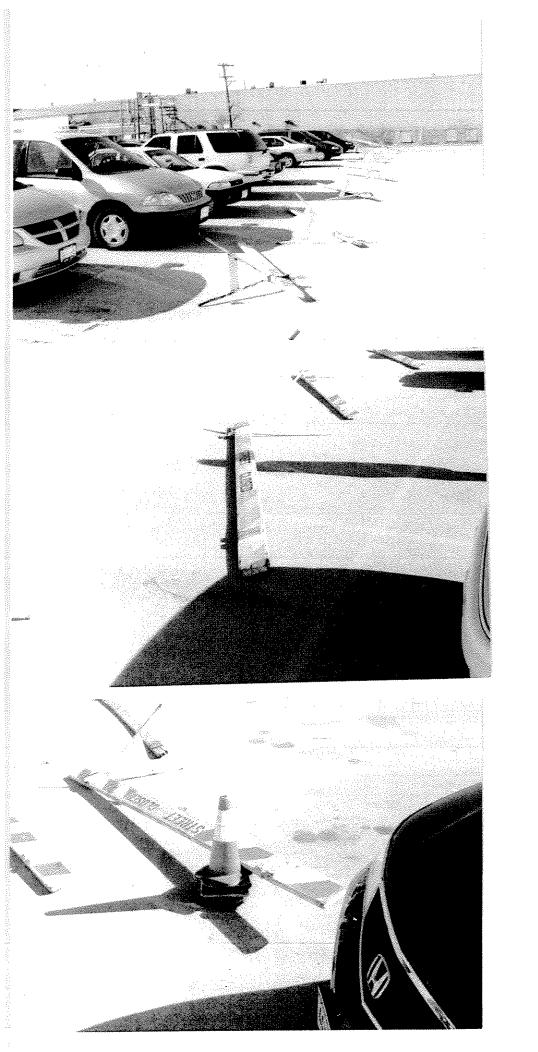
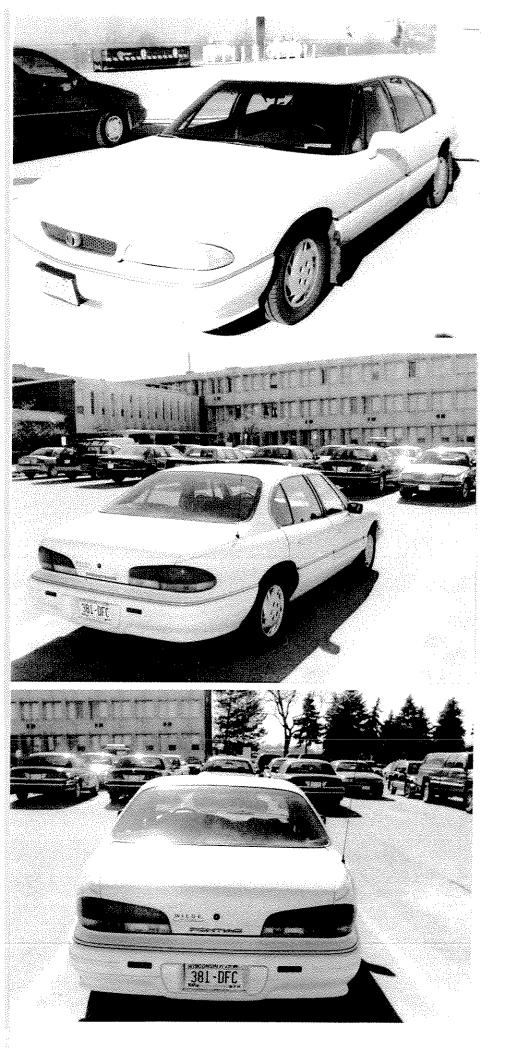
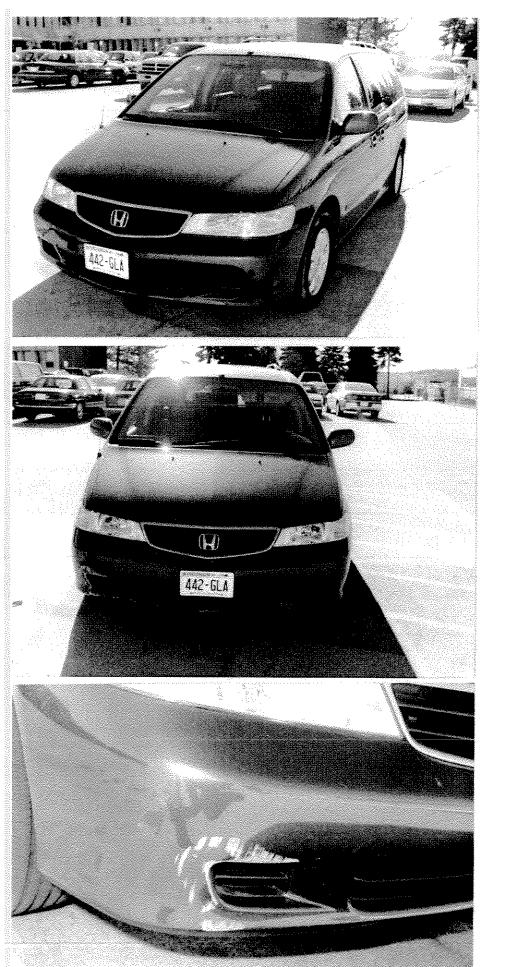
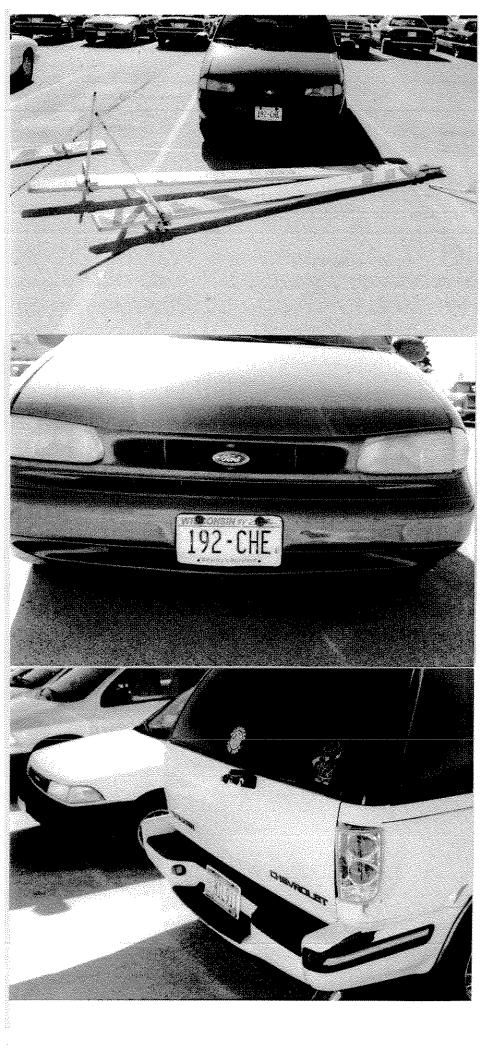
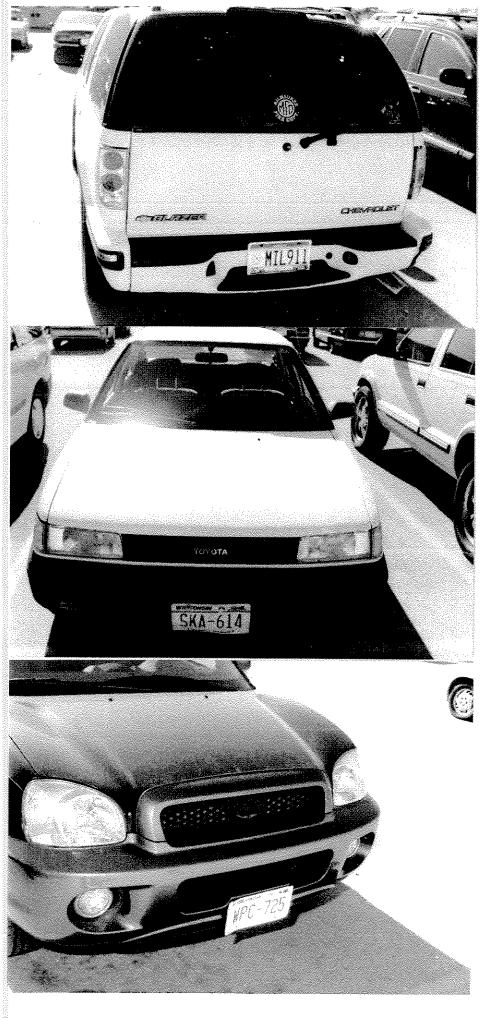
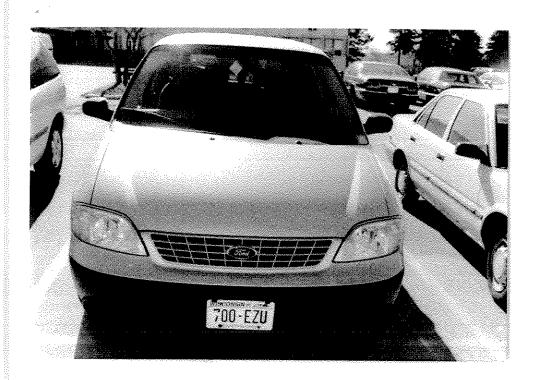
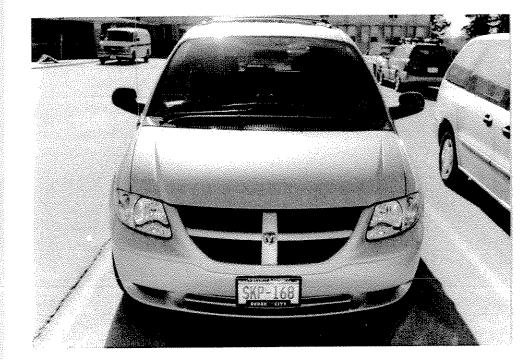
1994 Pontiac Bonneville, 4-dr, White, 381-DFC WI 06, VIN #1G2HX52L1R4245371 Registered to: James M. Crouse and Jori M. Crouse of 3676 S. 95<sup>th</sup> Street, 53228 Scratch, dents, and paint transfer to the trunk and rear bumper. Insurance-American Family.
