**Certificate of Appropriateness Application – Supporting Photos**  
Frank Lloyd Wright American System-Built Homes Model Two Flat “C” Exterior Restoration  
2732-2734 West Burnham Street  
American System Built Homes Historic District

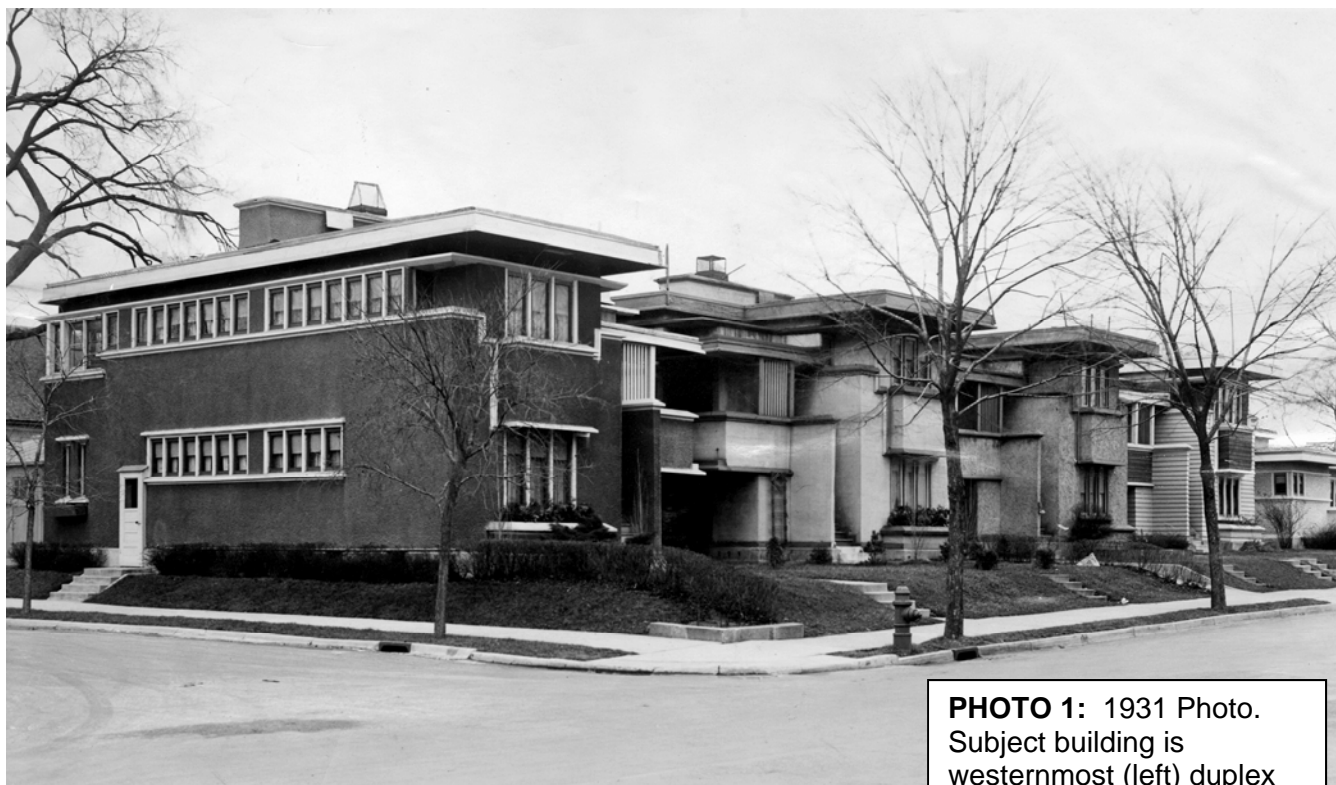
**PHOTO 1:** 1931 Photo.  
Subject building is  
westernmost (left) duplex

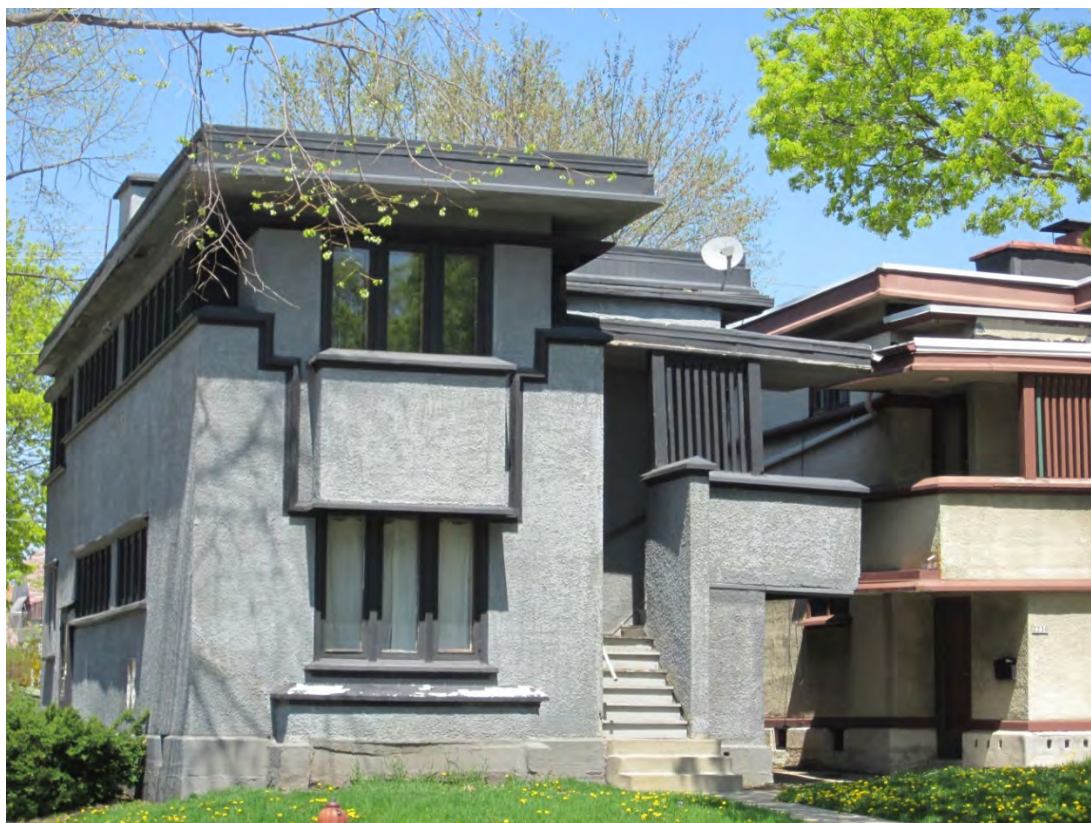
**PHOTO 2:**  
Existing south  
(front) elevation

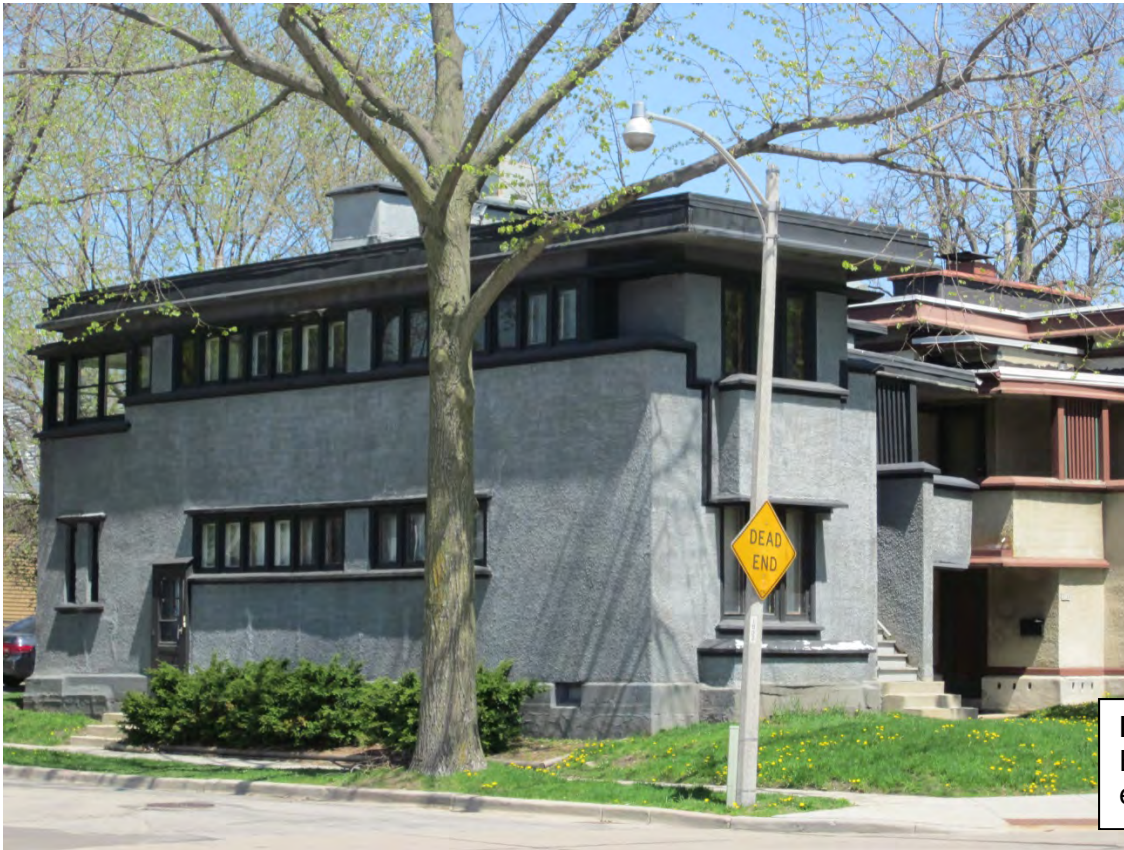
**PHOTO 3:**  
Existing west  
elevation

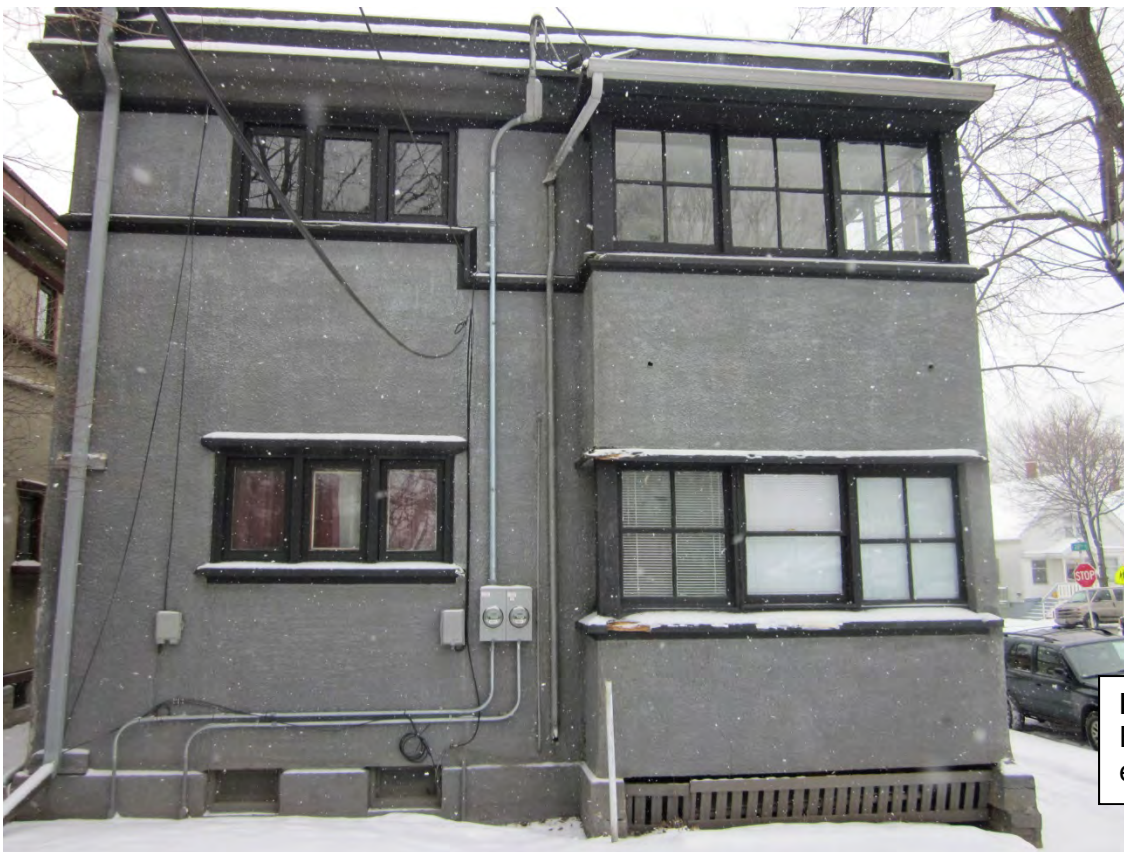
**PHOTO 4:**  
Existing north  
elevation

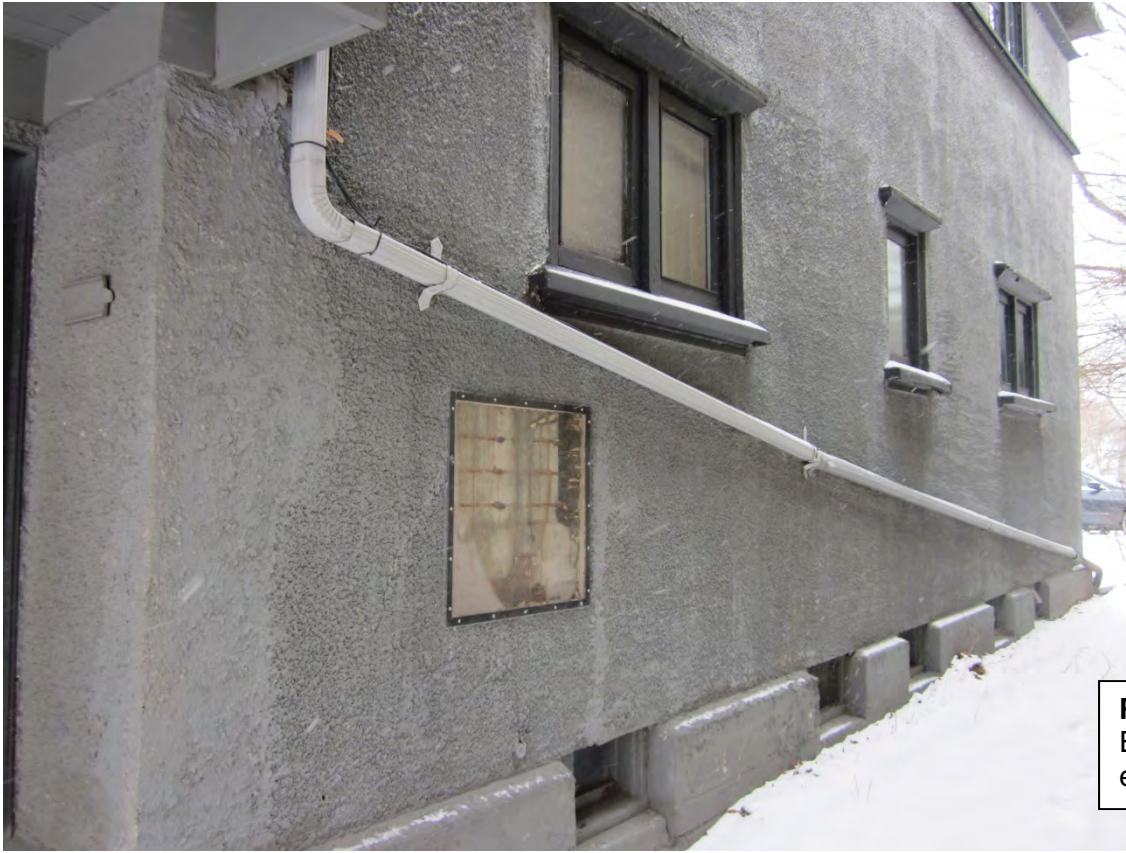
**PHOTO 5:**  
Existing east  
elevation

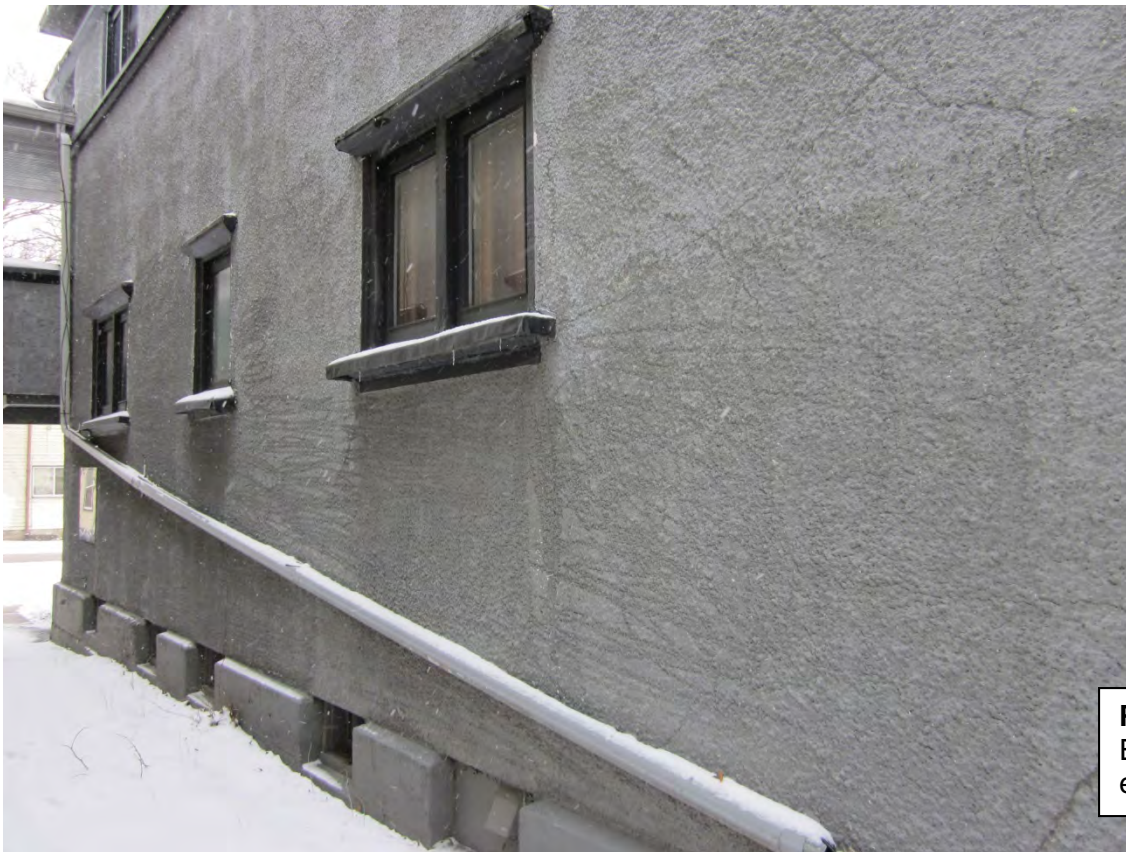
**PHOTO 6:**  
Existing east  
elevation

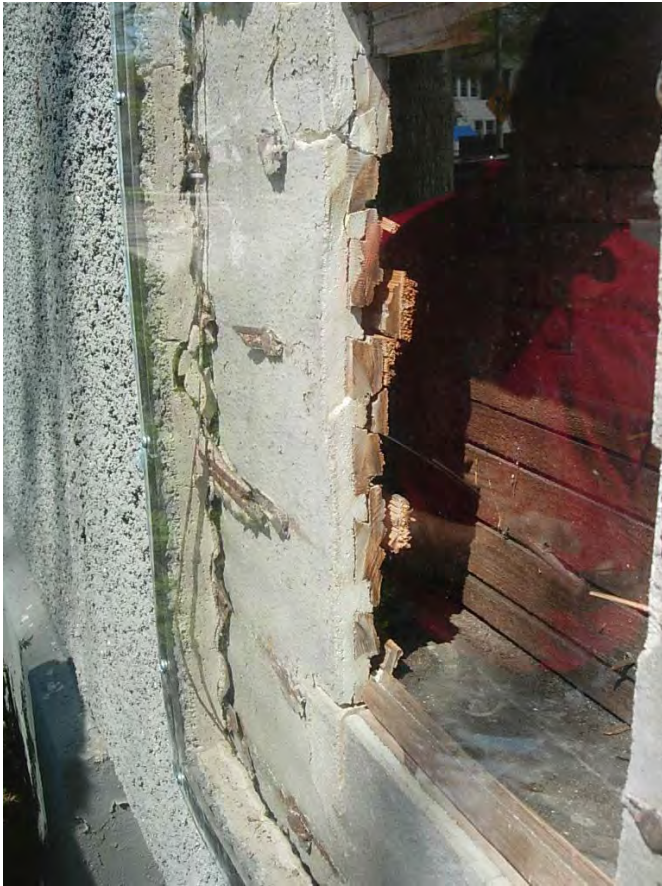
**PHOTO 7:**  
Exploratory window in exterior wall showing original and added stucco systems.

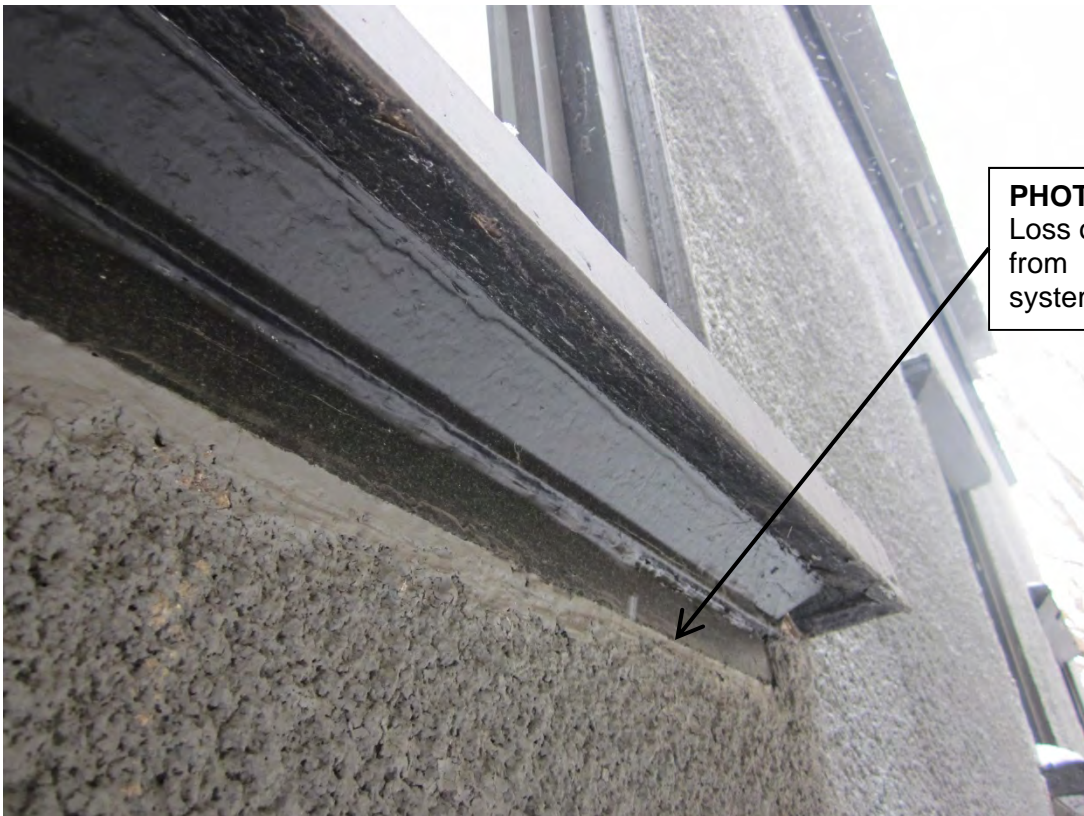
**PHOTO 8:**  
Loss of shadow line from added stucco system.

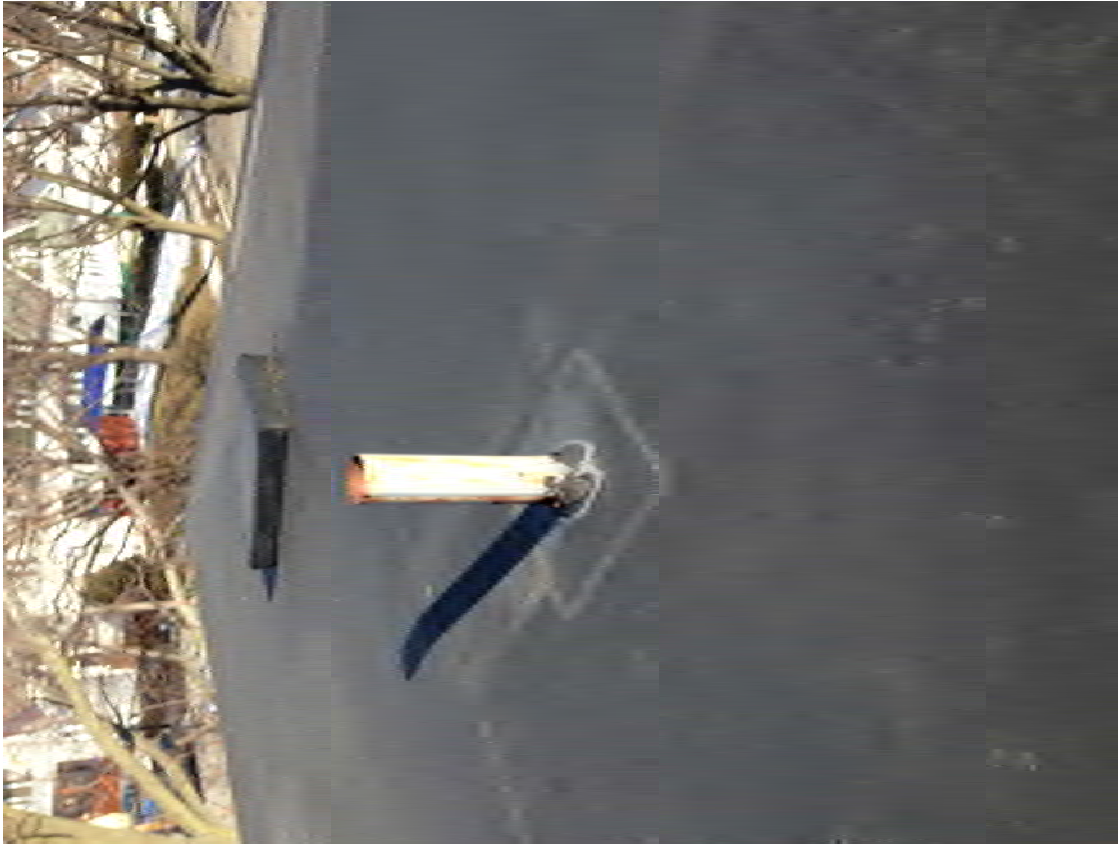
**PHOTO 9:**  
Low-pitched hip roof on  
top of original roof.

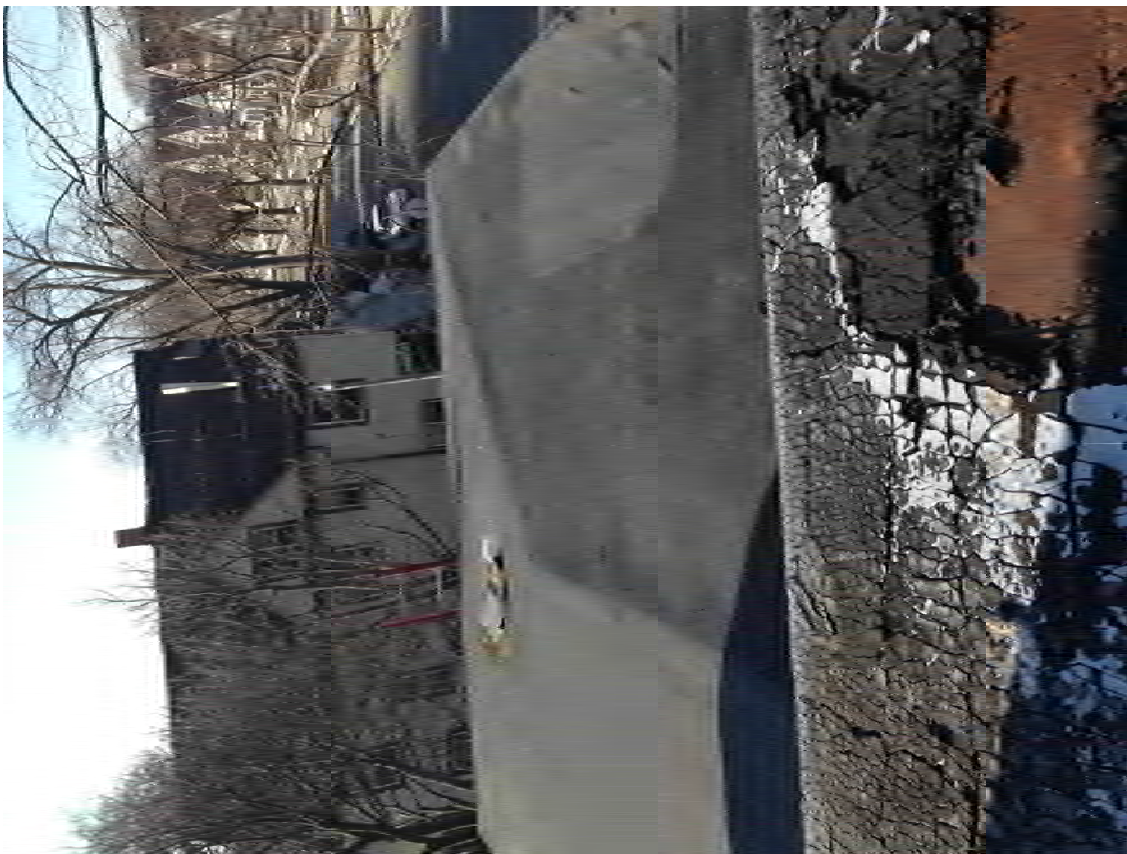
**PHOTO 10:**  
Low-pitched hip roof on  
top of original roof.  
Deteriorated roof on  
monitor.

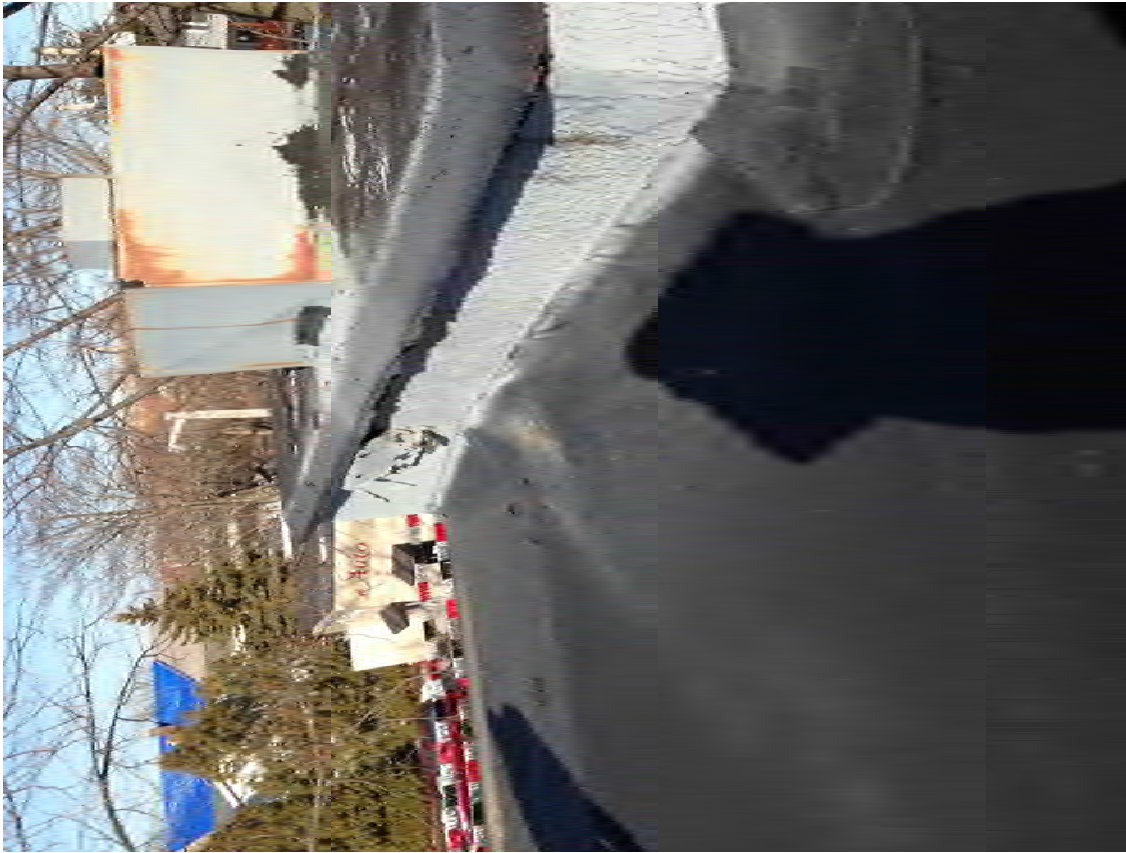
**PHOTO 11:**  
Low-pitched hip roof on  
top of original roof.  
Deteriorated roof on  
monitor.

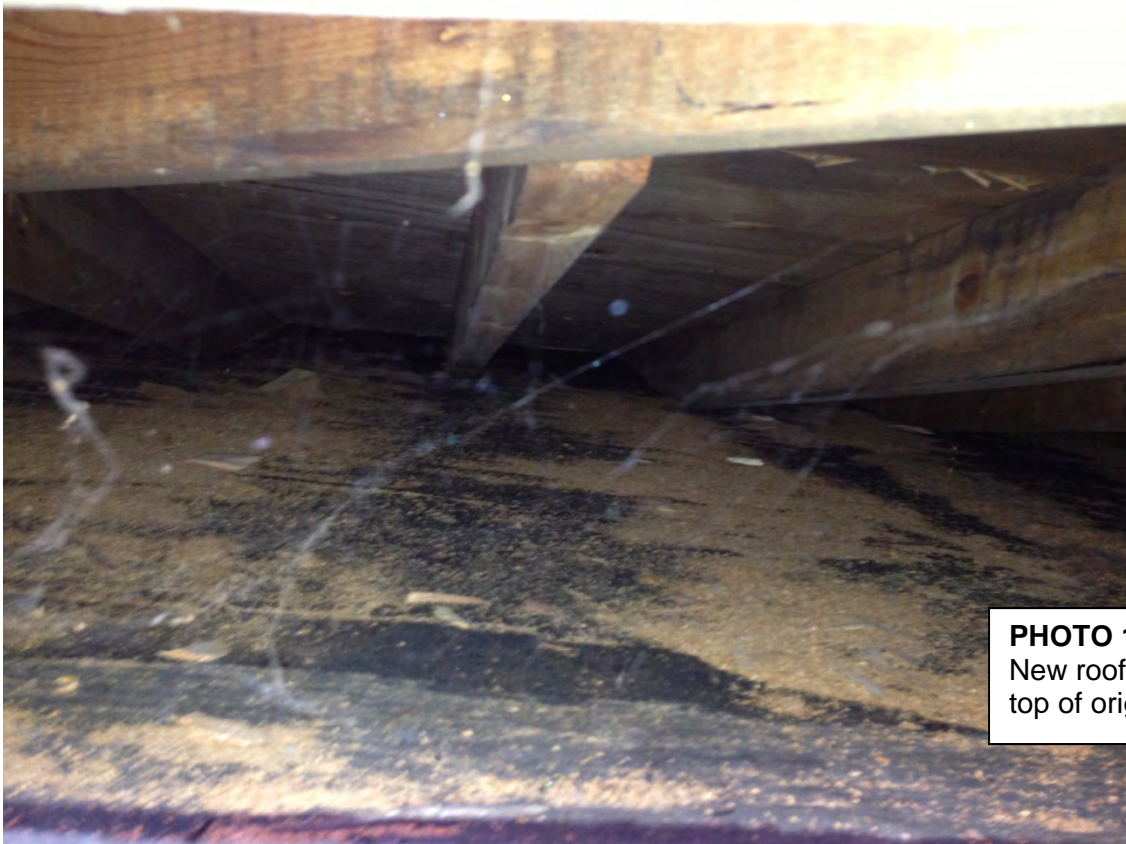
**PHOTO 12:**  
New roof structure on  
top of original roof.

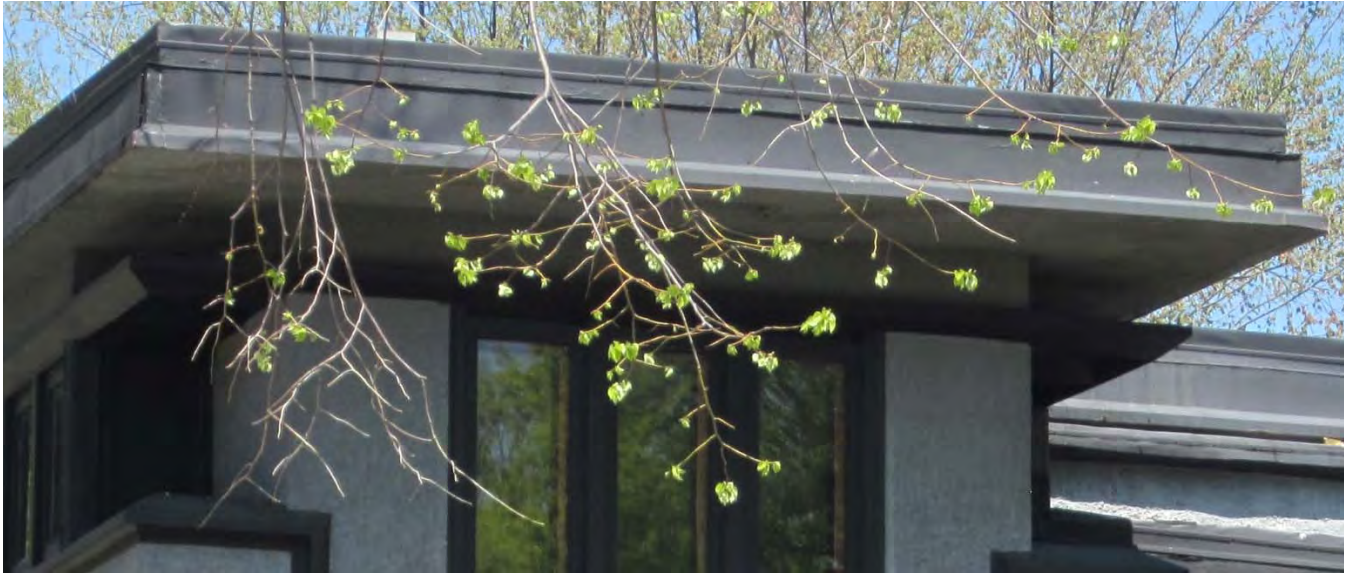
**PHOTO 13:**  
Existing fascia condition.

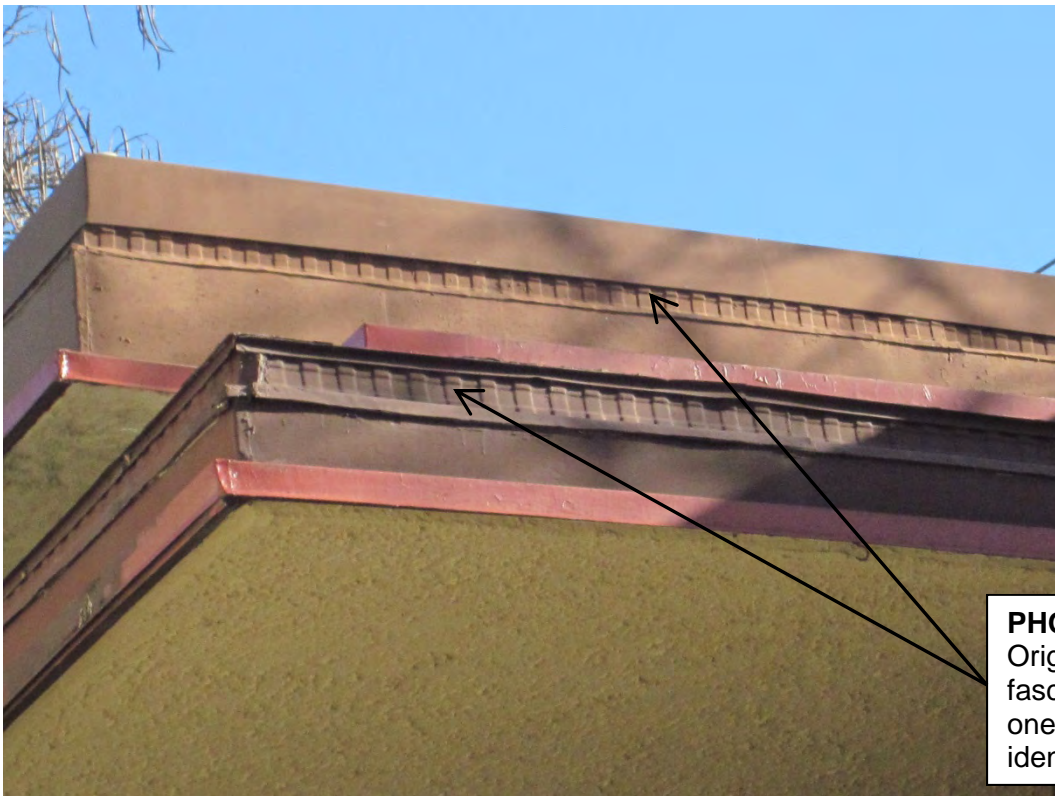
**PHOTO 14:**  
Original pressed metal fascia still remains on one of adjacent identical duplexes.

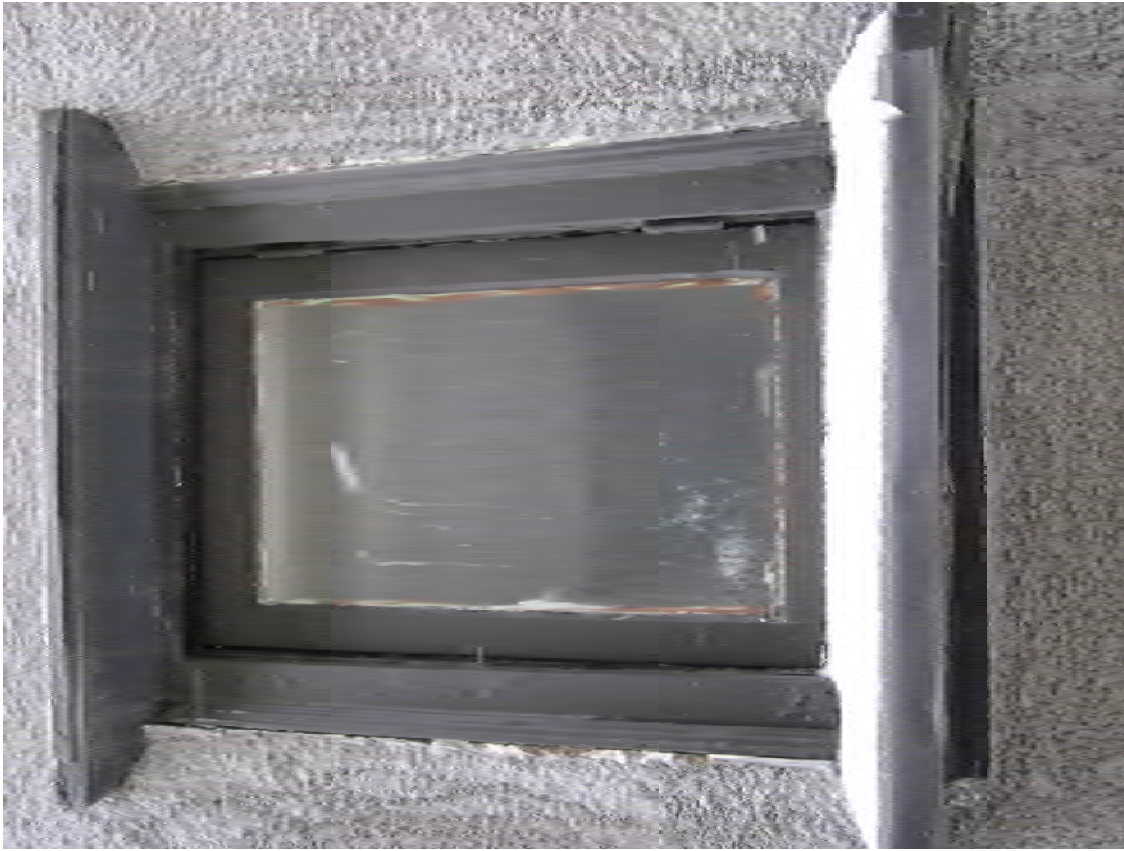
**PHOTO 15:**  
Deteriorated wood trim,  
covered with aluminum  
cladding.

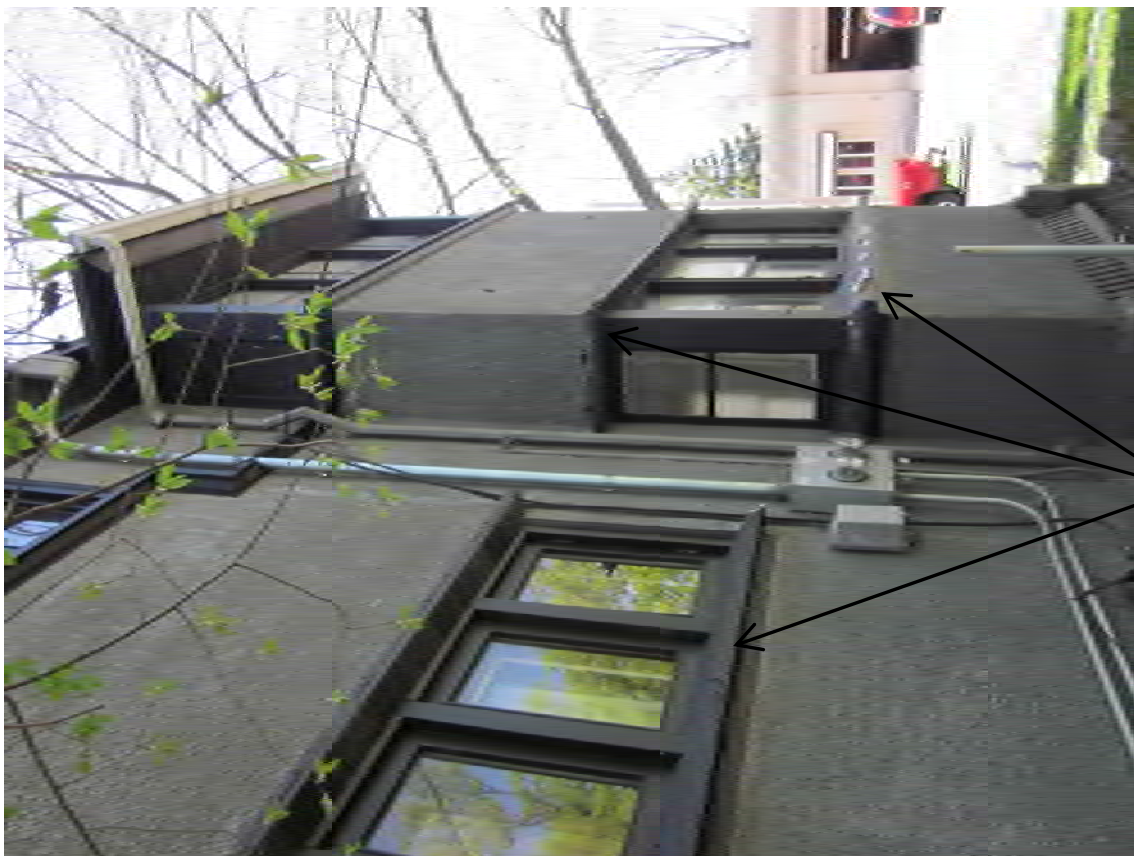
**PHOTO 16:**  
Wood trim, in various  
stages of deterioration/  
soundness.

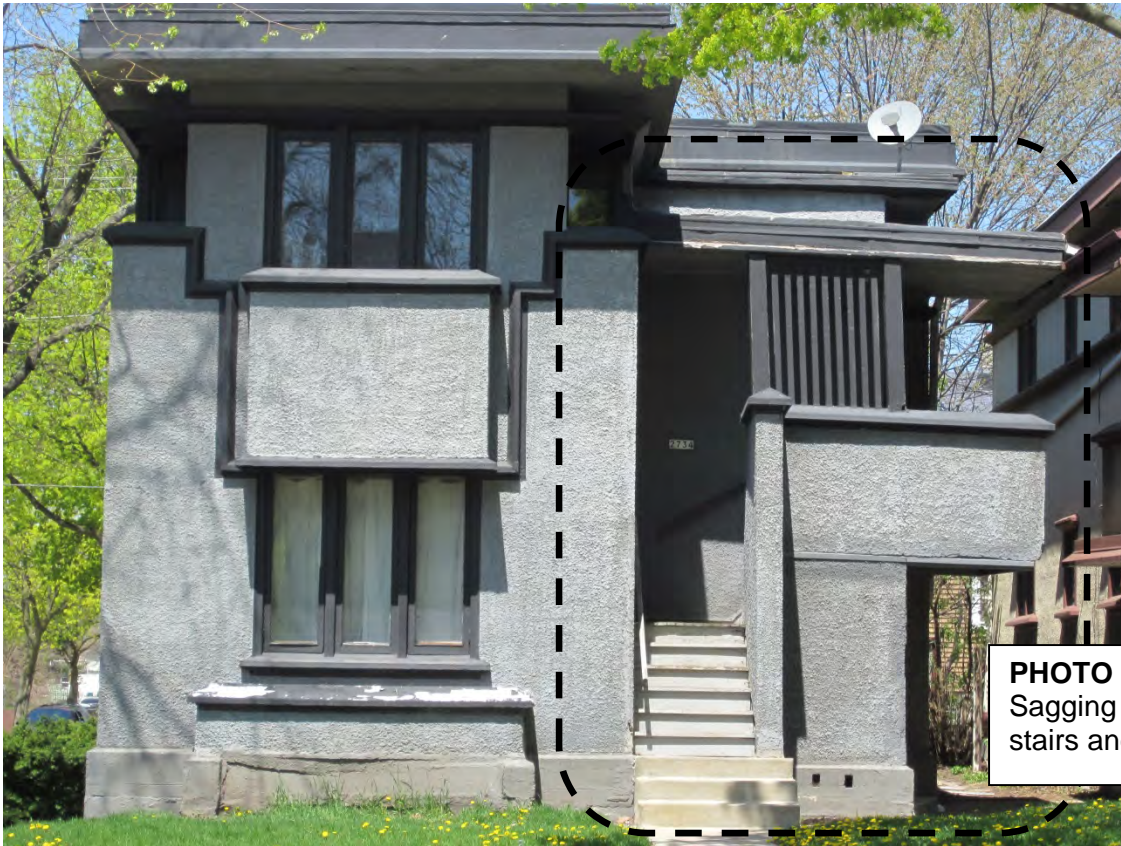
**PHOTO 17:**  
Sagging and twisting  
stairs and landing.

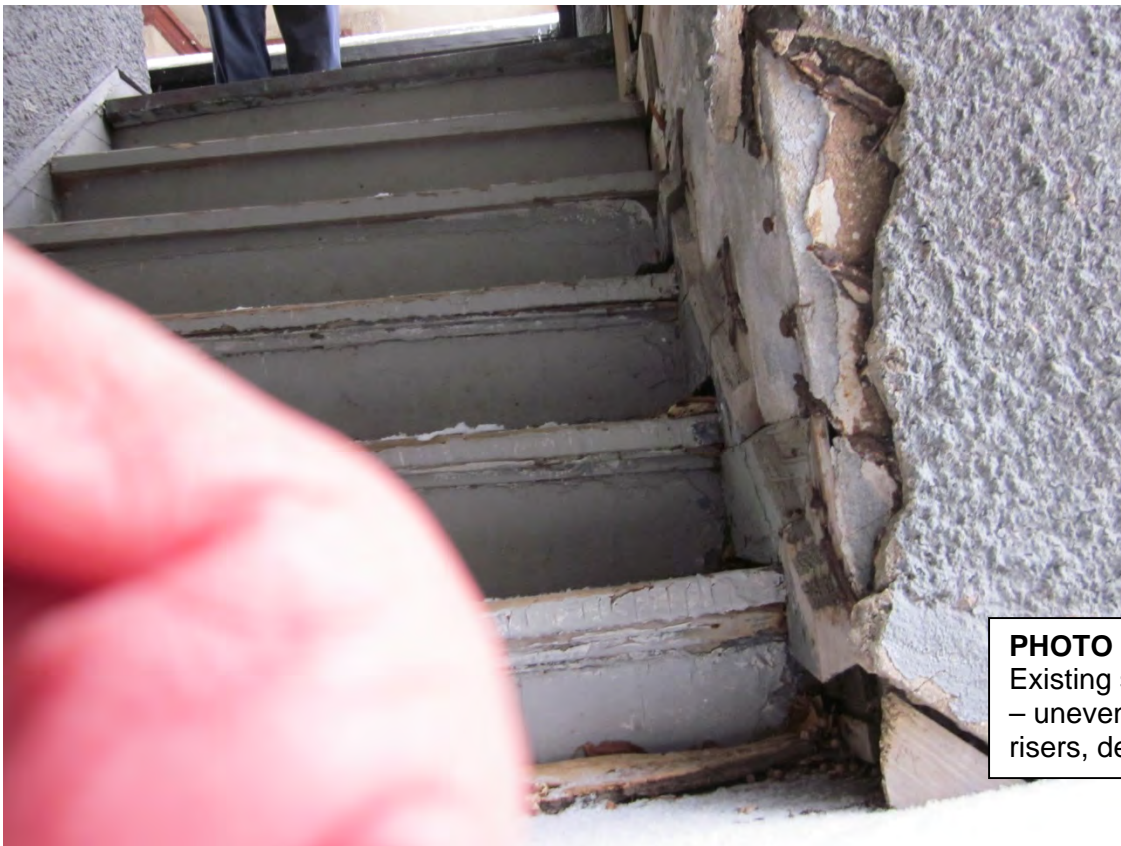
**PHOTO 18:**  
Existing stair condition  
– uneven treads and  
risers, deteriorated wall.

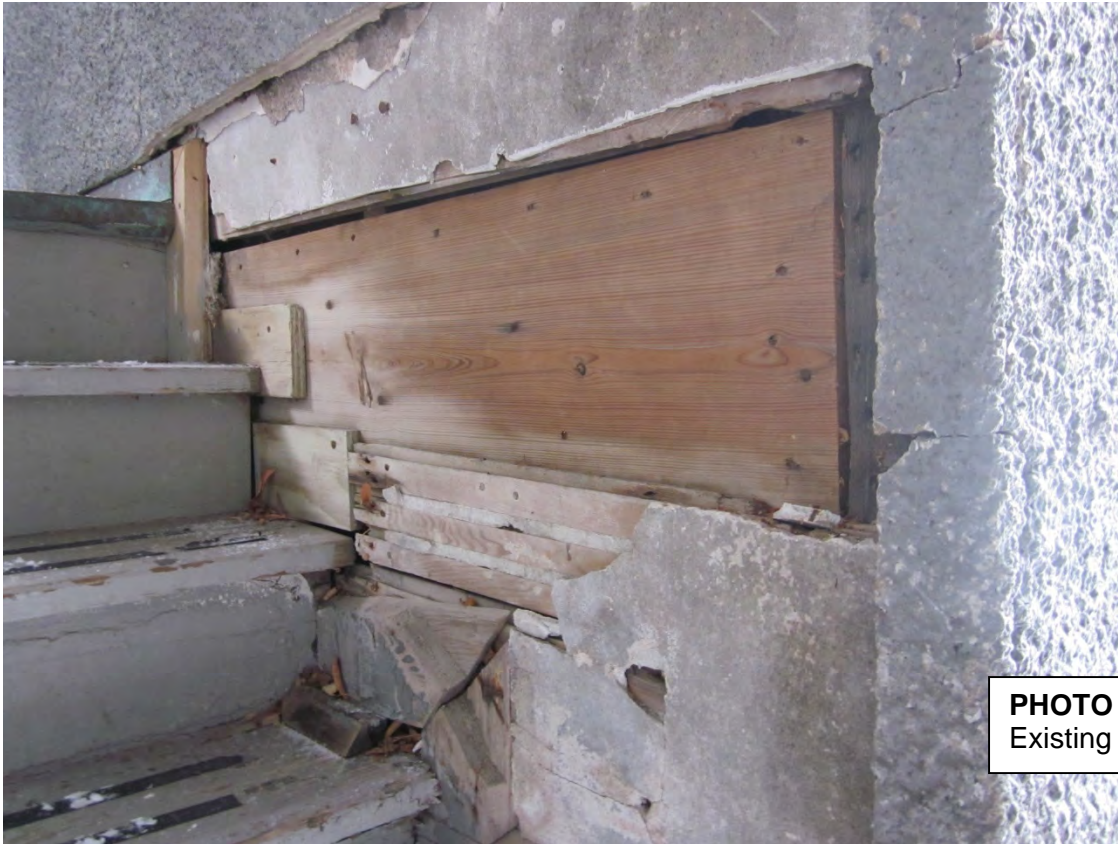
**PHOTO 19:**  
Existing stair condition.

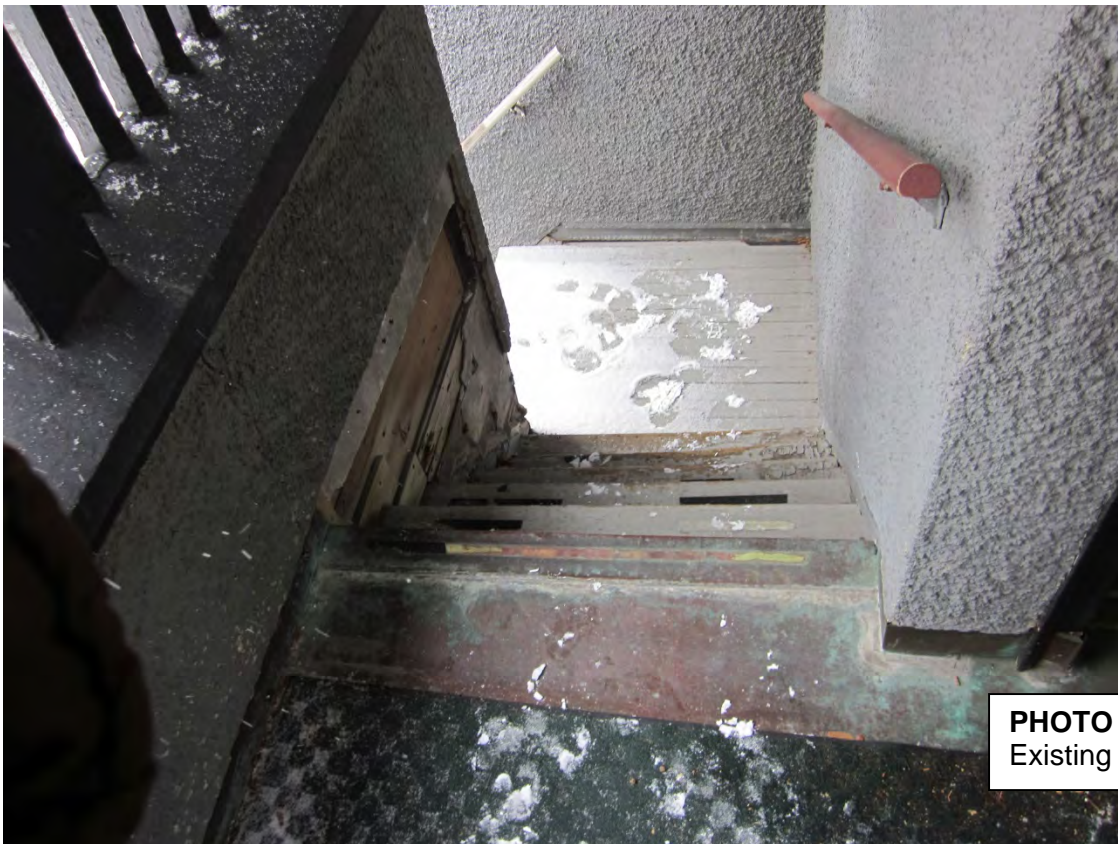
**PHOTO 20:**  
Existing stair condition.

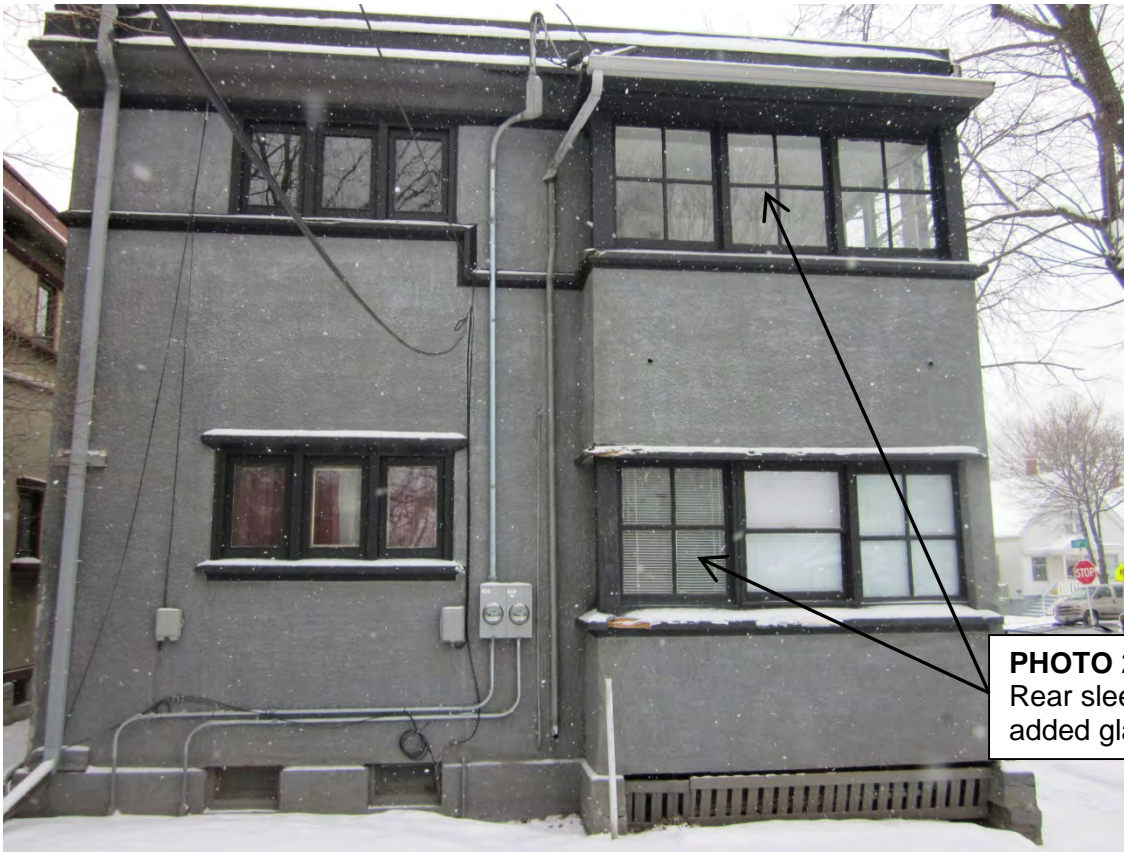
**PHOTO 21:**  
Rear sleeping porch  
added glazing.

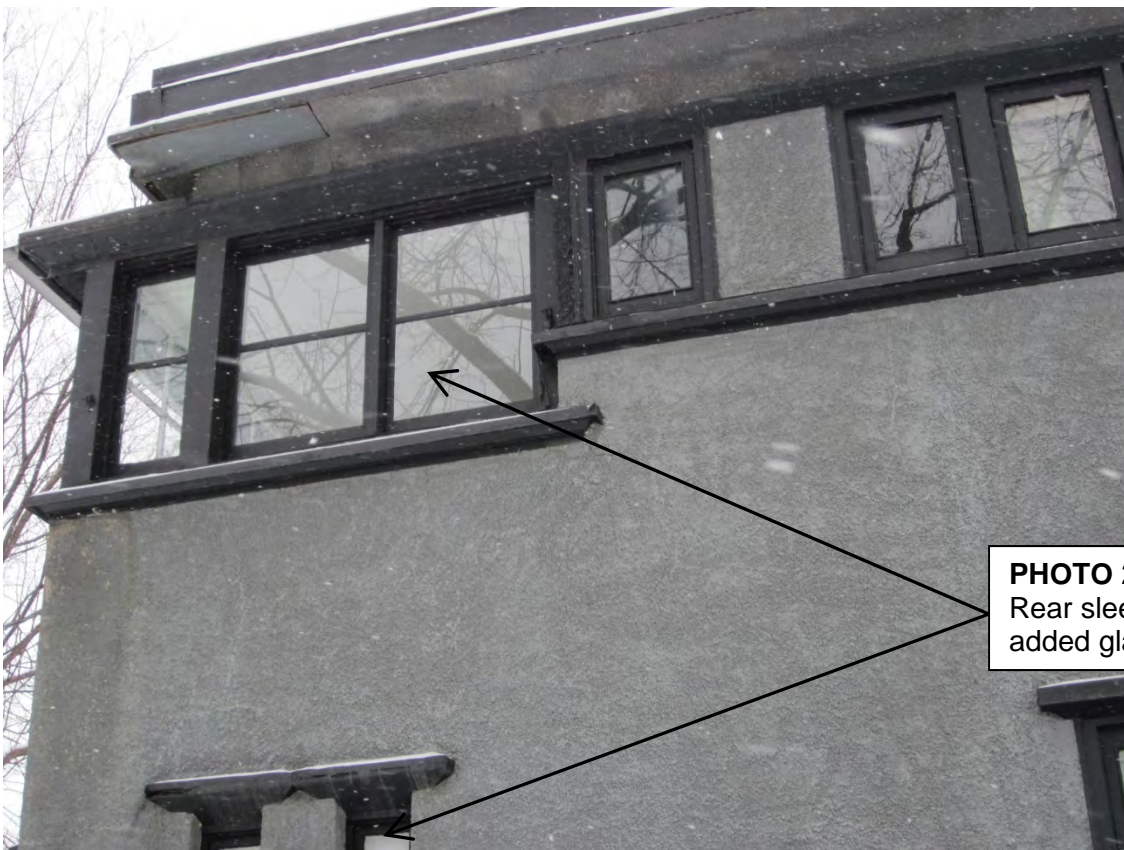
**PHOTO 22:**  
Rear sleeping porch  
added glazing.

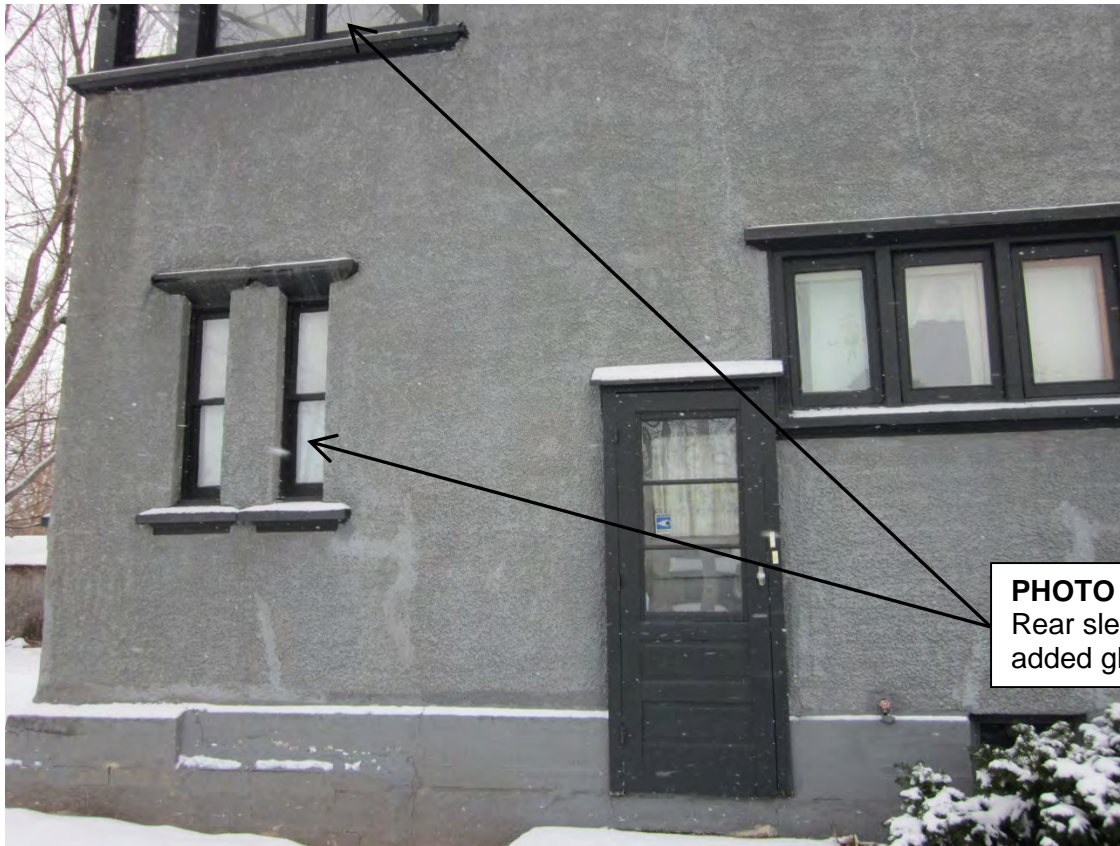
**PHOTO 23:**  
Rear sleeping porch  
added glazing.

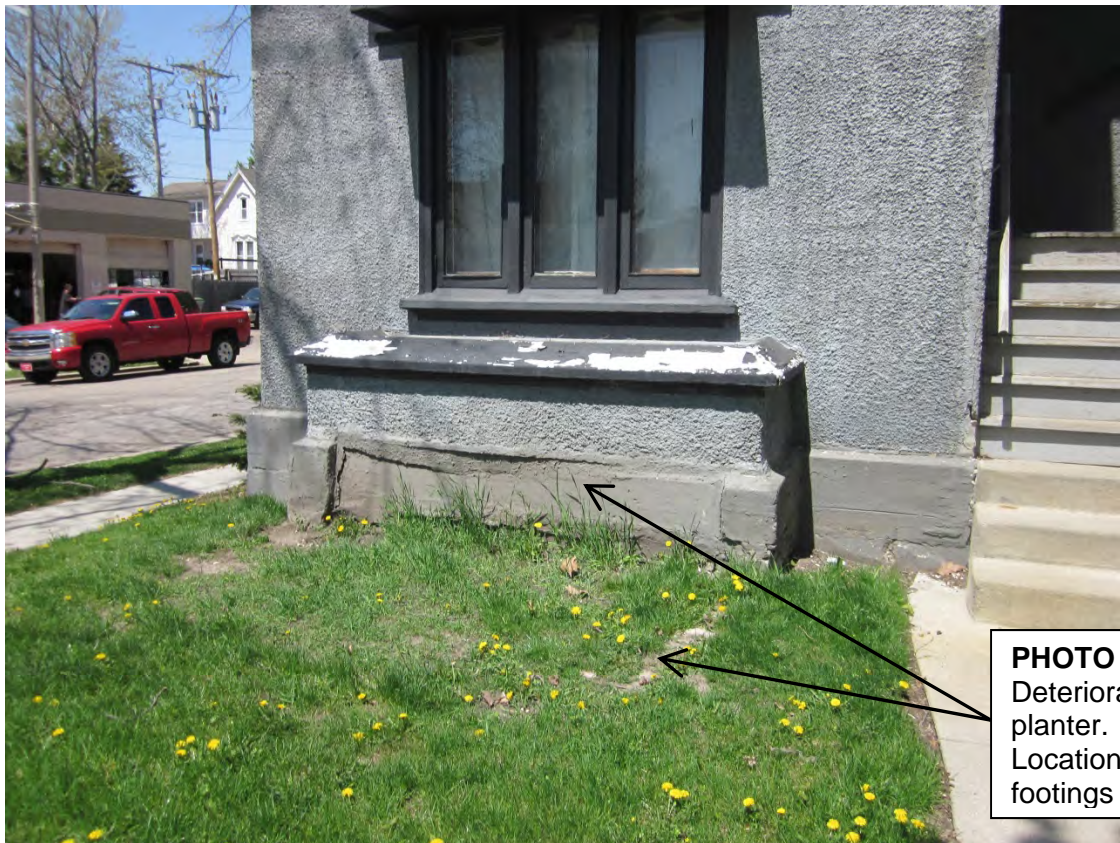
**PHOTO 24:**  
Deteriorated front  
planter.  
Location of existing  
footings below grade.
