2804 North Grant Blvd Milwaukee, WI 53210

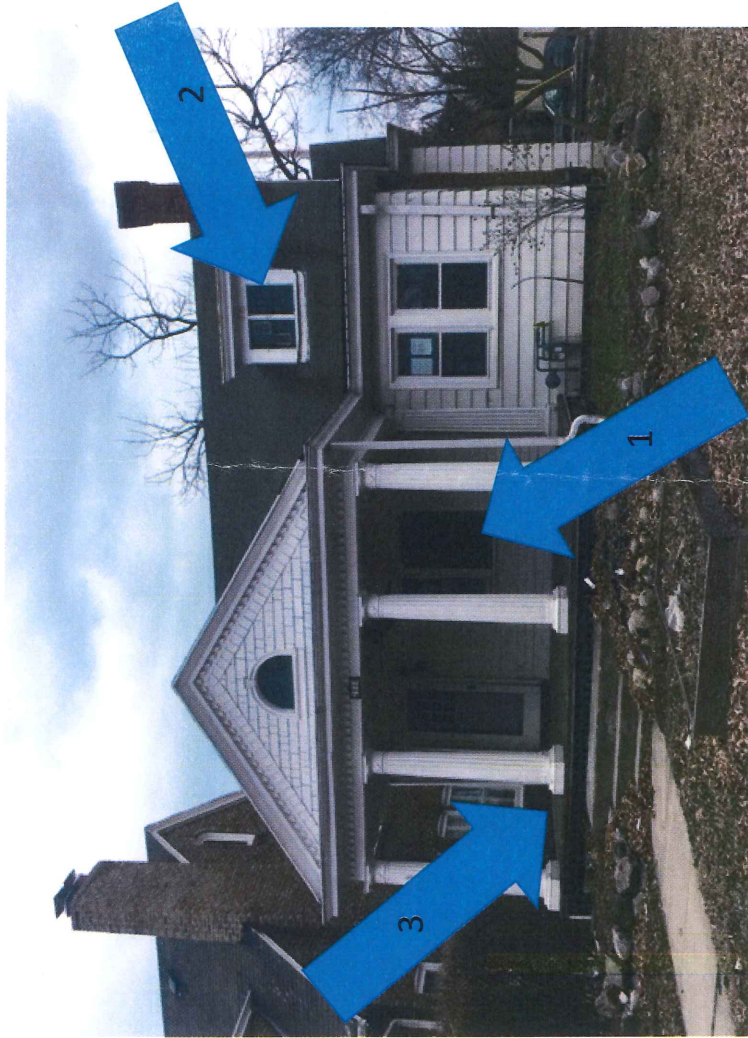
- 1.) Broken window was repaired.
- 2.) Rotted windows replaced with windows similar to other windows on the face of the home for uniformity.
- 3.) Porch deck has been sanded down and will be refinished.
- 4.) Both decorative windows adjacent to the fireplace were removed, repaired and painted, and will and/or have been reinstalled.

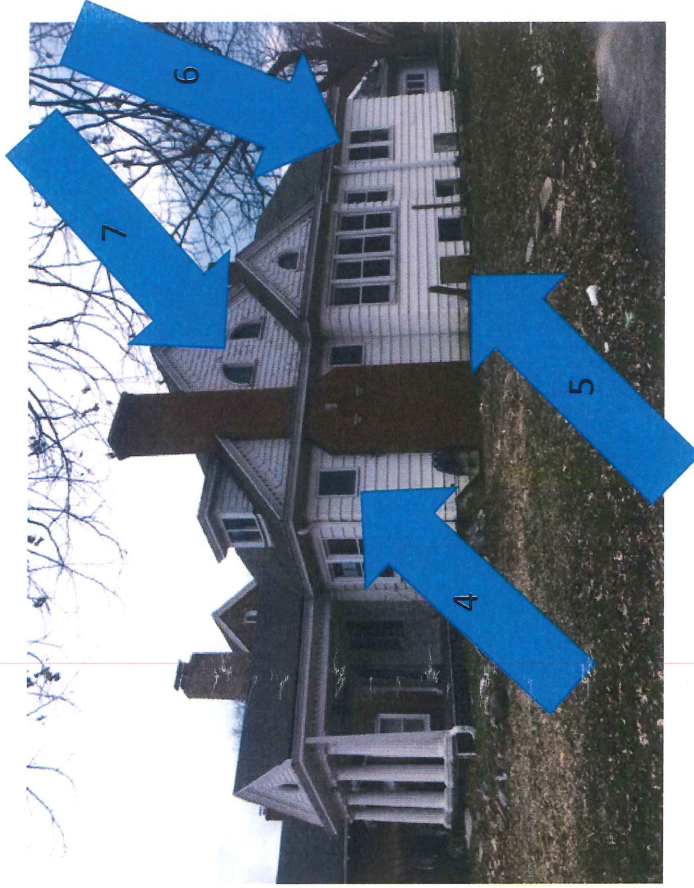
- 5.) Many of the basement windows were broken beyond repair, and were boarded up prior to purchase of the home. Replaced all with glass-block for safety, added light, and ventilation (total of eight).
- 6.) Rotted windows were replaced with vinyl window similar to the other five vinyl windows on this side of home for uniformity.
- 7.) Decorative windows were removed, repaired and painted, and will and/or have been reinstalled.

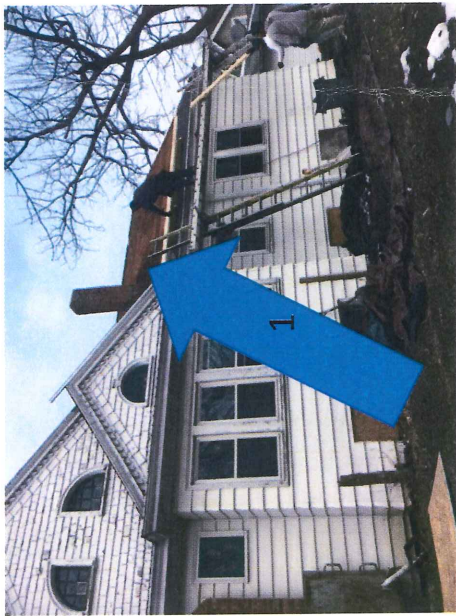
1.) Three layers of roofing shingles were removed from the home, revealing that there was no decking materials on the roof.

2.) A new roofing deck was put on the home, prior to a new roof being installed.

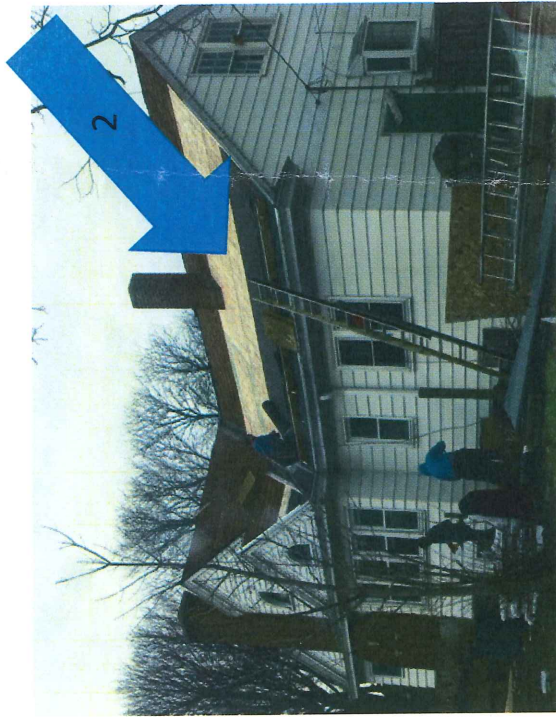
3.) Two layers of roofing shingles were removed from the garage, before a new roof was installed.

4.) The tree leaning on the garage, that was also entangled in the power lines, was removed to prevent the leaves and branches from affecting the power lines or from damaging the new roof on both the home and the garage.

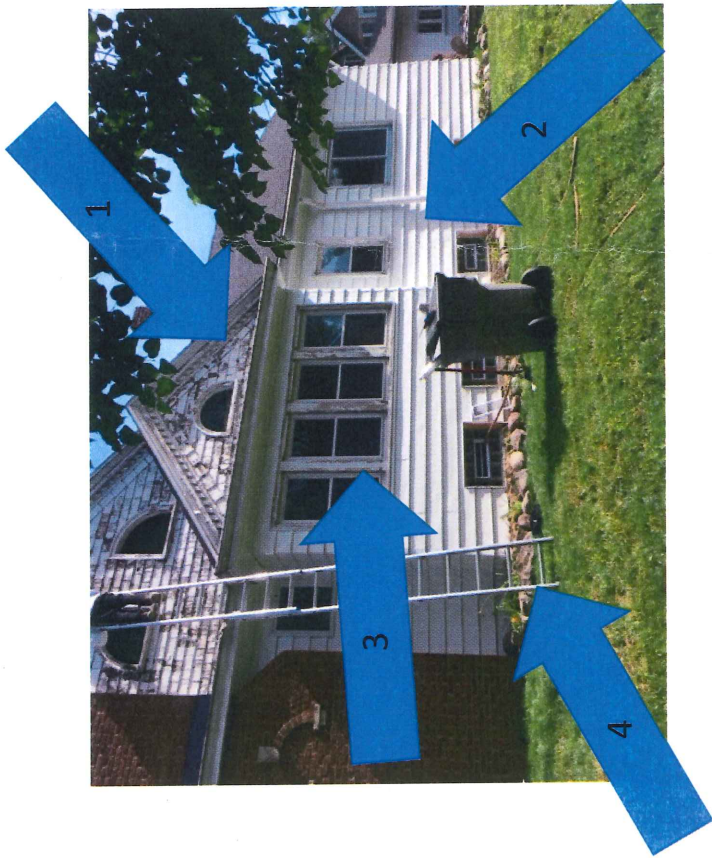
- 1.) Wood shingle siding was scraped and repainted.
- 2.) Aluminum siding was scraped and repainted.
- 3.) Wooden window frames were scraped and repainted.
- 4.) Flower bed formed on the side of the home, using stones already on the property.

- 5.) Aluminum siding that had been removed from the home prior to purchase was replaced with new aluminum siding, to match the existing siding on the home.
- 6.) Aluminum gutter that had been removed from the home prior to purchase was replaced with a new aluminum gutter to match the other gutters on the home.

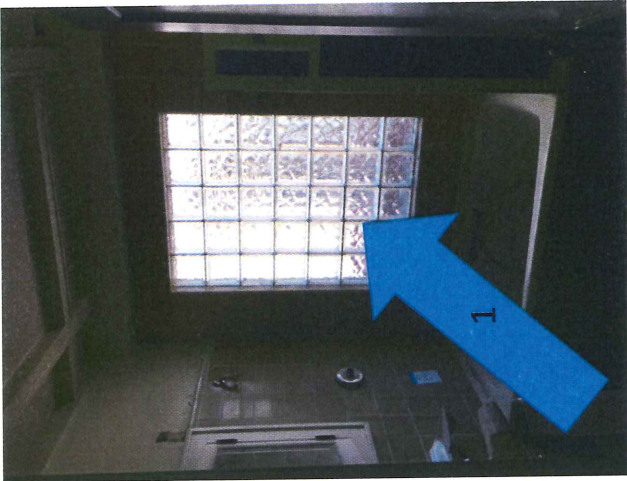
1.) Existing glass-block window saved and flanked with travertine tile, as part of bathroom renovation; including new plumbing, electrical, lighting, vent, HVAC, walls, travertine tile, vanity, sink, bathtub, toilet, doors, and brushed nickel finishes.

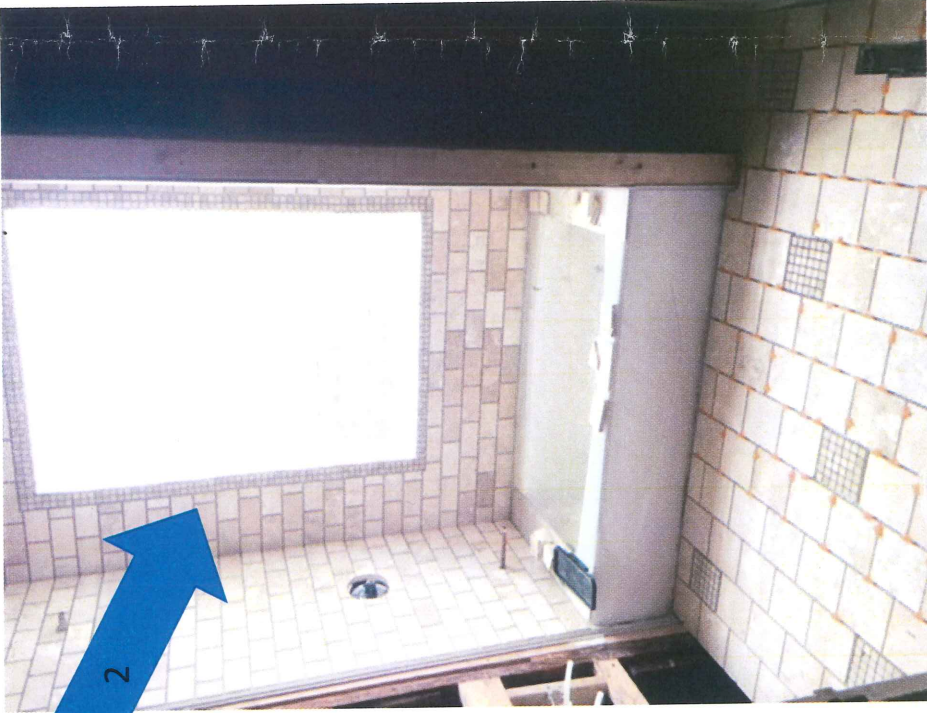
3.) Second floor window opening was covered with a board at time of purchase. There was no existing window or window frame on the property. A small window was installed to match other windows on the north side of the home.

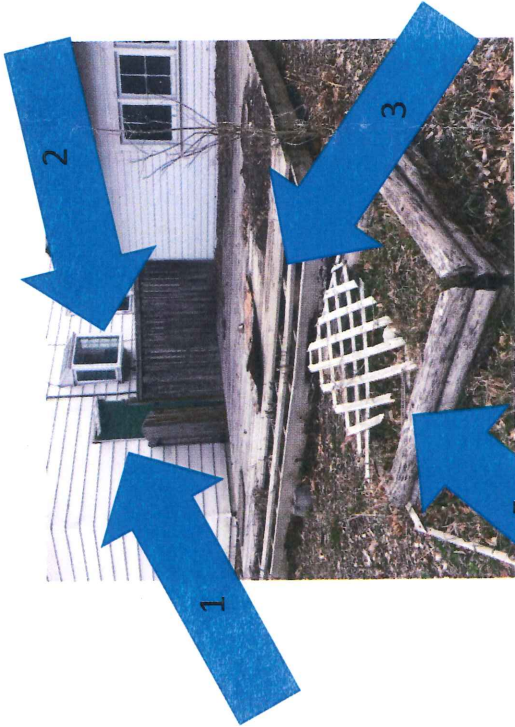
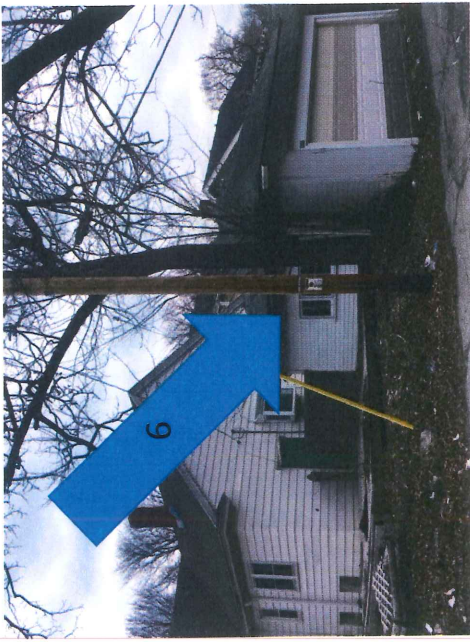
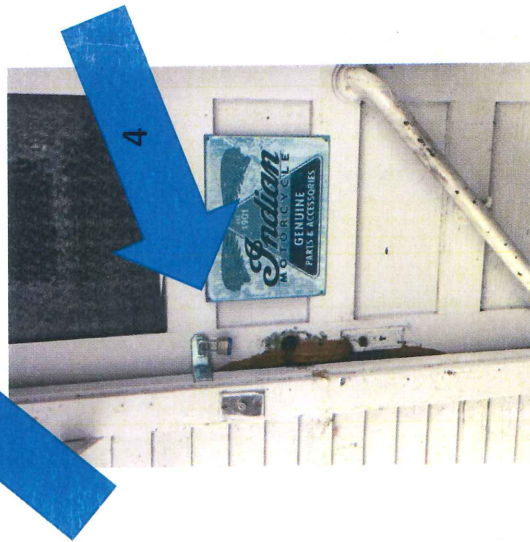
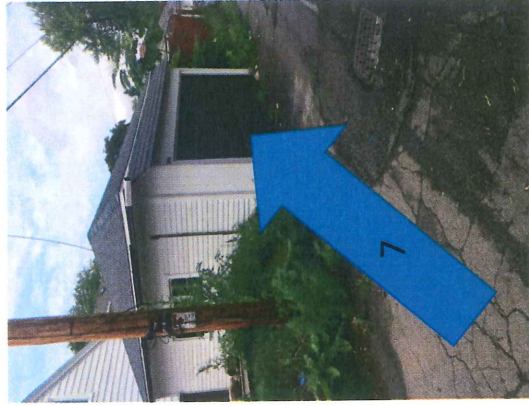
- 1.) Rear door that had been kicked-in and damaged beyond repair prior to purchase, was replaced with a steel door for safety. The door was painted to match the trim on the home.
- 2.) Leaky window was replaced with a window to match the other windows on this side of the home.
- 3.) Rotted and damaged deck boards were replaced.
- 4.) Garage entry door, damaged prior to purchase, will be replaced with a safety door, which will be painted to match the home.
- 5.) Rotted flower bed removed.
- 6.) Broken windows and window frames will be repaired if possible; if not replaced.
- 7.) Multi-colored garage door painted a single color uniform with the home's trim.

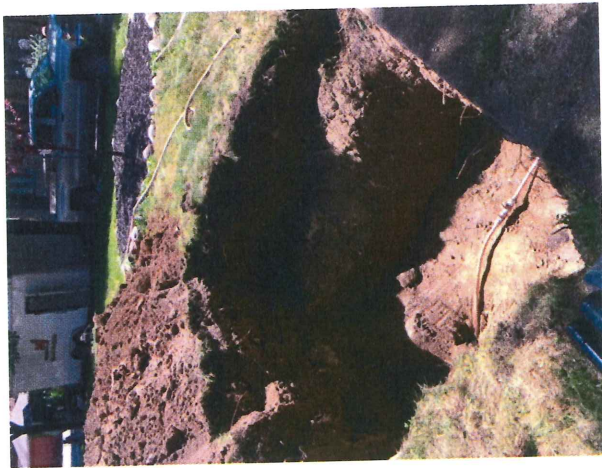
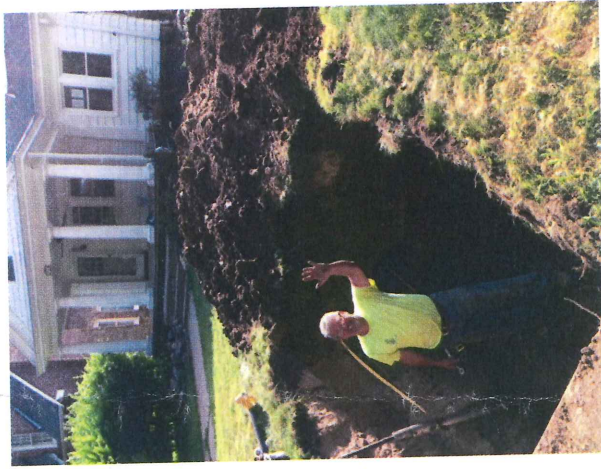
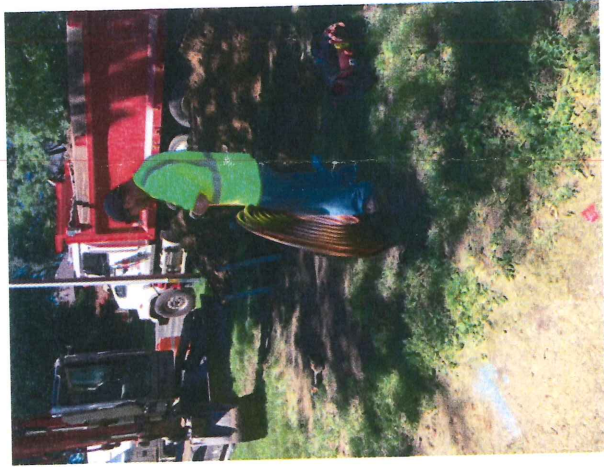
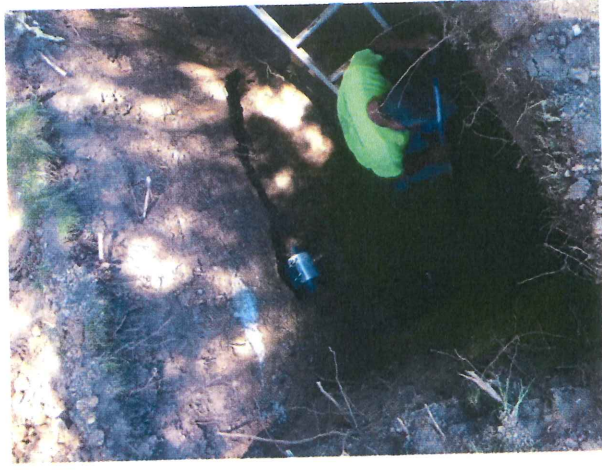
Lead water line replaced by the City of Milwaukee with a copper line; providing clean, safe drinking water to the home.

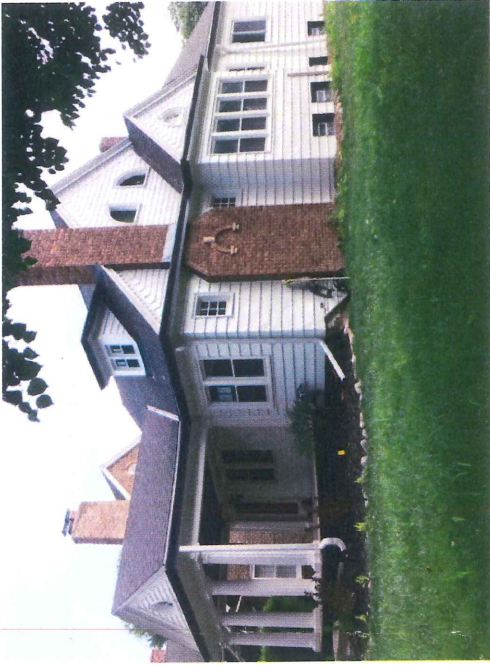
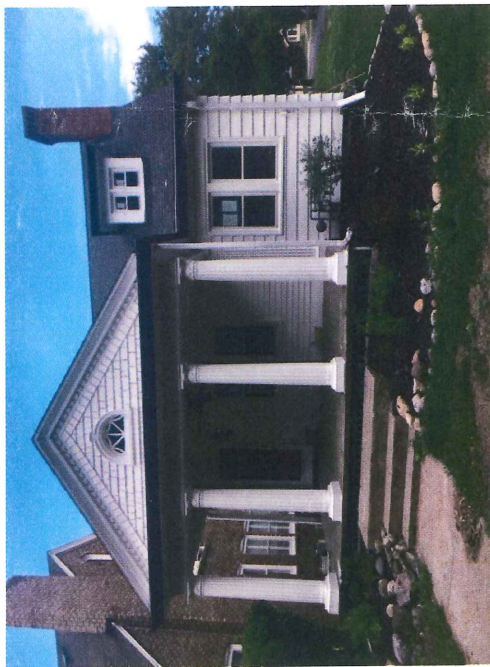
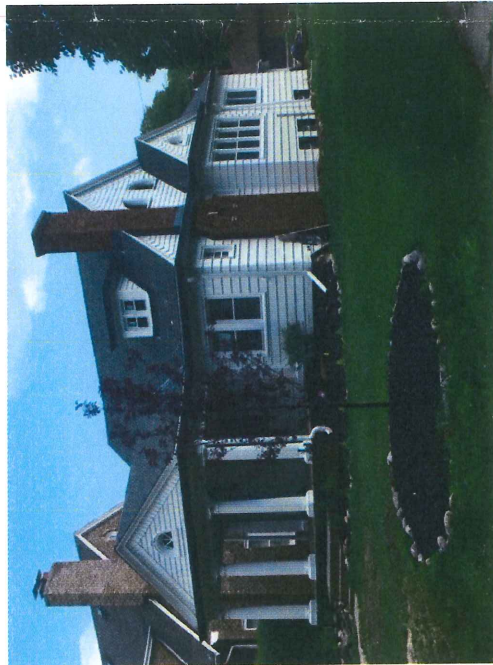
Current condition of home August 2018.

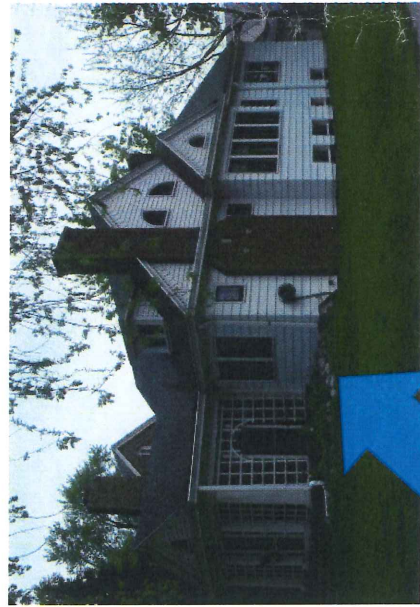
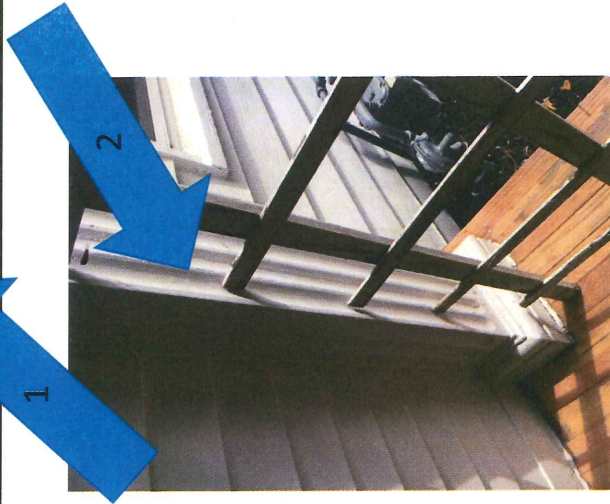
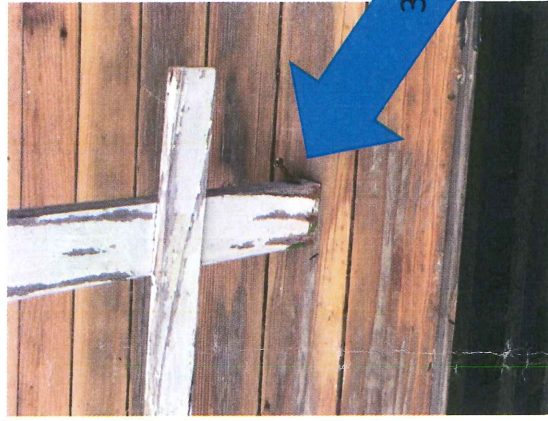
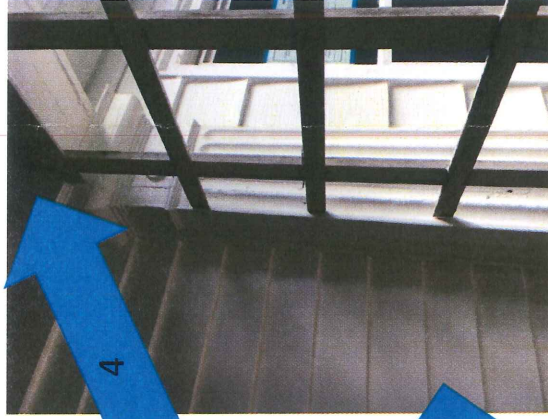
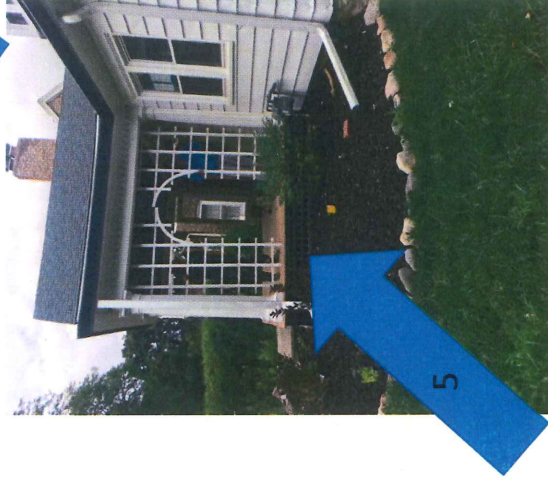
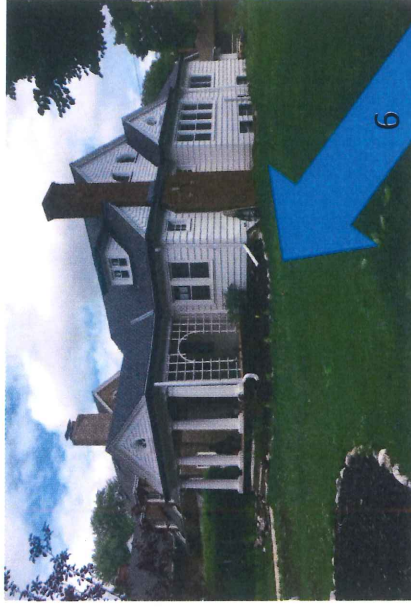
(1) Historic photo of home showing lattice on front porch. A single piece of lattice was found in the garage. Lattice does NOT attach itself to walls of home (2), but instead screws in to porch deck (3) and header beam (4). Lattice when held in place by two workers (5). Potential finished look of home; provided lattice can be restored and reinstalled safely and relatively inexpensively (6).
