Scot W. McLean, ASHI  
333 W. Brown Deer Rd. #117, Bayside, WI 53217  
Phone: 414-228-6573  
<http://www.tandcinspection.com>

# Report Index

## *Inspection Summary*

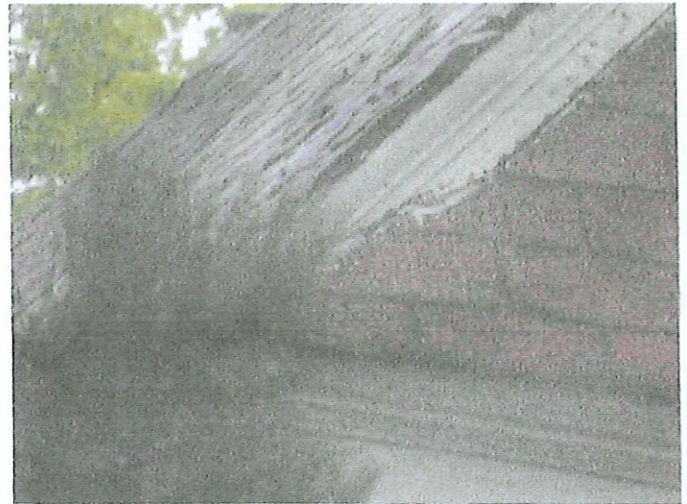
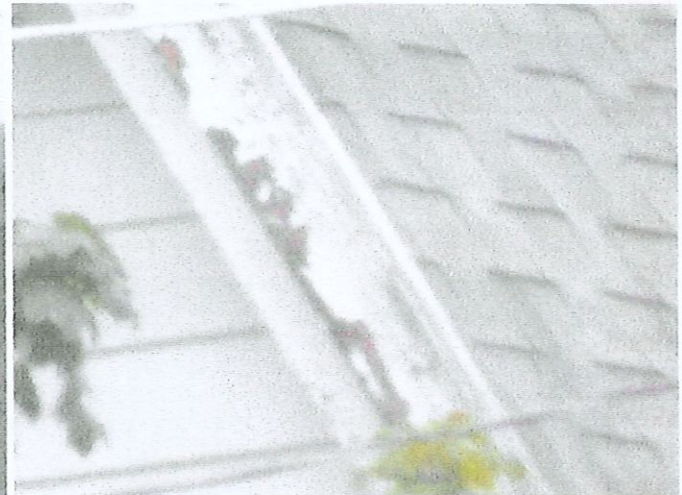
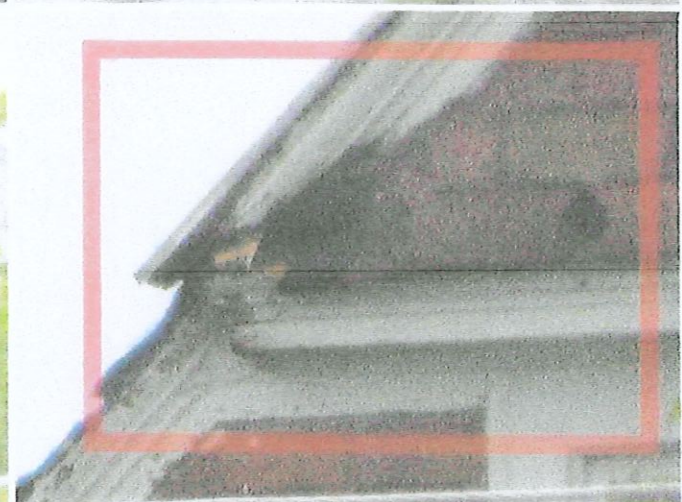
Siding Flashings

Inadequate flashings/sealants appear, There does not appear to be flashing on horizontal trim. This can cause deterioration. Ensure that a secure seal of caulk

is  
maintained  
as a temporary  
measure which  
may lead or  
install proper  
metal flashing.  
Missing cap  
flashing.  
Add flashing to  
prevent deterioration  
and other water  
penetration issues.  
Lack of kick  
out flashing  
noted. Add  
as needed.

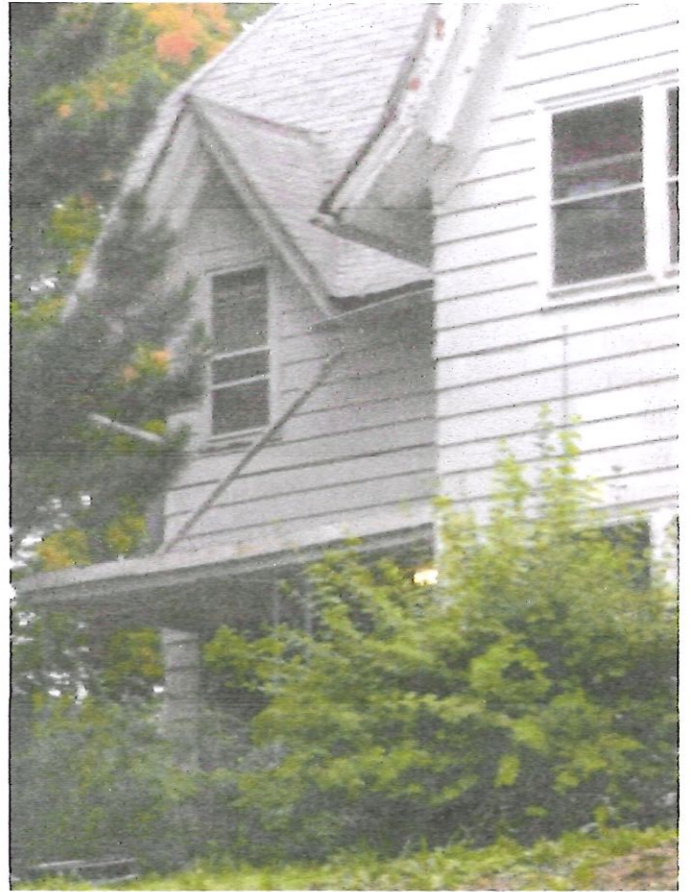
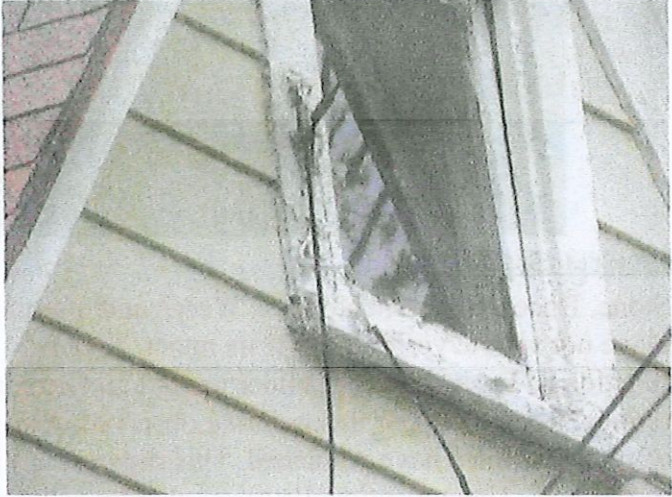
Older/worn, Loose siding, Misaligned, Missing sections/corners, Holes/gaps. Seal to prevent pest/water infiltration. Holes, Dents Vintage installation Evaluate now for common maintenance needs. Seal any gaps/openings. Seasonally evaluate for future maintenance needs.

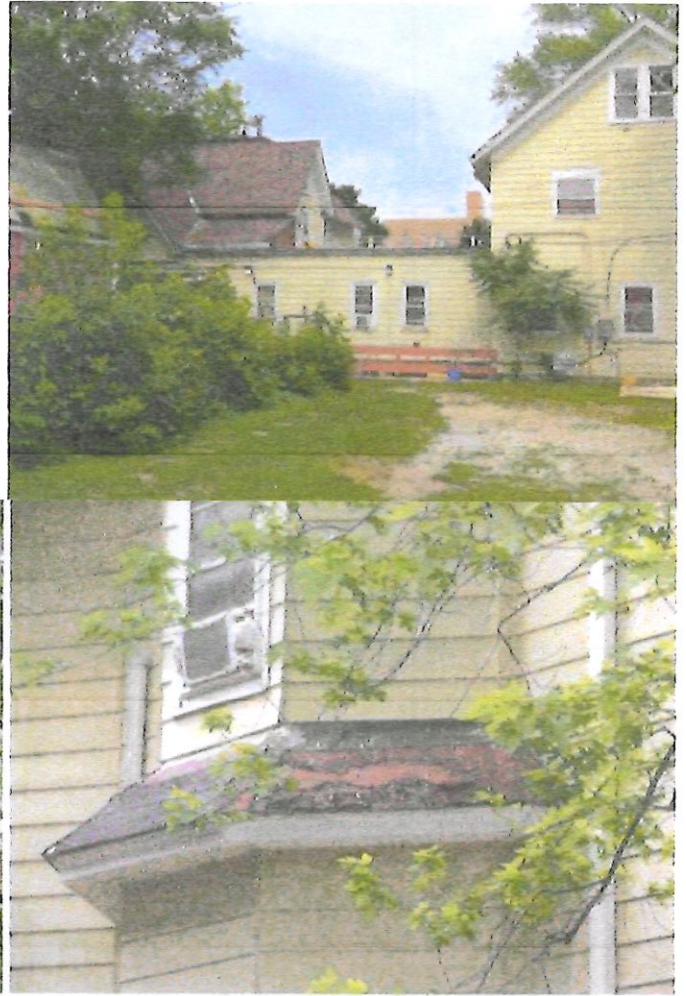
Wood:

Older/worn, Small areas of significant deterioration noted. Evaluate for repair needs including interior structures and framing for water intrusion/migration issues. Needs touch up paint/putty/caulk sealant, Holes/gaps. Seal to prevent water infiltration. Loose siding, Missing sections, Possible woodpecker/vermin holes. Cracked boards. Seal to prevent water intrusion/deterioration. Evaluate now for common maintenance needs. Seal any gaps/openings. Seasonally evaluate for future maintenance needs. Lifting painted surfaces with adjacent chip on the ground noted in some areas.

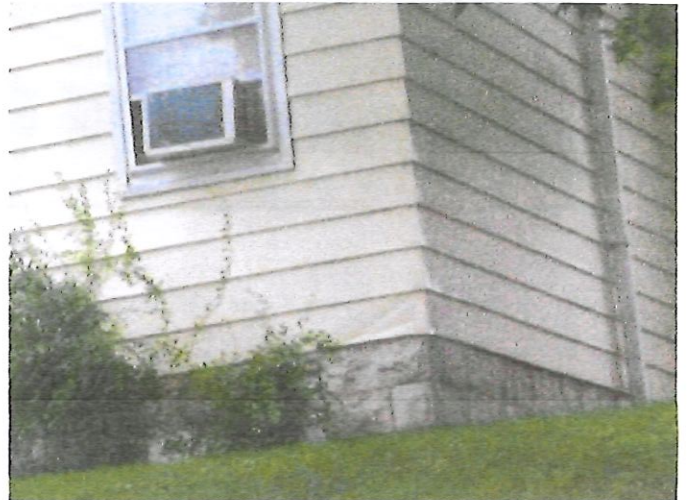
### Masonry Siding:

Stone, Decorative cement block, Weeps and draining plane not visible/verified, Appears intact, Appears functional, Typical for age, Older/worn, Fracturing noted (typical for age). Prior tuckpointing observed, Areas that were tuckpointed have re-cracked. This suggests further movement. Unconventional/curious workmanship. Caulking/mastic materials on masonry often means there has been water intrusion or other issues. Verify and repair as needed. Siding needs repair by a masonry restoration contractor now. Evaluate now for common maintenance needs including flashing maintenance. Seal any gaps/openings. Seasonally evaluate for future maintenance needs.

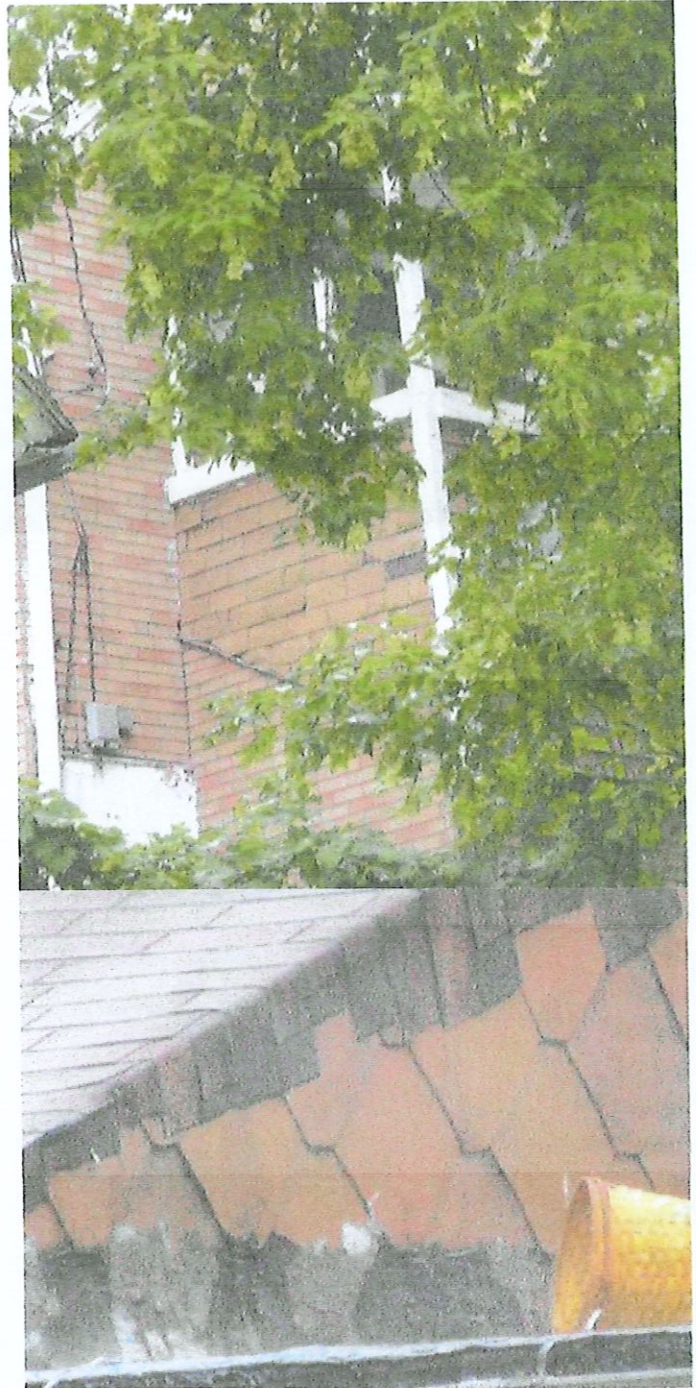
### Asphalt:

Older/worn, Deteriorated, Major damage to asphalt siding. Consult a siding contractor or carpenter. Holes/gaps. Seal to prevent water infiltration. Missing/loose/broken shingles/tabs. This may indicate a general area of loose/detached shingles that may not appear to be loose. Ca. 1930- 1950s.

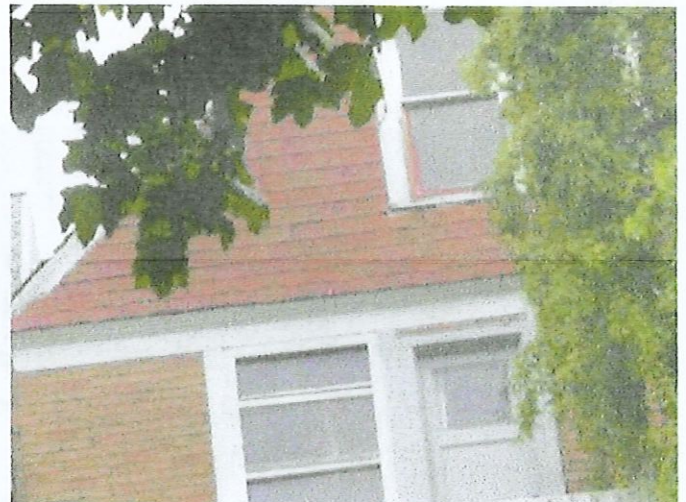
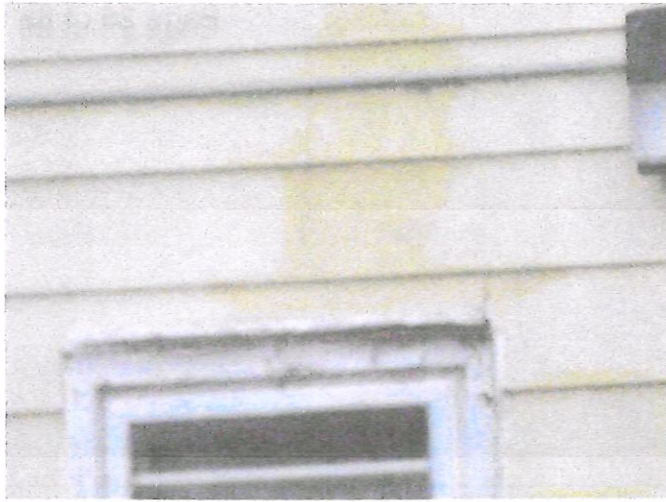
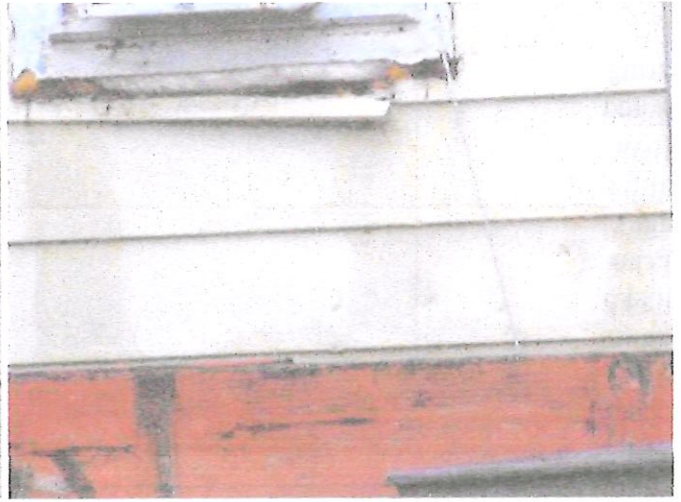
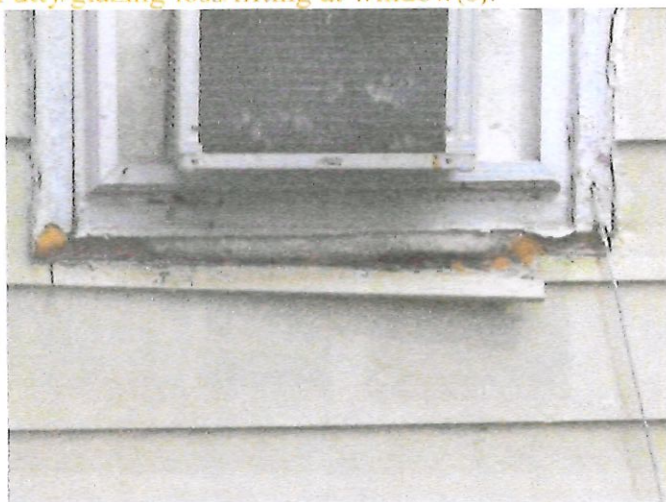
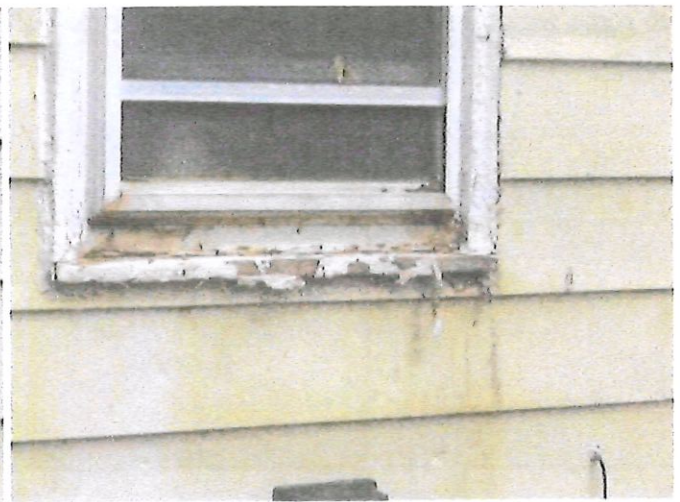
Some/ most- Older/worn, Vintage/Original era, Needs maintenance/caulk sealant/putty/paint. Gaps/openings observed. Unconventional installation of cladding will not protect trim and structure from water migration/leakage. Needs repair/flashing. Significant deterioration noted at approximately 75% or more of windows/trim. Significant deterioration noted at most windows/trim. Peeling paint, Spalling/shaling/surface deterioration at sills. Missing flashing. Add flashing to prevent deterioration and other water penetration issues. Putty/glazing loss/lifting at window(s).

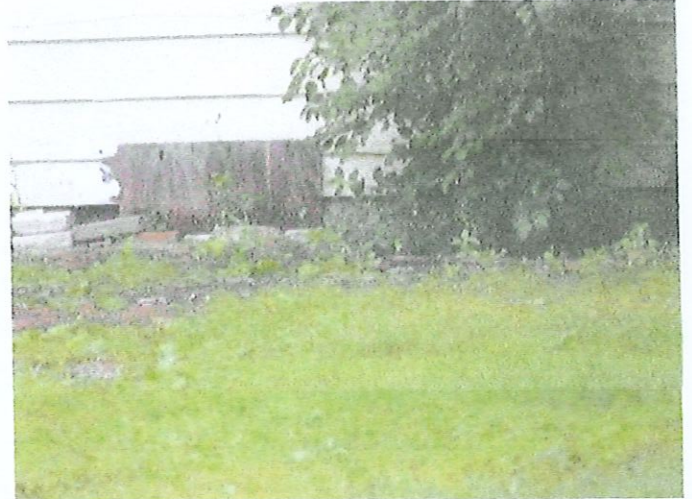
Older/worn, Sealed/nailed/boarded/blocked shut.

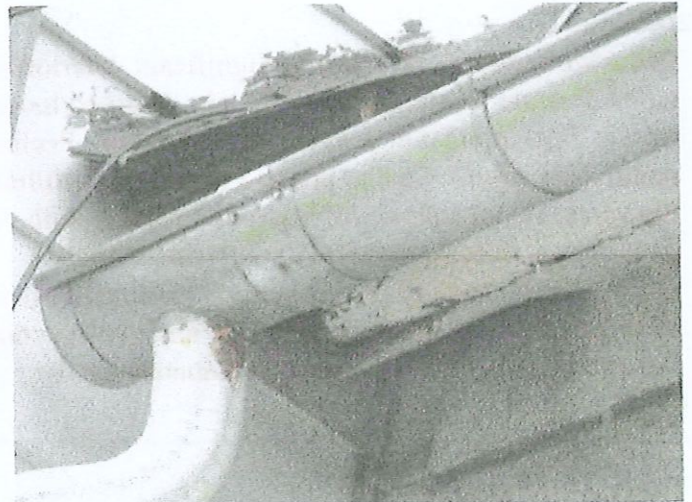
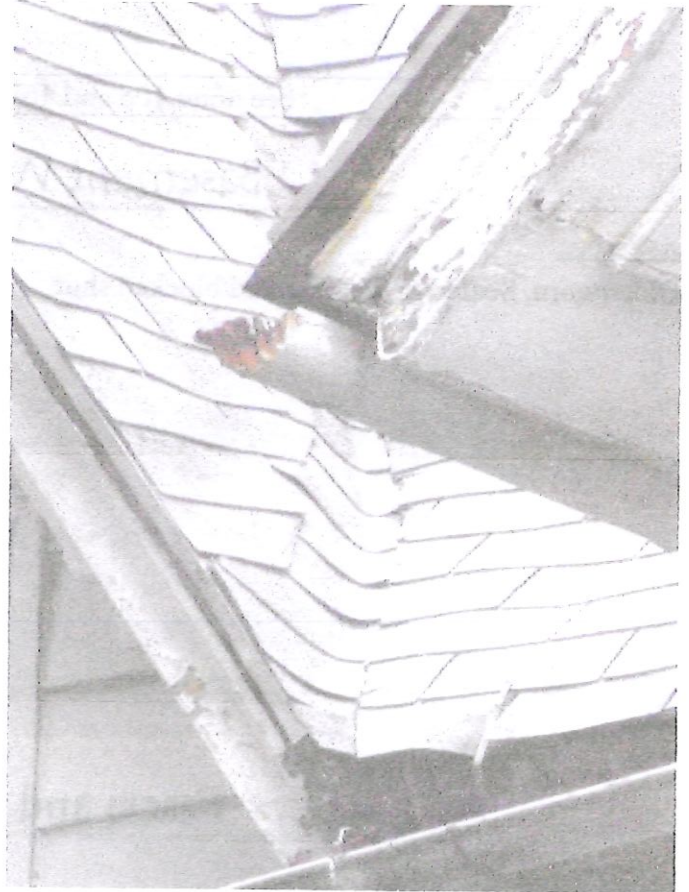
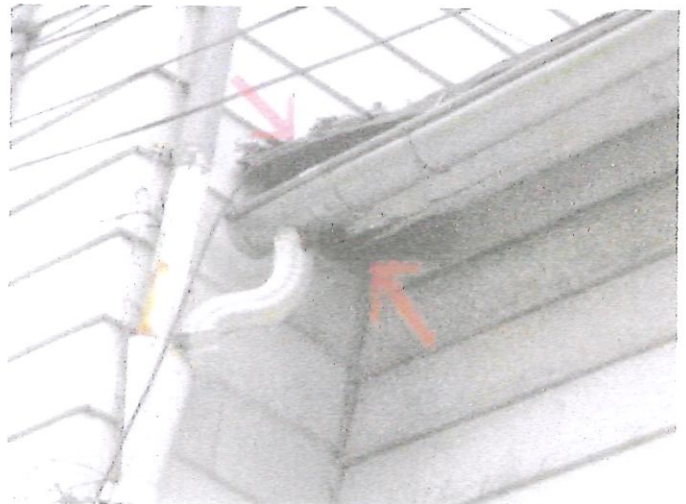
### Fascia and Soffits: (5)(a) 6

Older/worn, Needs paint/stain, Significant deterioration noted at some locations. Needs repair. Warped/loose panels. Seal to prevent pest/water infiltration. Peeling paint. Holes/gaps. Seal to prevent pest/water infiltration. No vents, Water stains, Holes/gaps consistent with vermin entry points. Needs common maintenance/touch up/repairs. Evaluate now for common maintenance needs including flashing maintenance. Seal any gaps/openings. Seasonally evaluate for future maintenance needs.

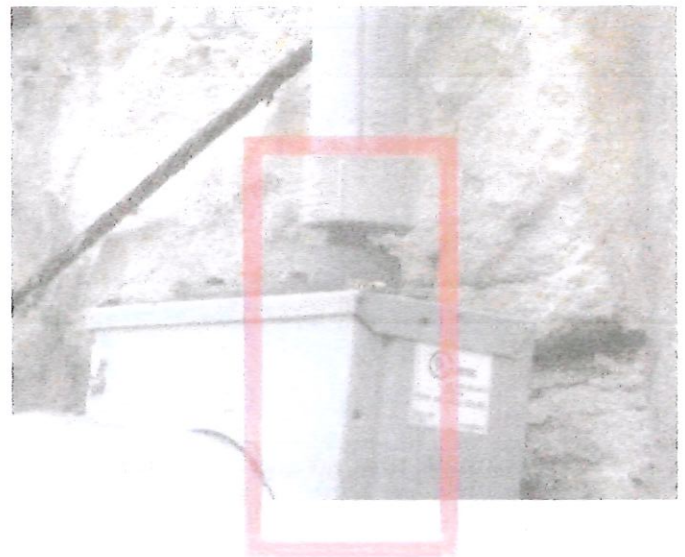
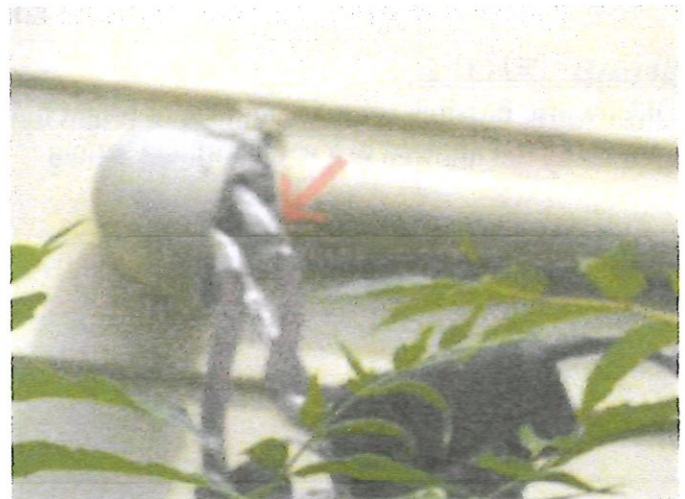
Electric Service Type (7) (a) 4.

Overhead, Cloth vintage era service wire at mast head at exterior. Older/worn. There appears to be fraying present. Overhead, Improperly fastened service conduit, Corrosion noted at service conduit. May need replacement in coming years. Consult an electrician for recommendations. Pulling away from building. This can pull on and detach the service wire connections. Have evaluated and repaired as needed by a licensed electrician for safety and good function. Detached conduit at alley,.

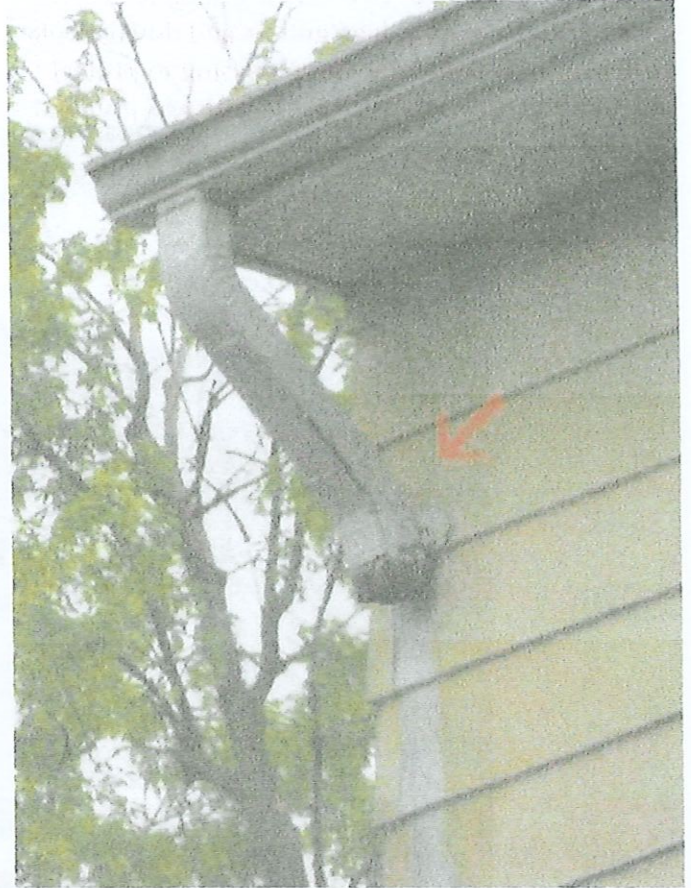
None, Metal, Discharges above grade, Discharges below grade. Monitor for damage, freezing, blockage. Older/worn, Add more downspouts, Disconnected sections, Missing sections, Add and maintain downspout extensions (6 ft minimum from building) and unlog as necessary now. Loose, Corrosion, Split, Drains onto roof. Consider directing to gutter. Downspouts need repair/replacement.

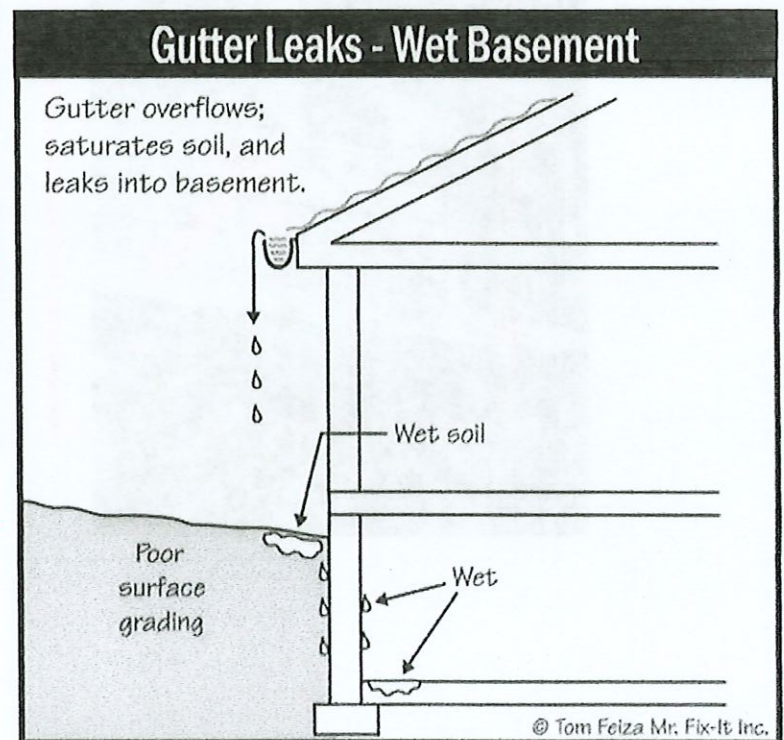
## Gutters: View From Ground

Height restricts view, Metal, Older/worn, Bent/twisted gutters, Evidence of possible ice damming. Monitor for leakage and ice damming. If ice damming occurs in the future, seek further evaluation by an Energy Auditor. Evidence of a history of gutter overflow conditions/drip line noted. This may be due to improper slope or debris in gutters or downspouts. Repair and improve function, and keep water off structure and foundation areas. Need cleaning/maintenance. Clogged gutters/downspouts do not function as designed. Slope in some locations may not allow water to drain well. Re-slope as needed. Bent, Loose, Not flashed to roof, Hung bracketed gutters at the edge of the roof not attached. They tend to overflow, bend, pull out, often need maintenance/repair, and can damage the roofing. No kick out flashing observed at one or more locations. When the shingles terminate at a wall joint, a kick out flashing behind the siding and on top of the shingles helps direct water into the

gutter. Add as prudent. Not aligned to roof edge, Trees nearby. Gutters will require frequent cleaning. Monitor for overflowing and clean as necessary. Repair/replace gutters and downspouts as needed. Add gutters where missing to protect the building, foundation, and structure as prudent.

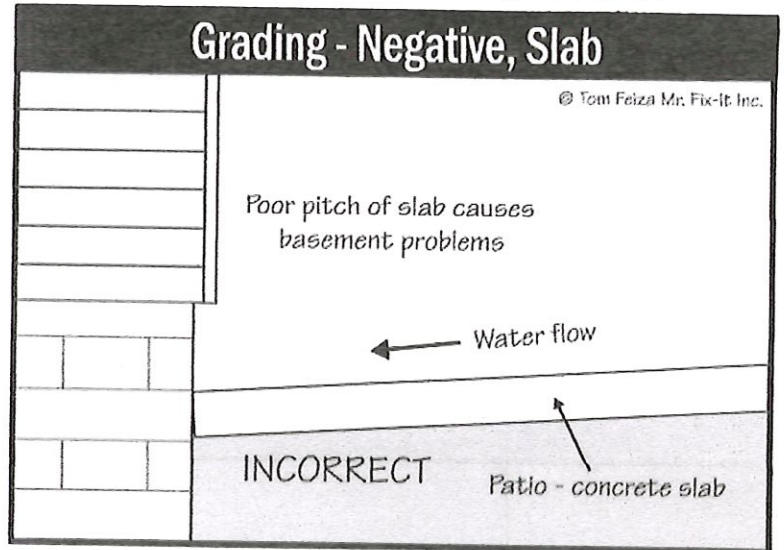
Appears functional, Typical for age, Older/worn, Uneven offsets greater than 1" are a potential trip concern. Correct as needed. Concrete is sloping toward building. This can cause water infiltration issues. Surface raised/settled, Water may pond and freeze. Concrete walk/patio needs repair. Suggest mudjacking/foam leveling and correcting water drainage issues now.

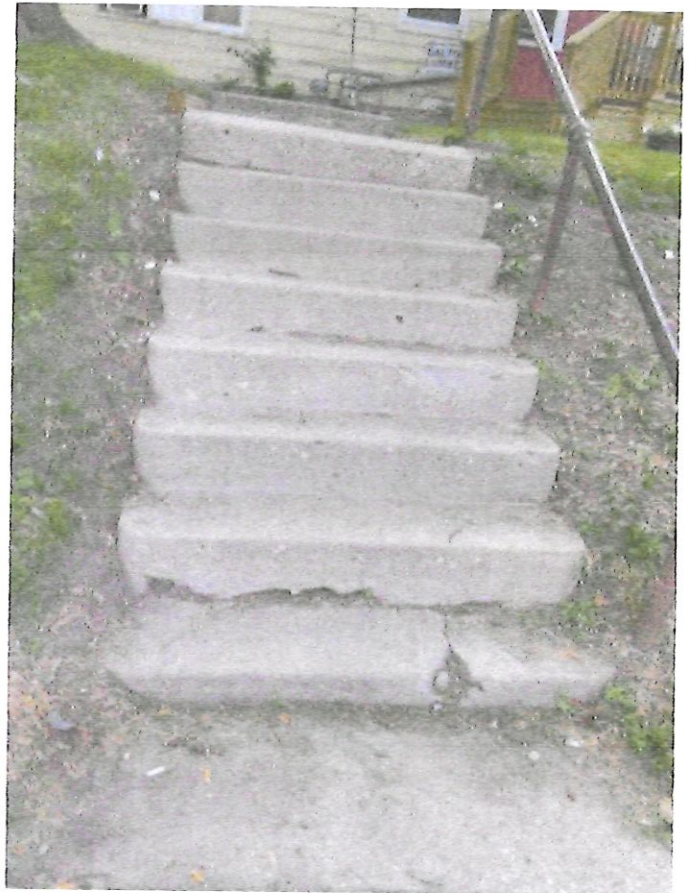
Steps:

Concrete, Older/worn, Typical cracking, Uneven/unconventional rise/run, Uneven offsets greater than 1" are a potential trip concern. Correct as needed. Concrete steps need major repair or replacement.

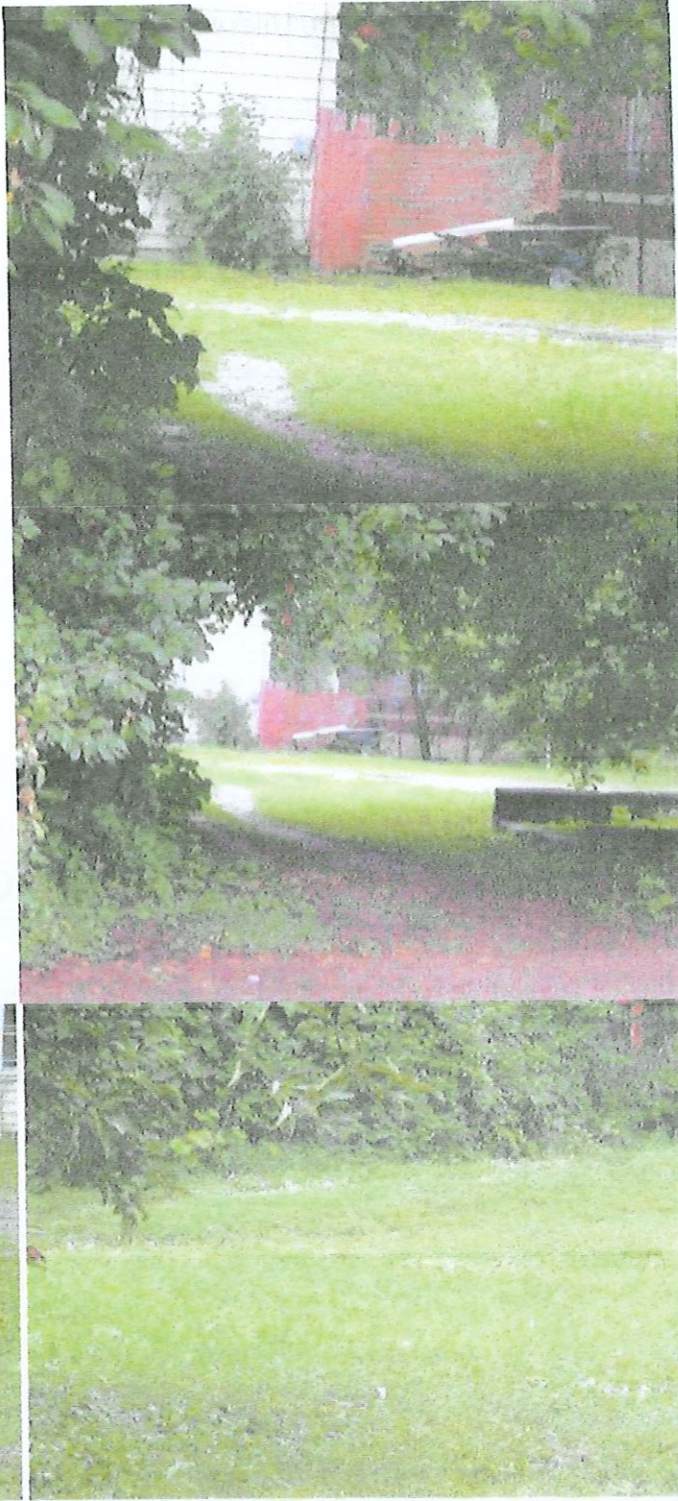
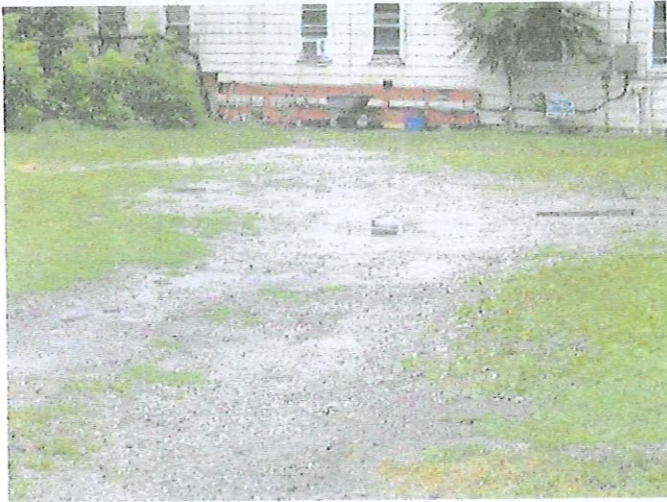
Gravel:

Trip hazard, Sloping toward building. This can cause water infiltration issues. Water may pond and freeze. Walk/patio needs major repair or replacement. And mud.

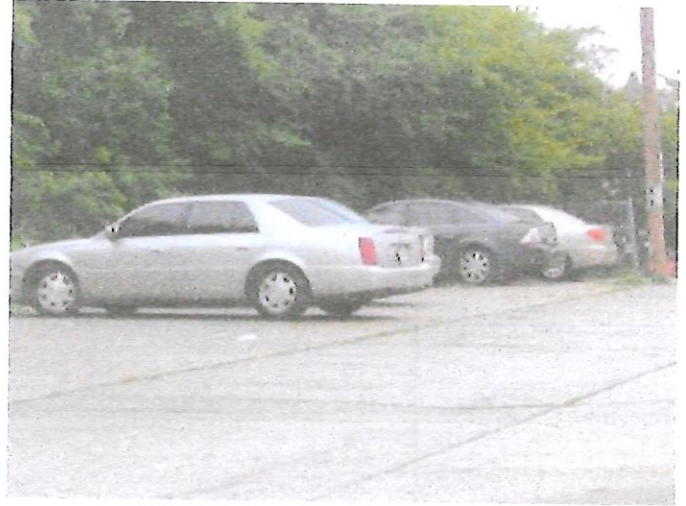
Gravel:

Trip hazard, Water may pond and freeze. Driveway needs major repair or replacement.

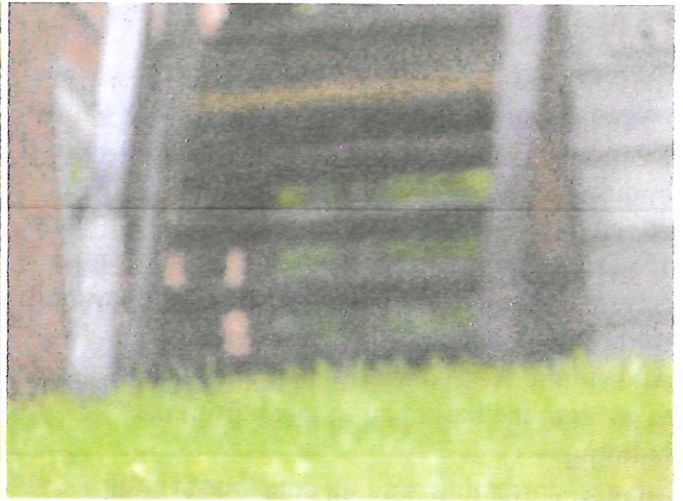
Porch  
/stoop  
needs  
repair

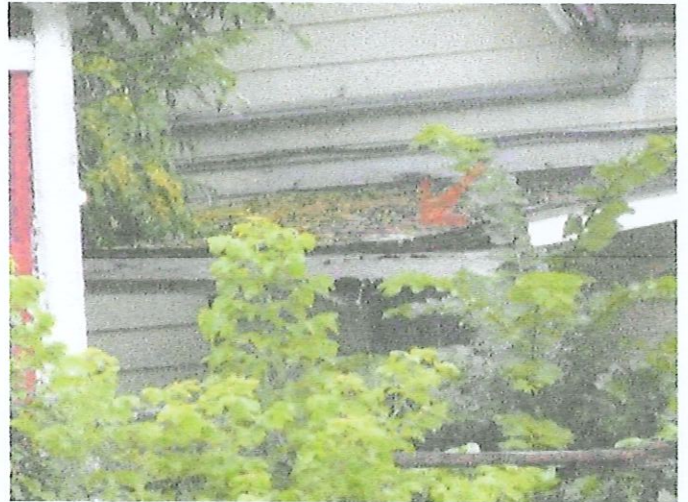
Restricted access/obscured view under deck limits the extent of the inspection. Older/worn, **Significant deterioration noted**. Bounciness/deflection observed. Loose boards, Unconventional construction, Peeling paint, Suggest adding railing. Non-standard rise/run, High step up where walk has settled. Bottom of steps worn. Monitor for maintenance. Warped/bowed posts, Implication- Weakened structure. Water management system not observable. No flashing observed. Structural life 10 - 15 years.

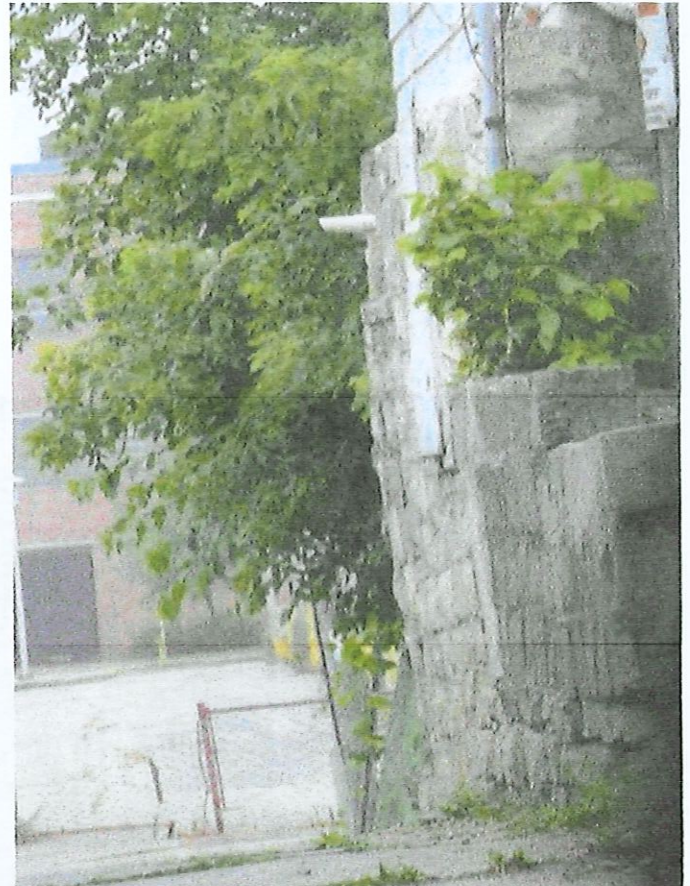
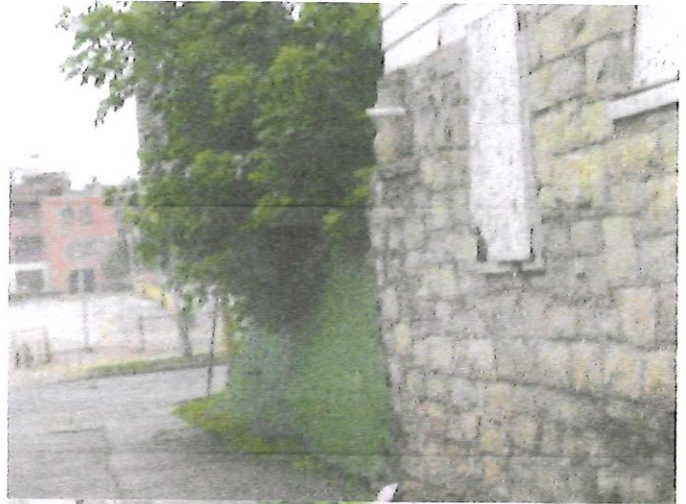
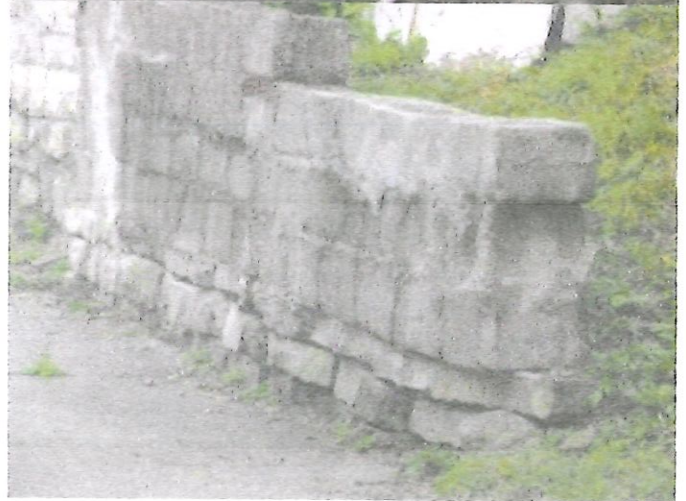
Significant cracks/damage noted. Older/worn, Spalling/shaling/surface deterioration, No drainage noted, Bowed, Leaning, Loose stones, Leaning, bulging, tipping, possible active movement. Open/wide joints between blocks/stones, Maintain grading and deflect water away from the soil behind retaining walls for maximum longevity. Needs replacement. A possible hazard, possible encroachment to/over public thorough-way alley.

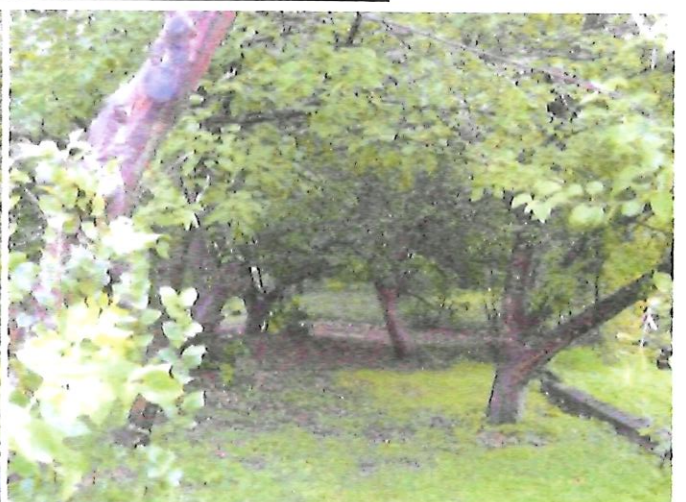
## Vegetation

Trees /Shrubbery too close to building; house

Trees too close to roof/s  
crapping on roof.

Correct to prevent damage and evaluate/repair shingles as needed. Need trimming or removing. Verifying the health of the vegetation on the property is beyond the scope of this inspection. In this region, Ash trees in partic

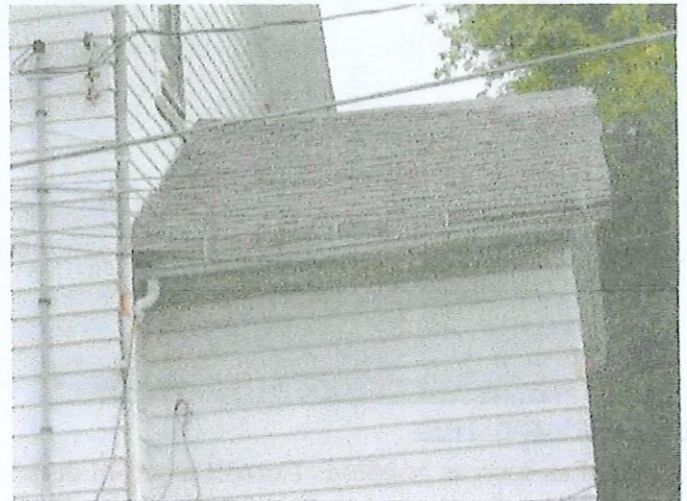
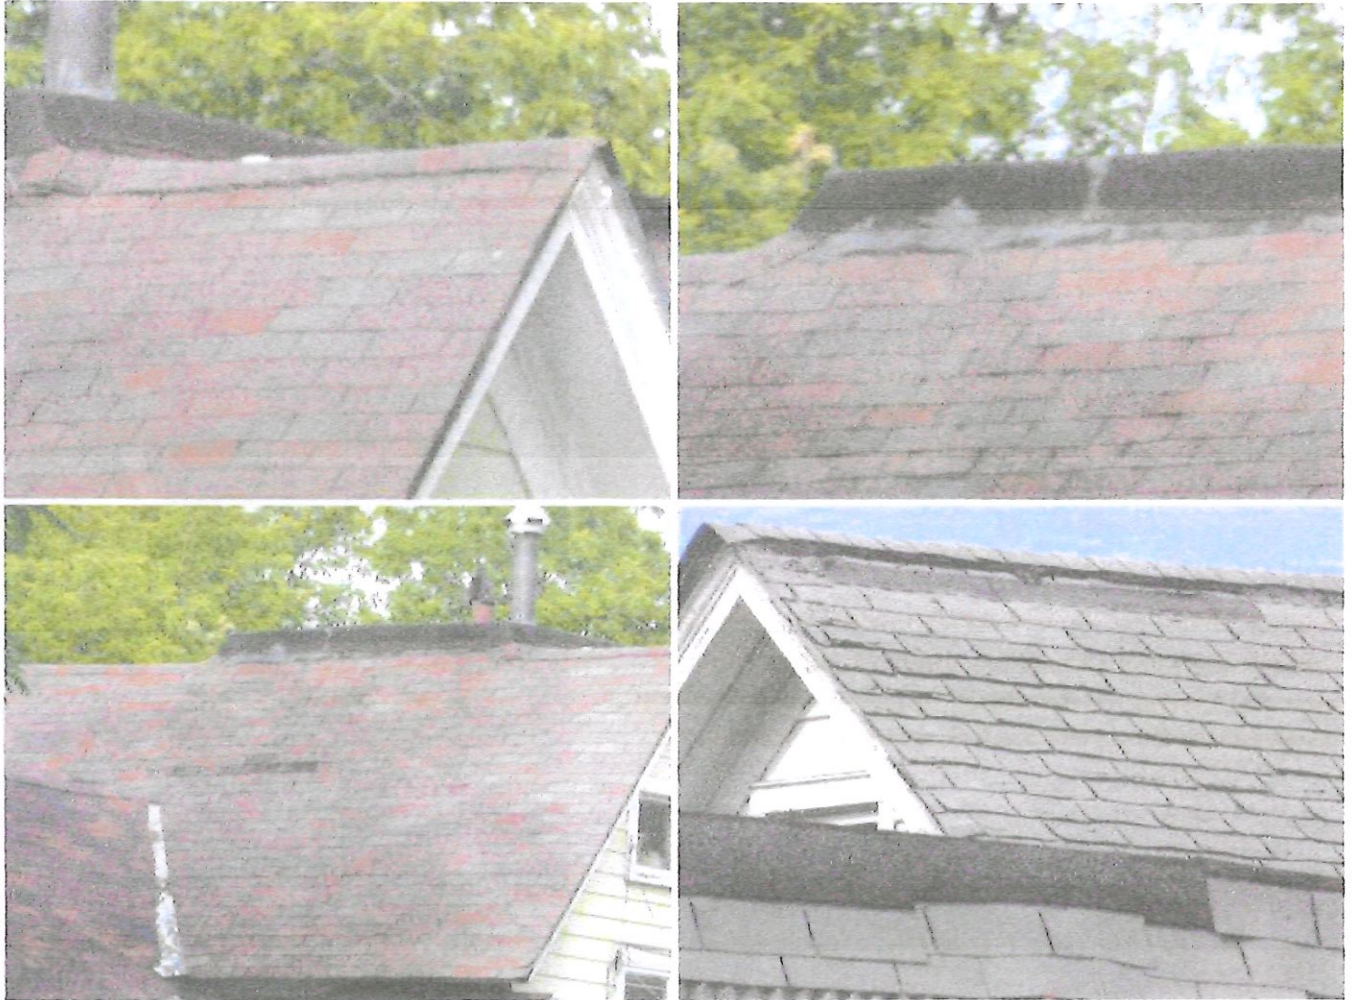
Serious signs of wear/aging. Some general observations include: Brittle/loss of elasticity/inflexible, Granule loss, Curling, Shrinkage, Waviness. Underlayment and decking structure are hidden from view and can not be evaluated by our visual Inspection; therefore, our observational review is not a guarantee or warranty against roof system leaks, seepage or structural condition, nor is a certification. Expect leaks. Cracking, Missing/loose/broken shingles/tabs. This may indicate a general area of loose/detached shingles that may not appear to be loose. Tar/caulk sealant patching may indicate a history of and potential for leakage. Ask owner for history. Exposed nail heads, Algae (dark streaking/staining) present on shingles. This discolors the shingles but does not generally harm the roof or structure. Replaced shingles noted. Ask seller for history. This may indicate a general area of loose/detached shingles that may not appear to be loose. More wear noted at some locations than others (possible ice chipping). Fiberglass visible through granules. See note 117 in Reference Addendum. Physical damage, Short shingle installation (not enough overlap of shingles). Pieces of shingles in yard/driveway, Shingles at peak are worn. This is common and easily repairable. Appears as insufficient overlap of dimensional shingles. Nail popping, Lacks drip edge flashing. Lacks gable end flashing. Trim overhanging trees, Caulk sealant is a short term patch and subject to deterioration and seepage if not maintained. Multiple roofs present. Roofs were installed at different times and are in different conditions. Generalized and accurate over all observations of several roof surface systems. Structure unknown at interior. lichen growth noted.

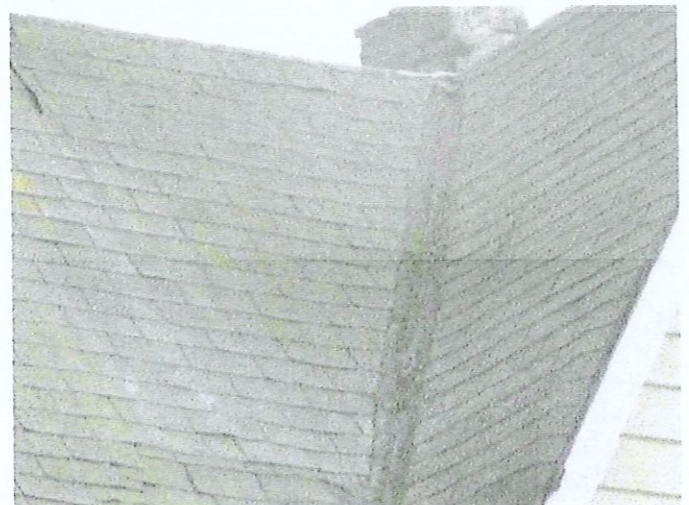
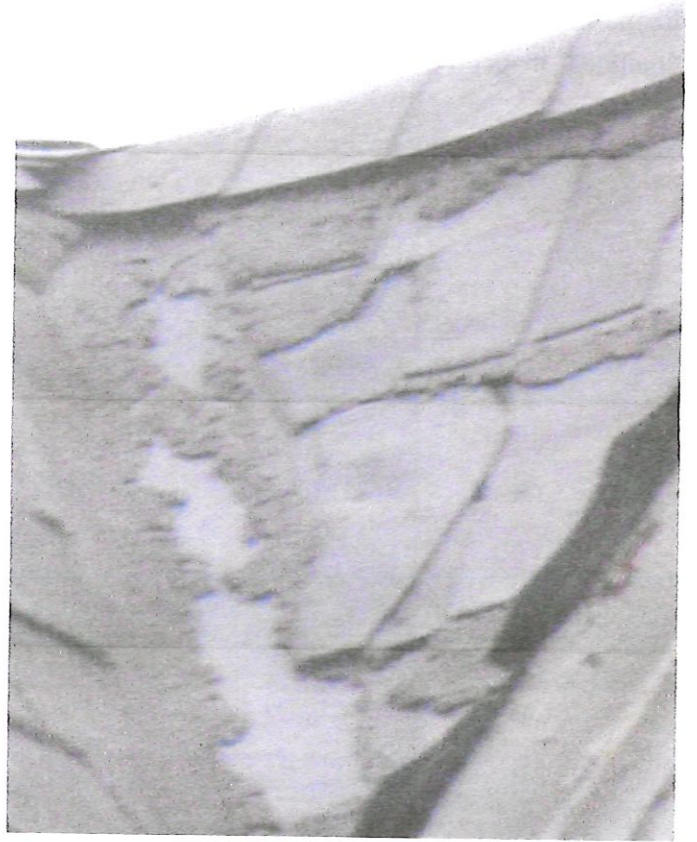
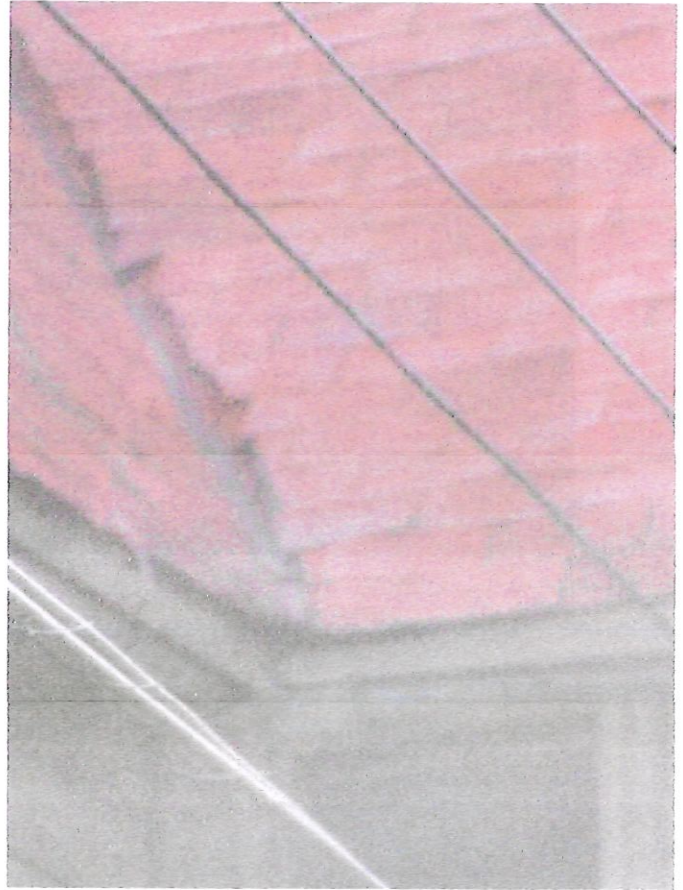
No/restricted access, Metal, Older/worn/original era, Worn/monitor closely, Debris present, Top layer worn away. Top layer prevents inspection of any flashing that may be underneath. Patched, Buckled, Gaps, Rusted, Holes/damaged, Needs repair, Improper installation, Ice chipping (more advanced wear)

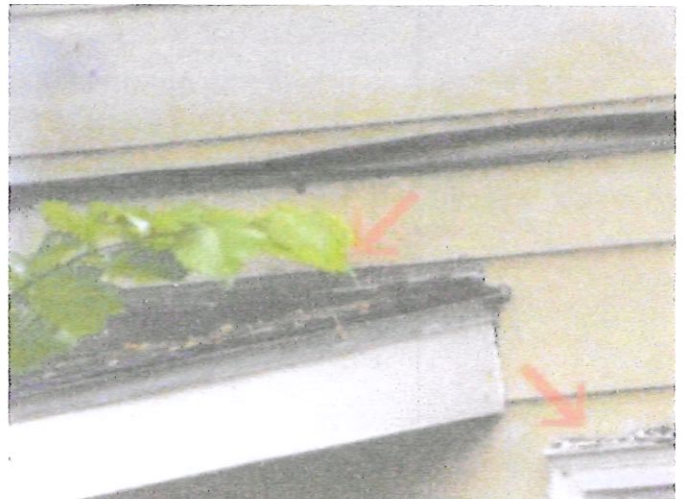
#### Roof/Wall:

Lifting/gaps/openings noted. Needs maintenance. Sealed with roofing mastic sealant. See note 121 in Reference Addendum. Little clearance between siding and roof. (Recommend a 1" minimum.) This restricts inspection of the presence or absence and condition of the flashing at this location. This can cause deterioration and water penetration issues. Multiple locations.

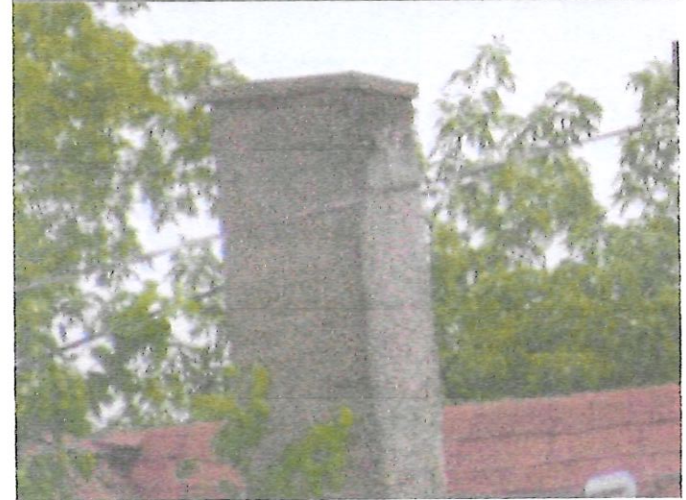
Stucco-like plaster covering present commonly holds water. It is a temporary short term patch that often covers structural deterioration and can lead to rapid further deterioration of the chimney structure. Seek further evaluation of chimney system. Painted. This restricts view of chimney condition. Ask seller for history and consider further evaluation of chimney system.

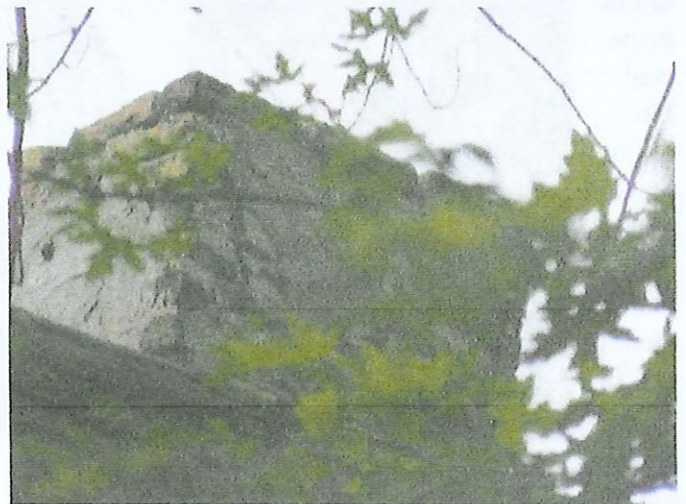
Chimney Cap: (4)(a) 4.

Top of chimney is not observed/evaluated. Major cracks, Wear/tar/patching/cracks noted at sides of chimney cap. Evaluate chimney system by a qualified contractor. Prior repairs noted. Older/worn, Missing/damaged brick/stone, Suggest renewing chimney cap. Consult a chimney or masonry restoration specialist.
