Memorandum | May 26, 2020

Lake Park Arch Bridge over Ravine Road

Concrete Repair and Surface Treatment Alternatives

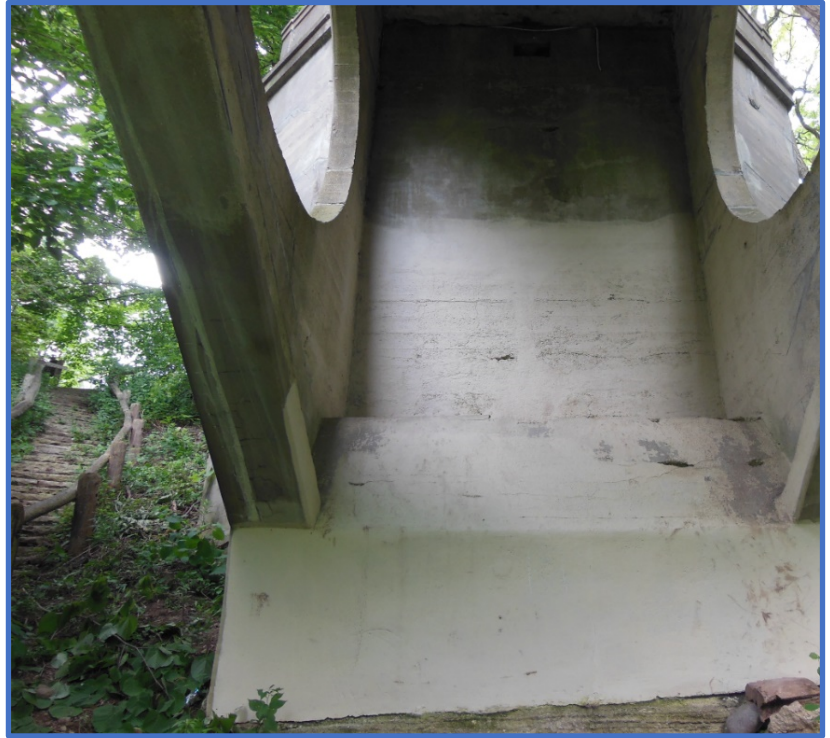
In general, observers of the Lake Park Arch Bridge will not be within arm's length from the original concrete. That is, there is limited opportunity to observe color, finish, texture, and details of the original concrete. At the south end of the bridge, spectators will have access only to uncoated concrete in the form of wing walls, railing, and deck. At the northwest corner of the bridge along the stone steps, original concrete will be within the viewshed of observers, but again not within arm's length. It is apparent that people have (will) congregated near the face of the north thrust block. The entire front face of the north thrust was repaired with shotcrete in circa 1974 and has been painted, presumably to mask graffiti. As such, there is limited original concrete in this area.

Figure 1: North Thrust Block Shotcrete Face

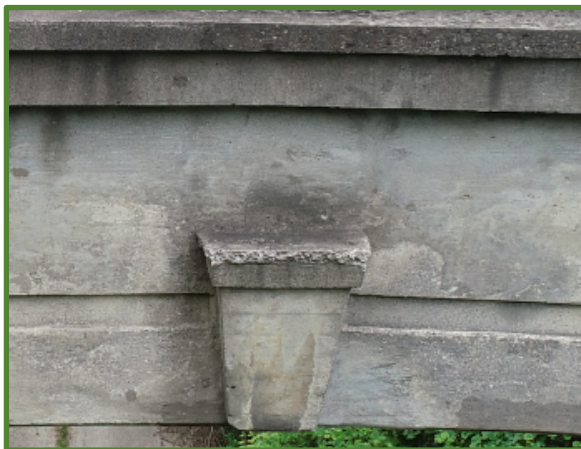
Figure 2: Arch Rib Finial

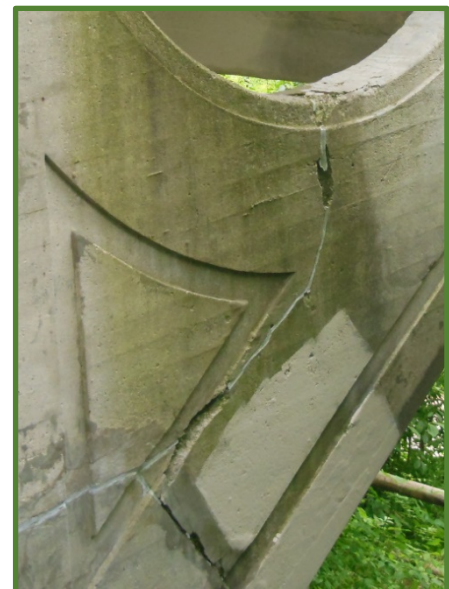
Figure 3: Rustication and Reveals

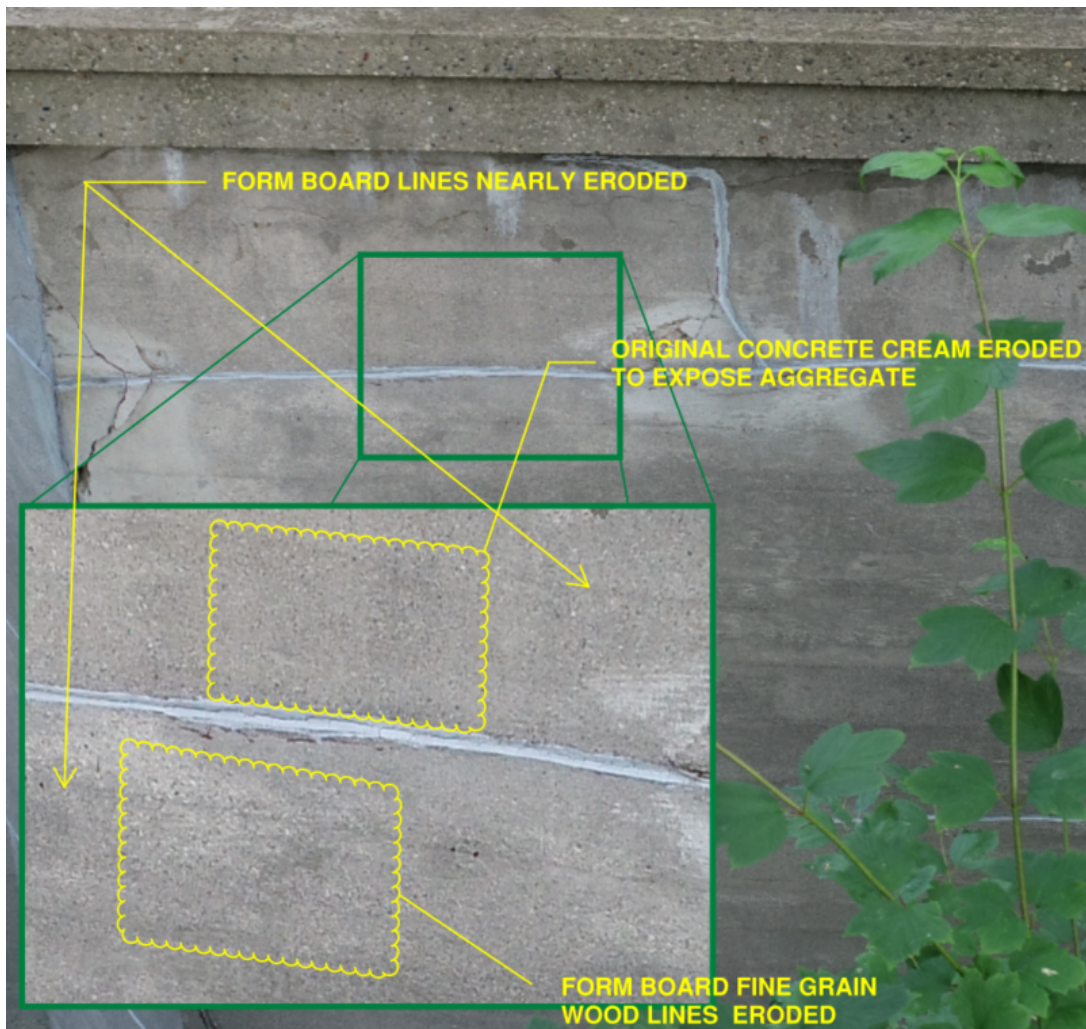
Form Board Demarcations: The horizontal lines demarking the interface of boards used to form the concrete are barely visible on the concrete surfaces exposed to the elements. The form board lines on the exposed surfaces of the concrete are obscure for two reasons: 1) The designers would attempt align the form boards on the prominent faces of the bridge to mitigate the visual distraction of form board lines and 2) Whatever lines of demarcation existed have largely been eroded away. Board form finish is often found in obscure locations where the original designers were less concerned about the texture of the concrete element. Evidence of form boards are a clue as to the age of a component, not a design feature.

Exposed Aggregate: The concrete cream on the exposed surfaces of the bridge have also eroded to the point it appears to be some form of exposed aggregate. The pseudo exposed aggregate is a byproduct of deterioration, it is not an original design detail. Point being that application of a pigmented film forming coating would not obscure what may be perceived as design features.

Figure 4: Existing Original Concrete Surface

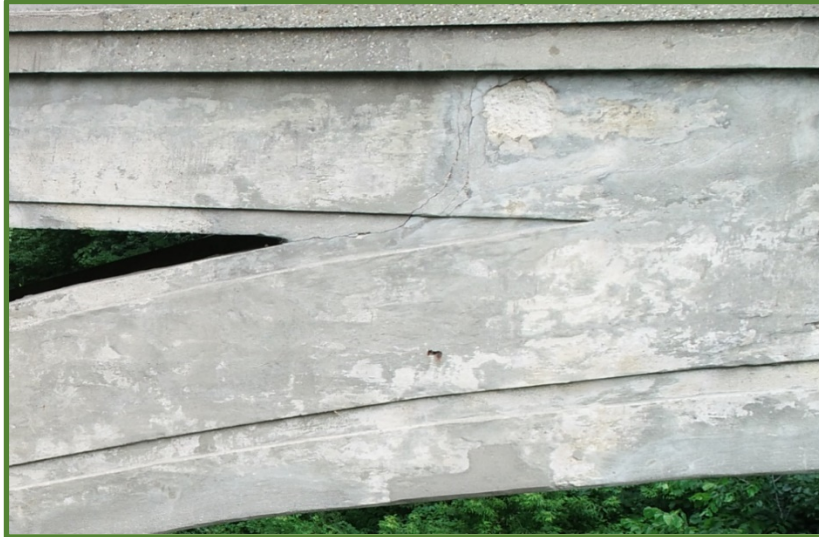
Parge Coating: It appears that the exposed faces of both the east and west arch ribs and spandrel walls have been coated with some form of cementitious parge material. Loose parge will be moved during the rehabilitation efforts. The fact that majority of the original concrete surface of prominent features of the bridge has already been concealed lessens the argument pigmented film forming coating should not be applied because it will conceal the color, finish, and texture of the original concrete

Figure 5: East Arch Rib and Spandrel Face w/ Parge Coat

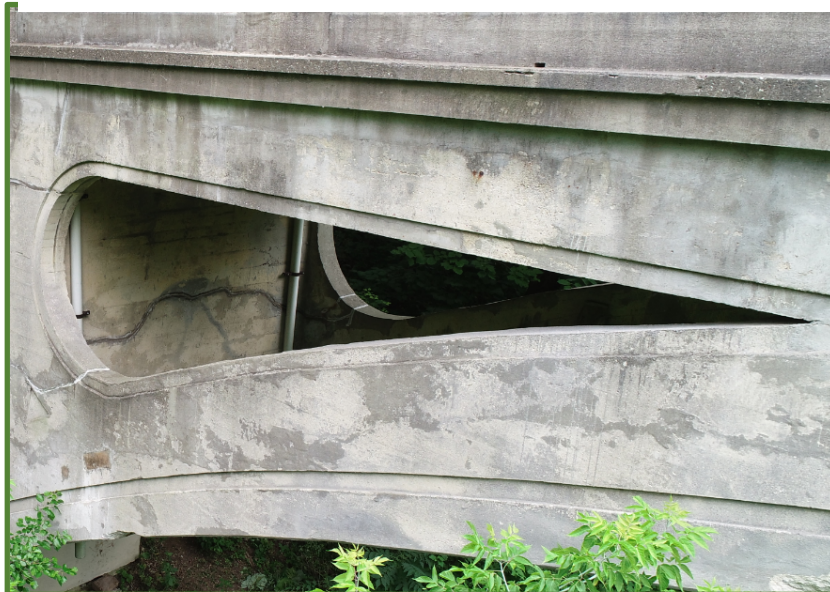
Figure 6: West Arch Rib & Spandrel Wall Face w/ Parge Coating
