Safeco Insurance Company of America

Claim Number: 465410366002
Insured Name: Joel Benway Katherine Benway
Date of Loss: July 15, 2017
Policy Number: OZ4593144
Underwriting Company: Safeco Insurance Company of America

Claim Number: 465410366002 **Policy Number:** OZ04593144 **Type of Loss:** Wind

Price List: WIMW8X_SEP17
Restoration/Service/Remodel
Estimate: JOEL BENWAY__
KATHERI

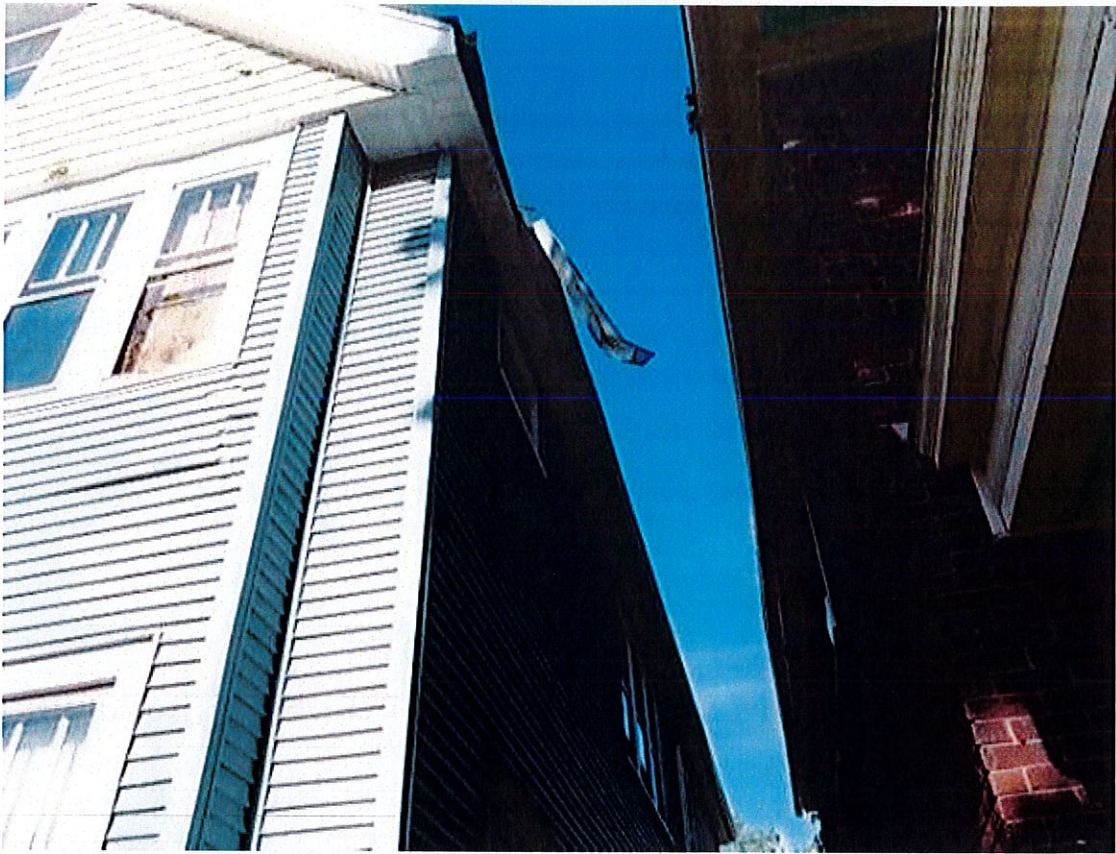
5-Risk
Right Elevation gutter damaged

DESCRIPTION	QUANTITY	UNIT PRICE	TAX	O&P	RCV	DEPREC.	ACV
18. R&R Gutter / downspout - aluminum - up to 5"	47.00 LF	5.62	5.66	53.96	323.76	(12.01)	311.75
45. R&R Wood fence 5'- 6' high - treated - panel only	4.00 LF	20.32	1.57	16.56	99.41	(6.19)	93.22
Totals: Right Elevation			7.23	70.52	423.17	18.20	404.97

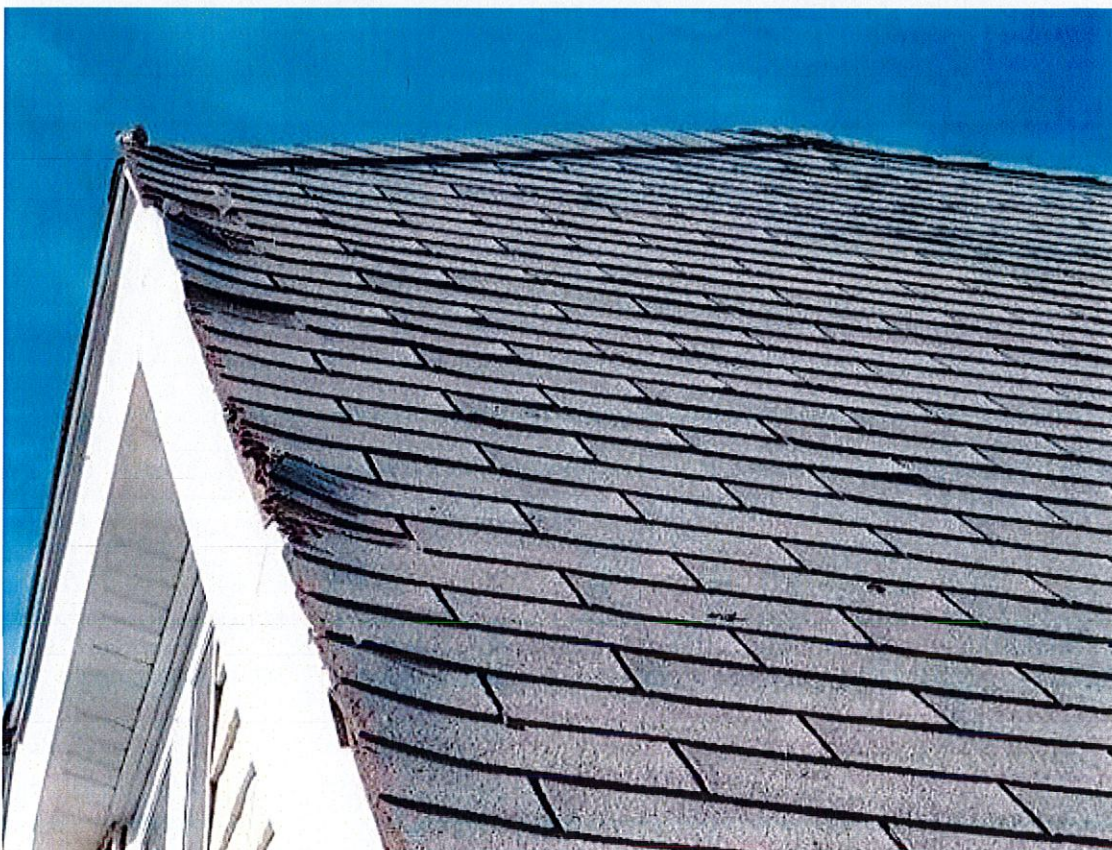
8-Roof
Shingle damage

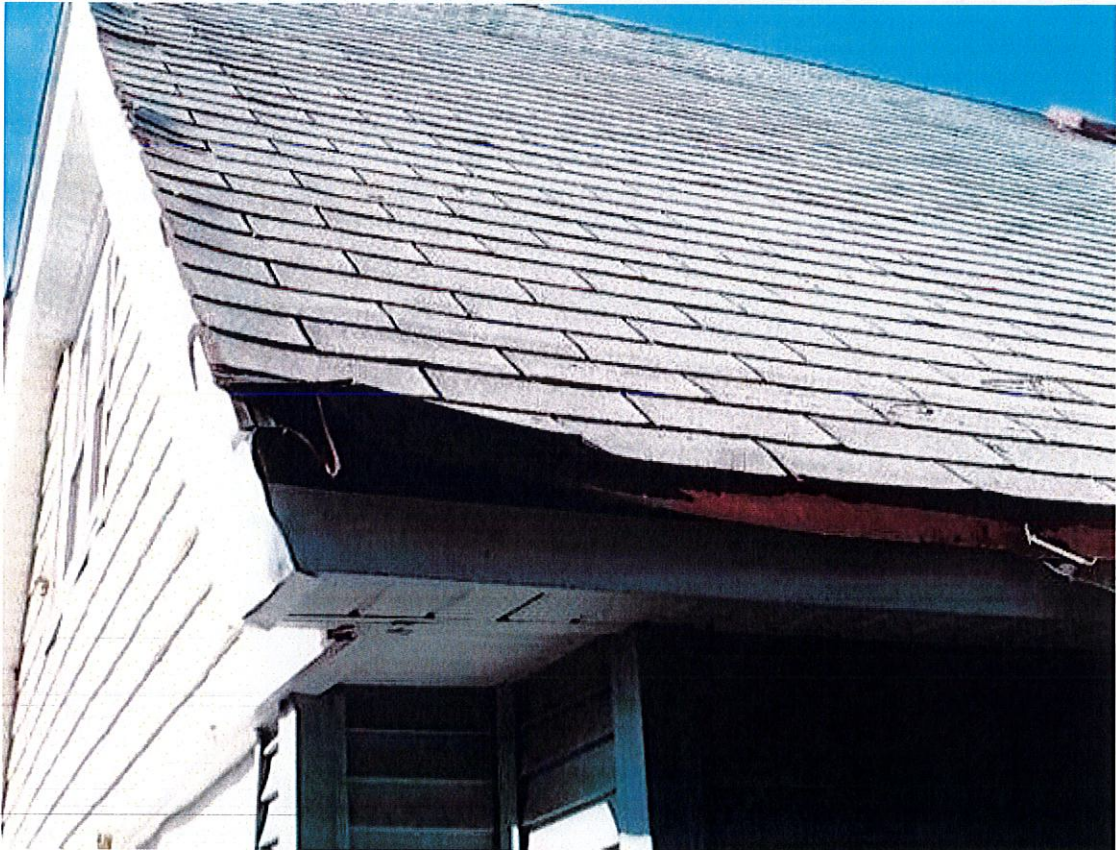
9-Roof
Shingle damage

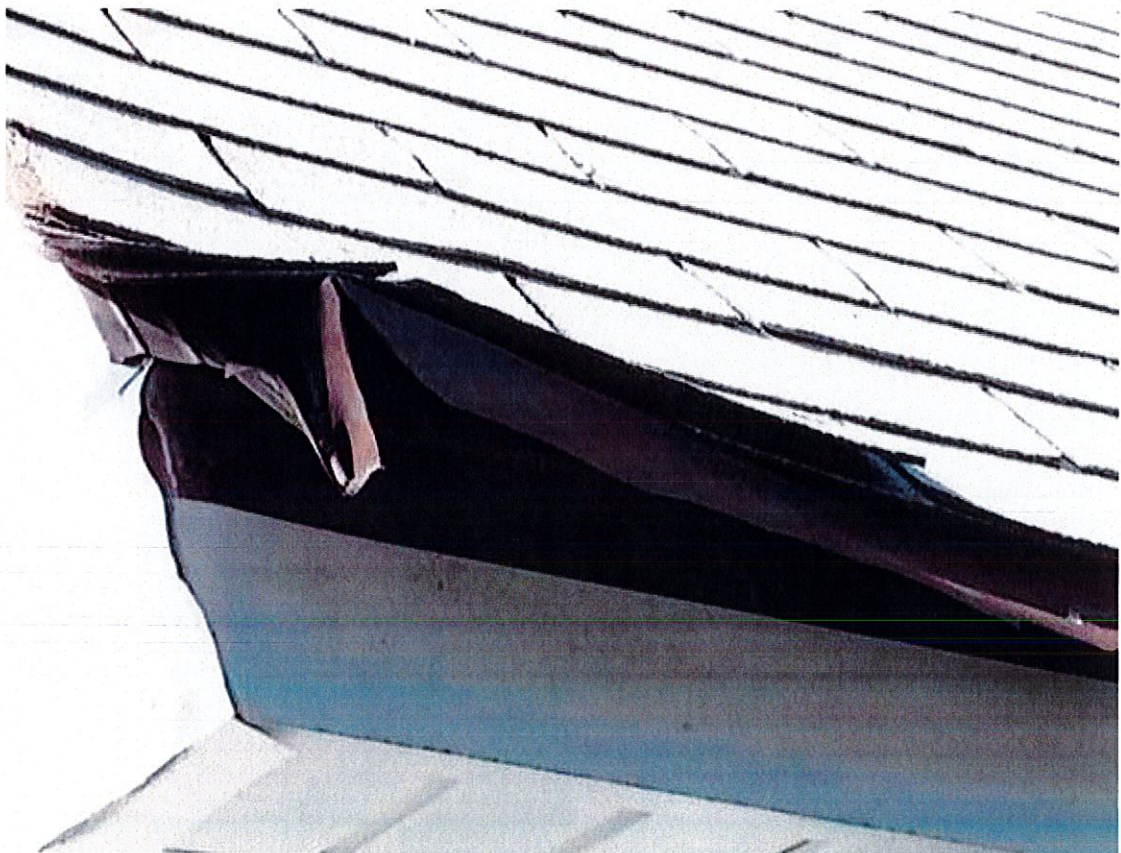
10-Roof
Metal IWS damaged

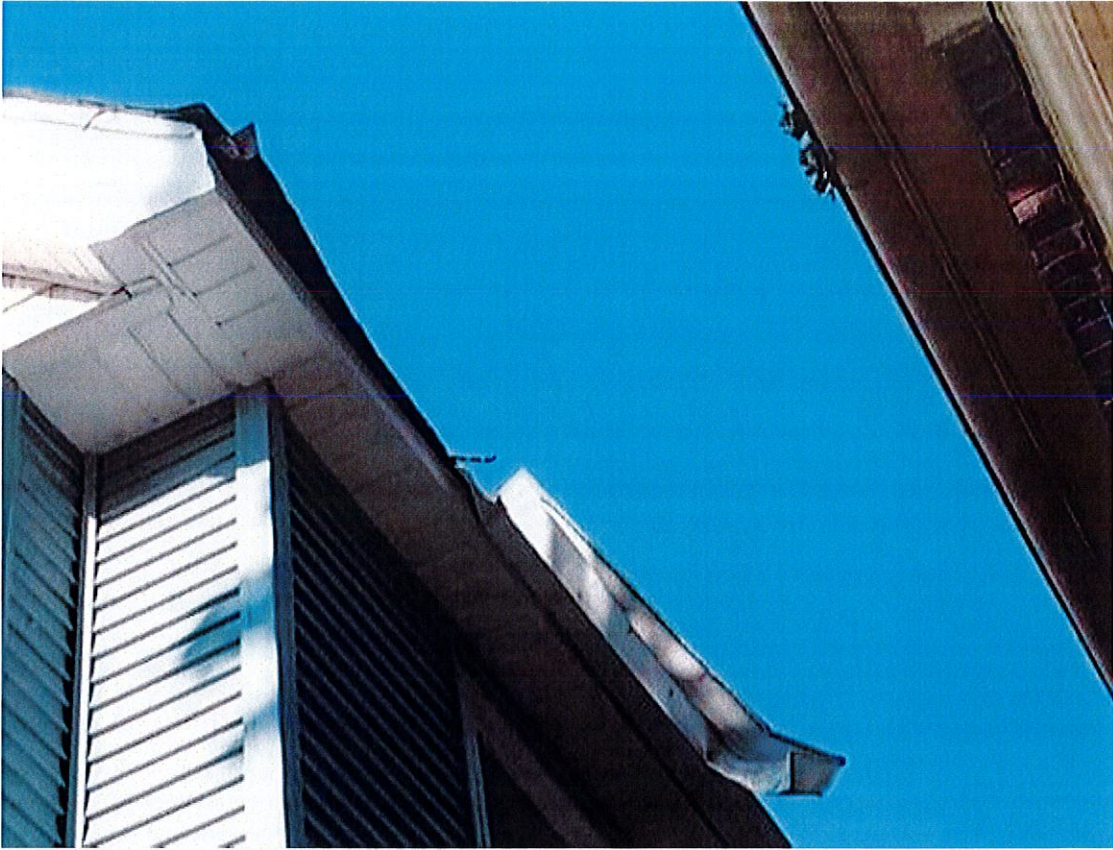
13-Right Elevation
Gutter damaged

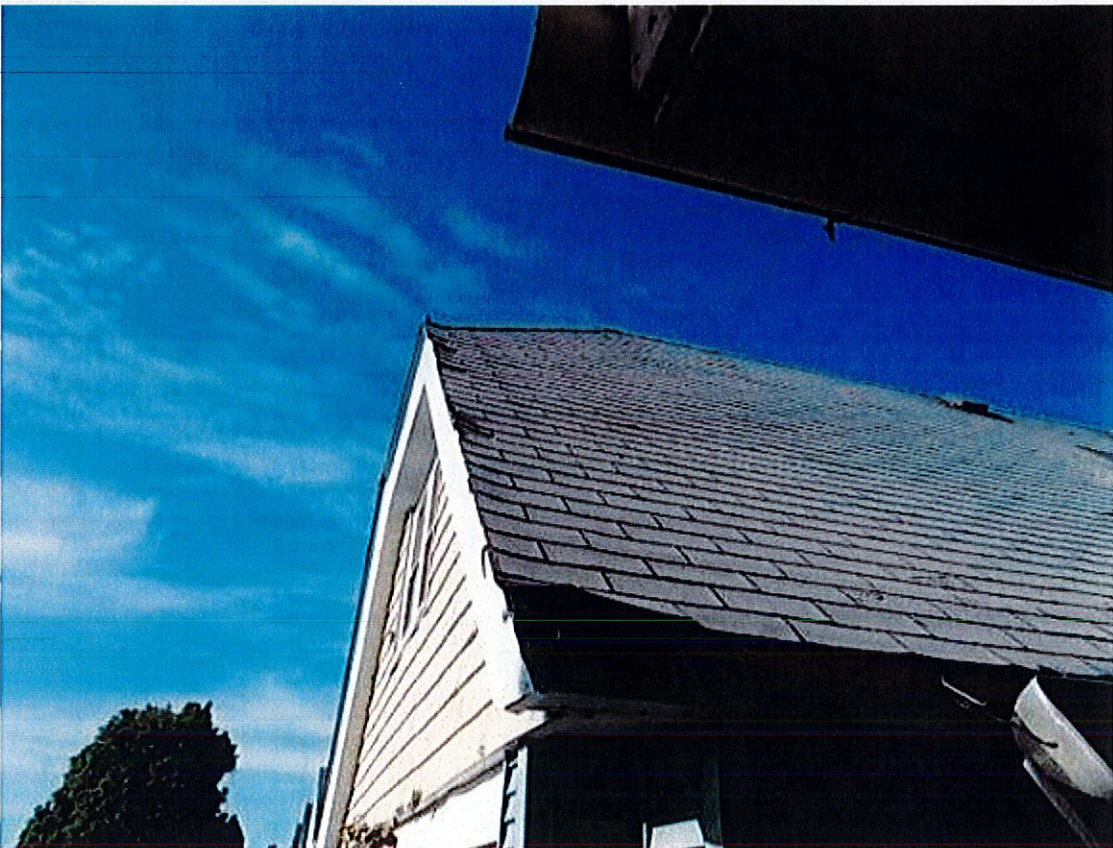
14-Right Elevation
Shingles damaged

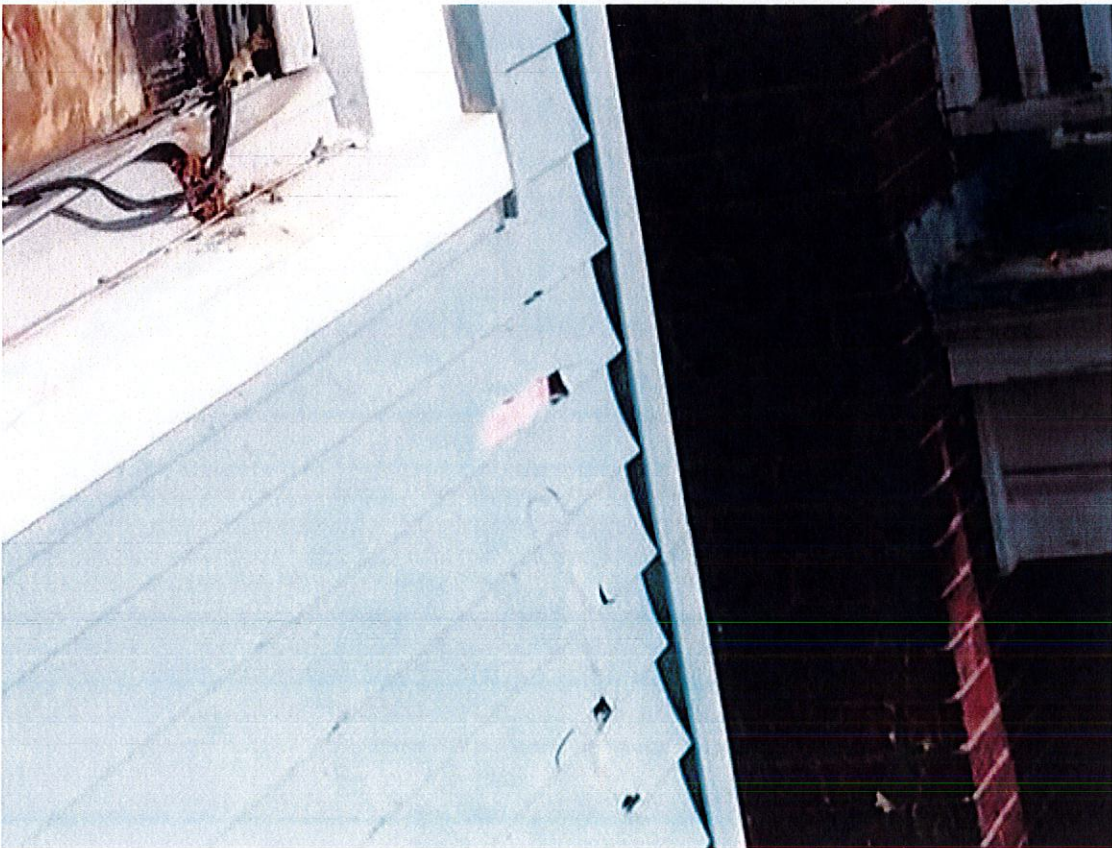
16-Front Elevation
Siding damaged

DESCRIPTION	QUANTITY	UNIT PRICE	TAX	O&P	RCV	DEPREC.	ACV
7. R&R Siding - vinyl	662.00 SF	3.68	50.79	497.38	2,984.33	(53.80)	2,930.53
8. R&R Rigid foam insulation board - 3/4"	662.00 SF	1.03	17.42	139.84	839.12	(4.22)	834.90

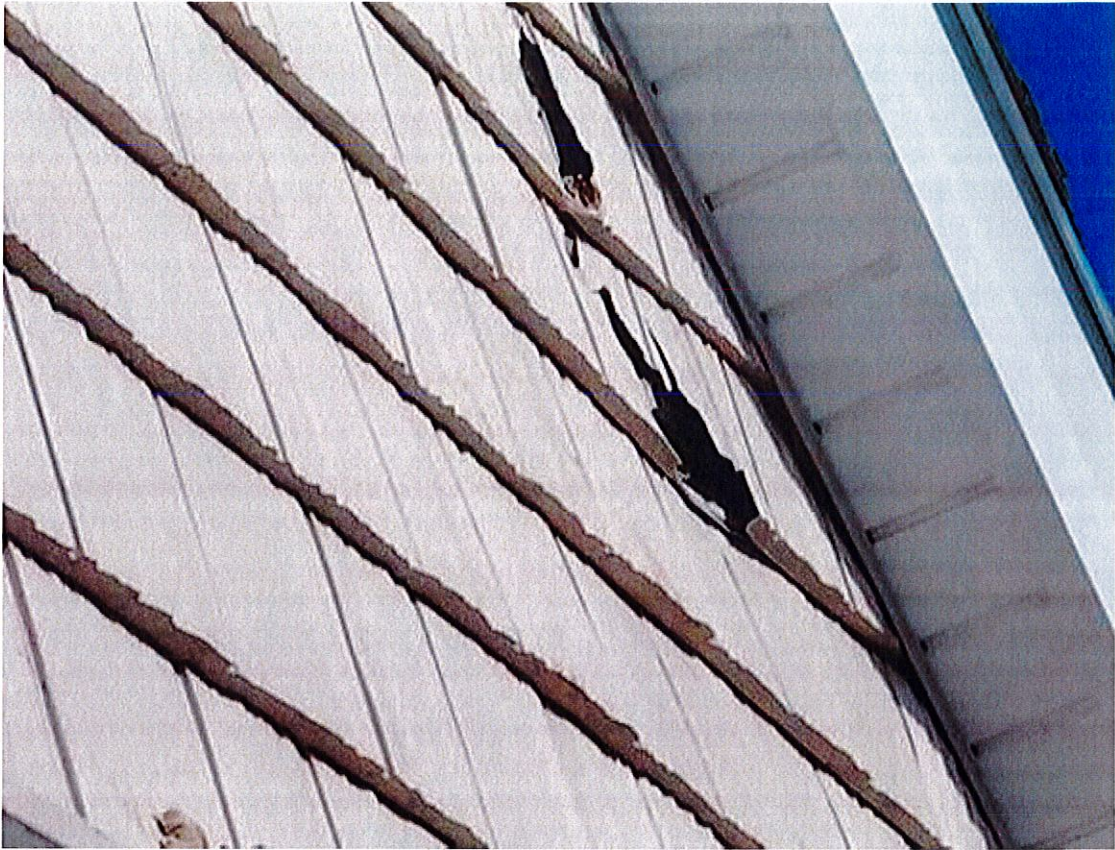
17-Front Elevation
Metal shake Siding damaged

9. R&R Siding - aluminum (.024 thickness)	108.00 SF	5.85	19.29	130.22	781.31	(14.62)	766.69
This is for the metal shake siding in the gable.							
10. R&R Wrap wood window frame & trim with aluminum sheet - XLarge	3.00 EA	298.97	9.53	181.28	1,087.72	(18.92)	1,068.80

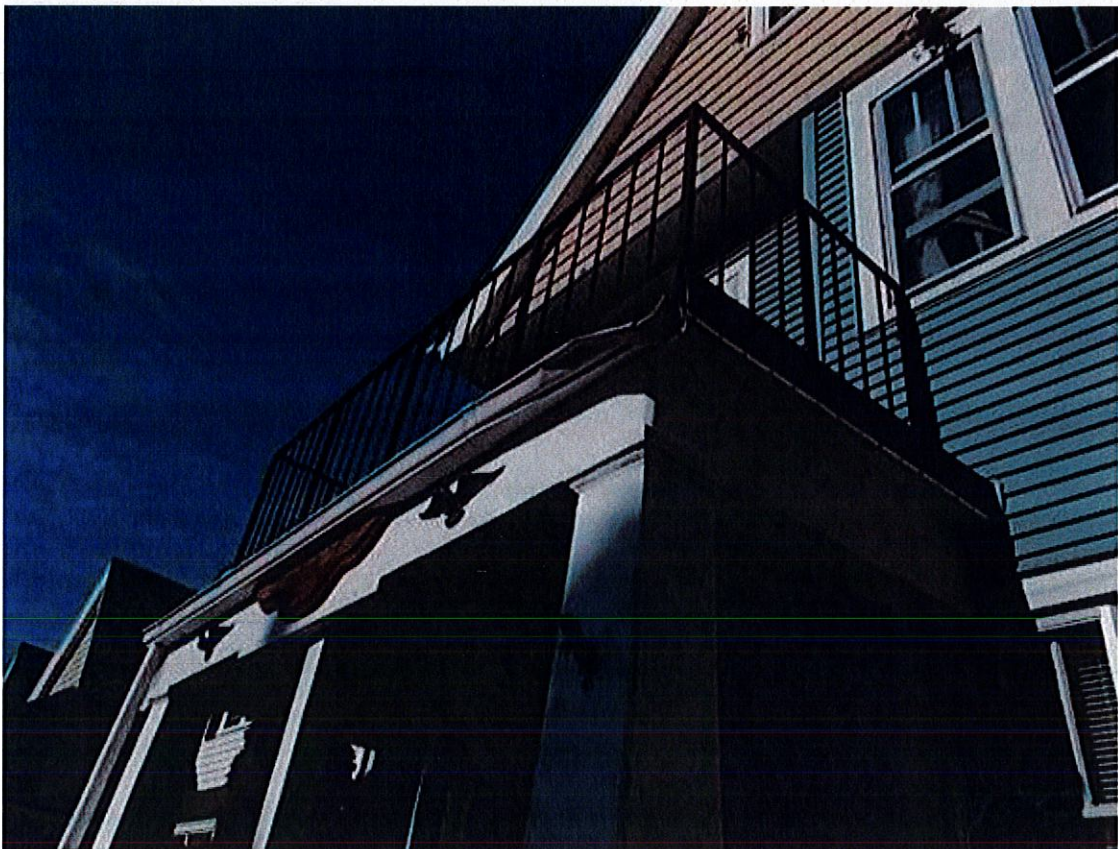
18-Front Elevation
Gutter damaged

12. Seal & paint wood window (per side)	4.00 EA	38.15	1.16	30.76	184.52	(12.29)	172.23
13. R&R Gutter / downspout - aluminum - up to 5"	20.00 LF	5.62	2.41	22.96	137.77	(5.12)	132.65

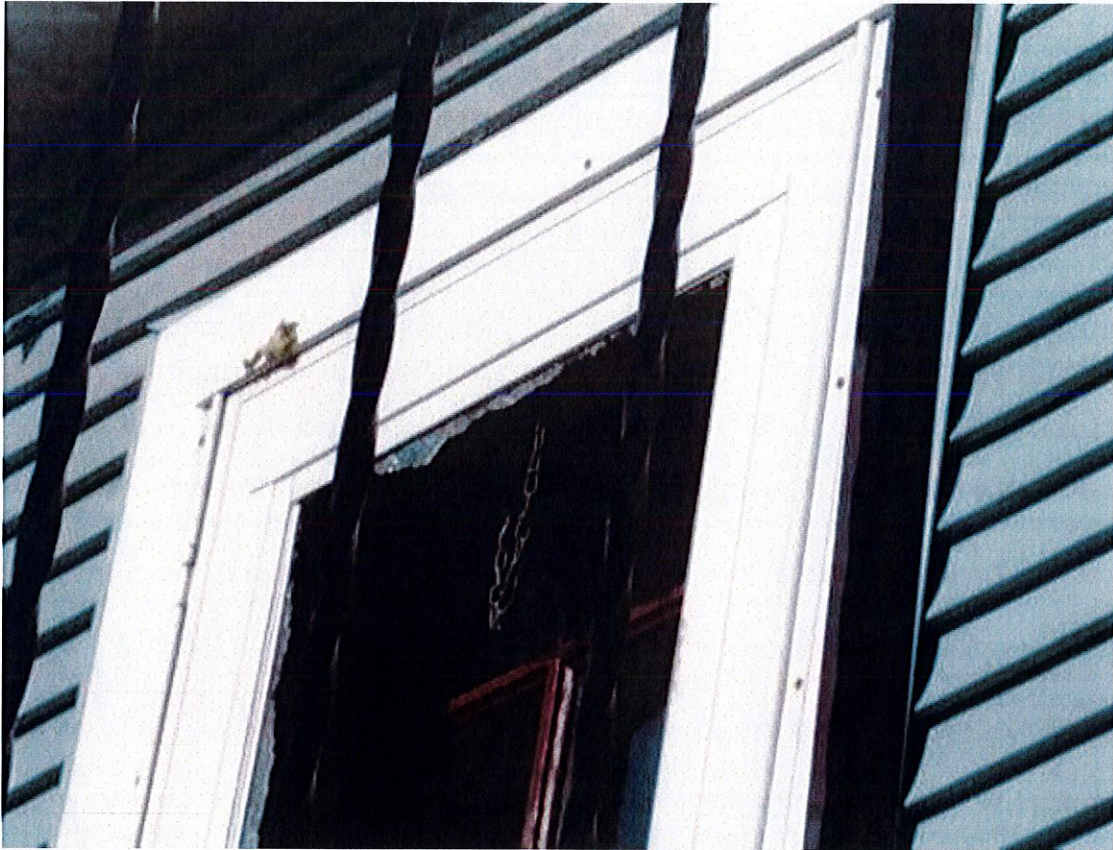
19-Front Elevation
Storm door damaged

14. R&R Storm window - aluminum, 12-24 sf	2.00 EA	156.16	13.78	65.22	391.32	(20.48)	370.84
15. R&R Storm door assembly	1.00 EA	230.37	8.03	47.68	286.08	(6.71)	279.37

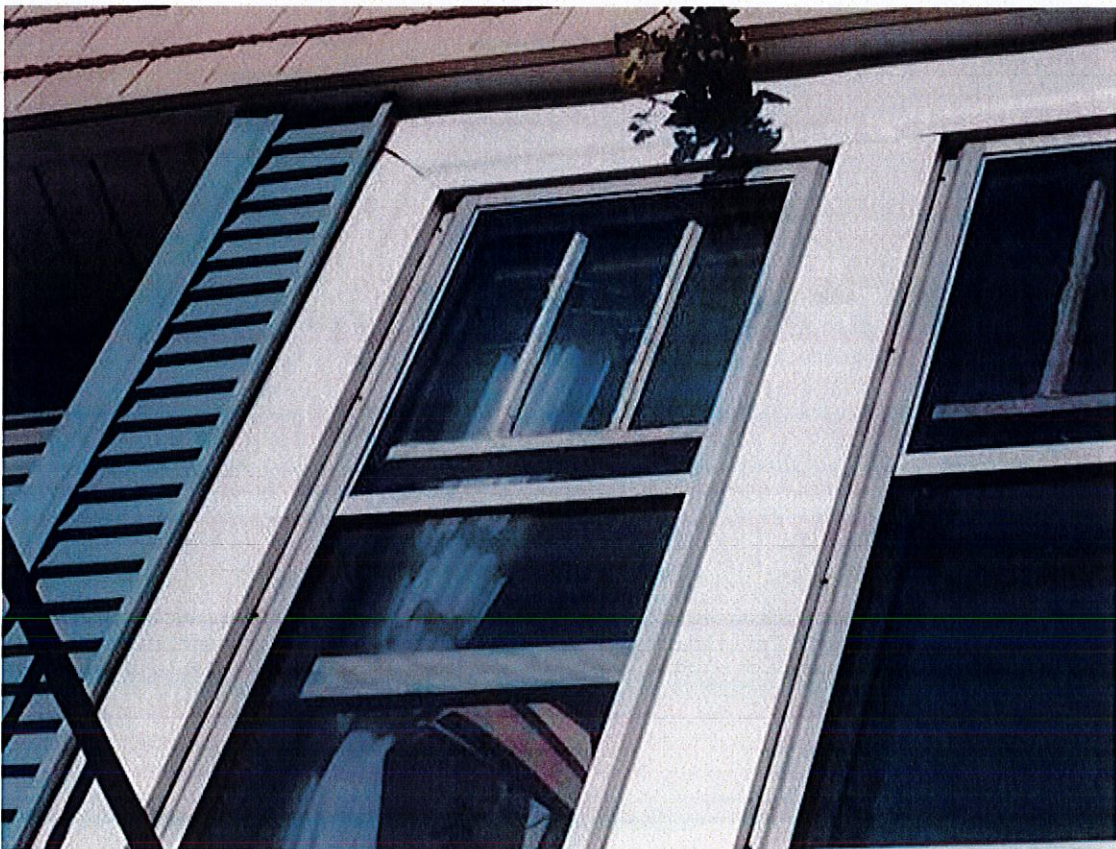
20-Front Elevation
Storm windows damaged and window wrap

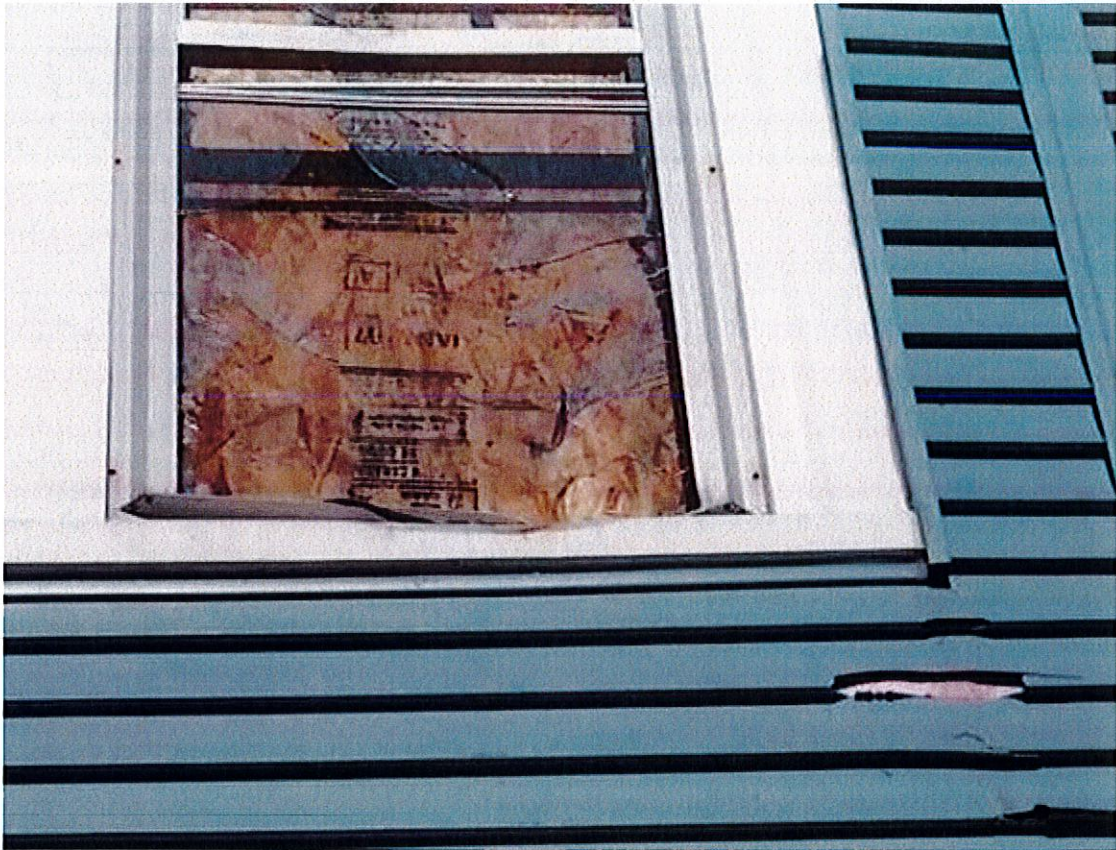
21-Front Elevation

Storm windows damaged and window wrap

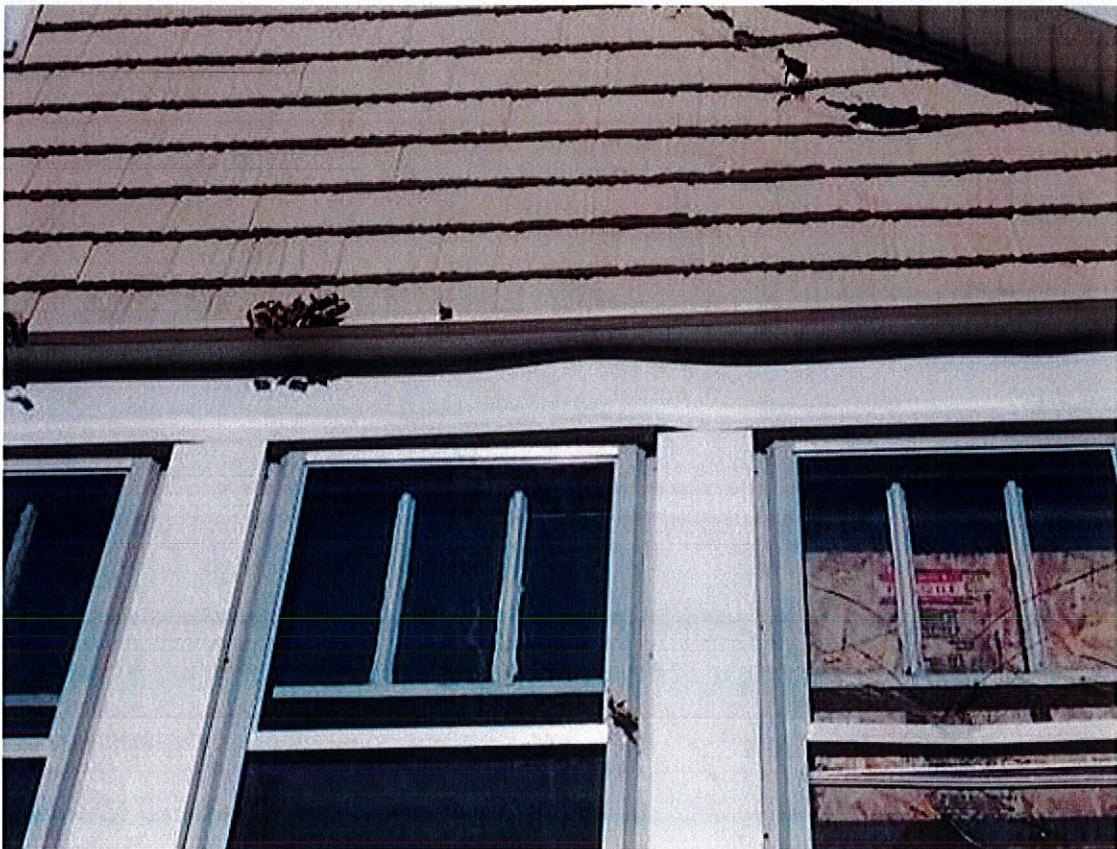
22-Front Elevation

Window wrap damaged

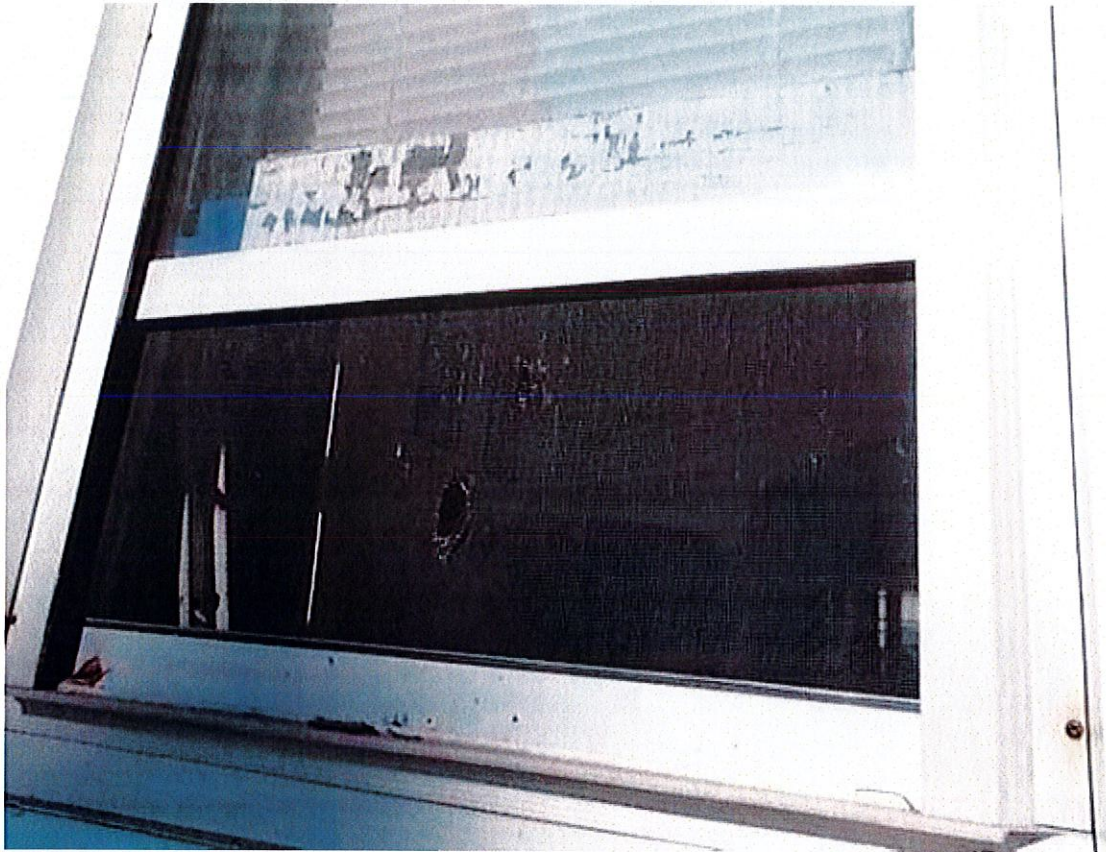
23-Front Elevation
Screen damaged

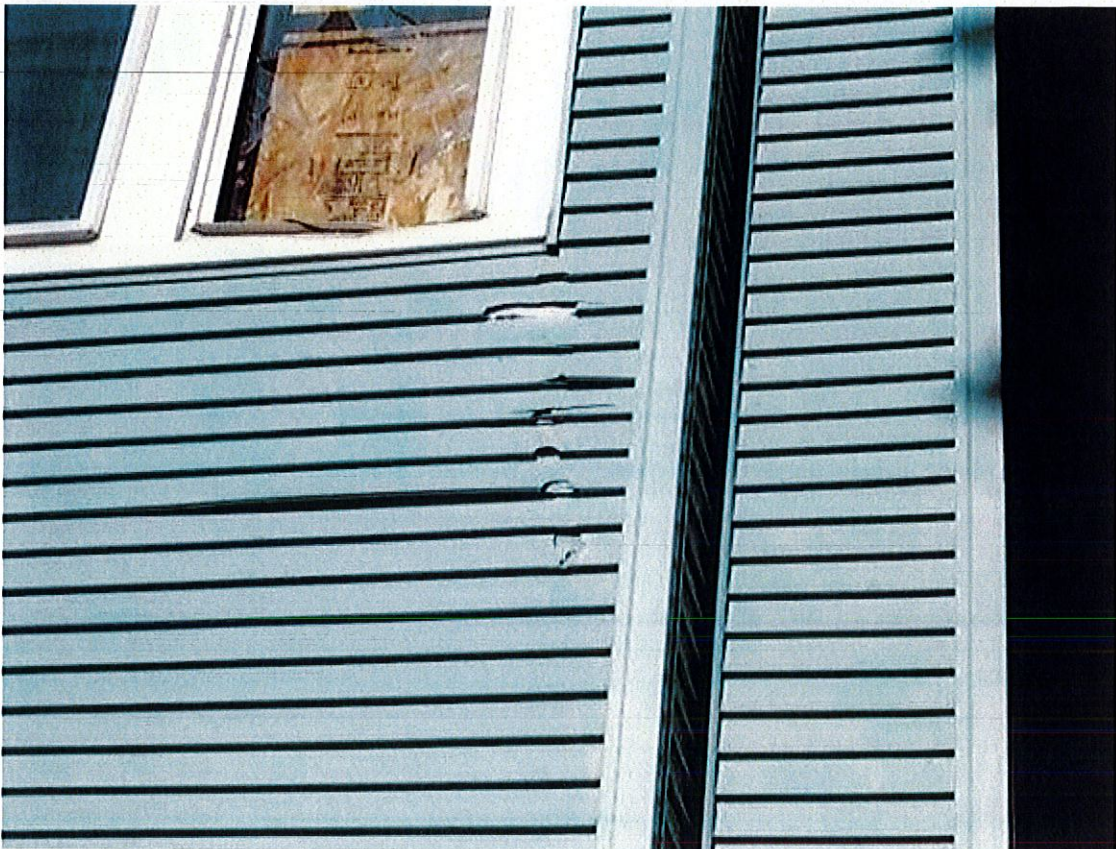
24-Front Elevation
Siding damaged

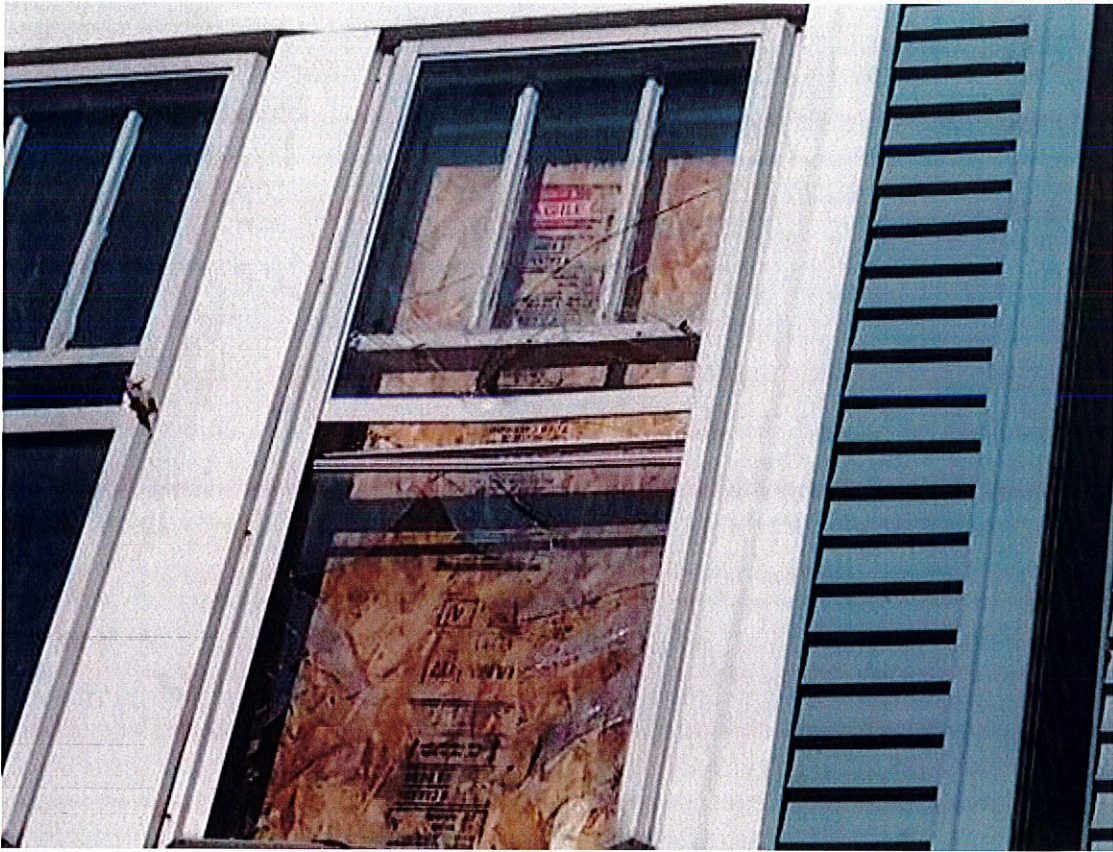
25-Front Elevation
Damaged wood shales

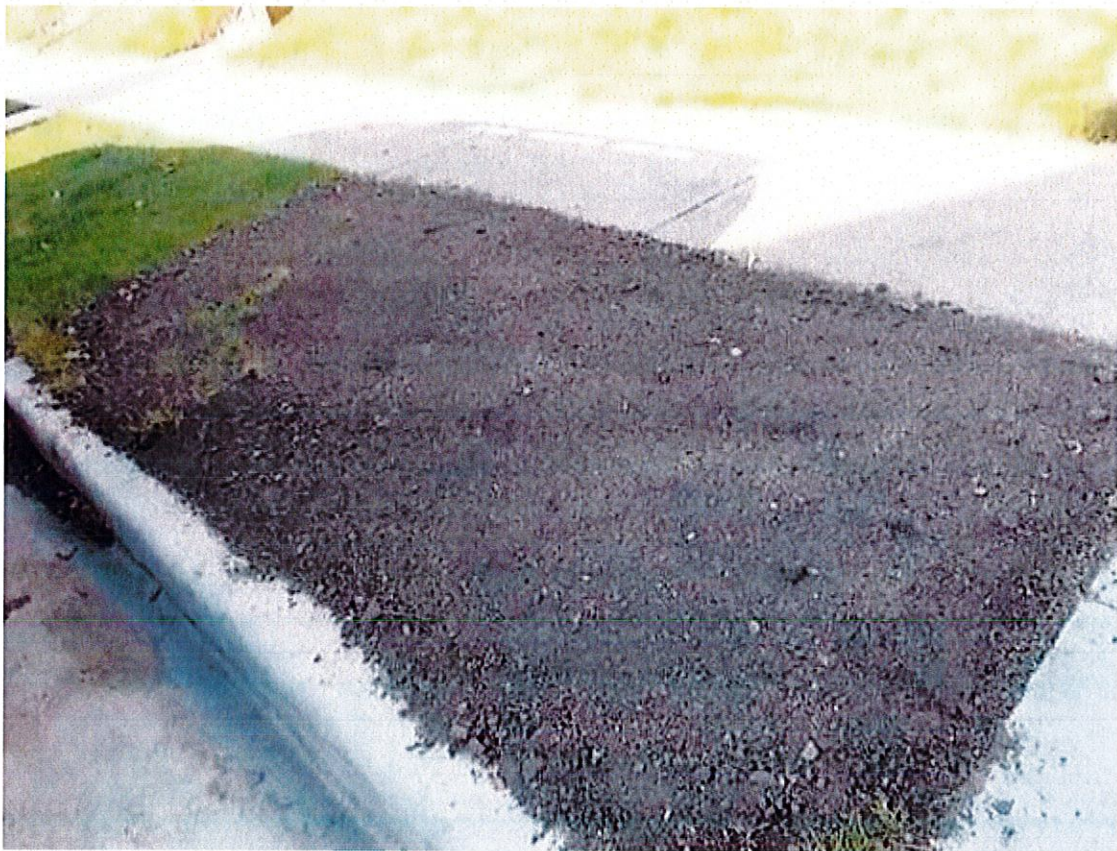
28-Tree
This is where the tree was

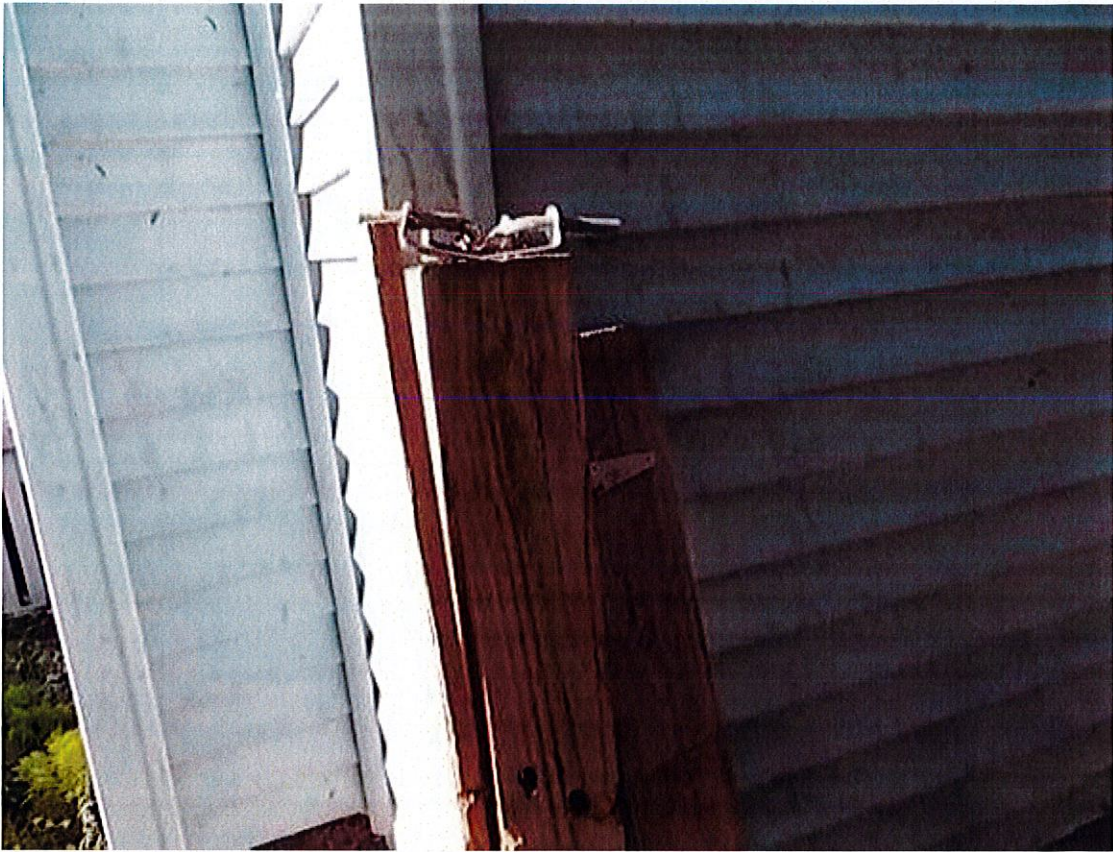
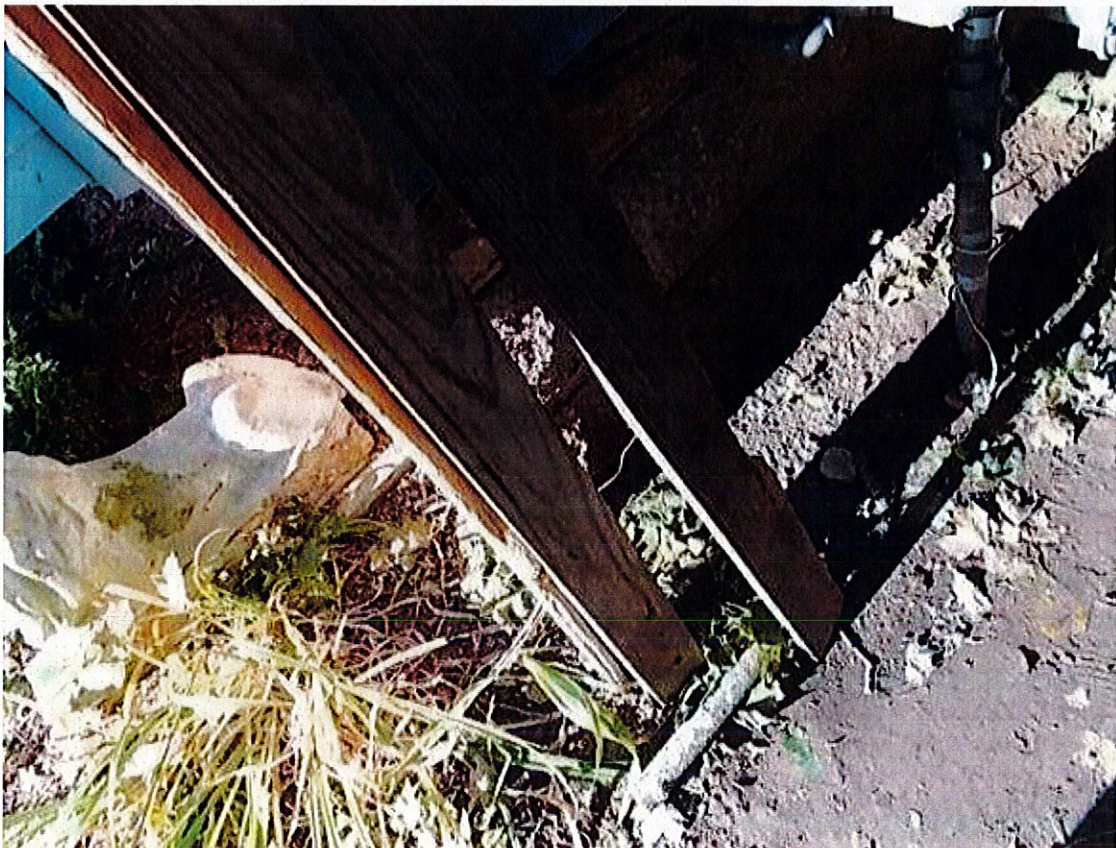
29-Fence
Fence damaged

30-Fence
Fence damaged

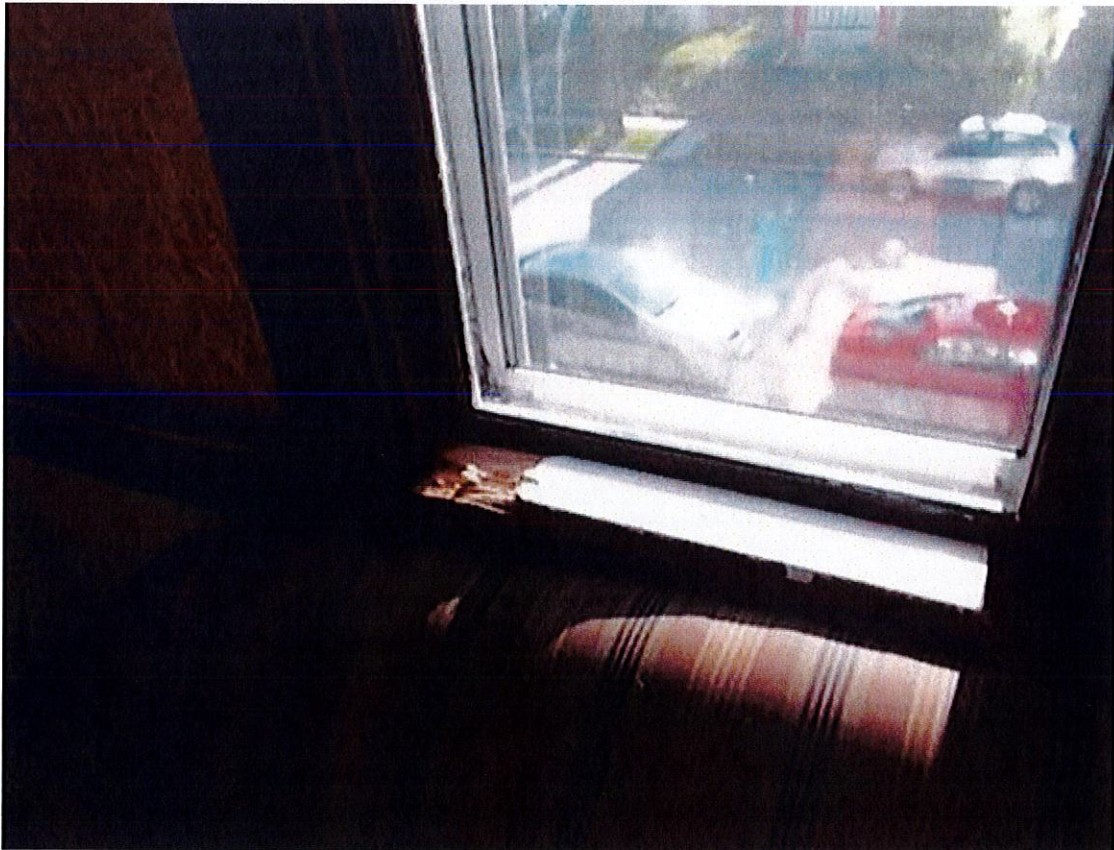
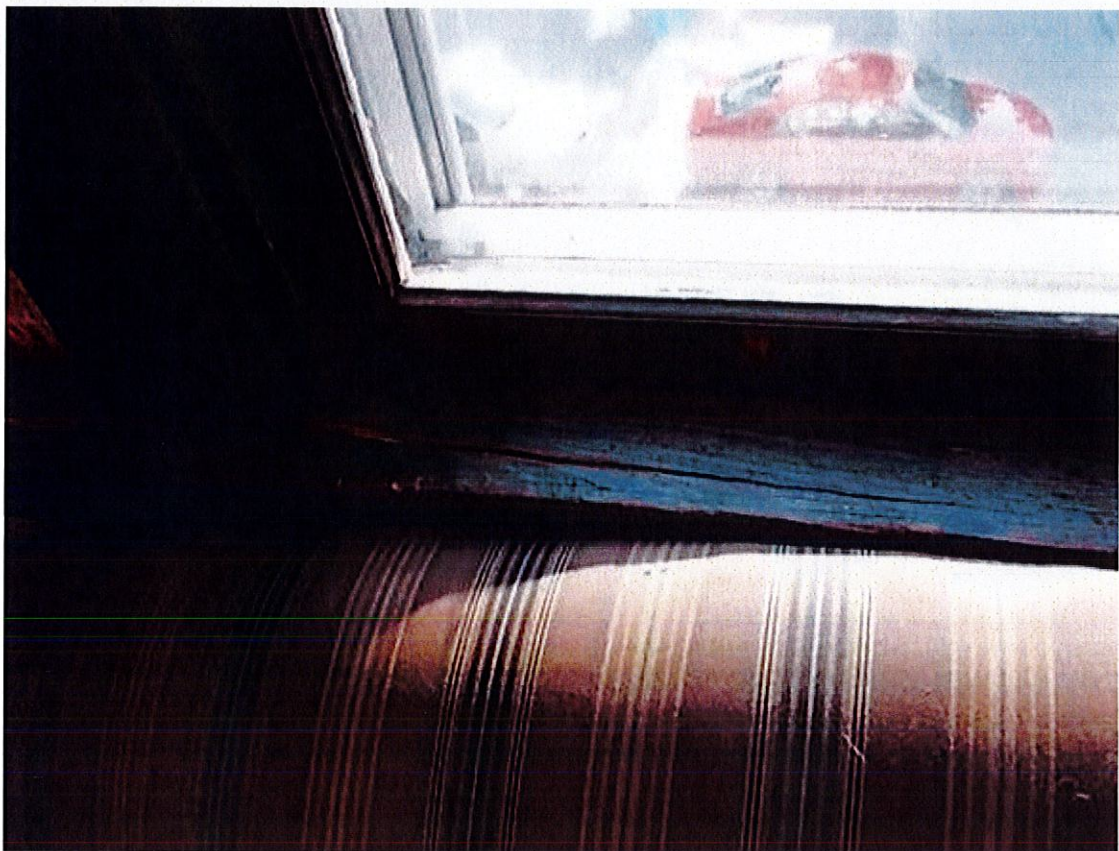
31-Living Room
Window sill cracked

32-Living Room
Window sill cracked

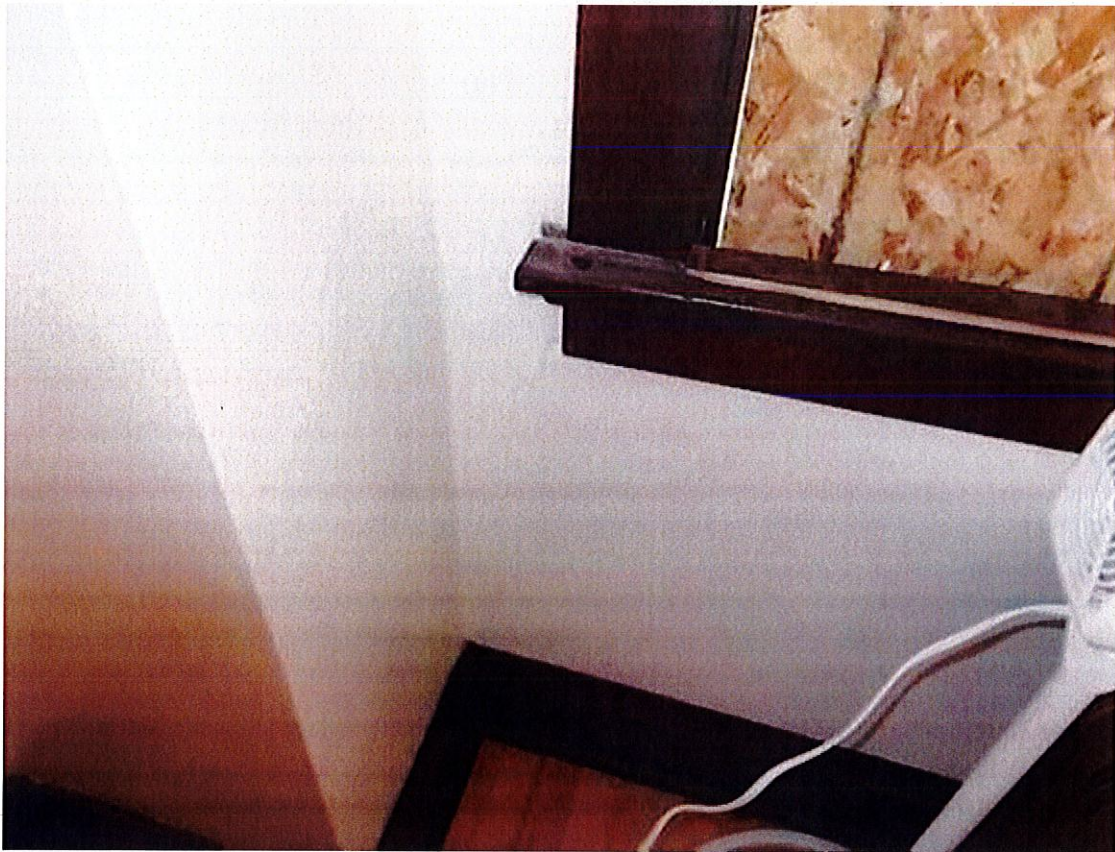
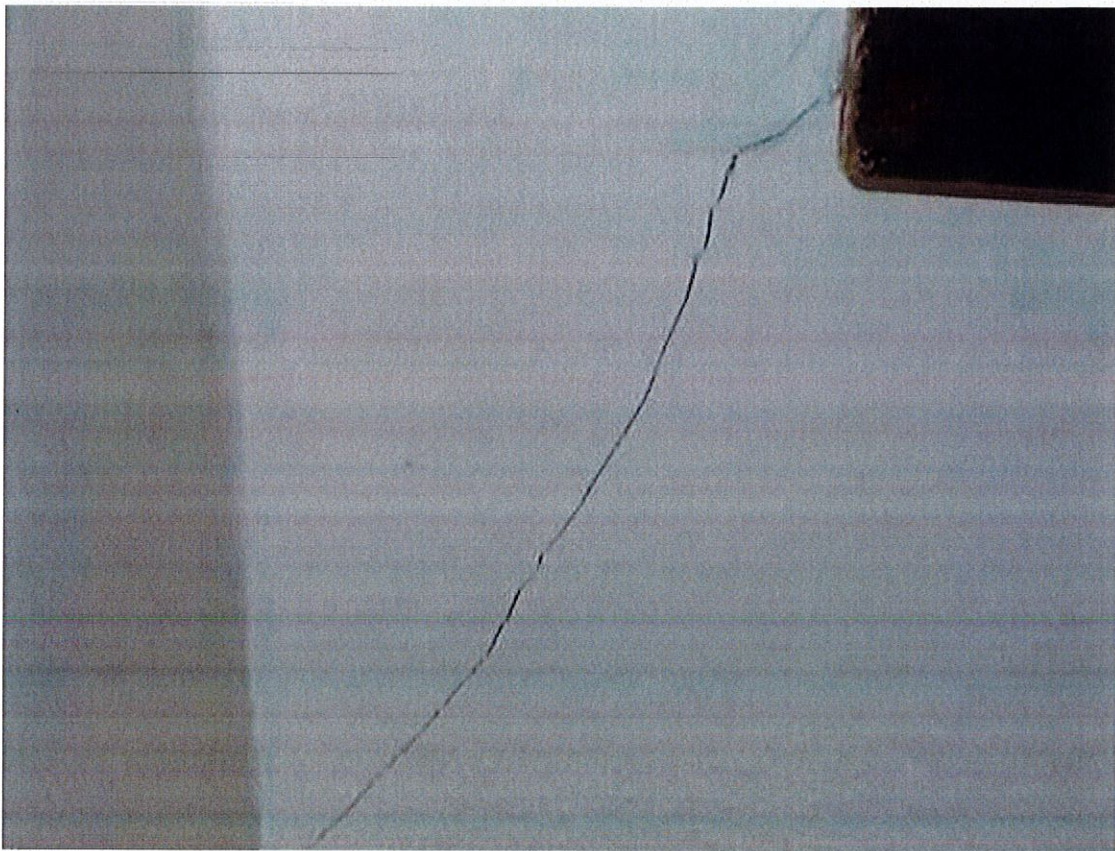
33-Living Room
Plaster wall cracked from impact.

34-Living Room
Plaster wall cracked from impact.

DESCRIPTION	QUANTITY	UNIT PRICE	TAX	O&P	RCV	DEPREC.	ACV
22. R&R Two coat plaster over metal lath	371.95 SF	6.88	30.20	517.84	3,107.05	(0.00)	3,107.05
23. Seal the walls w/latex based stain blocker - one coat	371.95 SF	0.43	1.46	32.28	193.68	(0.00)	193.68
24. Paint the walls - two coats	371.95 SF	0.68	3.96	51.38	308.27	(0.00)	308.27
25. R&R Window stool & apron	10.00 LF	6.17	1.42	12.62	75.74	(0.00)	75.74
26. Stain & finish wood window sill	10.50 LF	2.02	0.10	4.26	25.57	(0.00)	25.57
Totals: Living Room			37.14	618.38	3,710.31	0.00	3,710.31
Total: Interior			37.14	618.38	3,710.31	0.00	3,710.31
Total: Source - 3rd Party 1			464.37	2,553.62	23,879.53	1,294.13	22,585.40
