Safeco Insurance Company of America

Claim Number: 465410366002
Insured Name: Joel Benway Katherine Benway
Date of Loss: July 15, 2017
Policy Number: OZ4593144
Underwriting Company: Safeco Insurance Company of America

Claim Number: 465410366002 **Policy Number:** OZ04593144 **Type of Loss:** Wind

Price List: WIMW8X_SEP17
Restoration/Service/Remodel
Estimate: JOEL BENWAY__
KATHERI

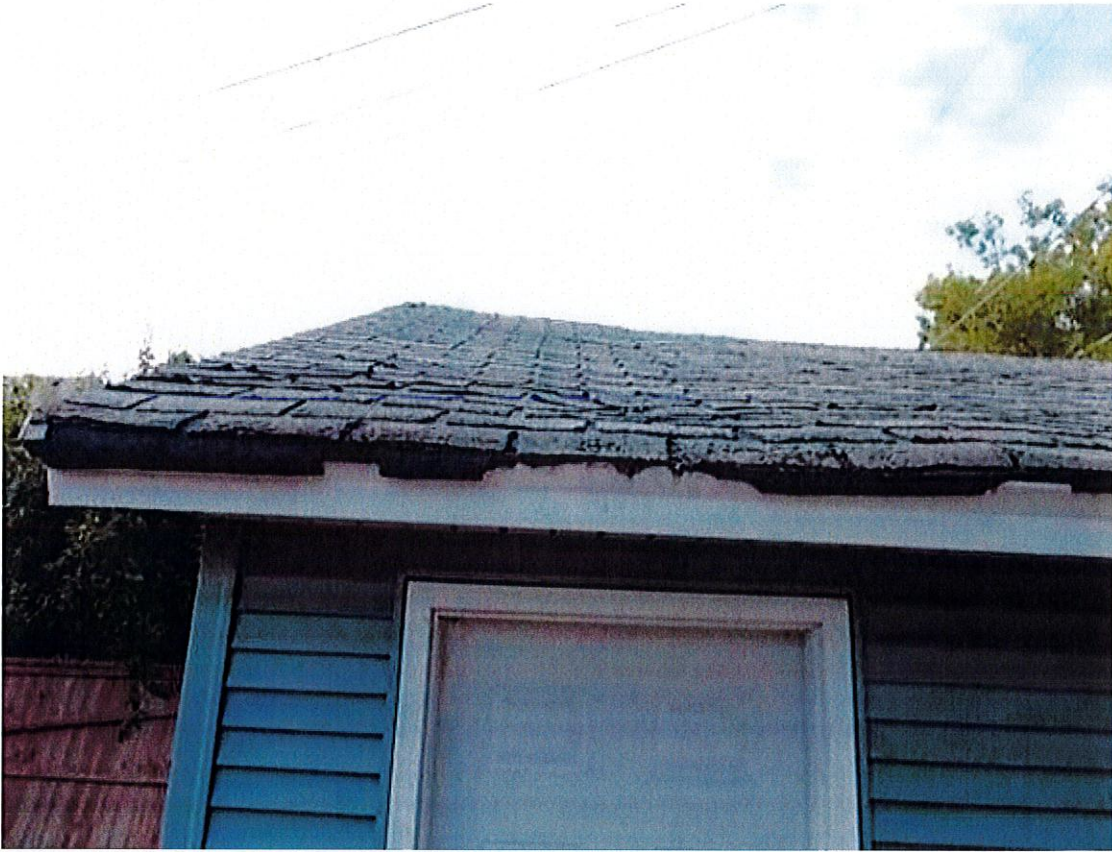
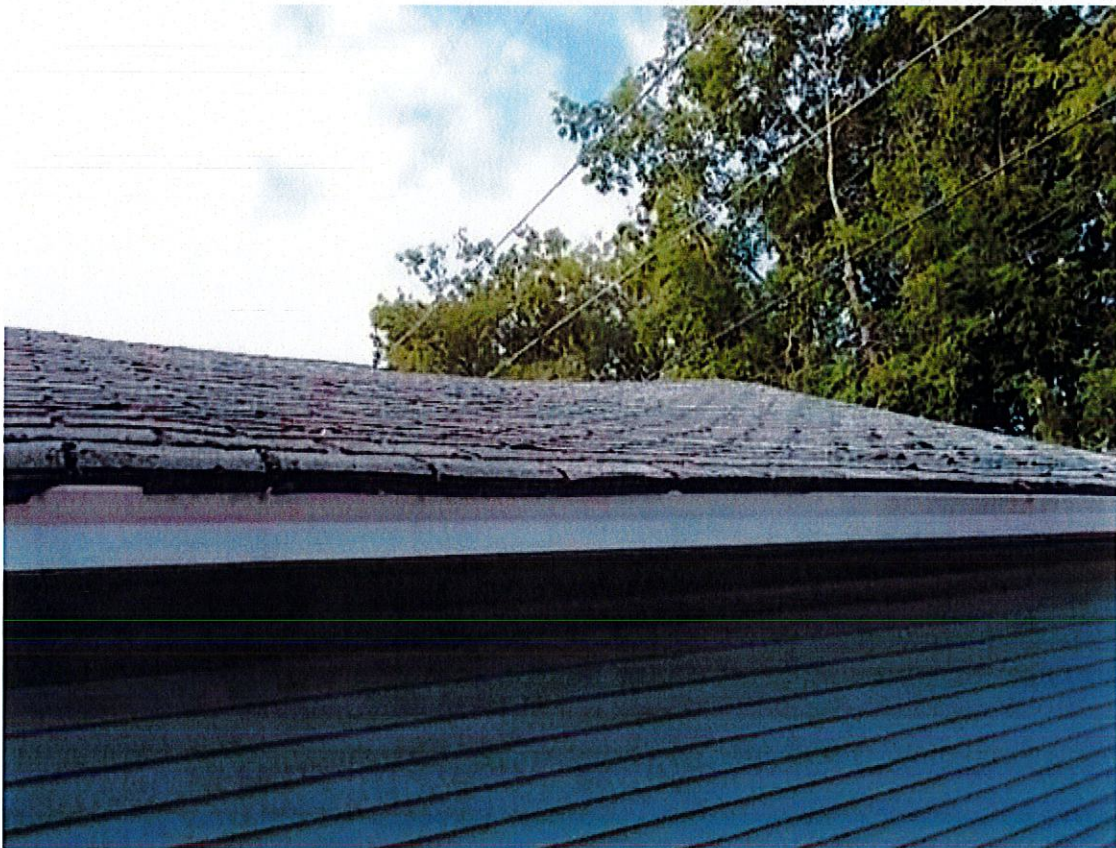
37-Detached Gargae

NO damage to the organic shingles.

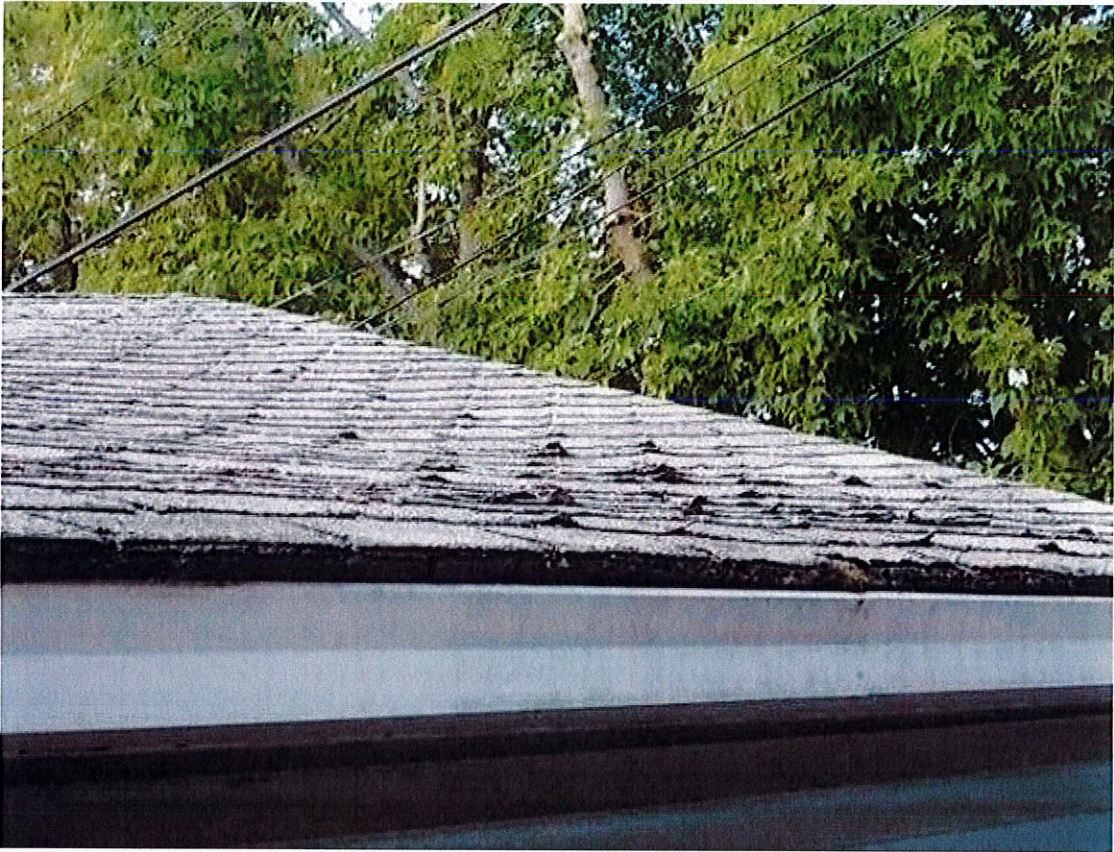
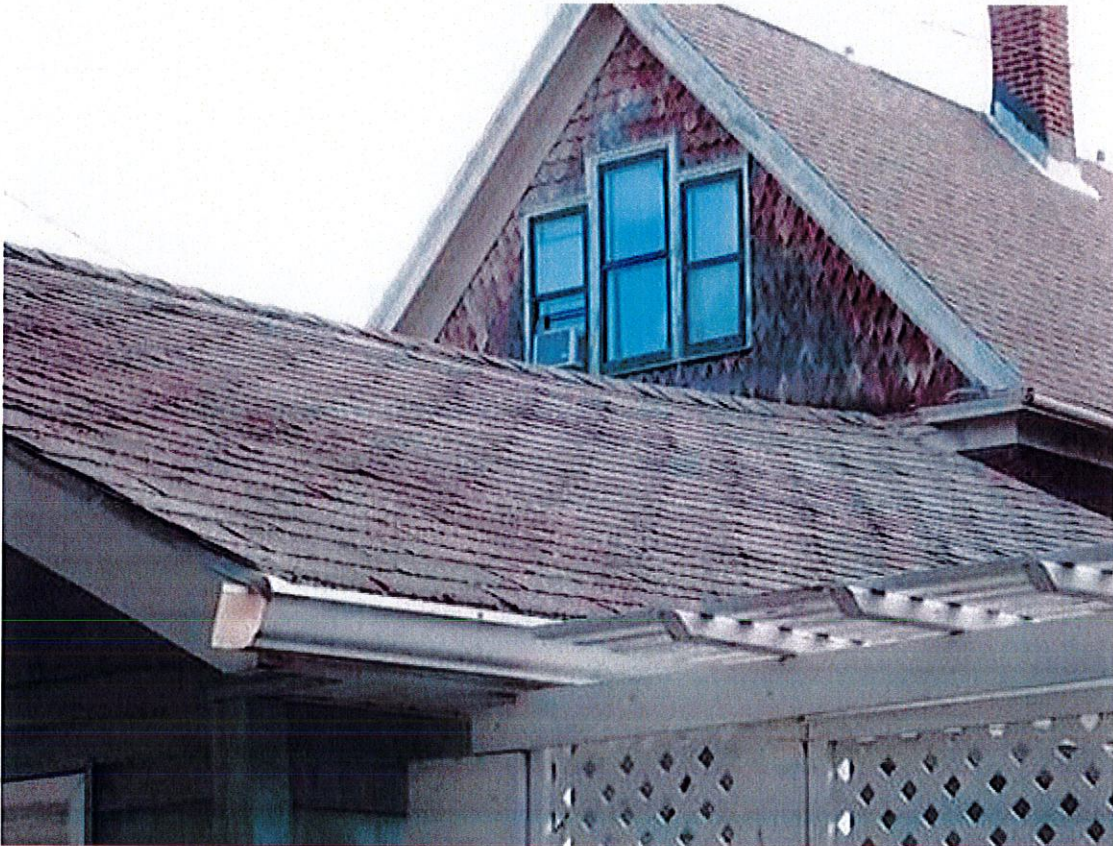
39-Detached Gargae
NO damage to the organic shingles.

40-Detached Gargae
NO damage to the organic shingles.

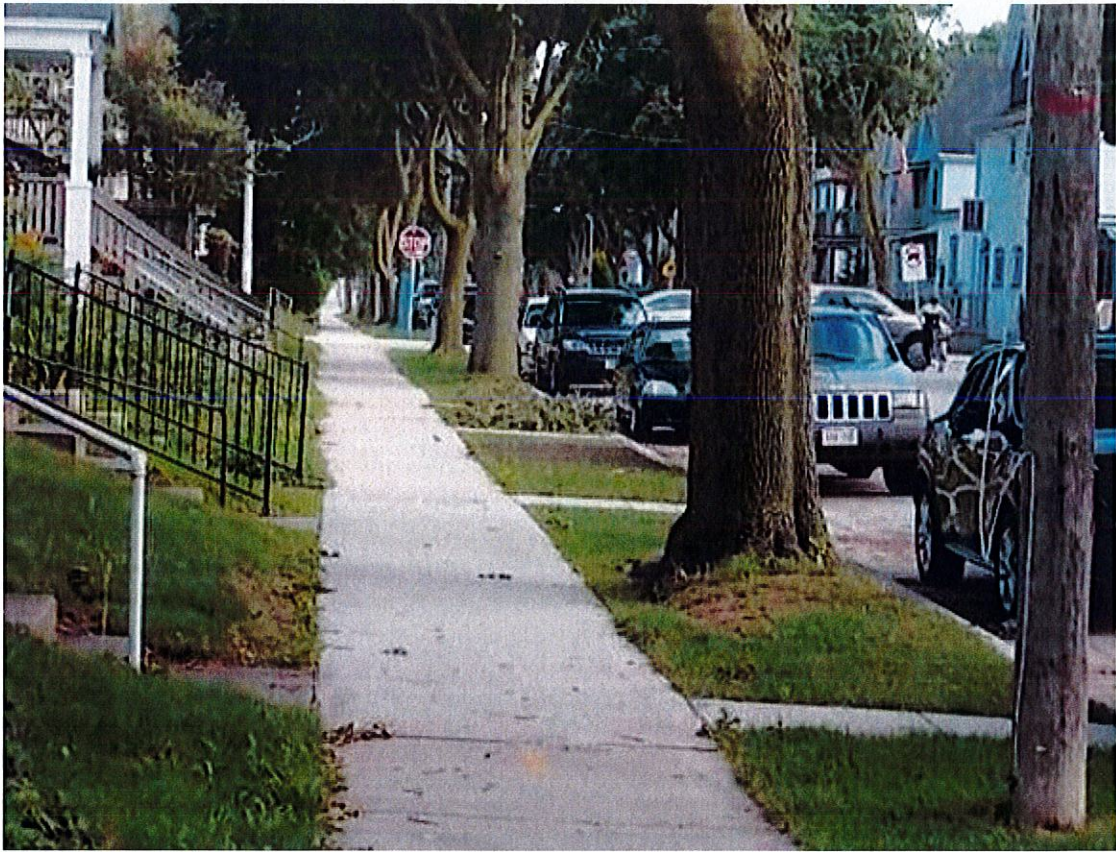
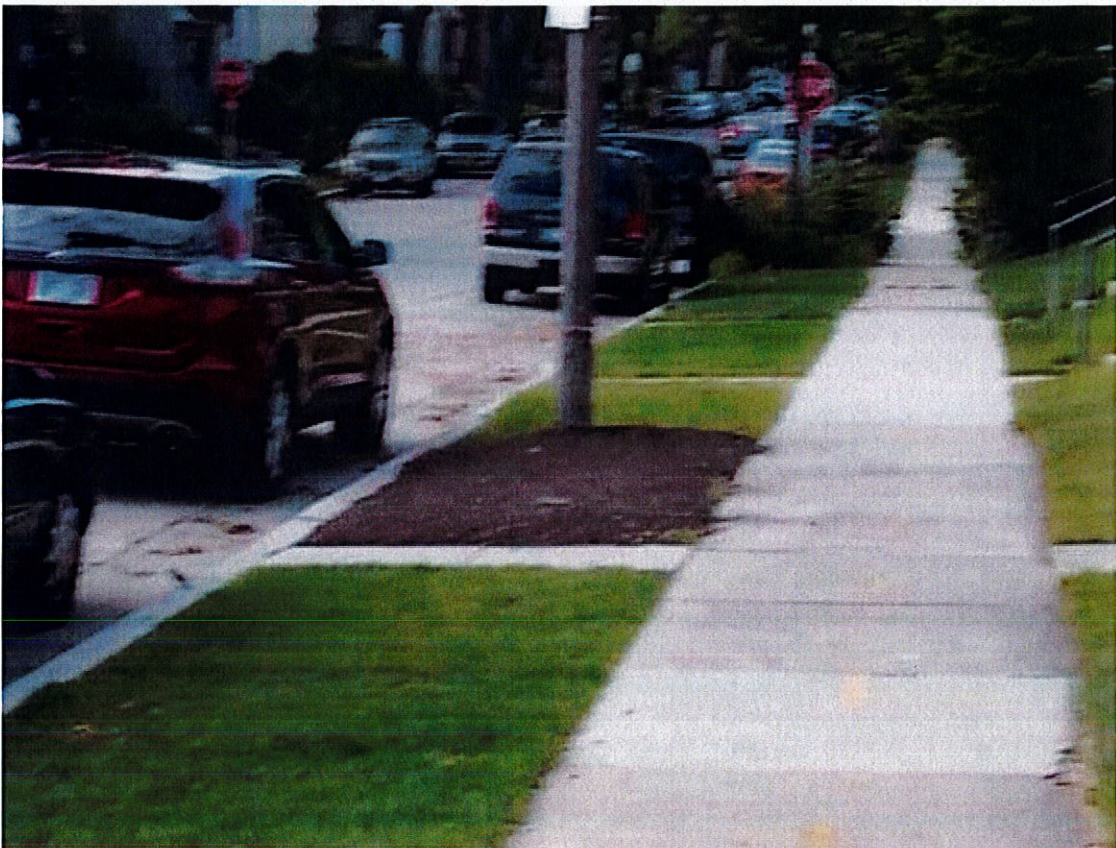
41-Tree

This is where there were two other trees that fell the same night.

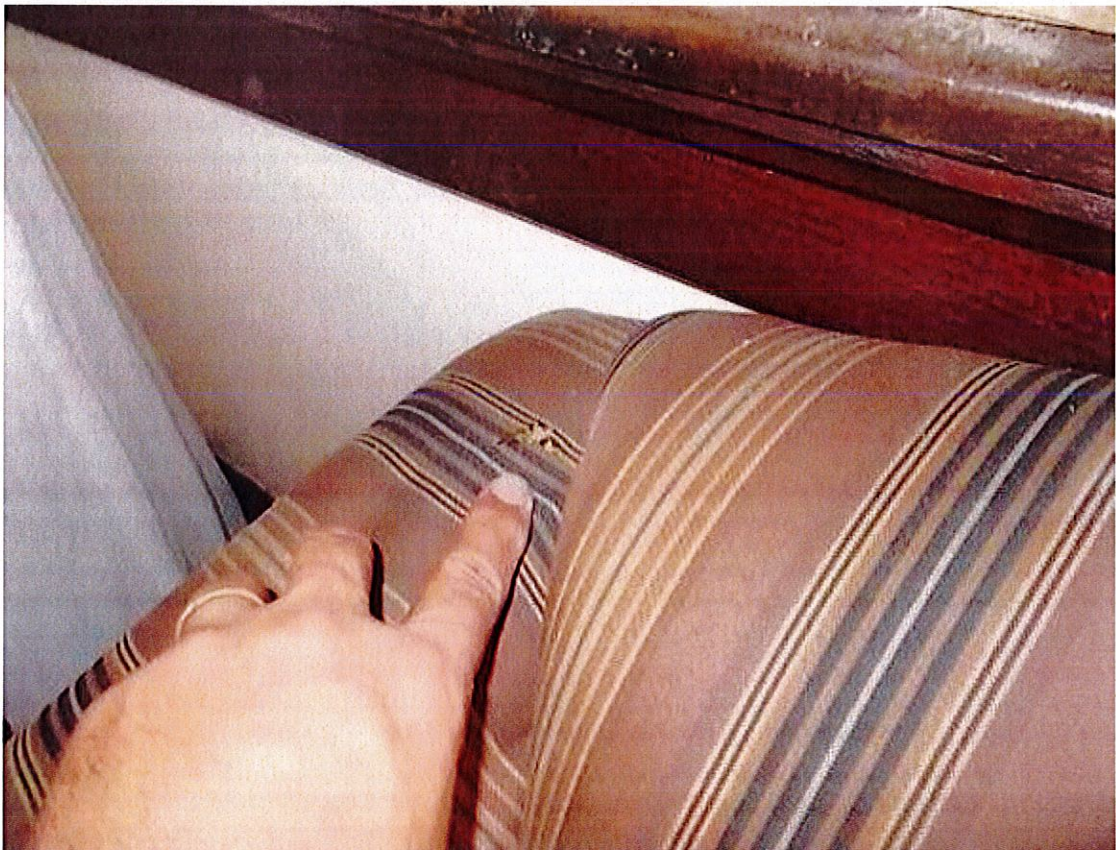
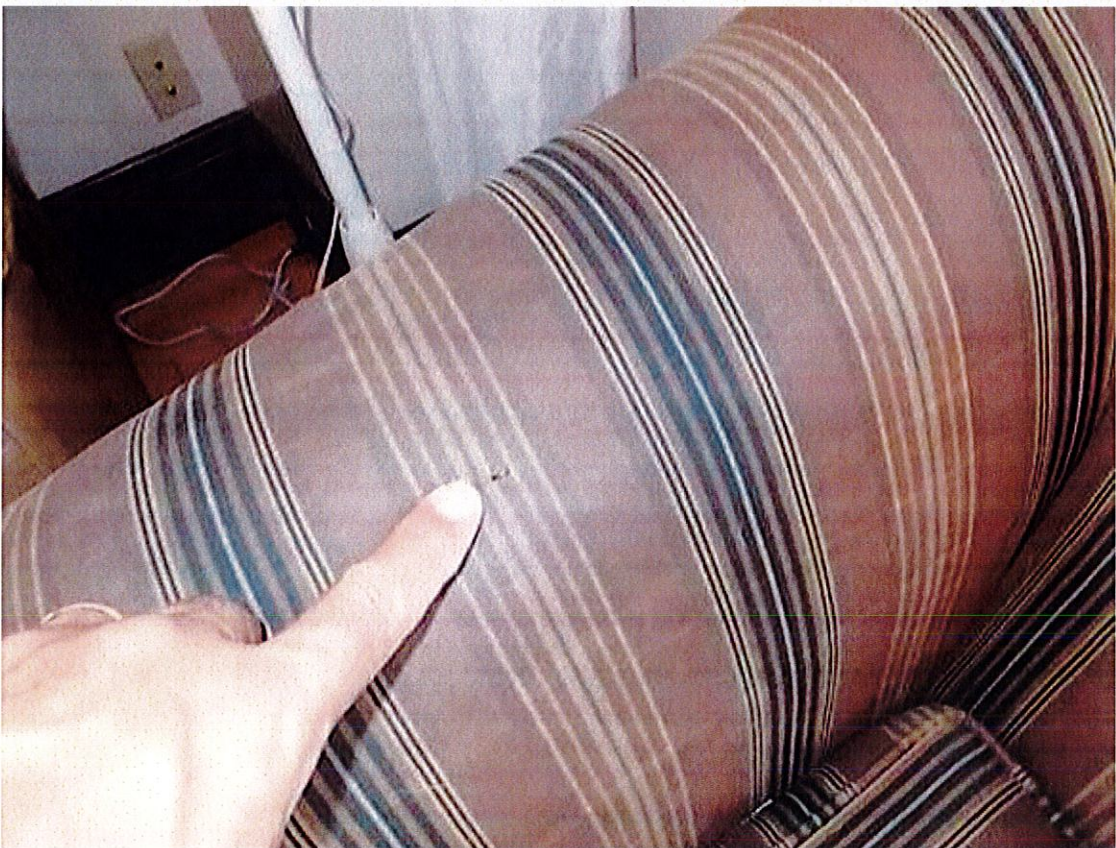
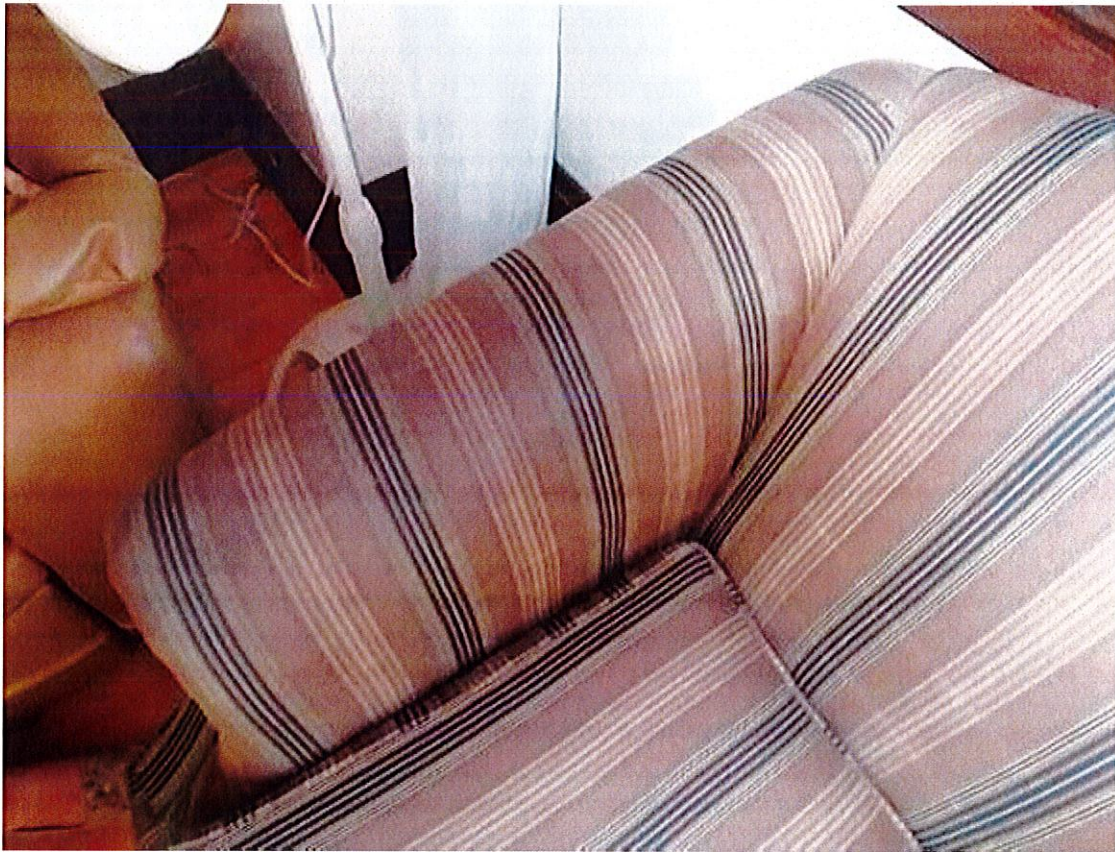
43-Contents

Sofa damaged when glass broke.

DESCRIPTION	QUANTITY	UNIT PRICE	TAX	O&P	RCV	DEPREC.	ACV
21. Sofa from Dutchcrafters.com	1.00 EA	1,299.00	72.74	0.00	1,371.74	<0.00>	1,371.74
Totals: Contents			72.74	0.00	1,371.74	0.00	1,371.74
Total: Source - 3rd Party 1			427.23	1,935.24	20,169.22	1,294.13	18,875.09

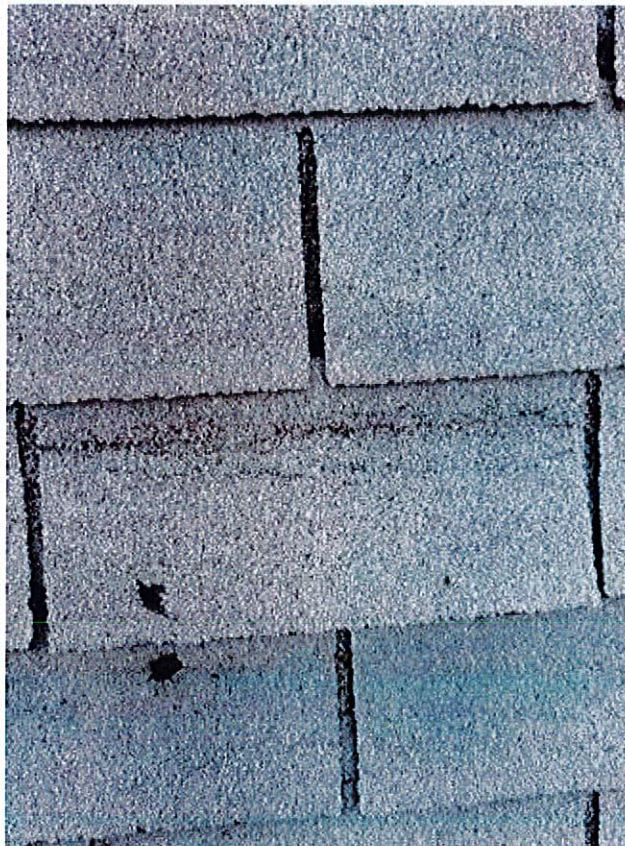
63-Failed brittle test

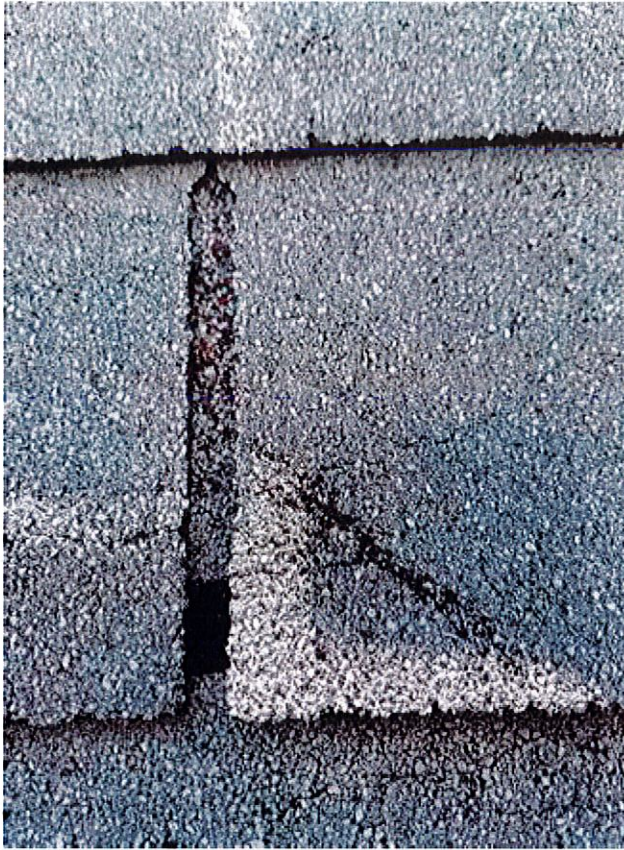
50-Wind damaged shingle

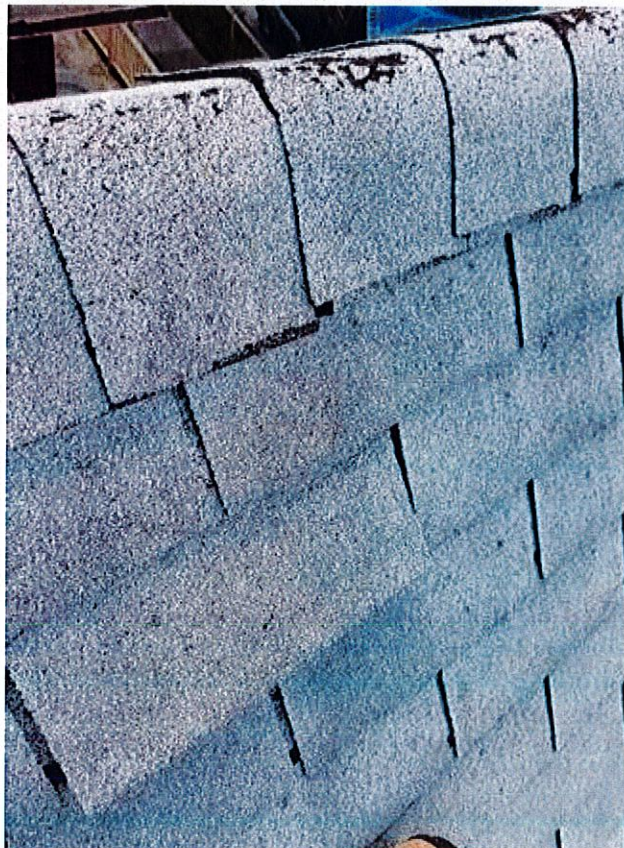
56-Roof ridge

Damage from wind blown tree

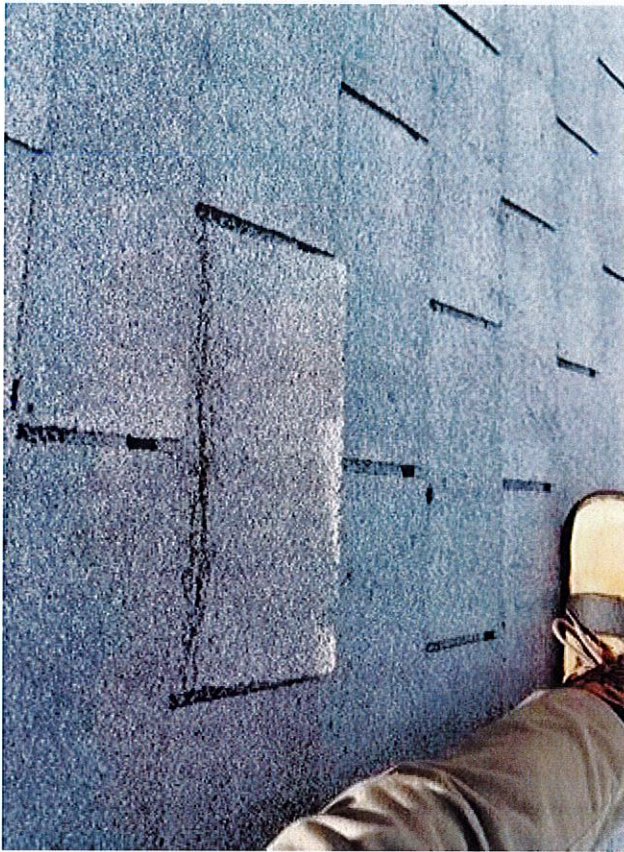
59-Failed brittle test

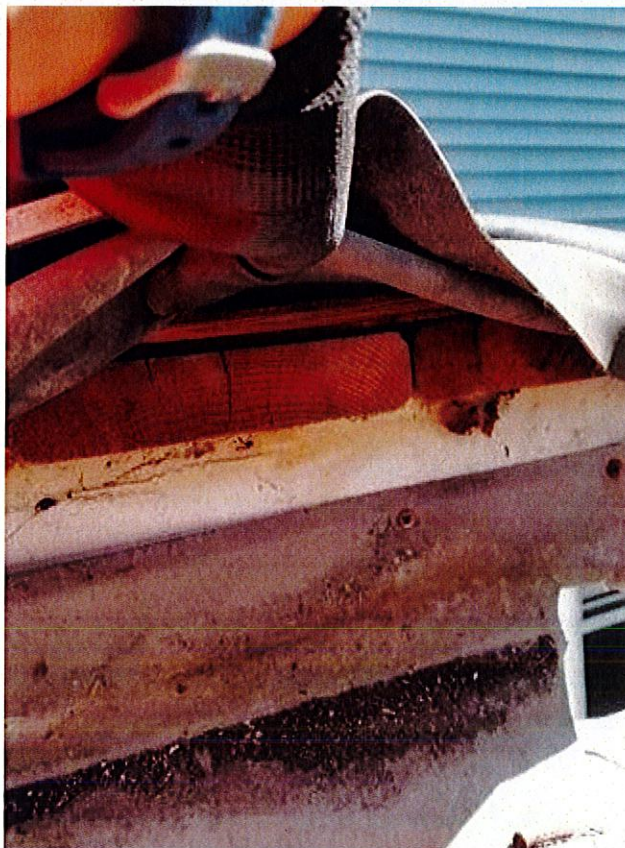
66-2nd floor patio deck

Patio was covered with a rubber cover

42. Storm window - wood, 12 - 24 sf	1.00 EA	110.25	3.85	22.84	136.94	(22.82)	114.12
43. General Laborer - per hour	4.00 HR	39.54	0.00	31.64	189.80	(0.00)	189.80
Allowance for 2 workers for 2 hours each to detach and reset the rubber cover over the front upstairs patio

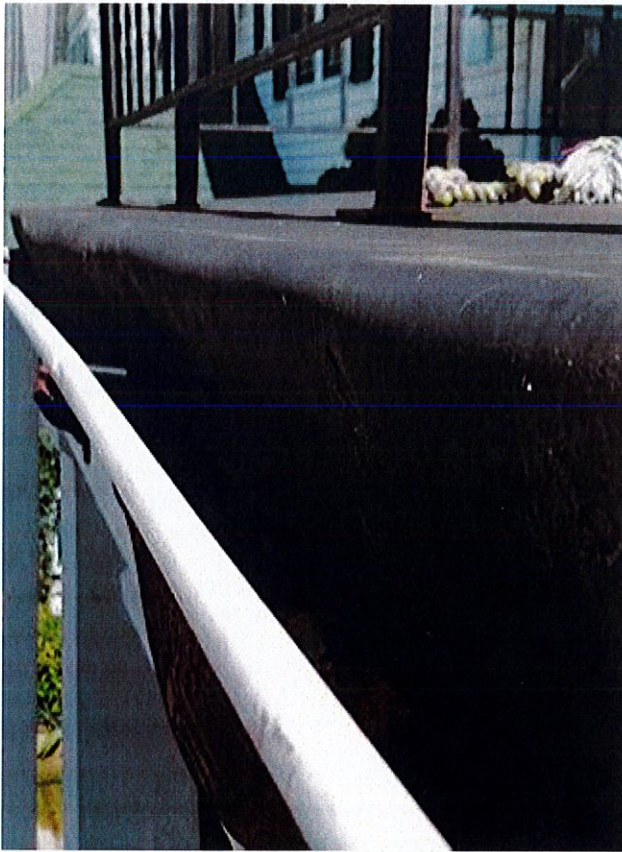
67-Rubber cover

Gutters were directly installed over the rubber cover

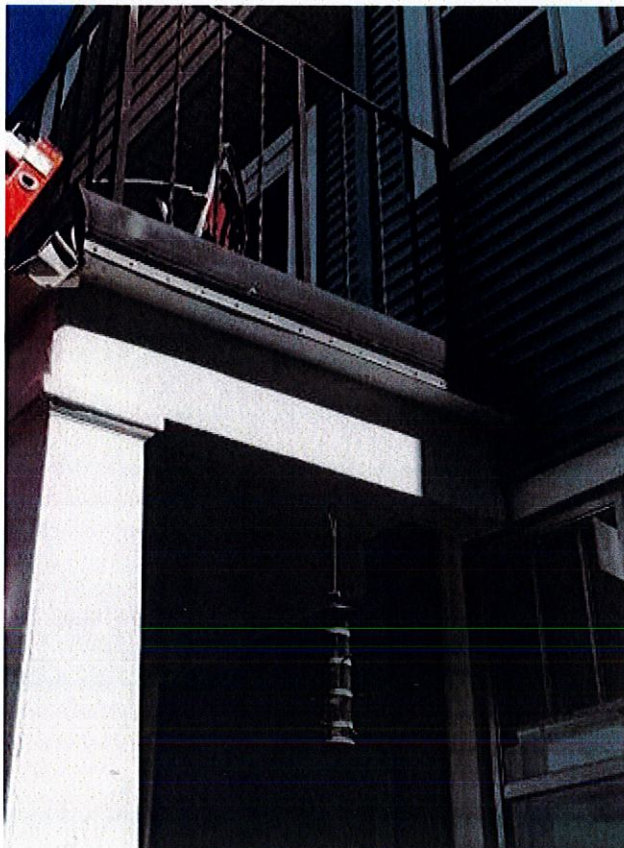
68-Rubber cover

Rubber cover was fastened by screws to the patio

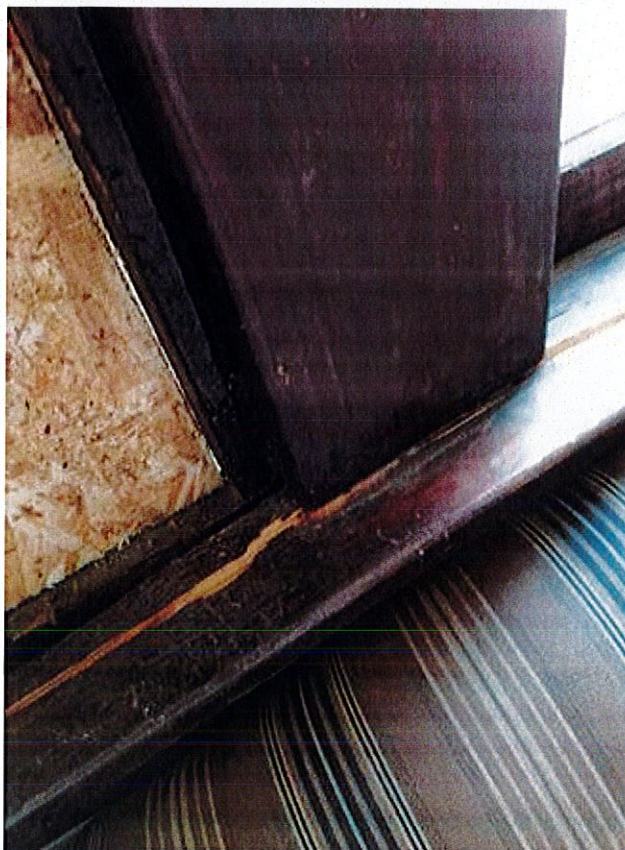
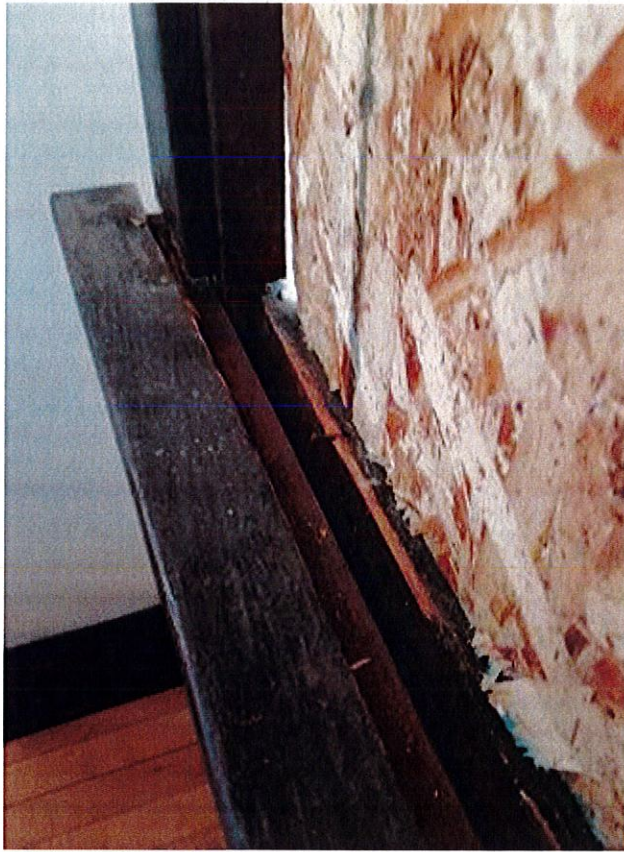
71-Window damage

72-Window damage

38. Add on for grid (double or triple glazed windows)	24.00 SF	2.35	3.16	11.92	71.48	(3.97)	67.51
39. R&R Wood window - double hung, 13-19 sf, High grade	3.00 EA	755.40	105.63	474.36	2,846.19	(90.64)	2,755.55
