# Certificate of Appropriateness

| <b>Property</b> | 2210 N. LAKE DR. | North Point South Historic District |
| <b>Date issued</b> | 8/22/2016 | PTS ID 113053 COA repair stucco, wood, and repoint |

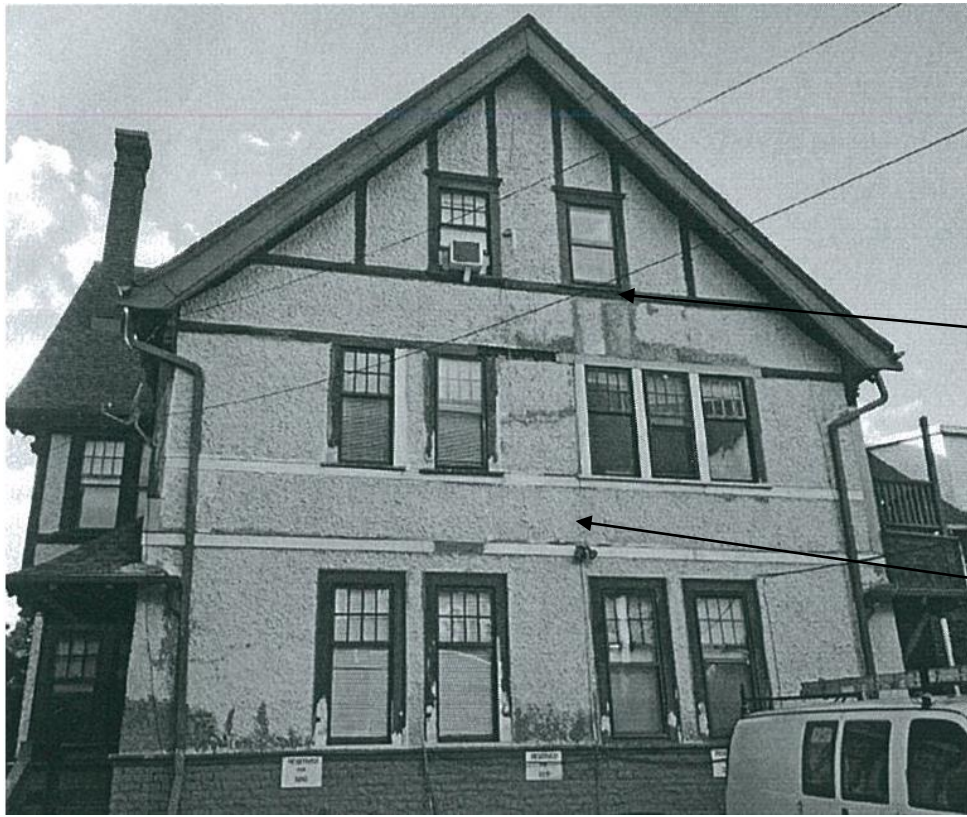
Stucco and wood trim are being repaired/replaced. Stucco repairs should have final texture to match original.

**The stucco mix should match the composition of the original stucco in order to have a compatible repair. The stucco is being applied over a base of metal mesh. Final texture will match the existing texture so that the repairs are not obvious.**

**Rotted or deteriorated wood will be replaced with wood that matches the dimensions of the original. The wood should be clear and free of knots. It is preferable to use a wood species that is decay resistant such as domestic Spanish cedar, western red cedar or redwood. Note: Ponderosa Pine or western white pine is not appropriate selections as they tend to decay within three to five years. All wood to be painted upon completion. Wood epoxies for spot repair are acceptable.**

Wood epoxies are appropriate for smaller repairs. Replacement of larger areas should be done with decay resistant wood as indicated above.

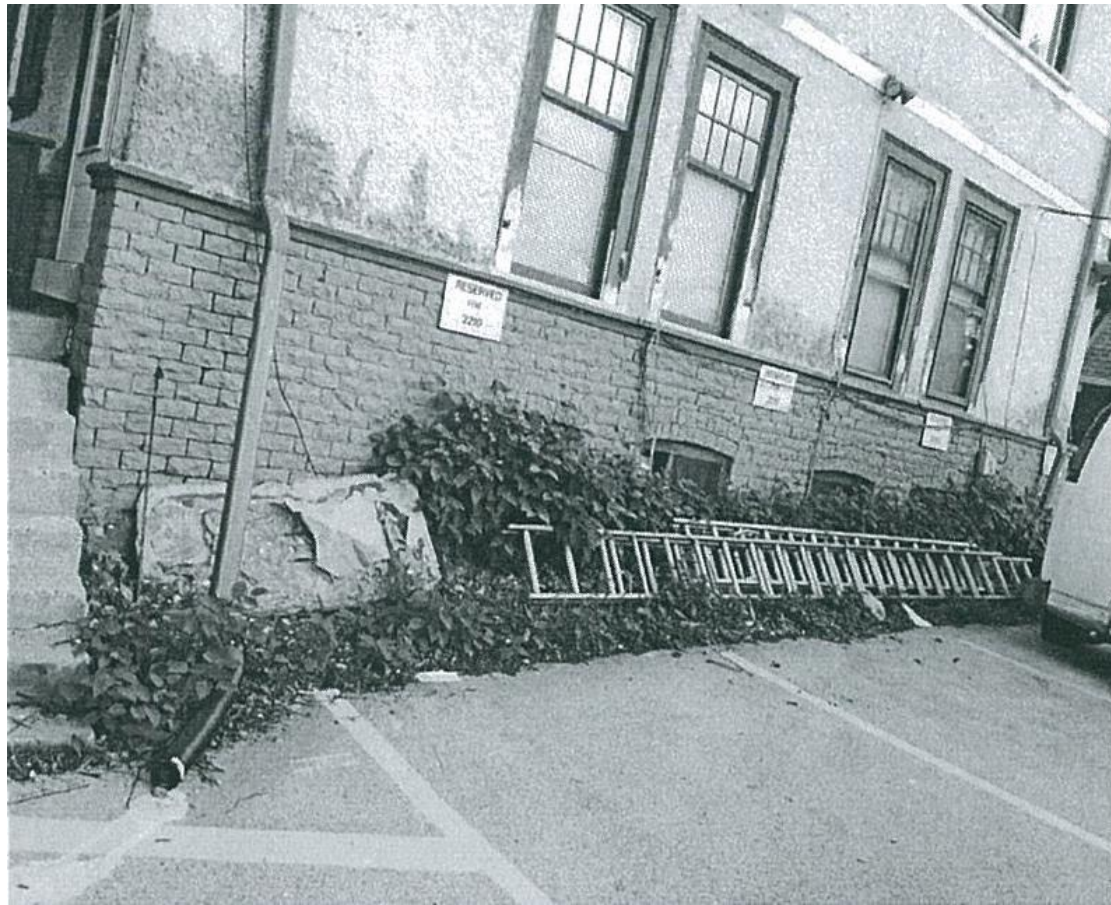
Brick is being repointed. All mortar should be compatible with the original mortar and no joints are to be enlarged by aggressive grinding.

The brick at the base of the building has been previously painted and will be repainted.

**Repointing will be carried out with an appropriate mortar mix that is not too hard. Joints should be struck deep enough to remove loose mortar and form a good bond between the mortar and the brick. Grinding out the joints to widen the mortar joints is not acceptable. Joint texture and shape will match original.**
