ARCHITECT'S FIELD REPORT

Charles Allis Art Museum
 Exterior Improvements
 Milwaukee County – Department of Administrative Services
 Milwaukee County Project No. O527-17438
 James G. Otto Architect, LLC Project No. 15005.00

Visit Number: Seven
 Date: September 7, 2018
 Time: 8:45 am
 Weather: Partly Sunny
 Temperature Range: High 60's
 Present At Site: Jim Otto

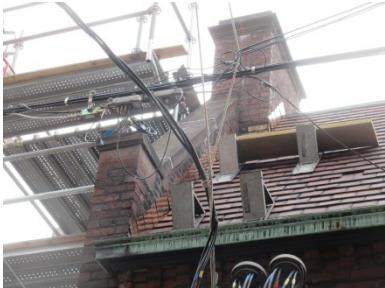
<p>Garage Flashing</p>	
	<p>East Parapet</p>

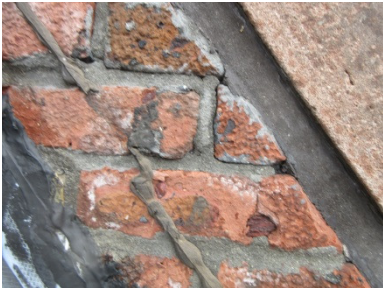
<ul style="list-style-type: none"> - Per various emails since the last report, the West Gable Parapet may not been reconstructed as required by the contract documents. Verification is required that complete demolition and reconstruction has occurred and all required anchors installed. 	MRI
	<ul style="list-style-type: none"> - The tile roof is not being installed in accordance with the contract documents. The Flashing / Underlayment / Self-Adhered Membrane at the parapet are not installed as detailed. 	MRI

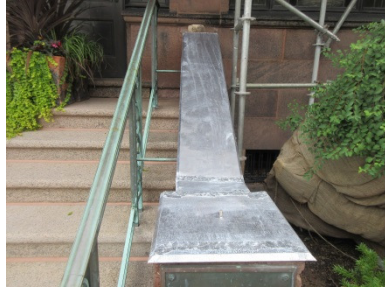
Cheek Wall Flashing

Item	Description	Action By
7.01	<p>Reviewed current work in progress as follows:</p> <ul style="list-style-type: none"> • Balcony; <ul style="list-style-type: none"> - No work since last report. • South Stair; <ul style="list-style-type: none"> - The cheek wall flashings are loose laid on the walls. The flashings are not corrugated as detailed / specified/ submitted. Revise to conform to the contract requirements. - Cheek wall coping dowels (2 per stone) must have soldered thimbles. - The foundation at the cheek wall posts was not properly constructed (sandstone is projecting into the air). The issue was documented in field report number four, dated July 5, 2018 and was discussed on site with MKE County and MRI. Revise foundation to provide solid bearing for the sandstone that continues down to the new concrete footing. - The sandstone at the cheek walls noted to be retooled has not been completed. - The Dutchman repairs at the upper landing have not been completed. • Fire Escape; <ul style="list-style-type: none"> - No work since last report. 	<p>MRI</p> <p>MRI</p> <p>MRI</p> <p>MRI</p> <p>MRI</p>

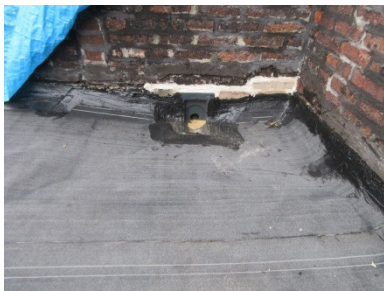
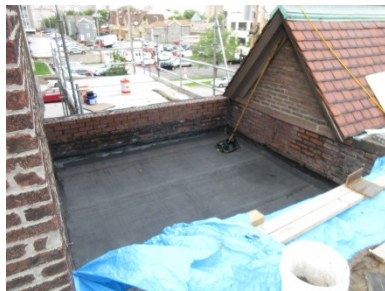
Item	Description	Action By
	<ul style="list-style-type: none"> - The fire escape foot has not been installed and the roof is complete except for the cap sheet. 	
	<ul style="list-style-type: none"> • Foyer Roof Area; <ul style="list-style-type: none"> - The roof base flashing has not been extended up the walls 8" minimum as detailed and required by the Manufacturer. 	MRI
	<ul style="list-style-type: none"> - The fire escape foot has not been installed and the roof is complete except for the cap sheet. The roof will need to be cut open to install the foot. 	MRI
	<ul style="list-style-type: none"> - The roof slope at the east side of the drain should be revised to ensure significant positive pitch to drain. 	MRI
	<ul style="list-style-type: none"> • Garage North Wall; <ul style="list-style-type: none"> - The East Gable Parapet has not been reconstructed as required by the contract documents. The parapet should be reconstructed as detailed to provide the stable masonry intended. 	MRI
