# Collision Analysis & Reconstruction Report

**Incident Report Number: 131640069**  
**DOT Document Number: QQJG3V2**  
**Crash Date: Thursday, June 13, 2013, 11:47 a.m.**

**Location: 4975 N. Teutonia Ave.**  
**City of Milwaukee**  
**Milwaukee County, Wisconsin**

Officer Christopher Bruns  
Officer Richard Schnier  
Milwaukee Police Department  
Neighborhood Task Force  
Crash Reconstruction Unit

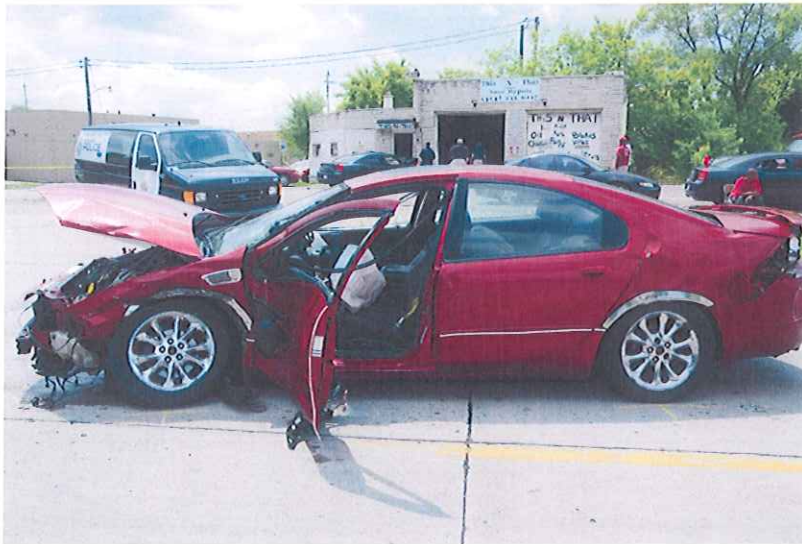
Following the collision, investigating officers observed two vehicles involved in the crash. One vehicle was identified as a maroon 2002 Dodge Intrepid, four-door, bearing WI disabled registration 97871D, VIN: 2B3HD56G42H265447, which listed to Lee GREEN (B/M 09/16/39 of 4924 N. 22<sup>nd</sup> St., Milwaukee, WI 53209). This vehicle was located facing southbound in the south travel lane of North Teutonia Avenue, approximately 95 feet north of West Cameron Avenue. The vehicle had severe damage to the left fender and driver's door. Figure 3 depicts the orientation and damage of the Dodge Intrepid at final rest.

*Figure 3 – Dodge Intrepid final rest position.*

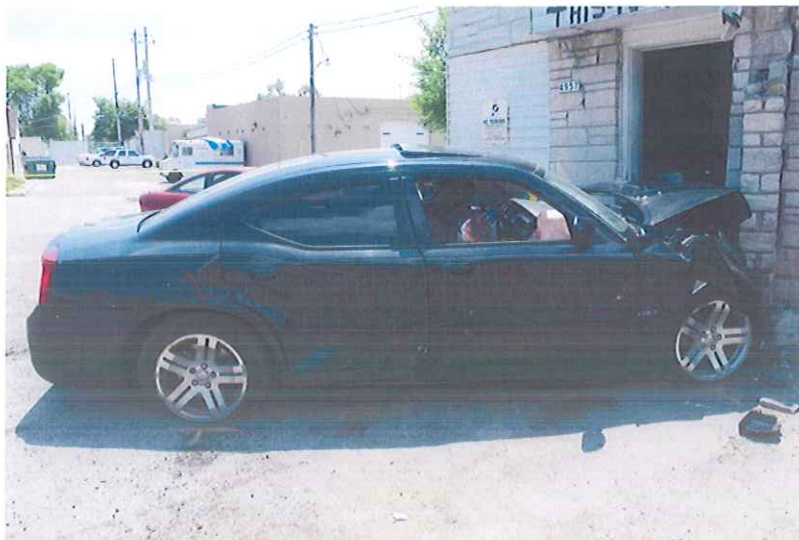
The second vehicle was identified as a black 2006 Dodge Charger, four-door, bearing WI registration PVANN, VIN: 2B3KA53H46H443567, which listed to Prentise D. VAN BEETS (B/M 05/13/79 of 923 Tower Lane, West Bend, WI 53090). The Dodge Charger was located in the parking lot on the northwest corner of the intersection, with the front end of the vehicle resting against the building at 4957 North Teutonia Avenue. The vehicle sustained severe front-end damage. Figure 4 depicts the orientation and damage of the Dodge Charger at final rest.

*Figure 4 – Dodge Charger final rest position.*

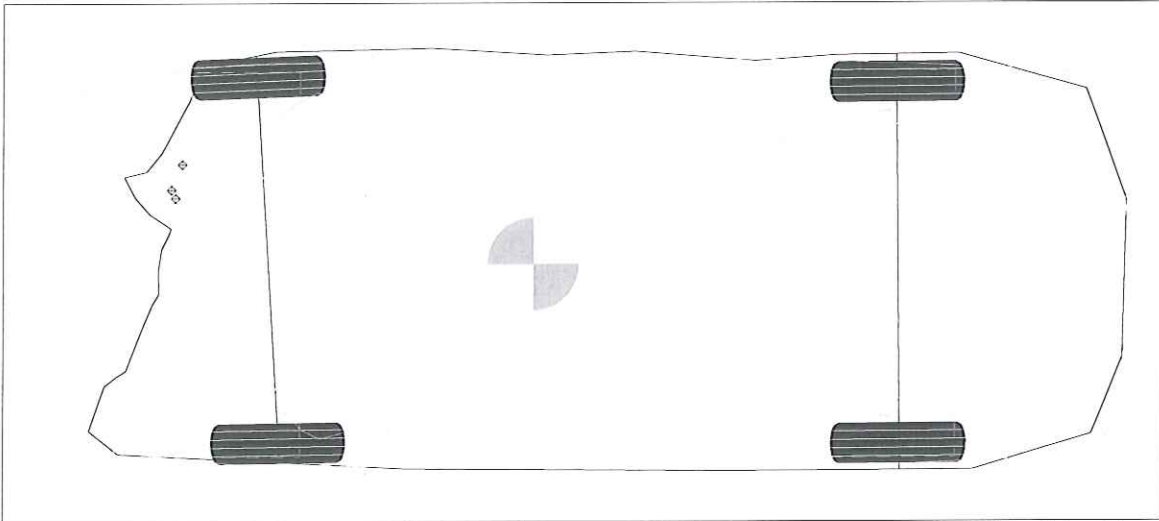
The entire front end of the Dodge Charger sustained severe rearward displacement as a result of the collision with the Dodge Intrepid, along with an undetermined amount of damage due to the collision with the building.

*Figure 5. The above drawing depicts the depth of crush sustained by the Dodge Charger as a result of this collision. The measurements were taken at bumper height with the Topcon Total Station.*

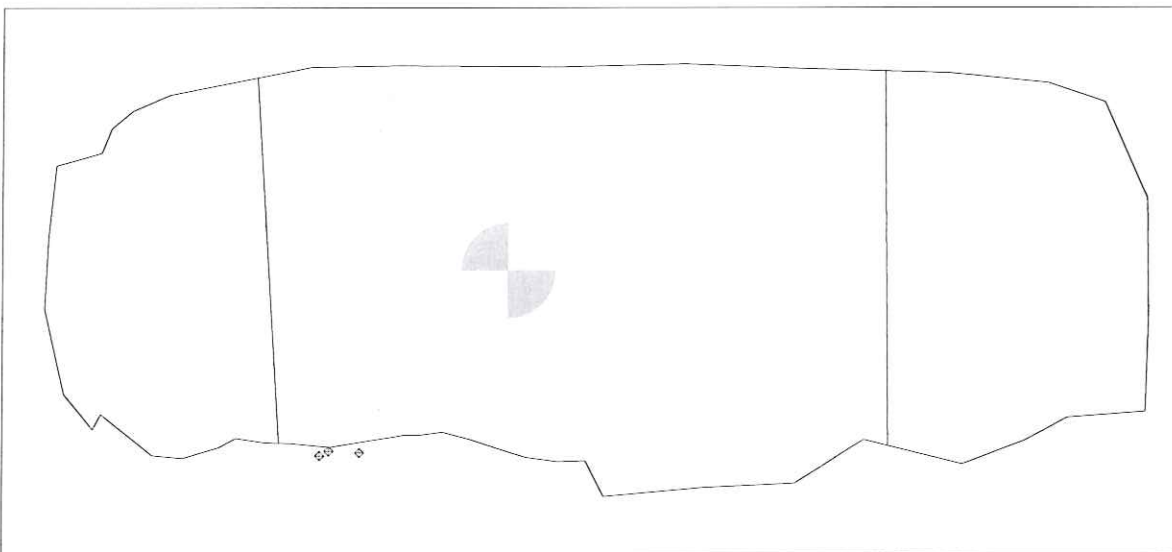
*Figure 6. The above drawing depicts the depth of crush sustained by the Dodge Intrepid as a result of this collision. The measurements were taken at bumper height with the Topcon Total Station.*
