Introduction

This report summarizes the condition and observations we made on our site visit to the property at 2841 Richardson Place on Wednesday, June 11, 2008. Tom Christiansen (VJS General Superintendent), Gary Jorgensen and I visited the home and walked through all areas of the property with the purpose of compiling costs required to upgrade the property to a useable level. Following are our findings and recommended actions.

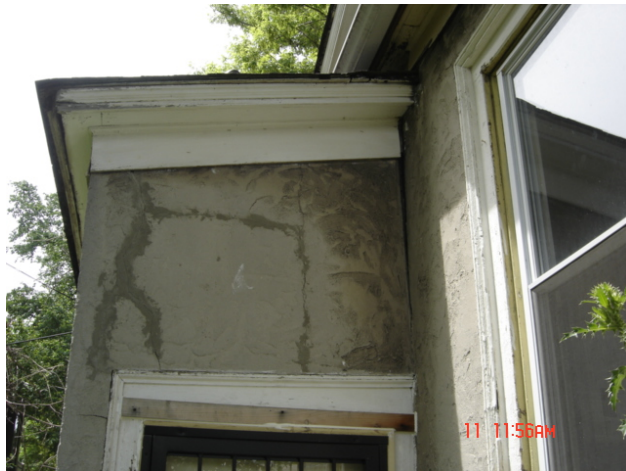
The stucco appears to be in need of extensive patching due to expansion and contraction cracking over time. The wood trim at all window & door conditions should be resealed to the wall system as well to prevent water infiltration to the interior. Extensive preparation and painting will need to be done all on exterior trim to bring the property up to a useable level.

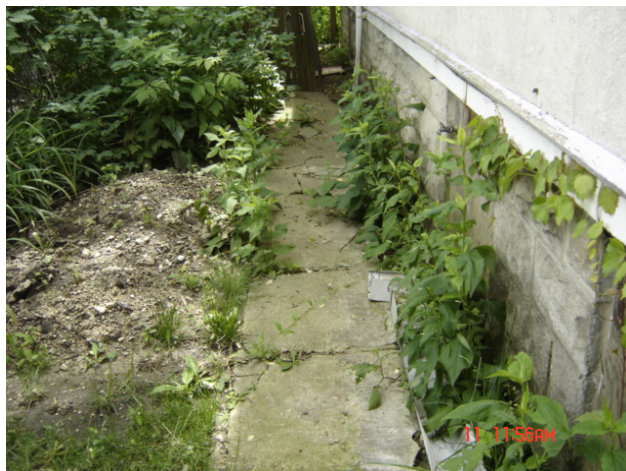
The exterior landscaping is very overgrown on all sides of the house and will require extensive work. The front, side and rear concrete walkways are very broken up and do not meet code requirements any longer. The walkways will need to be removed and re-poured, including the front stairs leading up to the entrance walkway to the house. The

existing wood fencing running around three sides of the house is in poor condition and falling over into the yard at most locations. This will need to be removed and/or replaced at some point.

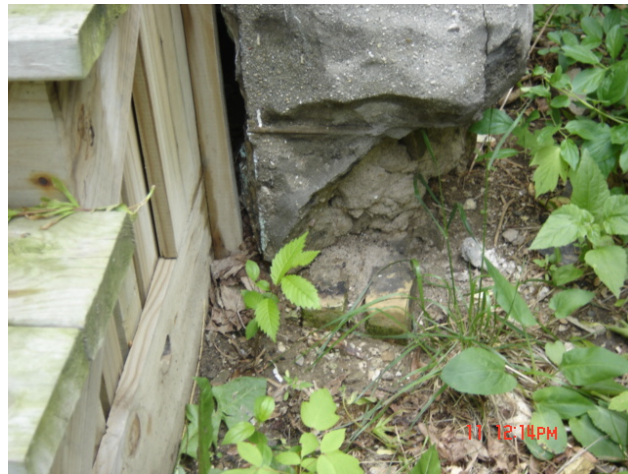
The foundation system consists of block basement walls with a poured-in-place concrete slab on grade in the basement. The foundation block was observed to be breaking away at corner areas of the building. A structural engineer will have to be hired to review and determine the structural integrity of the foundation walls.

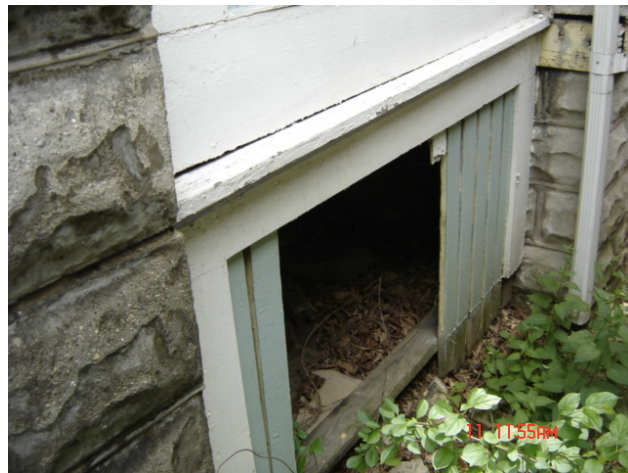
The front porch is need of some extensive work as well. A number of the pieces of window glass have been broken and will need to be replaced. The front wood steps leading up to the porch show significant wear and should be replaced to ensure they are still usable. The exterior trim on the front porch is in need of extensive scraping and repainting. The wood floor on the interior of the porch appears to have sustained some water damage over time and should be refinished or replaced. Some of the wood skirting around the base of the porch is damaged and missing and will need to be replaced.

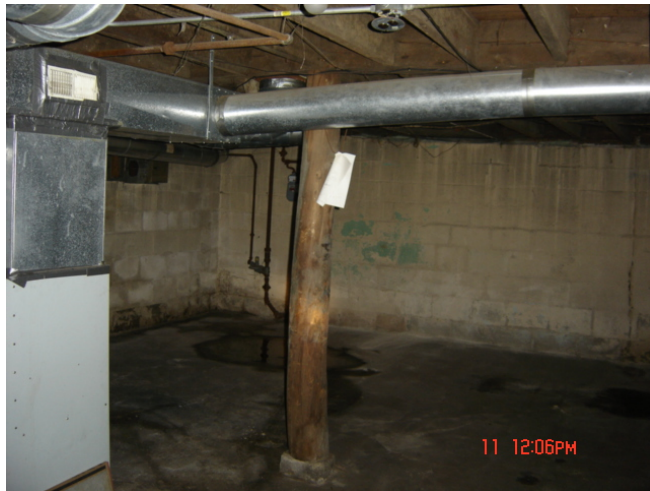
The basement holds an old furnace and water heater. A mechanical service technician will need to be hired to evaluate the condition of both pieces of equipment, however both appeared to be unusable and costs have been included in the budget to replace.

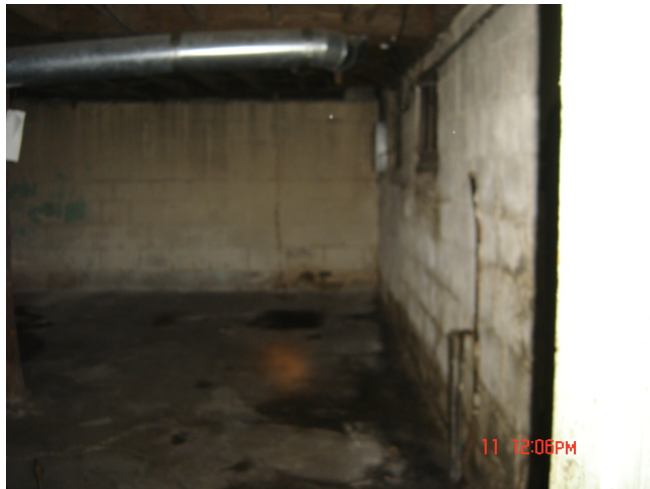
There is a single wood timber column in the center of the basement that was installed to provide intermediate support for the floor joists on the floor above. The wood column has bowed several inches and has caused both the first and second floor to slope into the center of the house. This column will have to be replaced and will require the surrounding first floor area to be "jacked-up" and a new steel column to be put in its place.

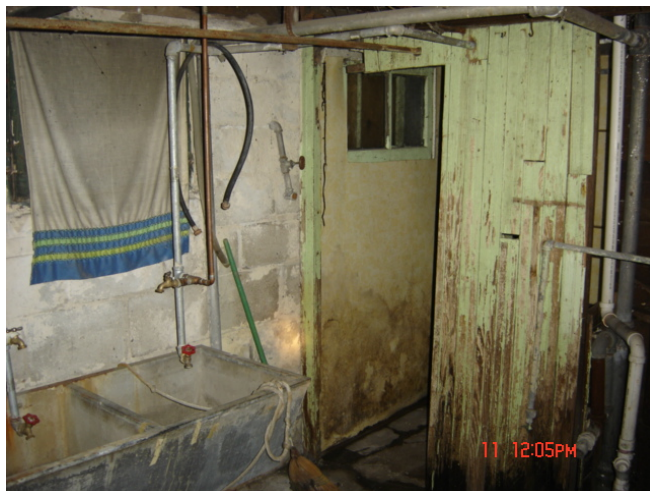
Significant ponding of water was observed in the basement as well. This may be caused by water infiltration through the existing foundation wall due to improper draining of the roof water both from this house and the neighboring garage. Steps may need to be taken to excavate around the entire foundation and waterproof the foundation wall to prevent any further water

infiltration. This has not been included in the budget but a waterproofing consultant should be hired to observe these conditions and provide a report.

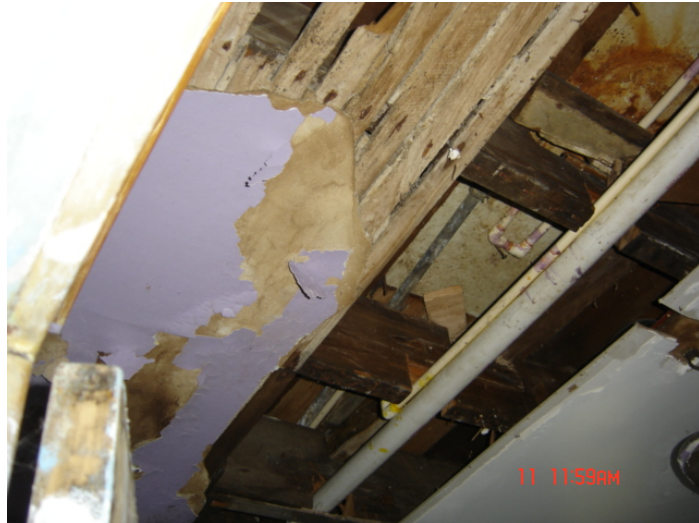
The first floor level has sustained significant water damage as well. Water appears to have leaked down from the second floor. The ceilings should be demolished and replaced with new gypsum board ceilings.

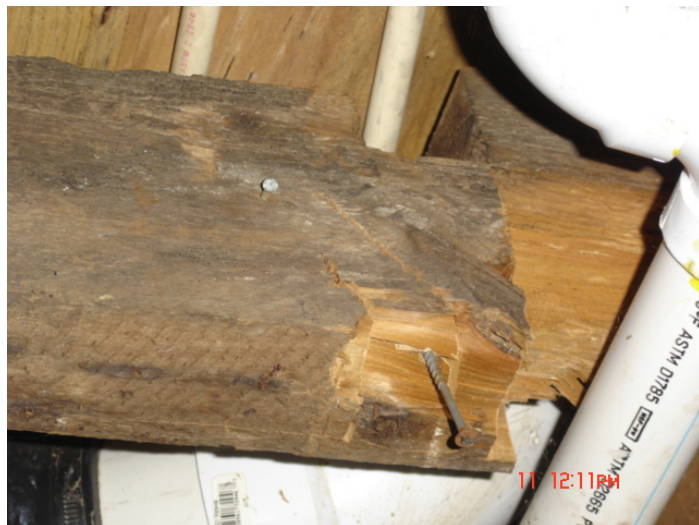
At one location, the ceiling has been removed and you are able to view the floor joists for the second floor. It appears that the previous installer of the plumbing lines cut away significant chunks of the existing 2nd floor joists to route the plumbing pipes in the ancillary space. At one location it was observed that only a couple of inches of joist remain intact. This may occur at more

locations than just the one observed, however this particular location is below the bathtub on the Second Floor. These floor joists are very unsafe in their current condition and will need to be replaced.

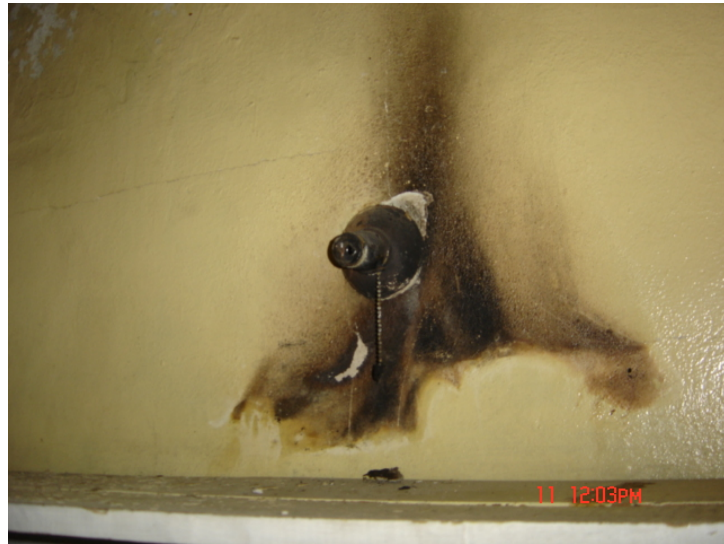
The electrical wiring and outlets will need to be inspected. At one location, there appeared to be heat or fire damage around a light socket. The entire system should be investigated and determined if still usable.

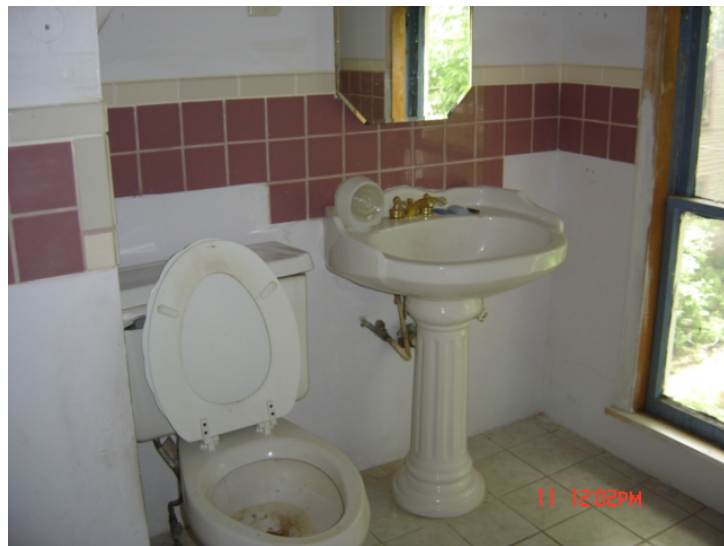
The bathroom fixtures appear to be unusable as well. Water to the building has been shut off, so we were unable to determine if the fixtures were still in working condition. But, regardless the fixtures appear to be beyond salvaging and will need to be replaced. A plumber should be hired as well to investigate the house's plumbing system and determine what additional deficiencies exist and need to be addressed.
