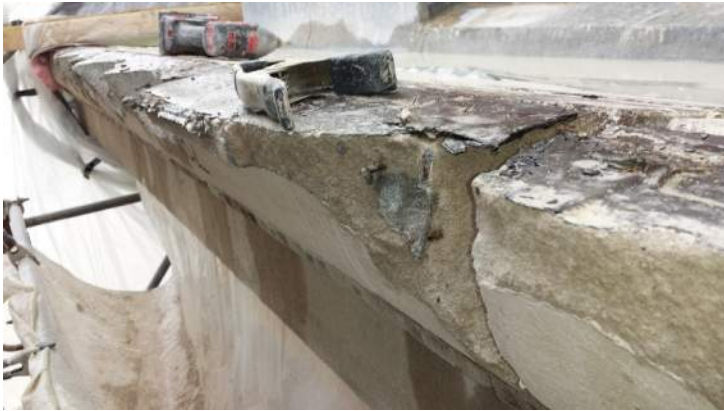
Photo 1 – O118 CORNICE GUTTER EDGE Southeast elevation. Existing condition with flashing removed. Nails shown held “filler” in-place. Damage done by power-fastening gutter flashing.

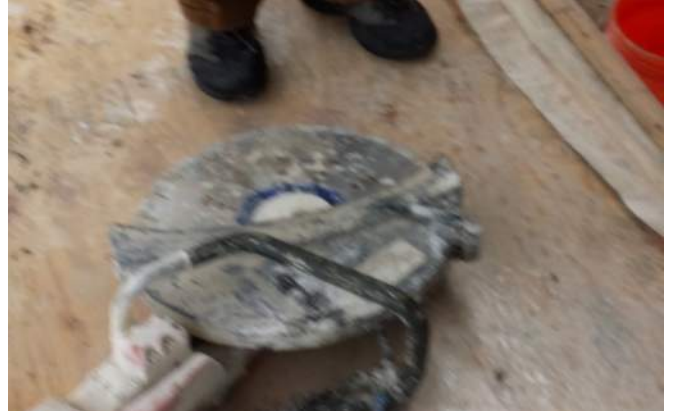
Photo 2 - Hand-sawn, no jig, removal of the damaged cornice gutter edge.

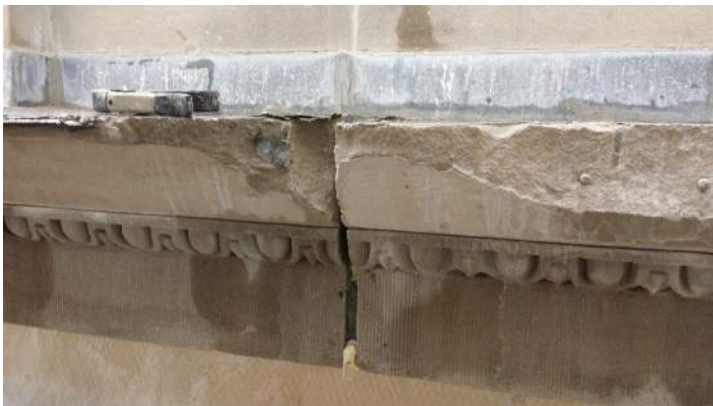
Photo 3 – East elevation. The horizontal cut is the first cut just above the carved egg and dart. Carefully made as this will seat the new Dutchman when damaged area is removed.

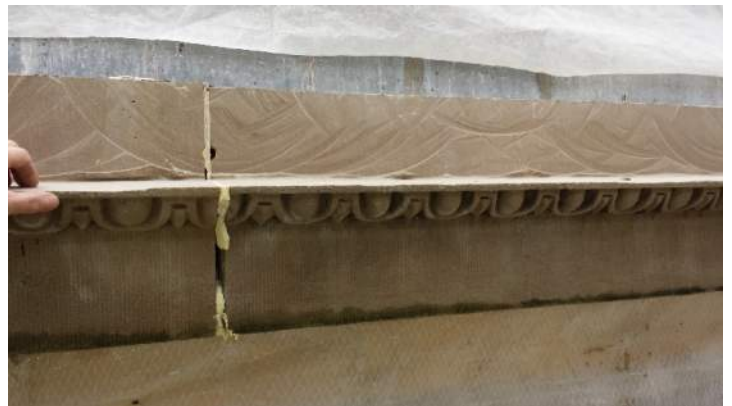
Photo 4 – East elevation. Removed the damaged stone. Note the successive lowering of the hand-held saw to the horizontal cut made, in the vertical cut.

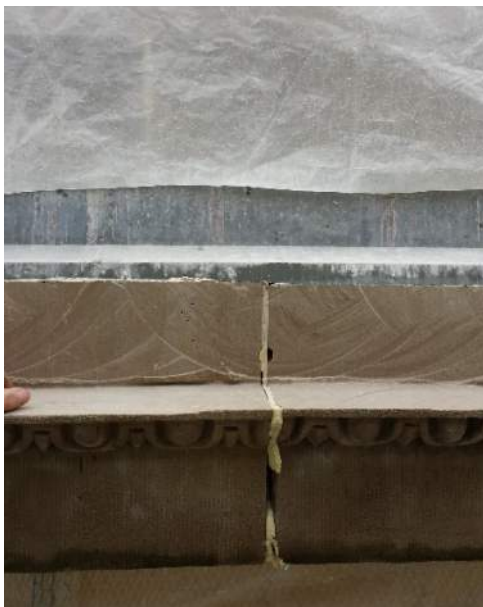
Photo 5 – East elevation. Detail of bare saw-cut and removal.

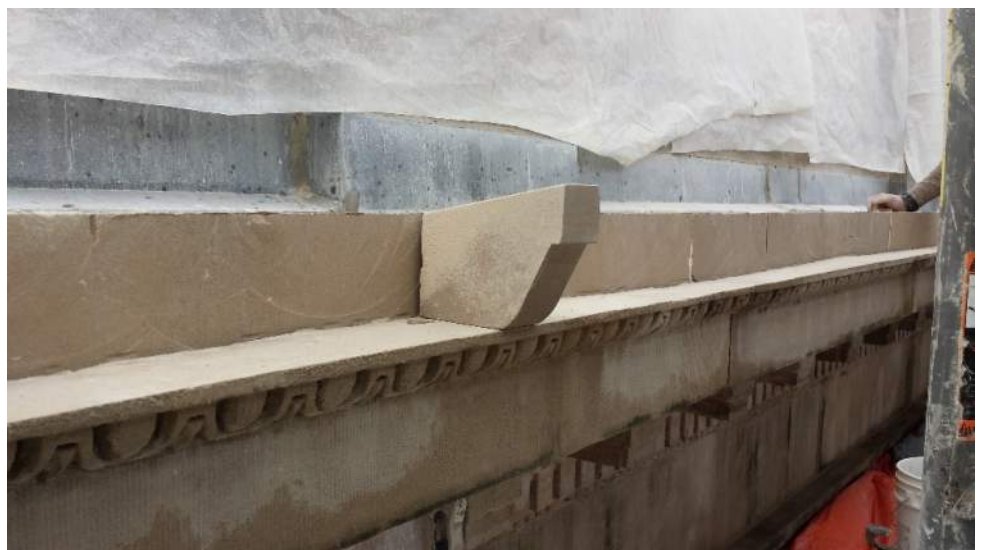
Photo 6 – East elevation. Preparatory work, sample Dutchman element, verifying drainage allotment and horizontal setting-bed.

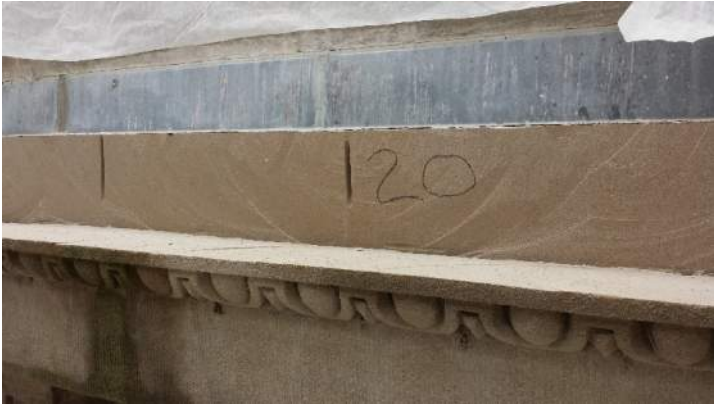
Photo 7 – East elevation. Placement corresponding to field measured stone Dutchman elements.

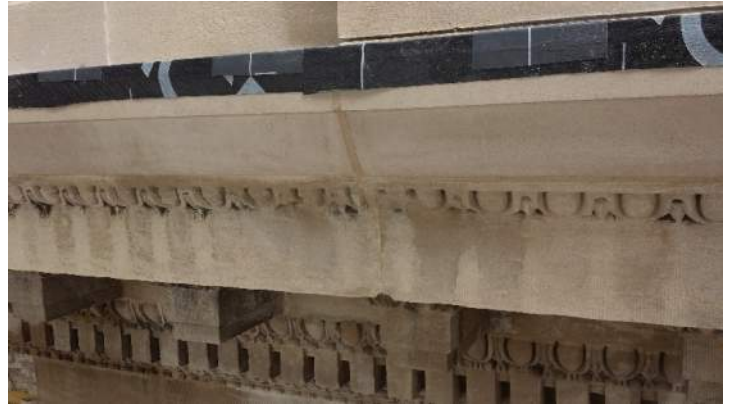
Photo 8 - West elevation. Installed, mortar-joint, cornice edge Dutchman. Waterproofing membrane laps over substrate of treated plywood with stainless steel end channels at border for continuous rigidity between plywood panels. Pending gutter flashing.

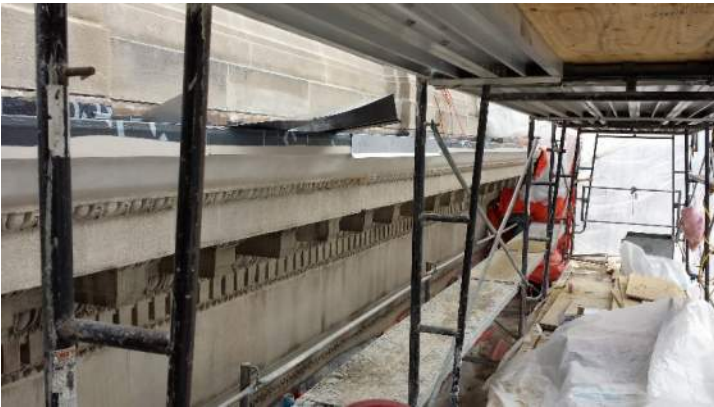
Photo 9 – West elevation. CORNICE GUTTER FLASHING. Lead-coated copper with expansion joints mock-up, in progress.

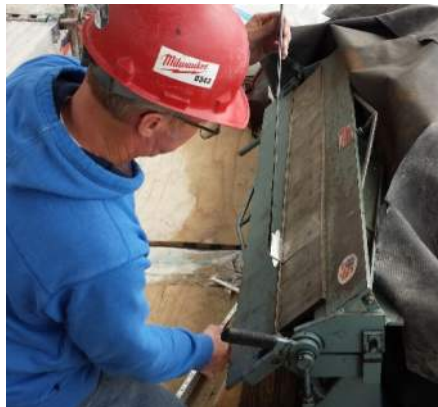
Photo 10 – Roofing/flashing tradesman, bending stainless steel for material development on-site of ad-hoc expansion joint at non-existent cornice drain location.

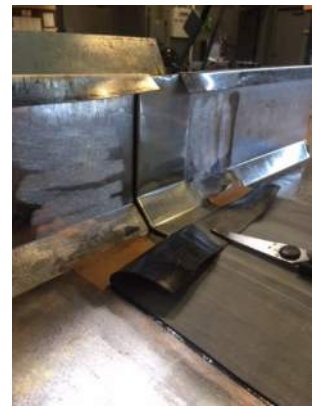
Photo 11 – IN SHOP MOCK-UP. Roofing/flashing tools, ad-hoc expansion joint for review.

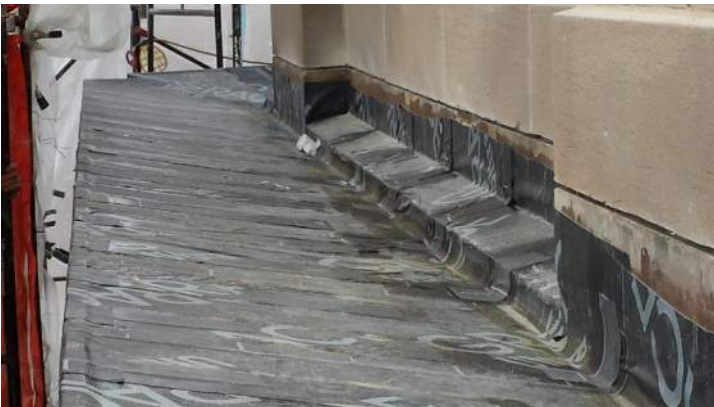
Photo 12 – West elevation. Installed dutchman, waterproofing membrane over treated plywood substrate on structurally sloped cornice gutter stone. Existing stone reglet, at back wall, cleaned and re-used at installation of the new metal counter-flashing.

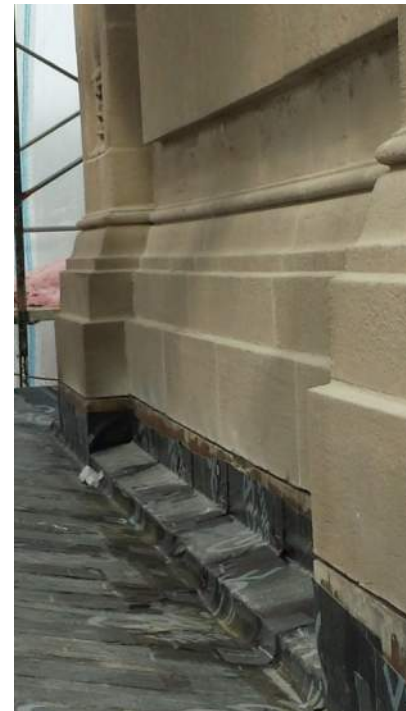
Photo 13 – REPOINTING. Northwest solid pier at parapet.-repointing of mortar joints. Note mortar match for color, texture. Tented working area is heated, also to allow specific lime mortar mix to cure at least seven days, in cold temperatures.

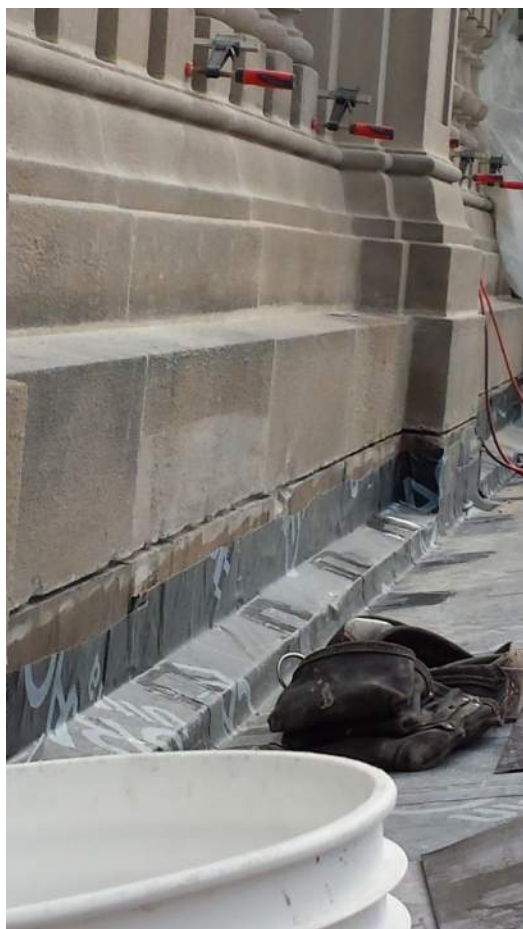
Photo 14 –
BALUSTRADE.
West elevation at
parapet – setting
of parapet
balusters.
Existing balusters
replaced the
missing and/or
damaged
balusters at the
northwest end
elevation. This
was for
coordination of
color, texture in a
single bay at the
most highly
visible elevation.

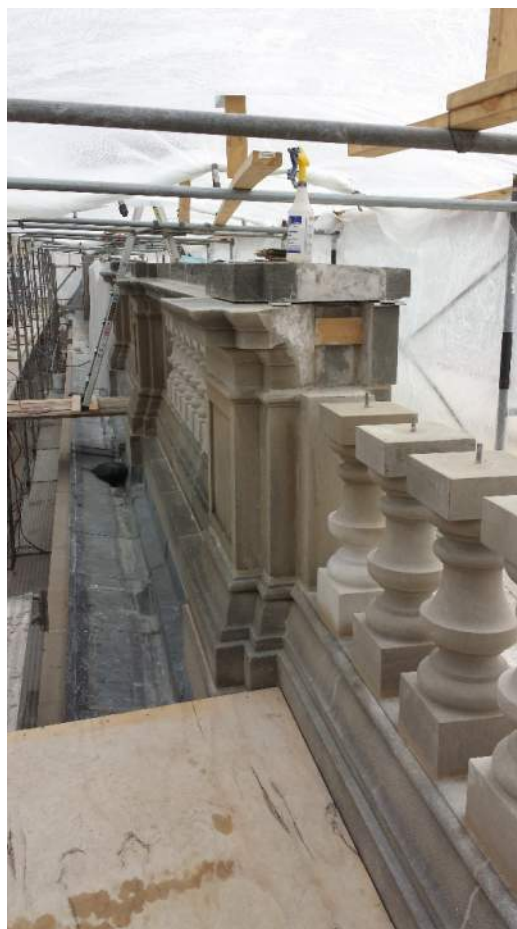
Photo 15 – East
elevation at
northern-end.
Setting of bay with
newly carved
balusters. Parapet
railing caps being
set. One hundred
percent of existing
mortar joints
cleaned, repointed.
All newly carved
balusters are
positioned on the
east elevation, two
northeast bays, as
the least visible
location for subtle
difference in color,
initially.

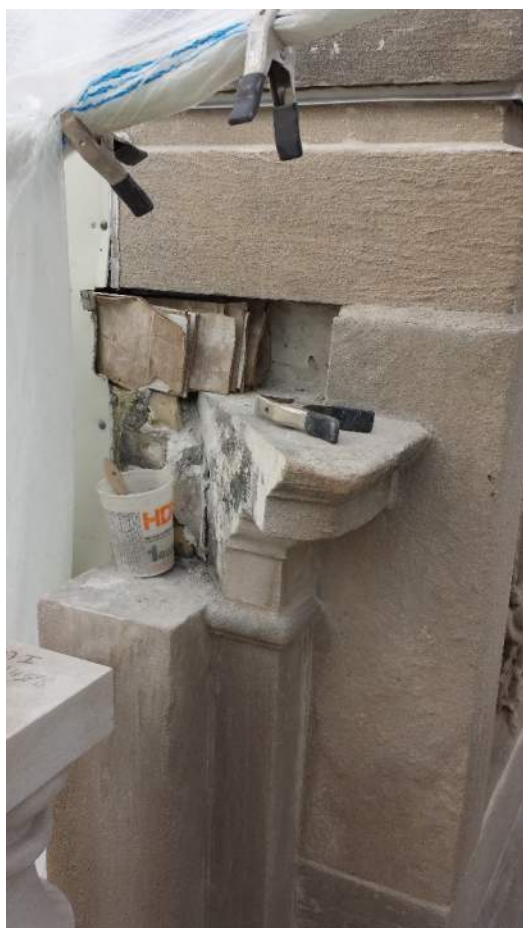
Photo 16 - West
elevation.
Tradesman tools
for cleaning,
repointing
mortar joints.
Severely
degraded
stones,
previously
assessed are
removed and
replaced with
carved
replicates. Note
stainless steel
flashing at solid
parapet
capstone.

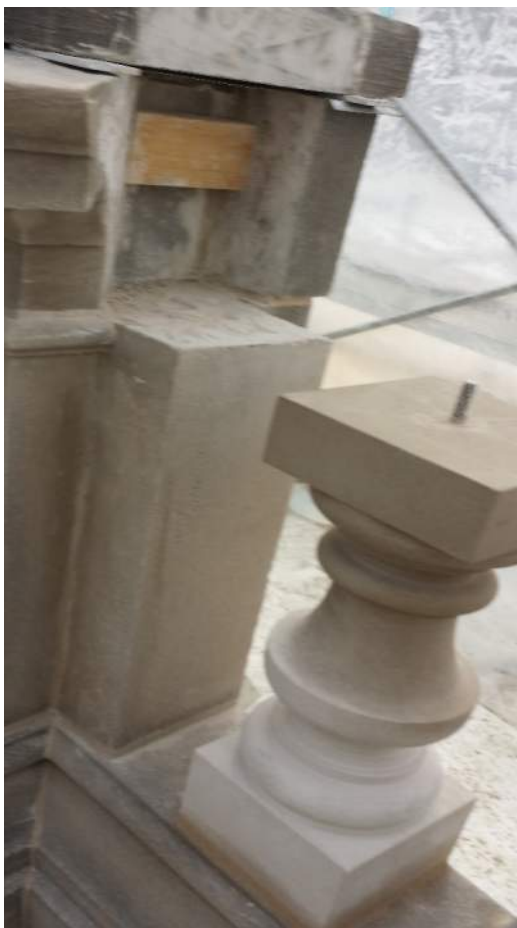
Photo 17 –
West elevation.
First bay at the
northern end,
newly-placed
baluster with
stainless steel
dowel.

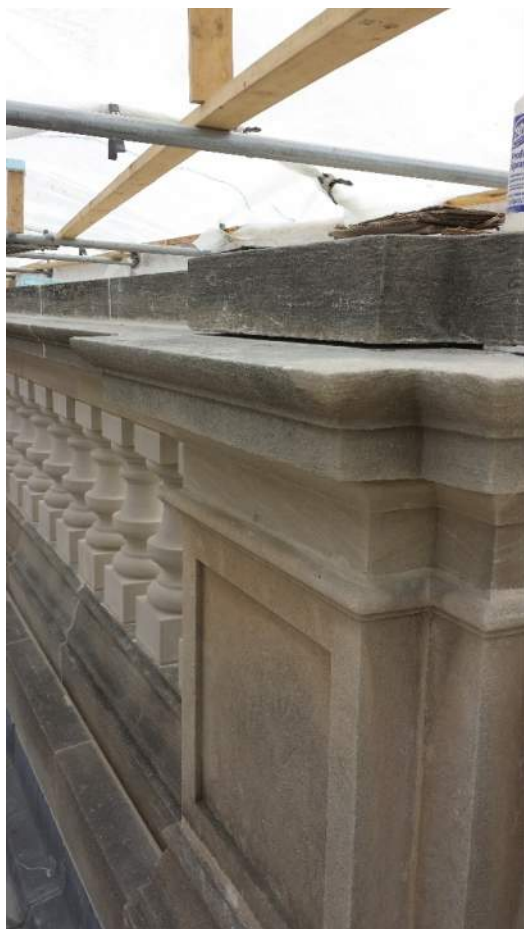
Photo 18 – West elevation. Open parapet railing capstones set. Solid pier cap shimmed for re-setting. Solid pier stones repointed.

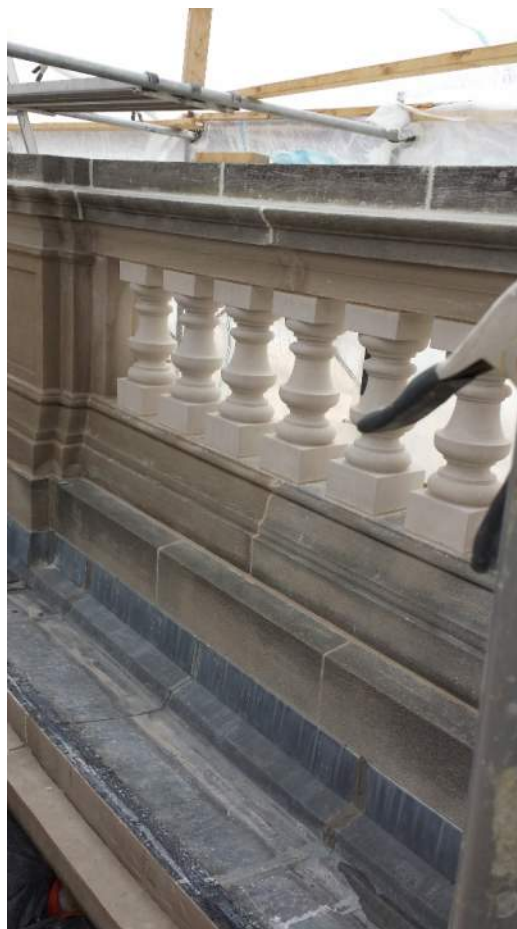
Photo 19 – West elevation. Second bay from the northern end, completely reset with new balusters. Railing capstones reset in restored, solid mortar joints. Special mortar for historic structures, for match in color, texture and structural stability.

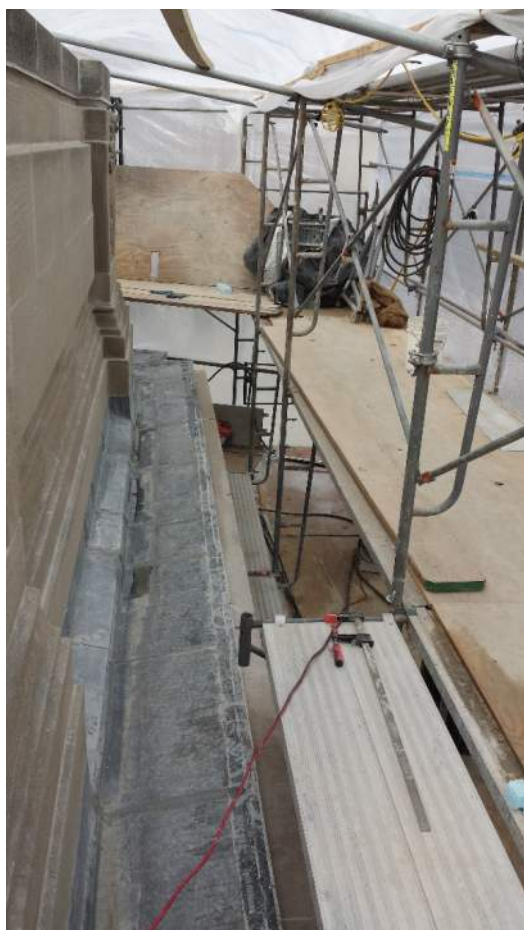
Photo 20 – West elevation, view from southern end. Parapet railing capstones reset. Cornice gutter edge removed by saw-cutting. Removal of existing flashing, in progress.

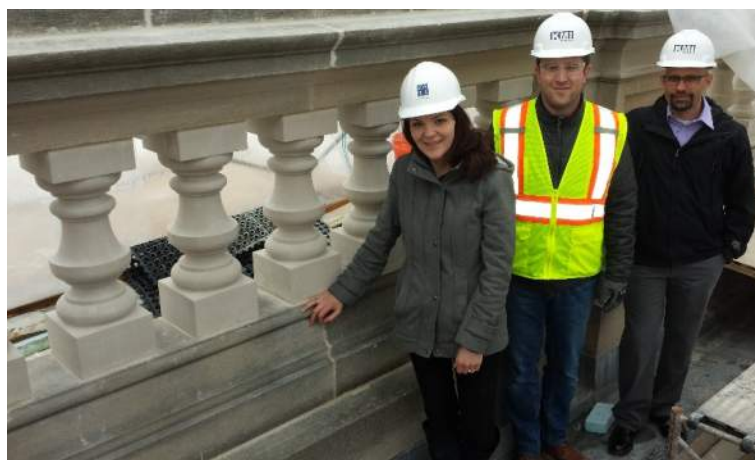
Photo 21 – West elevation, with the new balusters of second bay from the northern end.

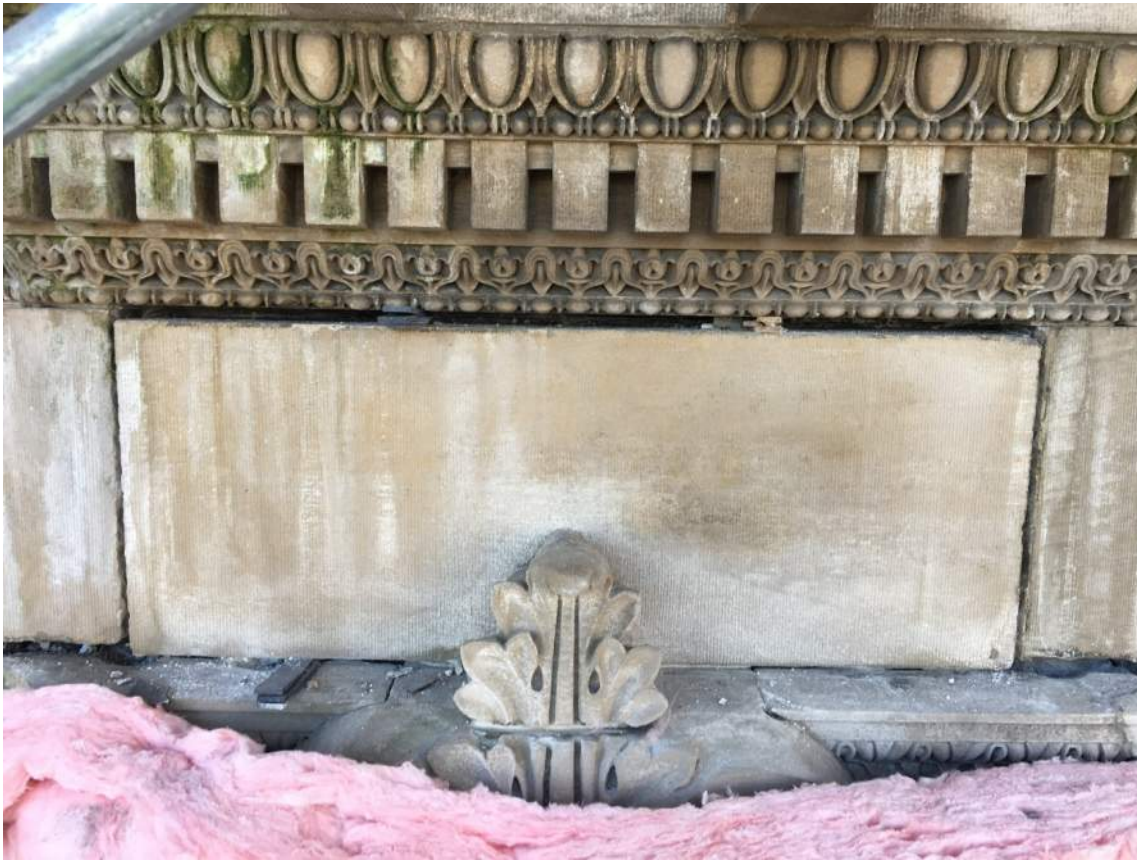
Photo 22 – CARTOUCHE. There are (7) cartouche made up of five elaborately carved stones. Structurally work under compression as the arch over windows, located beneath the solid parapet. North cartouche, upper veneer stone, just above the arch keystone (6" depth). Found condition of displacement, downward action.

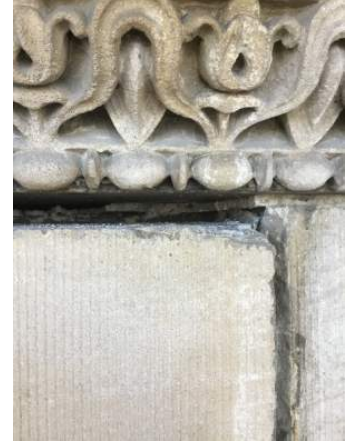
Photos 23 – North cartouche. Found condition of upper edge showing displacement.

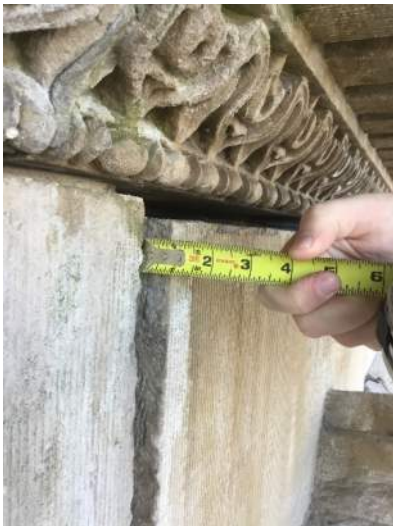
Photo 24 – Detail of past, unsuccessful intervention. Newly carved replacement stone band has been installed.

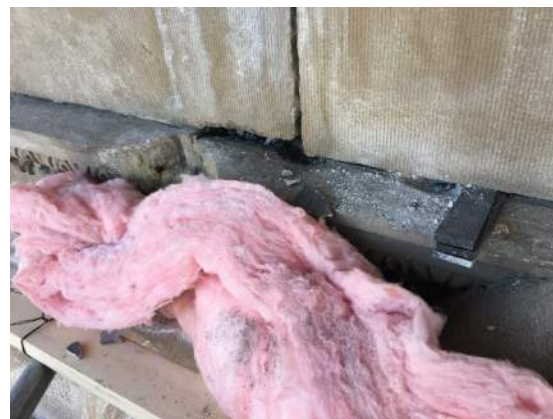
Photo 25 – North cartouche. Found condition of lower edge of displacement. Note insertion of dowels in the outer decorative stone band made in a past intervention.

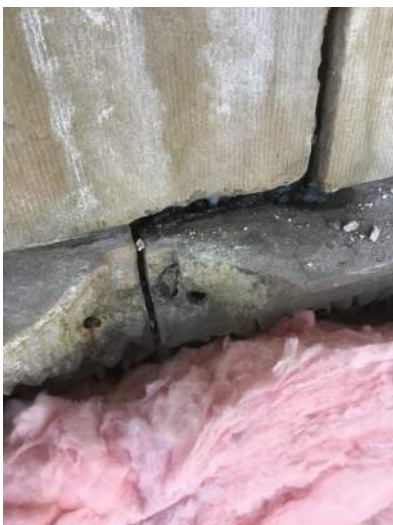
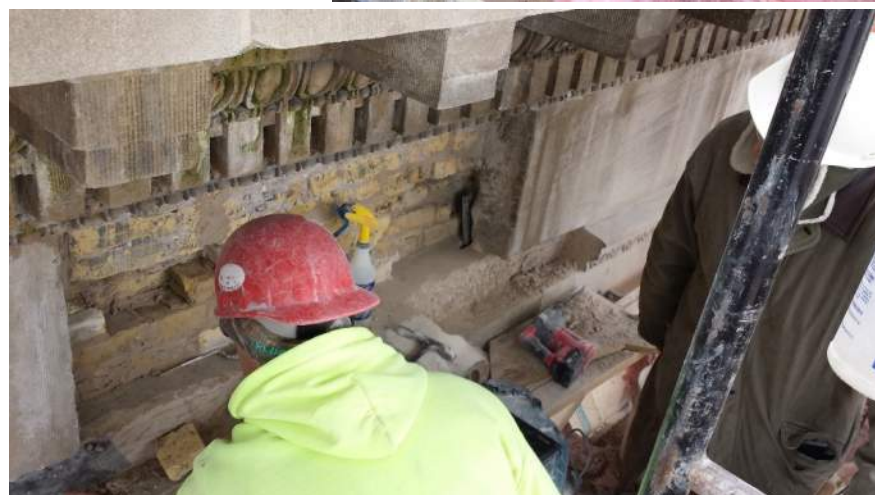
Photo 26 – North cartouche. Brick back-up wall restored, insertion of 0.0375mm steel plates for additional stabilization of facing stone, typical.

Unsuccessful and inappropriate solution for the displacement action taking place for the stone mass load.

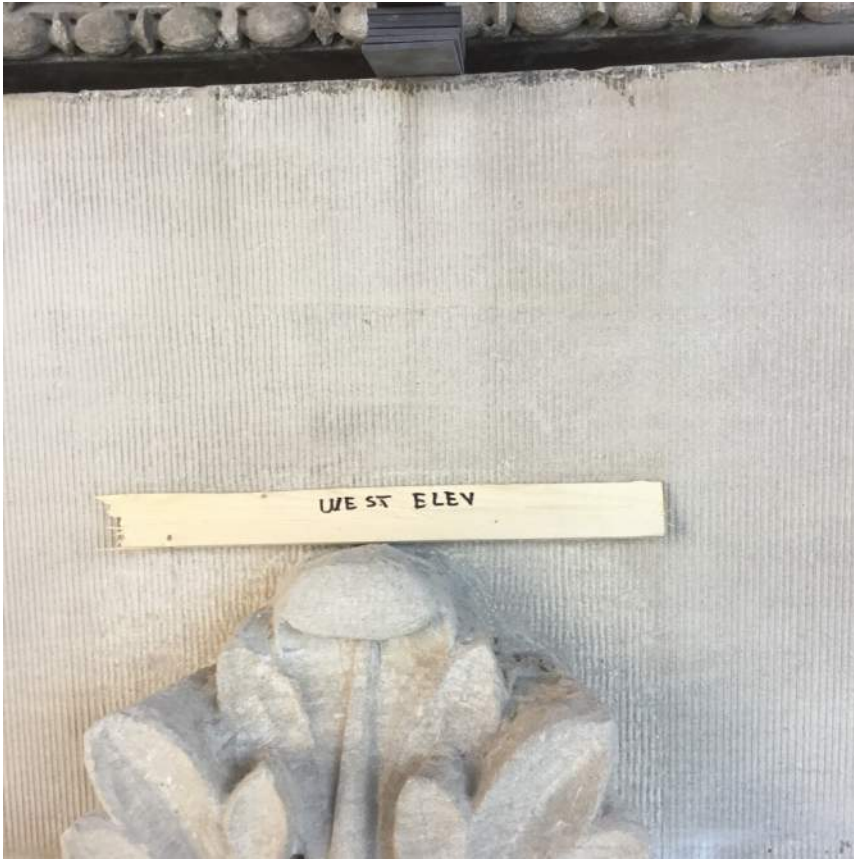
Photo 27 – NORTHWEST CARTOUCHE, upper stone. Found condition of displacement, downward settling action. First of seven (total) cartouche arch elements, assessed and subsequently to be re-set into place.

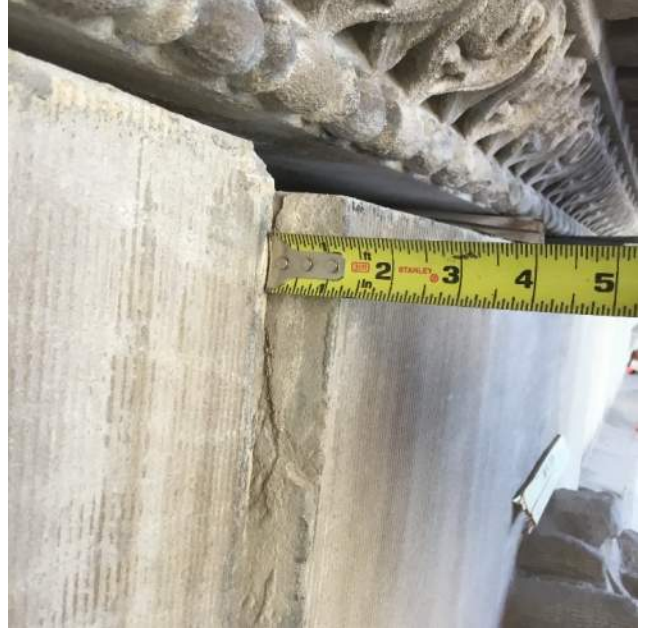
Photo 28 – Northwest cartouche, upper stone detail.

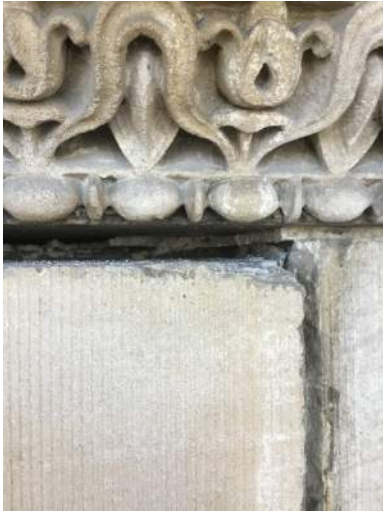
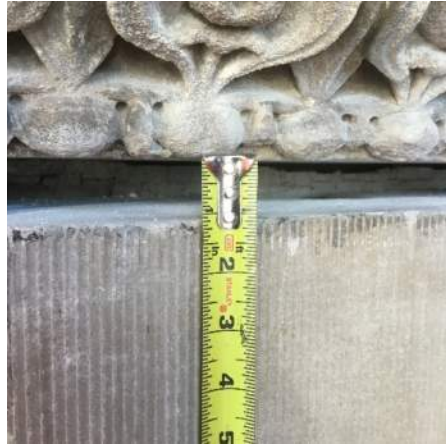
Photos 29, 30 – Northwest cartouche detail photos of displacement exposing brick back-up wall.

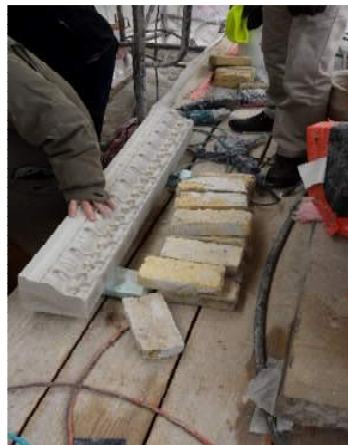
Photo 31, replacement decoratively carved stone.

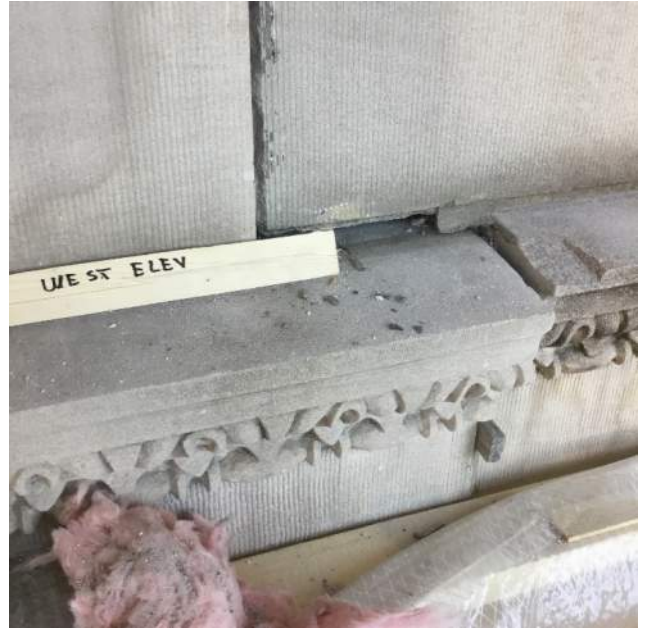
Photo 32 – Northwest cartouche. Found condition of lower edge of stone displacement.

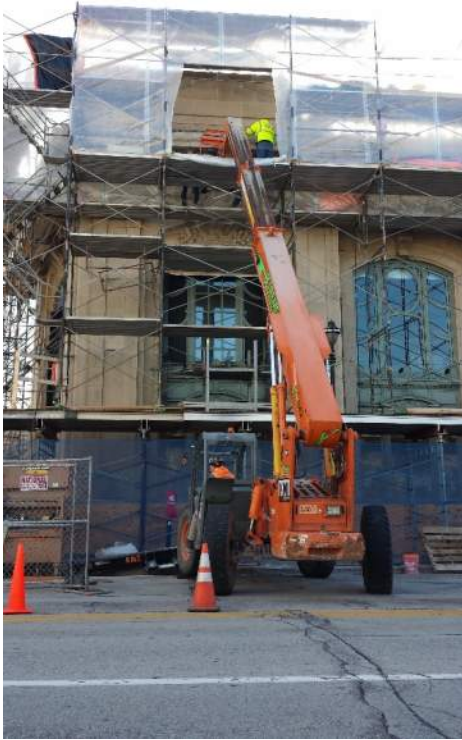
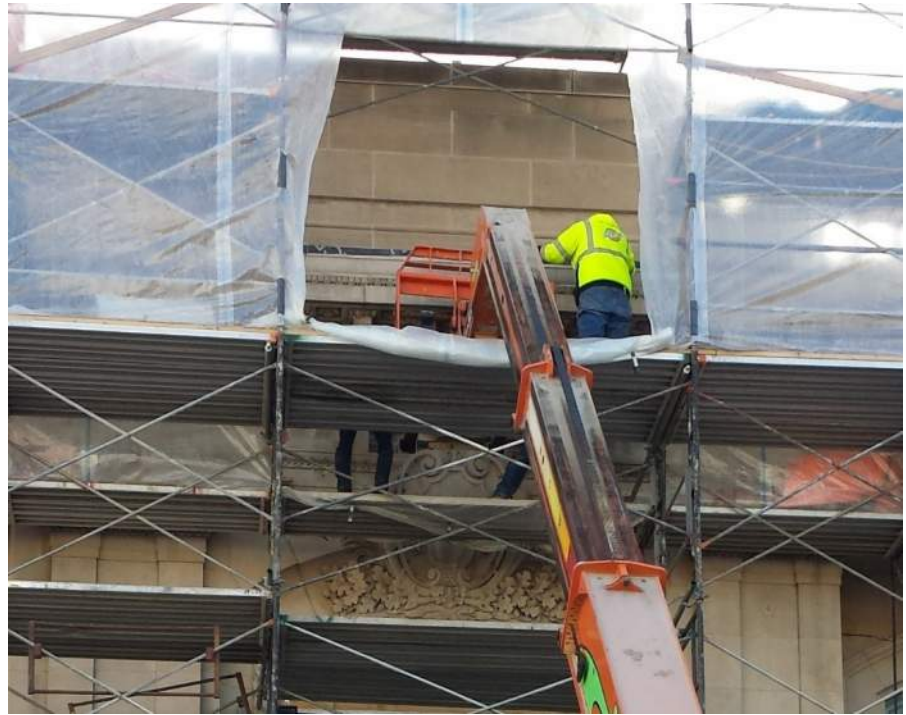
Photos 33, 34 – WEST ELEVATION. Northwest cartouche keystone, repositioned into place with specially fabricated steel hoist system attached to original keystone decoratively carved Indiana limestone block.

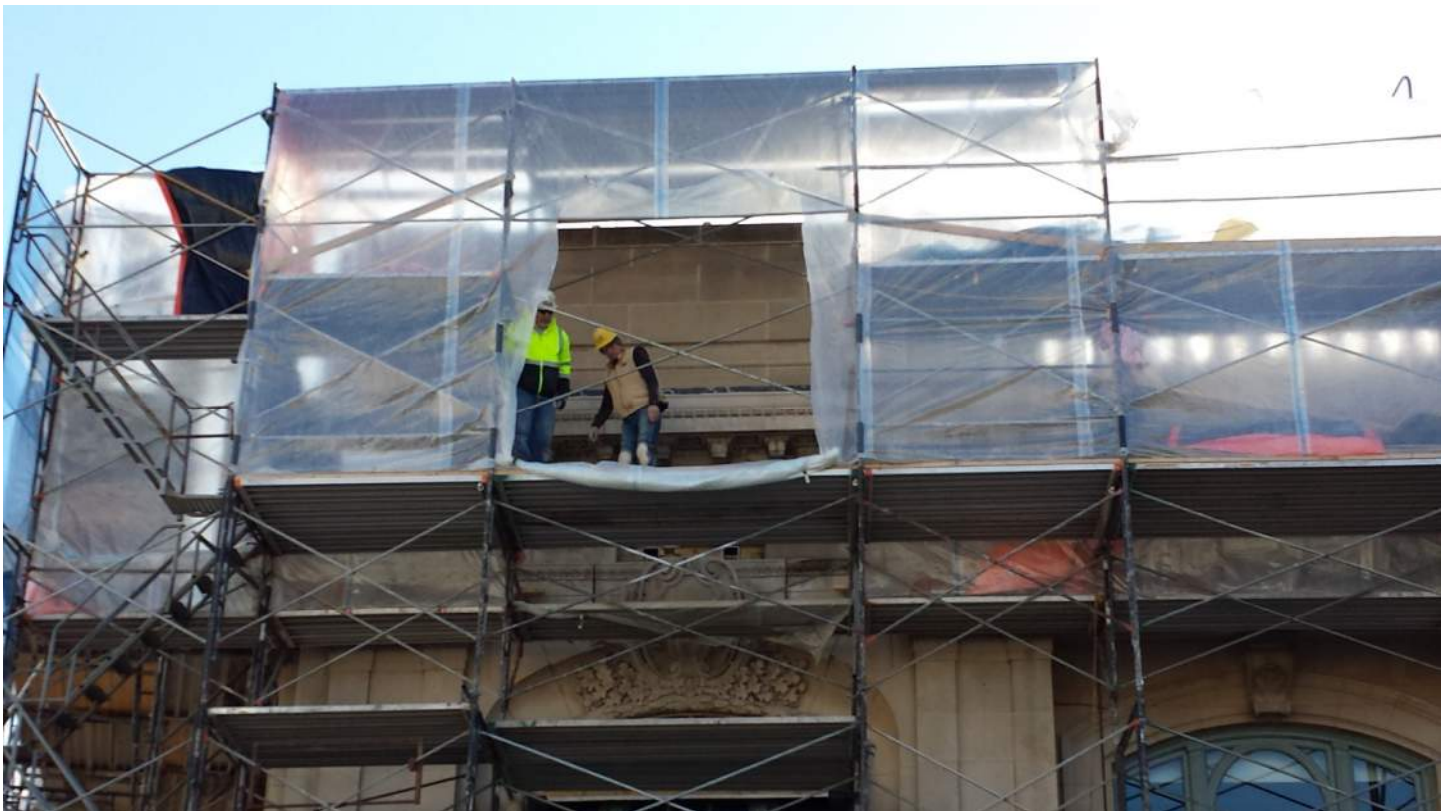
Photo 35 – WEST ELEVATION. Northwest cartouche keystone, repositioned into place.

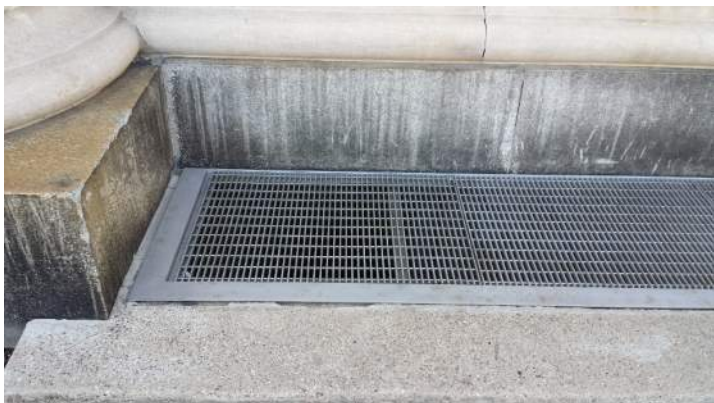
Photo 36 – WINDOW AREA WELL GRATE. O247. West elevation, grate no. 8, typical. Installation of new stainless steel grates, frames, fasteners. Annual maintenance required for “tea stains” resulting from oxidation (superficial only) caused by seasonal use of chemical deicers.

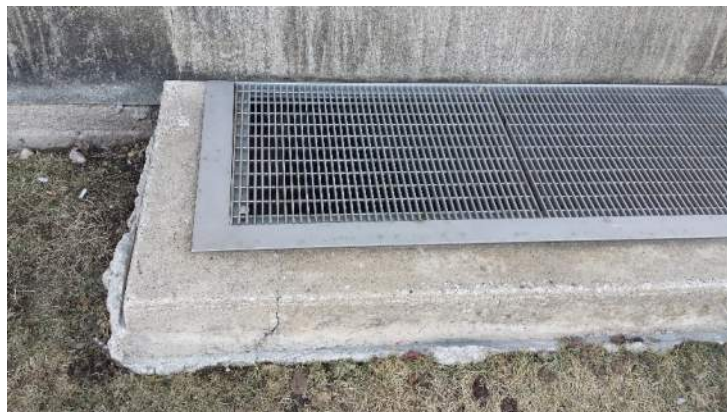
Photo 37 – Window area well grate no. 5, renovated.

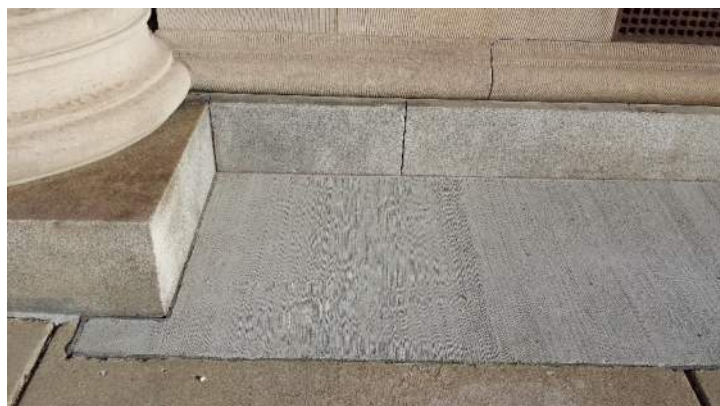
Photo 38 – Window area well grate no. 3 with new concrete cap and concrete support structure beneath. This area well was not draining and in heavy rain conditions would overflow into the lower level storage area. Concrete cap approved by the Historic Preservation Commission and Certificate of Appropriateness released 11/09/2017.

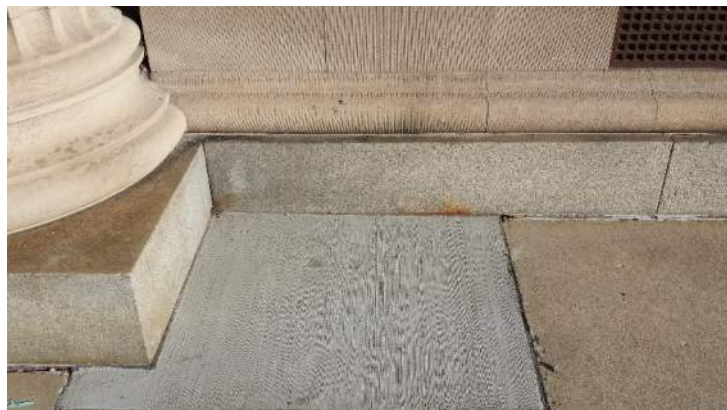
Photo 39 – Window area well no. 2, concrete capped.
