Facilities Condition Assessment Program

2nd and Plankinton Parking Garage

May 2011

Facilities Condition Assessment Program—2nd and Plankinton

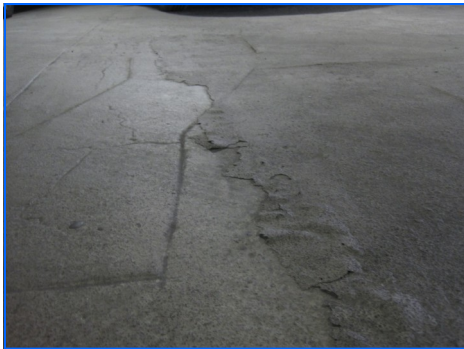
2nd and Plankinton comprises 153,000 square feet of elevated concrete parking and an additional 24,000 square feet of elevated helical exit ramps. The concrete parking contains a membrane, whereas the concrete helical ramp contains sealer application.

The east stair well at Floors 1 and 2 contains damaged concrete

Loose membrane at 3rd floor

The useful life of the membrane is up to 15 years and the useful life of the sealer application is up to six years. Parking should budget for membrane replacement by 2012 and every 15 years thereafter. Sealer application should be funded by 2012 and every six years thereafter.

Concrete surface repairs should be conducted in conjunction with membrane and sealer application.

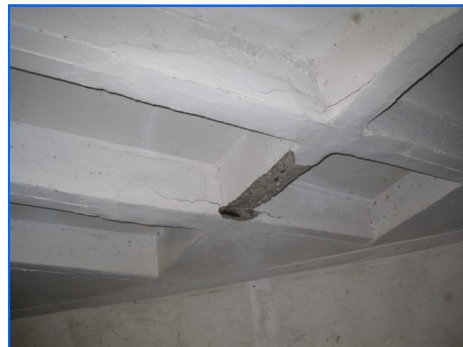
The paint finish is in fair overall condition. The useful life of interior paint finish applications is up to 15 years. Parking should plan the next paint finish application by 2015 and subsequent paint finish applications every 15 years thereafter.

Paint finish with rust

Concrete surface repairs at the walls and ceilings should be coordinated with paint finish applications.

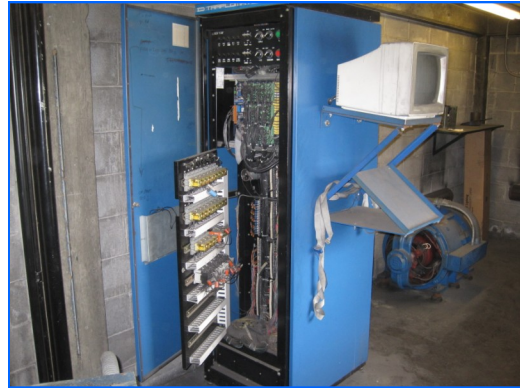
Two elevators serve 2nd and Plankinton parking structure. The useful life of traction elevators hoists and controls is up to 45 years. Parking should anticipate its upgrade by 2031.

Elevator controls

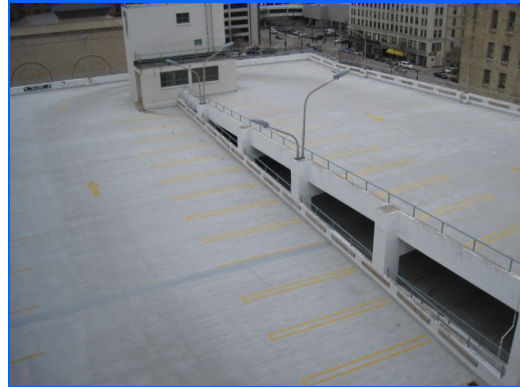
2nd and Plankinton contains 17 light poles and fixtures at the 8th level. The useful life of light fixtures is up to 35 years. Based on condition, Parking should fund light fixture replacement by 2023.

Light poles and fixtures at the eight floor

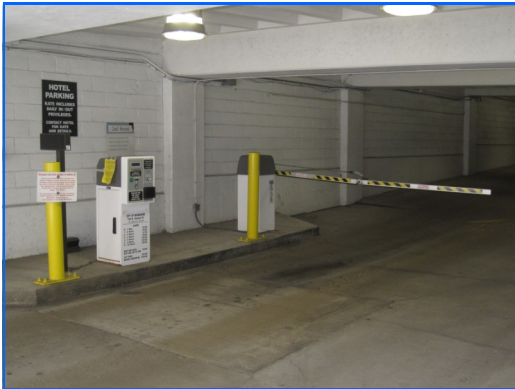
The useful life of these components and operating systems is up to 12 years. Parking should anticipate its replacement by 2019 and 2031. Interim repairs/replacements and upgrade to individual components should be funded by O+M.

Entrance ticket operator and gate arm

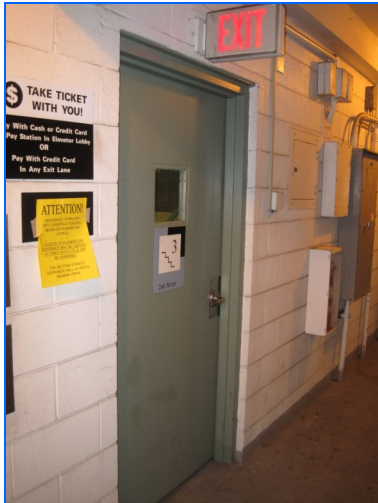
2nd and Plankinton comprises 24 steel doors, 2 glass/metal doors, and 2 overhead doors. The useful life of metal exterior doors is up to 35 years. Based on the varied conditions, Parking should anticipated phased replacement of 14 doors by 2019 and again by 2029.

Typical door

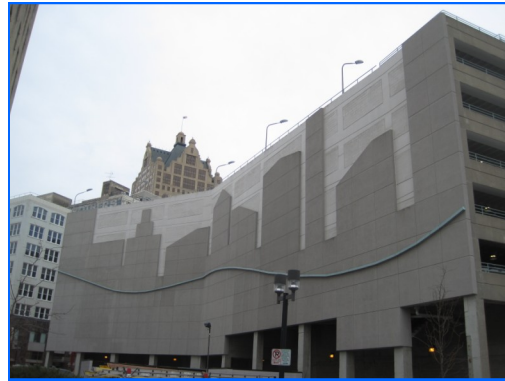
The north façade at 2nd and Plankinton comprises approximately 13,000 square feet of EIFS finishing. The useful life of EIFS paint finishes is up to 10 years. Based on condition, Parking should conduct EIFS paint finish application by 2015 and every ten years thereafter.

EIFS wall at north elevation

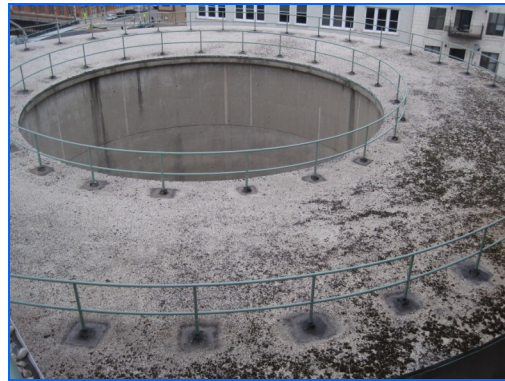
2nd and Plankinton contains three roof sections: one at the helical ramp, and one each atop the elevator penthouse roofs. The roof areas comprise 60 squares. The useful life of the roof is up to 20 years. Parking should budget replacement of the roofs by 2017.

Roof at helical ramps
