Structural Inspection Report

Property Inspected	
Address: 1116 W Mitchel St.	
Age Info: built in: No online information available, but appears early 1900s	
Problem Description: <input type="checkbox"/> Water <input type="checkbox"/> Foundation Structural <input checked="" type="checkbox"/> Other Structural	
Cracks noted in <input checked="" type="checkbox"/> Ext Walls <input type="checkbox"/> North <input checked="" type="checkbox"/> South <input type="checkbox"/> East <input checked="" type="checkbox"/> West <input type="checkbox"/> Floor <input type="checkbox"/> Other	
Inspection Date: 9/28/2015	Report Date: 1/11/2016

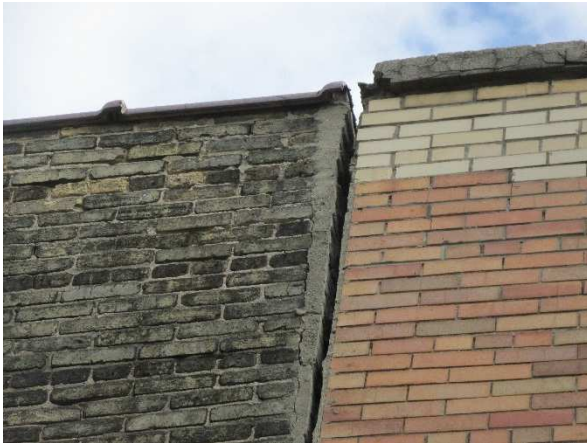
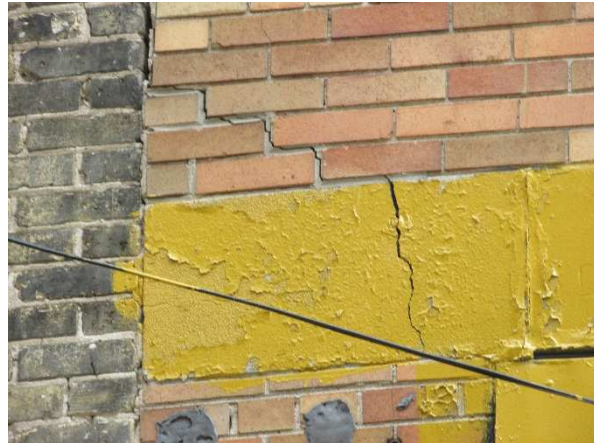
The noted concern is the gap existing on the west side of the building, and what the cause of this gap is, and whether it is experiencing ongoing movement. The photos below shows this gap.

1. Based on the observations and measurements taken during the inspection, it appears that water damage has compromised the wood framing and has caused the movement noted. However, interior wall finishes exist, so the damage is not readily visible at this time. This damage has been likely going on for some time, but the replacement of the roof has slowed down the rate of the deterioration. Any water entering the building is coming from the open cracks in the parapet wall, parapet wall caps, and the crack on the parapet wall cap on the west wall. The damage due to water infiltration is ongoing.

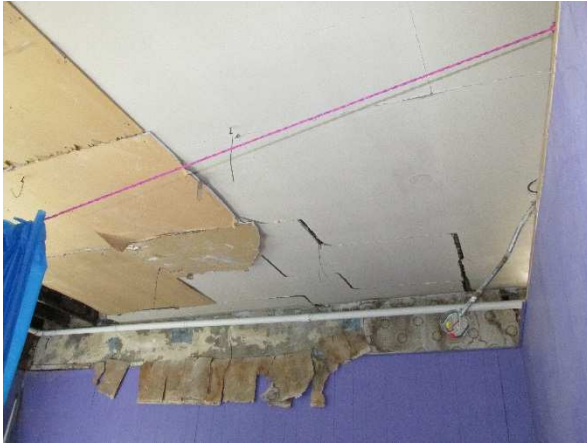
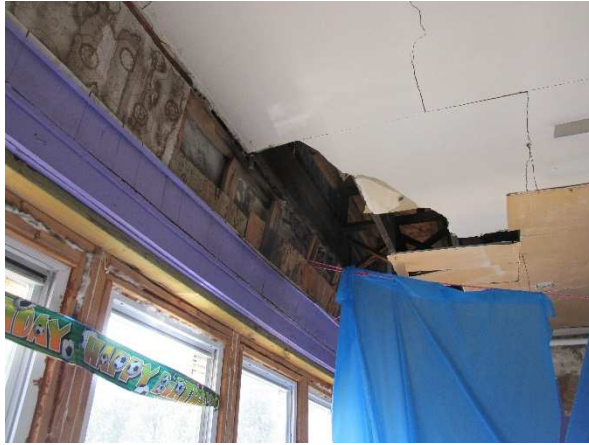
Observations were made on the second floor but the wall and floor coverings did not allow sufficient visibility of the framing members.

- a. Remove the interior finishes on the second floor. These should include the wall and ceiling materials as well as approximately 2 feet of flooring abutting the exterior walls. The interior finishes on the first floor should also be removed on the south wall.

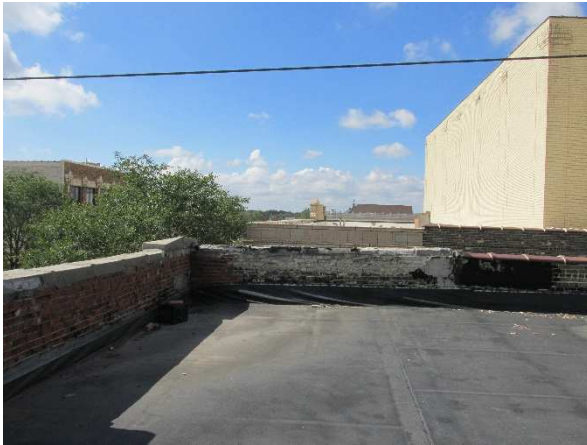
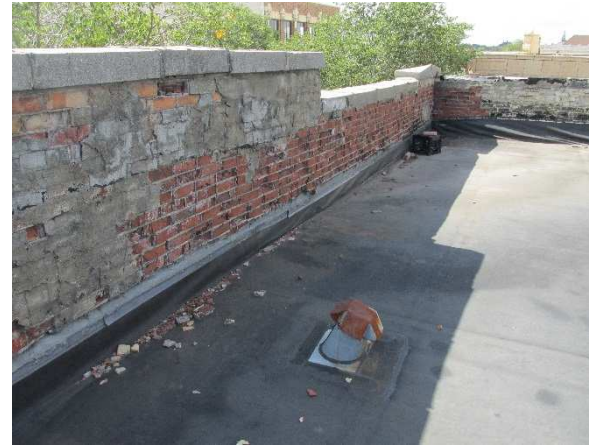
The roof appears recent (\approx 5-10) years and was in satisfactory condition at the time of the inspection.

- e. Any roof decking repairs will require repairs to the roof membrane. If the damage is significant, the entire rubber roof may require replacement.

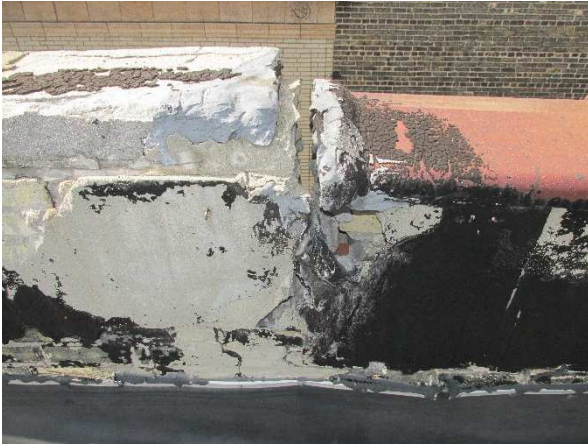
The photo below shows the gap where the building is separating (west wall).

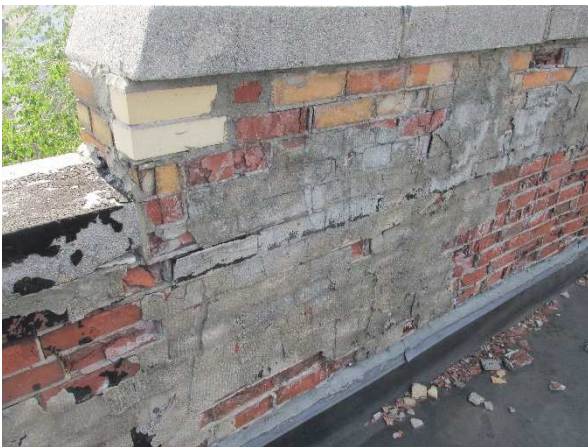
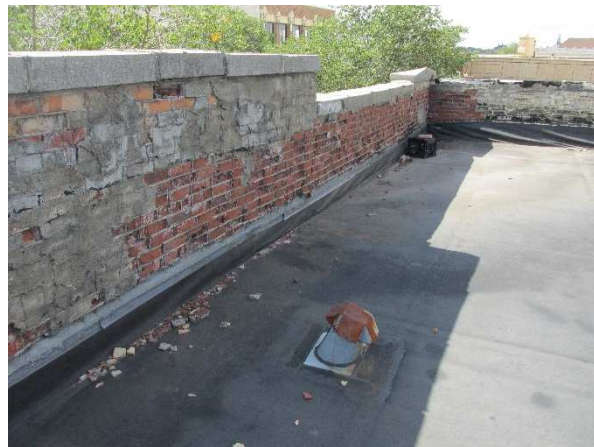
The south parapet wall shows severe damage to the mortar joints and repairs, and cracks are visible in the mortar joints on the caps.

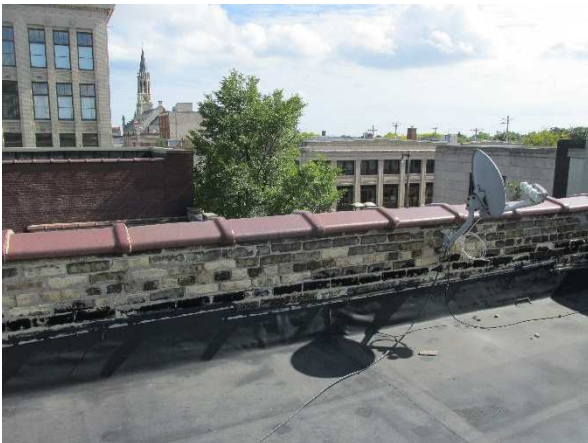
The east wall is in much better condition than the other parapet walls observed.

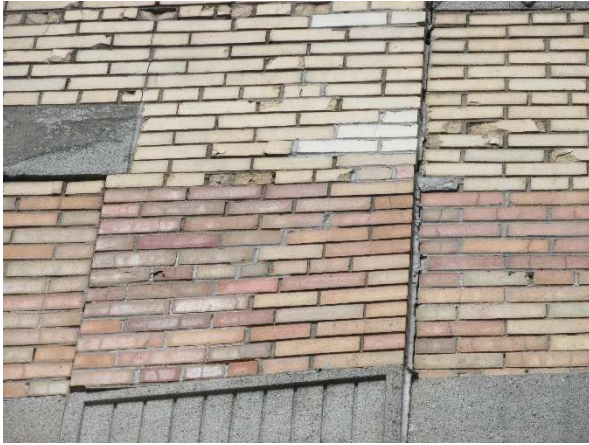
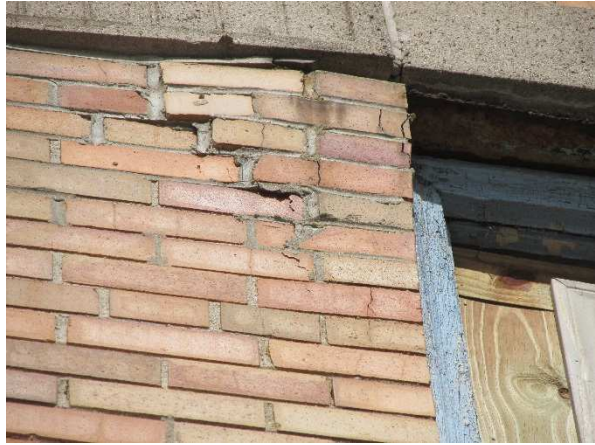
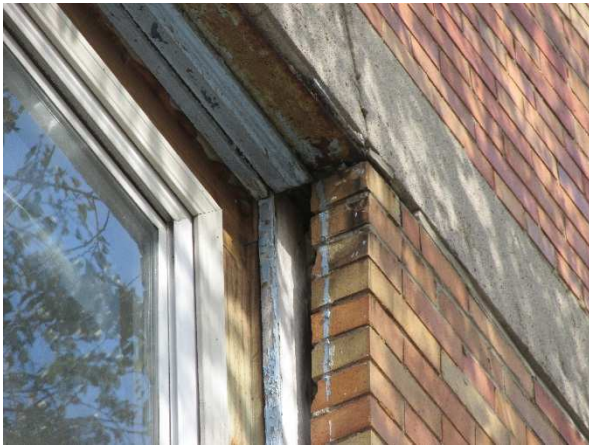
The south façade shows movement of the bricks away from the building, past repairs, and damaged mortar joints.

- f. In addition to these repairs, the entire front (south) façade of the building will require removal and replacement. Based on the conversation with Historic Preservation, an alternative (new) brick can be used. However, the existing detail items will need to be salvaged and this will be defined on the required elevation drawings. As part of these repairs, scaffolding will be required and may also require closure of the sidewalk. These items will have to be further discussed with the City.

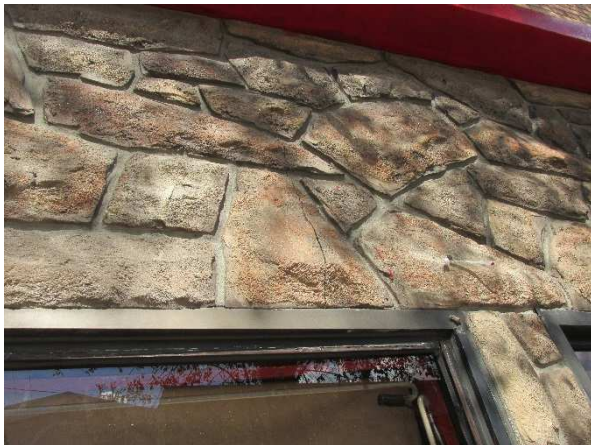
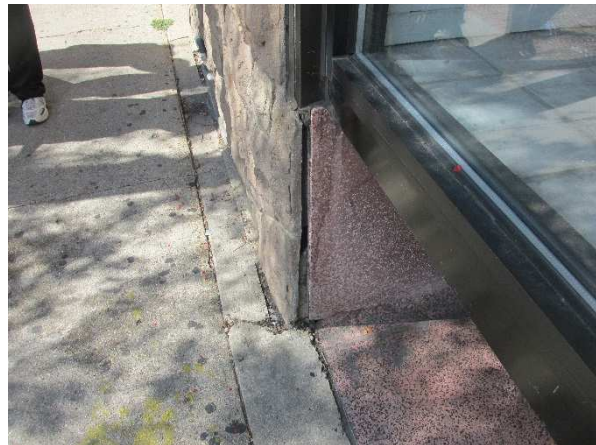
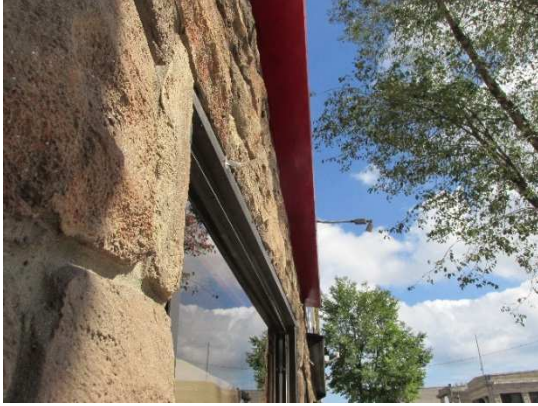
It appears that stone was added to the first floor at some point in the past as it does not appear original to the building. This stone façade shows cracking and sever outward bowing. Past mortar repairs also show cracking.

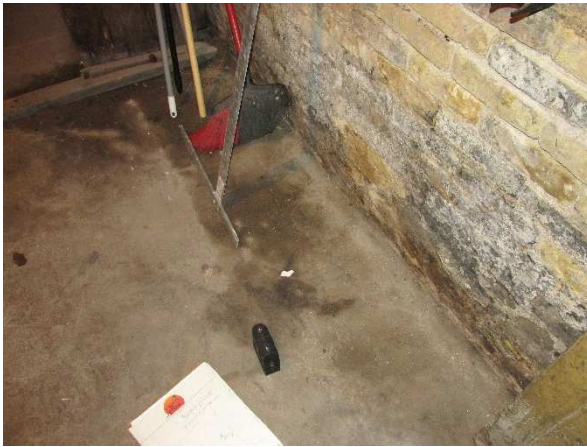
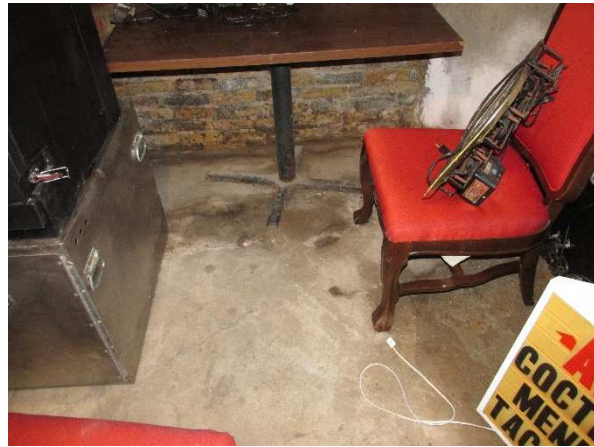
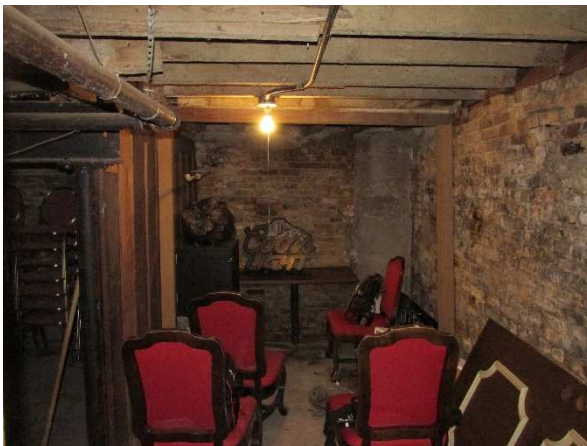
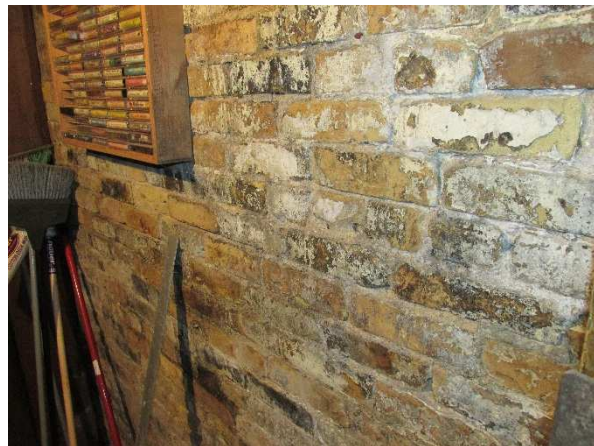
In the basement, measurements were taken with a laser from north to south and it was found that there is no settlement of the foundation on the south side of the building. The walls do show inward movement and some moisture infiltration, but not excessive for a wall constructed of brick. The maximum displacement measured, which occurred on the west wall, was 2". No excessive cracking or indications of recent movement were observed.

2. The foundation is not the reason for the movement observed, as there are no indications of settlement observed or measured in the basement.
3. Further investigation is required to identify where the damage exists, and steps taken to develop a plan for the design and implementation of the necessary repairs.
