5. DESCRIPTION OF PROJECT:

611 North Broadway

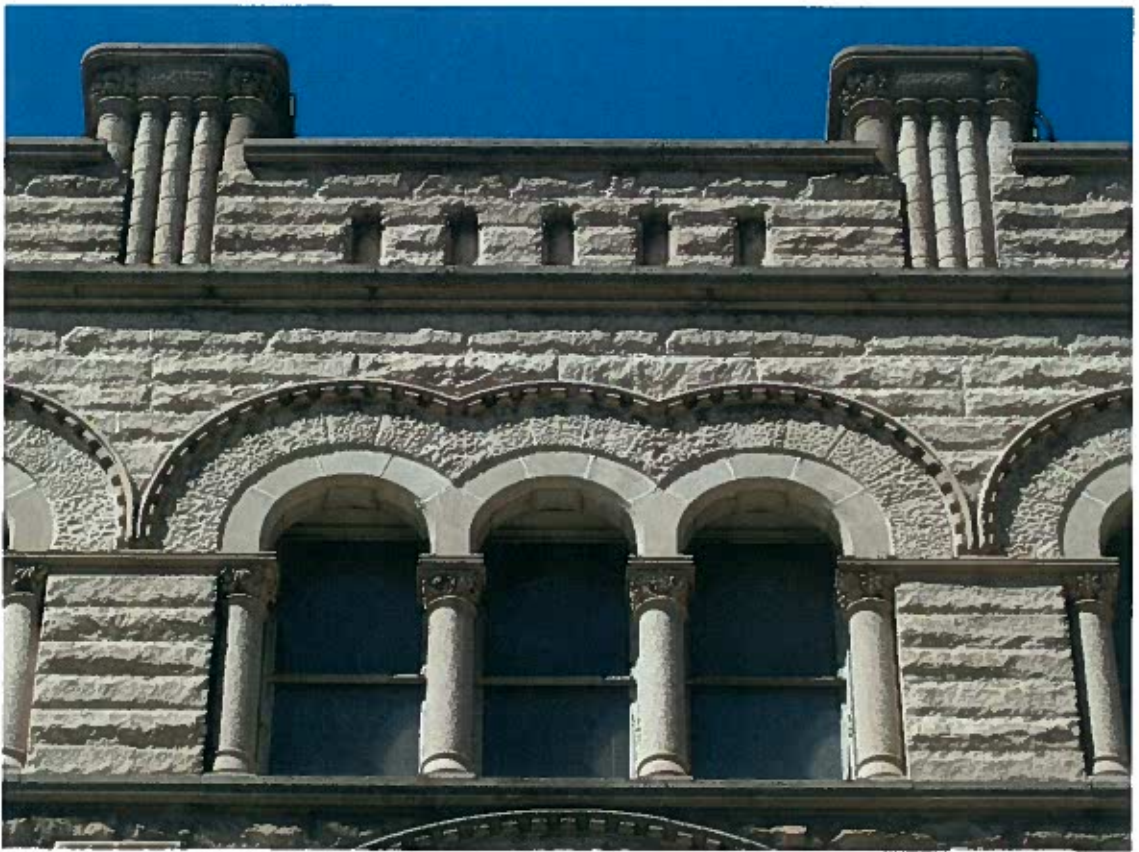
Photo 13: Parapet detail

The granite façade was painted in the 1960's and remains so today. An area around the main entrance was stripped and cleaned a couple of years ago as a test patch to reveal the natural stone. The underlying stone appears to be in very good condition. Mortar joints are in generally good condition, with minor repointing and other miscellaneous masonry repair required. The façade inspection report prepared in 2010 per City Ordinance notes some parapet shifting in the center of the east façade.

Granite joints will be repointed where existing mortar is loose, damaged, missing or has been replaced inappropriately with sealant. Mortar composition will be analyzed so that pointing mortar can match the original as closely as practical in mix design, hardness and color. Joint profiles will match the original. Selective demotion will be performed on the east parapet to determine the amount of reconstruction required. The parapet will be reconstructed as necessary to be structurally sound and match the original appearance. Skyward-facing joints at granite (parapet caps, window sills, etc.) will be cut out and replaced with sealant.

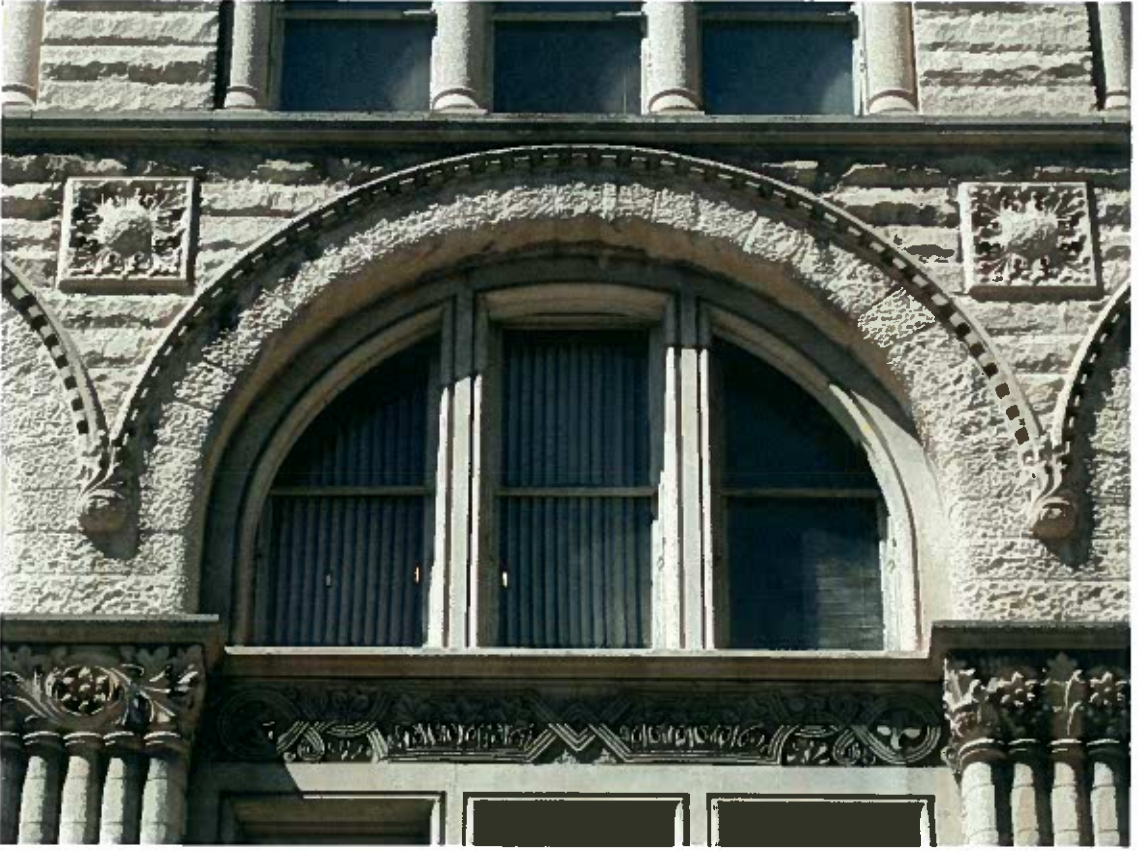
Photo 14: Fourth Floor window detail

Windows are in fair condition (Photos 13-16). Most of the windows in the building appear to be original wood sash with single-pane glazing. Storm sashes are not present. The windows have not been painted recently, so show significant areas of bare wood. Sills throughout the building exhibit severe checking (Photo 20). Some windows show deterioration of the bottom rail. Transom lites at the first floor of the Broadway façade have been infilled with an opaque material. A few windows have been replaced, particularly at the ground level of the Broadway façade, in the area well (Photo 17).

Windows will be scraped and sanded in preparation for painting. Sills will be repaired with Abatron LiquidWood and WoodEpoxy or equal by West System. Deteriorated sash members will be repaired with wood epoxy if possible, or replaced in kind. Windows will be fixed shut and repainted with exterior latex paint. Interior storm windows will be added for energy efficiency.

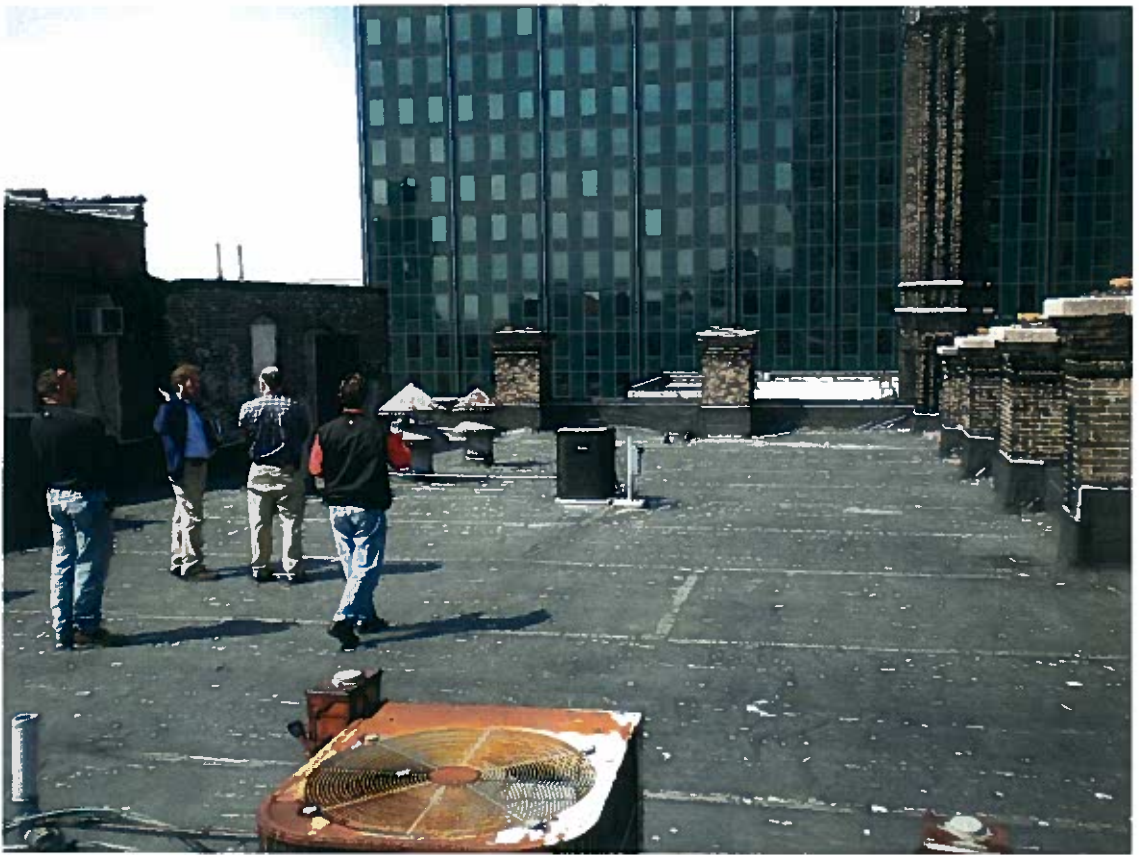
Photo 19: Roof, looking West

The existing roof has a low-slope EPDM roofing system. The roof membrane is in satisfactory condition. The roof slopes from the high side on the east down to the west. Ice damming on the roof behind the west parapet has been an ongoing problem, resulting in some masonry deterioration and leakage around the drainage scuppers.

The existing roofing will remain and be patched as necessary. Two cooling towers will be added above the northwest portion of the roof (Photo 19). The total height of the cooling towers, including support structure, will be approximately 13' above the roof surface. The northwest corner location was selected because it is furthest from the street facades and is at a relative low point of the roof. In addition, this location allows the cooling towers to be hidden from southeastern vantage points by the skylight dome and elevator penthouse. This location is pending confirmation of adequate structural support. The existing skylight will remain, any minor leaks will be repaired, and the metal structure will be repainted. A skylight will be added at the second floor roof to create a lightwell at the north end of the building. Historic photographs show a skylight in this location originally.

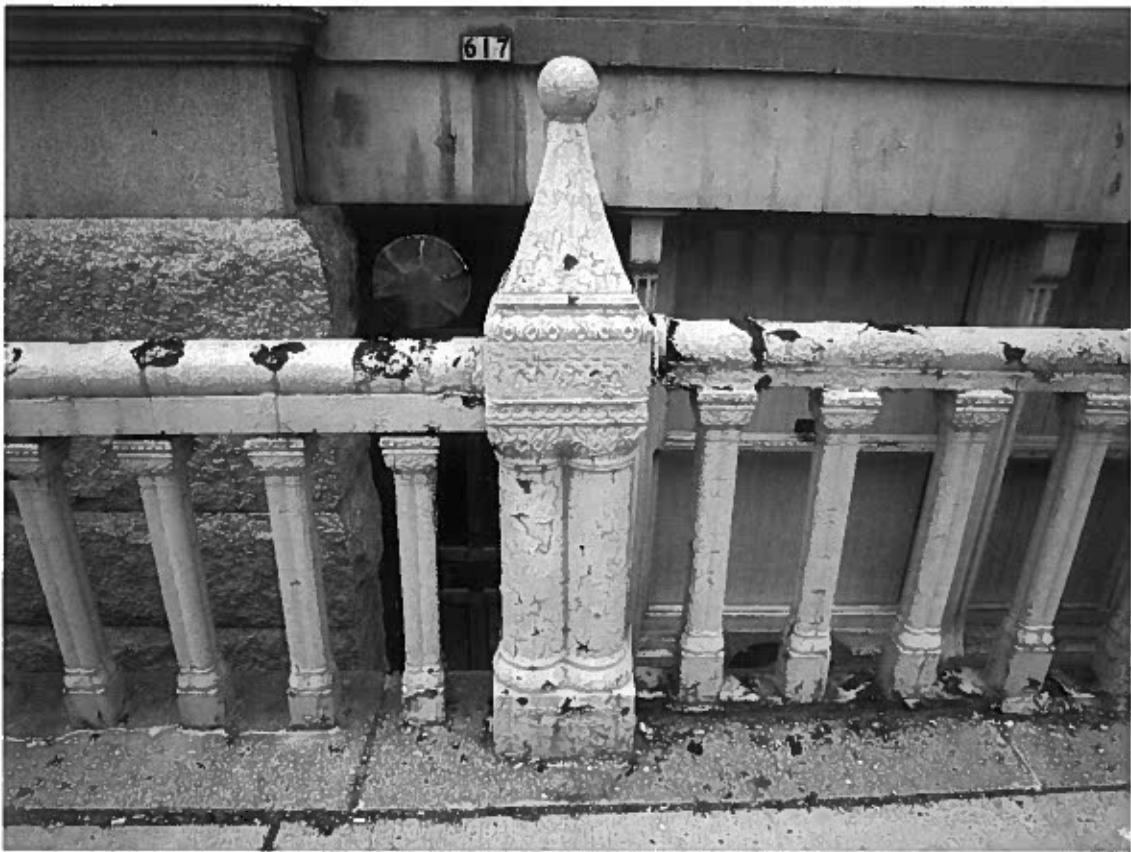
Photo 21: Sidewalk railing

There is a prominent cast iron railing along the Broadway sidewalk (Photo 21). The newel posts and balusters are in fair condition, showing some surface rust. The steel top rail is not original and exhibits severe rust. The entire railing is set on a concrete base which is deteriorating.

The cast iron railing will be disassembled and refinished. The existing paint will be removed and the members will be repainted. A new metal top rail will be fabricated. A new concrete base will be poured. The railing will be reassembled in its original location.
