ARCHITECT'S FIELD REPORT

Charles Allis Art Museum
Exterior Improvements
Milwaukee County – Department of Administrative Services
Milwaukee County Project No. O527-17438
James G. Otto Architect, LLC Project No. 15005.00

Visit Number: Eight
Date: September 11, 2018
Time: 1:00 am
Weather: Sunny
Temperature Range: High 60's
Present At Site: Jim Otto
Philip Schmidt
John Sterr
Scott Russell

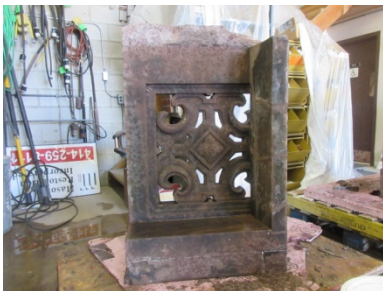
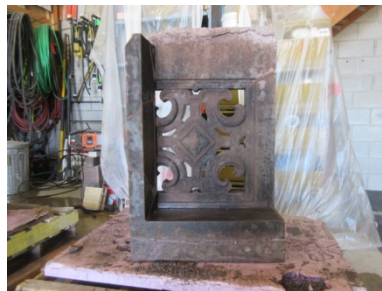
| Item | Description | Action By |
|---|---|---|
| 8.01 | <p>Reviewed current work in progress as follows:</p> <ul style="list-style-type: none">Reviewed the Balcony Railing Side Panels t MRI's shop;<ul style="list-style-type: none">The railing side panels have been reconstructed and are being wet cured.The side panels will be crated and delivered to the site for reinstallation after a one week wet cure period.The remaining whitish residual sealant areas will not be ground off to avoid reconfiguring the existing stone profiles. | |
