Collision Analysis & Reconstruction Report

Milwaukee Police Department Incident #: 12-309-0028
DOT Document #: 9H14322
Crash Date: Sunday, November 4, 2012, 2:09 A.M.

Location: 6324 W Fond Du Lac Ave
City of Milwaukee
Milwaukee County, Wisconsin

Milwaukee Police Department
Neighborhood Task Force
Crash Reconstruction Unit

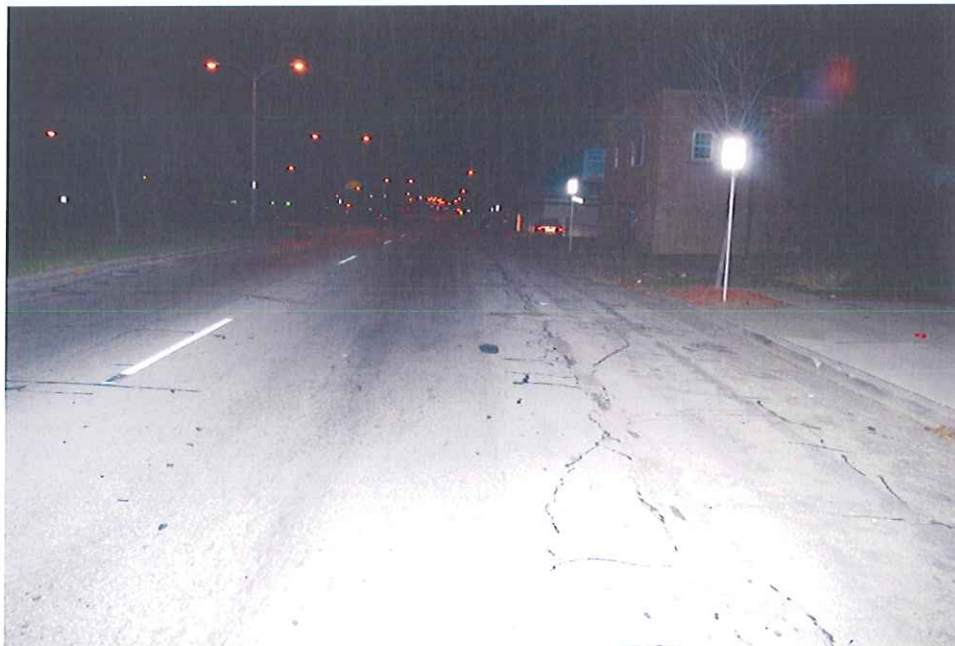
A black knit hat was observed in the roadway directly in front Brighter Days Child Care at 6324 W. Fond du Lac Avenue. Small black paint flecks were observed on the roadway in the area of the black knit cap, being first observed approximately five feet south of the black hat. The black paint flecks continued north in lane two towards the intersection with W. Armitage Avenue. Two bloody tire marks were observed on the roadway surface starting at about 6342 W. Fond du Lac Avenue. The tire marks were located in the curbside half of lane two, commonly referred to as the parking lane. A pair of blue jeans was observed in the roadway in lane two, in front of 6342 W Fond du Lac Avenue. Directly north of the blue jeans was a pair of blood stained underwear, a black boot and the right foot of the victim. The left boot was located near the median break in the intersection.

Directly west of the body, Officers observed a large pool of what appeared to be vehicle fluids. This was the first location that the vehicle fluids were observed. The fluid pool started near the center of lane two and then transitioned to lane one as it traveled to the north.

Figure 3. View of the scene looking northwest on West Fond du Lac Ave. from in front of 6324 West Fond du Lac Ave.

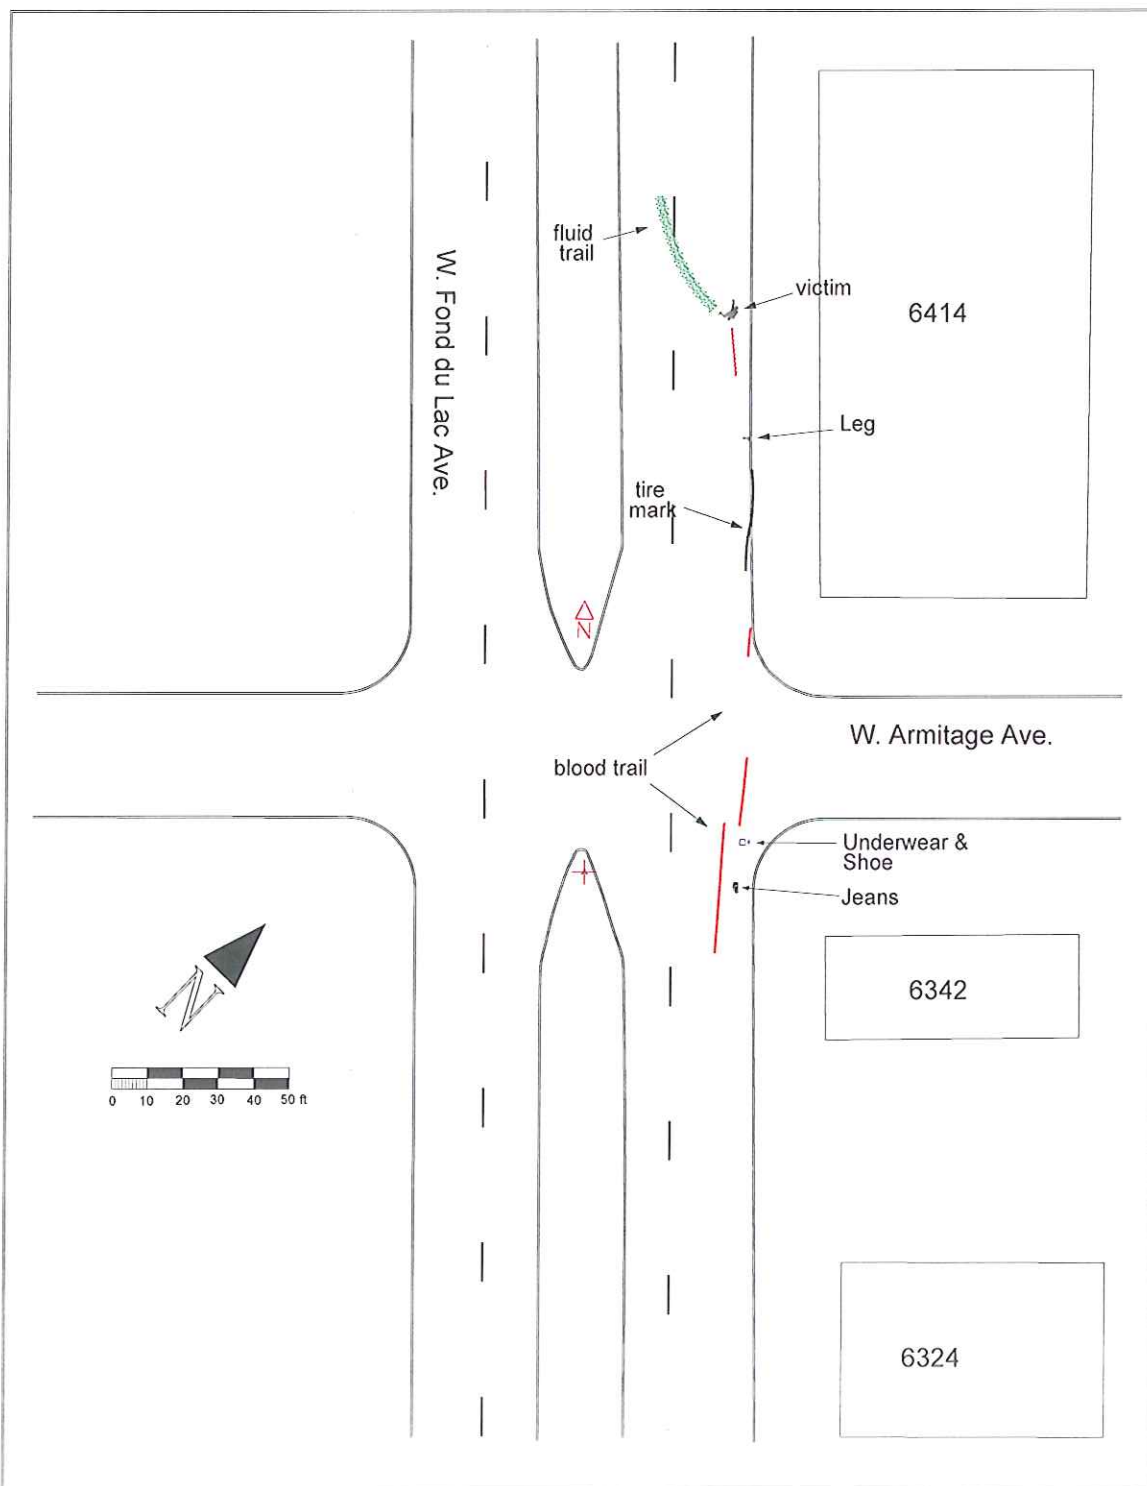
Figure 4. Scaled scene diagram

To the northwest of the area of impact, Officer Hanney located and collected forty-two distinct pieces of vehicle debris, which were left at the scene by the striking auto. In examining these vehicle parts, Officer Hanney observed a Lexus insignia on one of the larger pieces of debris. The vehicle parts were collected, individually packaged, and later sent to the Wisconsin Regional Crime Laboratory for analysis.

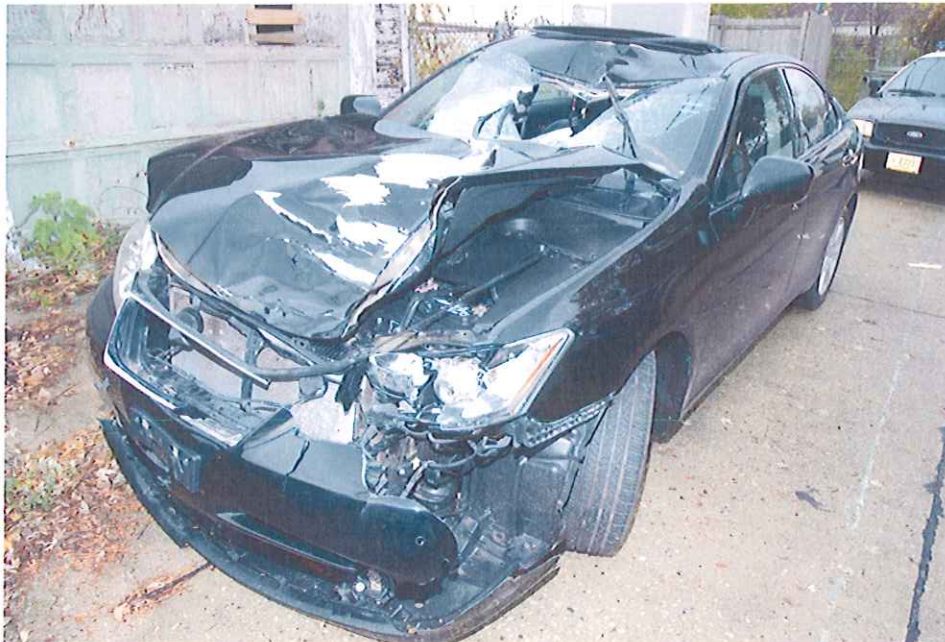
The Lexus ES350 is a four-door sedan powered by a 3.5 Liter, V-6 engine. The engine's power is delivered to the road through an automatic transmission coupled with front-wheel drive. The vehicle is equipped with four-wheel anti-lock disk brakes. The Lexus ES350 received severe damage across front of the vehicle, as well as to the hood, windshield and roof. The damage across the front of the vehicle is focused slightly left of the center of the vehicle with large sections of the driver's side bumper cover and headlamp assembly missing. The outer edges of the hood bend upward, and the center of the hood is has several

creases. The hood itself is pushed rearward towards the windshield. A significant amount of paint is missing from the hood, exposing the bare metal. The missing paint is primarily in the center of the hood. The windshield is shattered, with a large portion of the center of the windshield missing. The roof is pushed rearward and downward where the roofline meets the windshield. The vehicle is equipped with a moon roof. The glass for the moon roof is shattered and is mostly displaced from the vehicle. To the rear of the moon roof, there is a large dent that extends from the rear of the moon roof to the top of the rear window. Blood splatter was observed from the right side of the hood back to the trunk. Inside the vehicle, the driver's steering wheel and knee bolster air bags deployed. The pretensioners for both the driver's side and passenger side seat belts fired and the seat belts were locked in place against the B pillar. Shattered glass was located throughout the interior of the vehicle.

Figure 5. 2007 Lexus ES 350 used in this offense
