Certificate of Appropriateness AMENDED

1801 N. PROSPECT Charles Allis House an individually designated historic site

PTS ID 109045 COA Roof and Gables

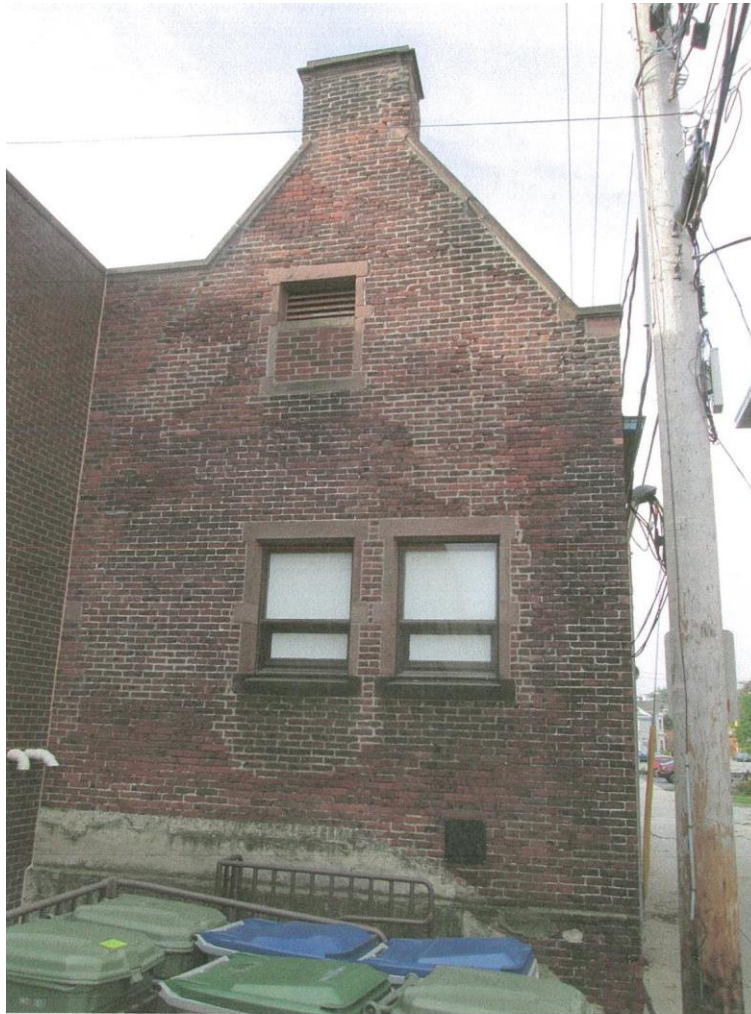
North Elevation – Garage, Charles Allis House

Repointing has been carried out in the past without regard to appropriate mortar composition and color as evidenced here.

At the north elevation of the garage, the upper portion of the gable, the gable parapet wall and the chimney will be taken down to sound masonry and reconstructed using salvaged face brick and new back up brick

Various areas will be repointed on the house and garage.

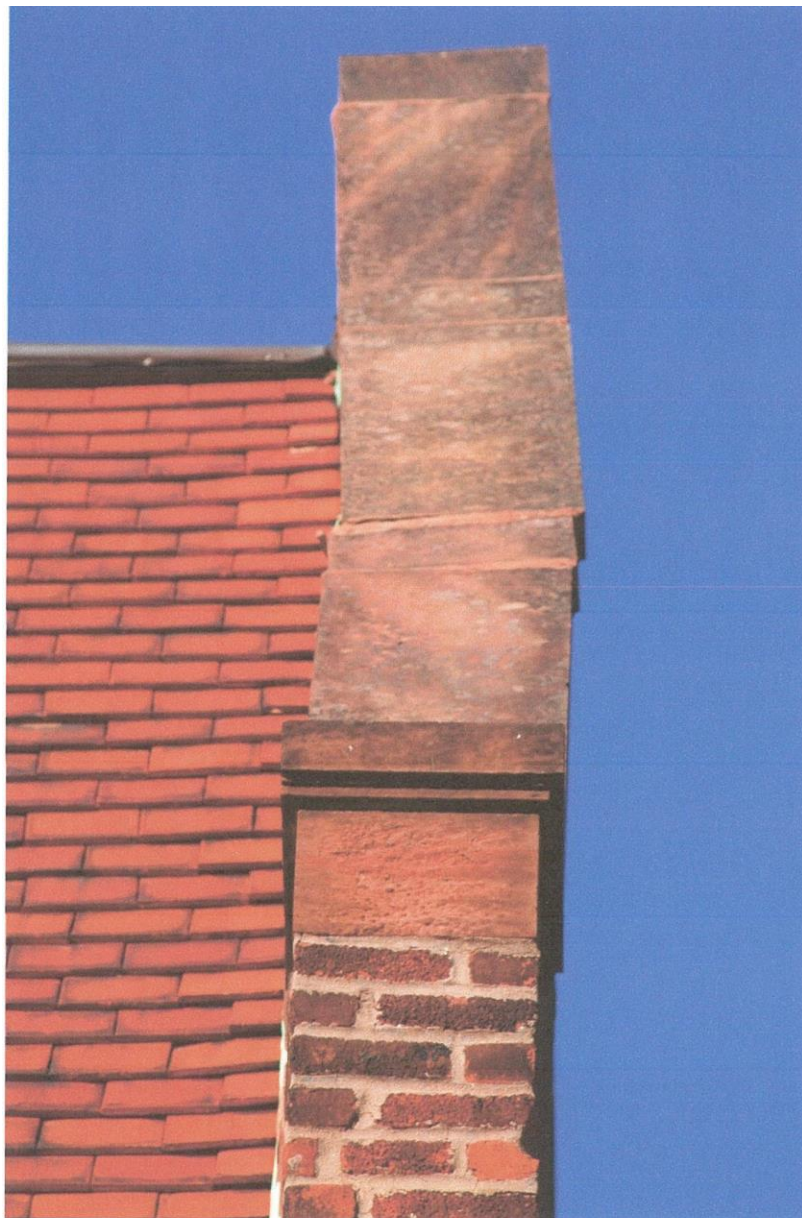
Leaning parapet and displaced gable coping – NE corner – Charles Allis House. Condition is typical to all of the gables, but to varying degrees.

Various gables at the house will be taken down to solid masonry and reconstructed using salvage face brick and new back up brick. Stone copings will be reset and remaining portion of gables will be repointed

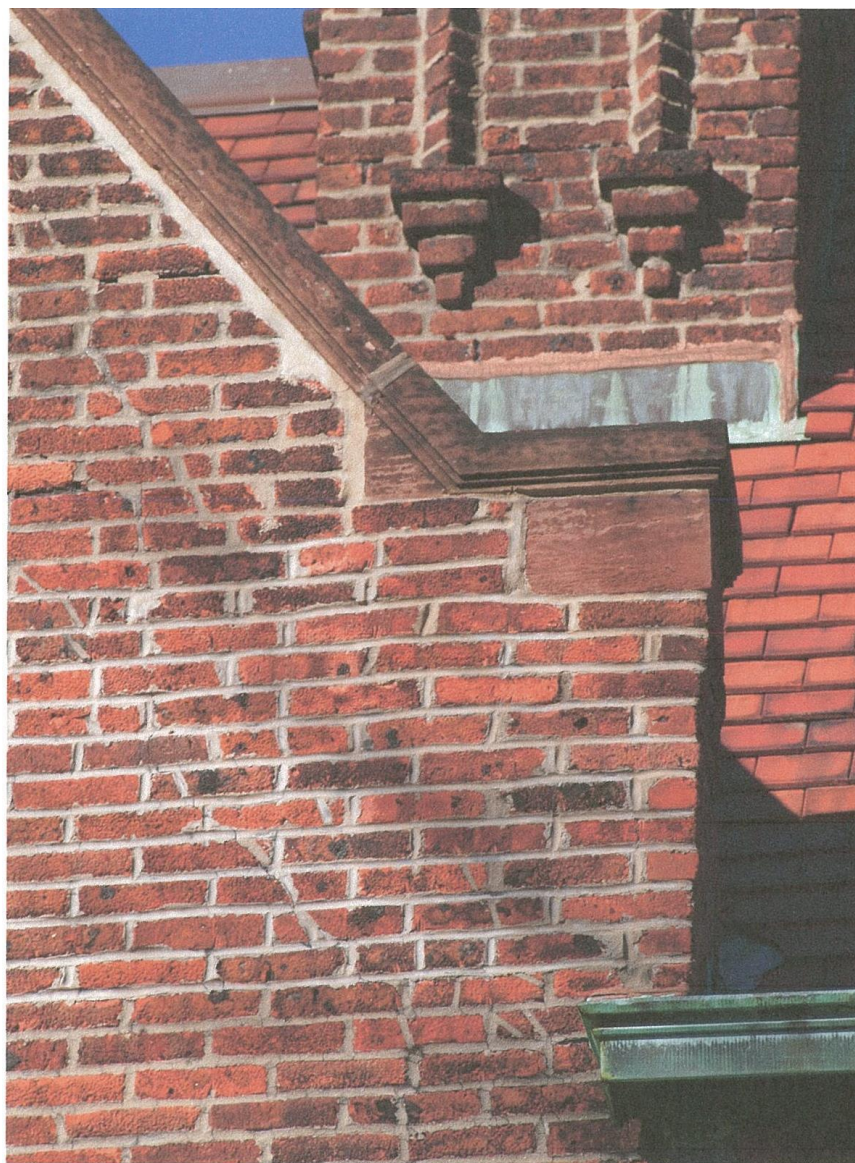
Cracked gable parapet walls – East Elevation, Charles Allis House. Condition is typical of all gables but to varying degrees. Note repaired cracks have re-cracked. Note condition of chimney in background.

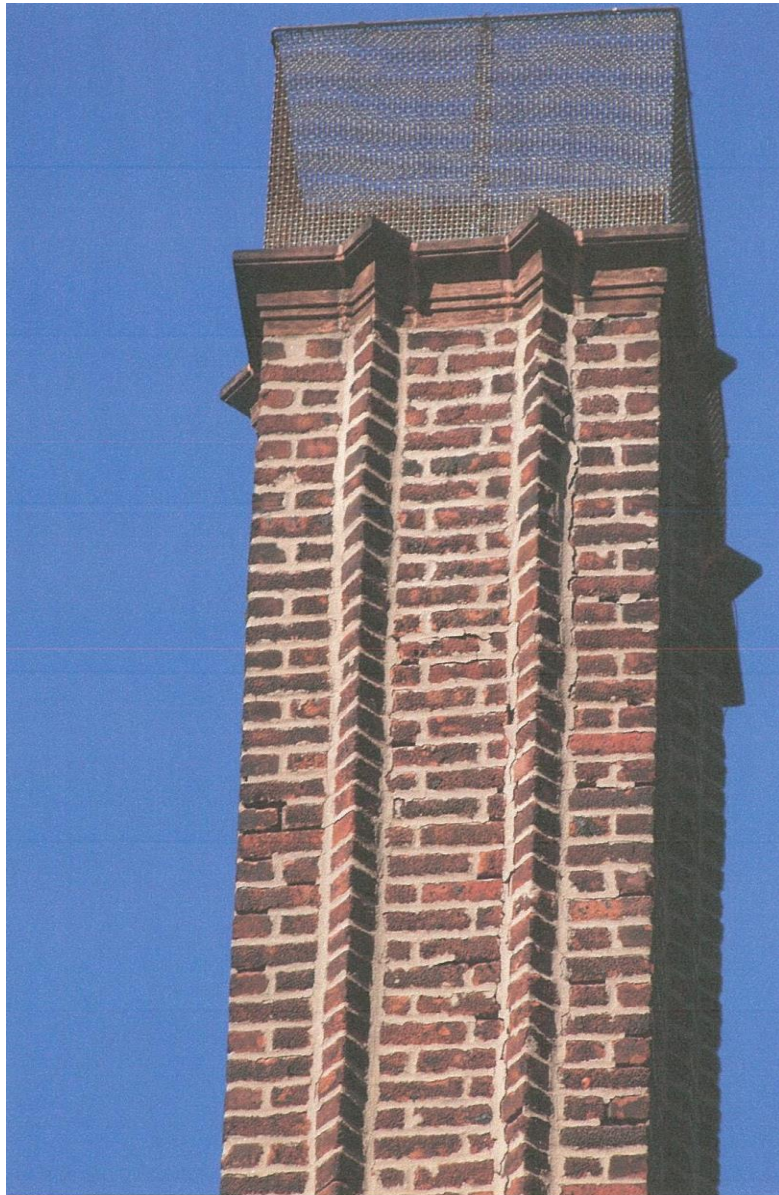
Typical Chimney Condition – East Chimney, East Elevation – Charles Allis House. Excessive spalling of hard grey pointing mortar and join cracking with brick displacement of stacked rotated brick accents.

Portions of chimneys extending above the roof will be repointed and repaired. Lead coated copper covers will replace metal cages at the flues and vented caps will be placed over unused flues.

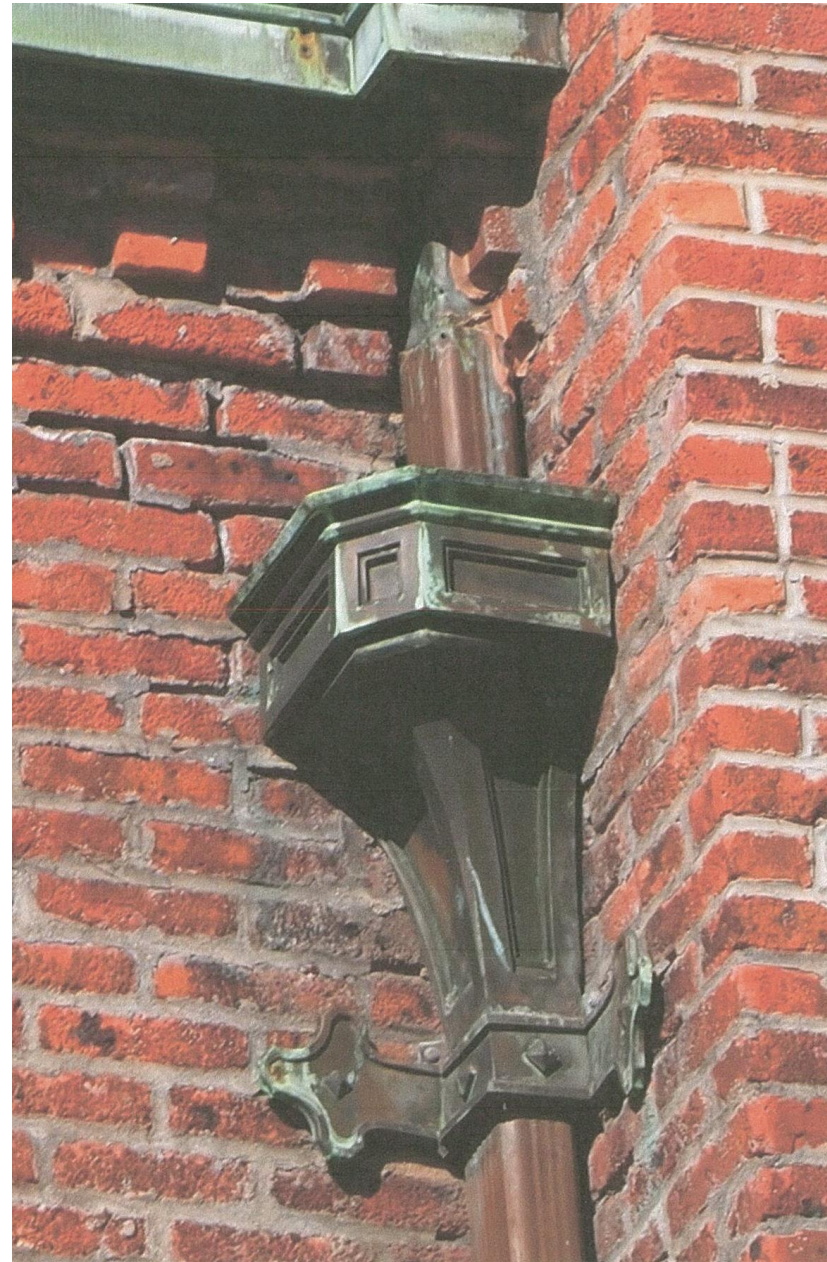
Mortar Deterioration at Downspouts, South Elevation – Charles Allis House. Typical at all downspouts.

Patch and repair existing gutters and downspouts and add downspout conductors with removable debris screens.

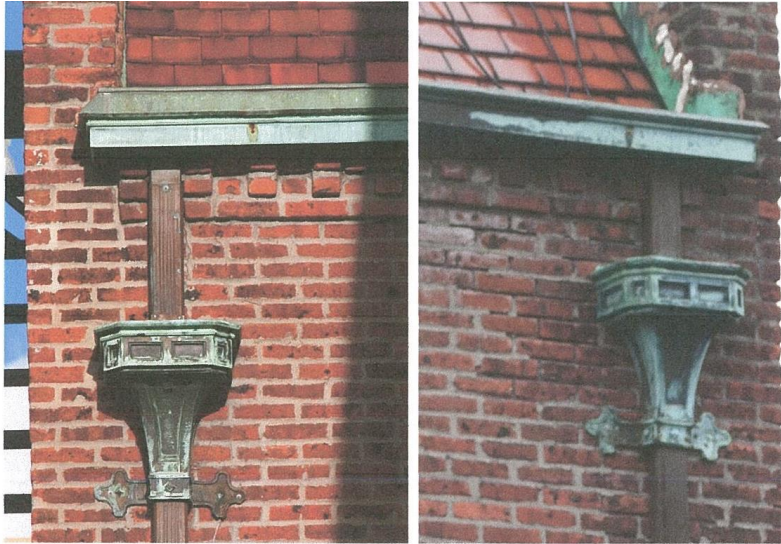
Existing Gutters – SE & NW Corners of Charles Allis House. It is proposed to raise the outer lip of the remaining unrepaired gutters to reduce the occurrence of rain runoff overflows which are contributing to the deterioration of the masonry immediately blow and further downstream of the gutters. The previous gutter work was accomplished in the 1990s as part of the previous restoration work.

Gutters at the west and north elevations were previously raised at the outboard gutter lip to keep water from cascading over the top of the gutters. This will also be done to the gutters on the other elevations as well as the gutters on the west elevation of the garage.

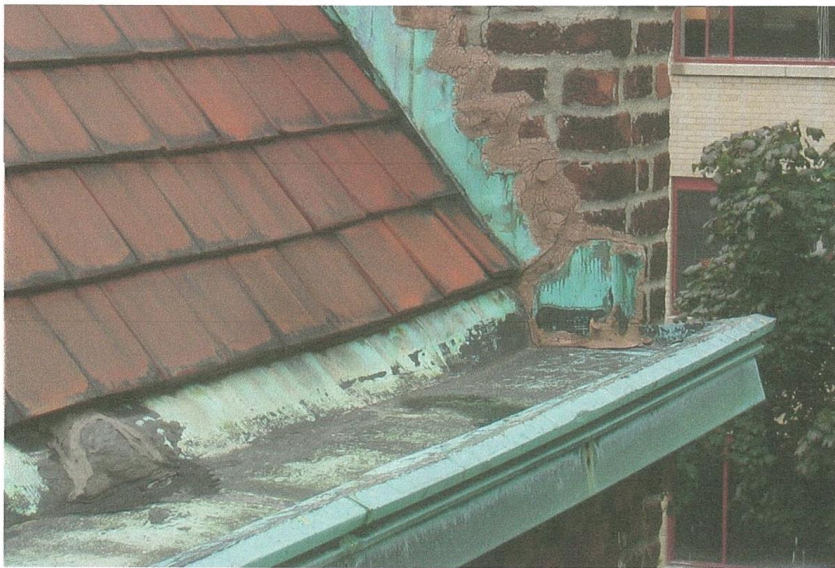
1.5" Deep Gutter at Termination - East Elevation, Charles Allis House

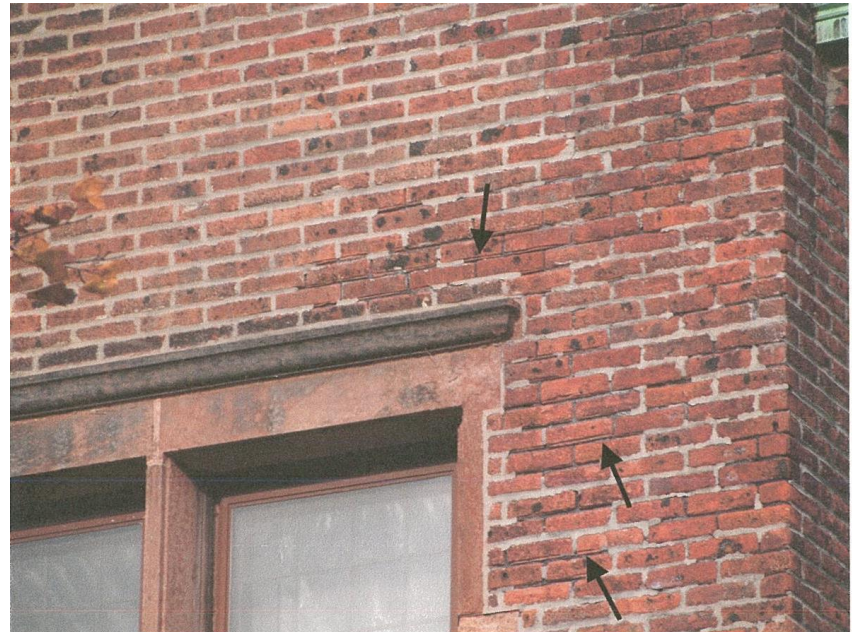
SE Corner – Charles Allis House. Wind blown runoff has repeatedly deteriorated the masonry in this area. Note the overcut bricks from a previous repointing project.

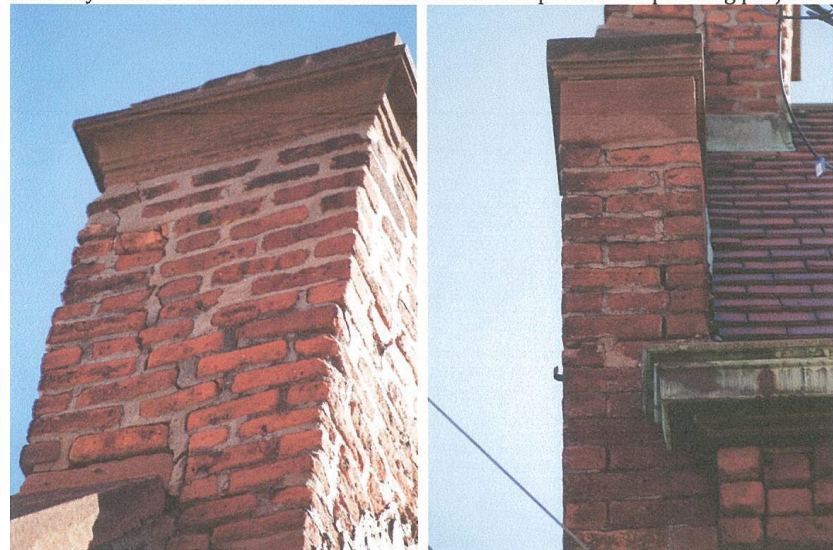
Garage North Gable & Chimney Deterioration – Charles Allis House. The leaning of the gable and chimney, along with the cracks, brick displacement required reconstruction of these elements.

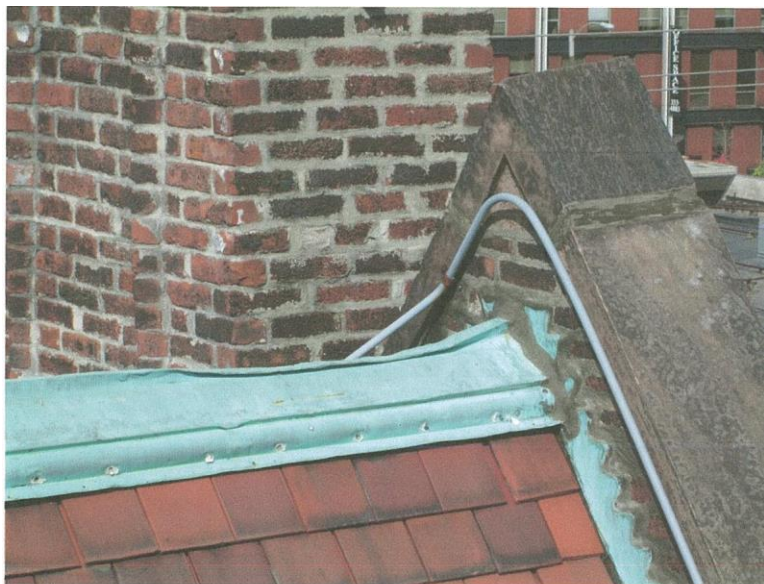
Crushed & Loose Ridge Cap – NW corner of Charles Allis House. Note excessive use of sealant on flashing, brick, and coping.

Copper ridge caps and valley flashings to be replaced or re-secured

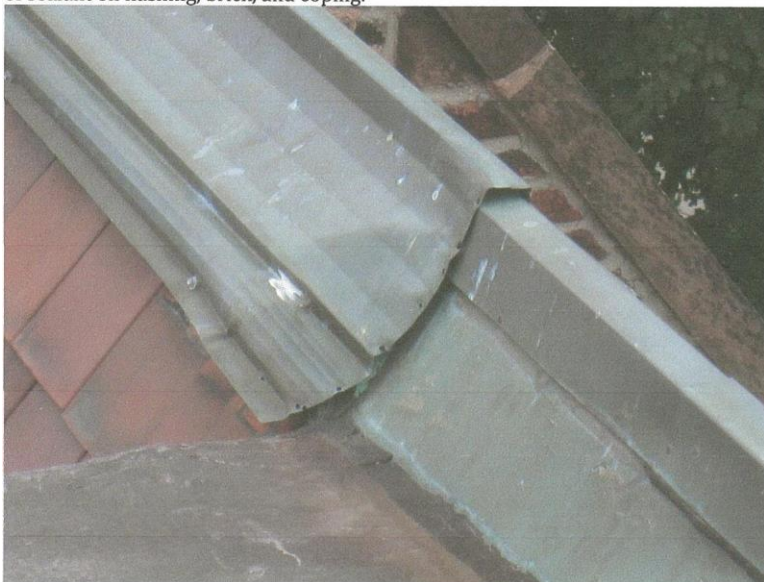
Loose Ridge Cap – NE Corner of Charles Allis House. A previous replacement, this cap was subsequently peeled open by wind or roof tile repair.
