# Certificate of Appropriateness

### **819 N. Cass St., Cass and Wells Historic District**

Masonry repairs and replacement of second-floor door and storm door. See scope of work for details.

## Date issued 11/7/2023

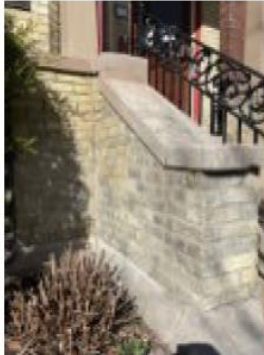
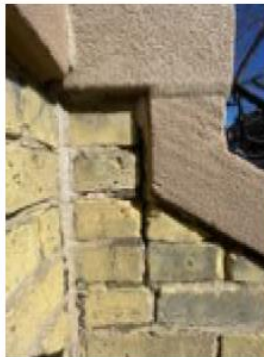
The front of the building facing East is in overall good condonation. The largest issue is the cheek walls along the stairs are falling apart and need to be rebuilt. We also find some of the joints within the face brick have deteriorated. Overall, 10% of the elevation would require spot pointing.

1. Take down coping stones on cheek walls and remove brick
  - a. Clean off mortar to reuse stone and brick
2. Address any foundation issues.
  - a. Review and repair foundation as needed.
  - b. Repairs to be charged as change order
3. Rebuild Cheek Walls
  - a. New mortar
  - b. Sealant at coping joints
4. Install sealant at vertical joints at water table stone.
5. Spot point 10% of mortar joints
6. Repair cracks in entry stone
7. Staging and site protection

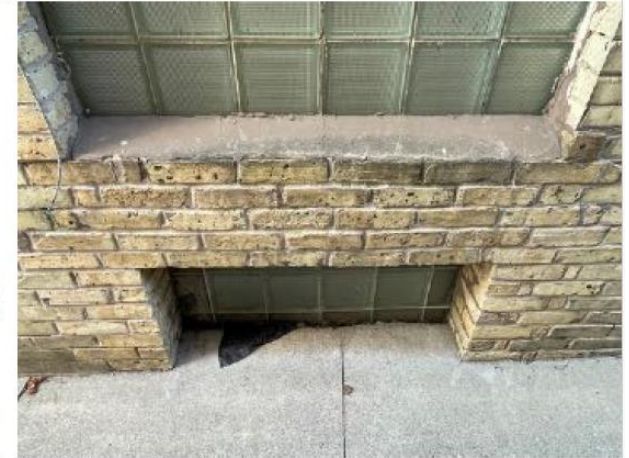
The north elevation appears to have the most amount of repairs needed. We find open joints in the masonry. Deteriorated masonry and joints around openings that were added at one point. Missing lintels above windows. An arch that needs rebuilding. Open joints in the water table stone. Open vent holes and growing vines on the masonry brick. We recommend addressing all these issues at once.

1. Install scaffolding/staging
2. Spot point 10% of masonry joints
3. Remove the growing vines on the elevation
4. Open brick headers above windows and install lintels
  - a. Install galvanized lintels
  - b. Rebuild original brick and joints
5. Open brick arch and rebuild plum and level
6. Install sealant joint at new/old brick expansion joint.
7. Install sealant around glaze block windows
8. Install a sill stone at the lower glaze block window
9. Install sealant at water table vertical joints
10. Recommending installing covers over vent openings in masonry

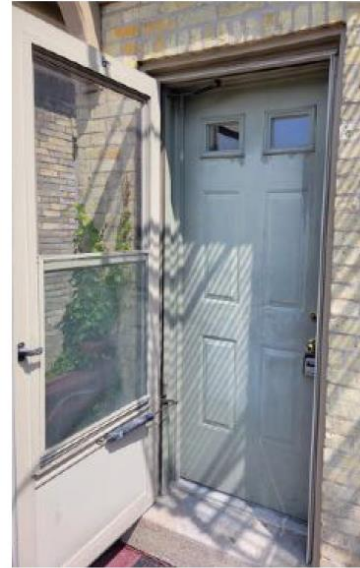
IMAGE 10: Current second floor west (rear) door.

- **Replace door scope**
- Replace the main door leaf with a 36" x 80" Simpson Door Company, 7118 Thermal Sash, Wood: Fir, clear upper light, three lower recessed panels. Finish: Painted.
- Note: If a storm door is permitted, the wood species and finish will be change to reflect a varnish to match the historic main east entry door.
- Replace the existing storm door with a powdered-coated aluminum Larson Premier Classic Elegance EasyVent® with Retractable Screen Away®, 2/3 glass doors with retractable Screen Away® design converts the storm door to a screen door with an unobstructed view

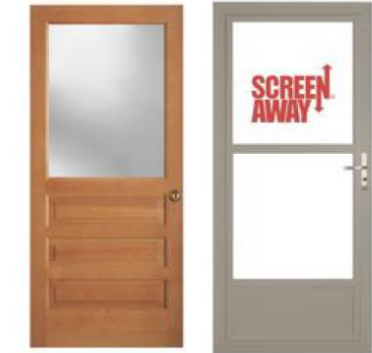
IMAGE 11: Proposed replacement door and storm door.
